INDOOR AIR QUALITY ASSESSMENT

**Winchendon District Court
80 Central Street
Winchendon, Massachusetts 01475**

Prepared by:
Massachusetts Department of Public Health
Bureau of Environmental Health
Indoor Air Quality Program
February 2009

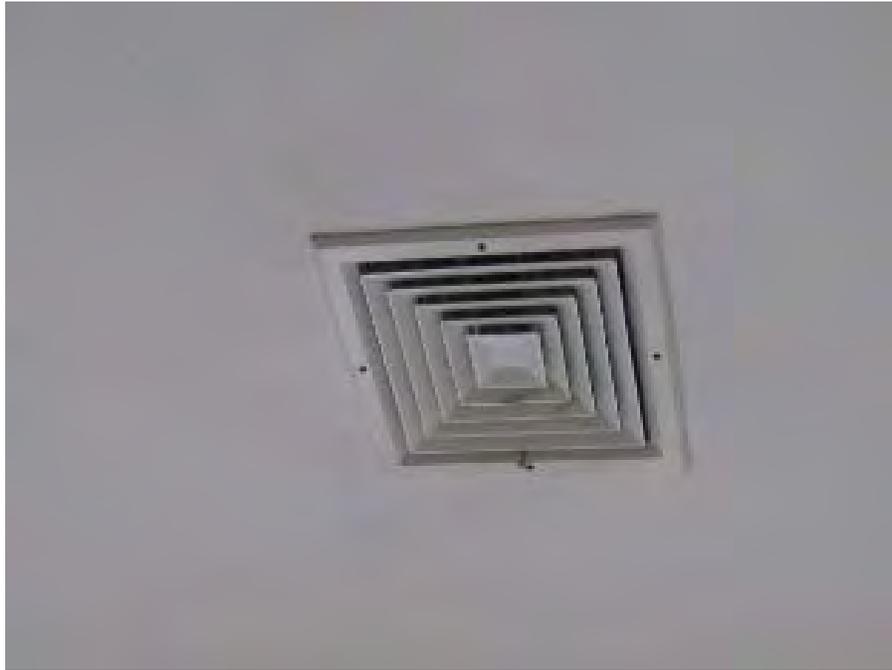
Picture 1

Ventilation is provided by a rooftop air handling unit (AHU). Fresh air is supplied to offices by ducted air diffusers, and stale air and contaminants are removed and returned to the AHU by ducted ceiling-mounted exhaust vents (Pictures 1 and 2).

Air Supply Diffuser

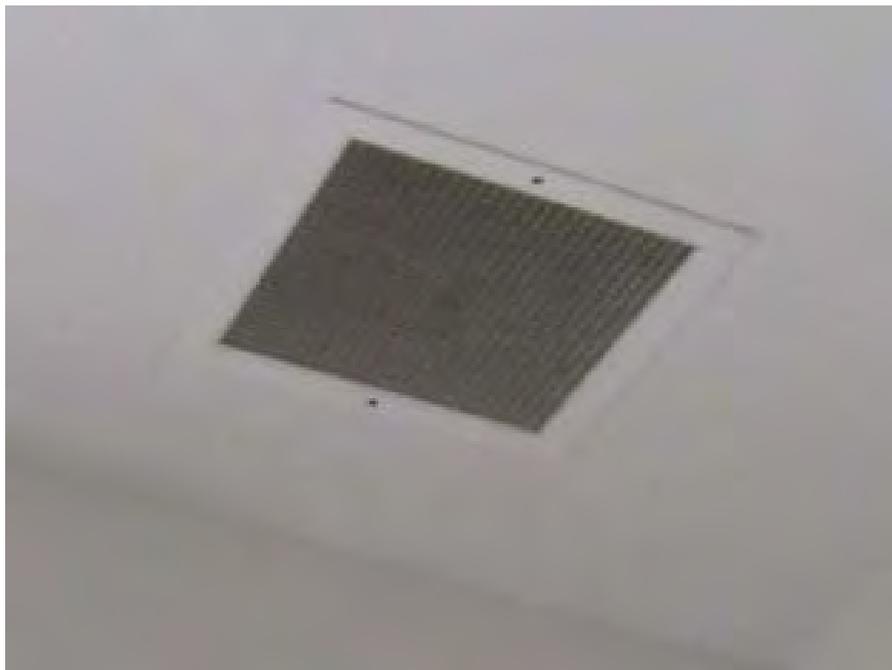
Picture 2

Exhaust Duct Grate

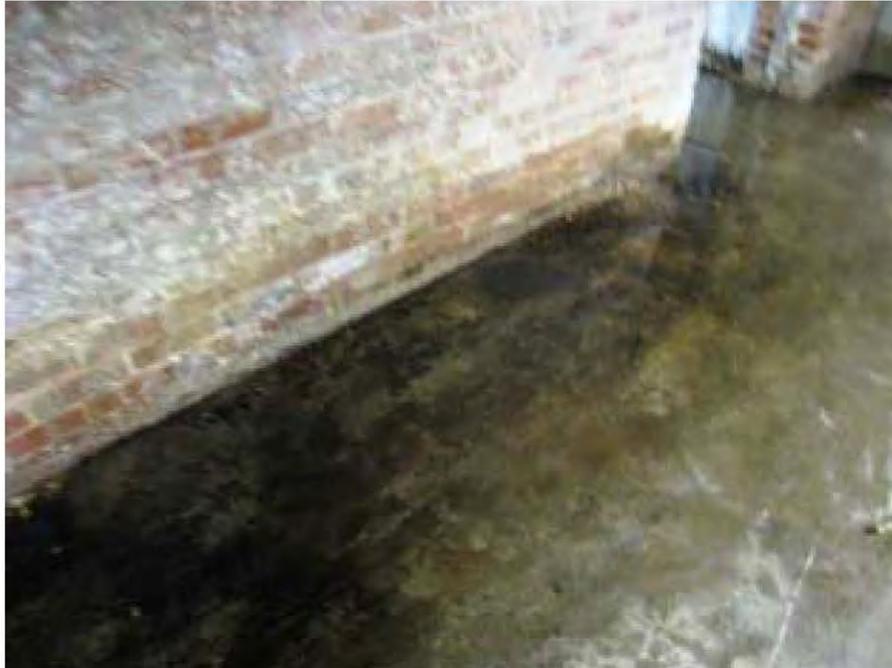
Picture 3

The initial request for assessment came as a result of a musty odor presumed to be originating from the basement and entering the first floor office space of the WDC. Several areas of the basement had standing water at the time of the assessment (Picture 3). A perimeter floor drain was originally designed to collect groundwater and to deposit it into a large brick distribution box located in the basement (Picture 4). From the distribution box, water was designed to be collected and distributed out of the building. At the time of the assessment, this drain was not functioning due to an obstruction of the inflow pipe. During the assessment, however, a contractor removed the obstruction and water could be seen flowing into the distribution box from the perimeter drain. Additionally, the perimeter drain appeared to contain

Standing Water on Basement Floor

1. Weather-strip the door from the basement to the first floor to prevent musty odors from entering office space.
2. Remove all porous materials (cardboard, paper storage) from the basement storage areas.
3. Eliminate standing water in the basement. Remove mulch from north side of building which will reduce the contact time of water against the WDC foundation. Have the storm

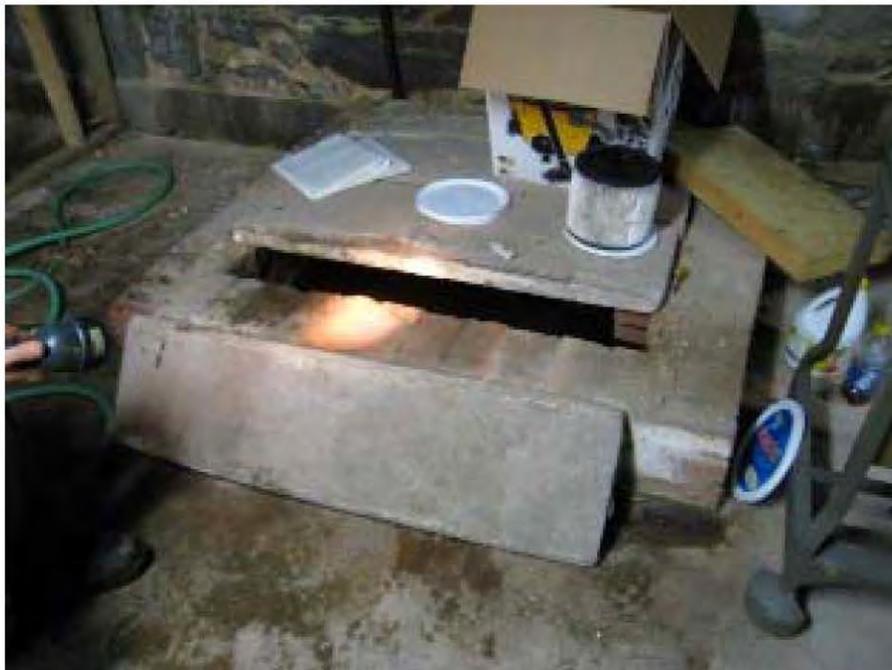
Picture 4

Distribution Box

6. Develop and maintain a schedule of inspecting and cleaning perimeter drains in the basement and ensure that lines to the distribution box are in good repair.

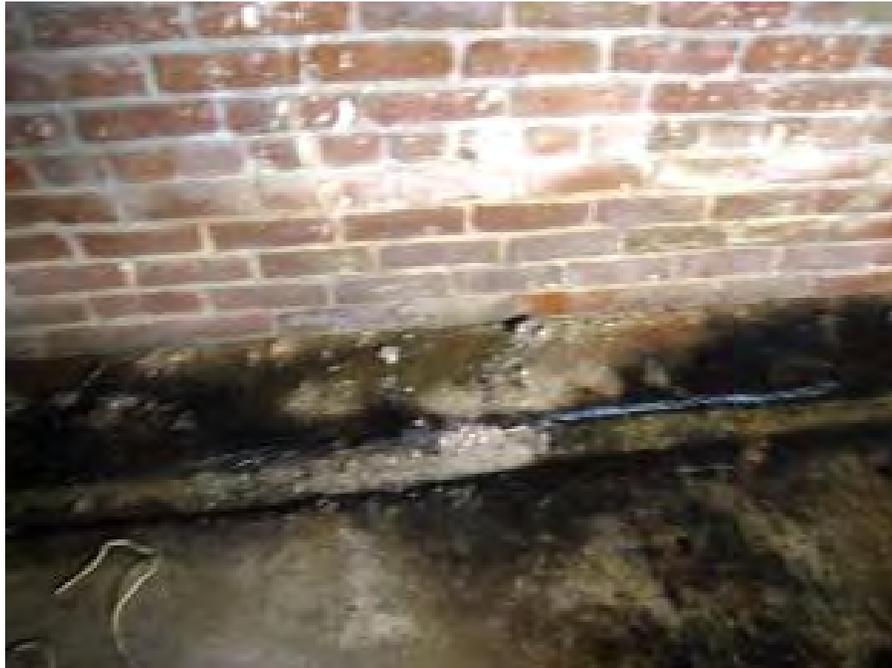
Picture 5

an accumulation of silt and debris which caused draining water to back up and escape the confines of the trough in the concrete floor (Picture 5). Old 2x4 pieces of wood adjacent to the drain were rotted due to moisture damage, as were portions of a wooden wall. Cardboard boxes, wood, paper and other porous debris are stored in the basement in the affected areas (Picture 6). Porous materials, when subjected to prolonged moisture, can promote mold colonization.

**Perimeter Drain in Basement Floor
Note Debris in Trough**

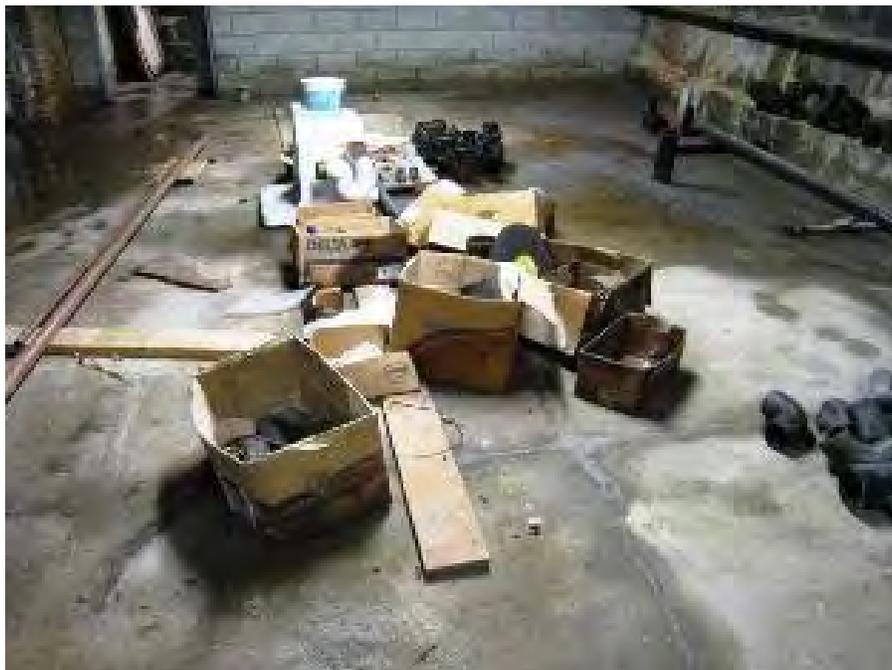
Picture 6

Wood, Cardboard and Debris Stored on Wet Floor

7. Remove all water damaged porous materials (including but not limited to cardboard, paper, rotted and water damaged wood) from the basement in accordance with EPA Guidelines for Mold Remediation of Schools and Commercial Buildings (US EPA, 2001).

8. Discontinue the practice of storing porous materials in the basement.
9. Repair windows to prevent unconditioned air, moisture and contaminants from entering the WDC.

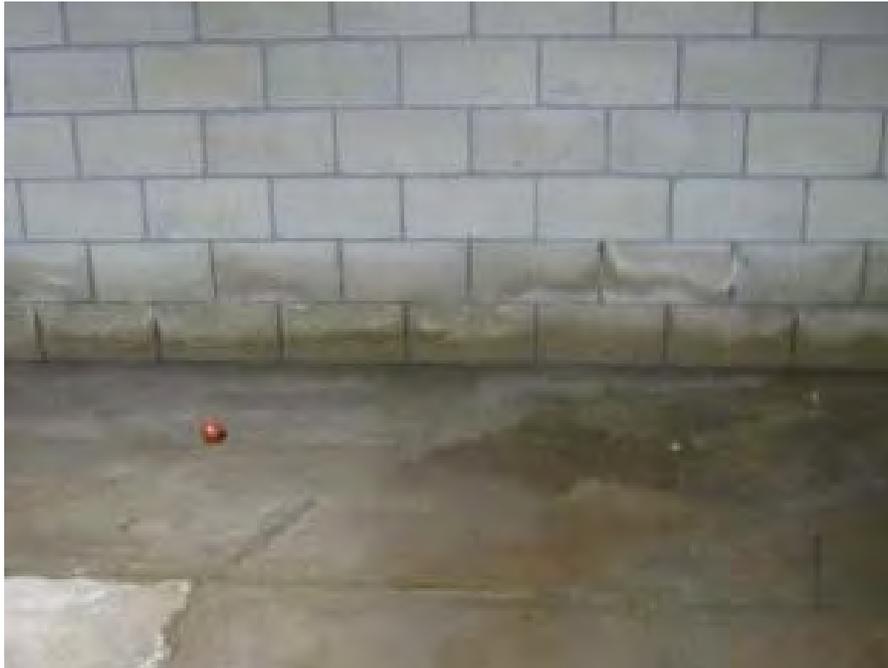
Picture 7

Walls in the basement, constructed of brick as well as newer block construction, exhibited water staining and efflorescence (Picture 7). Efflorescence is a characteristic sign of water damage, but it is not mold growth. As moisture penetrates and works its way through porous building materials (e.g., brick, plaster, cement), water-soluble compounds in the material dissolves, creating a solution. As this solution moves to the surface of the material, the water evaporates, leaving behind white, powdery mineral deposits. This condition indicates that moisture is penetrating through the building envelope in this area. This area should be cleaned, sealed, re-painted and monitored for further damage. If evidence of water penetration reoccurs, an evaluation of the building envelope/exterior in this area should be conducted for possible sources of water penetration.

Water stains and efflorescence on basement wall

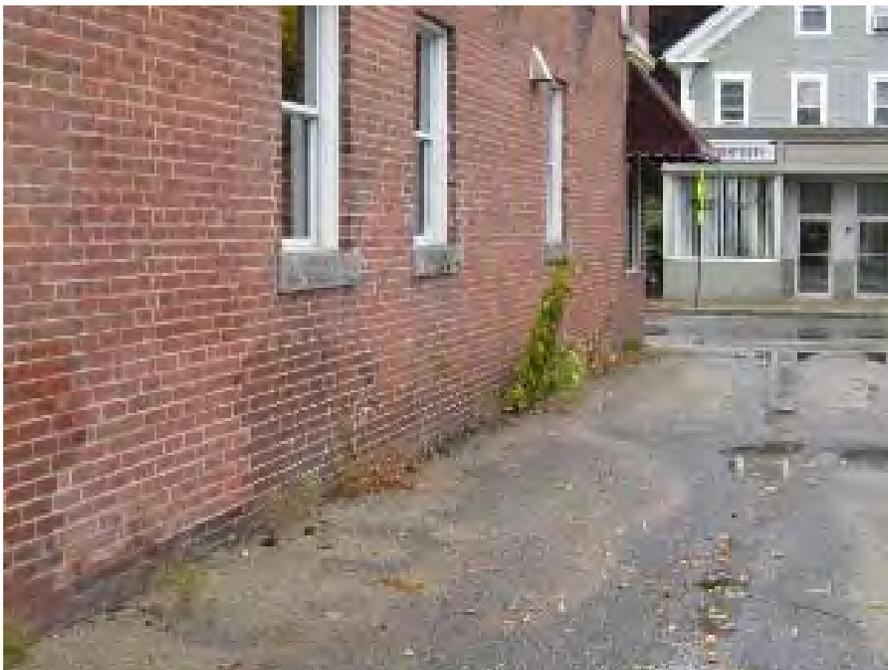
Picture 8

- The northeast side of the building had been landscaped utilizing mulch. The nature of mulch is that it holds water, which allows moisture to have prolonged contact with the exterior of the building. Prolonged exposure of masonry to water can result in water penetrating the building envelope. Plants were also observed growing in close proximity to the building (Picture 8). The growth of roots against exterior walls can bring moisture in contact with the foundation. Plant roots can eventually penetrate,

leading to cracks and/or fissures in the sublevel foundation. Over time, this process can undermine the integrity of the building envelope, providing a means of water entry into the building via capillary action through foundation concrete and masonry (Lstiburek & Brennan, 2001).

Plant Growth Against Base of Building

15. All plants in contact with the foundation or walls of the WDC should be removed.
16. Eliminate use of air deodorizers/reed diffusers in the building.

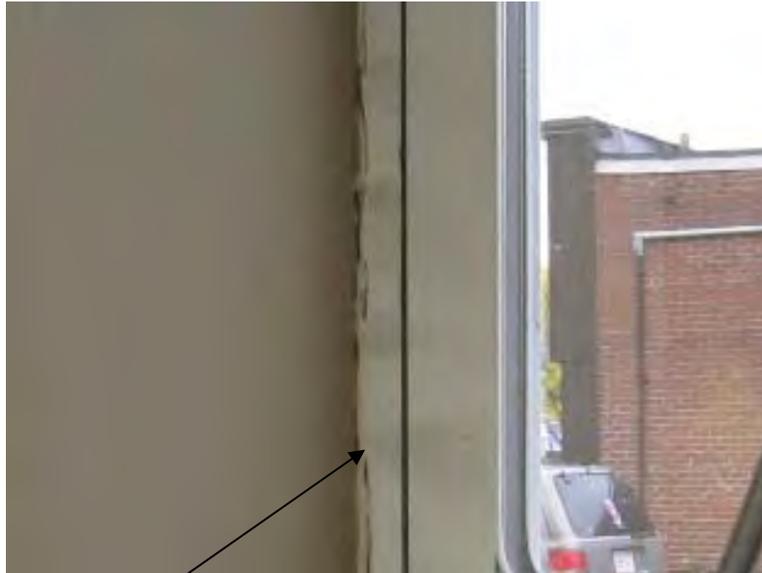
Picture 9

Numerous window frames exhibited discoloration indicating windows may not be properly sealed (Picture 9). This condition may allow odors, particulates and contaminants as well as unconditioned air to enter the indoor environment. During the heating season, this condition could allow condensation to occur adjacent to the window frames. This condition may

contribute to the mold colonization observed on the deteriorated caulking on several windows throughout the WDC. A large gap was observed on the bottom of the lockup door, which can allow moisture, pests, and unconditioned air to enter the lockup area. The door casing was exhibiting oxidation due to prolonged contact with moisture.

**Discoloration of window frame due to air infiltration
Note deteriorated caulking**

10. Install a gutter/downspout along the edge of the roof at the rear of the building to direct rainwater to the storm drain.
11. Clean mold from caulking adjacent to windows. Replace deteriorated caulking.

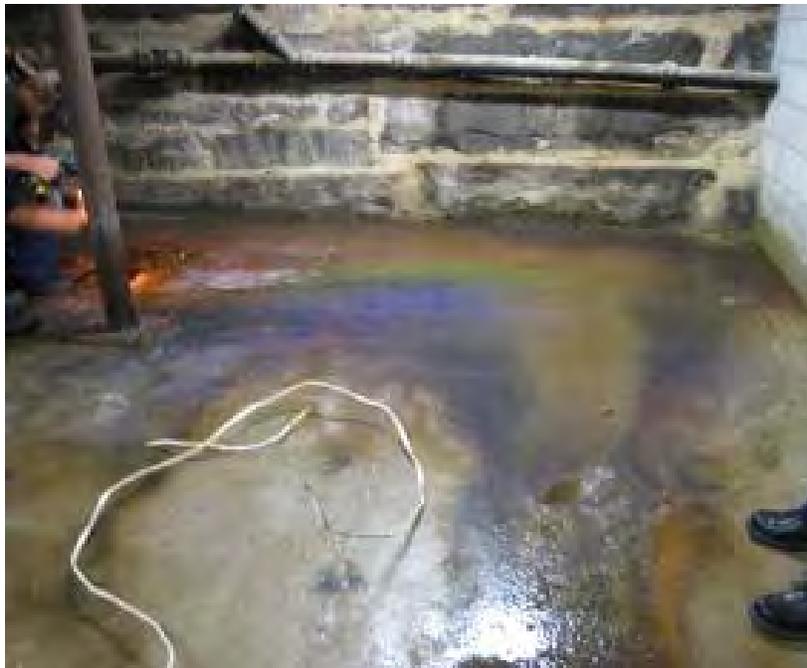
Picture 10

As previously mentioned, at the rear of the basement area was standing water that had a sheen, indicative of the presence of a petroleum product such as gasoline (Picture 10). Two potential sources of petroleum are: leakage of oil from abandoned heating system [e.g., furnace (Picture 11)] or infiltration of gasoline from the storm drain on the northwest corner of the building (Picture 12). Gas and oil can form vapors that will contain volatile organic compounds (VOCs) which can irritate the eyes, nose and throat. The source of the contaminant should be investigated and remedied.

**Standing Water Containing Sheen Indicative of
Petroleum Products**

4. Contact the appropriate agency to identify and remedy the contamination responsible for the sheen observed on the standing water in the basement.
5. Maintain integrity of pavement around perimeter of the building to eliminate surface water from entering crevices adjacent to the building.

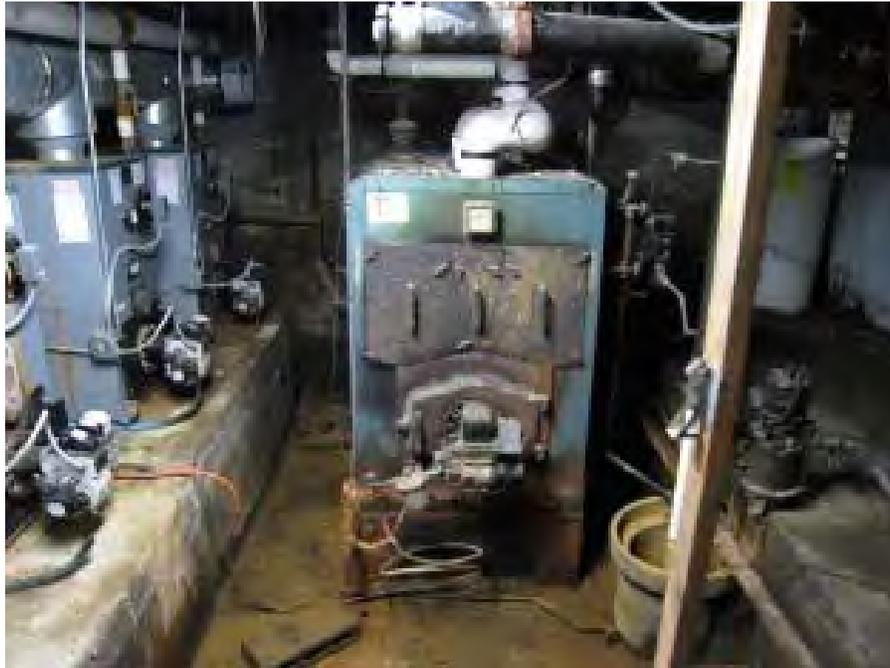
Picture 11

Abandoned Furnace in Basement

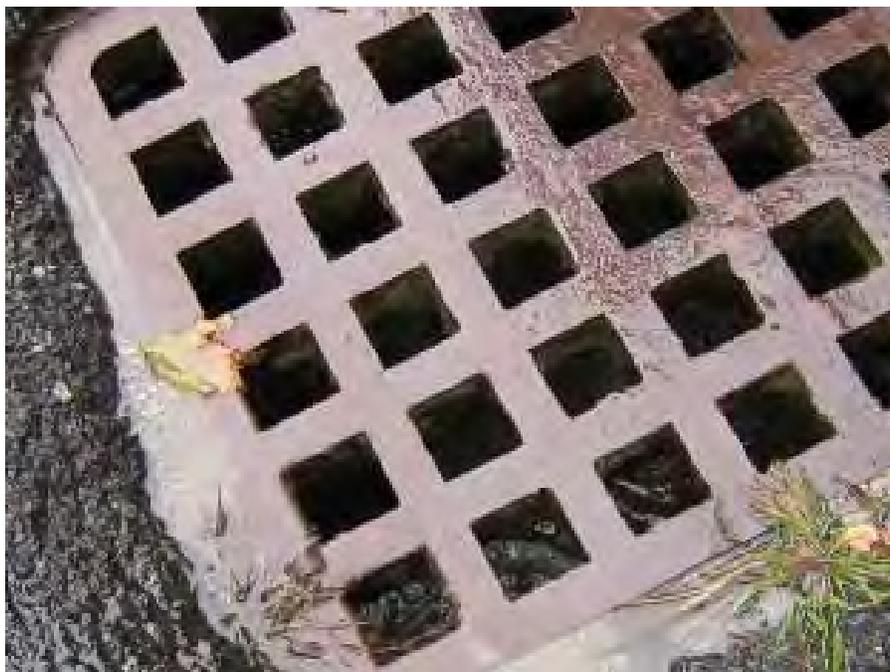
Picture 12

- A storm drain at the rear of the property was filled with debris. A storm drain filled with sediment can impede the drainage process, resulting in standing water at the base of the building. Additionally, the water level observed in the storm drain was higher than the floor of the basement, which may also result in water infiltration of the basement area.

Storm Drain Located at North End of Building

drain cleared to ensure appropriate drainage. Contact a firm to periodically clean and maintain the storm drain at the rear of the building. Avoid having snow plowed over the drain in the winter to prevent ice blockage.

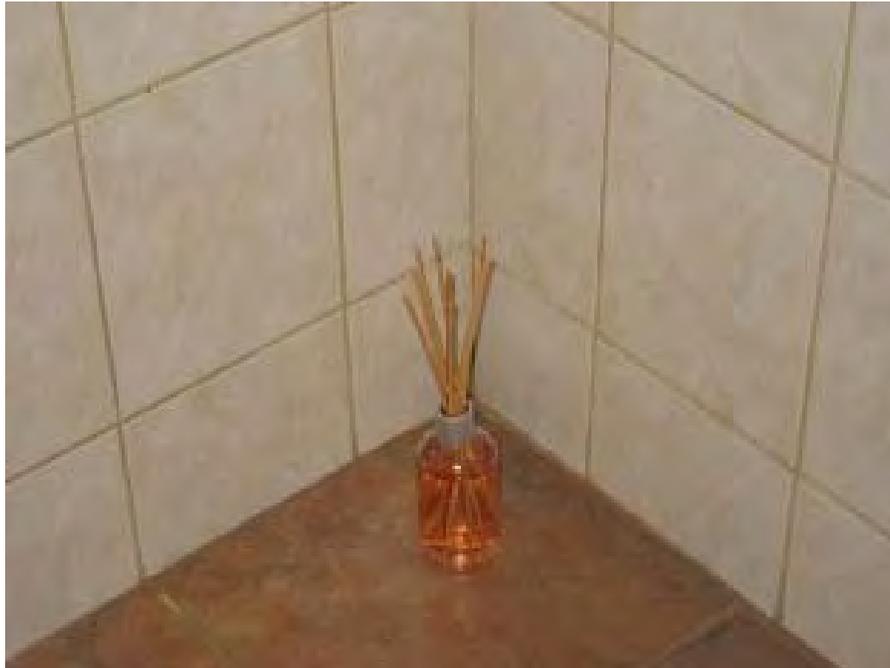
Picture 13

In an effort to identify materials that can potentially increase indoor VOC concentrations, BEH staff examined the CDC offices for products containing these respiratory irritants. Strong odors were noted in rooms which contained reed diffusers. A reed diffuser is generally composed of a small container holding scented oils, out of which protrude the reeds, in order to disperse the fragrance throughout the room (Picture 13). Air fresheners/deodorizers contain chemicals that can be irritating to the eyes, nose and throat of sensitive individuals. Many air fresheners contain 1,4-dichlorobenzene, a VOC which may cause reductions in lung function (NIH, 2006). Furthermore, deodorizing agents do not remove materials causing odors, but rather mask odors that may be present in the area.

Reed Diffuser Emitting Fragrance

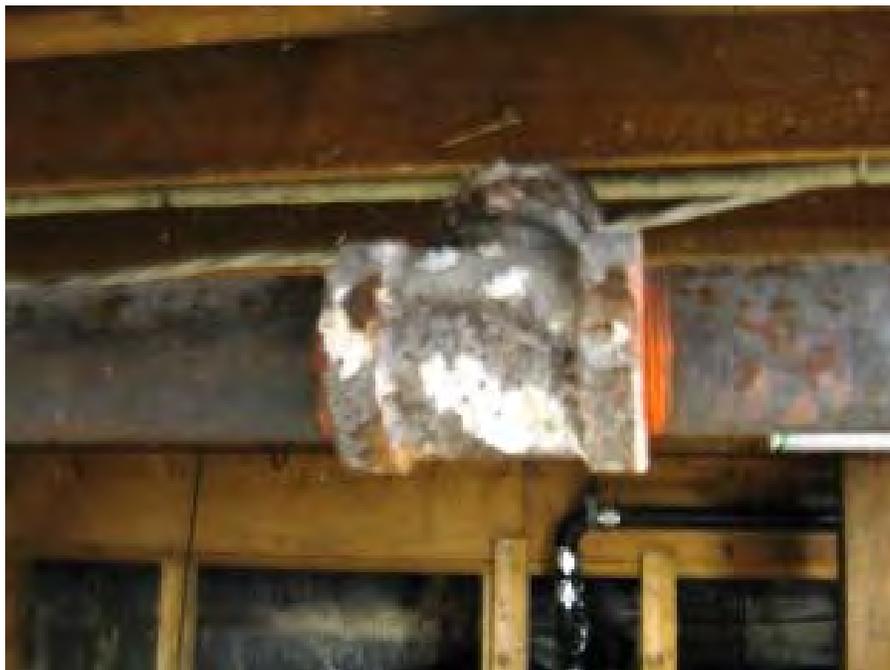
Picture 14

Numerous pipes were observed in the basement with what appeared to be traces of a white, powdered insulating material (Picture 14). If the material contains asbestos, then it should be remediated in conformance with all applicable Massachusetts asbestos abatement and hazardous materials disposal laws. Additionally, a sump pump in the basement appeared to be connected to the city sewer.

Remnants of Insulating Material on Pipe
