INDOOR AIR QUALITY ASSESSMENT

**Amesbury Public Library
139 Main Street
Amesbury, Massachusetts**

Prepared by:
Massachusetts Department of Public Health
Bureau of Environmental Health
Indoor Air Quality Program
March 2010

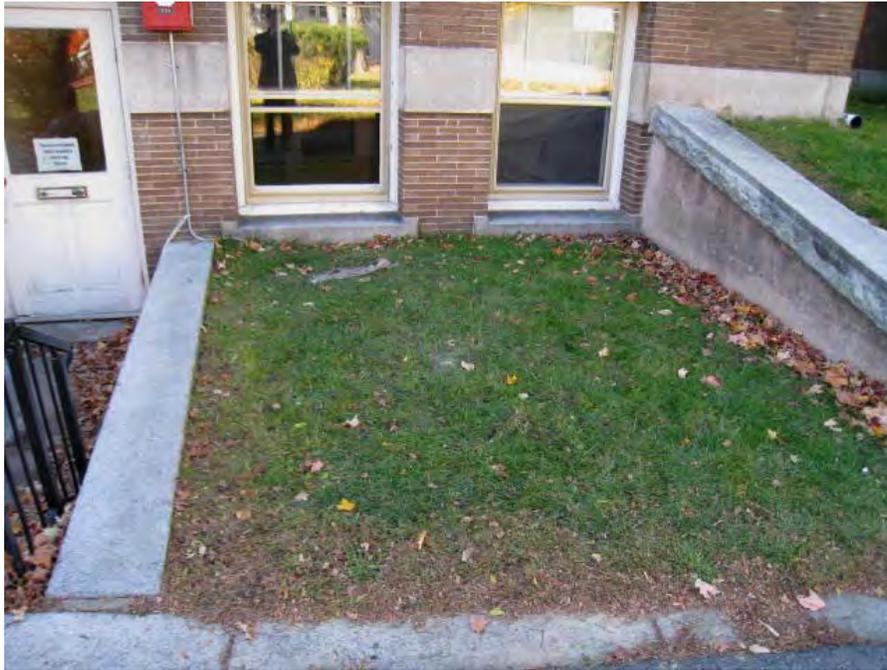
Picture 1

Exterior Wall of Flooded Area

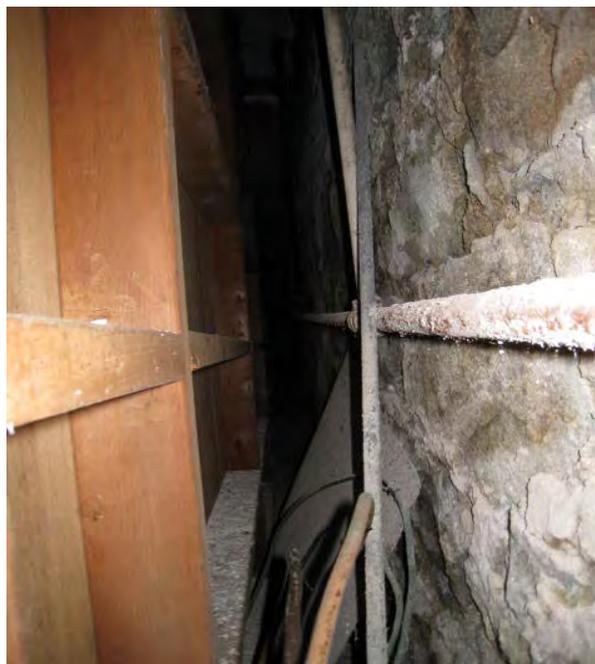
Picture 4

It appears that insulation on a pipe in the utility room of the lowest level stacks had been removed, leaving behind a friable material (Picture 4). The pipe should be examined to determine if this material contains asbestos. Where asbestos-containing materials are found damaged, these materials should be removed or remediated in a manner consistent with Massachusetts asbestos remediation laws (MDLI, 1993).

**Paneling Installed Over Foundation Walls in Lowest Level of the Stack Wing,
[Note White Powdery Material on Foundation (Efflorescence) and Condition of Pipe on Right-hand Side]**

1. Consider removing the wood paneling that exists in close proximity to the foundation walls.
2. Consider consulting with an architect, masonry firm or general contractor regarding the integrity of the building envelope, primarily concerning water penetration through the roof/exterior walls.
3. Consider replacing carpeting in lower level with a non-porous material (e.g., tile).
4. Replace or make repairs to the original slate roof.

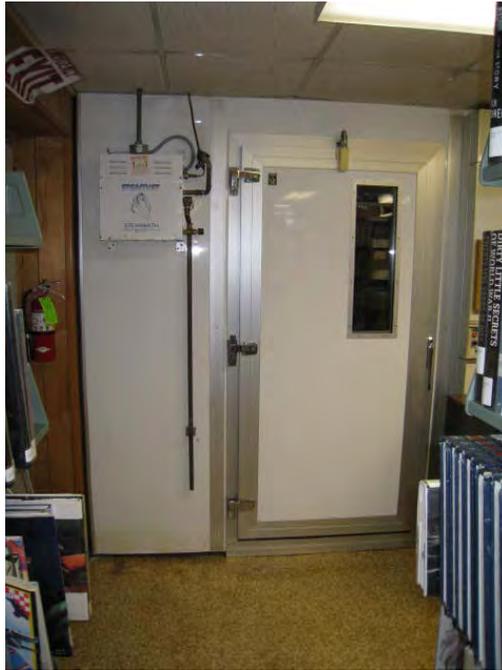
Picture 5

vault was not operating at the time of the assessment, and reportedly has not functioned for some time. Windows are openable throughout the building.

Environmentally Controlled Document Storage Vault

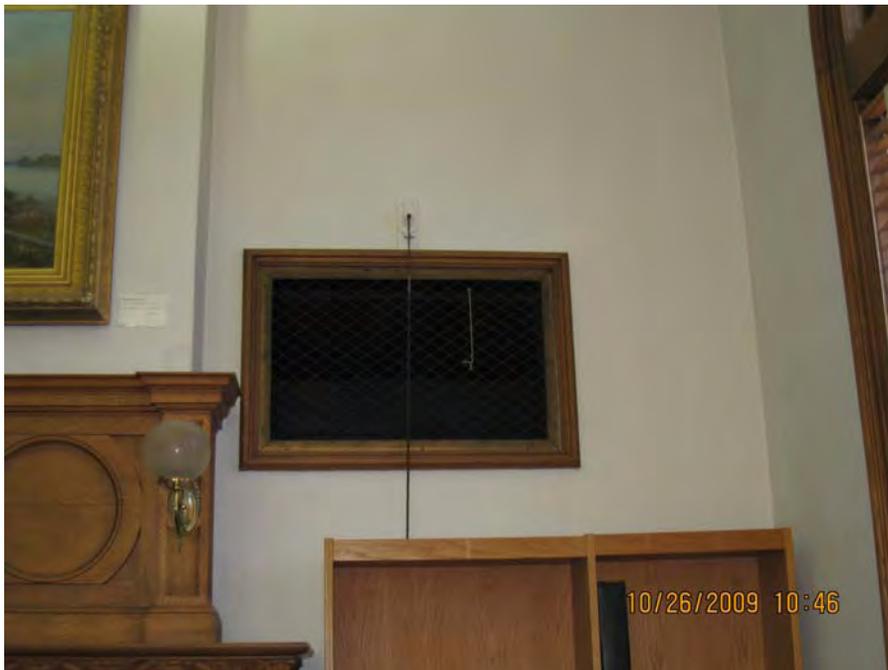
Picture 6

Ventilation in the original building was provided by grated, louvered wall vents (Picture 6). The vents are connected by a ventilation shaft to vault-like “air-mixing” rooms in the basement. The draw of air into these vents is controlled by a draw chain pulley system. The chains of the pulley system were designed to set the flue in the ventilation shaft at a desired angle to adjust fresh air intake.

As mentioned previously, the ventilation system has been abandoned, and the air-mixing rooms have been converted to office space. Without a functioning ventilation system, normally occurring environmental pollutants can build up. If this system remains abandoned, care should be taken to ensure ventilation shafts are rendered airtight in the library, in the basement air-mixing rooms and at the top of abandoned chimney/ventilation stacks to prevent the egress/movement of particulates, pests and drafts into occupied areas. Relative to the flooding incident, moisture and other odors could also migrate to occupied areas via this abandoned vent system.

Fresh Air Supply Vent of Original System

3. Seal the gravity duct vents in a manner to permanently render all openings air-tight.
4. Seal the breach in the roof to prevent bird entry.
5. Ensure that the second floor restroom vent is ducted to the outdoors.

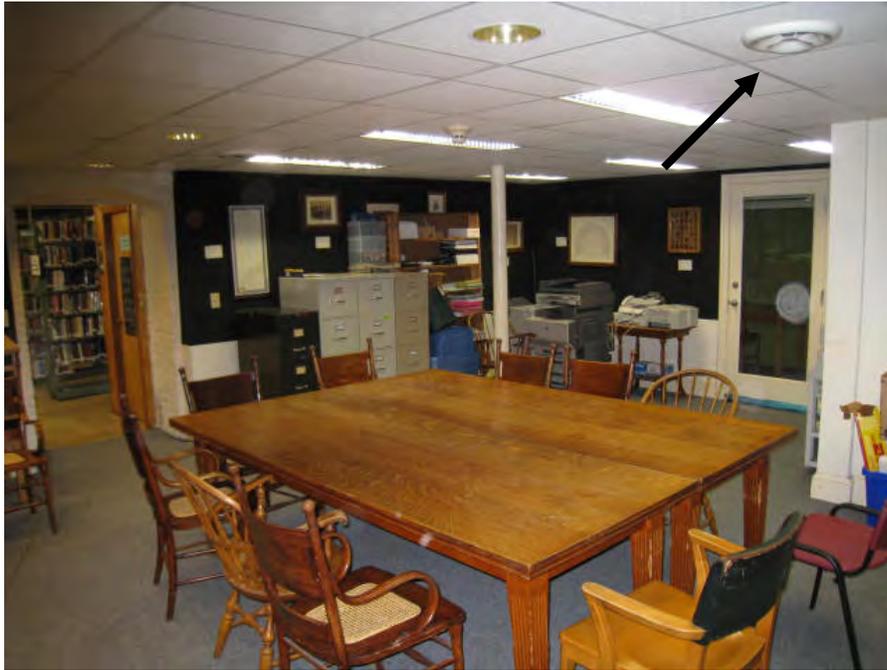
Picture 7

Of note was the presence of ceiling-mounted air diffusers in the suspended ceiling of the original building (Picture 7). This type of air diffuser is typically used to supply air from a mechanical ventilation system. BEH staff traced the flexible ductwork (Picture 8) back to vents opening in the boiler room (Picture 9). The flexible ducts are not connected to a mechanical system. It appears that this combination of flexible ductwork and diffusers may be a method to passively provide heated air to the basement area. However, this duct system appears to breach the fire integrity of the boiler room wall, providing a ready pathway for fire to spread into the ceiling plenum of the lowest level of the APL.

Fresh Air Diffuser on Lower Level Suspended Ceiling

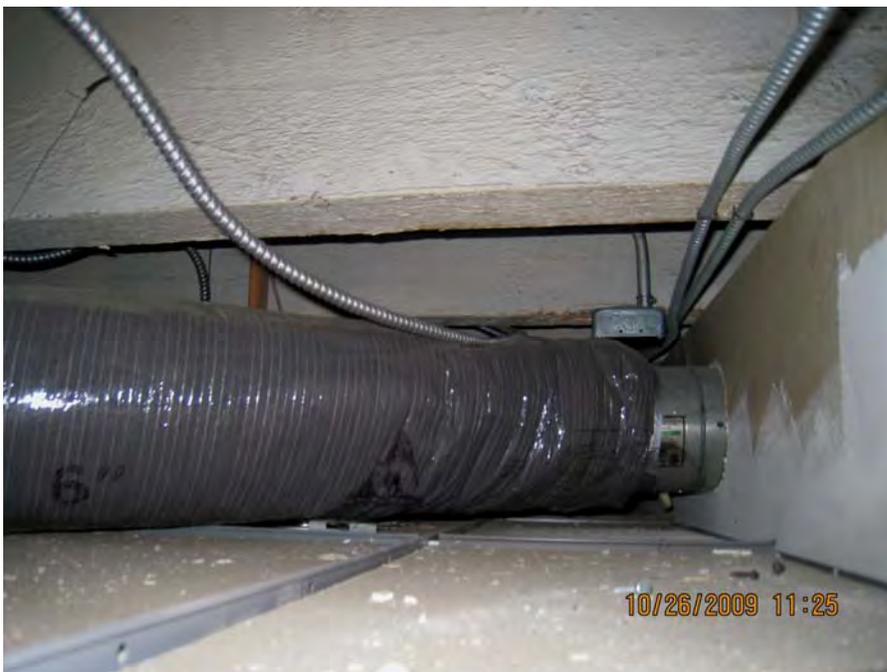
Picture 8

Flexible Duct in Ceiling

- d. Vacuum carpets (and other surfaces) with a high efficiency particulate arrestance (HEPA) filter equipped vacuum cleaner.
2. Disconnect the flexible ductwork from the boiler room and seal breaches in the boiler room wall with a fire-rated material.

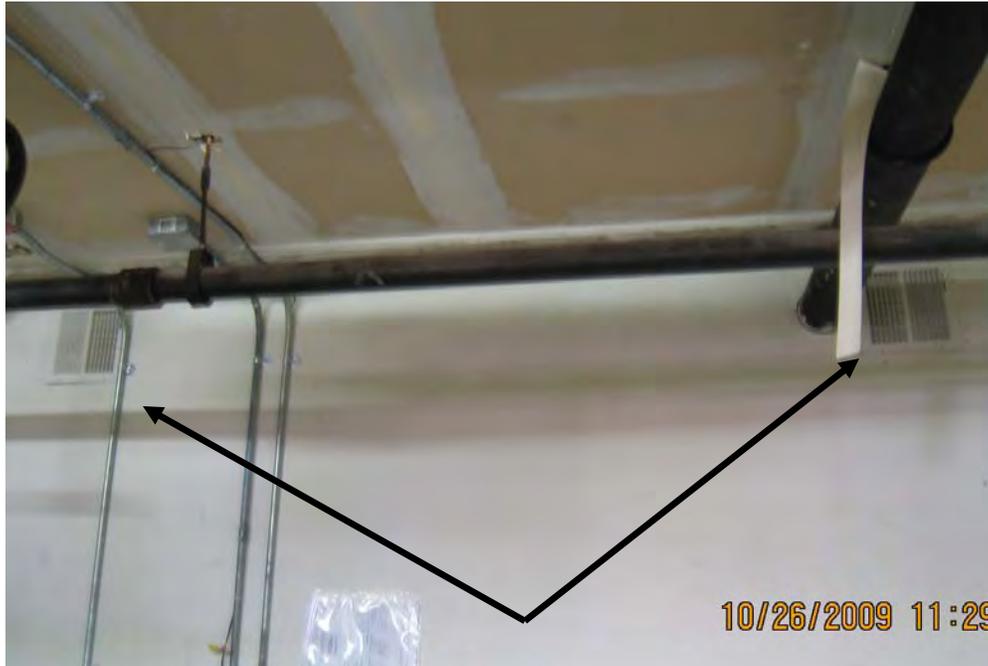
Picture 9

Vent in Furnace Room Connected To Ceiling Vent via the Flexible Ductwork in Picture 8

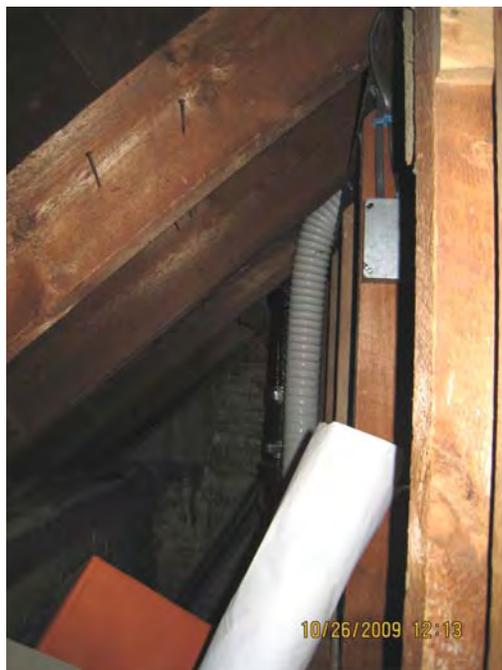
Picture 10

Restrooms in the lowest level appear to vent directly outdoors. The restroom in the uppermost floor of the original building, vents into the attic space (Picture 10). Exhaust ventilation is necessary in restrooms to remove excess moisture and prevent restroom odors from penetrating into adjacent areas. Bathroom exhausts should be vented to the outdoors.

Top Floor Restroom Vent Open to Attic Space

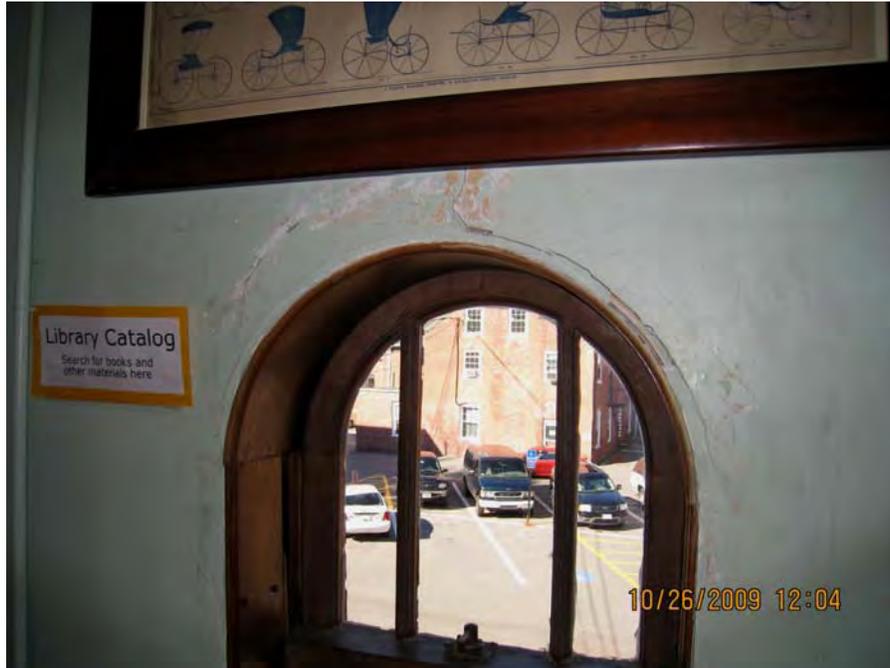
Picture 11

Water-damaged wall plaster, peeling paint and other moisture indicators were observed in a number of areas throughout the building. In the uppermost level, such damage to plaster is likely associated to roof leaks (Picture 11). While plaster is not likely to grow mold, repeated water damage can lead to its deterioration. Most notable was efflorescence observed on the foundation brick wall in the lower level (Pictures 12). Efflorescence is a characteristic sign of water damage to brick and mortar, but it is not mold growth. As moisture penetrates and works its way through mortar, brick or plaster, water-soluble compounds dissolve, creating a solution.

Water-Damaged Plaster

8. Consider having exterior brick foundation re-pointed and waterproofed to prevent further water intrusion. Repair/replace water-damaged interior plaster. Examine surrounding non-porous areas for mold growth and disinfect with an appropriate antimicrobial if necessary.

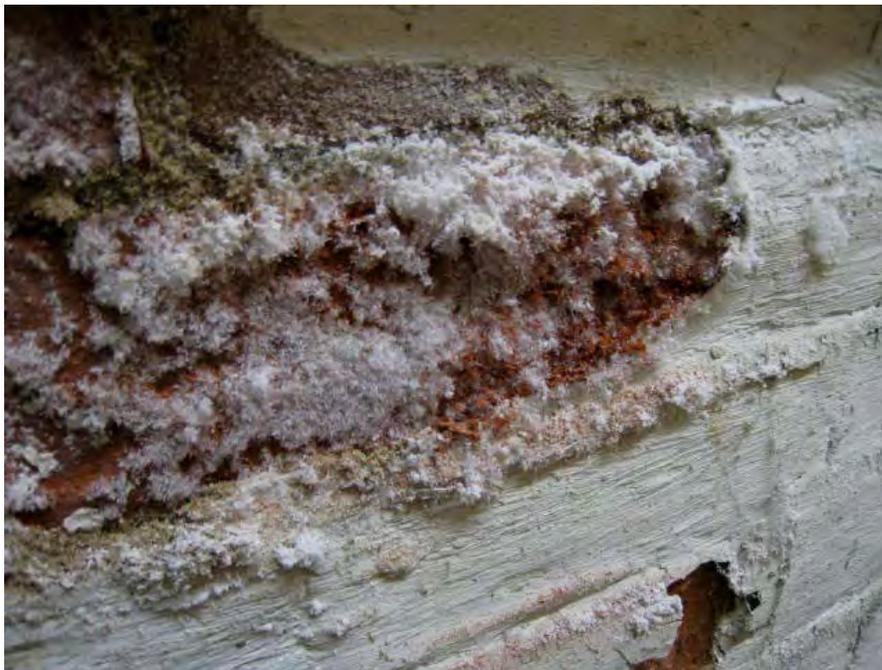
Picture 12

As the solution moves to the surface of the material, the water evaporates, leaving behind white, powdery mineral deposits. Water damage in this area is most likely the result of water penetration through the building envelope (foundation and exterior brick). The most obvious source of the moisture appears to be downspouts from the roof emptying at the base of the building.

Efflorescence on brick wall

9. Repair/replace missing/damaged sections of gutter/downspout system to direct water away from the foundation of the building.

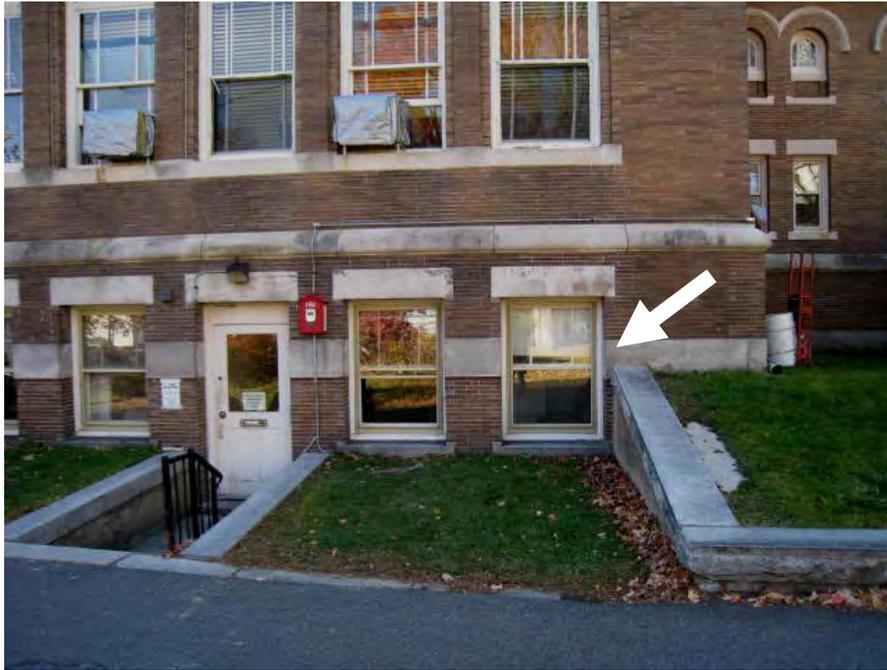
Picture 13

It appears that at one point a sloped cement apron lined the edge of the building to aid in the drainage of rainwater away from the foundation (Picture 13). Over the years, the surrounding lawn has grown over the building's cement apron (Picture 14). The grassy surface can both hold water against the foundation and form a natural trough for rain to puddle against the building. These conditions present potential moisture penetration sources. Over time, these conditions can undermine the integrity of the building envelope and provide a means of water entry into the building via capillary action through foundation concrete and masonry (Lstiburek & Brennan, 2001). The freezing and thawing of water during winter months can lead to further damage and subsequent water penetration into the interior of the building. In addition, these breaches may provide a means for pests/rodents into the building.

Cement Sloped Apron Overgrown With Grass

10. Remove grass and repair cement apron around the building to direct rainwater away from the foundation.
11. Clean/change filters for ACs as per the manufacturer's instructions or more frequently if needed.
12. Install weather-stripping underneath boiler room/hallway doors to prevent the migration of odors and particulates.
13. Contact a licensed asbestos inspector to examine the pipe in the in the utility room (Picture 4). If asbestos, take measures the remediate the condition of this pipe in a manner consistent with federal and Massachusetts laws and regulations.
14. Refer to resource manuals and other related indoor air quality documents for further building-wide evaluations and advice on maintaining public buildings. These materials are located on the MDPH's website: <http://mass.gov/dph/iaq>.

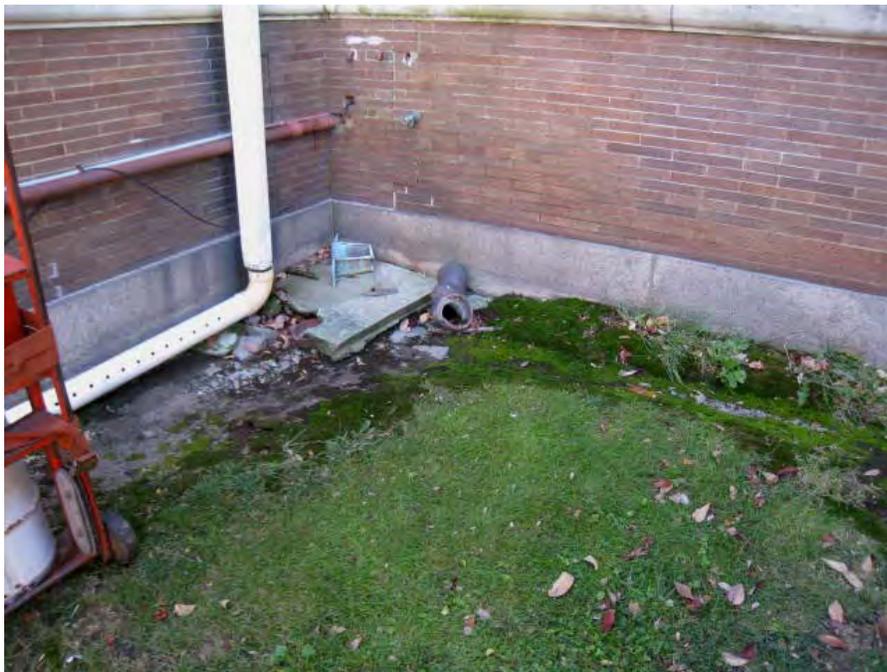
Picture 14

Corner of Building Overgrown With Moss

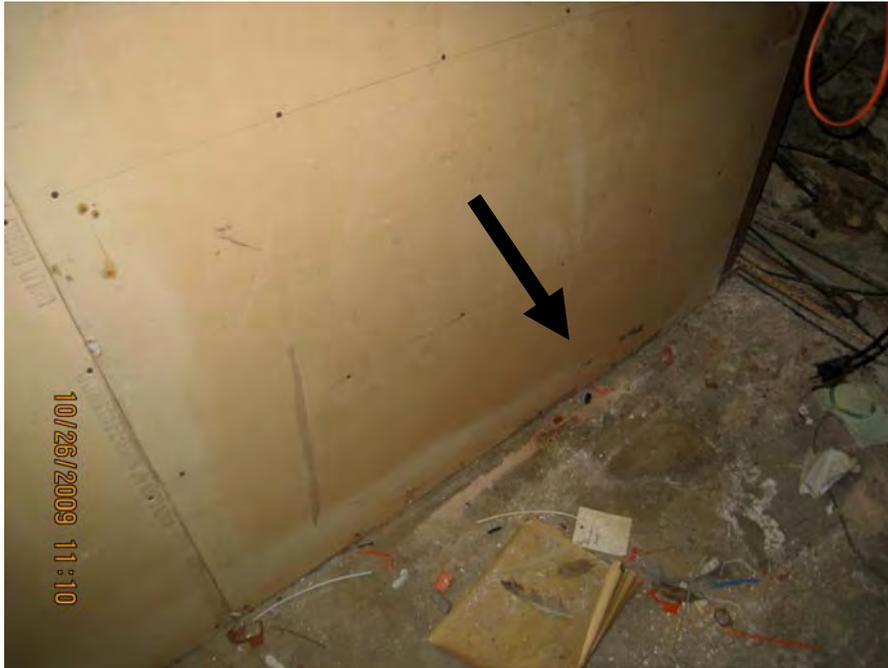
Picture 15

With water readily travelling through the foundation walls, it is also likely that moisture is affecting various building materials in the basement. Upon entering the lowest level of the stack wing, a distinct musty odor was noted. The source of the odor was tracked to a utility room, which is formed by a wall of wood paneling and the foundation of the original building. The interior wall space appears to be one that is chronically moistened (Picture 4), which can lead to mold growth in the wood paneling and gypsum wallboard (Picture 15). Since the utility room had such a distinct musty odor, it is likely that these materials have become mold colonized and should be removed.

Water Damage to Paneling Wall, Note Stains and Mold Colonies

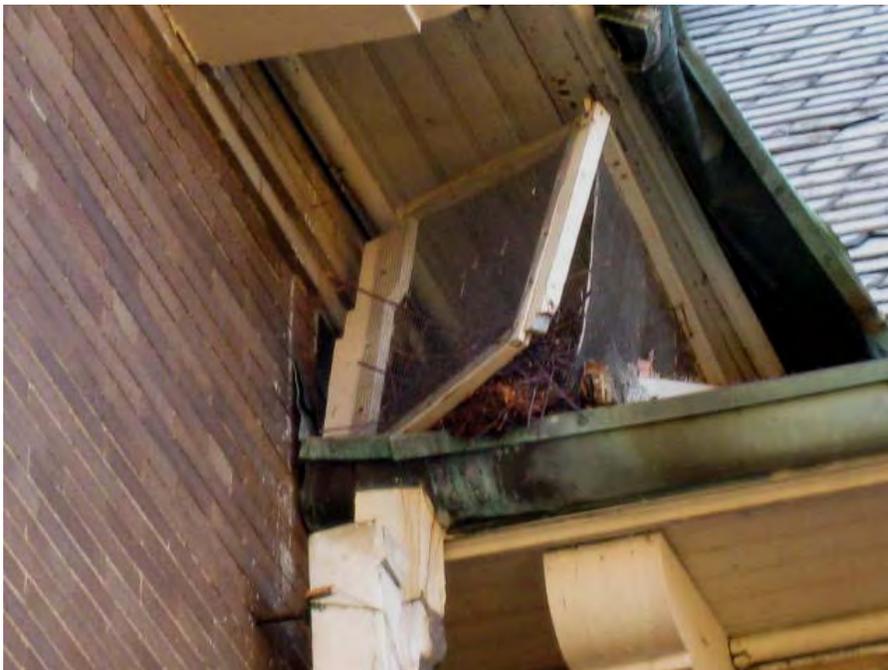
Picture 16

Building occupants reported problems with birds entering the attic crawlspace. During the evaluation, BEH staff observed a flying bird inside the attic a window while facing the rear of the building outdoors. BEH staff observed light penetrating into the closet when inspecting the attic, indicating a breach in the roof, which is the likely route for birds to access the interior of the building (Picture 16). Birds can be a source of disease, and bird wastes and feathers can contain mold and mildew, which can be irritating to the respiratory system. No obvious signs of

Likely Route for Birds to Access the Interior of the Building
