INDOOR AIR QUALITY ASSESSMENT

**Brackett Elementary School
66 Eastern Avenue
Arlington, Massachusetts**

Prepared by:
Massachusetts Department of Public Health
Bureau of Environmental Health
Indoor Air Quality Program
December 2010

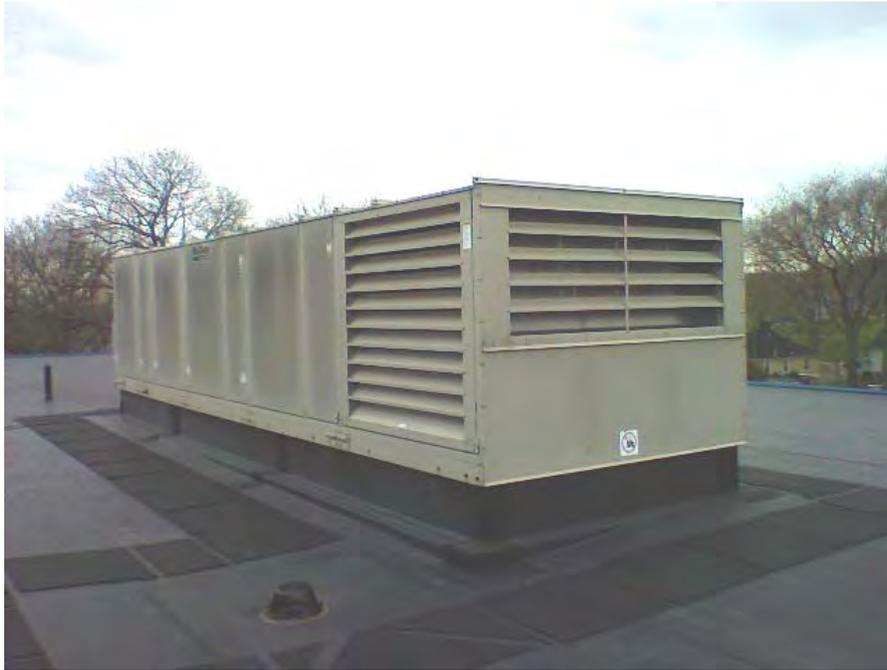
Picture 1

Mechanical ventilation throughout the building is provided by rooftop air-handling units (AHUs; Picture 1). In classrooms and offices, fresh air is distributed via ceiling-mounted air diffusers (Picture 2) and ducted back to AHUs via ceiling mounted return vents (Picture 3). Please note, the type of vent used for some classroom return vents is identical to those used for the supply vents. Supply ductwork at the BES is fitted with multi-directional diffusers. The blades for multi-directional supply diffusers are horizontal, allowing air forced out from the

Rooftop air-handling unit

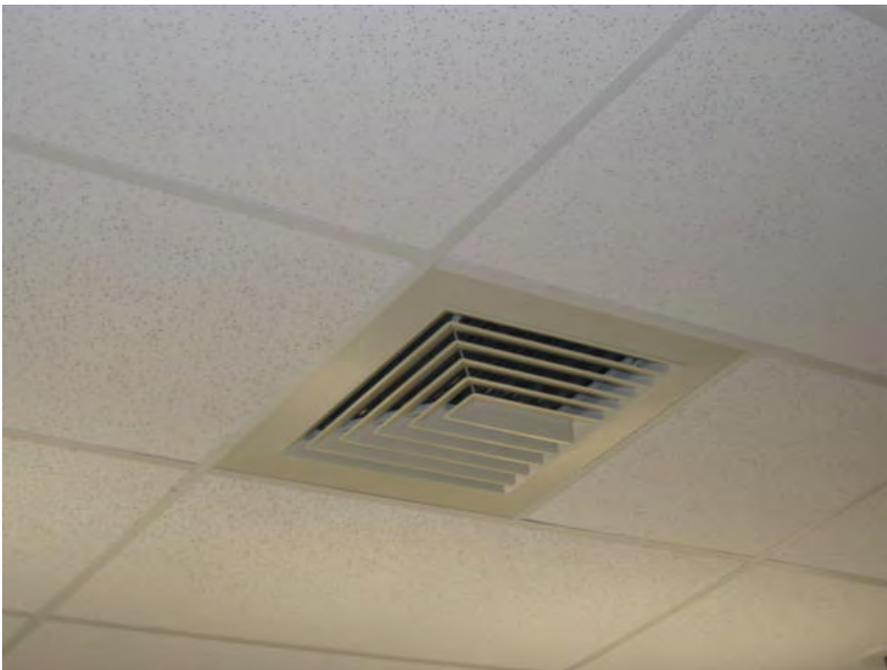
Picture 2

Supply diffuser

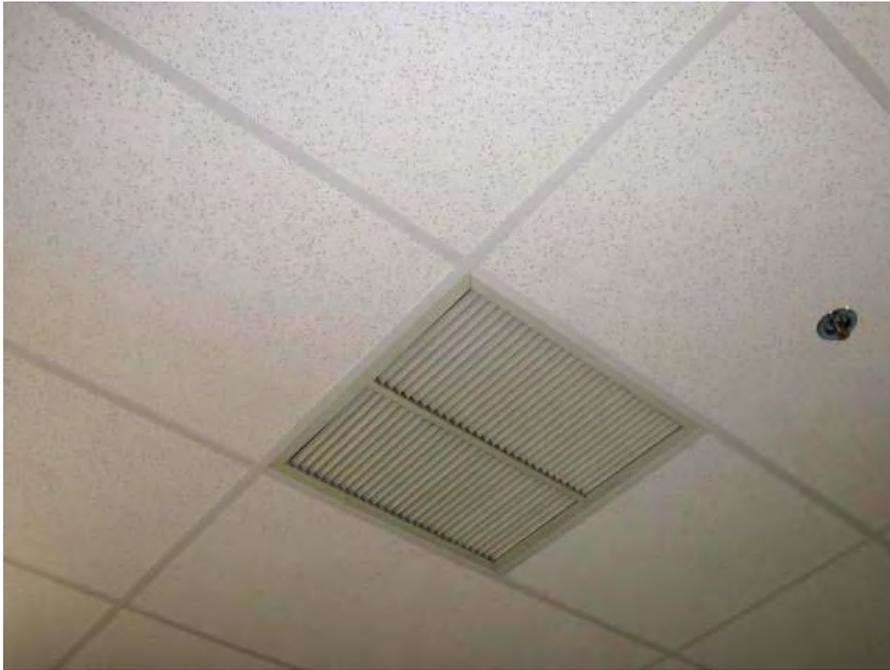
Picture 3

ductwork to be directed in various directions so as to distribute conditioned air to an area/space. The orientation and design of the blades would result in increased resistance when air is drawn *into* and returned to the AHU via these diffusers. It is likely that the use of such supply diffusers as return vents is reducing exhaust efficiency and effectiveness in removing common environmental pollutants from classrooms. Without adequate exhaust ventilation, excess heat and environmental pollutants can build up and lead to indoor air/comfort complaints. Consideration should be given to replacing current diffusers with more common exhaust coverings.

Typical return vent

11. Consider replacing exhaust vents with appropriate grilled vents to aid in the removal of air from classrooms.

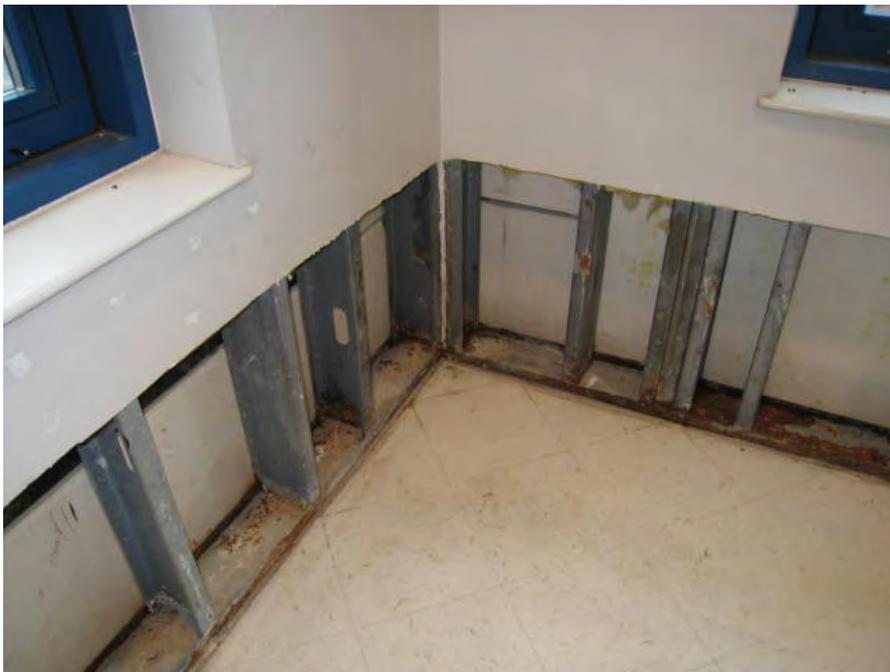
Picture 4

As discussed previously, the primary purpose of the assessment was to evaluate damage sustained in a classroom following heavy rain that occurred in March, 2010. Rain water reportedly penetrated classroom 205 through the exterior wall, causing water damage to gypsum wallboard (GW). At the time of assessment, approximately three-feet of water-damaged GW and insulation had been removed from the classroom (Pictures 4 and 5) and the remaining fixtures had reportedly been cleaned and disinfected. Waterproofing had also reportedly been applied to a portion of the exterior wall had also been reportedly waterproofed.

Open wall cavity, GW and insulation removed from classroom 205

1. Contact a building envelope/roof professional to examine the flashing and rubber membrane installation to the roof adjacent to classroom 205.
2. Continue with repairs/replacement of insulation and GW in classroom 205.

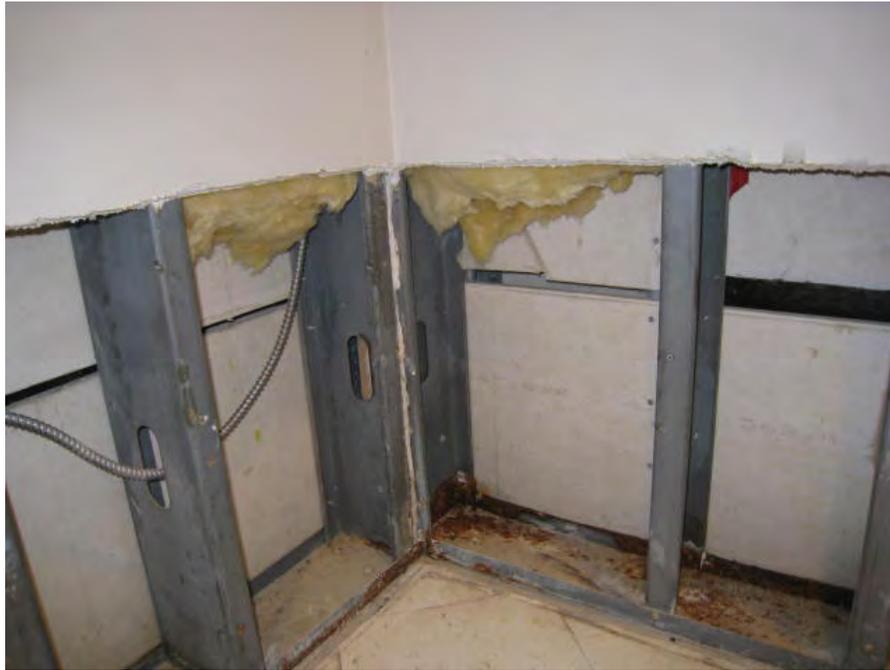
Picture 5

Open wall cavity, GW and insulation removed from classroom 205

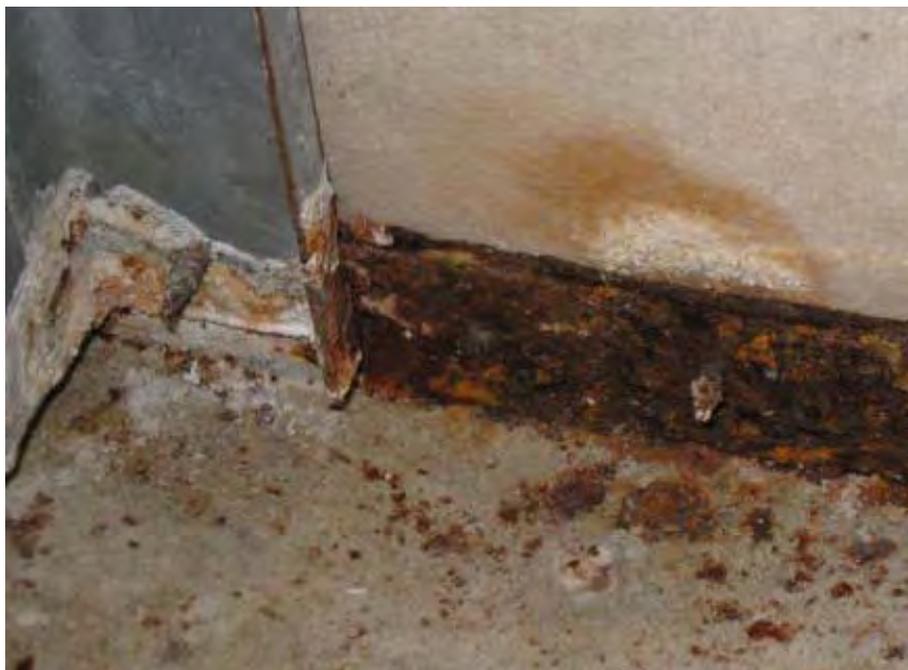
Picture 6

BEH staff examined conditions in classroom 205 and observed efflorescence in the wall cavity (Picture 6). Efflorescence is a characteristic sign of water damage to brick and mortar, but it is not mold growth. As moisture penetrates and works its way through mortar and brick, water-soluble compounds in mortar and brick dissolve, creating a solution. As the solution moves to the surface of the mortar or brick, the water evaporates, leaving behind white, powdery mineral deposits. Efflorescence observed is likely from salts that leached from the exterior brickwork.

Water staining and efflorescence in the wall cavity

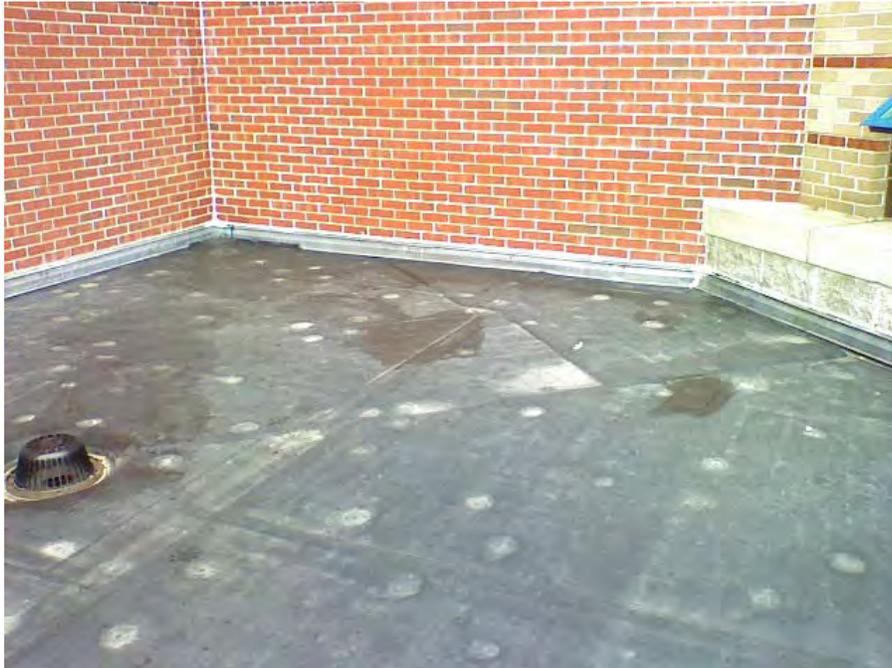
Picture 7

While examining the lower roof area outside of classroom 205, BEH staff observed that the rubber membrane of the roof was *not* installed through the metal flashing to create a continuous surface for water to shed away from the building (Pictures 7 to 9). As a result, rain water hitting against the brick wall is likely penetrating behind the metal flashing and down the interior-facing side of the rubber membrane. Since water trapped behind the rubber membrane cannot escape, it penetrates through brickwork and causes water pooling.

Rubber membrane roof adjacent to classroom 205

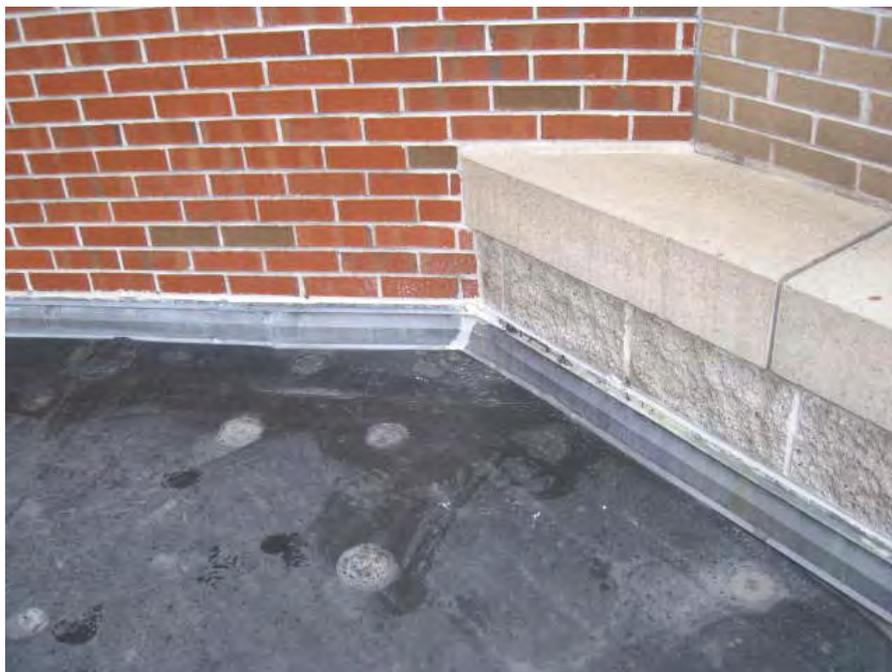
Picture 8

Rubber membrane roof adjacent to classroom 205, note rubber membrane not installed through metal flashing

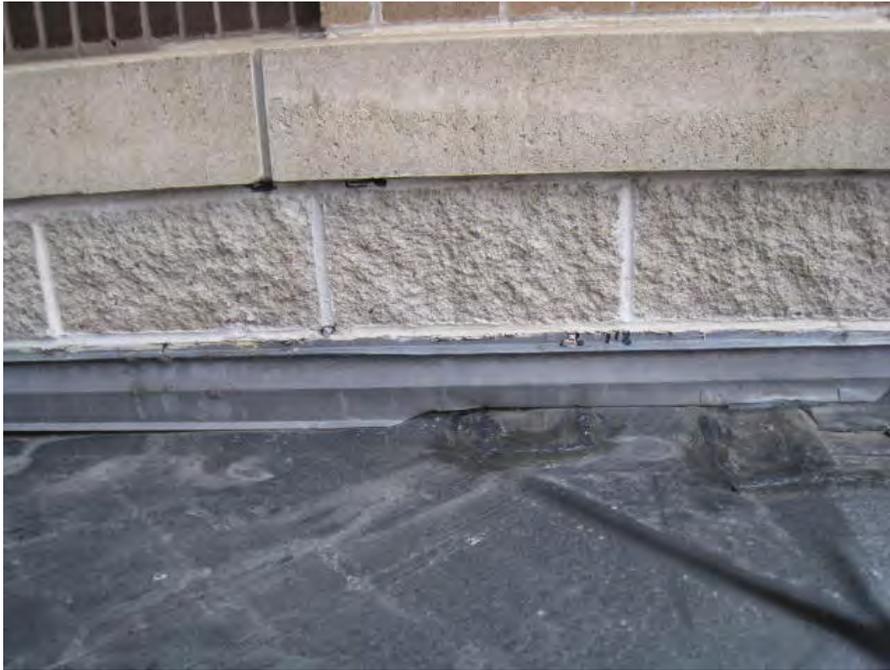
Picture 9

Rubber membrane roof adjacent to classroom 205, note rubber membrane not installed through metal flashing

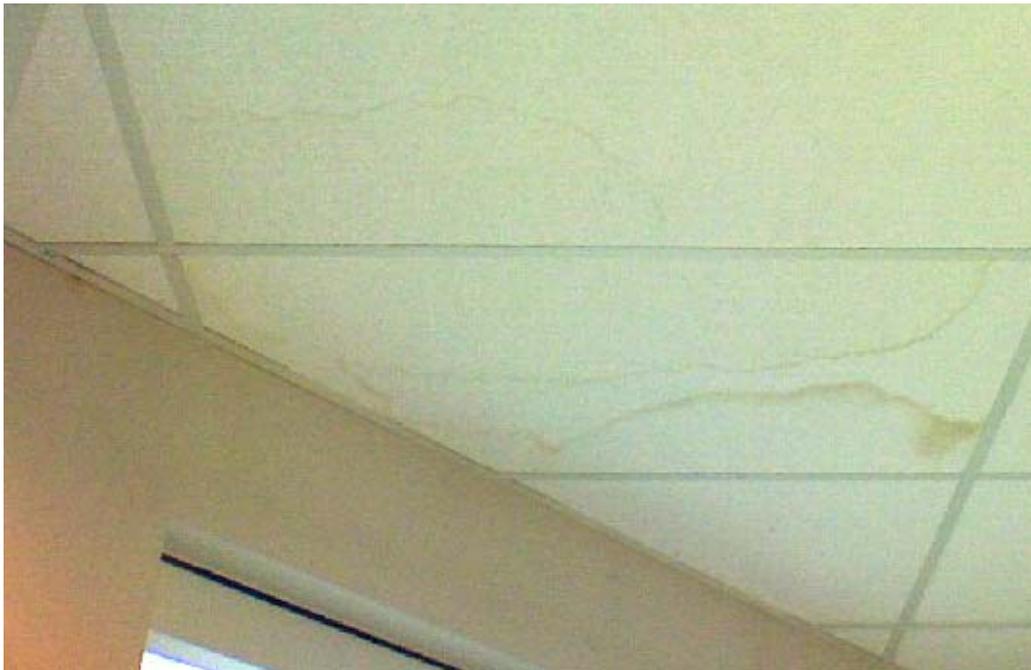
Picture 10

While assessing the main office, BEH staff observed water-stained ceiling tiles (Picture 10) and bubbling paint near/along the wall directly below the damaged wall in classroom 205 (Picture 11). Using a Delmhorst Moisture Meter, BEH staff determined that some GW on the exterior wall was still moist. The presence of moist GW was reported to BES staff at the time of the assessment. Subsequently, it was reported to BEH staff that moistened/damaged GW was removed and replaced the weekend following the assessment.

Water-damaged ceiling tiles in main office

3. Monitor repairs to both classroom 205 and the main office to ensure further water penetration/damage is not sustained.
4. Once repairs are made, remove damaged paint and refinish walls.

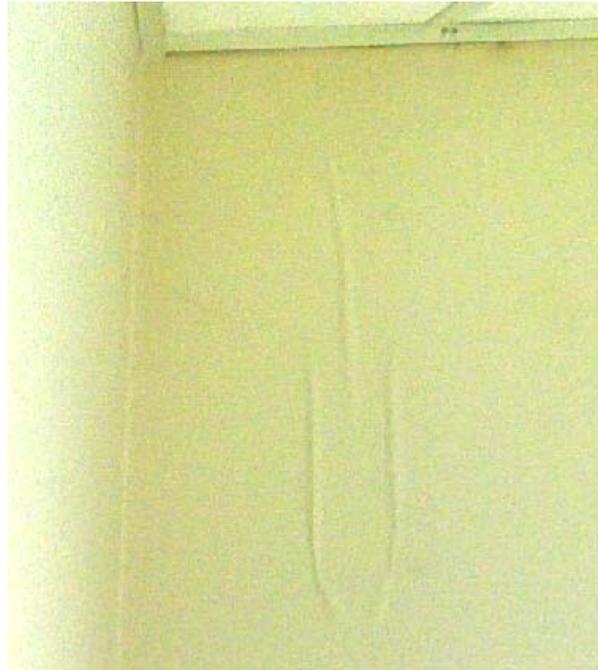
Picture 11

Bubbling paint on wall in main office

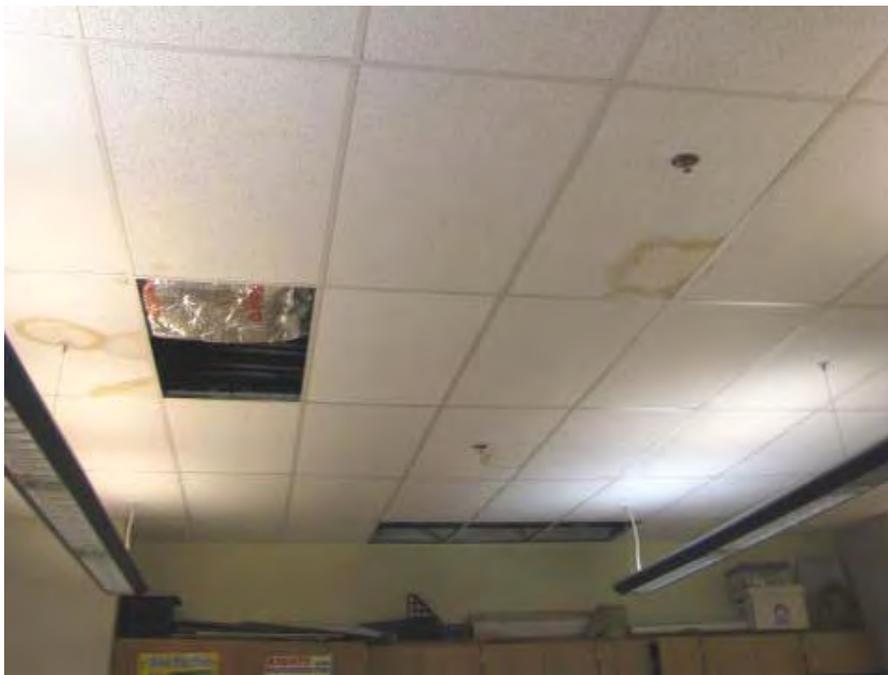
Picture 12

Water-damaged ceiling tiles were observed in a number of areas in the building (Picture 12), which can indicate sources of water penetration from either the building envelope or the plumbing system. Water-damaged ceiling tiles can provide a source of mold and should be replaced after a water leak is discovered and repaired. An active leak was observed in the hallway of the BES, where a pail was being used to collect dripping water (Picture 13). At the time of assessment, BEH staff observed water stains on the metal roofing, indicating water the leak is most likely associated with a roof leak (Picture 14).

Water-damaged and missing ceiling tiles

5. Ensure active roof leaks are repaired (Pictures 12 and 13) and replace water damaged/missing ceiling tiles. Examine the area above and around these areas for mold growth. Disinfect areas of water leaks with an appropriate antimicrobial.

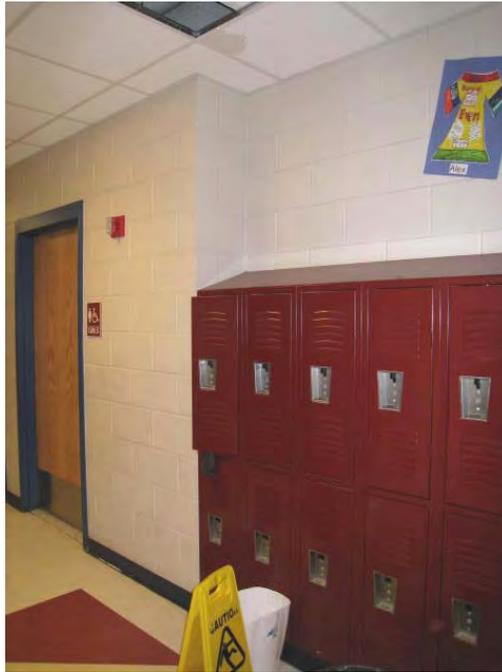
Picture 13

Active leak in hallway

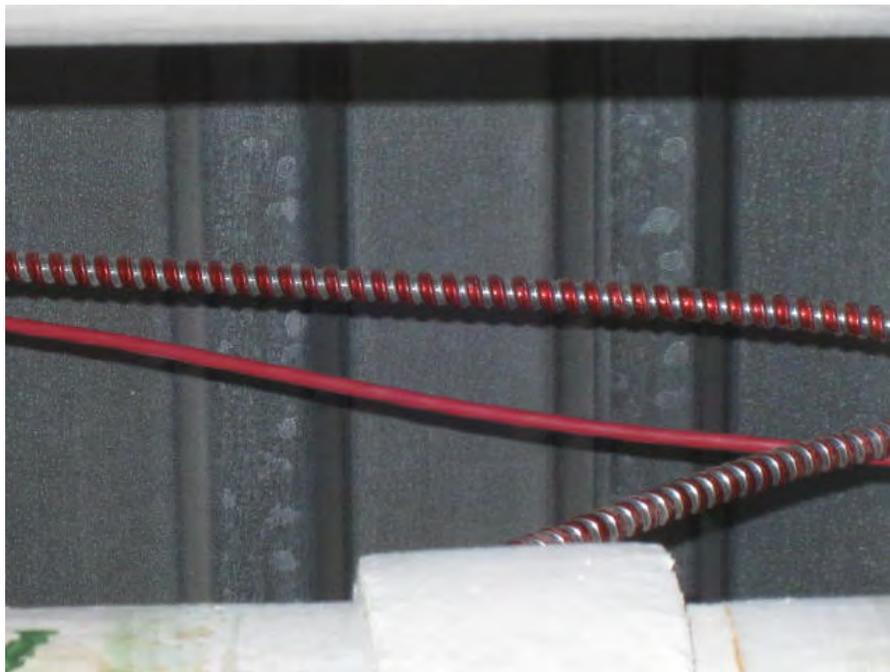
Picture 14

Water staining on metal roof, indicating leak

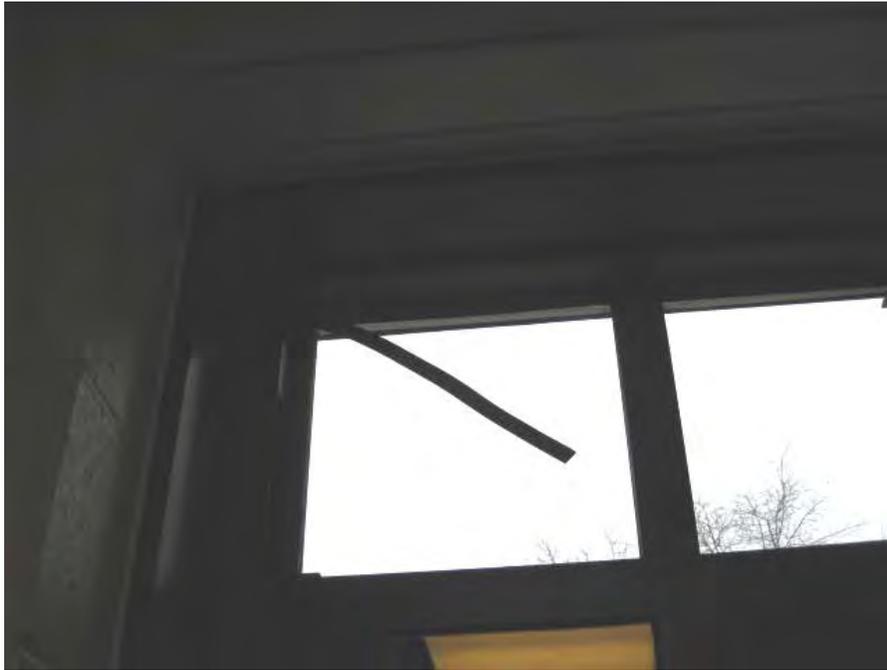
Picture 15

A failing window gasket was observed ES (Picture 15). Gaskets are designed to prevent water penetration through the window system. Gaskets should be properly installed/maintained to prevent water intrusion and damage to building materials.

Failing window gasket

8. Replace failing window gaskets.
9. Trim shrubbery/trees back approximately 5-feet to prevent water impingement on exterior brick.
10. Improve air exchange in classrooms. An increase in the percentage of fresh air supply and/or increased exhaust capabilities is recommended. Contact an HVAC engineering firm to determine if AHUs/exhaust motors can be modified/adjusted to increase the introduction of fresh air and/or removal of stale classroom air.

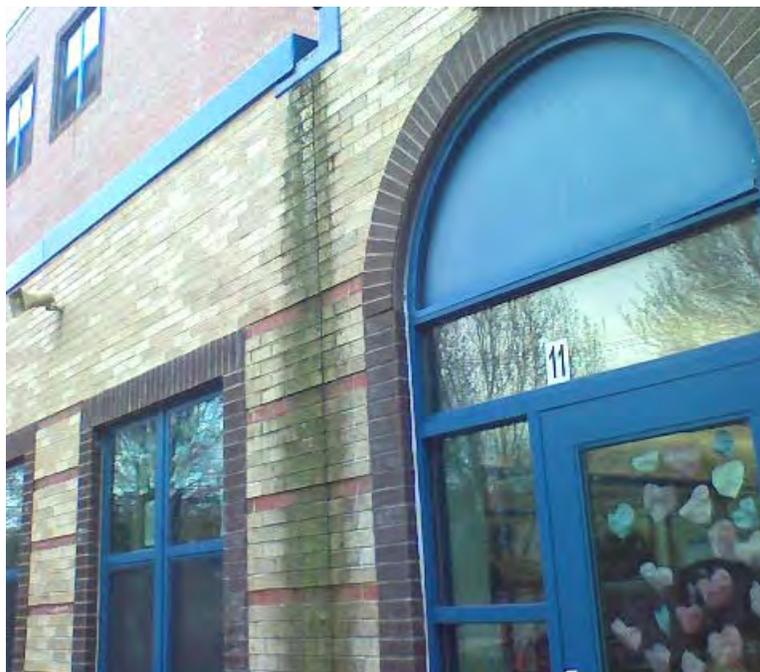
Picture 16

Water staining and moss growth was observed on the building's exterior (Pictures 16 and 17). Such staining can be an indication that the roof's gutter and downspout system may not be draining water sufficiently. The system should be examined to prevent damage to exterior brick and mortar. Overtime, repeated moistening can result in erosion of mortar and damage to brickwork, which can result in water penetration to the building.

Water staining on building exterior

6. Examine the roof drainage system to ensure proper water removal and prevent damage to exterior of the building.
7. Repair deteriorated mortar on exterior masonry; clean existing moss growth and monitor for further moss growth, remove as needed.

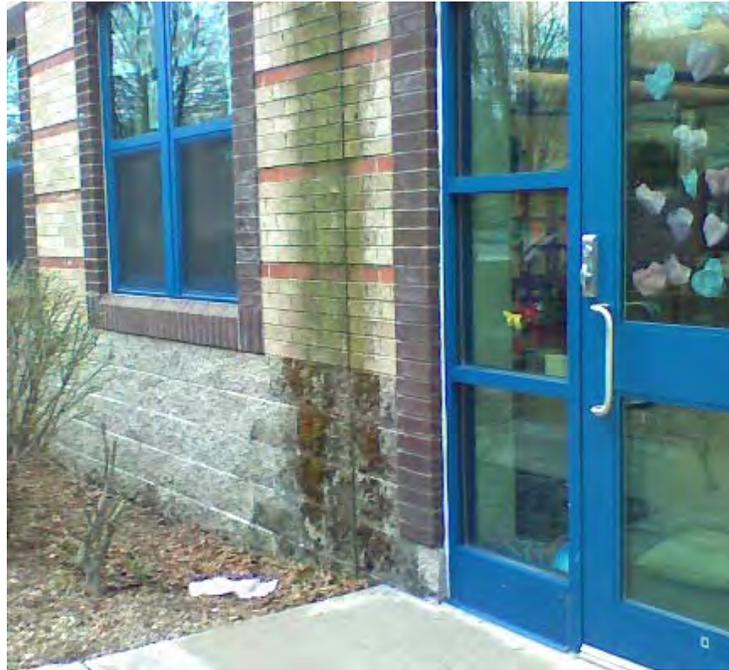
Picture 17

Water staining and moss growth on building exterior

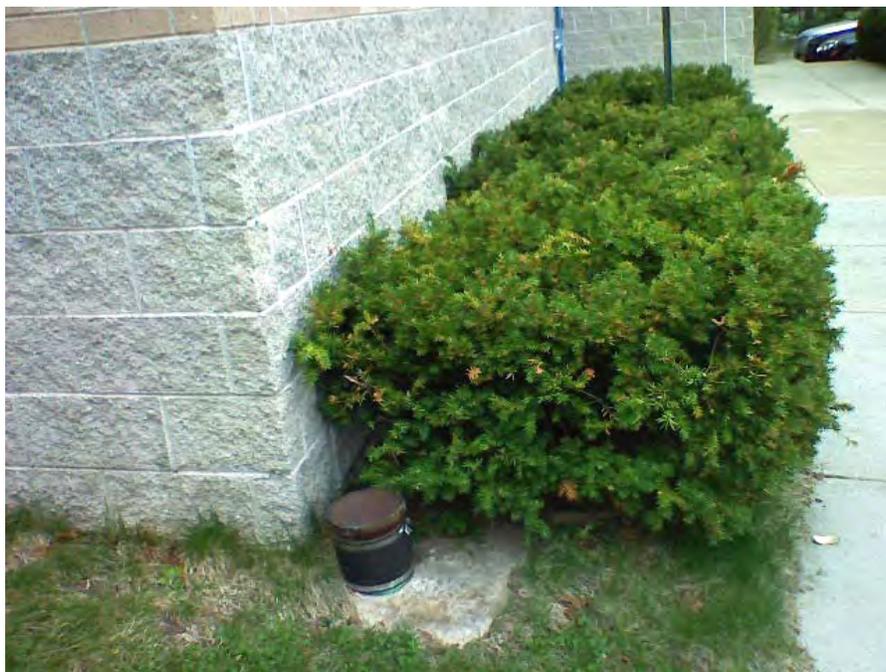
Picture 18

Shrubbery and other plants were observed in close proximity to the foundation/ exterior walls of the building (Picture 18). The growth of roots against exterior walls can bring moisture in contact with and eventually lead to cracks and/or fissures in the foundation below ground level. Over time, this process can undermine the integrity of the building envelope and provide a

Shrubbery in close proximity to the building

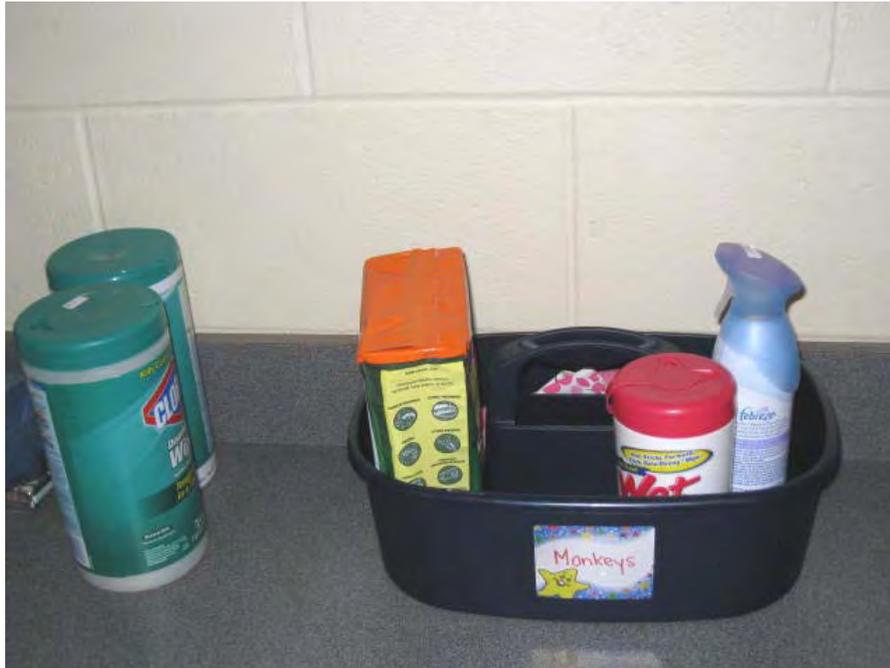
Picture 19

Cleaning products were also observed in a number of classrooms (Picture 19). Like dry erase materials, cleaning products contain VOCs and other chemicals. These chemicals can be irritating to the eyes, nose and throat and should be kept out of reach of students. A Material Safety Data Sheet (MSDS) should be available at a central location for each product in the event of an emergency. Consideration should be given to providing teaching staff with school issued cleaning products to ensure that MSDS information is available for all products used at the school.

Air fresheners and deodorizing materials were also observed (Picture 19). Air deodorizers contain chemicals that can be irritating to the eyes, nose and throat of sensitive individuals. Many air fresheners contain 1,4-dichlorobenzene, a VOC which may cause reductions in lung function (NIH, 2006). Furthermore, deodorizing agents do not remove materials causing odors, but rather mask odors that may be present in the area.

Cleaning materials and air deodorizers

19. Routinely clean dry erase boards and trays.
20. Consider providing school issued cleaning products to staff.

21. Eliminate use of air fresheners and deodorizers.
22. Routinely clean dust accumulation from personal fans and supply/exhaust vents.
23. Seal spaces around utility holes and breaches in walls/floors with an appropriate fire-rated sealant, paying particular attention to breaches between the first floor and the crawlspace.

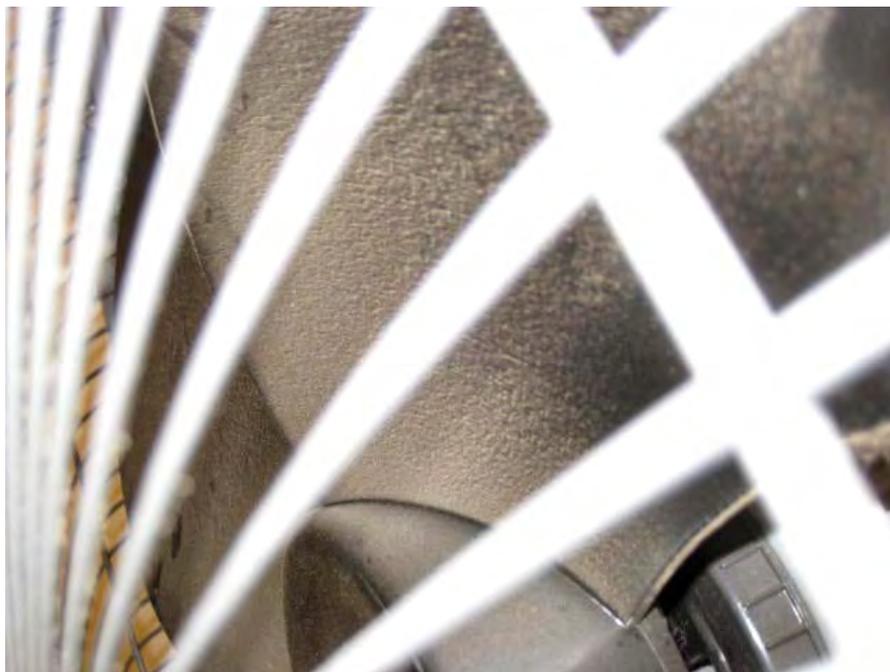
Picture 20

A number of personal fans (Picture 20) and supply vents (Picture 21) were observed to have accumulated dust/debris. These fans and vents should be cleaned in order to prevent dust/debris from being aerosolized and redistributed throughout the room.

Dust occluding personal fan

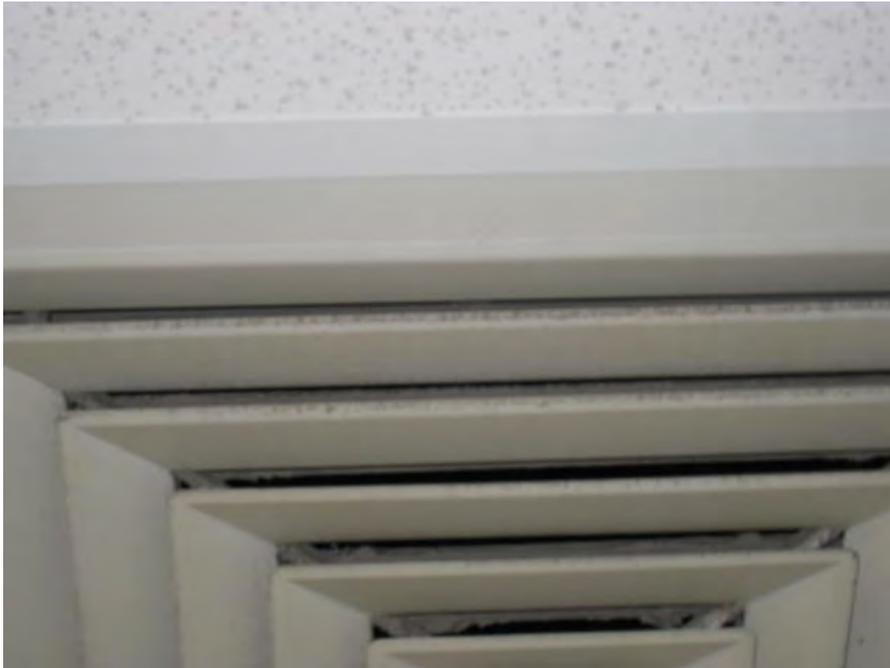
Picture 21

Dust on supply vent

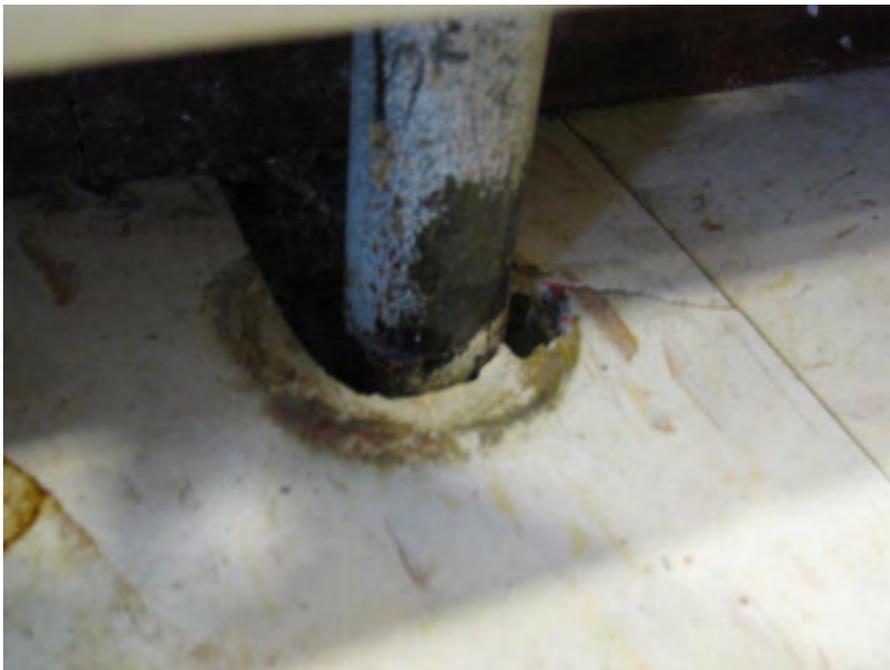
Picture 22

Open utility holes were observed around heating units in many areas (Pictures 22 and 23). Open utility holes can provide a means of egress for odors, fumes, dusts and vapors between rooms and floors.

Breach around piping to heating unit

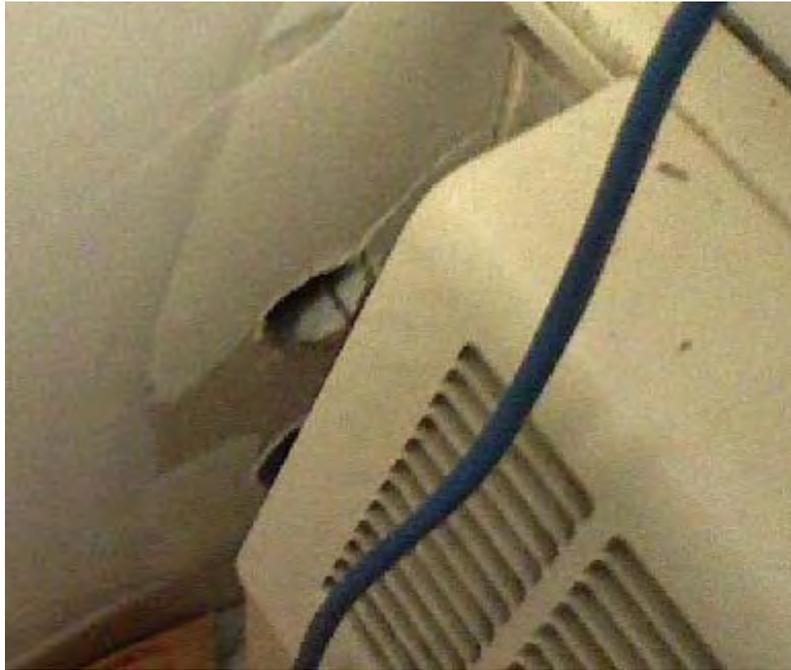
Picture 23

Utility hole in wall

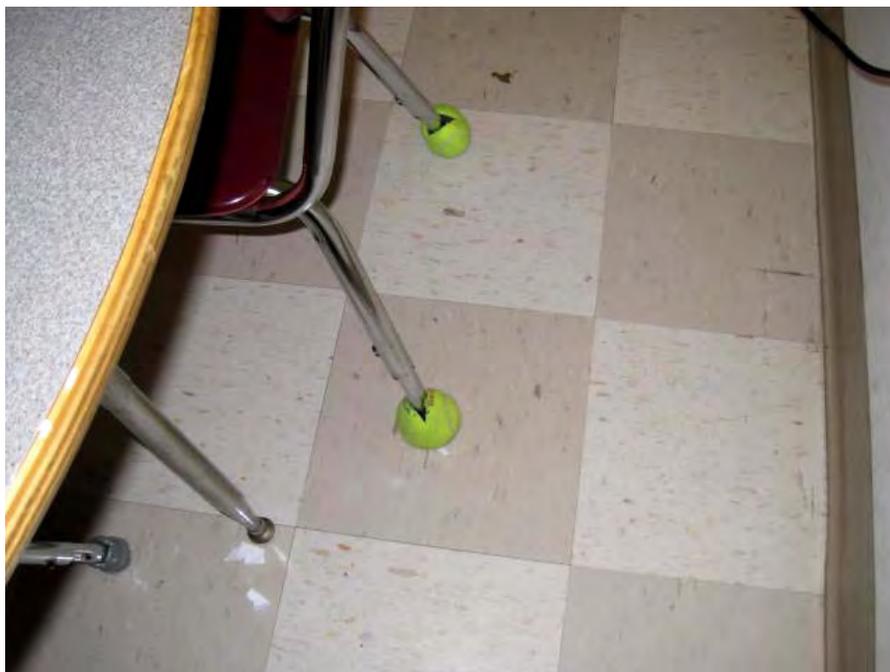
Picture 24

Tennis balls were observed sliced open and placed on the base of the legs likely in an effort to reduce noise from sliding desks/chairs (Picture 24). Tennis balls are made of a number of materials that can serve as respiratory irritants. Constant wearing of tennis balls can produce fibers and cause VOCs to off-gas. Tennis balls are made with a natural rubber latex bladder, which becomes abraded when used as a chair leg pad. Use of tennis balls in this manner may introduce latex dust into the school environment. Some individuals are highly allergic to latex (e.g., spina bifida patients) (SBAA, 2001). It is recommended that the use of materials containing latex be limited in buildings to reduce the likelihood of symptoms in sensitive individuals (NIOSH, 1997).

Tennis balls on chair leg

25. Remove tennis balls and consider replacing with latex free tennis balls and/or chair glides.
26. Consider adopting the US EPA (2000) document, “Tools for Schools”, as an instrument for maintaining a good indoor air quality environment in the building. This document is available at: <http://www.epa.gov/iaq/schools/index.html>.
