# **INDOOR AIR QUALITY REASSESSMENT**

**Department of Children and Families  
24 Farnsworth Street  
Boston, Massachusetts**

Prepared by:  
Massachusetts Department of Public Health  
Bureau of Environmental Health  
Indoor Air Quality Program  
December 2010

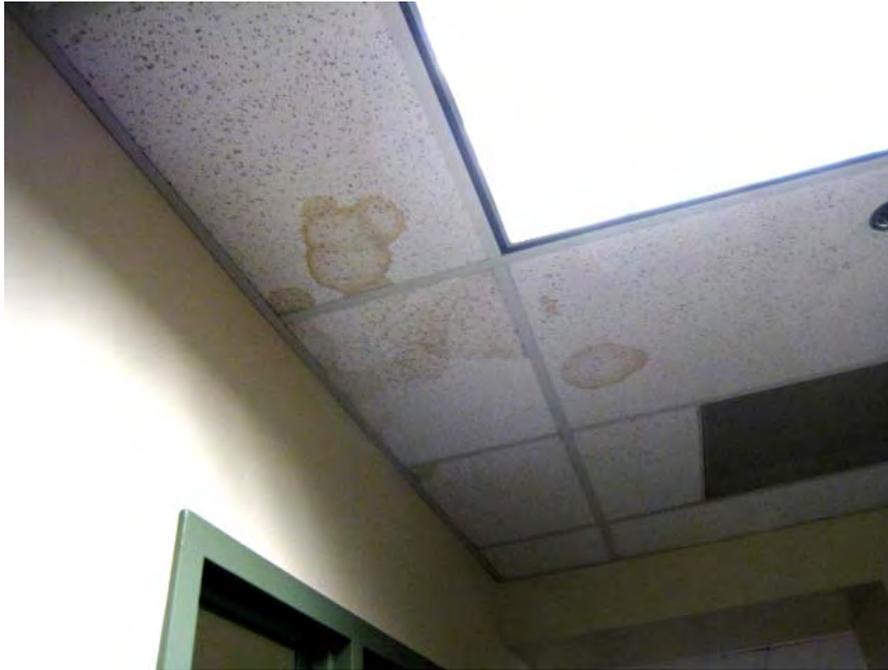
**Picture 1**

source for mold and should be replaced after a moisture source or leak is discovered and repaired. Occupants reported mold concerns above water-damaged ceiling tiles in the Adoption Subsidy Unit on the fourth floor (Picture 1). BEH staff removed ceiling tiles in this area to inspect the ceiling plenum and found the area to be dry with no signs of visible mold growth. In subsequent correspondence with Mr. Freer these ceiling tiles had reportedly been replaced.

**Water-Damaged Ceiling Tiles in 4<sup>th</sup> Floor Adoption Subsidy Unit**

6. Continue to replace water-damaged ceiling tiles and monitor for further leaks to report to building management for prompt remediation, particularly in the 4<sup>th</sup> floor Adoption Subsidy Unit.

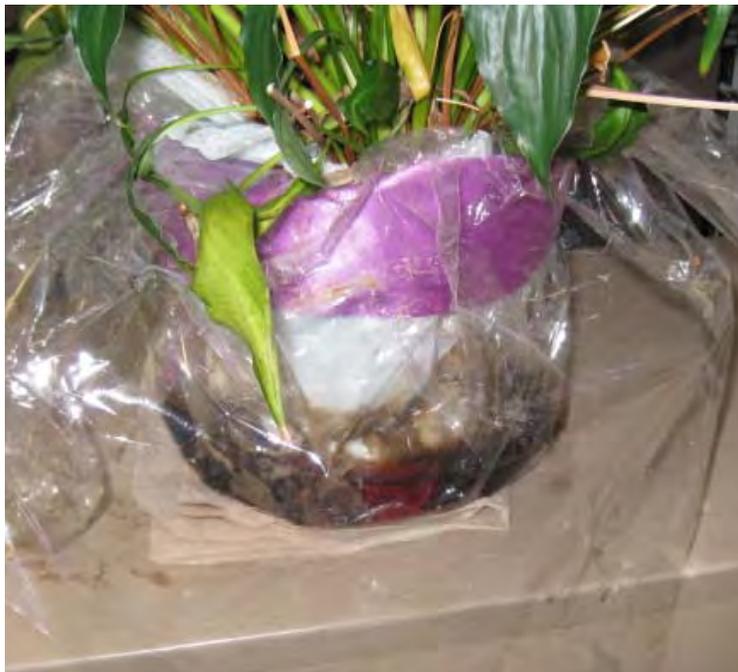
**Picture 2**

Several areas contained a number of plants. Plants, soil and drip pans can serve as sources of mold growth, and thus should be properly maintained. Plants should have drip pans to prevent wetting and subsequent mold colonization of window frames. Plants should also be located away from ventilation sources to prevent aerosolization of dirt, pollen or mold. A plant in one area was noted on a paper towel in standing water that was black with mold (Picture 2).

**Plant on Paper Towel in Standing Water Black with Mold**

7. Avoid over watering of plants. Ensure flat surfaces around plants are free of potting soil and other plant debris. Examine drip pans periodically for mold growth and disinfect with an

appropriate antimicrobial where necessary. Do not place plants on porous materials (e.g., paper/cardboard).

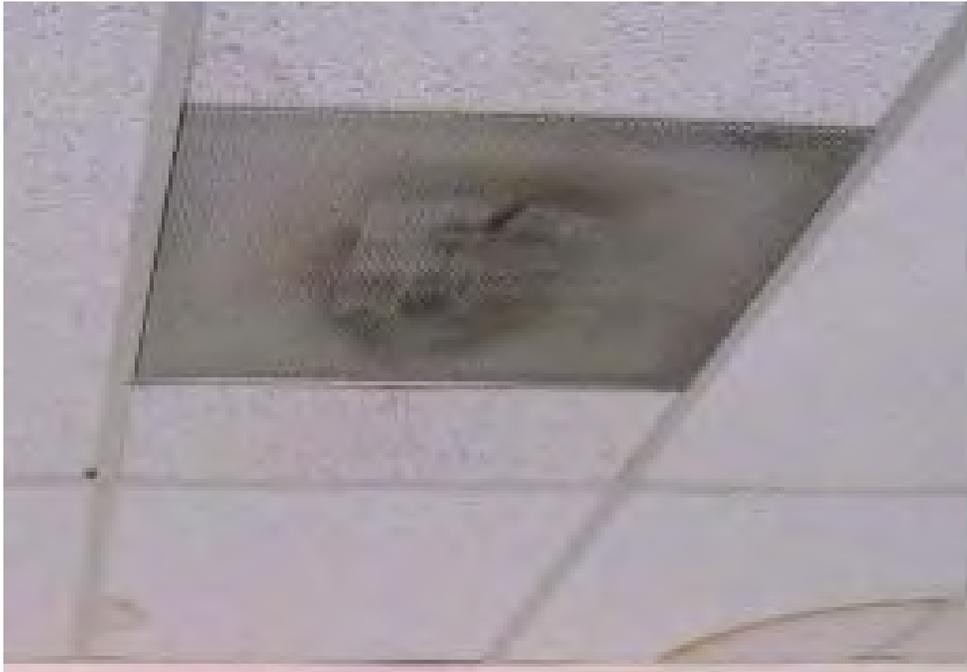
**Picture 3**

Several other conditions that can potentially affect indoor air quality were identified. A number of supply and return/exhaust vents had accumulated dust (Picture 3). If exhaust vents are not functioning, backdrafting can occur, which can aerosolize dust particles. In addition, these materials can accumulate on flat surfaces (e.g., desktops, shelving and carpets) in occupied areas and subsequently be re-aerosolized causing further irritation. Dust can be irritating to eyes, nose and respiratory tract. Accumulated dust/stains were also observed in a consistent pattern on walls above radiant heat vents throughout the space (Picture 4).

**Accumulated Dust and Debris on Vents and Vent Screens**

9. Clean supply and return/exhaust vents periodically of accumulated dust. Screens should be removed to gain access to vents; vents should be wiped/cleaned and screens should be soaked and cleaned. Consider cleaning on regular schedule quarterly or semi-annually as needed.

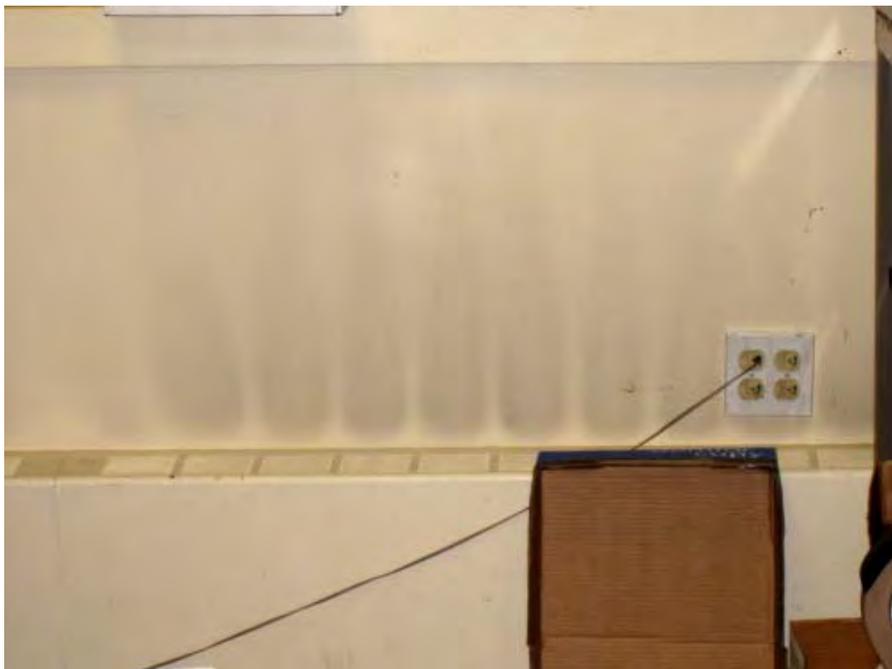
**Picture 4**

**Dust/Debris Pattern on Walls above Radiant Heat Units**

10. Clean/wash accumulated dust/debris on walls above radiant heat units (Picture 4) throughout the DCF area.
11. Refer to resource manuals and other related indoor air quality documents for additional building-wide evaluations and advice on maintaining public buildings. These materials are located on the MDPH's website: <http://mass.gov/dph/iaq>.

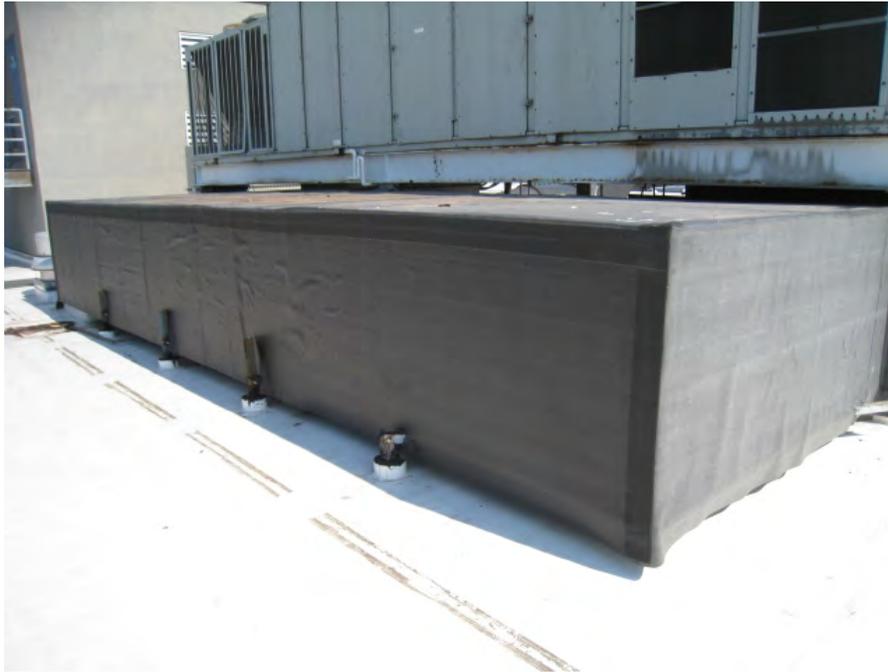
**Picture A-1**

**Exterior of Ductwork Sealed with Waterproofed Material**

12. Repair breaches in rooftop ductwork to prevent loss of conditioned air.
13. Action: **Rooftop ductwork was sealed (Picture A-1).**
14. Consult a ventilation engineer concerning re-balancing of the ventilation systems. The Ventilation industrial standards recommend that mechanical ventilation systems be balanced every five years (SMACNA, 1994).

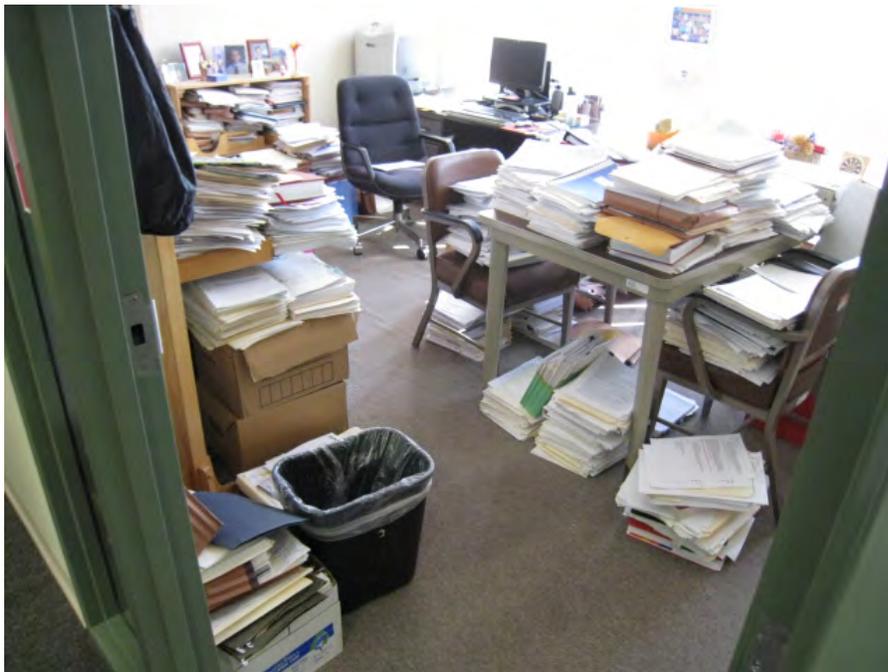
**Picture A-2**

**Action:** Cleaning and dust control is problematic at the DCF due to the excessive amount of materials stored in the space coupled with the lack of storage (Pictures A-2 through A-4). In open work areas/cubicles, common areas and private offices alike, large amounts of papers, boxes, files, etc., are piled on desks, tables, floors and other flat surfaces which provides a source for dusts to accumulate. These accumulated items make it difficult to clean. Dust can be irritating to eyes, nose and respiratory tract and may be the most obvious source of IAQ issues at the DCF.

**Accumulated Items in Private Office**

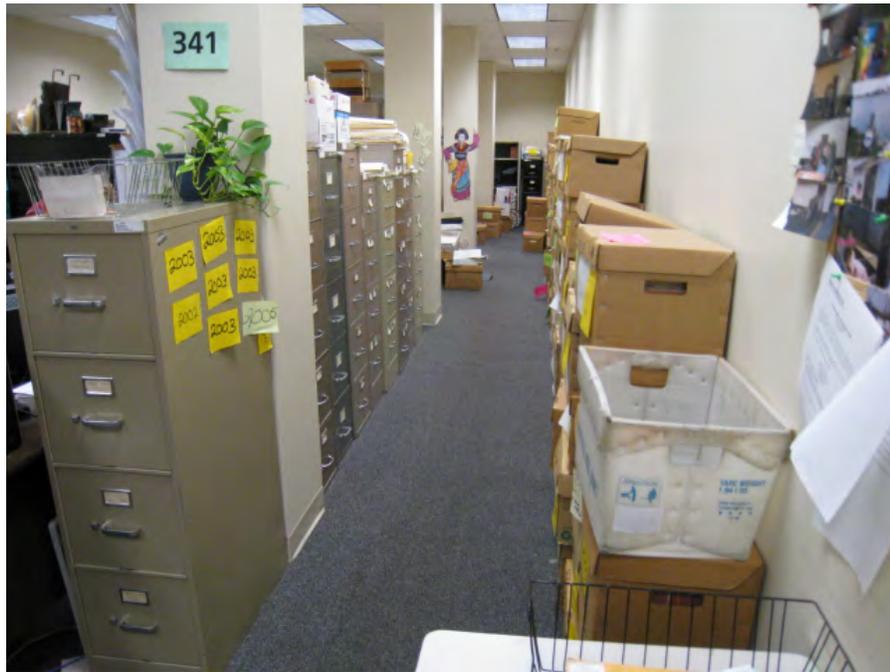
Picture A-3

Accumulated Items in Common Area

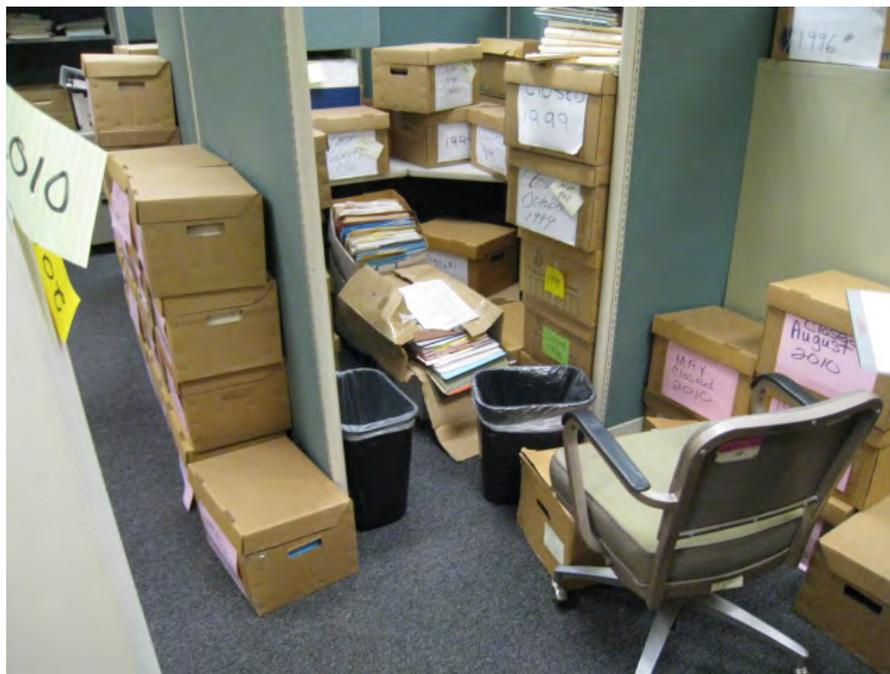
Picture A-4

Accumulated Items in Work/Common Area

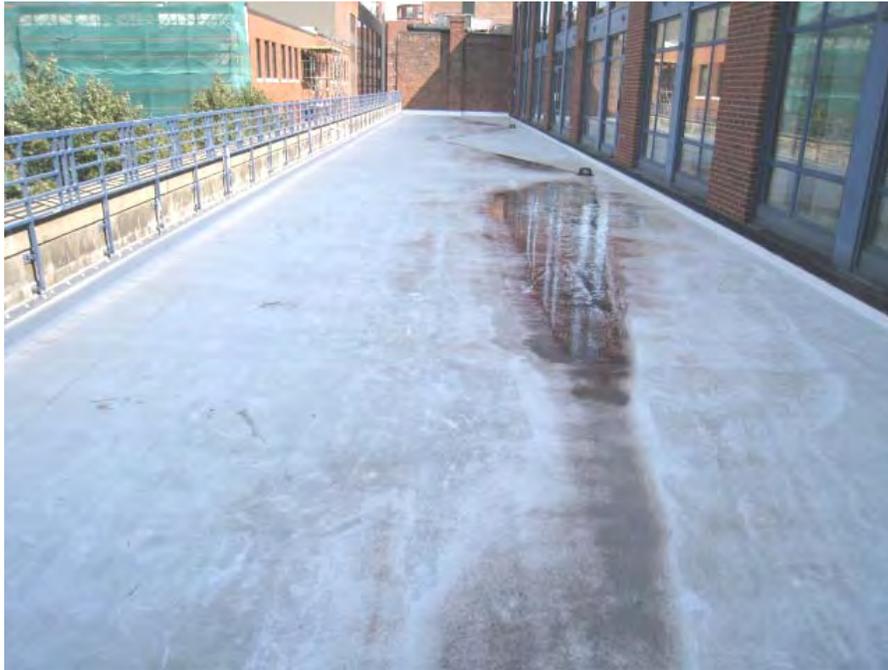
Picture A-5

**Water Impermeable Membrane Installed over 5<sup>th</sup> Floor Roof Deck**

22. **Action: A water impermeable membrane was installed over the roof deck on the fifth floor, which has reportedly reduced leakage (Picture A-5).**
