# **INDOOR AIR QUALITY ASSESSMENT**

**Alternative Education High School  
111 Goodrich Street  
Fitchburg, Massachusetts**

Prepared by:  
Massachusetts Department of Public Health  
Bureau of Environmental Health  
Indoor Air Quality Program  
October 2010

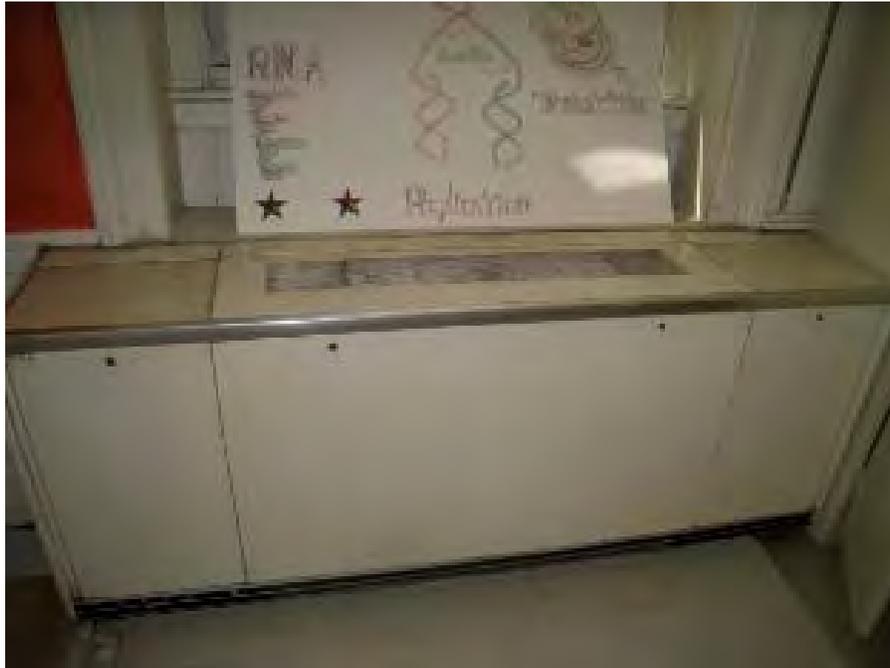
**Picture 1**

It can be seen from Table 1 that carbon dioxide levels were below 800 parts per million (ppm) in all 16 areas surveyed, indicating adequate air exchange throughout the building. Fresh air in classrooms is supplied by a unit ventilator (univent) system ([Figure 1](#)). Univents draw air from outdoors through a fresh air intake located on the exterior walls of the building and return air through an intake located at the base of each unit. The mixture of fresh and return air is drawn through a filter and heating coil, and is then expelled from the univent by motorized fans through fresh air diffusers (Picture 1).

**Unit Ventilator (Univent)**

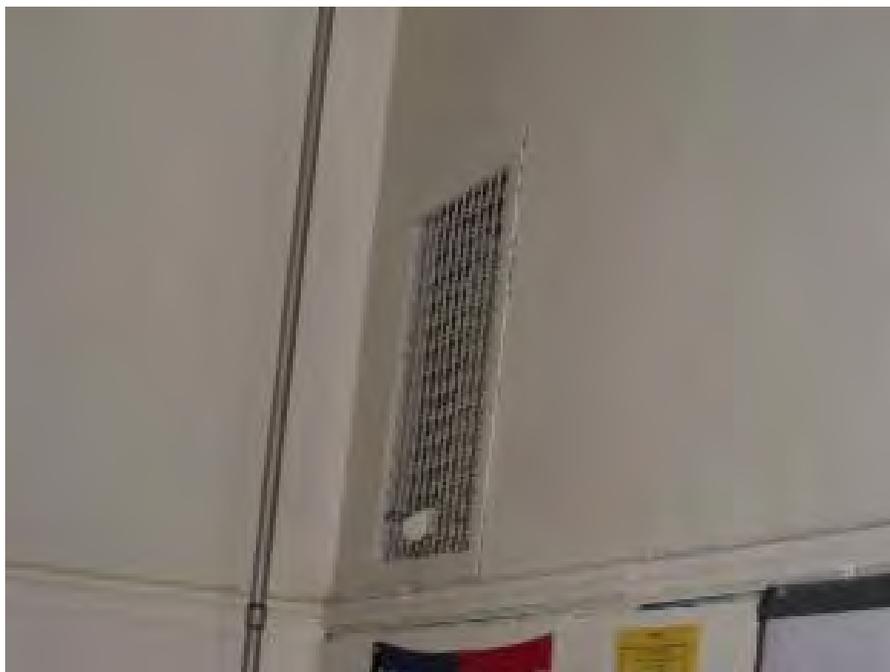
**Picture 2**

One classroom is equipped with mechanical exhaust ventilation, which is provided by a unit exhaust ventilator. A unit exhaust ventilator appears similar to a univent, but removes air from the classroom and exhausts it out of the building. The building was originally designed to provide heated air by means of wall-mounted vents and stale air was originally exhausted to the roof by means of ducted exhaust vents located near the floor. This type of system was known as a natural gravity system. Some of the vents to this abandoned system were obstructed, while others were not, therefore many of the exhaust vents likely provide some measure of exhaust by means of gravity, rather than by mechanical means (Pictures 2 through 4).

**Wall-Mounted Air Supply Vent from Old Gravity System**

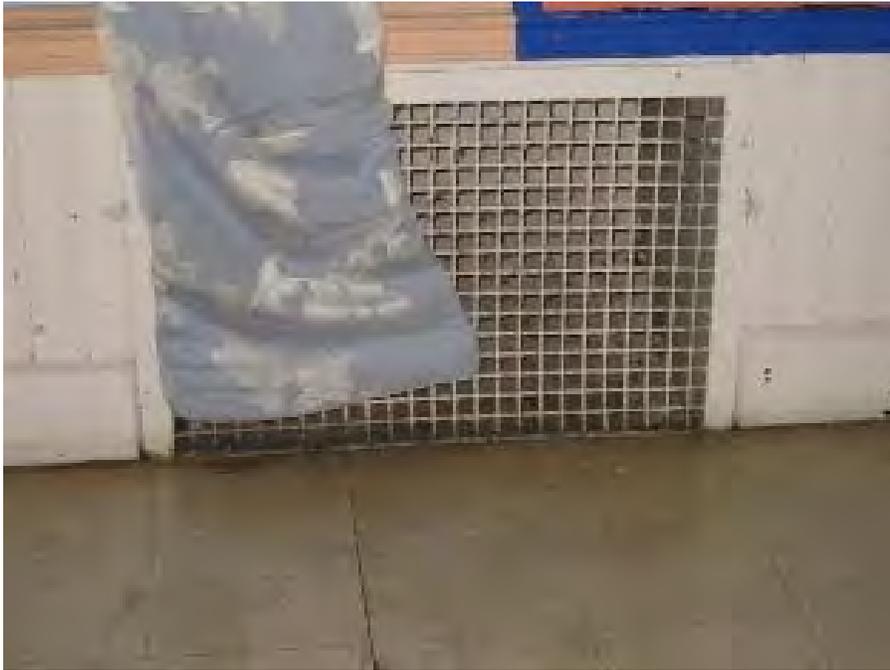
**Picture 3**

**Passive Exhaust Vent**

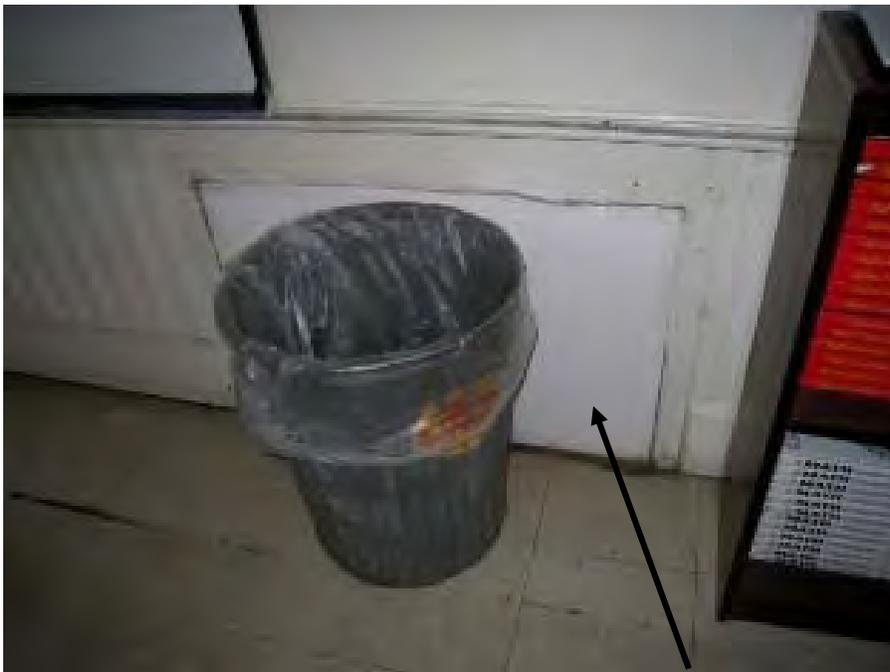
**Picture 4**

**Blocked Exhaust Vent**

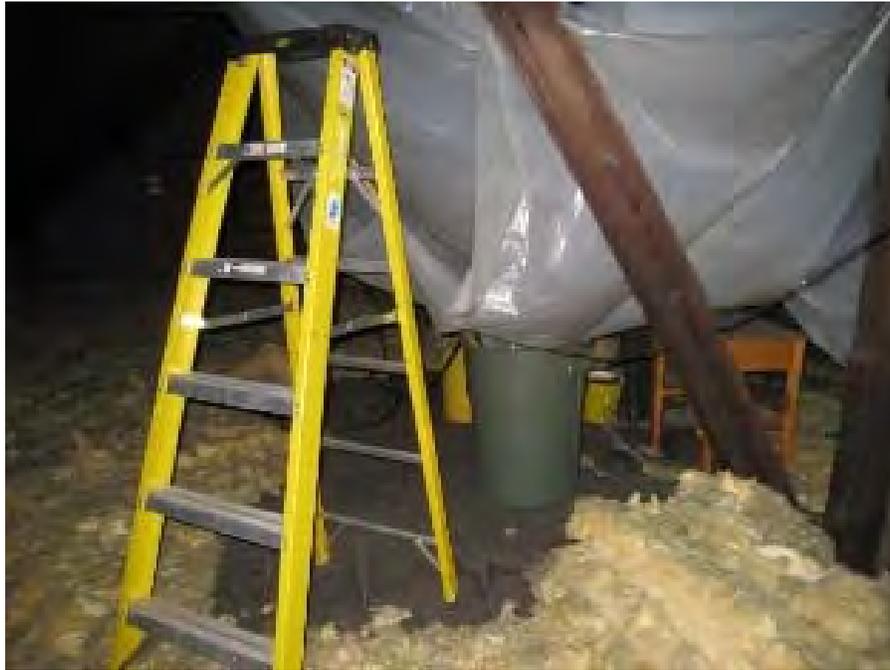
**Picture 5**

Several potential sources of water damage and/or moisture infiltration were observed during the assessment. As can be seen in Picture 5, water leaking through the roof was gathered by sheets of plastic and collected in a large plastic refuse container in the attic. The water collected was set up to be pumped via a hose running through an attic window to the exterior of the building (Picture 6). Attic windows covered by plywood were not weathertight and exhibited signs of water penetration (Picture 7). Water-damaged ceilings and walls were also observed in several areas (Picture 8). A large number of materials that can support mold growth were also being stored in the attic, including numerous cardboard boxes (Picture 9). All porous materials stored in this unconditioned location have the potential for mold colonization and should be discarded. Standing water was observed in the basement due to a leaking boiler (Picture 10). BEH staff were informed that boiler replacement was in the planning stages.

**Water from Roof Leak Collected in Waste Receptacle**

6. Continue with plans to repair the roof.
7. Repair any existing water leaks (particularly in the attic); repair water-damaged surfaces. Disinfect areas of water leaks with an appropriate antimicrobial, as needed.

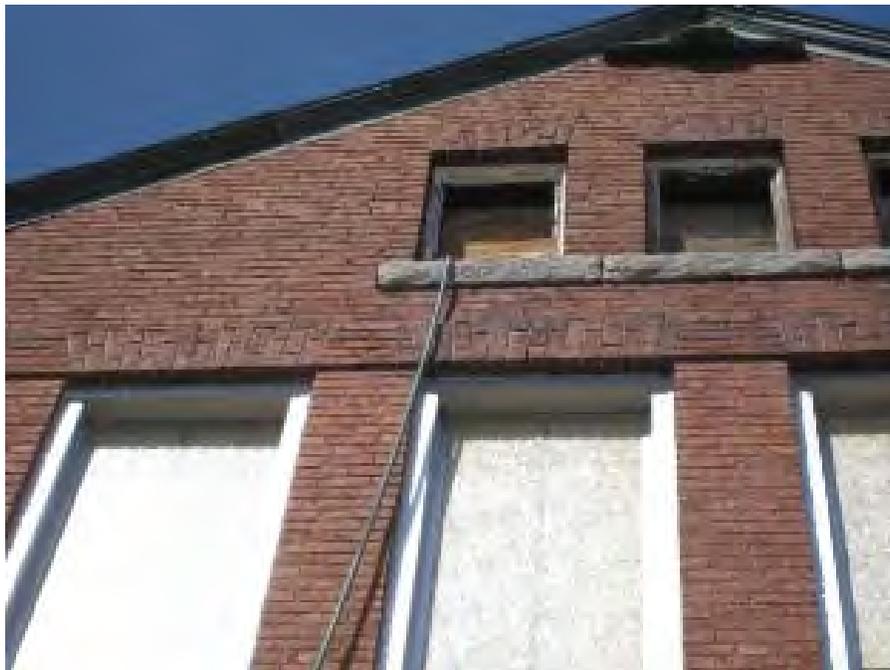
**Picture 6**

**Hose Pumping Water from Attic out of Building**

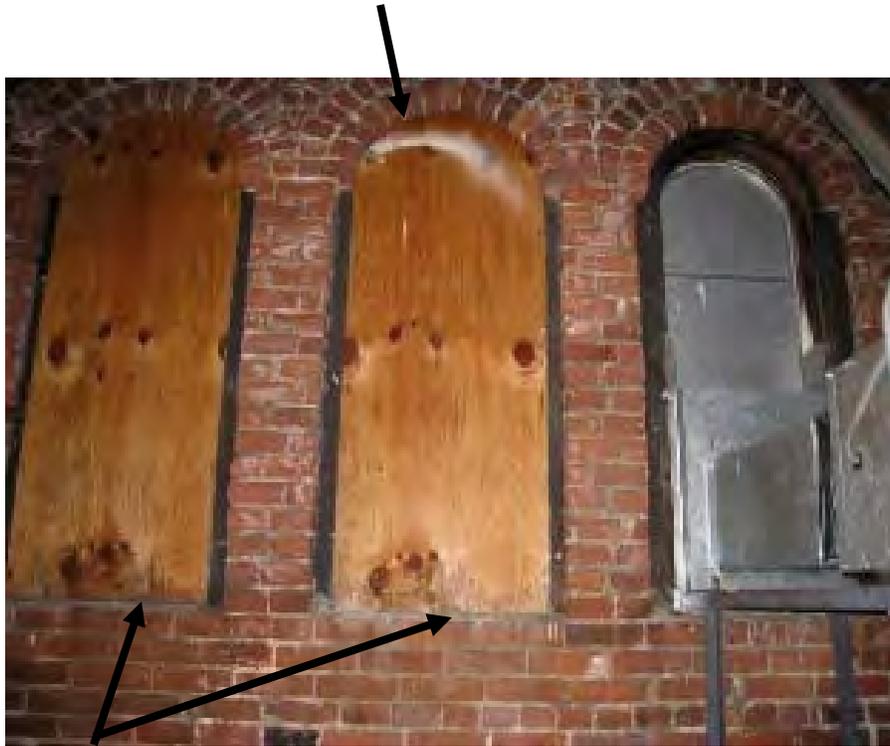
**Picture 7**

**Windows Covered with Plywood are not Weathertight;  
Note Light Visible at top of Window and Water Damage at Bottom of Plywood**

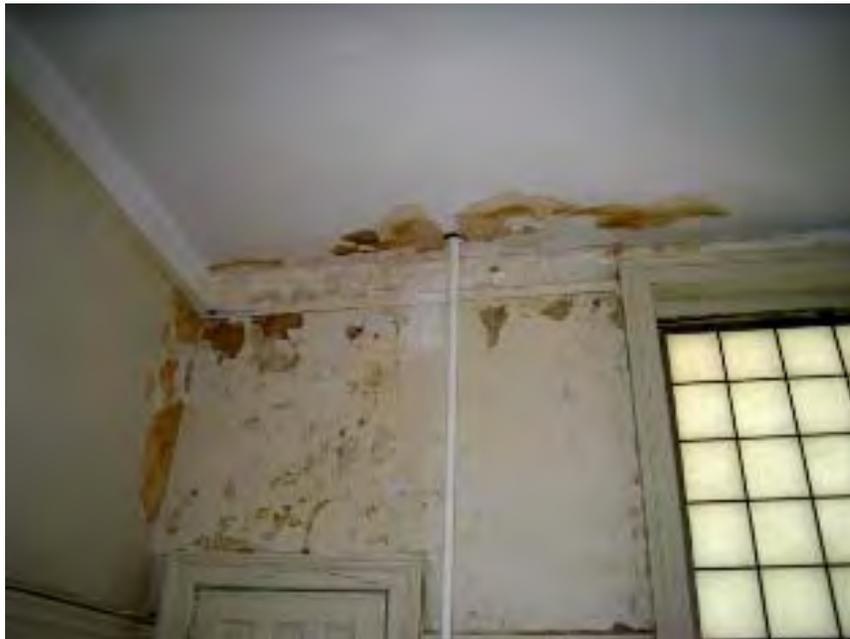
**Picture 8**

**Water-Damaged Ceiling and Wall**

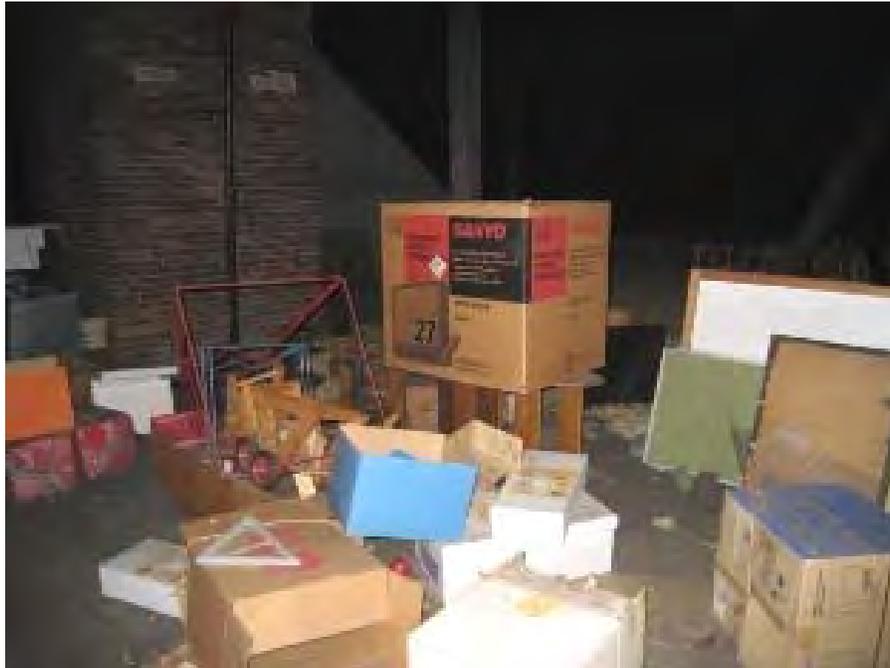
**Picture 9**

**Porous Materials Stored in Attic**

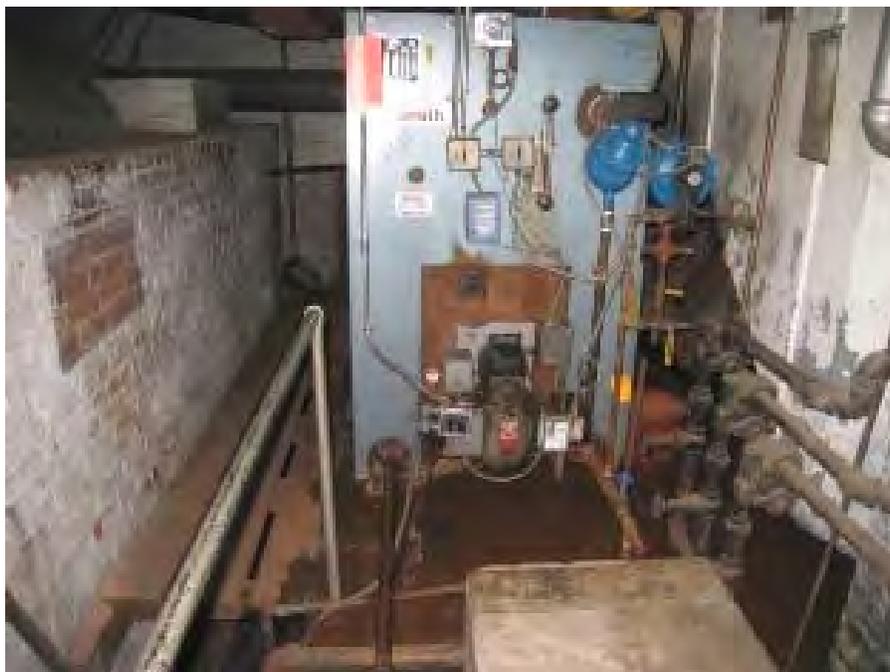
**Picture 10**

**Standing Water in Boiler Room**

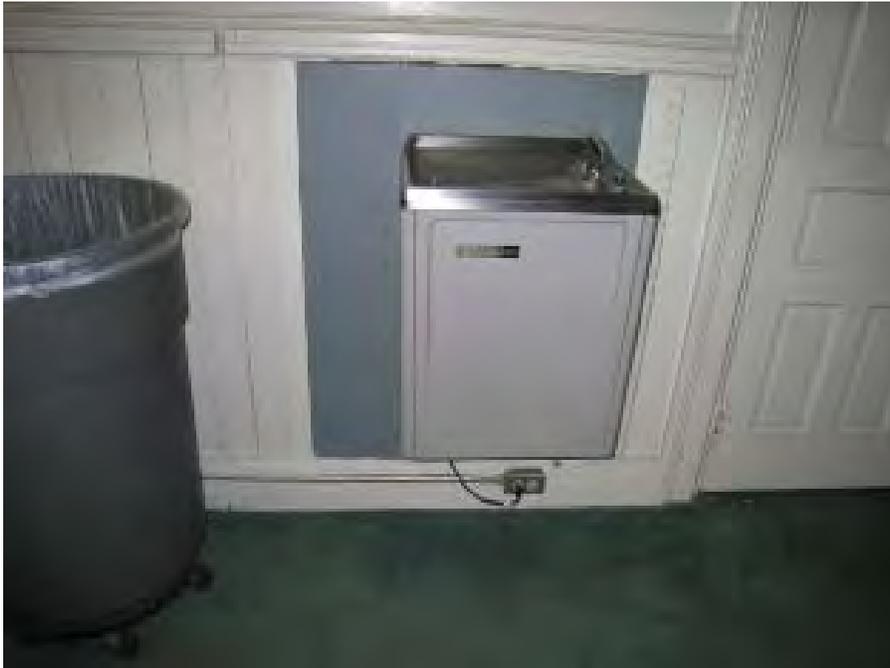
**Picture 11**

A water fountain was observed to have been installed over a carpeted area (Picture 11). Overflow or spills that often occur can moisten carpeting, which can lead to mold growth. Carpets were also observed in basement areas. Basement areas can become moist with condensation during hot, humid summer months. Relative humidity concentrations indoors above 70 percent can foster mold growth in susceptible materials (ASHRAE, 1989). Materials that can foster mold growth if repeatedly exposed to high humidity include cardboard, paper, books, cloth and other materials in addition to carpeting. Therefore, alternative (non-porous)

**Water Cooler Located over Carpeting**

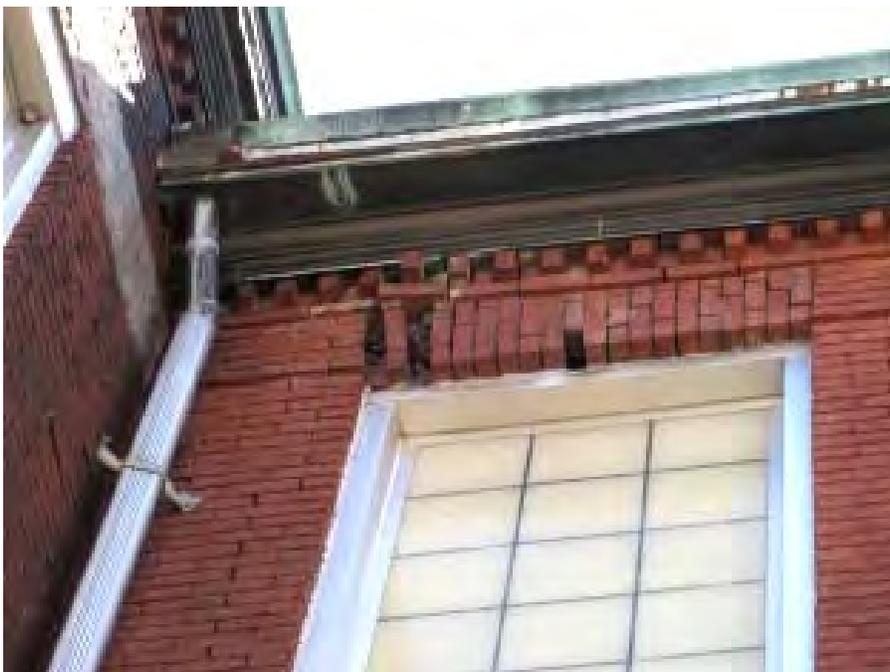
**Picture 12**

**Loose, Broken and Missing Brick**

14. Contact a building contractor/mason to repair second floor masonry adjacent to window.
15. Repair mortar on exterior of building.
16. Remove moss accumulation on masonry and mortar.

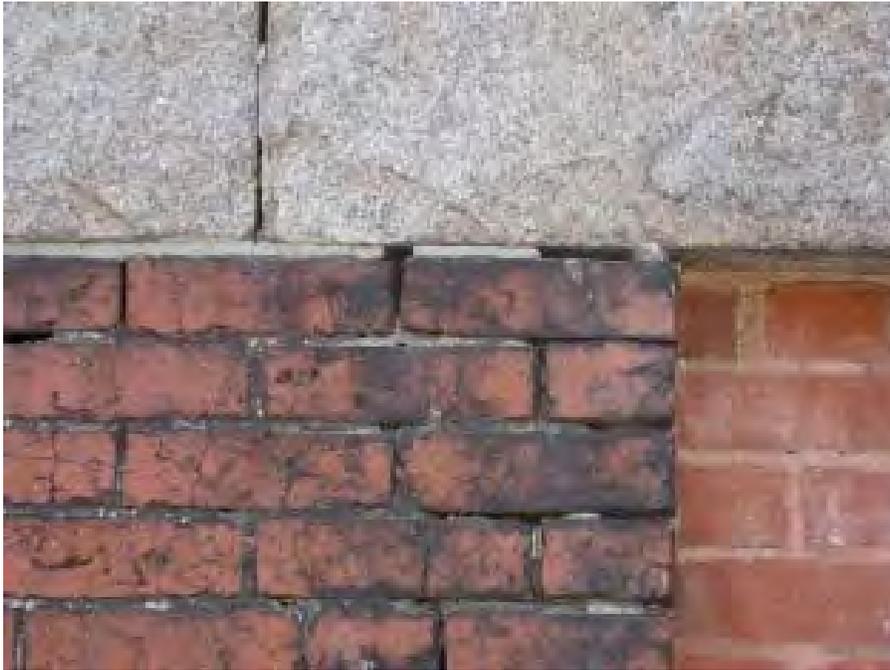
**Picture 13**

**Loose and Missing Mortar**

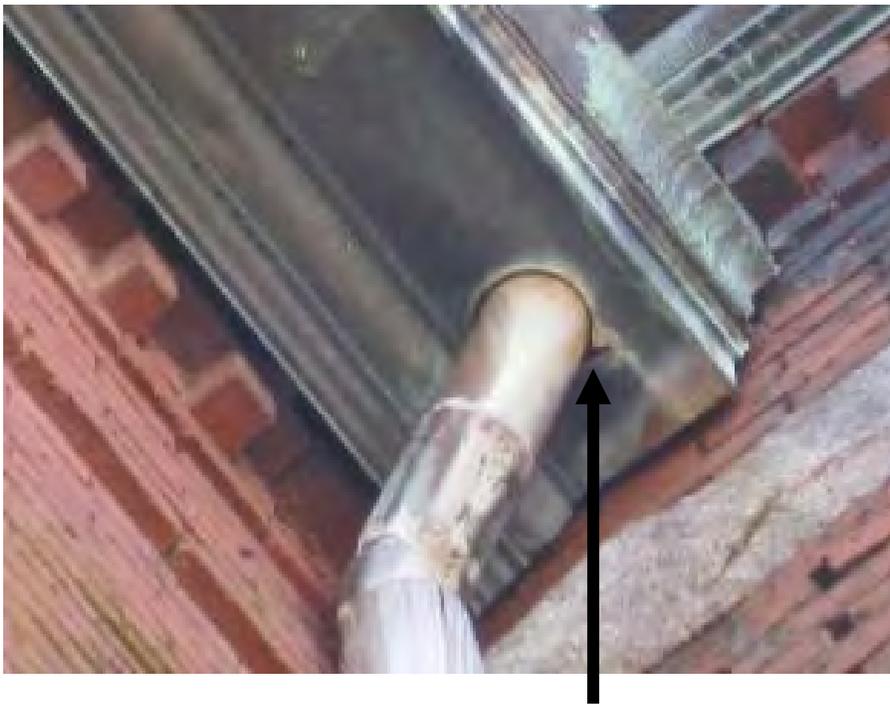
**Picture 14**

**Deteriorated Gutter (Arrow)**

17. Ensure repairs are made to gutters and downspouts. Once water is properly collected and directed away from the building, moss growth on exterior brick should decrease.

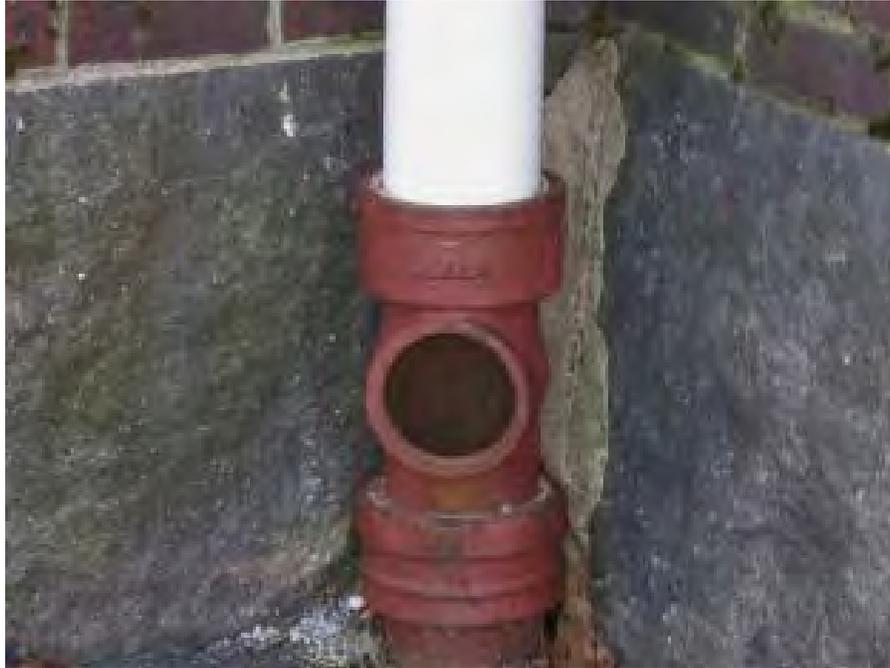
**Picture 15**

**Open Downspout**

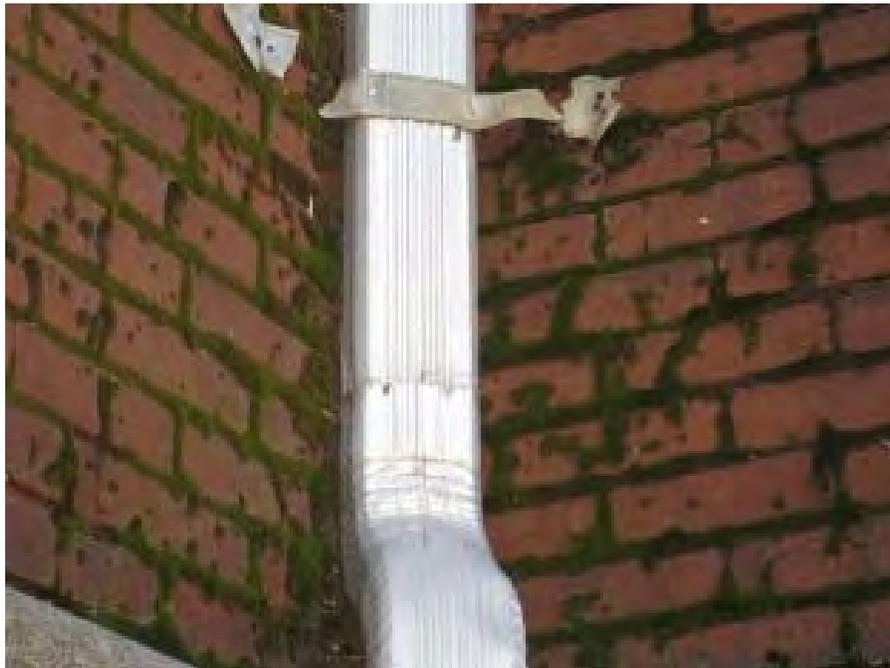
**Picture 16**

**Moss Growth on Masonry and Mortar**

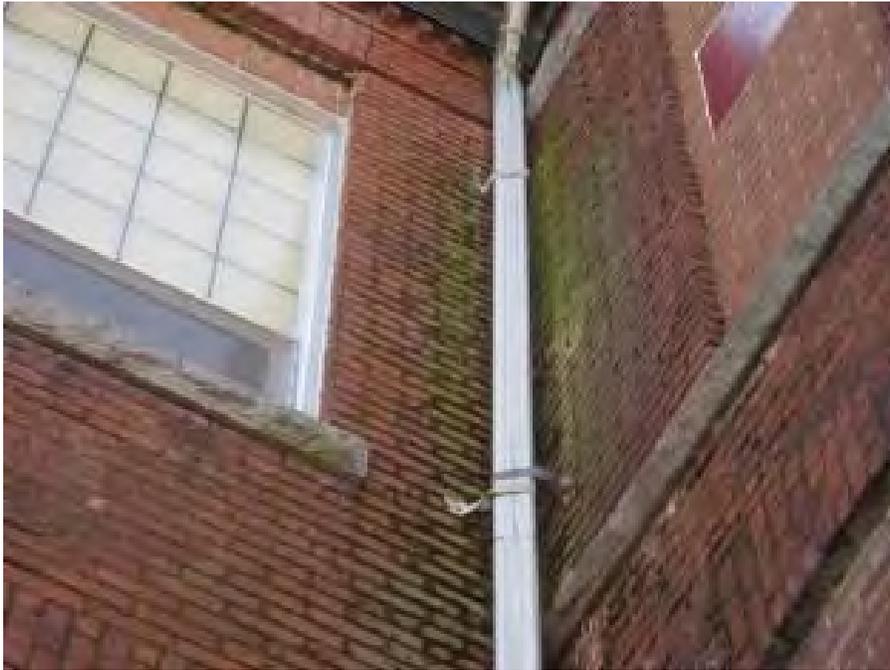
**Picture 17**

**Moss Growth on Masonry Adjacent to Downspout**

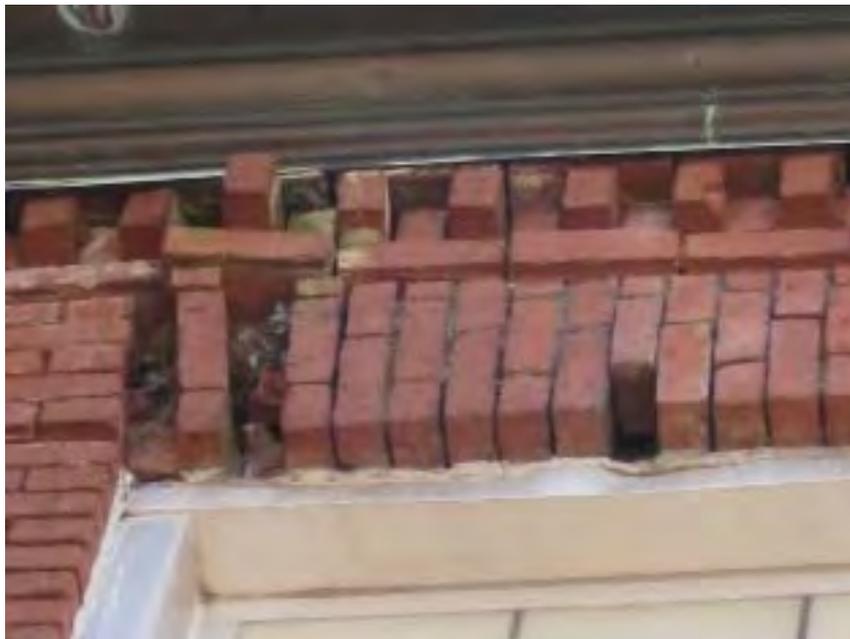
**Picture 18**

**Window Casing is Buckled and Caulking is Deteriorated  
Due to Loose and Missing Brick**

18. Repair window casings. Prior to conducting any work on windows and window sealants, consult MDPH guidance on PCBs in Schools in Appendix B.
19. Repair mortar at edge of wall and tarmac.

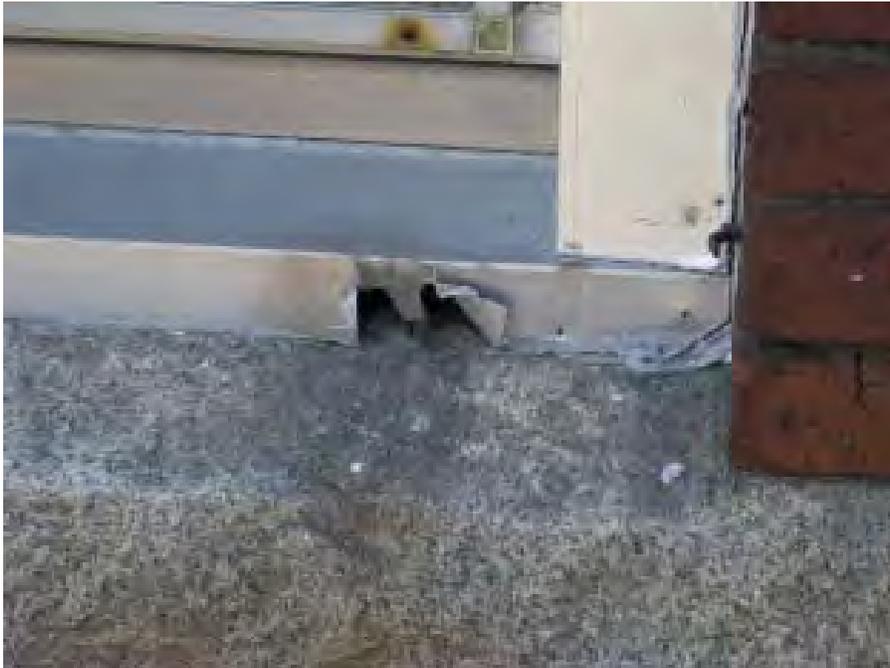
**Picture 19**

**Window in Disrepair**

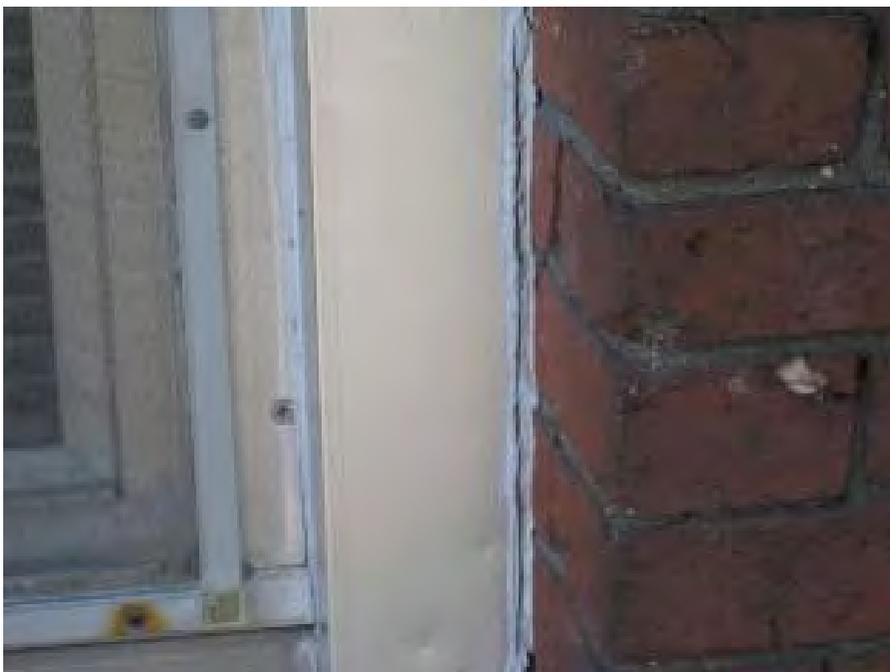
**Picture 20**

**Deteriorated Window Caulking**

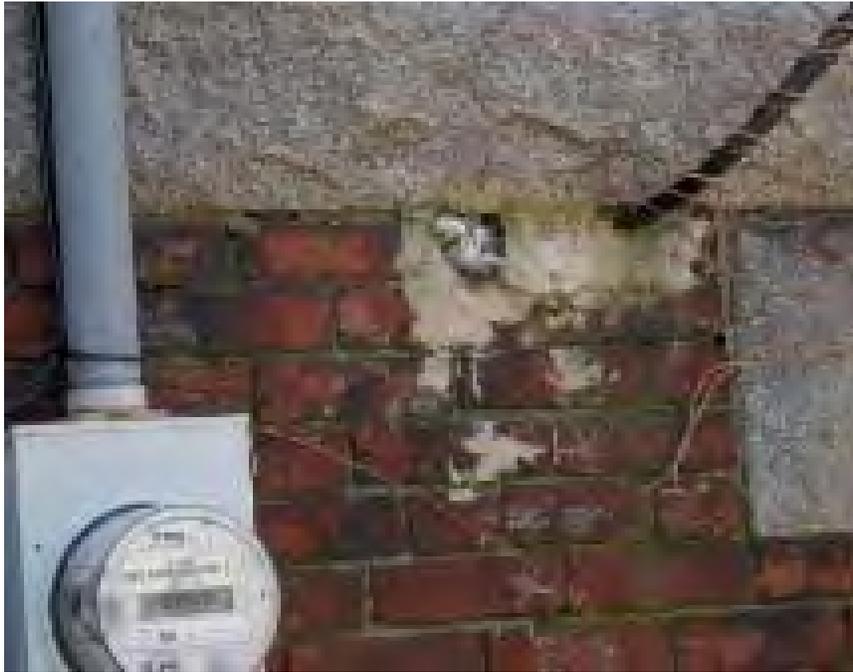
**Picture 21**

**Penetration in Masonry not Properly Sealed**

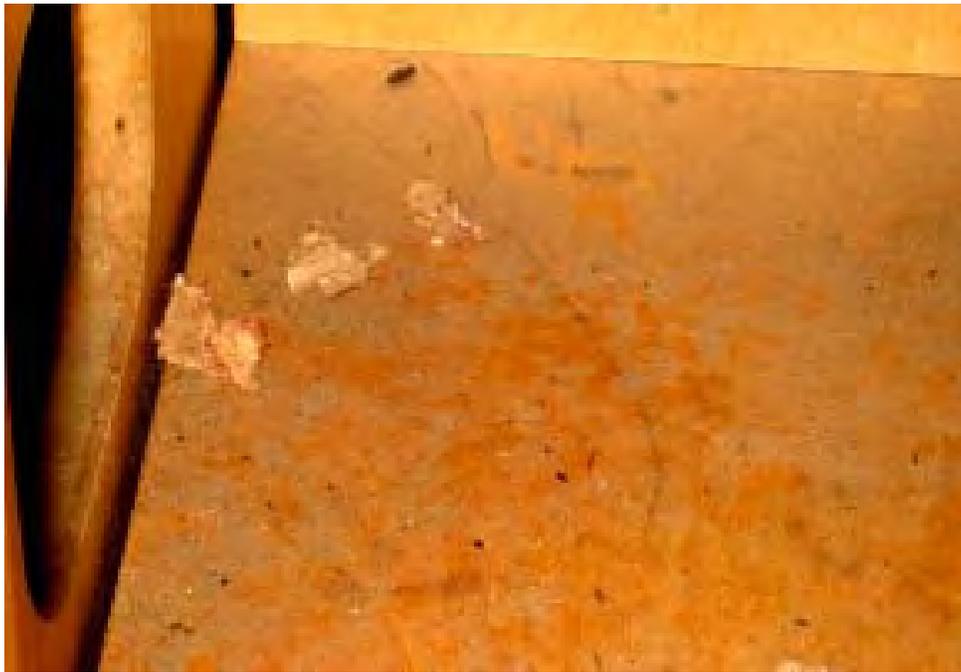
**Picture 22**

Other conditions that can affect indoor air quality were observed during the assessment. Evidence of rodent activity was observed in the attic (Pictures 22 and 23). To penetrate the exterior of a building, rodents require a minimal breach of ¼ inch (MDFA, 1996). Utility holes on the exterior of the building and other breaches in the building envelope would be sufficient to allow rodents to enter the building. Rodent infestation results from easy access to food and water in a building. Rodent infestation can result in indoor air quality related symptoms due to materials in their wastes. Mouse urine contains a protein that is a known sensitizer (US EPA, 1992). A three-step approach is necessary to eliminate rodent infestation:

**Rodent Droppings in Attic**

23. Take steps to ensure rodents and their wastes are removed from the building. Eliminate food sources and seal pathways for movement within the building. Seal all breaches in the exterior building envelope. Eliminate rodent harborage by reducing weeds adjacent to the building's exterior and by eliminating unused cardboard and other materials that can be utilized as bedding material.

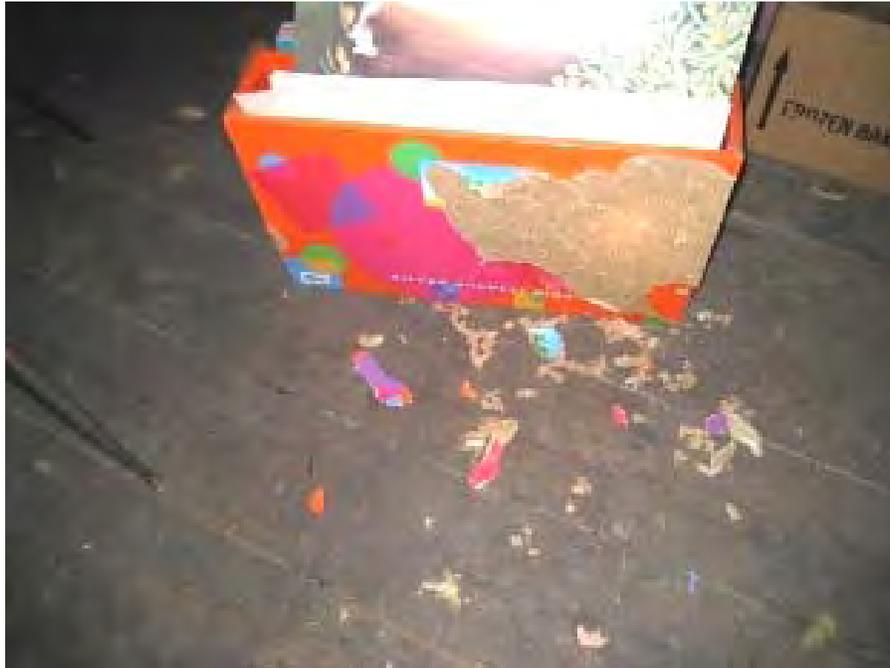
**Picture 23**

**Shredded Material in Attic Indicative of Rodent Infestation**

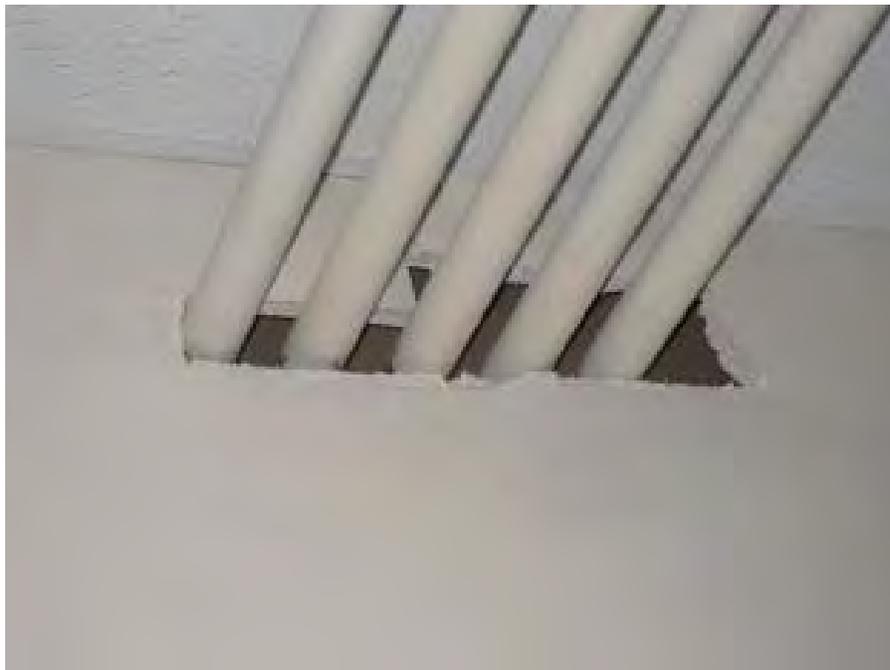
**Picture 24**

Numerous open utility holes and large penetrations through gypsum wallboard were observed (Picture 24). An open-ended pipe was observed in a basement storage area. These conditions may allow dust, particulate matter, odors and vapors to move from one room to another and may irritate the respiratory systems of sensitive individuals. Peeling paint was also observed on water-damaged ceilings and walls.

**Penetration of Pipes through Gypsum Wallboard**
