INDOOR AIR QUALITY ASSESSMENT

**Massachusetts Department of Transitional Assistance
473 Main Street
Fitchburg, Massachusetts**

Prepared by:
Massachusetts Department of Public Health
Bureau of Environmental Health
Indoor Air Quality Program
June 2010

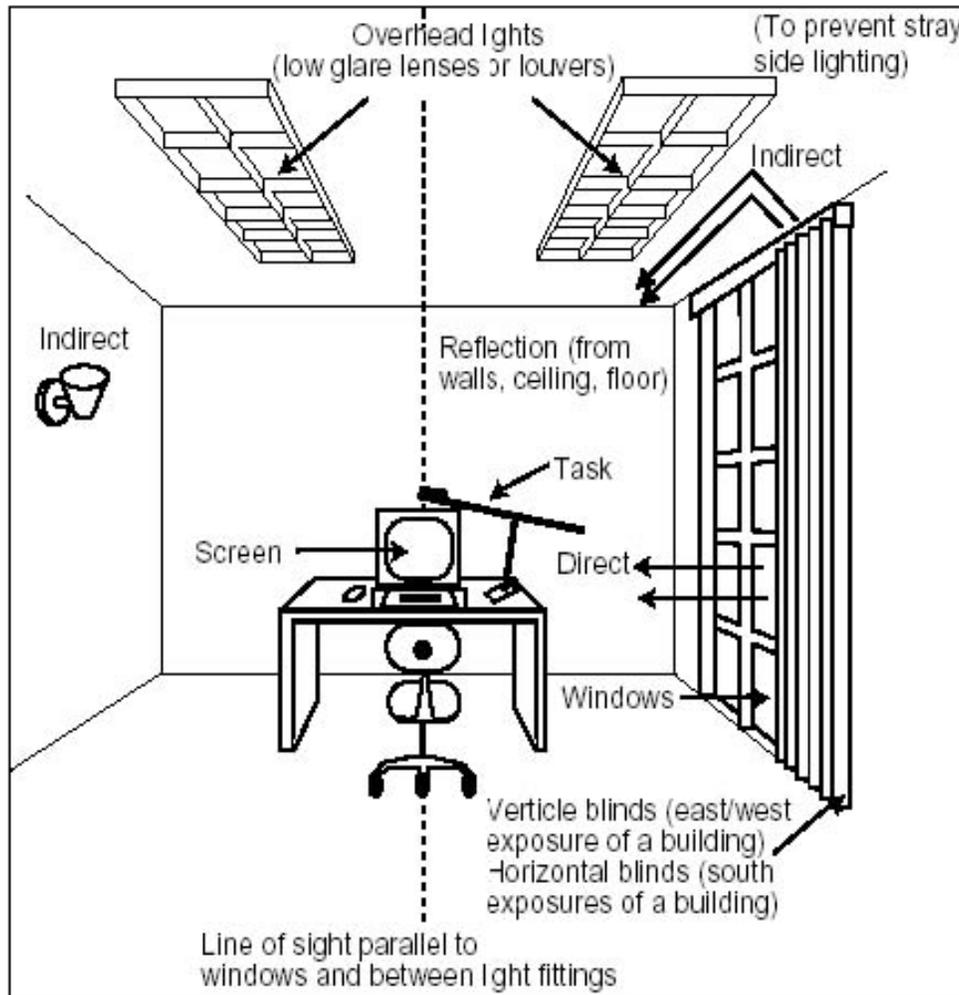
Figure 1
Typical Florescent Lighting Schematic for Office Use

In addition, if the fluorescent lights tend to produce a light of a single color, eye strain and resulting headaches may occur (Figure 1). BEH staff observed the light system in the ceiling

of the building “flickering” during operation and the light bulbs tend to emit green spectrum light. In this situation, the existence of glare and flickering monochromatic light can have a significant influence on the development of eye strain and headaches. At the time of the assessment, both the ceiling mounted fluorescent lights as well as workstation florescent lights had this flickering problem.

6. Ensure that all cracked and broken ceiling tiles are replaced and that they fit snugly within their frames.
7. In order to reduce glare and the flickering of fluorescent lights, it is recommended that each workstation have a light with an incandescent light bulb. Incandescent lamps do not

flicker and also emit chromatic light, which will help to both wash out the fluorescent light flickering and monochromatic light.

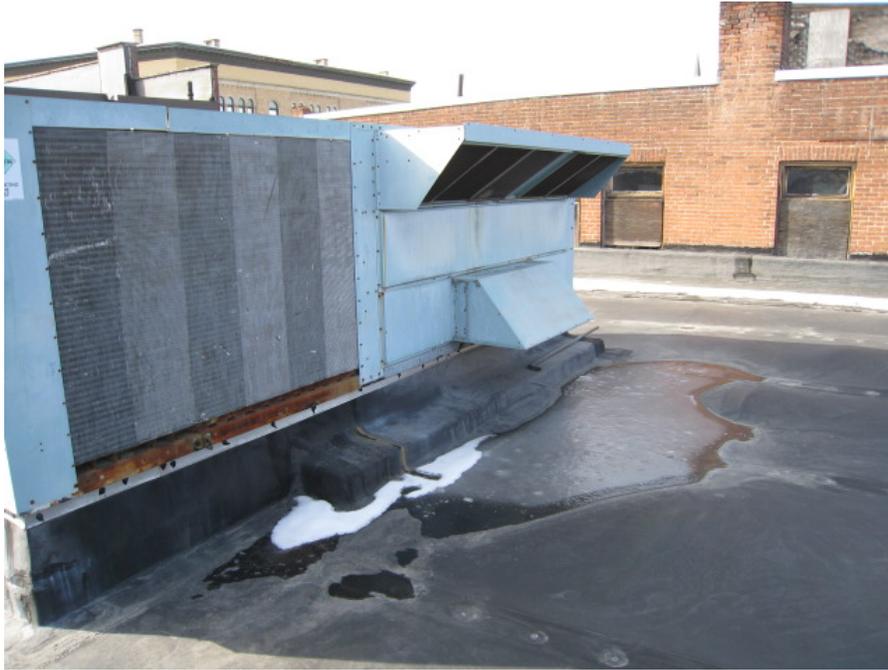
Picture 1

Several potential sources of water damage and/or mold growth were observed at the time of the assessment. Standing water was evident on the rubber membrane roof (Pictures 1 through 4). In addition, the rubber membrane had become detached from the roof decking, creating a bulging effect (Picture 4). The freezing and thawing of water during winter months can lead to roof leaks and subsequent water penetration through seams and/or membrane damage into the interior of the building. This phenomenon has occurred in the central area of the office space where chronic water leaks reportedly occur over desks. The location of this chronic water penetration is directly below the AHU on the roof, where frozen puddles of water were observed (Picture 1). The pooling water is likely damaging the roof membrane resulting in water penetration down the ductwork and wetting ceiling tiles.

Rooftop AHU, Note Standing Water in Close Proximity to Unit

3. Eliminate standing water from the roof. Make roof repairs to eliminate bulging and membrane damage.
4. Ensure roof drains are routinely inspected and maintained.

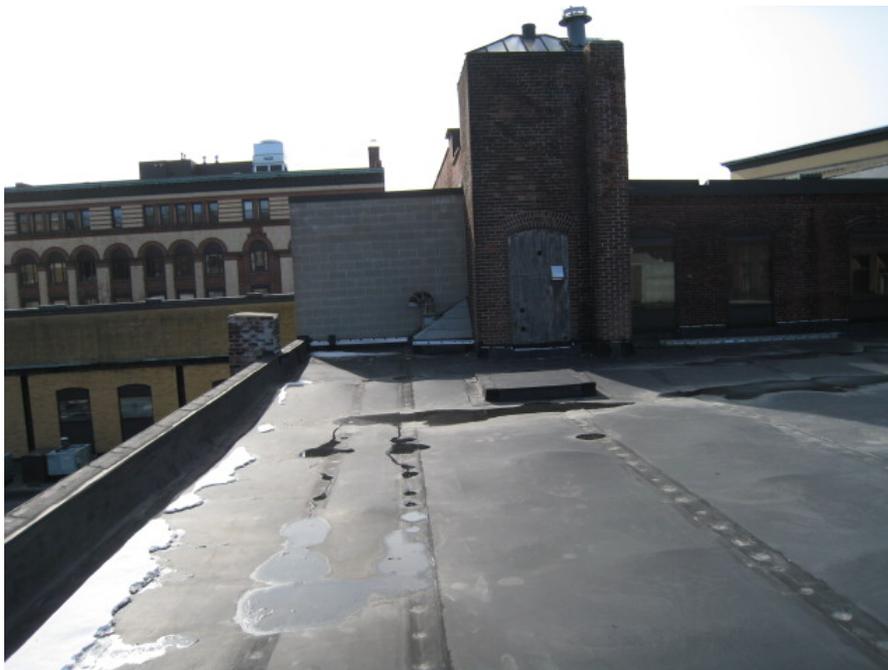
Picture 2

Standing Water on Roof

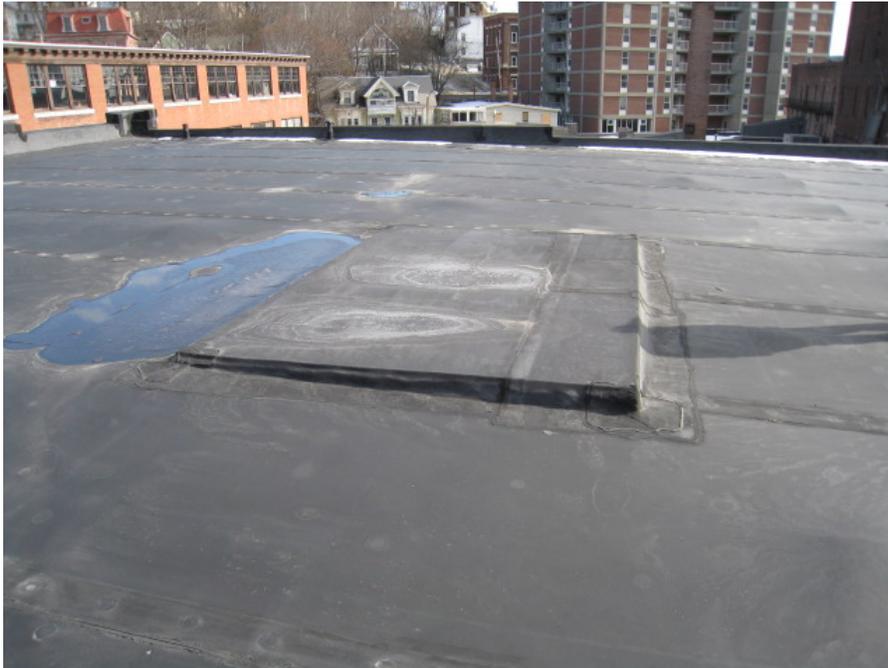
Picture 3

Standing Water on Roof

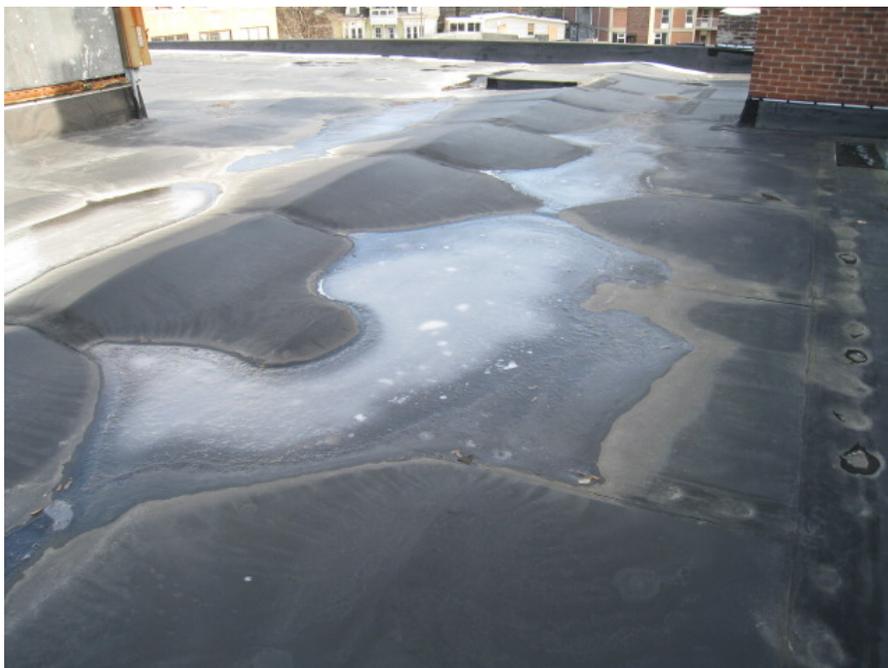
Picture 4

Standing Water and Bulging Roof Membrane

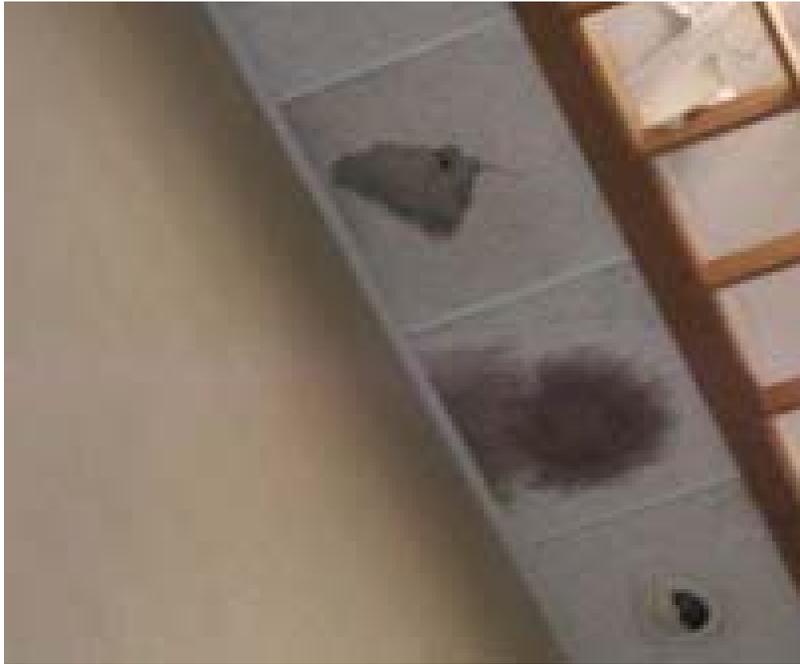
Picture 5

Upon entering the building, a musty odor was detected. Ceiling tiles in the hallway adjacent to a skylight showed significant water damage and discoloration (Picture 5). Water-damaged ceiling tiles can indicate sources of water penetration and provide a source of mold. Ceiling tiles should be replaced after a water leak is discovered and repaired.

Water-Damaged Ceiling Tile and Wall

5. Ensure leaks are repaired and replace water-damaged ceiling tiles. Examine the area above and around these areas for mold growth. Disinfect areas of water leaks with an appropriate antimicrobial.
