INDOOR AIR QUALITY REASSESSMENT

**Helen Mae Sauter Elementary School
130 Elm Street
Gardner, Massachusetts**

Prepared by:
Massachusetts Department of Public Health
Bureau of Environmental Health
Indoor Air Quality Program
September 2010

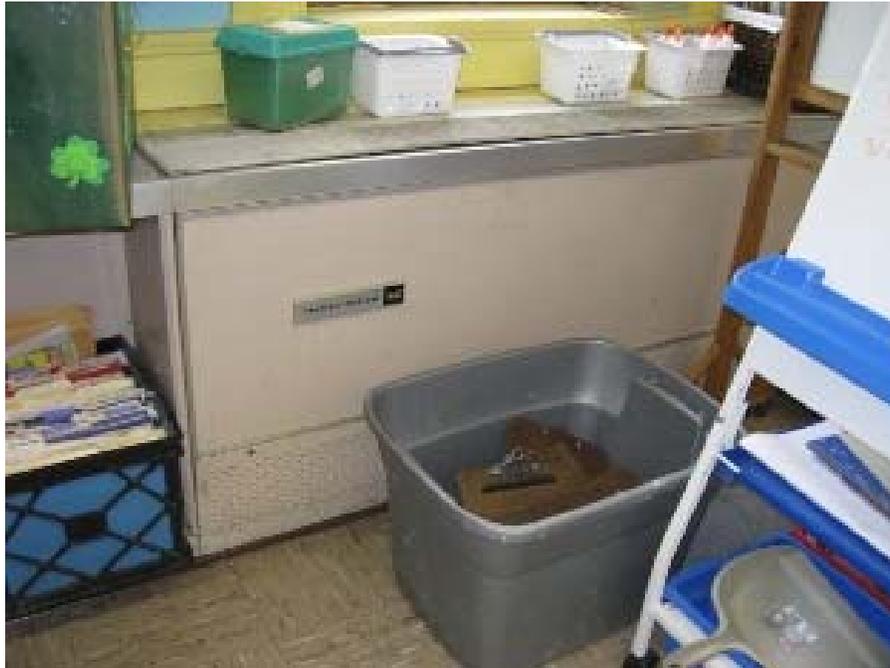
Picture 1

univents were seen in some areas (Picture 1/Table 1). In order for univents to provide fresh air as designed, units must be activated and remain free of obstructions.

Obstructed Unit Ventilator

5. Remove all blockages in classrooms from univents and exhaust vents to ensure adequate airflow.
6. Use openable windows in conjunction with mechanical ventilation to facilitate air exchange. Care should be taken to ensure windows are properly closed at night and weekends to avoid the freezing of pipes and potential flooding during winter months.

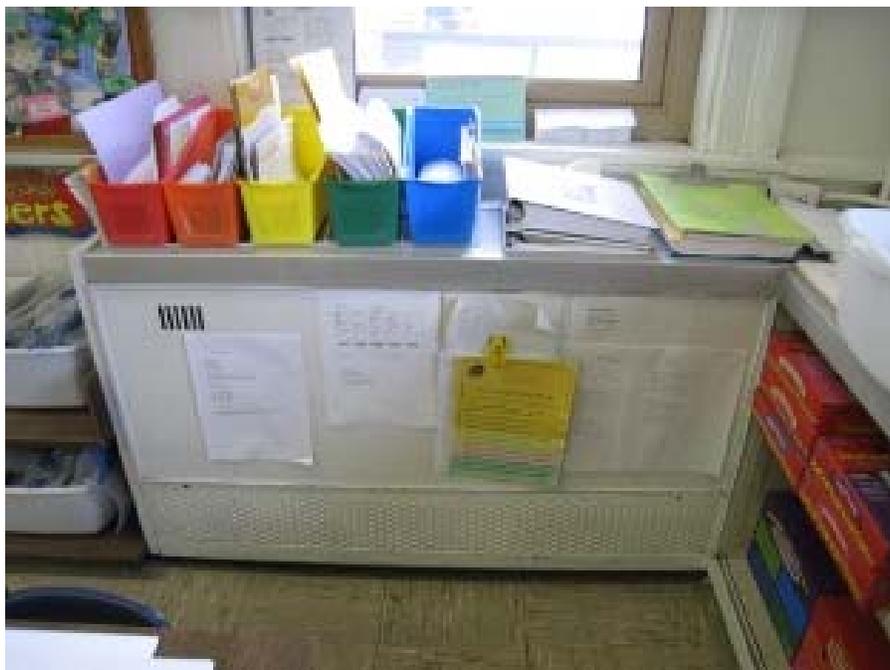
Picture 2

Exhaust ventilation is provided by unit exhaust vents (Picture 2). This equipment contains two fans that draw air from the building, several of which were not operating during the assessment. Without functional exhaust ventilation, environmental pollutants can accumulate within the building and lead to air quality/comfort complaints.

Unit Exhaust Vent

3. Ensure exhaust vents are operational, make repairs as needed.
4. Once repairs are made, operate all ventilation systems throughout the building (e.g., gym, cafeteria, classrooms) continuously during periods of occupancy.

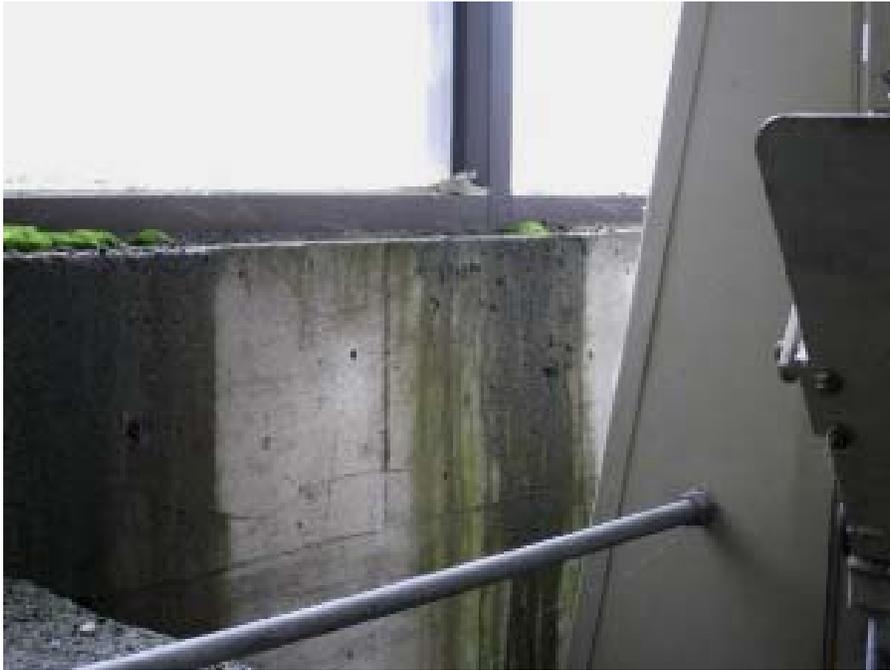
Picture 3

- Evidence of current water leakage in the chair lift enclosure (Picture 3). Heavy accumulation of moss was observed on the interior and exterior of the enclosure (Picture 4). Moss was also observed on exterior window sealant and on windows. The presence of moss as shown in Picture 4 is indicative of chronic water exposure;

**Water Infiltrating into Chair Lift Enclosure,
Note Moss Accumulation**

11. Eliminate water leakage into chair lift enclosure.
12. Routinely remove organic debris from floor/walls of chair lift enclosure and ensure drain remains unobstructed. Inspect/clean periodically.

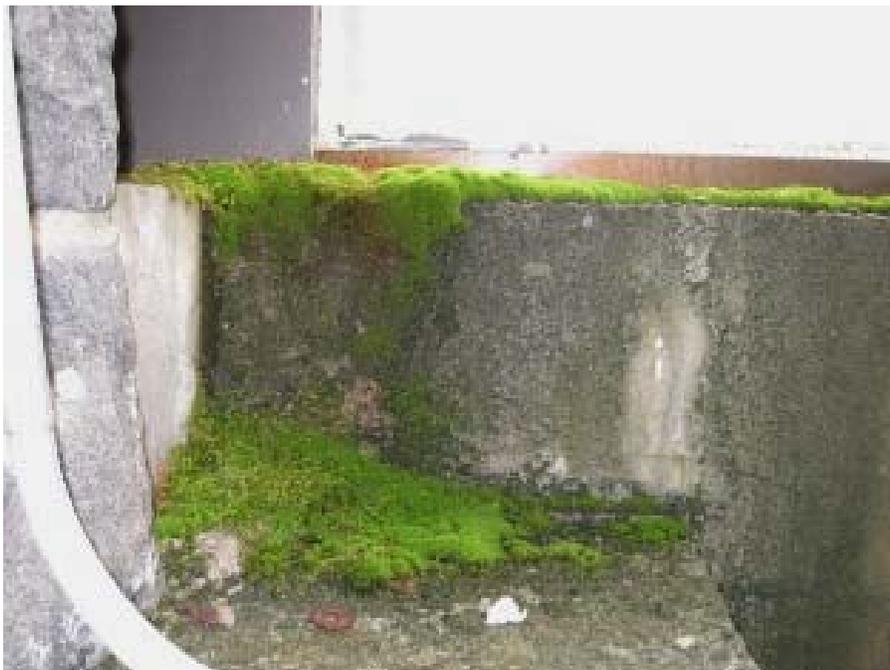
Picture 4

Moss Growth on Interior of Chair Lift Enclosure

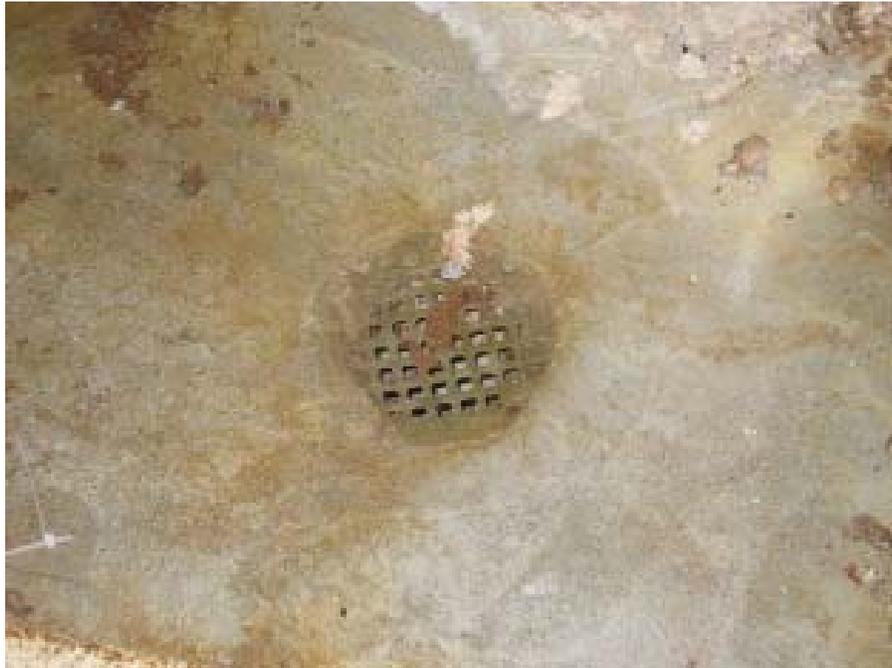
Picture 5

- The bottom of the chair lift enclosure was littered with organic debris, some of which was partially obstructing the drain at the base of the enclosure (Picture 5);

Organic Debris Partially Obstructing Drain in Chair Lift Enclosure

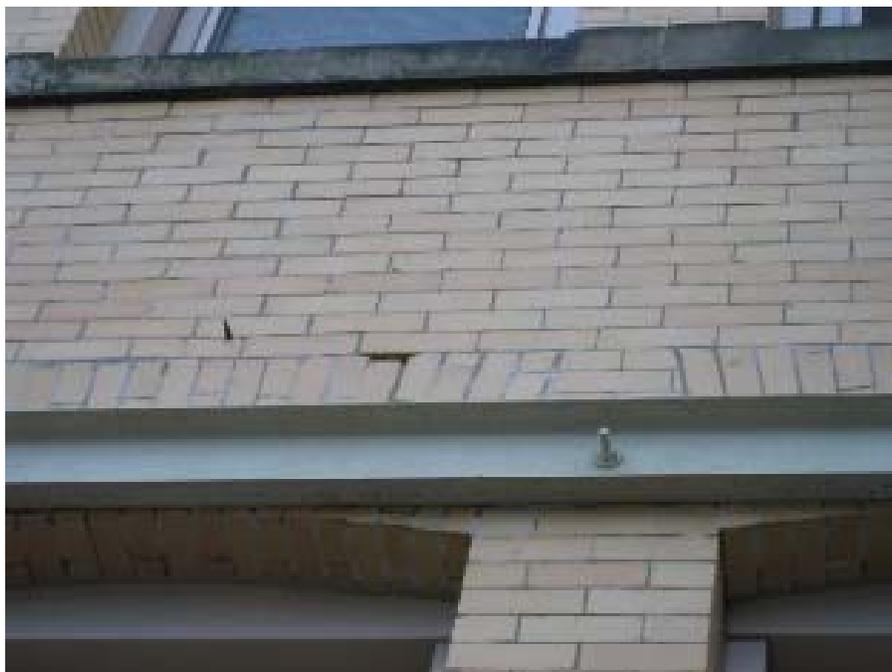
Picture 6

Missing Mortar

13. Repair all cracked, missing mortar, with particular attention to the junction of the original building and the foundation of the chair lift enclosure.

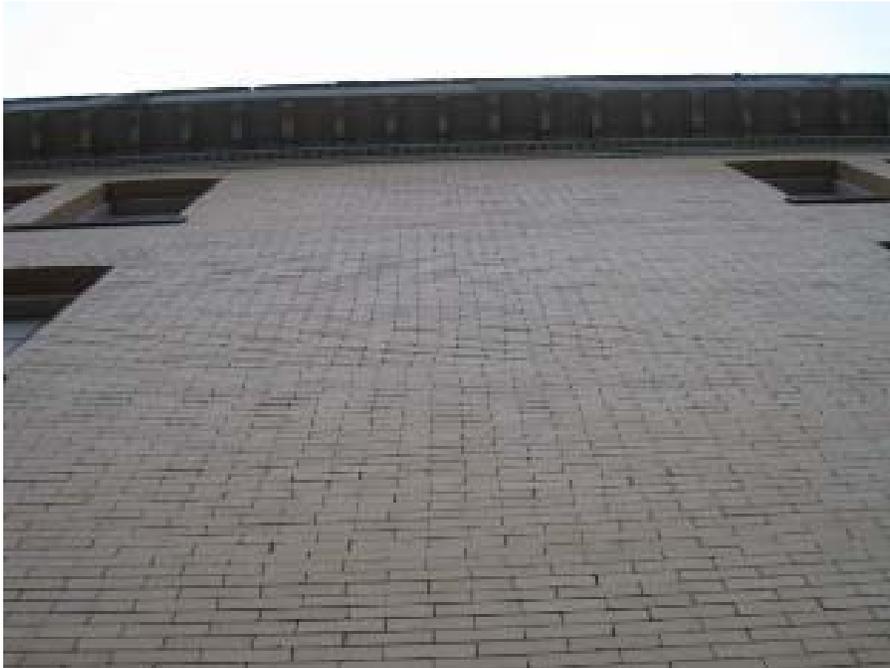
Picture 7

Bulging, Uneven Masonry Surface

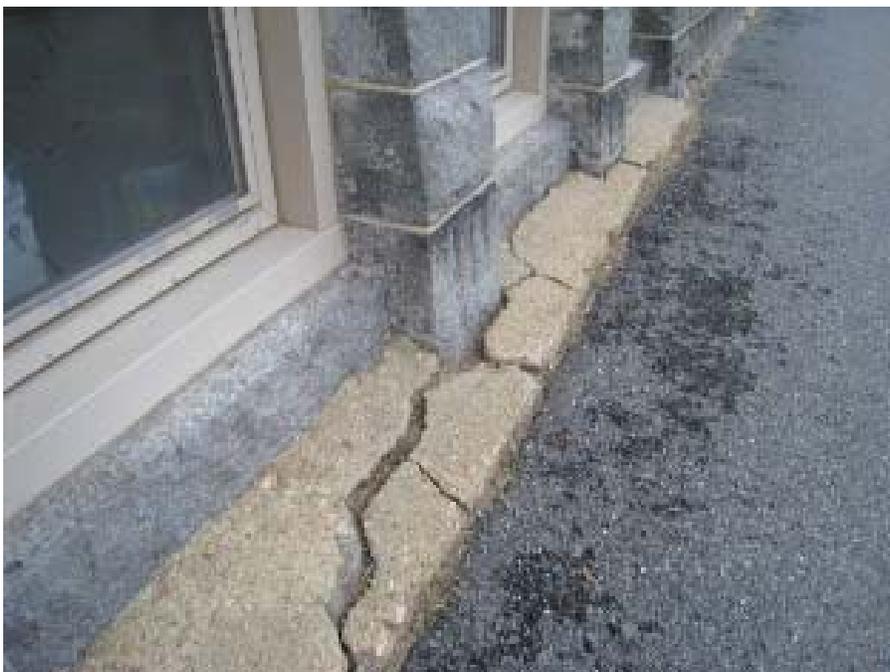
Picture 8

Numerous Cracks in Concrete Apron

14. Repair/replace deteriorated concrete apron.
15. Eliminate pooling water at base of building by re-grading depressed areas and by sloping perimeter landscaping to drain away from the building.

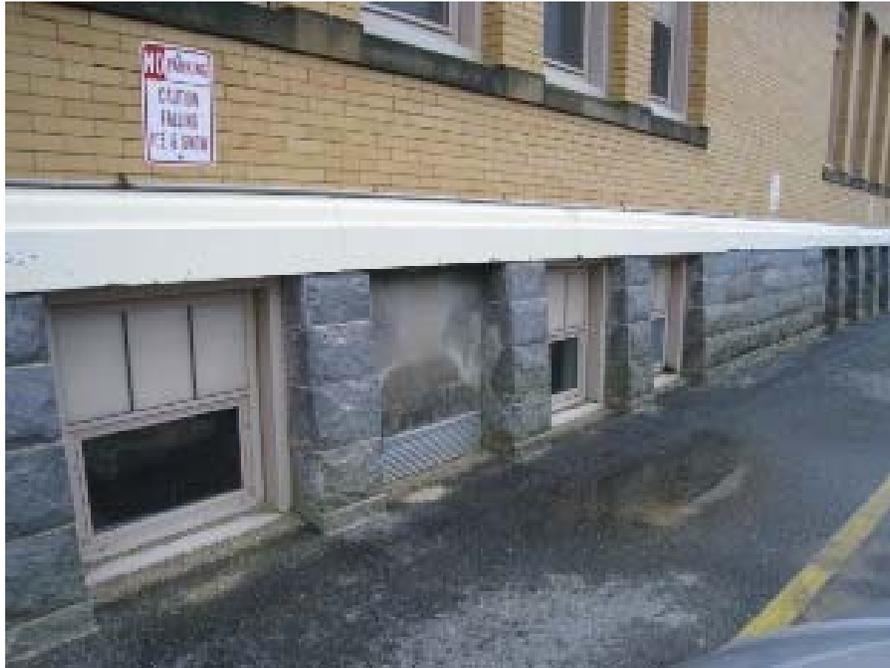
Picture 9

- Pooling/splashing water was observed at the base of the building. The roof edge does not appear to have a gutter/downspout system. Rainwater pours off the roof, which then impacts on the tarmac and wall at the base of the building. Organic debris deposited in the crevices of windows is then moistened, providing a growth media for mosses and grass (Pictures 9 through 11);

Pooling Water and Moistened Wall Due to Splashing

9. Consider providing gutters/downspouts to collect water and deposit at least five feet away from the foundation of the building.
10. Remove organic material (e.g., sand, grass, moss) from exterior windows and adjacent to the wall of building. Inspect/clean periodically.

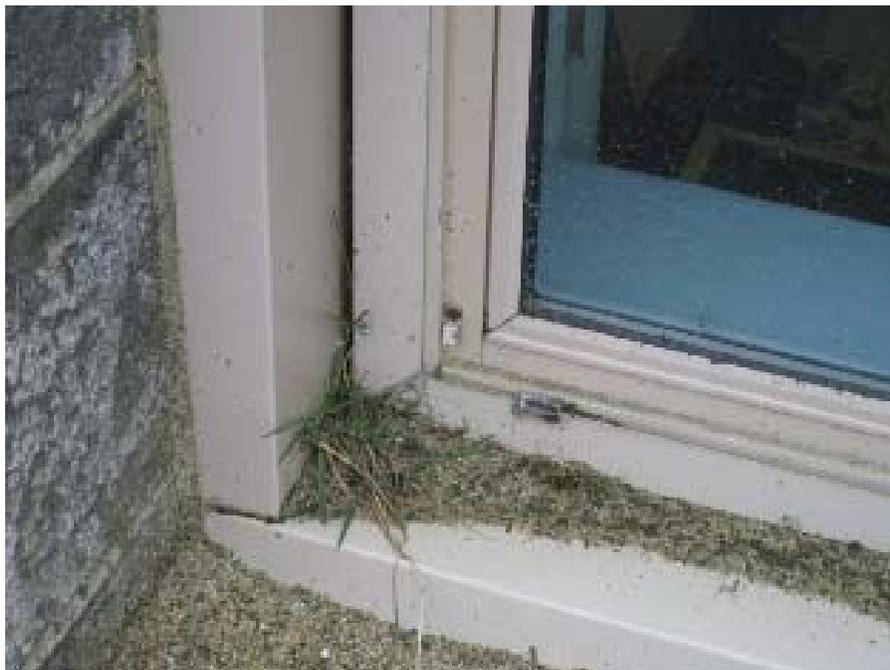
Picture 10

Plant Growth in Window on Moist Organic Material

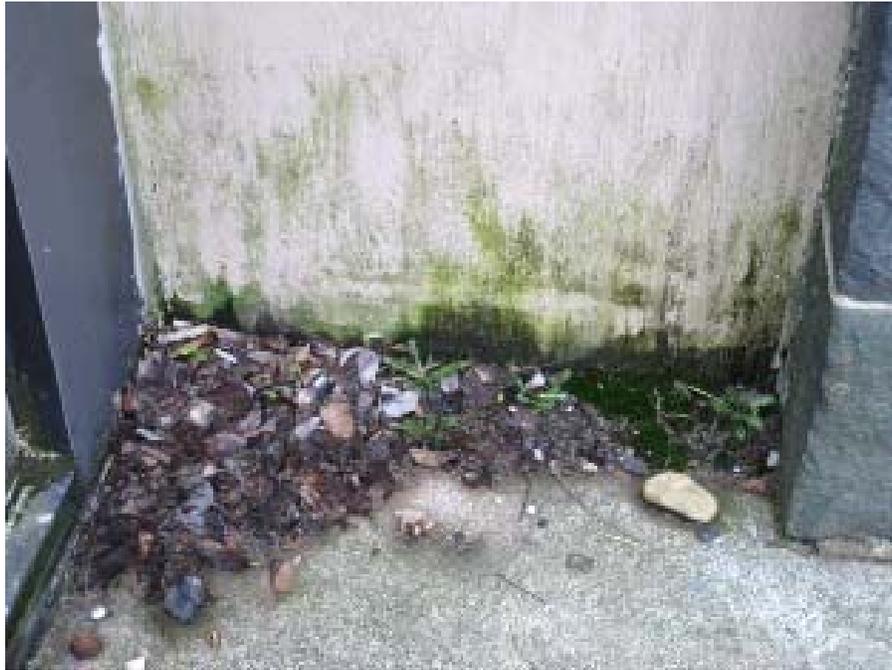
Picture 11

Plant and Moss Growth (Dark Staining on Wall) Adjacent to Moistened Organic Material

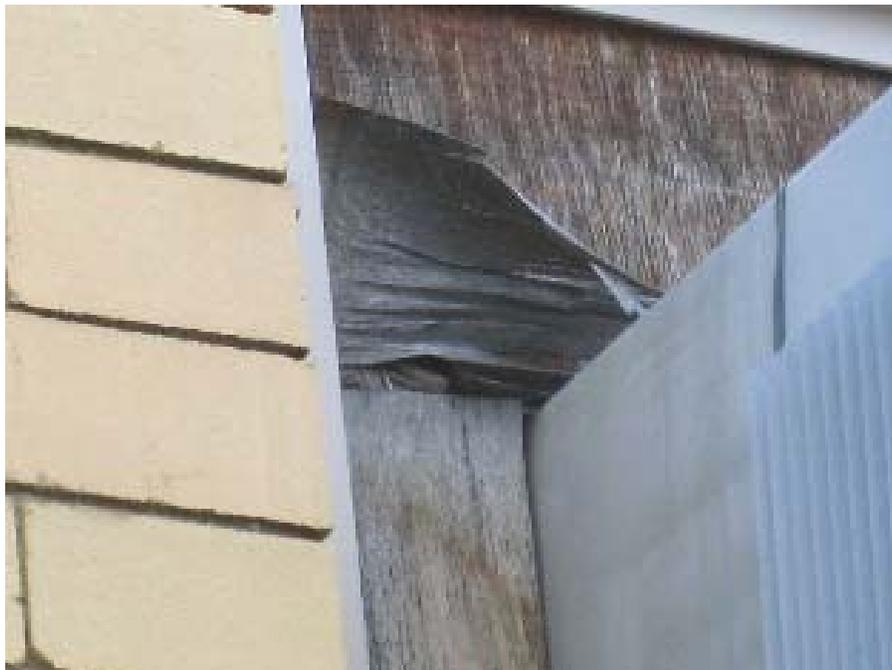
Picture 12

Delaminating Plywood above Window Mounted Air Conditioner

16. Remove/replace delaminating plywood adjacent to AC.
17. Repair/replace cracked exterior masonry windowsills.
18. Replace rotted windowsill in cafeteria window.

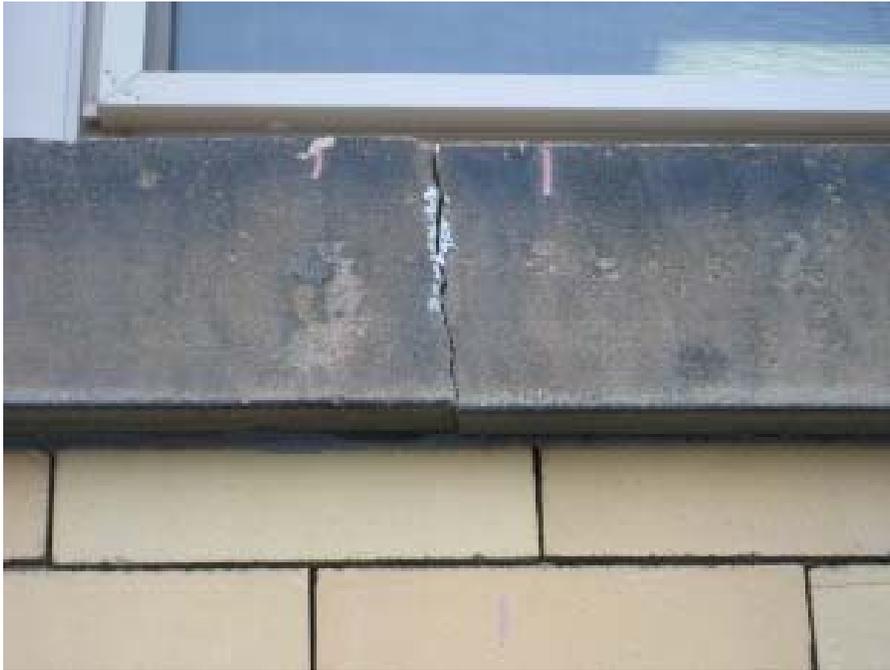
Picture 13

Cracked Exterior Window Sill

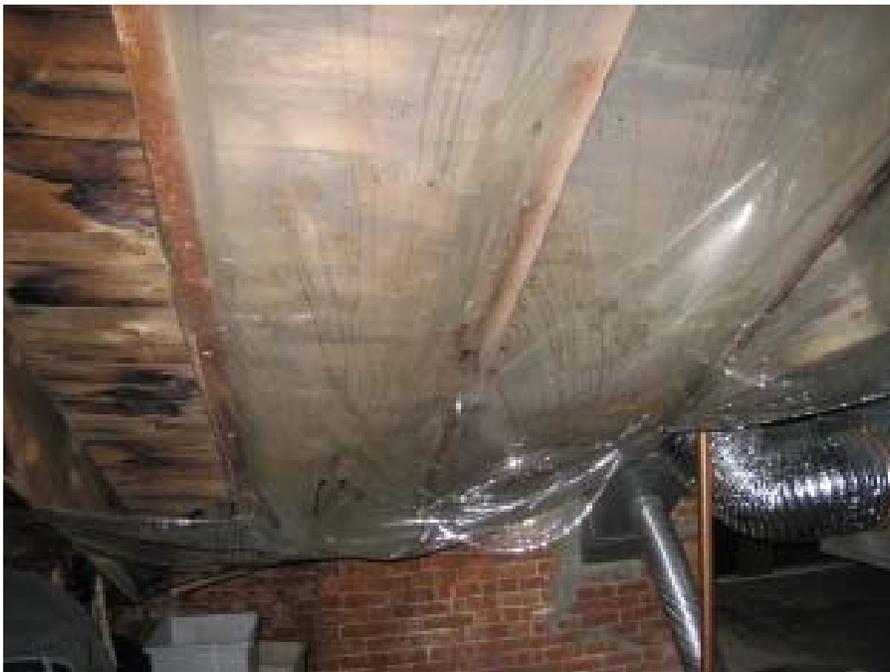
Picture 14

Water damage was evident in numerous areas throughout the interior of the building as well. The roof is in need of repair as evidenced by plastic sheeting installed in the attic to collect and direct rain water into a trash container (Picture 14). Several classrooms had water-damaged ceiling tiles indicating sources of water, such as penetration through the building envelope or leaks from the plumbing system (Pictures 15 and 16). Water-damaged ceiling tiles can provide a source of mold and should be replaced after a water leak is discovered and repaired. Some water-damaged ceiling tiles had been saturated and removed, while others had been painted over (Picture 17).

Plastic Sheeting Directing Water Infiltration to Plastic Trash Receptacle

19. Repair any existing roof and plumbing leaks and remove and replace any remaining water-damaged ceiling tiles. Discontinue practice of painting water-damaged ceiling tiles. Examine the area above these tiles for mold growth. Disinfect areas of water leaks with an appropriate antimicrobial, as needed.

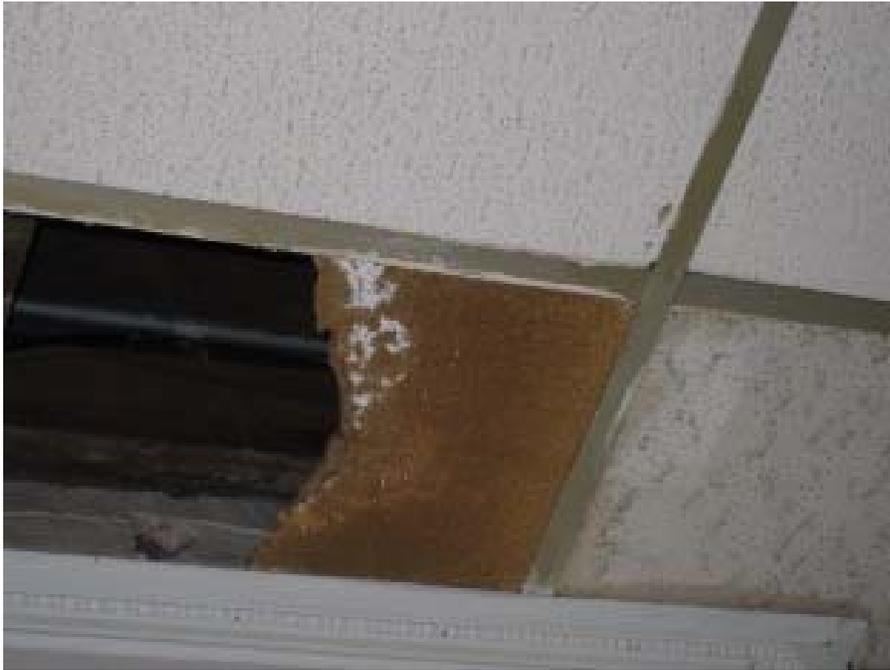
Picture 15

Previously Saturated Section of Broken Ceiling Tile

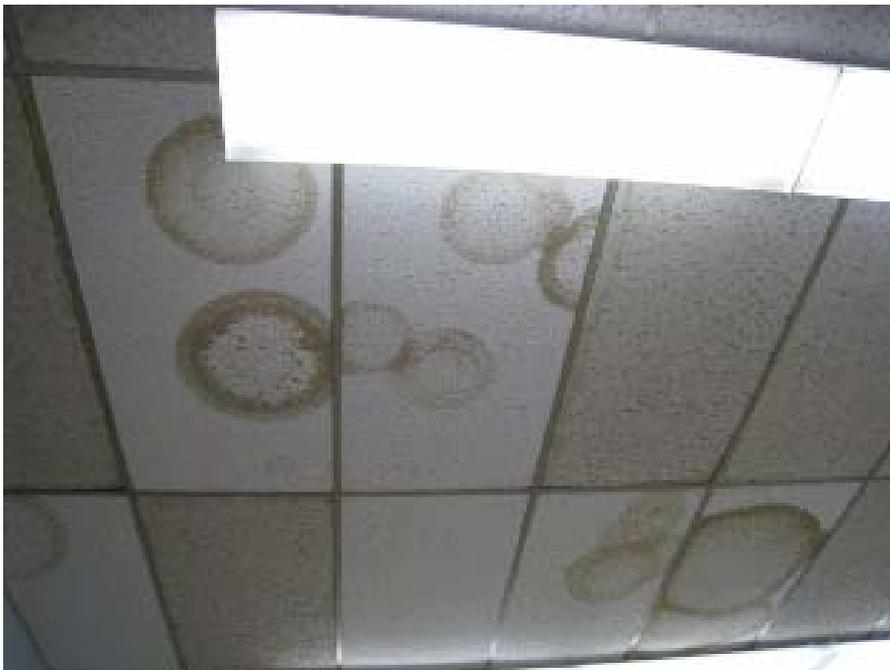
Picture 16

Numerous Previously Replaced Water-Damaged Ceiling Tiles

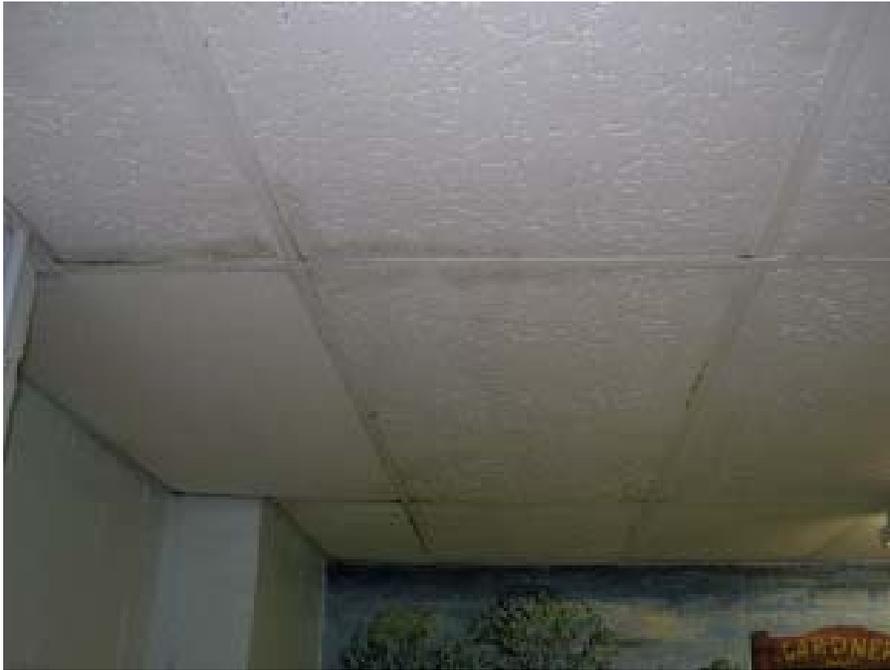
Picture 17

Water-Damaged Ceiling Tiles Appear to have been Repainted

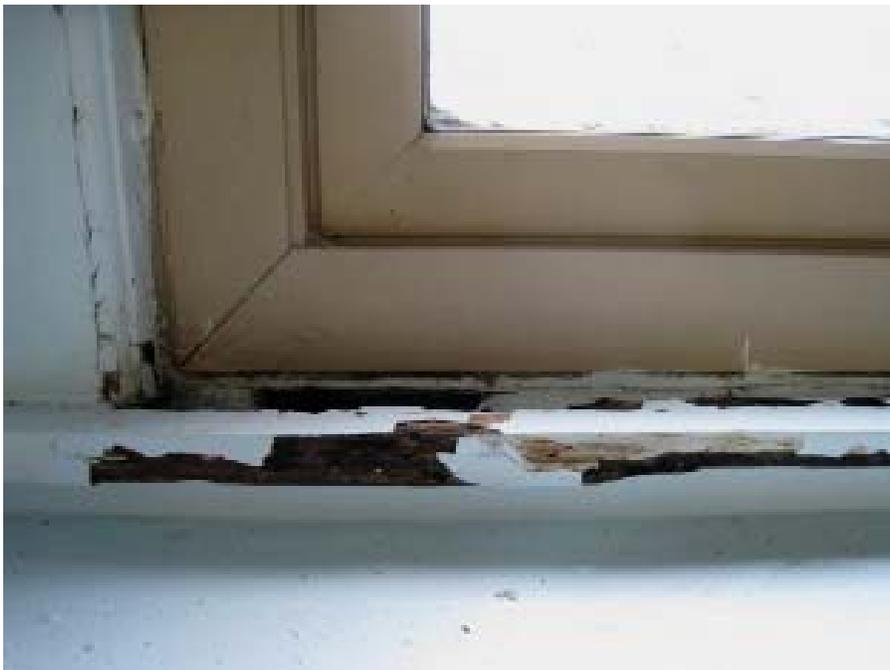
Picture 18

The basement exhibited numerous issues potentially related to penetration of moisture through the building envelope. A rotted windowsill was observed in the basement cafeteria (Picture 18). Peeling paint and efflorescence¹ was observed on basement walls (Picture 19). Peeling paint was observed on the cafeteria floor, adjacent to the entrance ramp, presumably

Water-Damaged/Rotted Sill

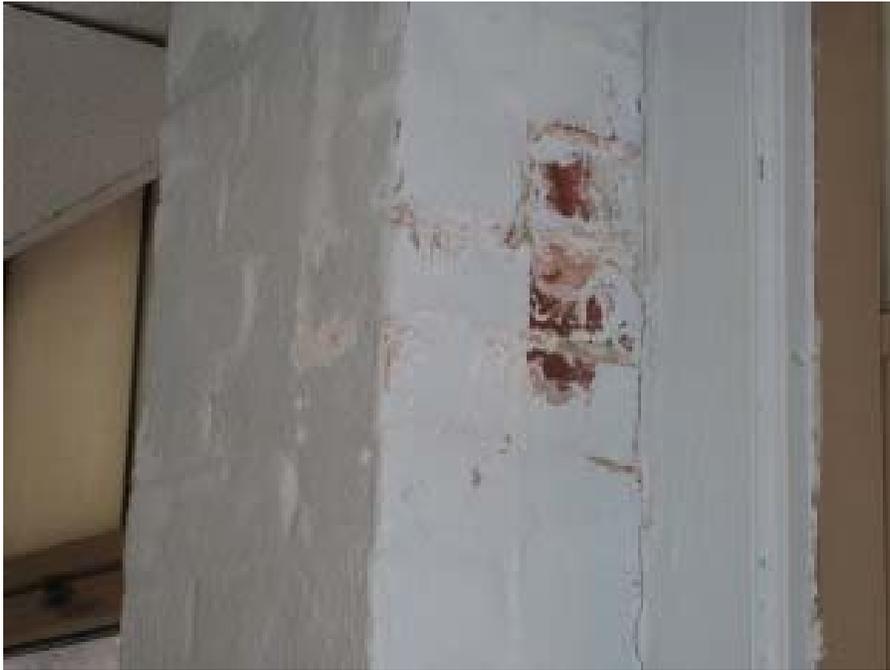
Picture 19

Peeling Paint and Efflorescence

20. Investigate and repair source(s) of water infiltration into basement.
21. Ensure plants are equipped with drip pans and are not located on porous materials (e.g., paper towels). Examine drip pans periodically for mold growth and disinfect with an appropriate antimicrobial, as needed. Ensure plants are located away from fresh air supply sources.

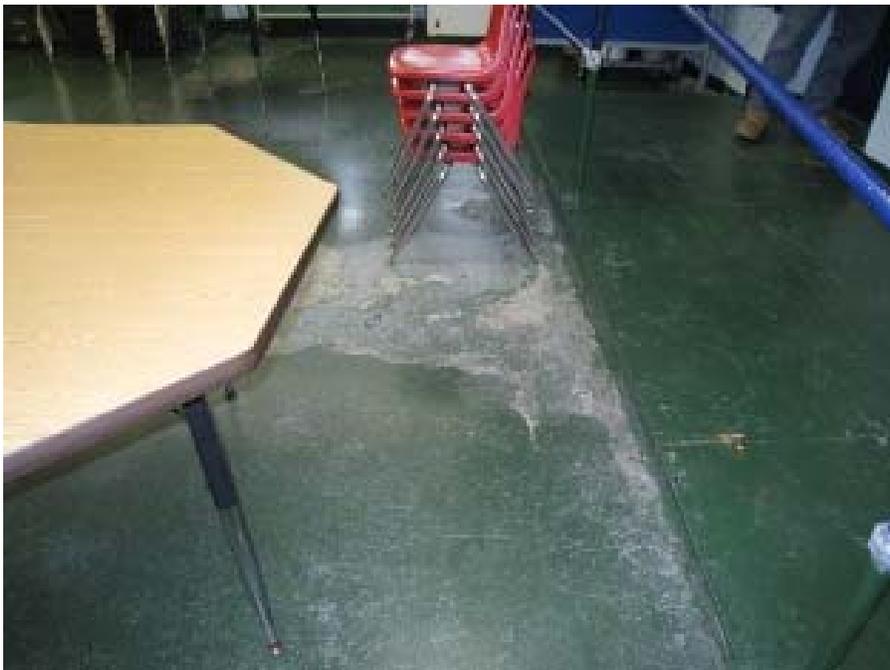
Picture 20

from water infiltration from the door leading to the chair lift enclosure (Picture 20). Evidence of chronic water penetration was also observed in the mechanical room. Finally, water-damaged window coverings were observed (Picture 21), indicating window leaks.

Peeling Paint on Basement Floor Adjacent to Ramp

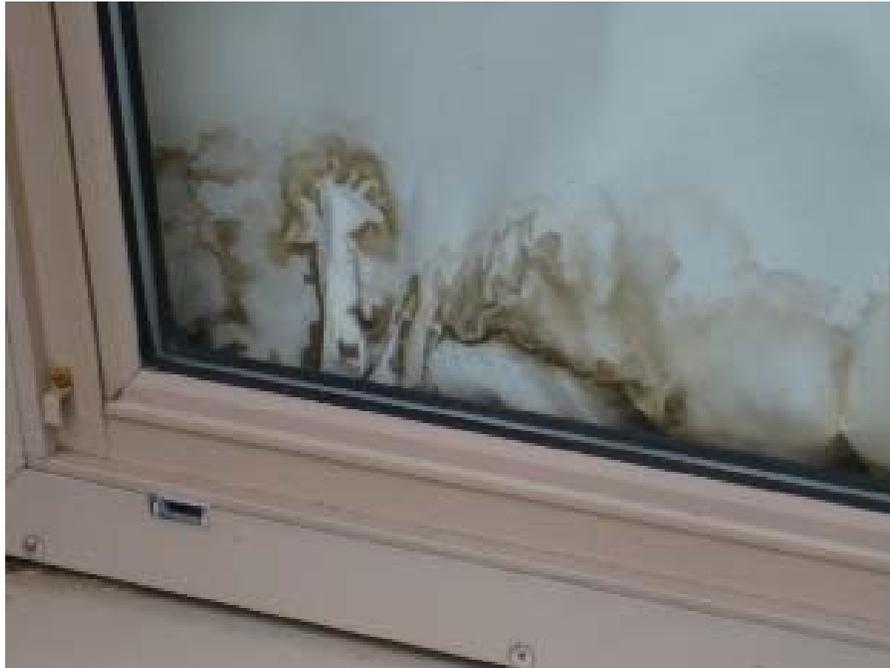
Picture 21

Water-Damaged Window Covering

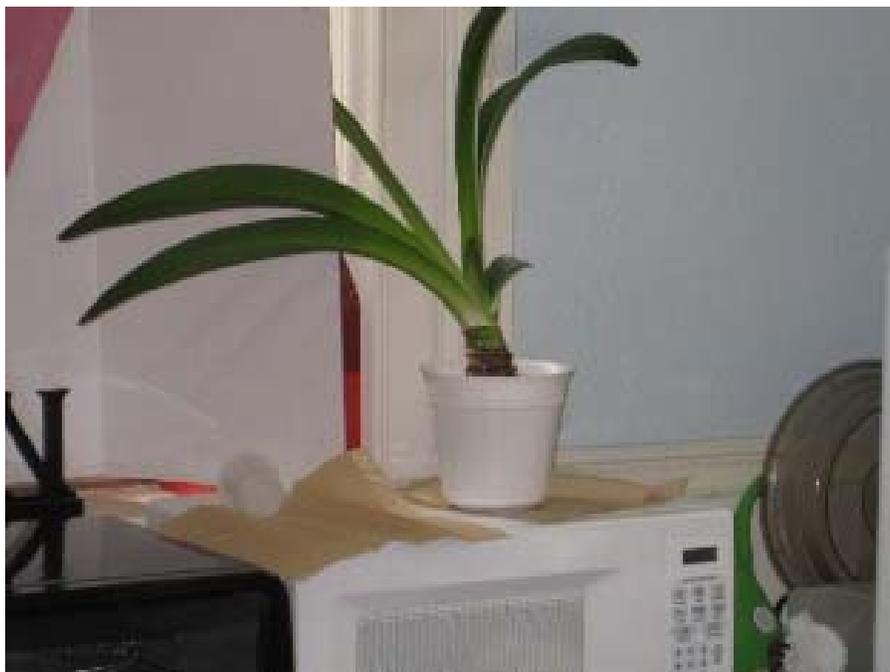
Picture 22

Plants were noted in several classrooms, one of which was resting on a paper towel (Picture 22), which is a porous material susceptible to mold growth. Plants can be a source of pollen and mold which can be respiratory irritants to some individuals. Plants should be properly maintained and equipped with drip pans and should be located away from ventilation components to prevent the aerosolization of dirt, pollen and mold.

Plant Resting on Paper Towel

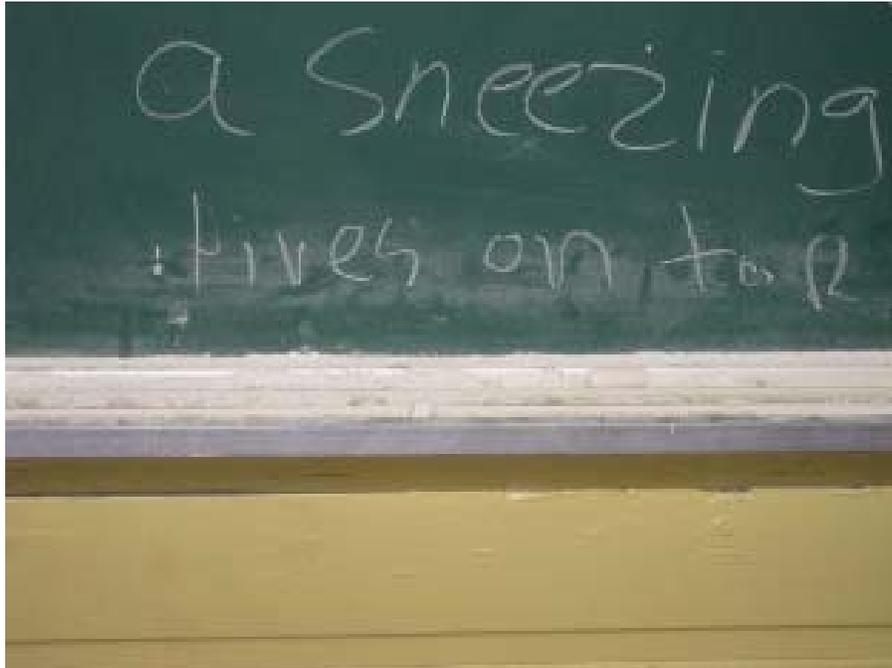
Picture 23

was noted in many classrooms (Picture 23). Chalk dust is a fine particulate, which can be easily aerosolized and serve as an eye and respiratory irritant. Dust accumulation was also observed on the blades of several personal fans, and within the interior of some univents. These items should be routinely cleaned in order to prevent dust/debris from being aerosolized and redistributed throughout the room.

Heavy Accumulation of Chalk Dust in Tray

22. Routinely clean chalk/dry erase boards and trays.
23. Refrain from using air fresheners or other air deodorizers.
24. Consider installing local exhaust ventilation in areas using lamination machines and photocopiers or relocate to well-ventilated area. In the interim, consider opening a window and operating a fan in a manner that removes excess heat and odors when operating this equipment.

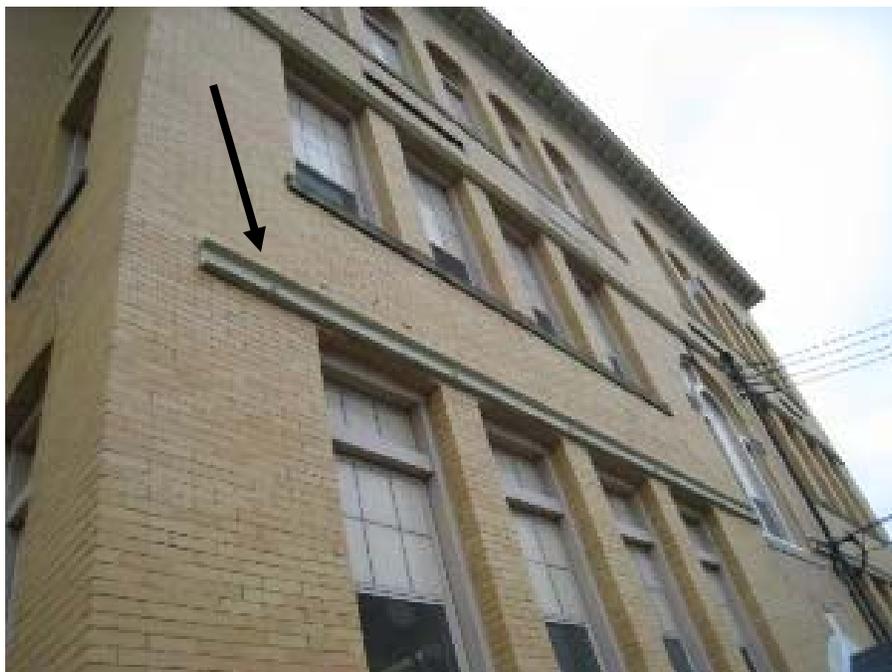
Picture 24

A steel beam was observed on the exterior of the building, which was likely installed as an attempt to stabilize the exterior structure at some point (Picture 24). It may be prudent to consider contracting with a structural engineer to examine the building to ensure its structural integrity.

Steel Beam Installed on Exterior Masonry (Arrow)

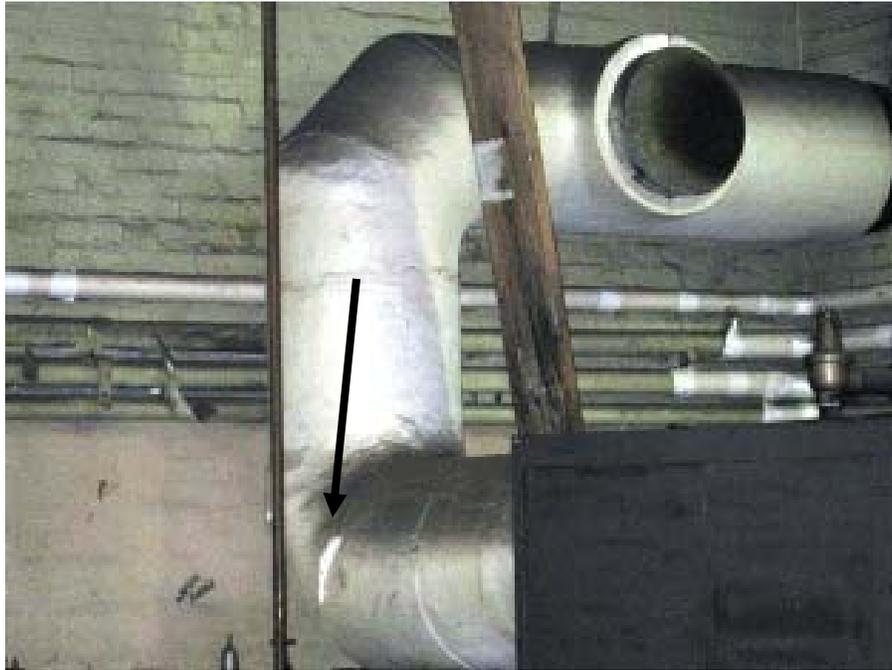
Picture 25

Damaged or/or missing floor tiles were observed in some areas. These floor tiles may contain asbestos. In addition, a white insulating material in the boiler room was also observed to be in some disrepair and may contain asbestos (Picture 25). Intact asbestos-containing materials (ACM) do not pose a health hazard. If damaged, ACM can be rendered friable and become aerosolized. Friable asbestos is a chronic (long-term) health hazard, but will not produce acute (short-term) health effects (e.g., headaches) typically associated with buildings believed to have indoor air quality problems. Where asbestos-containing materials are found damaged, these materials should be removed or remediated in a manner consistent with Massachusetts asbestos remediation laws (MDLI, 1993).

Cracked Insulating Material (Arrow)

30. Ensure compliance with the Asbestos Hazard Emergency Response Act (AHERA).
31. Remediate damaged ACMs (e.g., floor tiles, pipe insulation) throughout the building in conformance with Massachusetts asbestos remediation and hazardous waste disposal laws and regulations.
