INDOOR AIR QUALITY ASSESSMENT

**Milton Department of Public Works
629 Randolph Ave
Milton, Massachusetts**

Prepared by:
Massachusetts Department of Public Health
Bureau of Environmental Health
Indoor Air Quality Program
June 2010

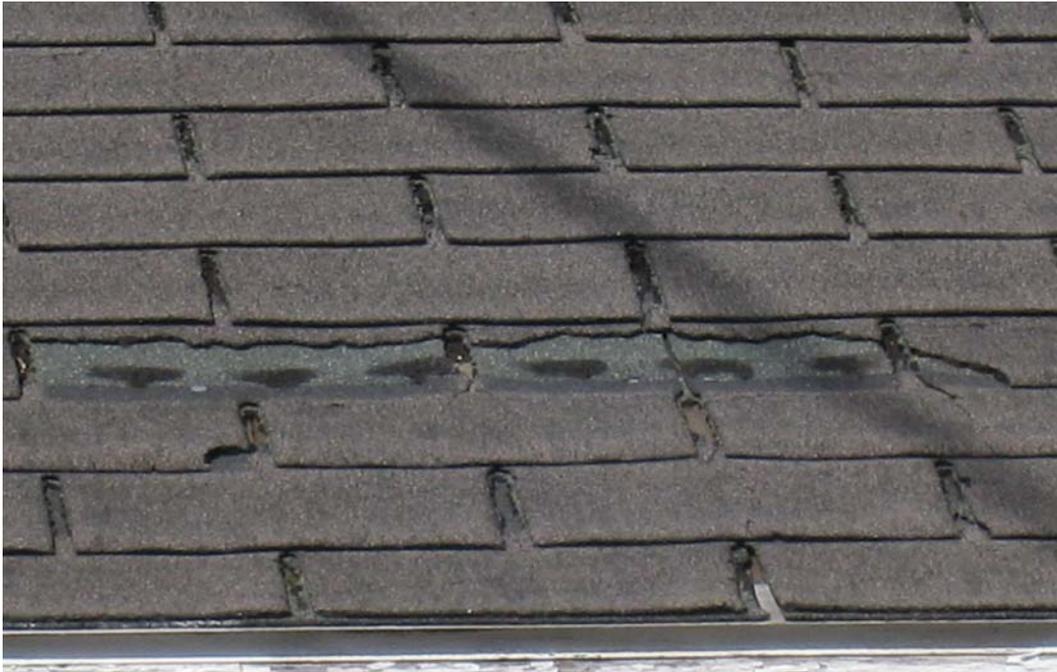
Picture 1

In order for building materials to support mold growth, a source of water exposure is necessary. It appears that the DPW has had chronic issues with water penetration through the building envelope, mainly in the form of roof leaks and water penetration through the foundation. It was reported that roof repairs and drainage improvements have been conducted in recent years, which have improved conditions; however significant signs of water damage remain in both the attic and basement. The roof is reportedly over 20 years old, which is near the end of its useful lifespan. Although the roof has been patched/repaired, damaged/degraded shingles and flashing exist in several areas (Picture 1).

Missing/Damaged Roof Shingles

3. Replace missing/damaged roof shingles.
4. Repair/replace faulty/leaking roof flashing.
5. Continue to monitor areas of the building for roof leaks, make repairs and change ceiling tiles as necessary. Disinfect areas of water leaks with an appropriate antimicrobial.

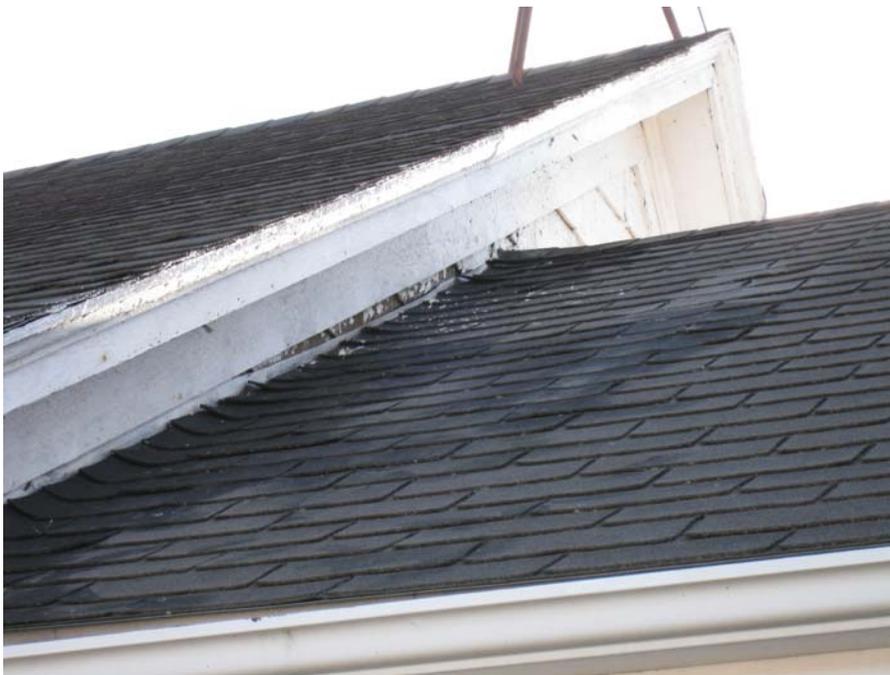
Picture 2

- Missing/damaged flashing along the roof (Picture 2);
- Damage creating spaces between wooden shingles was observed (Picture 3);
- Paint on exterior fascia board and walls had chipped/peeling paint, exposing wood fibers to moisture which can accelerate decomposition (Pictures 4 and 5);
- Open utility holes (Picture 5), and
- Signs of past water pooling in the basement in the form of efflorescence. Efflorescence is a characteristic sign of water damage but it is not mold growth. As moisture penetrates and works its way through mortar, brick or plaster, water-soluble compounds dissolve,

Missing/Damaged Flashing along Roof Junction

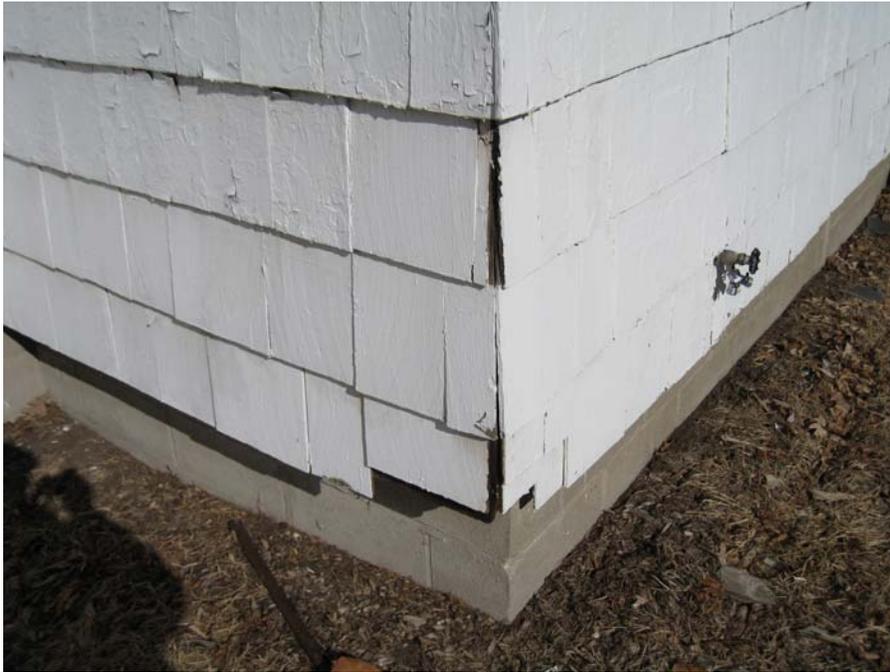
Picture 3

Damaged Wooden Shingles

6. Repair rotted, cracked and broken wooden clapboards/shingles.
7. Repaint exterior surfaces that exhibit peeling paint.
8. Seal open utility holes and other breaches around exterior of building.

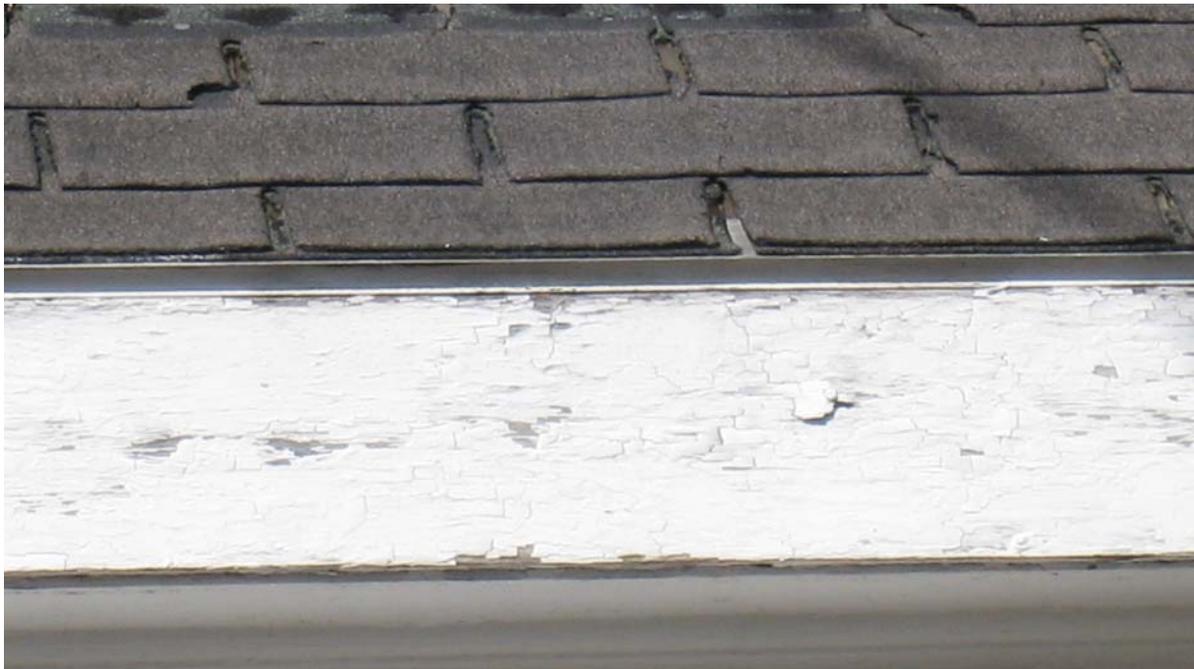
Picture 4

Chipped/Peeling Paint on Fascia Board

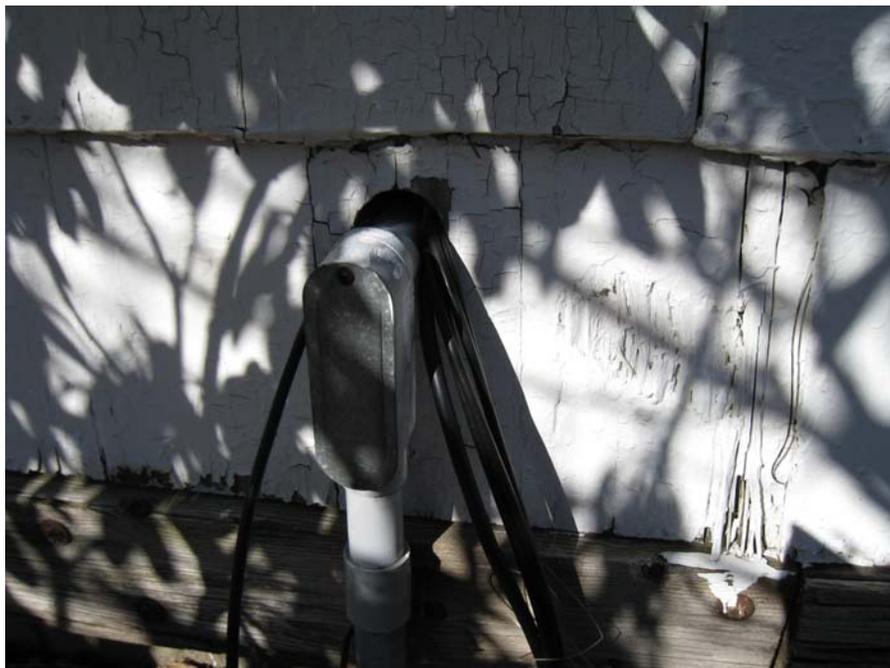
Picture 5

Utility Hole and Chipped/Peeling Paint
