Mold/Water Damage Investigation

**Princeton Town Hall
6 Town Hall Drive
Princeton, Massachusetts**

Prepared by:
Massachusetts Department of Public Health
Bureau of Environmental Health
Indoor Air Quality Program
December 2010

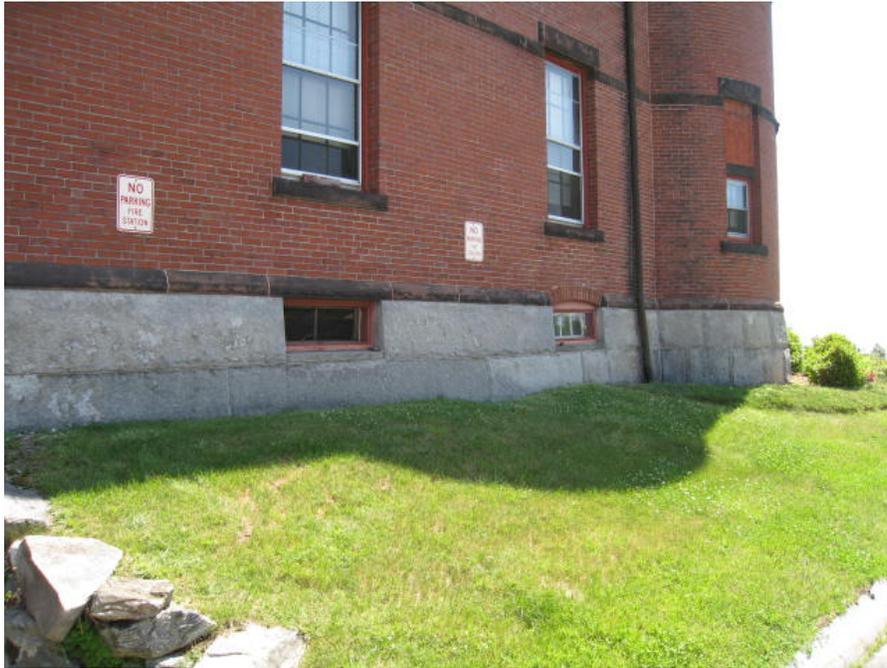
Picture 1

Southern Wall Basement Windows

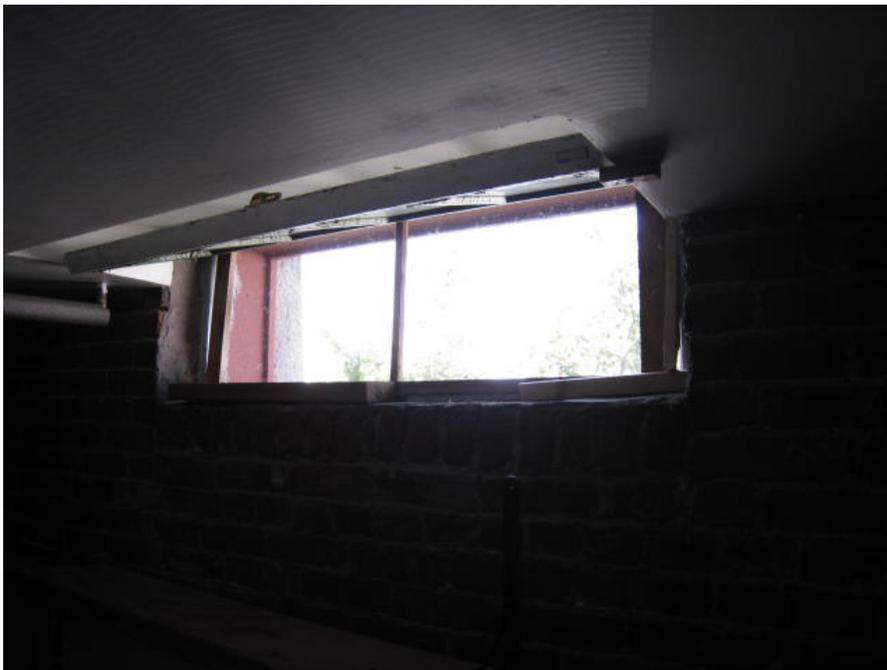
Picture 2

- The basement appears to have its north exterior windows sealed/buried. During the assessment, one window in the south wall of the basement was open with a detectable

draft entering the basement. The original design would have this air movement pressurize the basement, which would have forced air to exit through the north wall windows, if opened. Since the north wall basement windows are sealed/buried, airflow from the open south wall basement window will pressurize the basement and force basement air through any openings in the floor (e.g., heating pipe openings) resulting in musty/wet/basement odors in first floor offices. This phenomenon also exists in the foyer at the rear of the building where the stairs leading to the basement are located. Upon entering the foyer, strong musty odors were detected emanating from spaces around the basement door frame. Basement odors are more likely to be noticeable in office spaces during significant wind conditions.

Open Southern Wall Basement Window, Interior

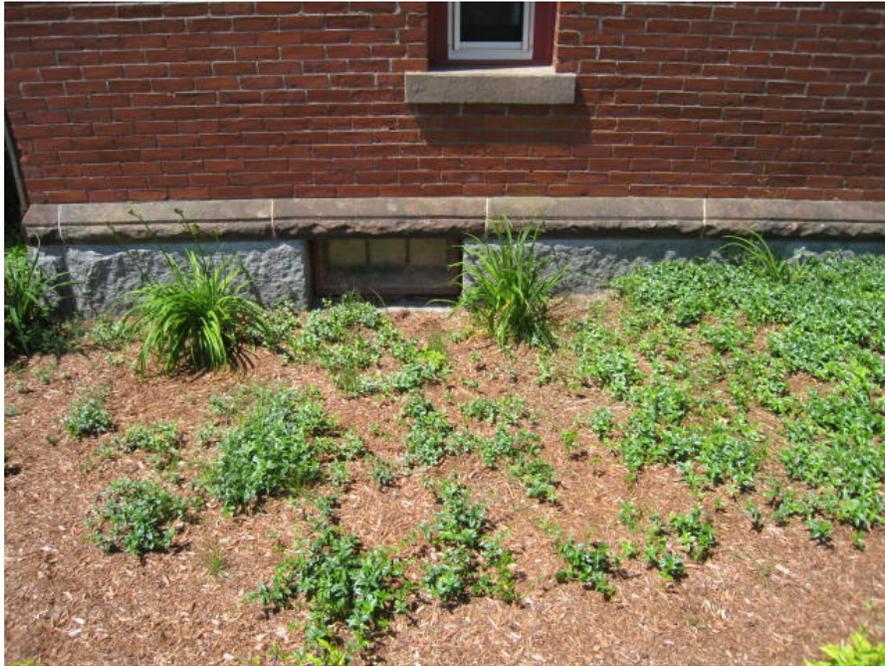
Picture 3

North Wall Basement Window

1. Cross ventilation in the basement should be reestablished in order to prevent musty odors from entering into the first floor office space. This may be accomplished by redesigning the walkway to provide a grid over the buried window so that airflow through the basement north wall can be restored.
2. Consider contacting an HVAC engineering firm to design a mechanical ventilation system to depressurize the basement.
3. All floor penetrations in the office space should be sealed using an appropriate fire-rated sealing compound.

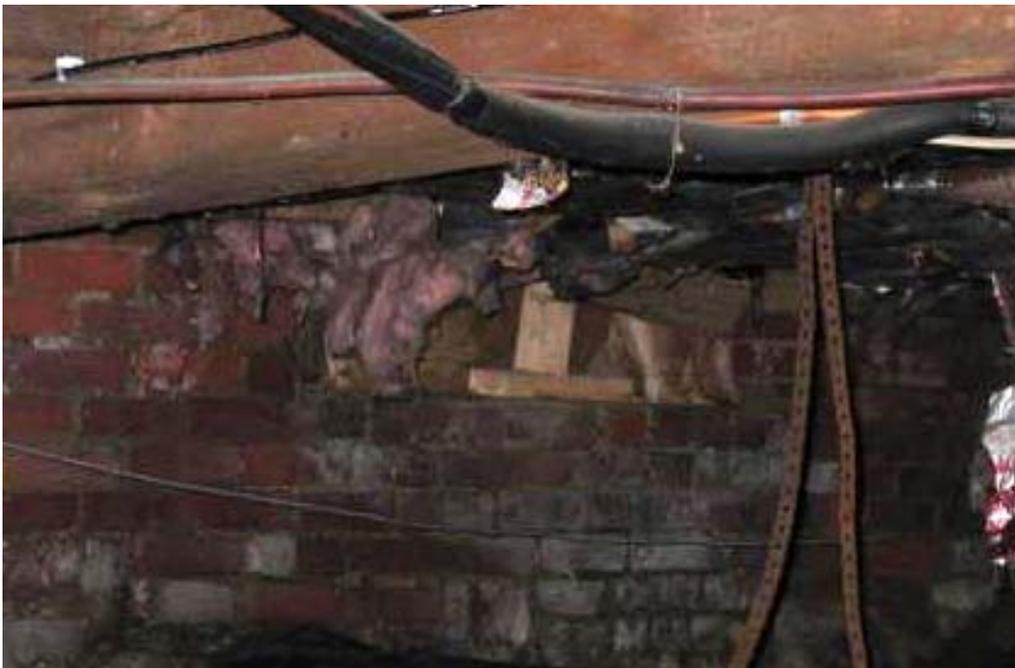
Picture 4

Sealed North Wall Basement Window (Interior view), Note Insulation

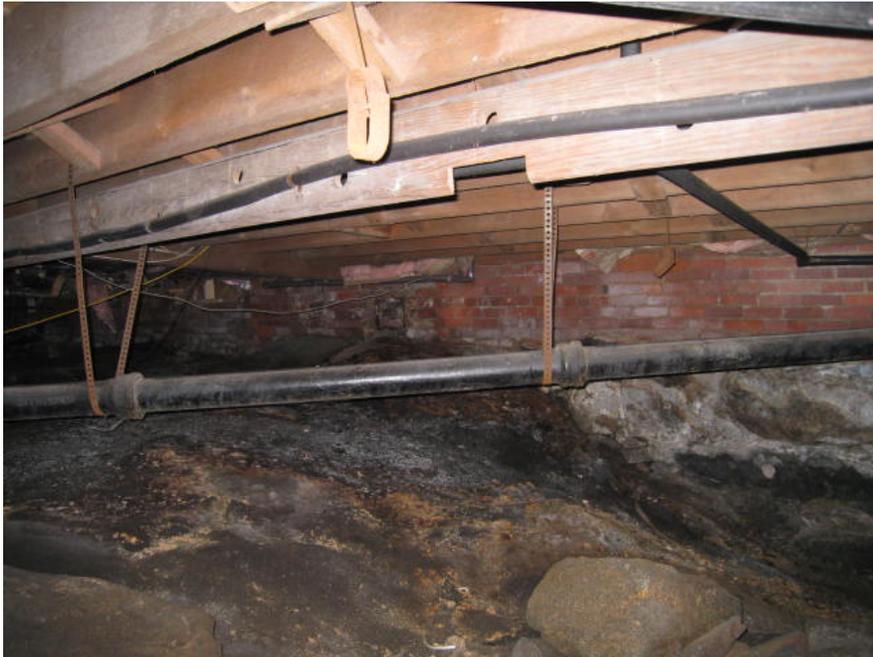
Picture 5

During summer months, ventilation was originally controlled by the use of openable windows. The building was configured in a manner to use cross-ventilation to provide comfort for building occupants. The building is equipped with windows on opposing exterior walls. This design allows for airflow to enter an open window, pass through the large open room, pass through the open office door and exit the building on the leeward side (opposite the windward side) ([Figure 1](#)) if there was a prevailing south/westerly wind. With all windows open, airflow can be maintained in a building regardless of the direction of the wind. This system fails if the windows or doors are closed ([Figure 2](#)). The basement also had windows on the opposing north and south exterior walls (Pictures 1 through 4) and would use cross ventilation to reduce moisture accumulation and odors in the dirt floor/natural stone basement (Pictures 5 and 6).

Irregular Stone Basement Floor, Note Moisture

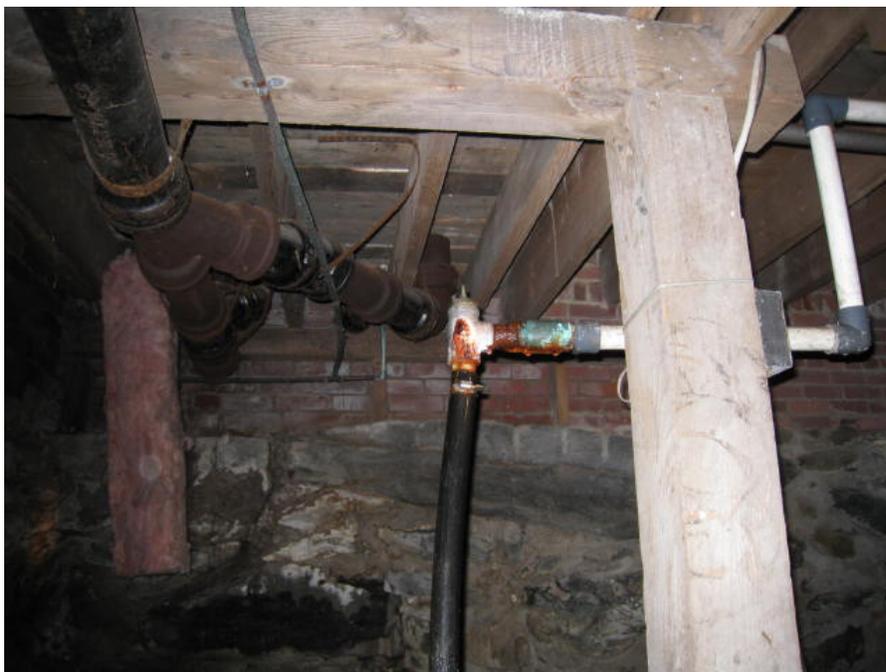
Picture 6

Irregular Basement Floor

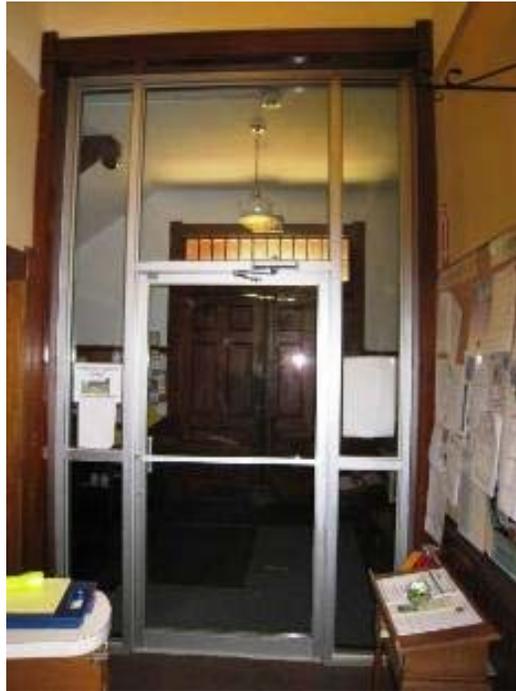
Picture 7

- In order to prevent cold air during the winter from entering into occupied space from the front door, a large glass and metal frame door system was installed to separate the front lobby from the workspace (Picture 7). The installation of this door system prevents the natural movement of heated air from the first floor to draft upwards to the second floor via the main staircase in the front of the building. These doors also prevent the natural venting of accumulated odors/particulates that may exist in offices.

Interior Glass Door

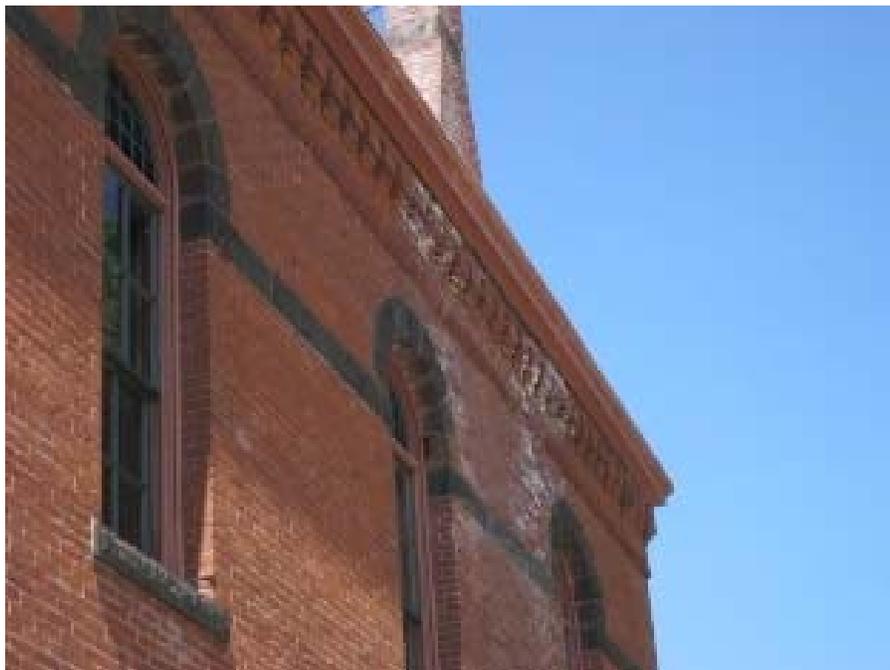
Picture 8

- Efflorescence was observed on numerous areas of exterior masonry. Efflorescence is a characteristic sign of water intrusion. As penetrating moisture works its way through mortar around brick, it leaves behind white, powdery mineral deposits (Picture 8). This is not mold, but it is characteristic of chronically moistened materials.

Efflorescence on Exterior Masonry

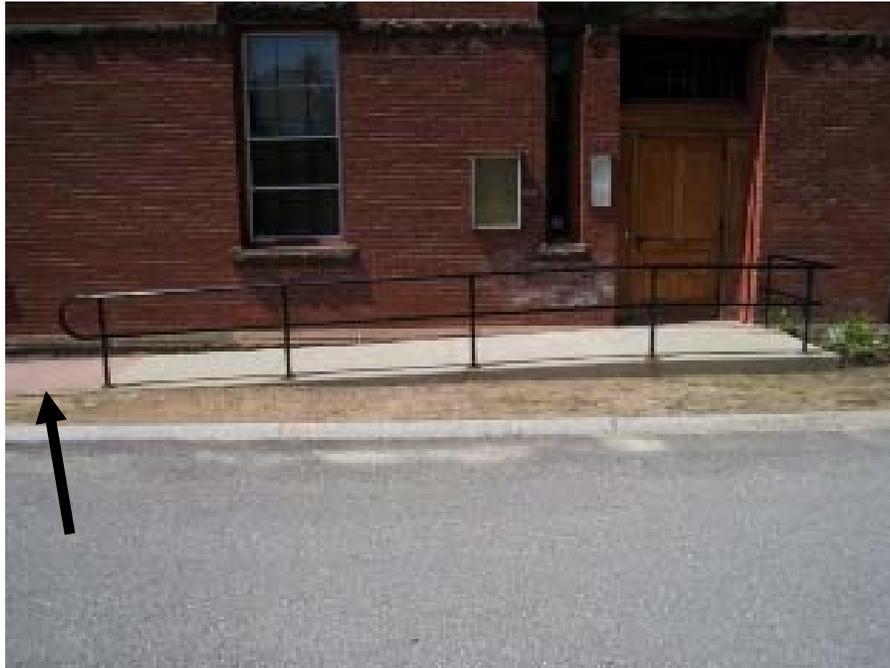
Picture 9

- On the exterior of the building, an extension of the ramp was created by filling in at least one basement ventilation window with cinder blocks and creating a brick walkway (Pictures 9 through 11). As can be seen in Picture 11, a portion of this walkway has settled which creates a trough for water to accumulate. As reported by building occupants, standing water gathers at this location and in the winter freezes.

**Concrete Ramp to Side Door,
Note Brick Walkway Obscuring Basement Window (Arrow)**

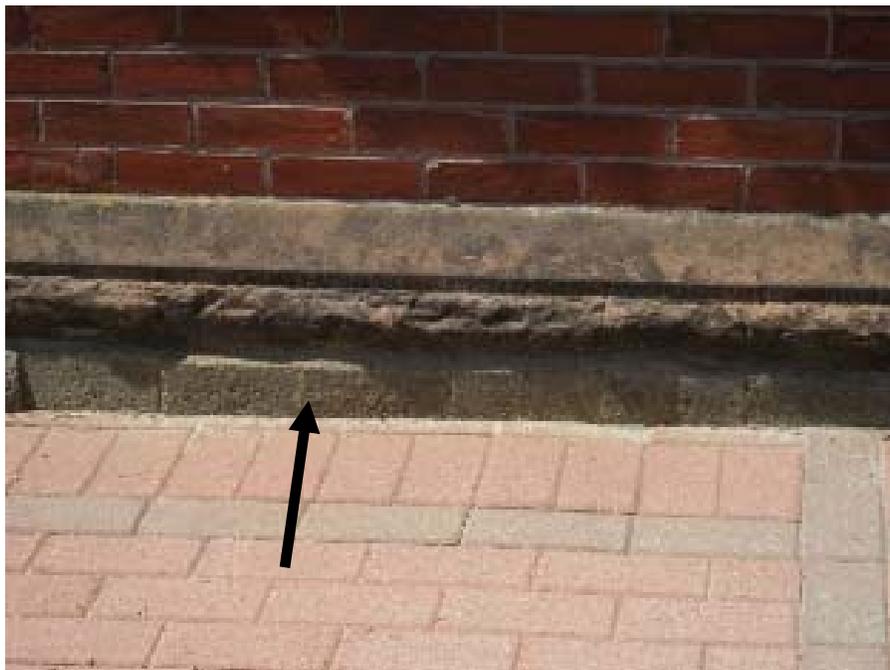
Picture 10

Basement Window Sealed with Blocks behind Brick Walk

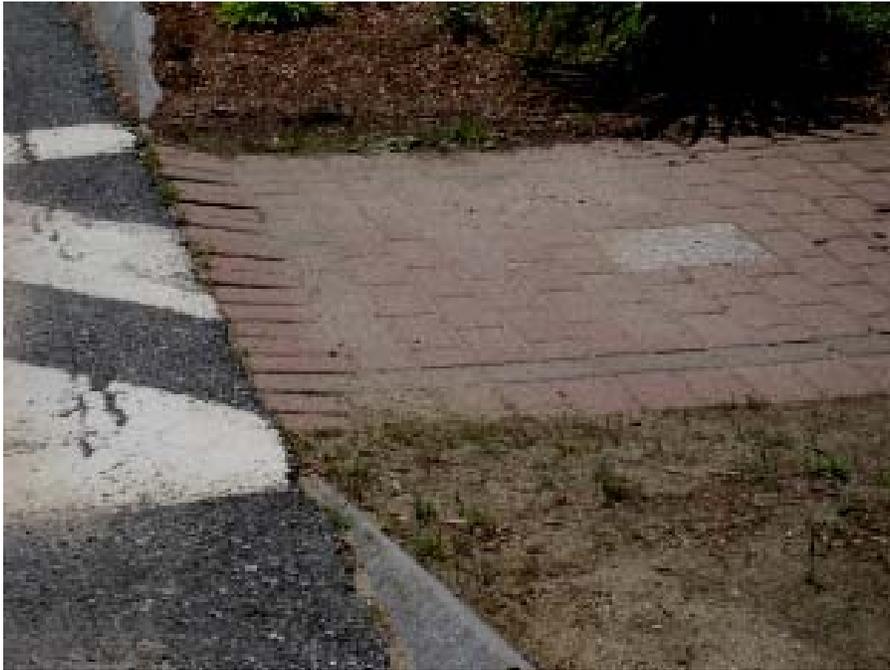
Picture 11

**Depression in Brick Walkway,
Note Sand Accumulation**

7. Repair or replace deteriorated windows.
8. Consider redesigning brick walkway to eliminate standing water from the base of the ramp.
9. Consider consulting a structural engineering firm in order to investigate whether any further movement of the structure has occurred since the last time the mortar was repaired.

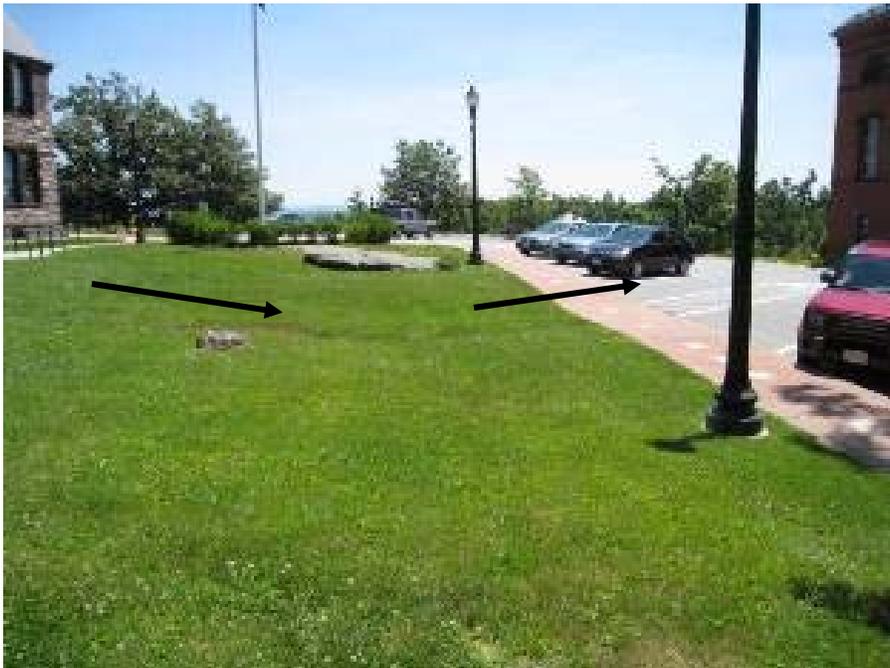
Picture 12

- The accumulation of water on the brick walkway may be exacerbated by the drainage swale on library property north of the town hall which appears to direct water on to the driveway and down slope toward the town hall walkway (Picture 12).

Pathway of Surface Runoff from Adjacent Property (Library)

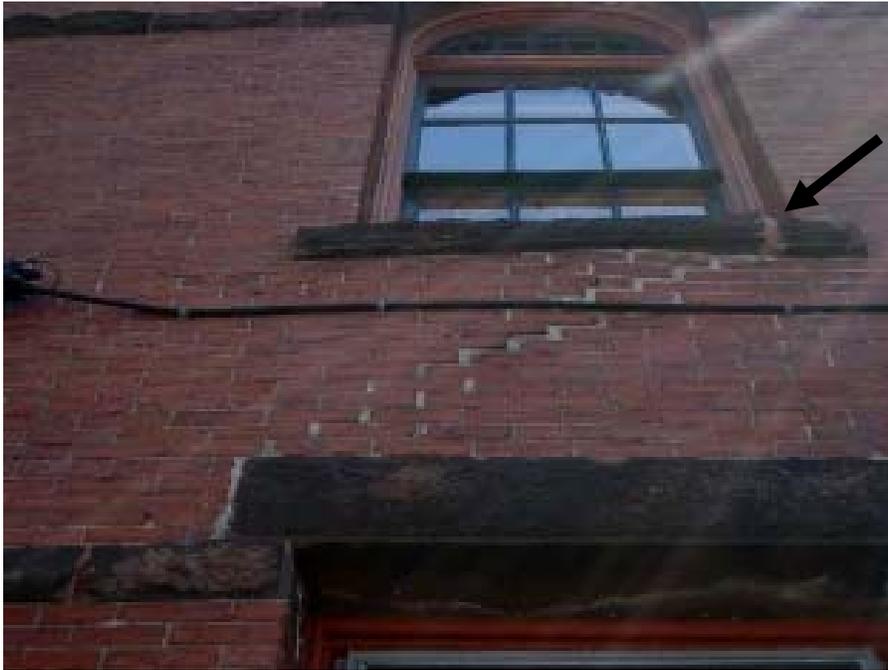
Picture 13

- Missing mortar and cracked masonry was observed on exterior brickwork.
- The south west corner of the building appears to have settled substantially, likely due to the addition on the west side of the building. This addition has a flat roof and does not appear to have gutters. These conditions may have caused rainwater to be deposited at

the base of the building which, over time, may have undermined its structure, placing stress on the masonry and mortar and eventually causing the mortar to shift and deteriorate (Pictures 13 through 15).

Repairs to Mortar and Stone Window Sill (Arrow)

10. Repair missing, loose mortar and cracked masonry.
11. Contact an engineering firm to design and install gutters on the roof of the addition at the rear of the building, ensuring that water is deposited at least five feet away from the building. Ensure the junction of the two buildings is adequately sealed/flushed and is impervious to water.

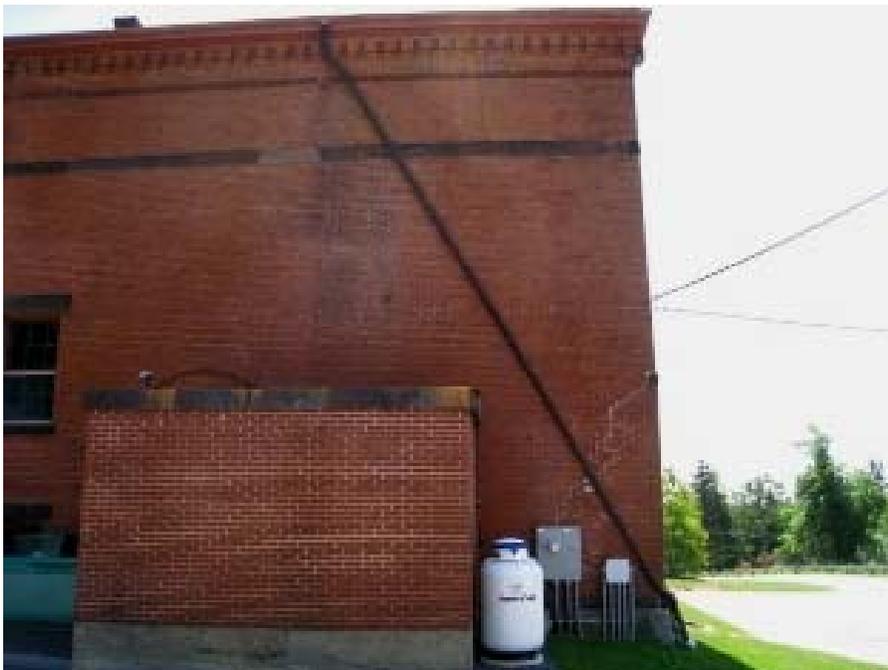
Picture 14

Repairs to Mortar, Note Addition Lacks Gutters

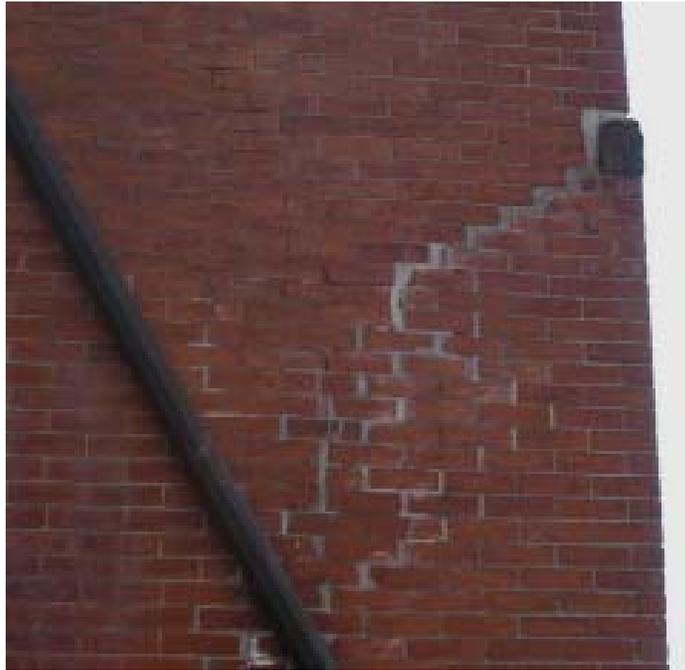
Picture 15

**Close-up of Repair to Mortar,
Note Brick Location at Edge of Building**

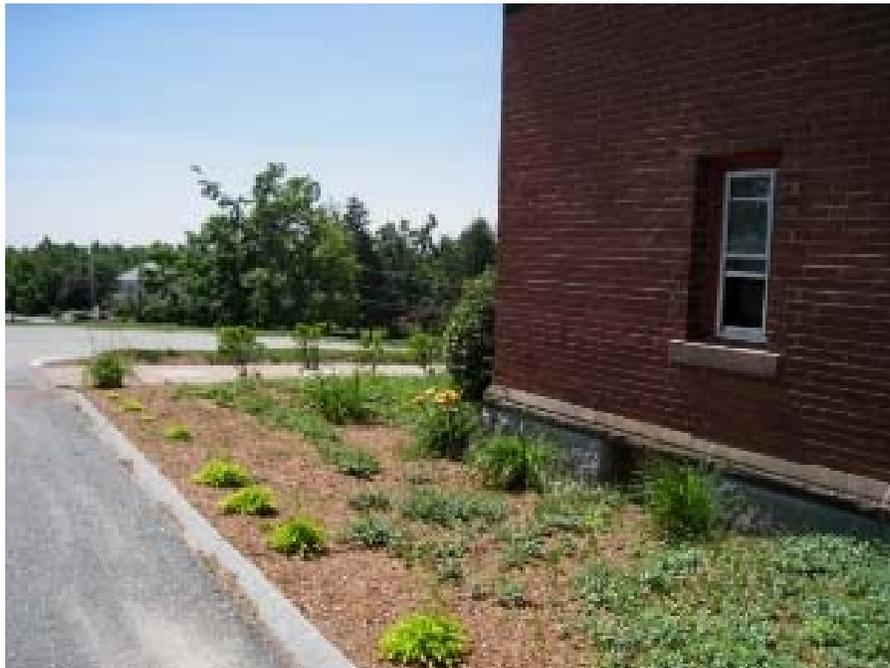
Picture 16

- Heavily mulched flower beds were observed on the front and north side of the building (Picture 16). One of the characteristics of mulch is its ability to hold moisture. Moisture accumulation at the base of a building encourages plant growth. Over time, the roots from plants and shrubs in this location can compromise the building's foundation.
- Moss was observed on the ground on the south side of the building immediately adjacent to the building (Picture 17). Moss is a sign of chronic dampness and can hold moisture against building components which can accelerate their decomposition.

Mulch in Garden Adjacent to Building

12. Clean/remove moss growth periodically from exterior walls/foundation of building.
13. Consider removing mulch from flower beds and relocating shrubs. Cut shrubbery in a manner to maintain a space of 5 feet from the building. Improve the grading of the ground away from the foundation at a rate of 6 inches per every 10 feet (Lstiburek & Brennan, 2001).

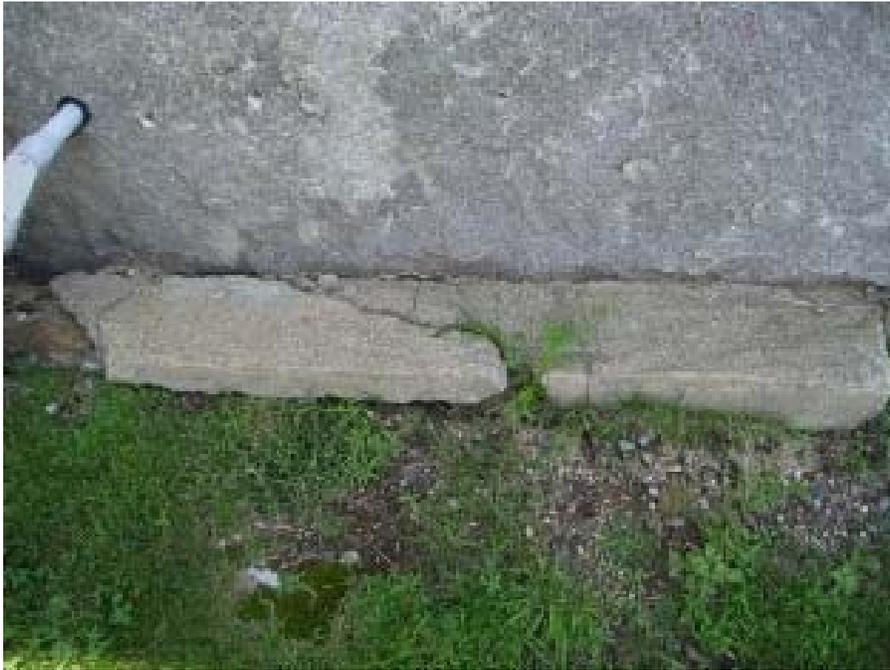
Picture 17

Moss Accumulation at Base of Building

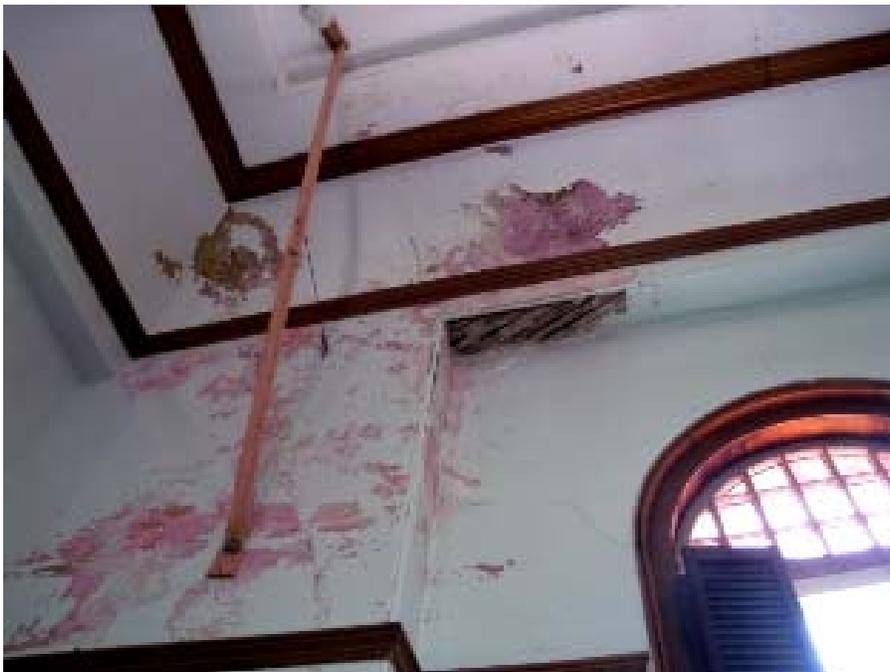
Picture 18

- On the second floor, severe water damage was evident on ceilings and walls (Pictures 18 and 19). Peeling paint, cracked and broken plaster and heavy particulate deposition were observed on the upper floor.
- In the balcony, windows were in disrepair.

Water Damage on Ceiling and Wall

6. Repair interior wall and ceiling surfaces and repaint. Be advised if the paint contains lead, it must be abated in conformance with all state and federal remediation/renovation regulations.

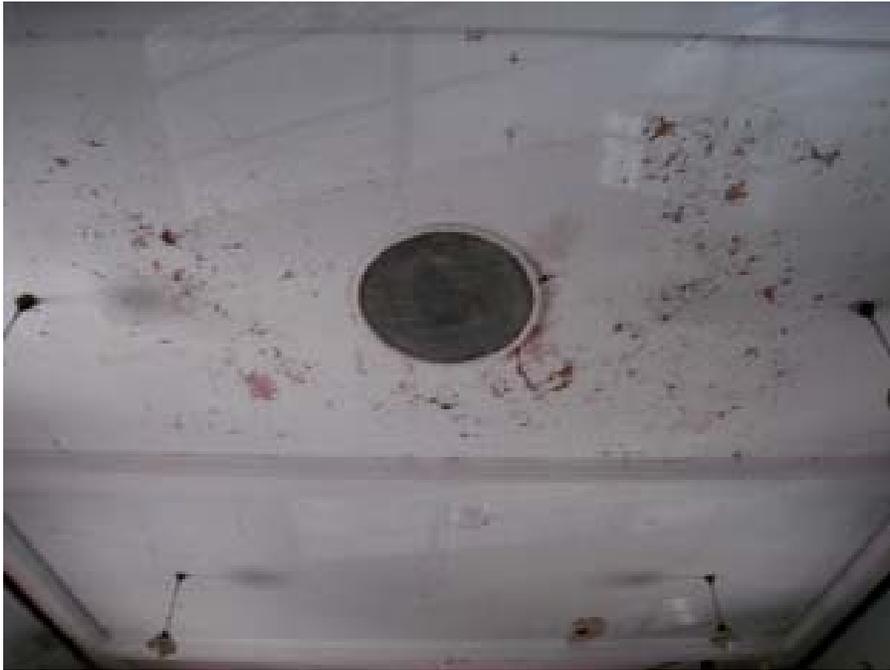
Picture 19

Peeling Paint and Water Damage on Ceiling

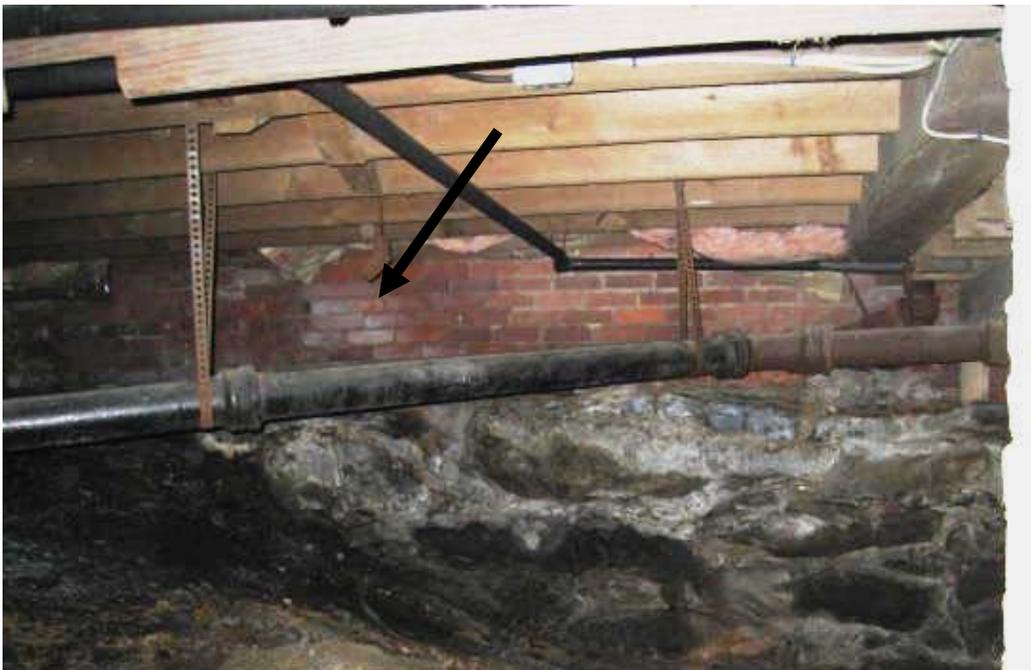
Picture 20

- Immediately upon entering the basement, a strong musty odor was observed by BEH staff, indicating the presence of mold colonization.
- Heavy efflorescence was observed on basement masonry indicating that water often penetrates the building envelope (Picture 20).

Efflorescence on Brick Basement Wall (Arrow)

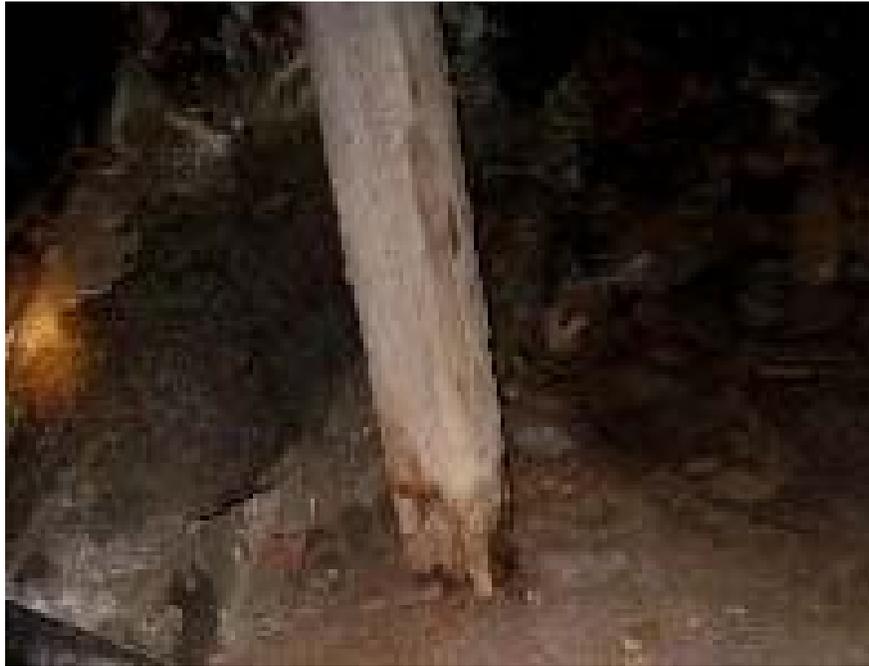
Picture 21

- As previously discussed, the PTH is built on top of exposed ledge. As such, it would be expected that groundwater travels close to or on top of ledge outcrops. Therefore, one would expect to see a substantial amount of groundwater in the basement during certain times of the year, such as spring thaw, etc. Moisture entering the basement is evident by the rotted wooden support posts (Picture 21).

Water-Damaged Wooden Support in Basement

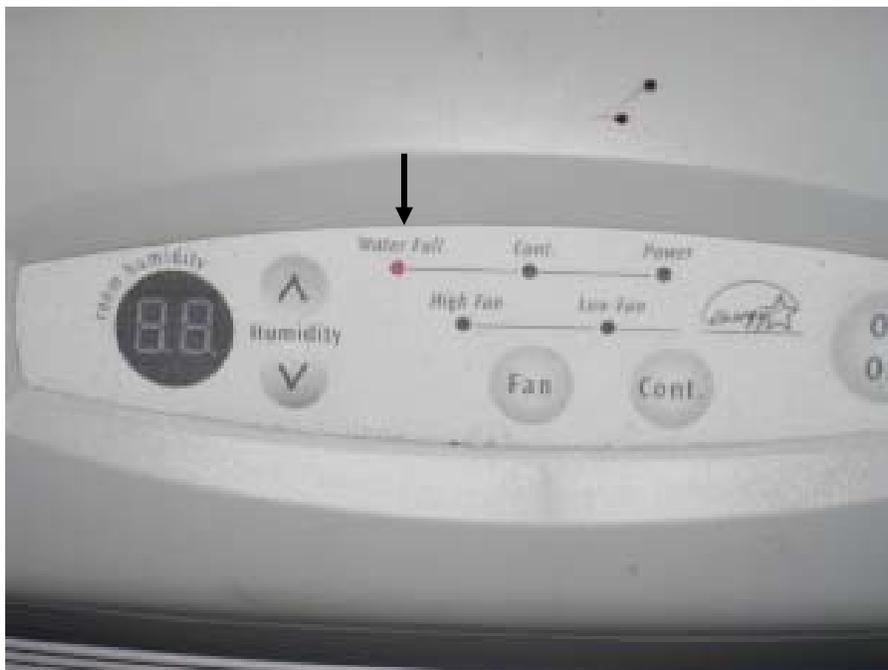
Picture 22

- A dehumidifier was noted in the basement. The indicator light revealed that the reservoir was full of water (Picture 22). If not emptied on a routine basis, water in the reservoir will simply evaporate back into the basement.

**Dehumidifier in Basement,
Note Light Indicates Dehumidifier is Full**

14. Develop a schedule for maintaining/emptying dehumidifiers.

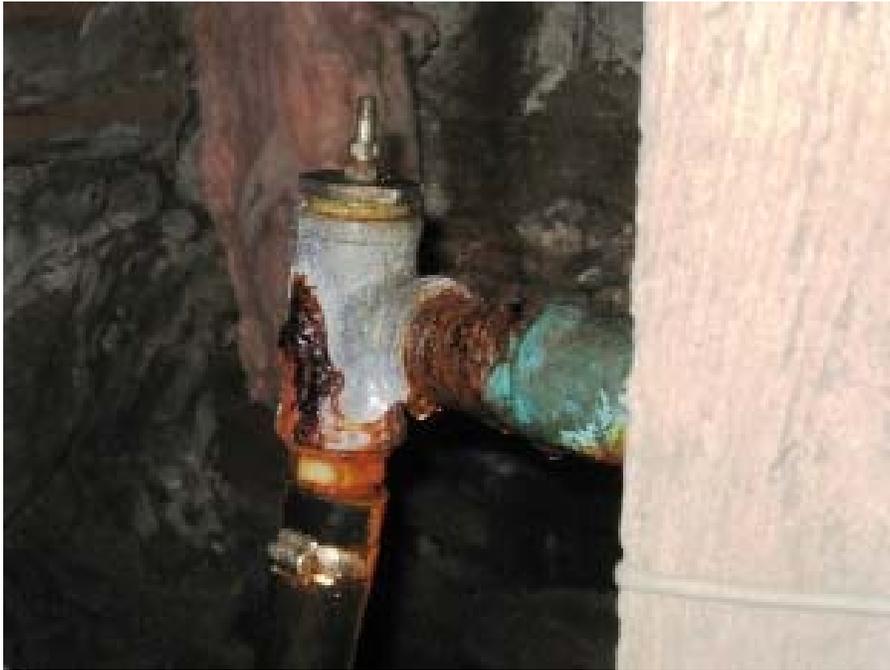
Picture 23

- Cross ventilation could not be achieved in the basement due to blocked/nonfunctioning windows.
- A leaking water valve was observed in basement (Picture 23).

Leaking Water Valve in Basement

15. Repair leaking water valve in basement.
16. Locate water cooler on a surface that is impervious to water.
17. Consider contacting an HVAC engineering firm to assess the feasibility of providing an air handling unit capable of ventilating the first floor of the building.

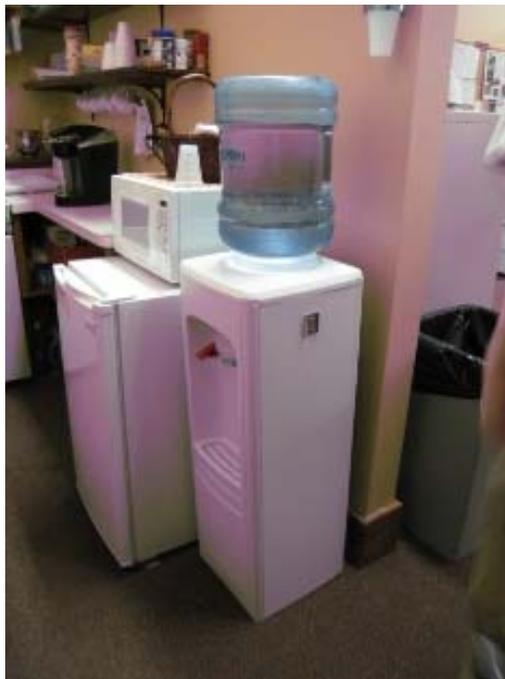
Picture 24

- A water cooler was observed located on a carpeted area (Picture 24). Overflow of the water basin or spills that often occur can moisten carpeting, which can lead to mold growth. It is important that the catch basin of a water cooler be cleaned regularly as stagnant water can be a source of odors, and materials (i.e., dust) collected in the water basin can provide a medium for mold growth.

Water Cooler on Carpeted Surface

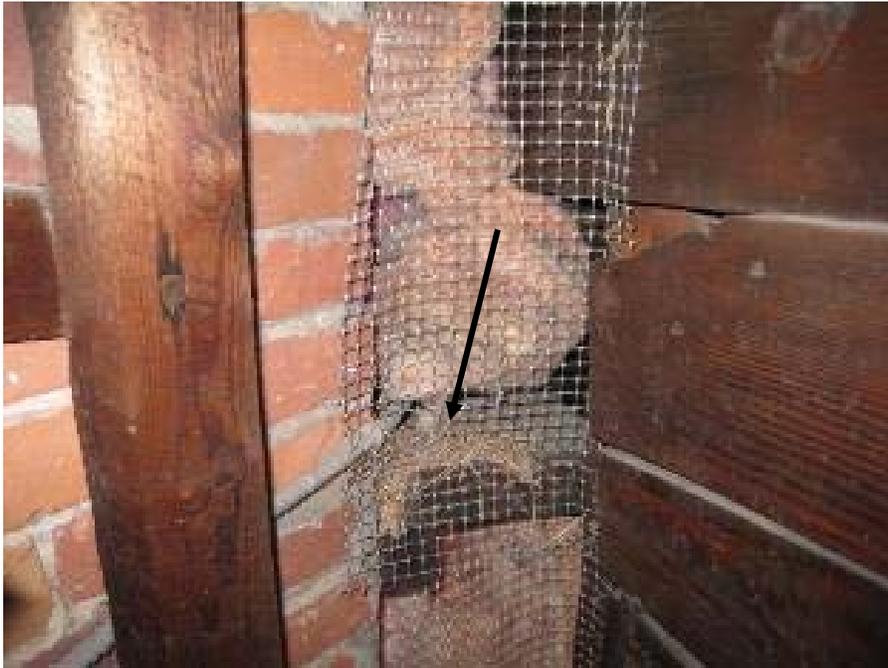
Picture 25

It appears that the tower of the building was occupied by birds at one point. Screening has been installed in the tower and nesting material can be seen behind it and on the tower stairs (Picture 25). Although no bird waste was observed at the time of the assessment, bird wastes can be a source of particulates that are irritating to the respiratory system. In addition, bird wastes contain bacteria and mold, which can be a source of disease, such as psittacosis and hypersensitivity pneumonitis.

**Wire Mesh Installed in Tower to Discourage Birds from Roosting,
Note Nesting Material**

20. Clean/change air conditioner filters as per manufacturer's instructions.
21. Ensure bird screening is intact, inspect periodically.
22. Consider storing fewer cleaning products within the building or providing a storage cabinet for these items. Ensure Material Safety Data Sheets (MSDS) are available for every cleaning product at a central location in the event of an emergency.

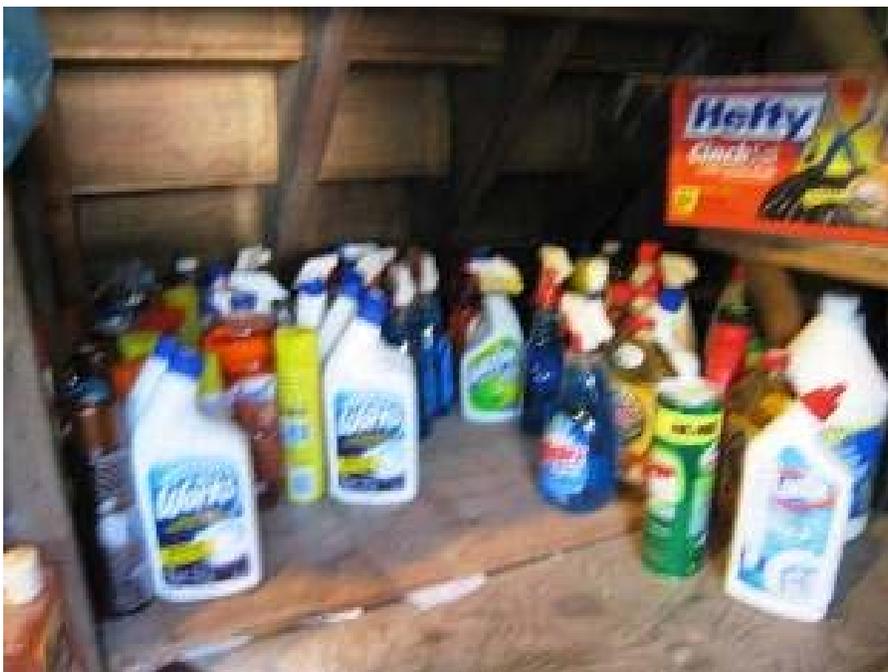
Picture 26

A substantial number of cleaning products were found stored beneath basement stairs (Picture 26). Cleaning products contain VOCs and other chemicals that can be irritating to the eyes, nose and throat of sensitive individuals.

Cleaning Products Stored Under Stairs
