INDOOR AIR QUALITY ASSESSMENT

**Merrymount Elementary School
4 Agawam Road
Quincy, Massachusetts**

Prepared by:
Massachusetts Department of Public Health
Bureau of Environmental Health
Indoor Air Quality Program
July 2010

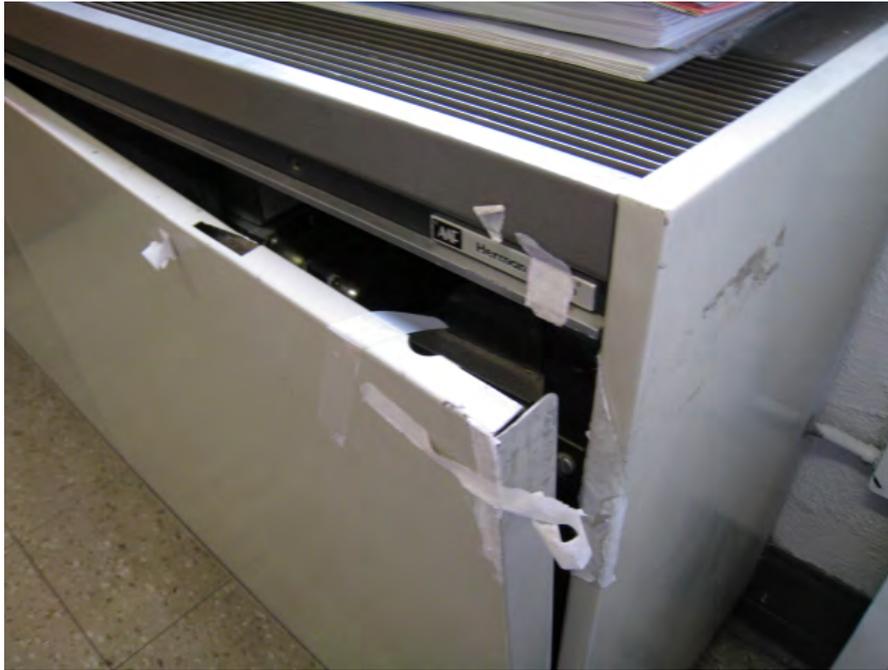
Picture 1

Univents have control settings of ‘off, low, and high’. At the time of the assessment, BEH staff found univent cabinets opened and switched ‘off’ in a number of areas (Picture 1). When univents are deactivated, no fresh air is introduced into these rooms (Table 1). In addition, univent air diffusers and return intakes were blocked by books, furniture and other stored items in front and on top of the unit, thereby limiting airflow (Picture 2). In order for univents to provide fresh air as designed, air diffusers and intakes must remain free of obstructions. Importantly, these units must remain “on” and be allowed to operate while rooms are occupied.

Classroom Univent Opened and Deactivated

1. Operate all ventilation systems (e.g., univents, exhaust vents and AHUs) throughout the building *continuously* during periods of occupancy. To increase airflow in classrooms, set univent controls to “high”. School staff should be encouraged not to deactivate classroom univents; rather, report any temperature/comfort complaints to the facilities department.

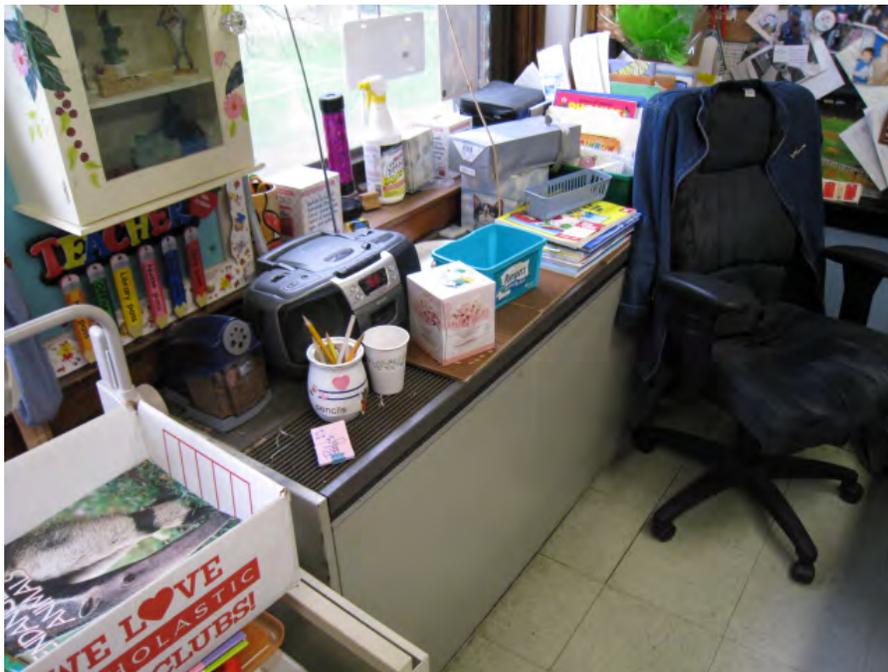
Picture 2

Items Obstructing Airflow from Univent Air Diffuser

3. Restore unit exhaust ventilators in rooms 12 and art and restroom exhaust vents to operate as designed.
4. Remove all blockages from univents and exhaust vents to ensure adequate airflow.

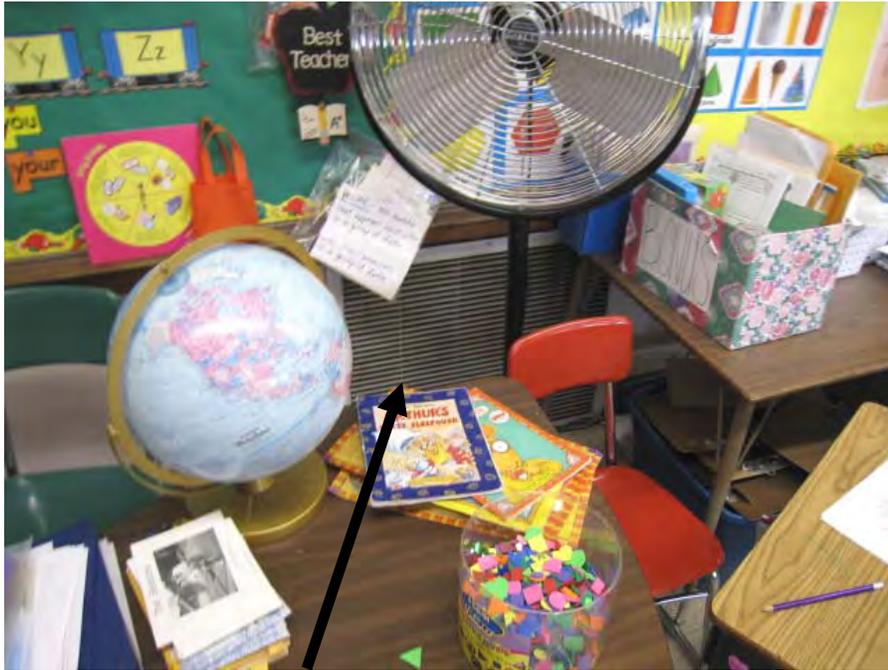
Picture 3

Exhaust ventilation in the majority of classrooms is provided by ceiling or wall-mounted vents ducted to rooftop motors (Pictures 3 through 6). The exhaust ventilation system is designed to continuously remove moisture, odors, *excess heat* and pollutants from the indoor environment. Exhaust vents were not functioning in the majority of areas surveyed at the time of the assessment (Table 1). BEH staff also found several exhaust vents blocked by furniture and other stored items (Pictures 3 and 4). In order to function properly, exhaust vents must be activated and allowed to operate without obstruction while rooms are occupied. Without adequate supply and exhaust ventilation, excess heat and environmental pollutants can build up leading to indoor air/comfort complaints. In subsequent correspondence, Mr. LaPierre reported that rooftop exhaust vents were being repaired.

Exhaust Vent Partially Obstructed by Classroom Items

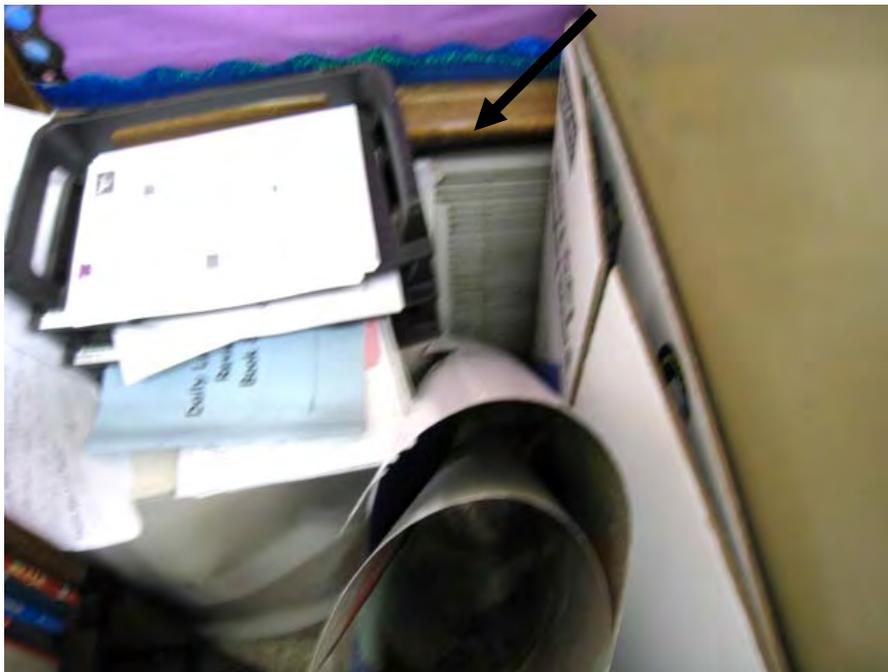
Picture 4

Exhaust Vent Partially Obstructed by Classroom Items

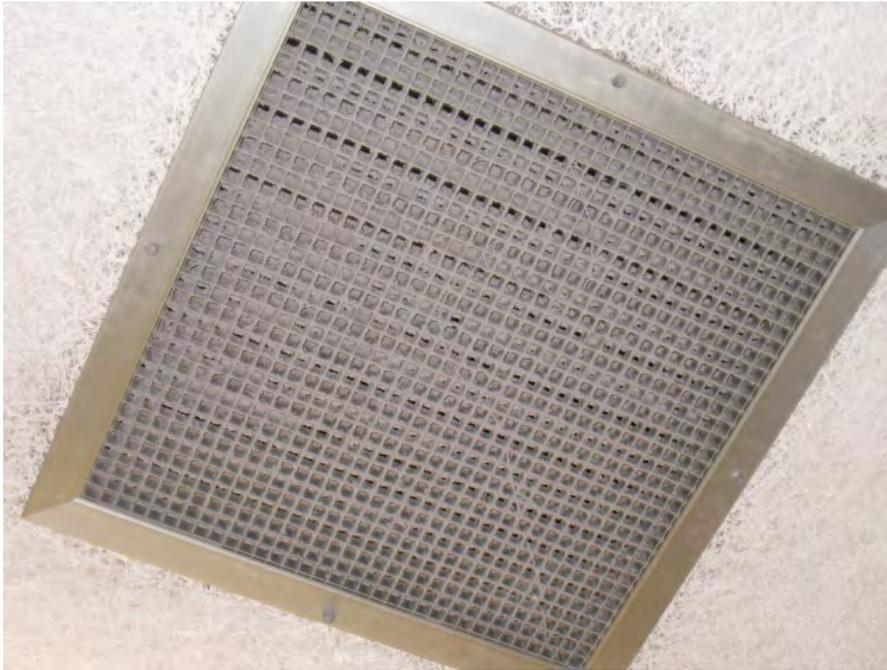
Picture 5

A number of personal fans, exhaust vents, air diffusers and surrounding ceiling tiles were observed to have accumulated dust/debris (Pictures 5 and 20/Table 1). Re-activated diffusers, vents or fans can aerosolize accumulated dust. If exhaust vents are not functioning, backdrafting can occur, which can re-aerosolize dust particles.

Ceiling-Mounted Exhaust, Note Accumulated Dust/Debris

17. Clean air diffusers, exhaust vents and personal fans periodically of accumulated dust. If soiled ceiling tiles cannot be cleaned, replace.
18. Replace covers for fluorescent light fixtures.

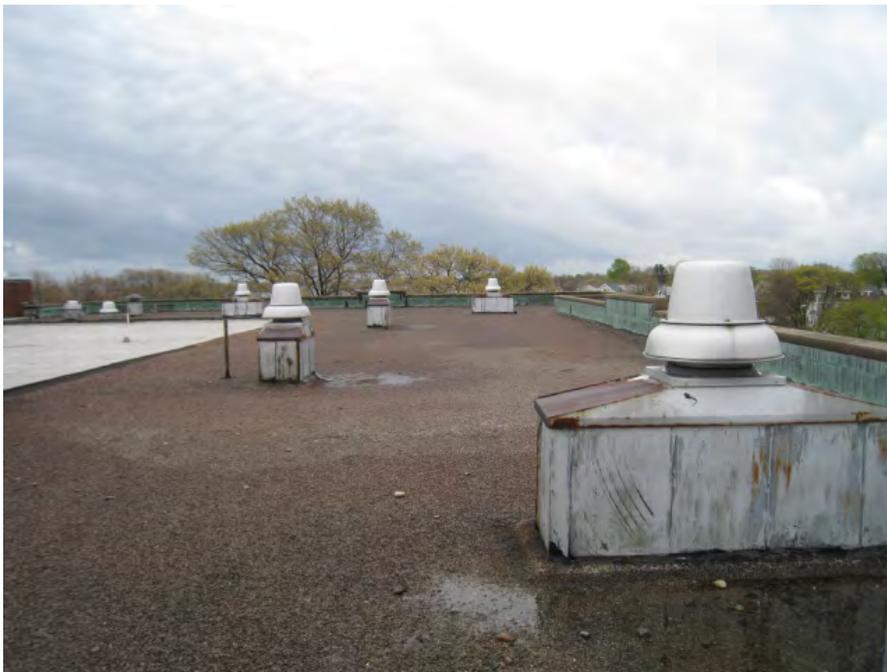
Picture 6

Rooftop Exhaust Motors

2. Inspect exhaust motors and belts on a regular schedule (e.g., 2-4 times per year) for proper function, and perform repairs and adjustments as necessary.

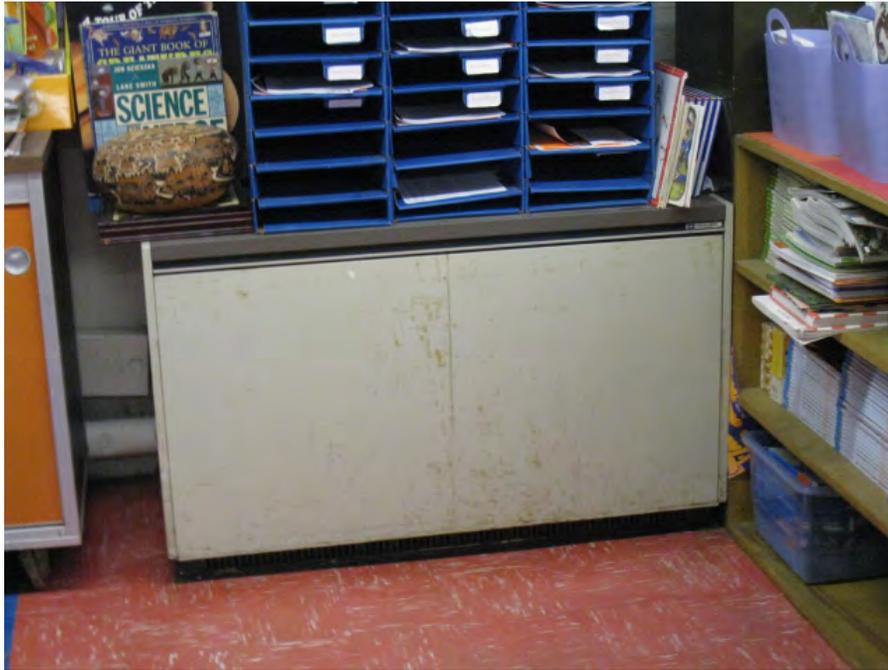
Picture 7

Mechanical exhaust ventilation in the art room and room 12 is provided by unit exhaust ventilators (Picture 7). A unit exhaust ventilator is similar to a univent in appearance, except that it removes air from the classroom and expels it out of the building. Unit exhaust ventilators were not operating at the time of the assessment and appeared not to have been operated for some time.

Unit Exhaust Ventilator as Seen in Room 12 and the Art Room

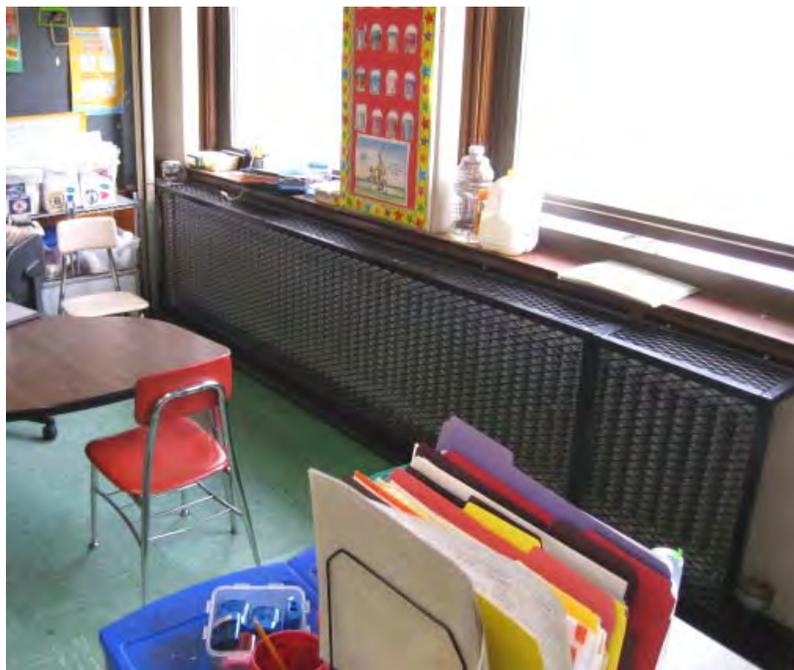
Picture 8

Large Radiator in Classroom

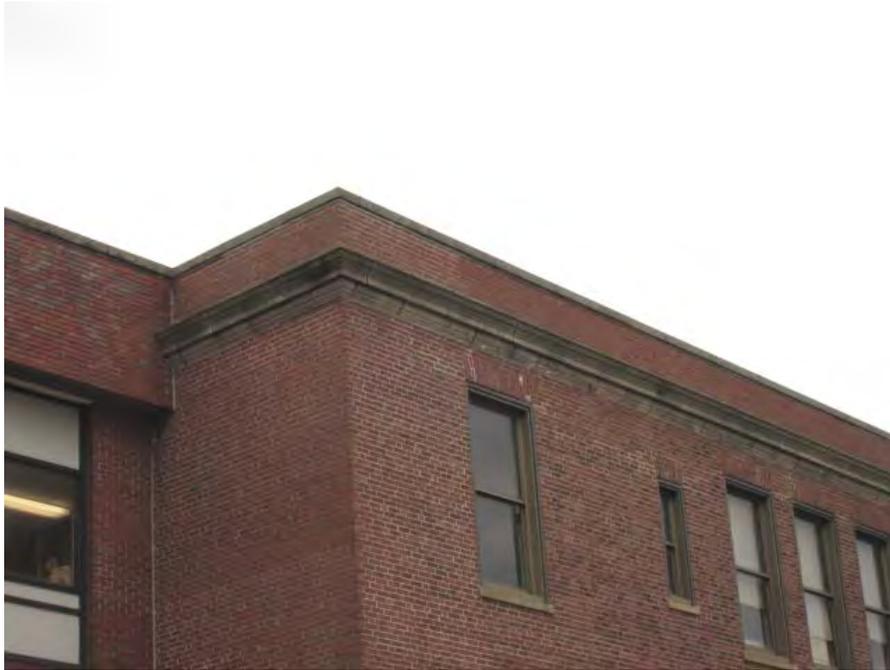
Picture 9

Parapet Roof and Exterior Brick

10. Continue with plans to make repairs to roof/parapet/exterior brick and flashing. In the interim, efflorescence, loose paint and plaster debris should be periodically cleaned using a vacuum with a brush attachment. Once repairs to the roof/parapet are completed, water-damaged plaster ceilings and walls should be prepped and refinished.

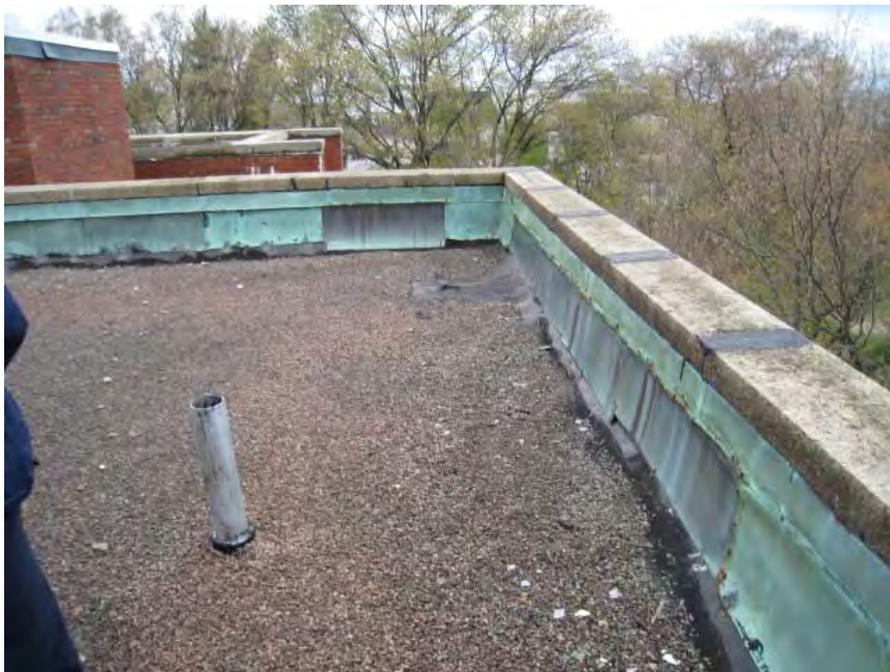
Picture 10

Parapet Roof and Flashing

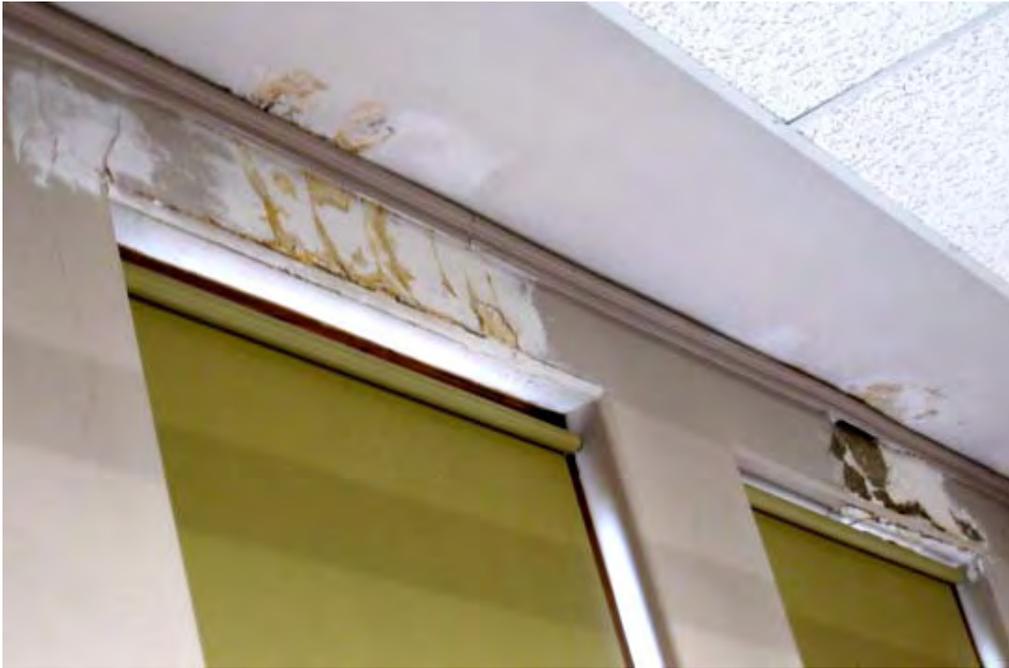
Picture 11

Water-Damaged Ceiling/Wall Plaster and Efflorescence in top Floor Classroom

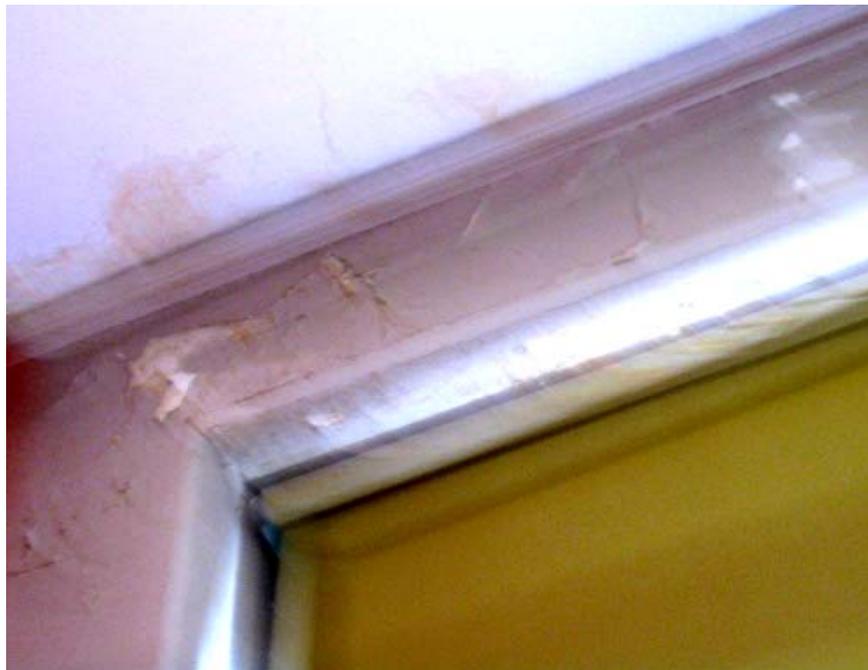
Picture 12

Water-Damaged Ceiling/Wall Plaster and Efflorescence in top Floor Classroom

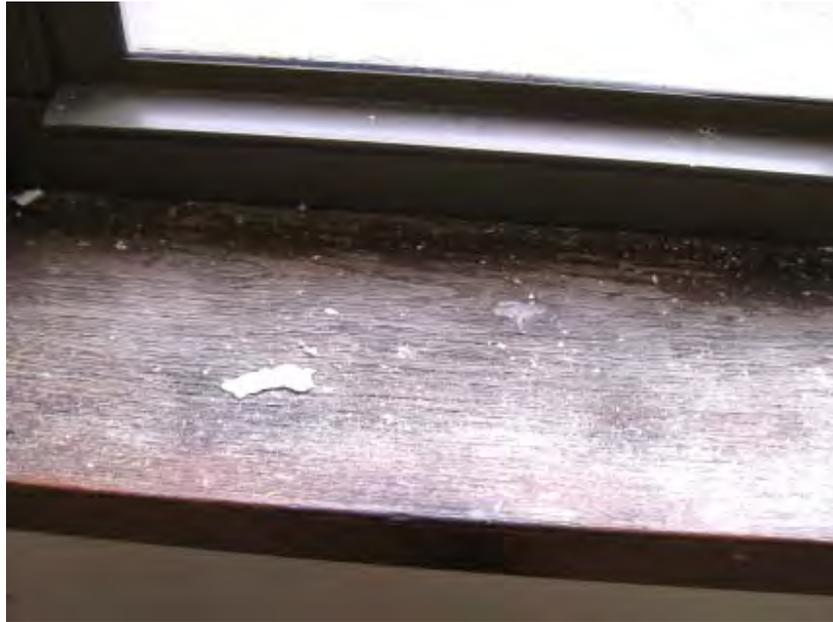
Picture 13

Flaking Paint/Plaster Debris on Window Sill in Classroom below Damaged Ceiling/Wall Plaster

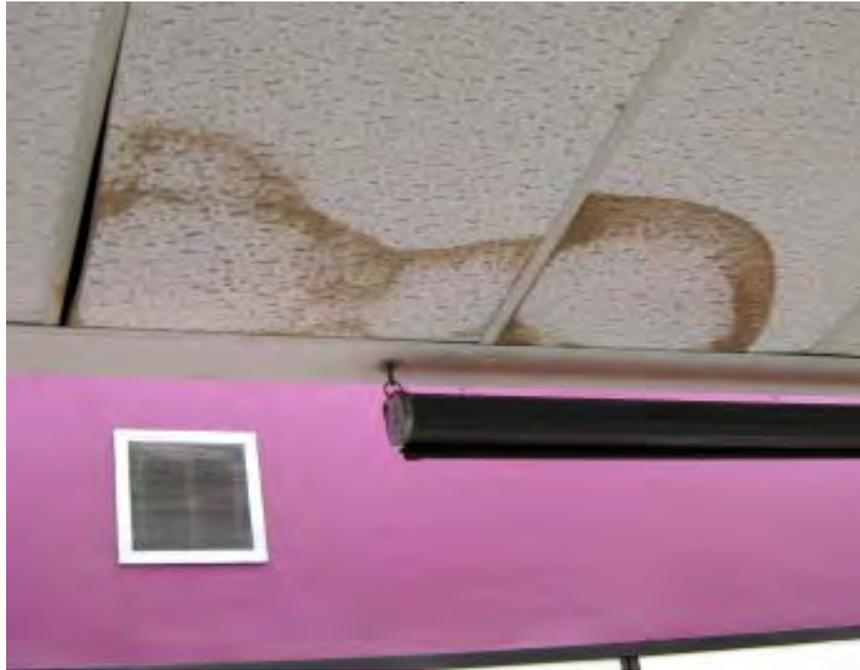
Picture 15

BEH staff examined building materials inside the building for water-damage and/or microbial growth. A number of areas had water-damaged ceiling tiles, which can indicate leaks from the roof/plumbing system or water penetration through the building envelope (Picture 15/Table 1). Ceiling tiles should be replaced after a water leak is discovered and repaired.

Water-Damaged Ceiling Tiles

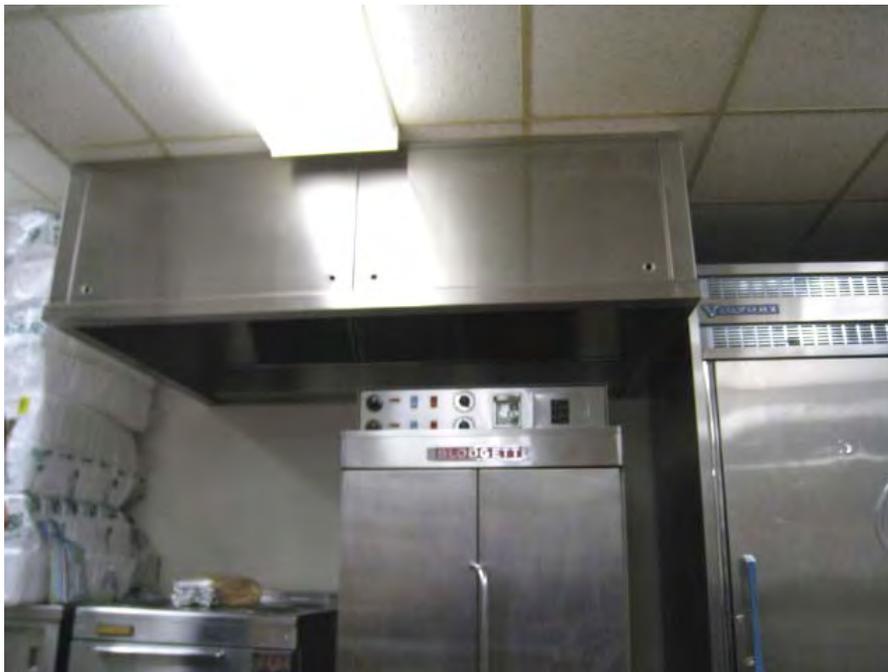
Picture 16

Kitchen Exhaust Hood

12. Operate local exhaust hood in kitchen during food preparation.

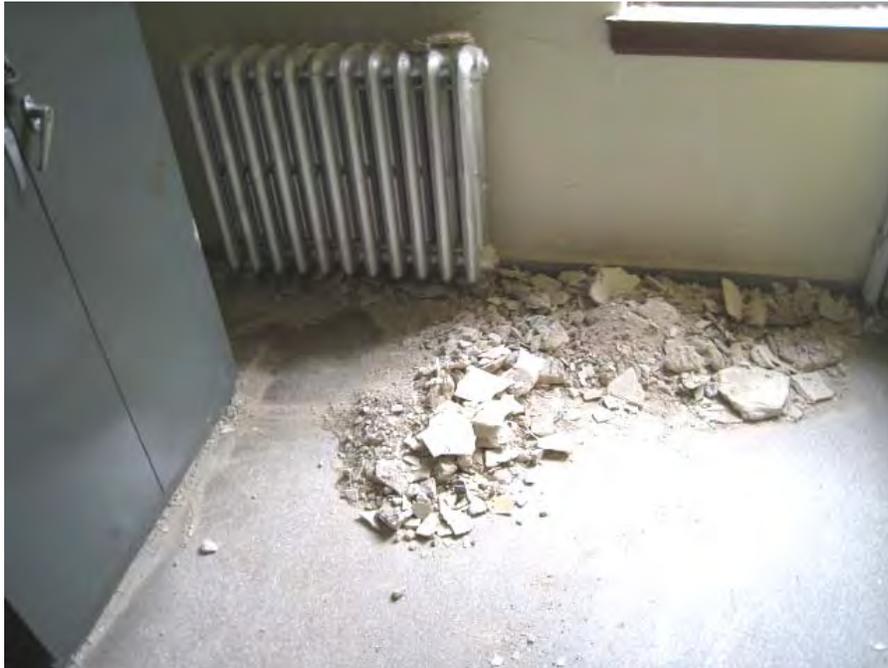
Picture 17

Plaster Demolition Dust/Debris in 2nd Floor Girls Restroom

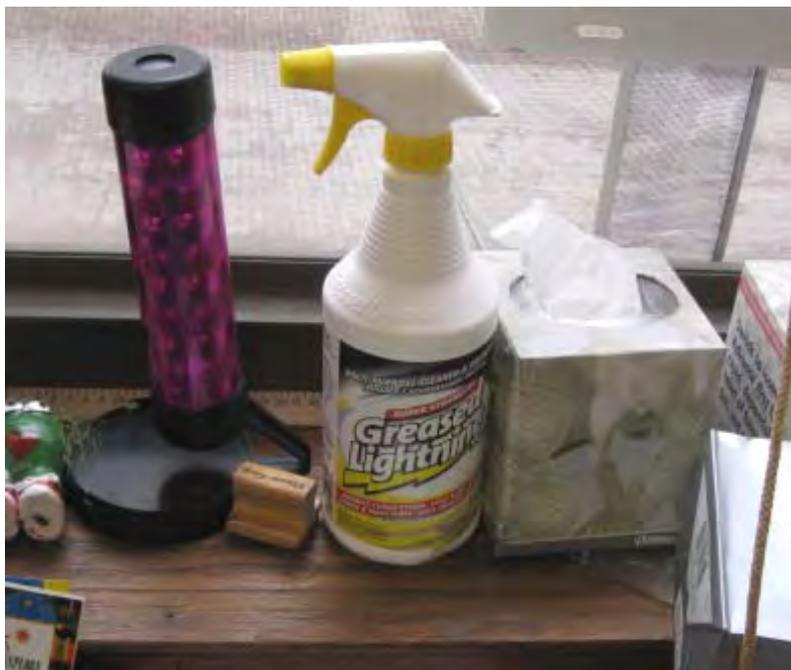
Picture 18

Cleaning products were found on countertops in several rooms (Table 1). Of particular concern was a spray bottle of degreaser that was found on a windowsill (Picture 18). The material safety data sheet (MSDS) for this product states “Immediate Concerns: Caution: Eye and Skin Irritant: May Be Harmful If Swallowed. Avoid contact with eyes. Do not taste or swallow. Avoid prolonged contact with skin. Use rubber gloves for sensitive skin” (Chemtura, 2007). Cleaning products contain chemicals that can be irritating to the eyes, nose and throat of sensitive individuals. These products should be properly labeled and stored in an area

Spray Bottle of Degreasing Agent on Classroom Windowsill

11. Store cleaning products properly and out of reach of students. Ensure spray bottles are properly labeled. All cleaning products used at the facility should be approved by the school department with MSDS' available at a central location.

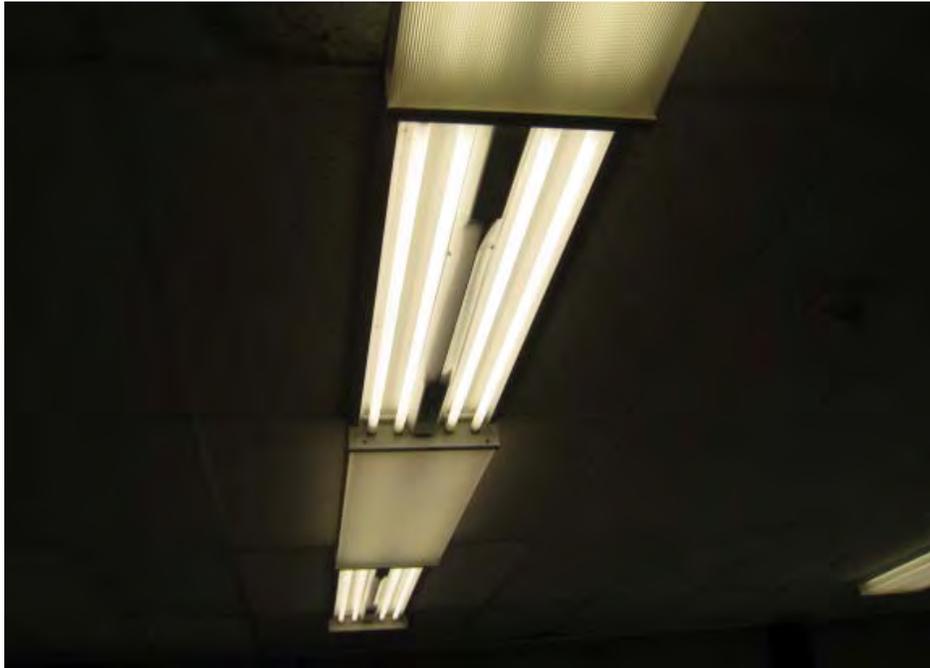
Picture 19

Fluorescent light fixtures were missing covers in a number of areas (Picture 19/Table 1). Unshielded fluorescent lights can produce glare which can cause eye strain. Light fixtures should be equipped with access covers installed over fully secured bulbs. Breakage of glass can cause injuries and may release mercury and/or other hazardous compounds. For that reason, they must be stored, utilized and disposed of with care (refer to Appendix B for more information).

Missing Fluorescent Light Covers

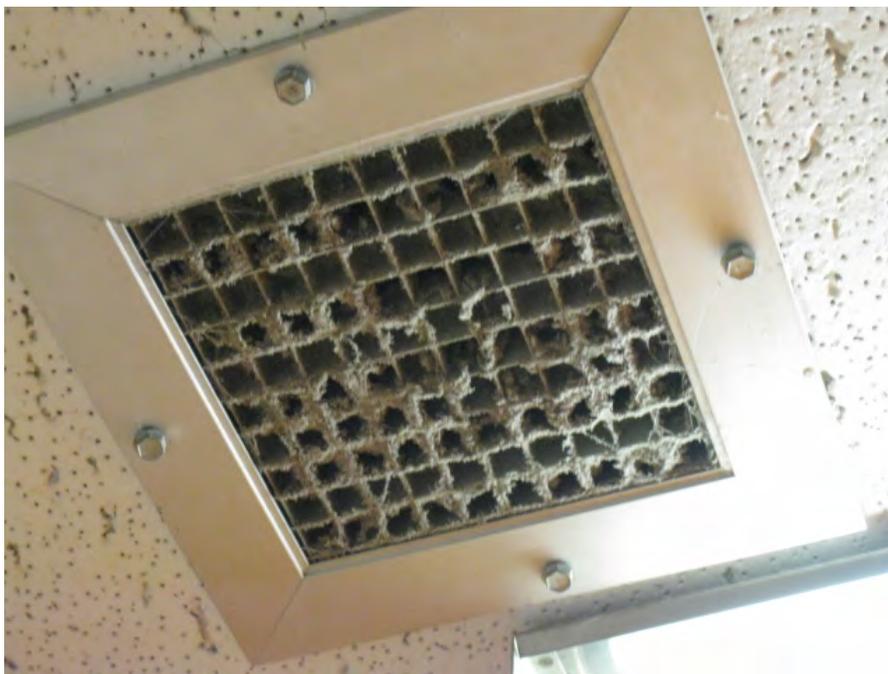
Picture 20

Exhaust Vent with Accumulated Dust/Debris
