INDOOR AIR QUALITY ASSESSMENT

**Sex Offenders Registry Board
Shetland Park Office Complex
45 Congress Street
Salem, MA**

Prepared by:
Massachusetts Department of Public Health
Bureau of Environmental Health
Indoor Air Quality Program
October 2010

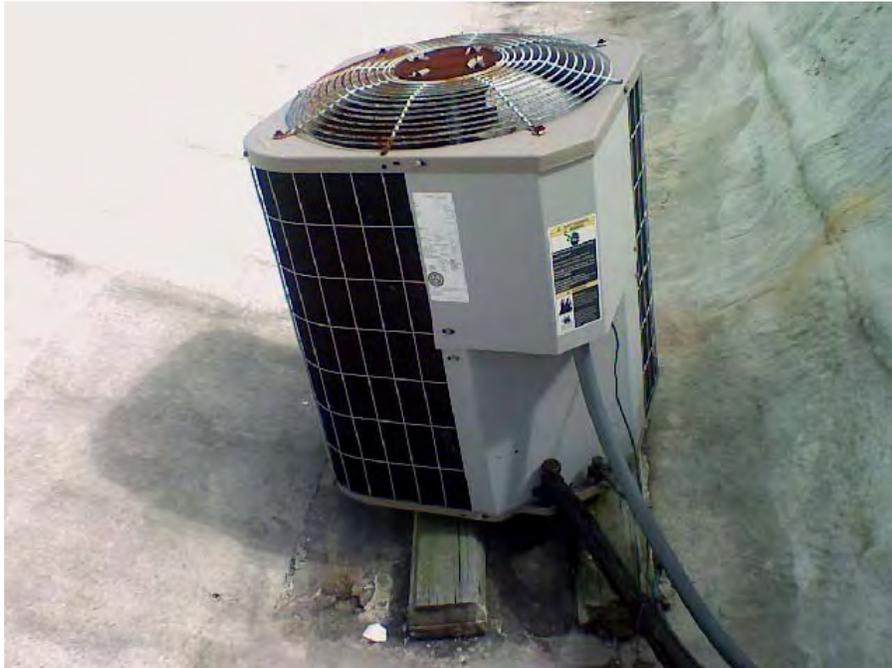
Picture 1

Rooftop condensing unit

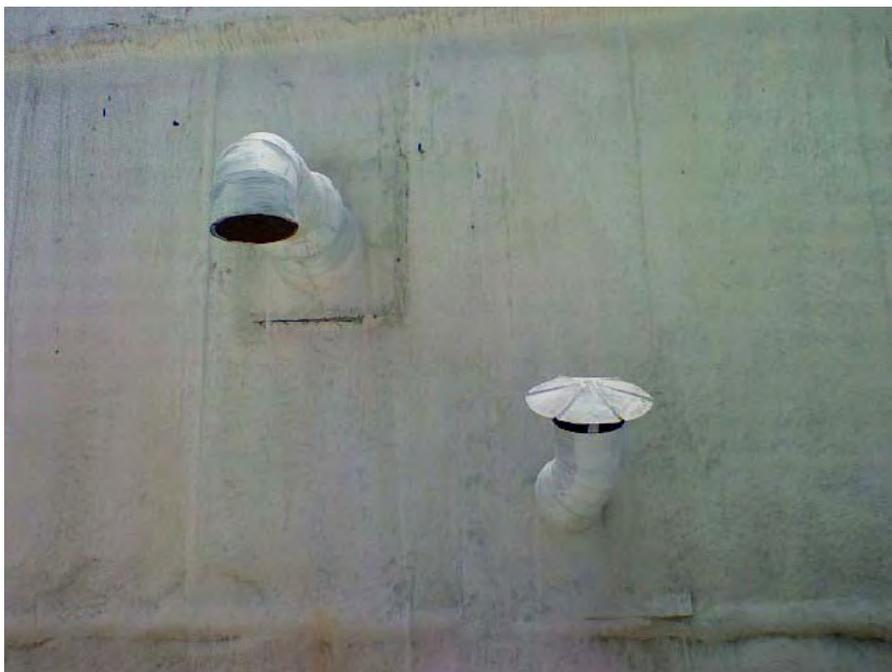
Picture 2

Please note, the opening for each fresh air intake is in close proximity to the terminus of the corresponding exhaust flue. Under certain weather conditions (i.e. temperature inversion, winds), air exhausted from the flue can be captured by the fresh air intake, then re-introduced

into occupied spaces. Consideration should be given to extending the height of the intakes to prevent entrainment of exhaust air.

Fresh air intake on the left, exhaust on the right

1. Extending the height of the fresh air intake to prevent entrainment of exhaust air.
2. Continue to coordinate with building management, administration, HVAC vendor and SORB staff to achieve/maintain optimal comfort levels.

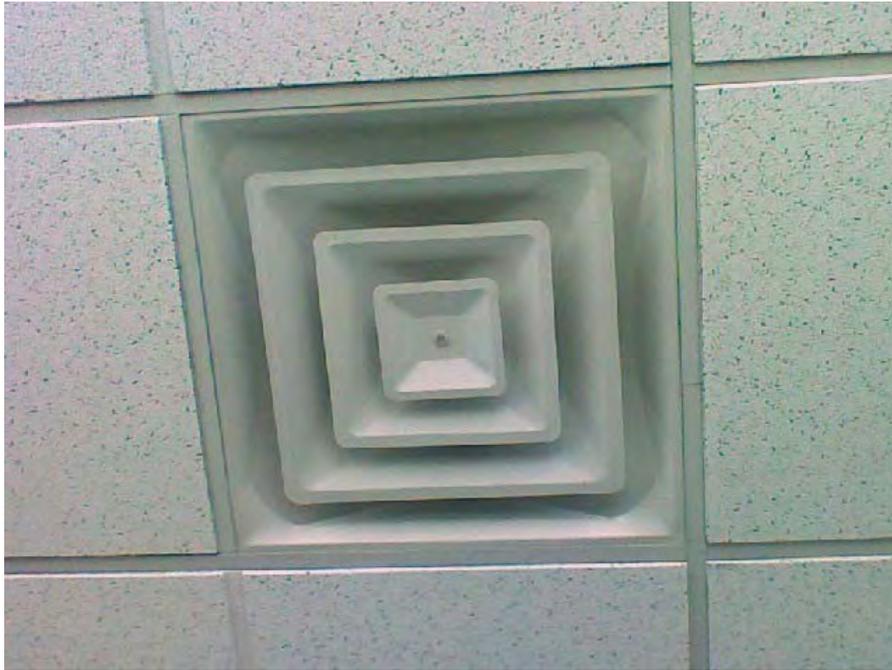
Picture 3

Air supply diffuser

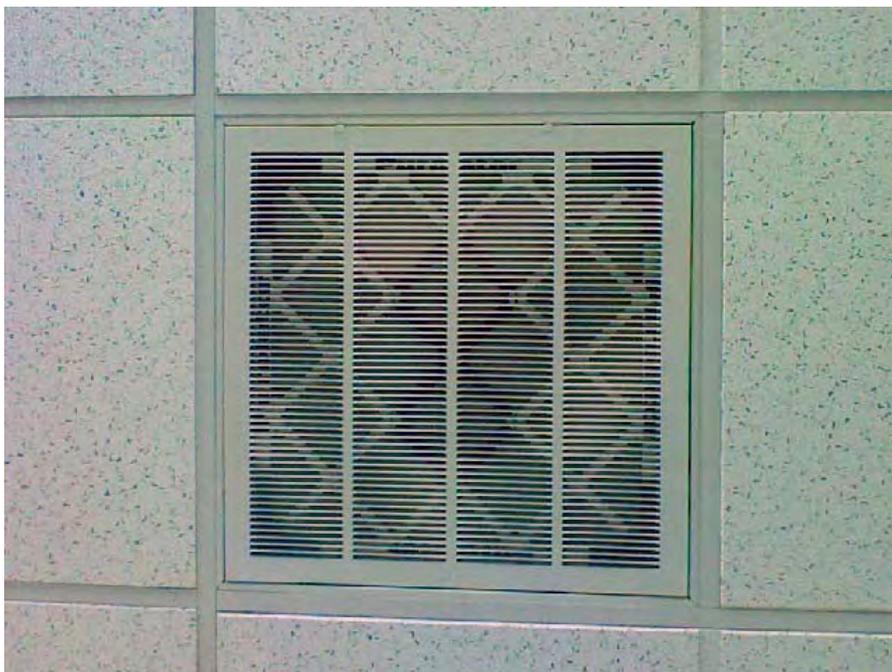
Picture 4

Return vent with pleated filter

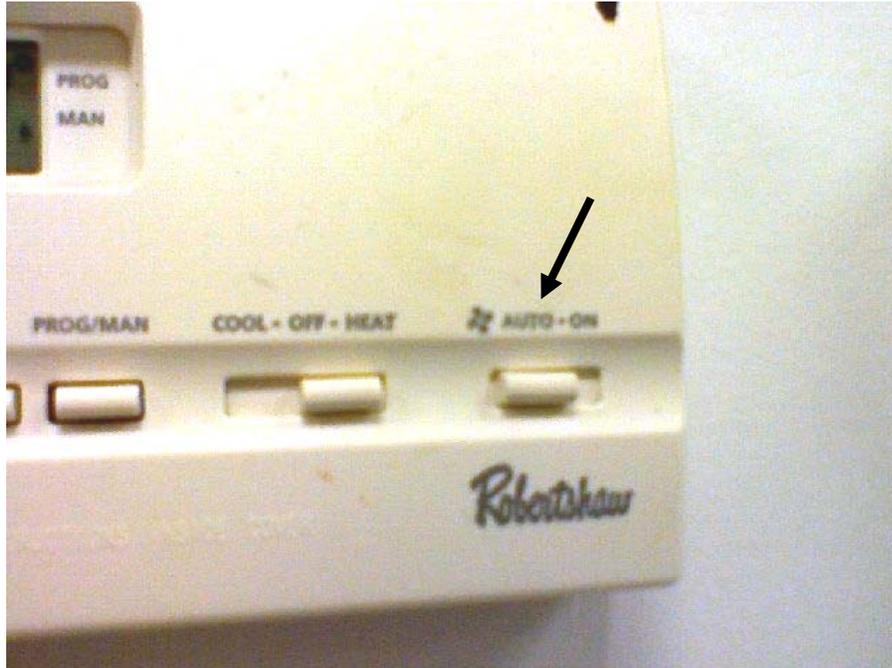
Picture 5

Digital wall-mounted thermostats control the HVAC system. Each thermostat has fan settings of “on” and “automatic”. The automatic setting on the thermostat activates the HVAC system at a preset temperature. Once the preset temperature is reached, the HVAC system is deactivated. Therefore, no mechanical ventilation is provided until the thermostat re-activates the system. At the time of assessment, all but one thermostat was programmed for the fan “on” setting. The thermostat for the file room was set in the “automatic” setting (Picture 5). Without a continuous source of fresh outside air and removal via the exhaust/return system, indoor environmental pollutants can build-up and lead to indoor air quality/comfort complaints.

Thermostat fan setting in the auto position

3. Set the thermostat to the fan “on” position to operate the ventilation system continuously during business hours.
4. Keep door to LAN room shut and remove cardboard from passive vent to facilitate airflow as designed.

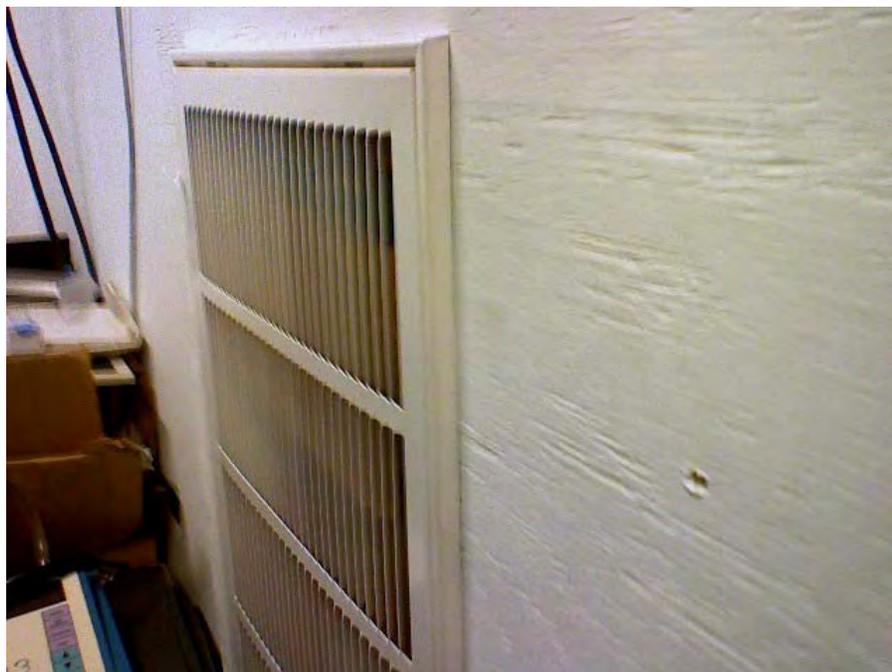
Picture 6

A passive vent is located between the local area network (LAN) room and the hallway. The purpose of this passive vent is likely to provide makeup air for the wall-mounted air conditioning (WAC) system located at near the doorway of the room. This passive vent was blocked by cardboard inhibiting airflow (Picture 6). At the time of assessment, the entrance to the LAN room was open. It’s likely that since the door to the LAN room is typically open, the WAC draws makeup air from the adjacent office. The positive pressure created by the WAC likely pushes conditioned air (rather than drawing it) through the passive vent.

Passive vent with cardboard

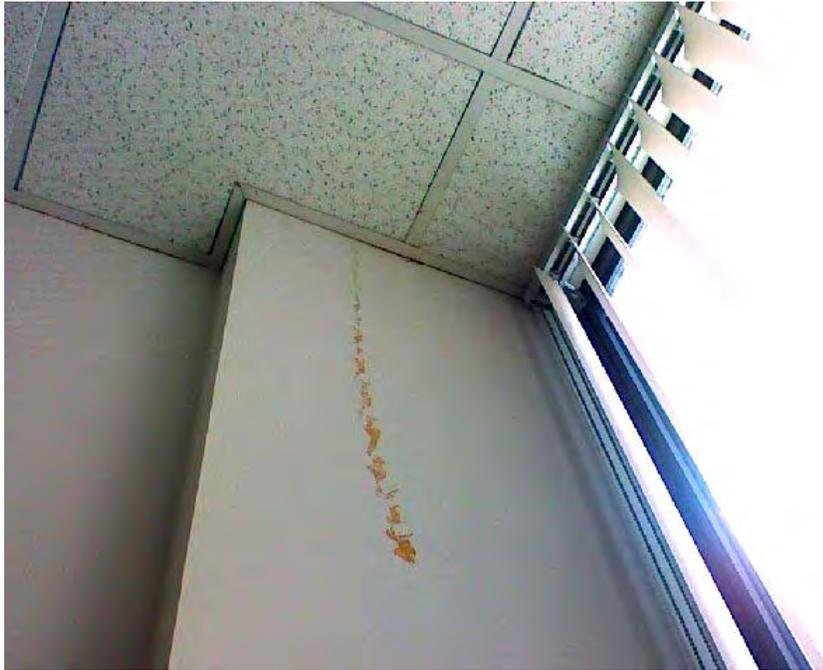
Picture 7

Water-damaged ceiling tiles and building materials were observed in a number of areas (Pictures 7 and 8), many of which were near columns through which roof drains traverse the building. The water-damaged ceiling tile observed in the records room may have mold growth (Picture 8). Based on reports from David Raines of SORB, Shetland Park Management indicated that roof drain pipes were damaged and failing at the base. Plans to replace the roof drainage system are reportedly underway. BEH also noted that roof drains lacked cages/strainers to

Water stain/drip on wall column

6. Continue to plans to repair/replace roof drain system.
7. Install cages/strainers on roof drains to prevent materials from falling in and lodging at the base of the drainage system.

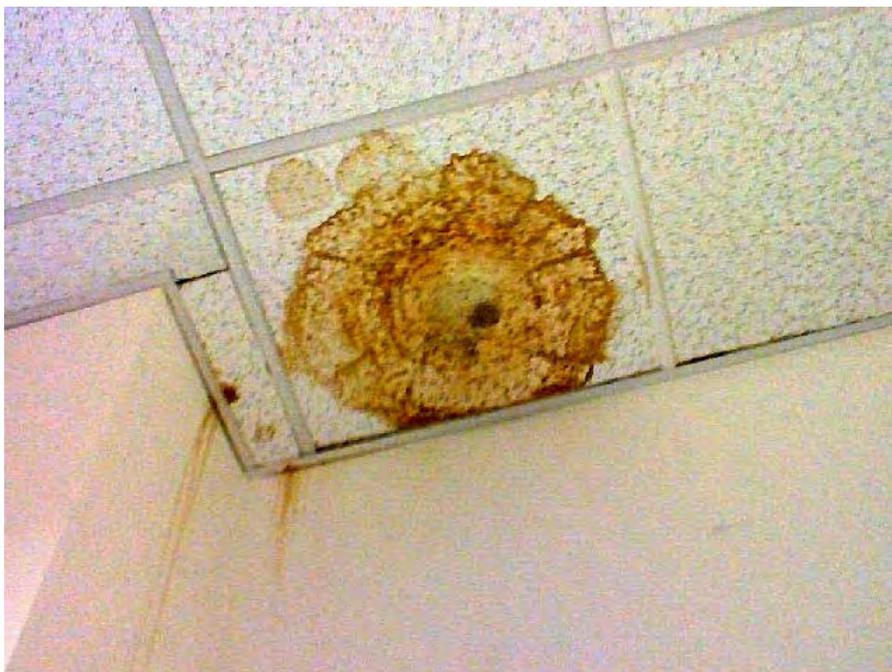
Picture 8

Water stain/drips on wall column; water-damaged ceiling tile with potential mold growth

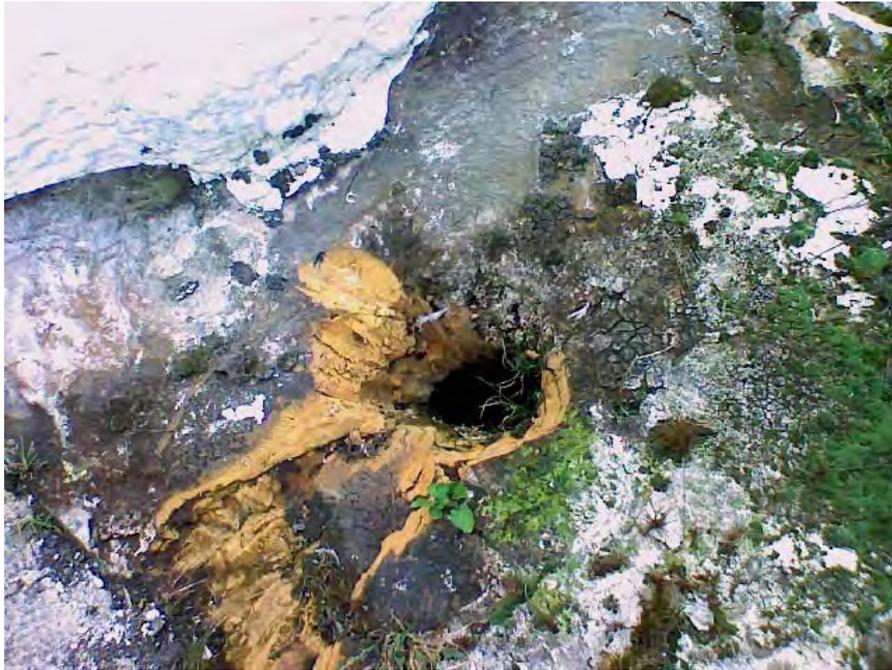
Picture 9

prevent materials from falling in and collecting at the base of the system (Picture 9). Materials collected at the base of the drainage system can prevent proper drainage and ultimately damage the system.

Roof drain lacking cage/strainer; note exposed insulation and plant growth

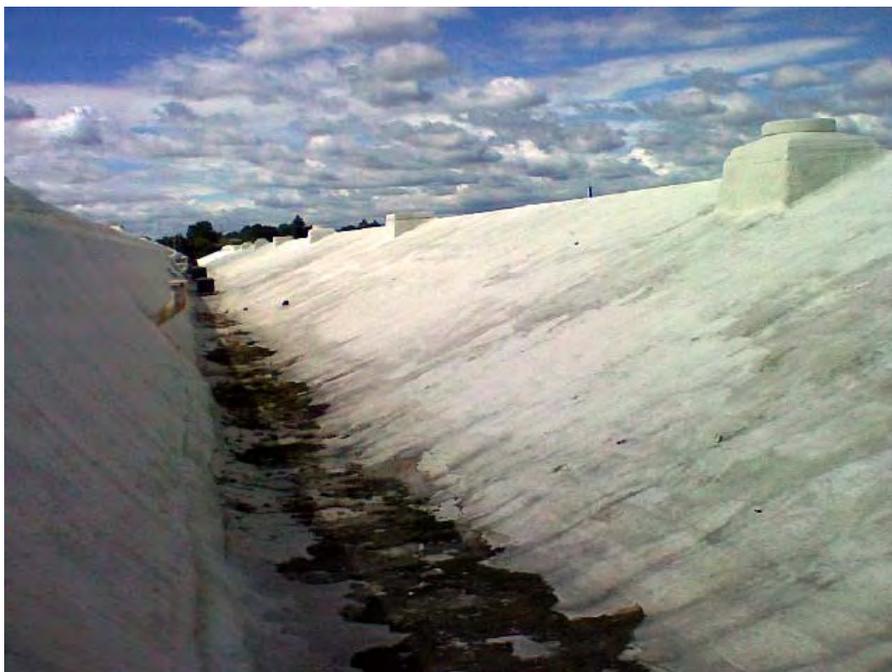
Picture 10

Damage to the rooftop coating and membrane is also likely to be contributing to water-damaged ceiling tiles. BEH staff examined one section of the saw-tooth roof and observed a number of issues. The white membrane observed on the roof appeared cracked and damaged (Pictures 10 and 11). Water was observed collected in areas where the roof coating was missing, and plants were growing in cracks (Pictures 12 and 13). Water trapped beneath the membrane bubbled out from breaches in the coating when pressure was applied (Picture 14). In some areas, a material resembling roof insulation was exposed (Pictures 9 and 15). According to Ms. Platt, Shetland Park Management is aware of roof issues and has indicated that existing issues would be addressed, likely through roof replacement.

Breaches/missing roof membrane and plant growth

8. Continue with plans to repair/replace the roof membrane system. Such work should be conducted during off-work hours to prevent entrainment of materials and odors related to roof repairs/replacement.

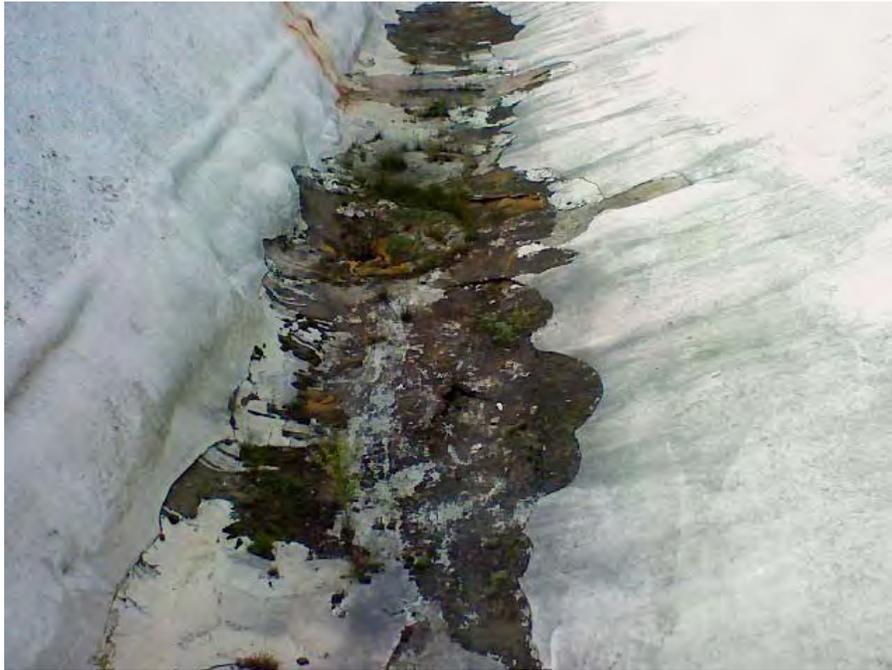
Picture 11

Plant and moss growth on roof

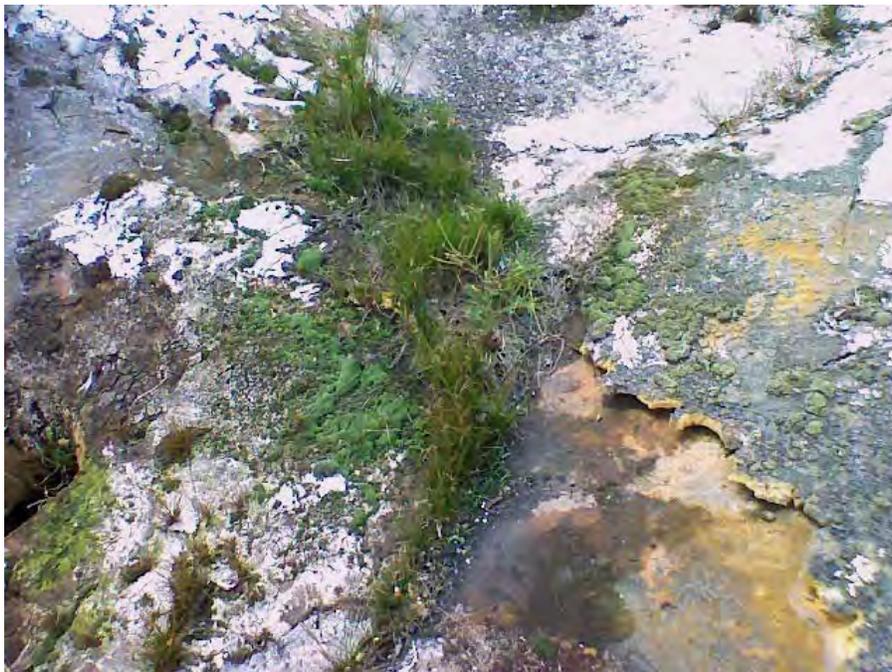
Picture 12

Damaged roof membrane with plant growth

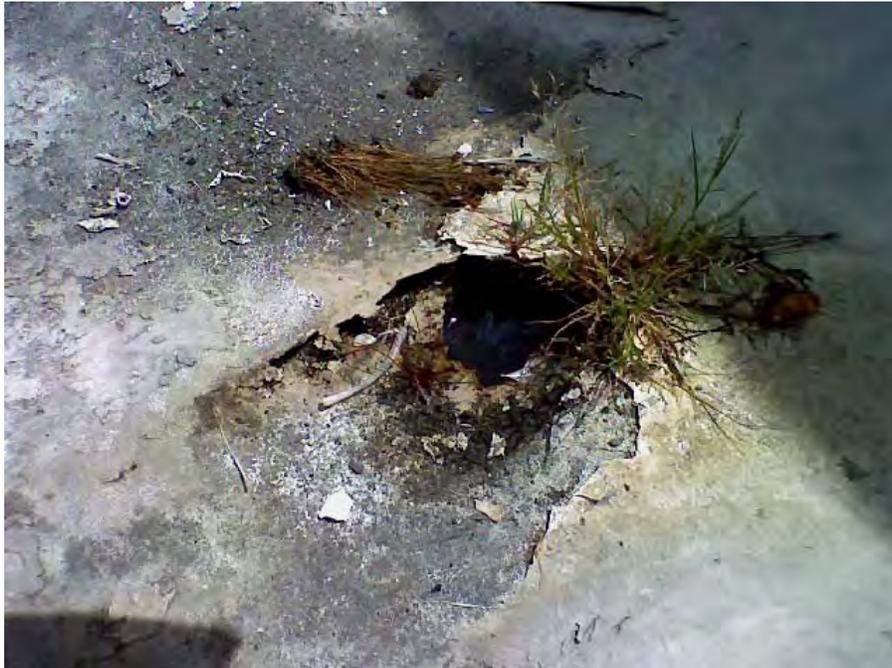
Picture 13

Collected water and plant growth in damaged roof

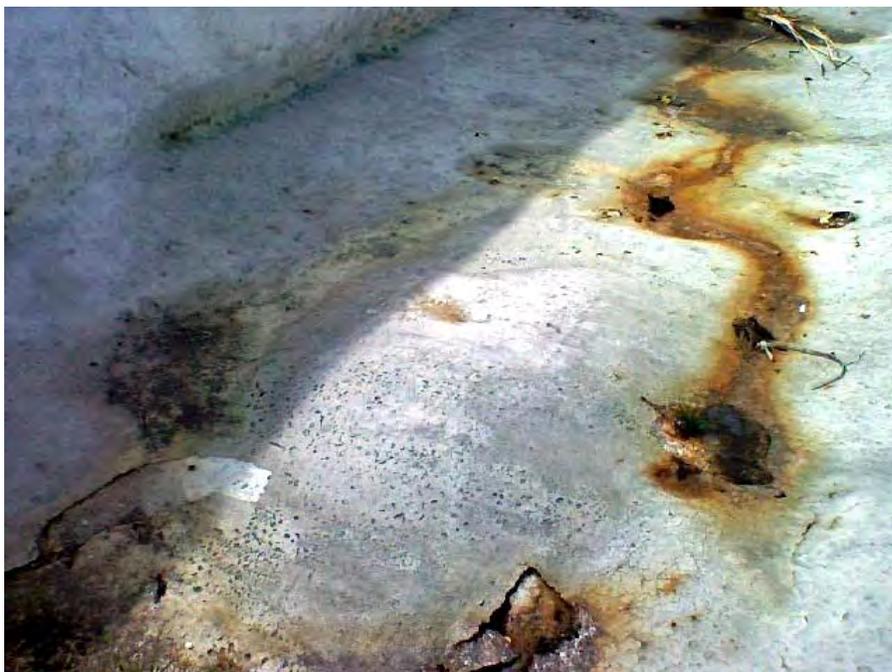
Picture 14

Blister in roof membrane holding water; note water leaking from pocket

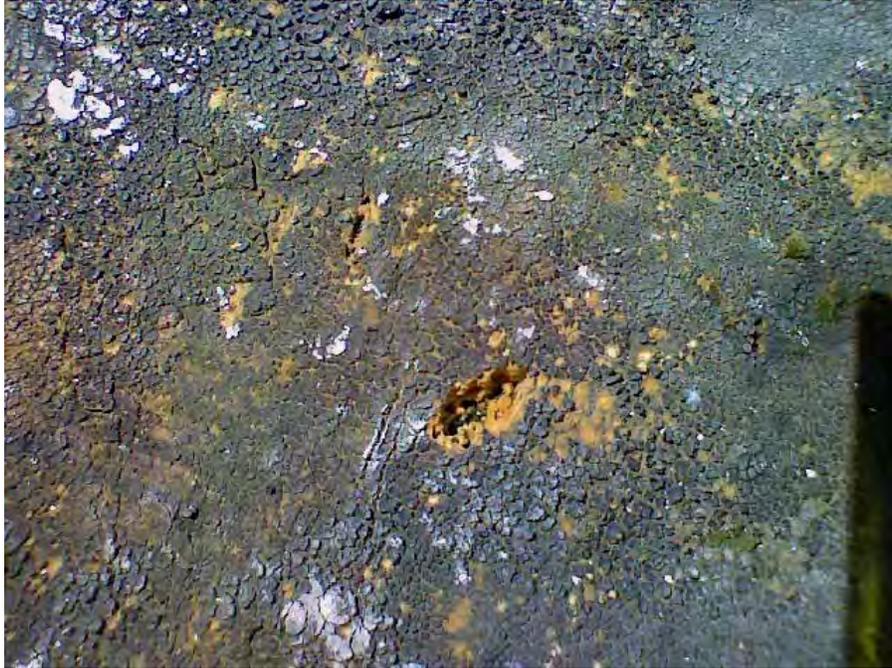
Picture 15

Exposed roof insulation

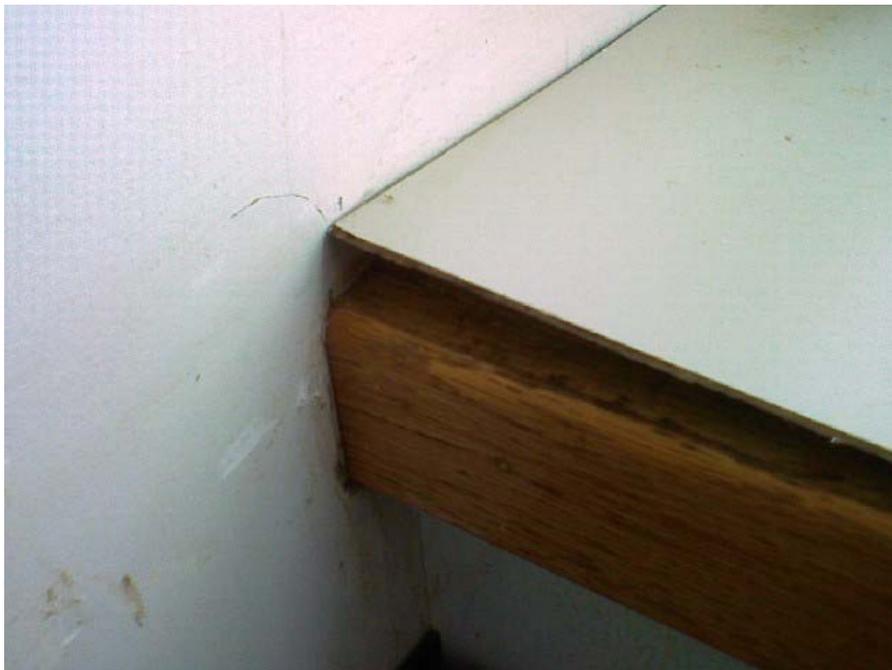
Picture 16

Window ledges at the SORB consist of pressed wood materials with a laminate coating; these ledges also appeared water-damaged at the time of assessment (Pictures 16 and 17). While these ledges may be sustaining some damage via the previously discussed roof drain system leaks, it is more likely that water penetrating from the window system is wetting these ledges. BEH staff observed the conditions of the windows and found failing gaskets and caulking, which can cause water to penetrate the building during wind-driven rains (Pictures 18 and 19). Water staining of glass windowpanes is a further indication of water penetration through failing gaskets (Picture 20). Measures should be taken to repair/replace failing gasket/caulking materials. Damage to these window ledges should also be examined and, if warranted removed and replaced with new ledges to prevent the potential for microbial growth.

Water-damaged pressed wood ledge

9. Repair damaged gaskets and caulking around window system to prevent water penetration.
10. Consider replacing damaged window ledges once repairs to the window system have been made.

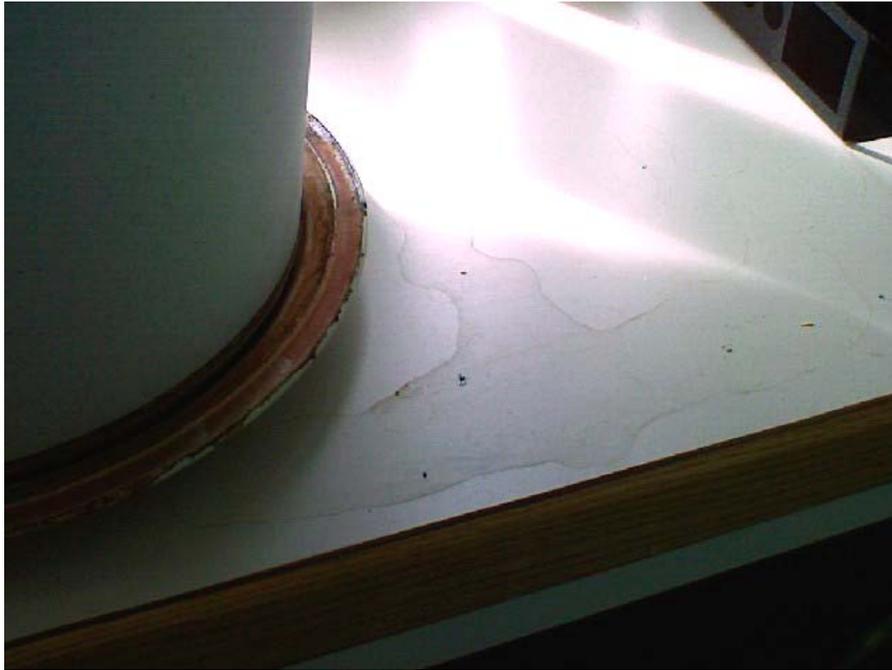
Picture 17

Water staining on wood ledge

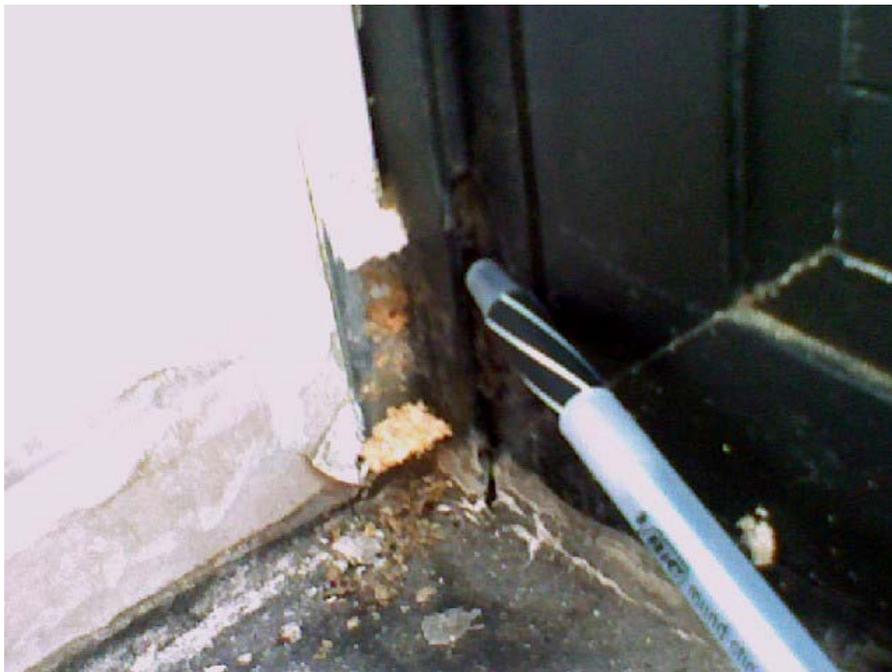
Picture 18

Missing gasket and caulking

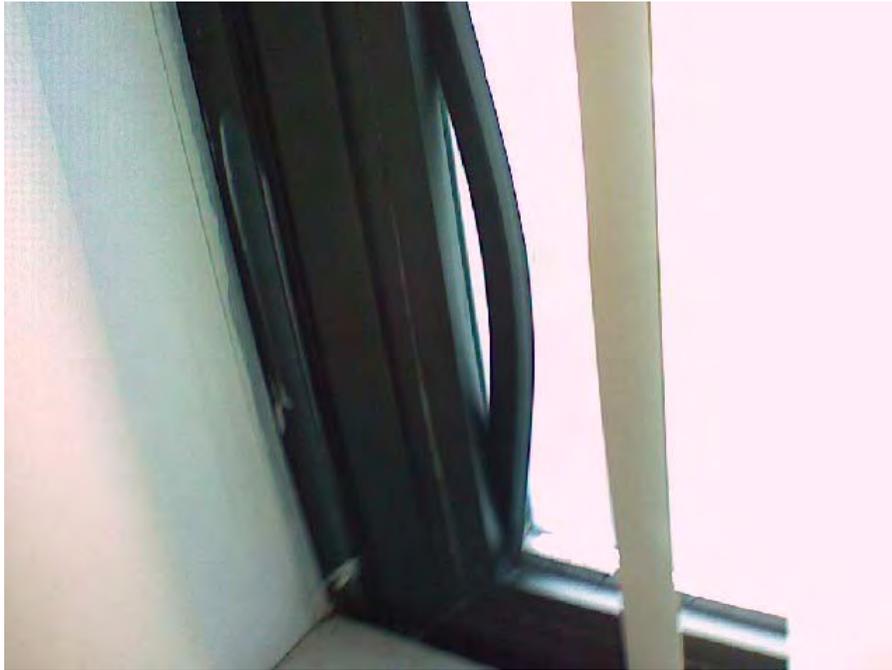
Picture 19

Failing gasket

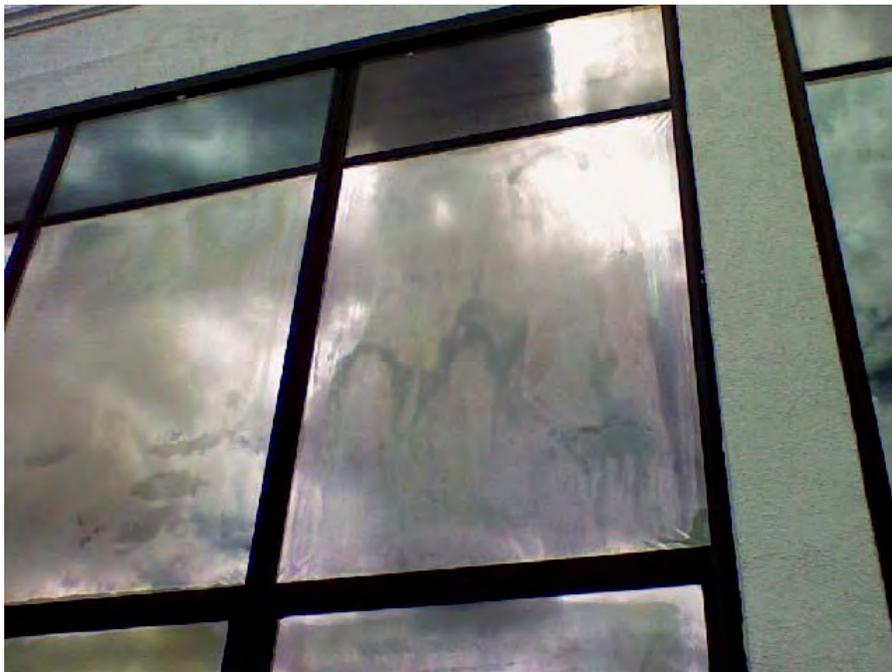
Picture 20

Water staining between window pane
