INDOOR AIR QUALITY ASSESSMENT

**Woodland School
80 Powder Mill Road
Southwick, Massachusetts**

Prepared by:
Massachusetts Department of Public Health
Bureau of Environmental Health
Indoor Air Quality Program
February 2010

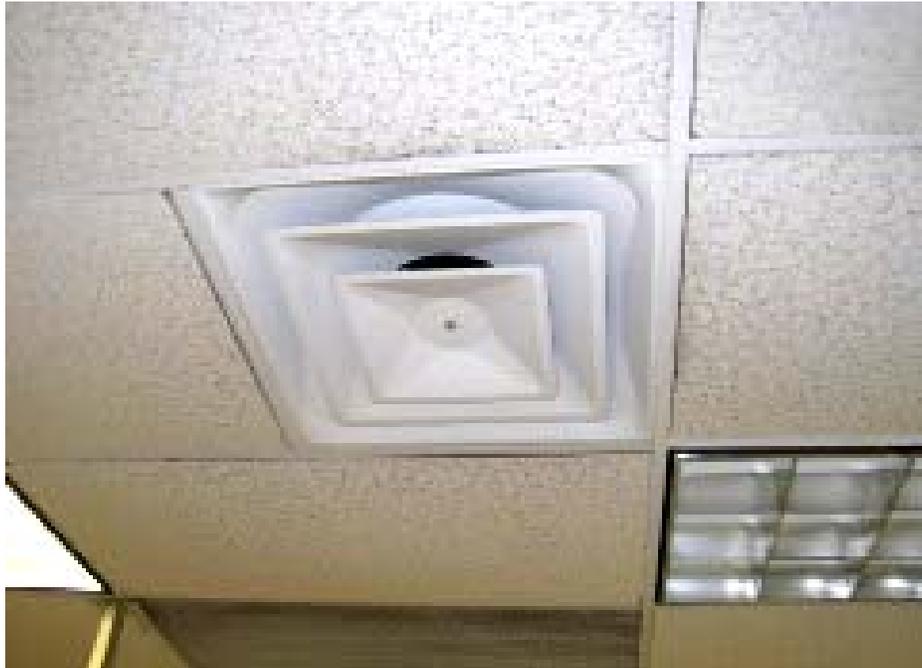
Picture 1

Fresh air is supplied to the original section of the WES by means of an air handling unit (AHU). Fresh air enters these classrooms via ceiling mounted fresh air diffusers (Picture 1). Air is returned to the AHU by means of a plenum located below floor level (Picture 2). Both subsequent additions were provided with fresh air by means of unit ventilators (Picture 3). Both systems exhaust air via rooftop motors. WES staff informed BEH that the south wing does not have a mechanical exhaust; however a passive system consisting of vents and ductwork was present.

Fresh Air Diffuser

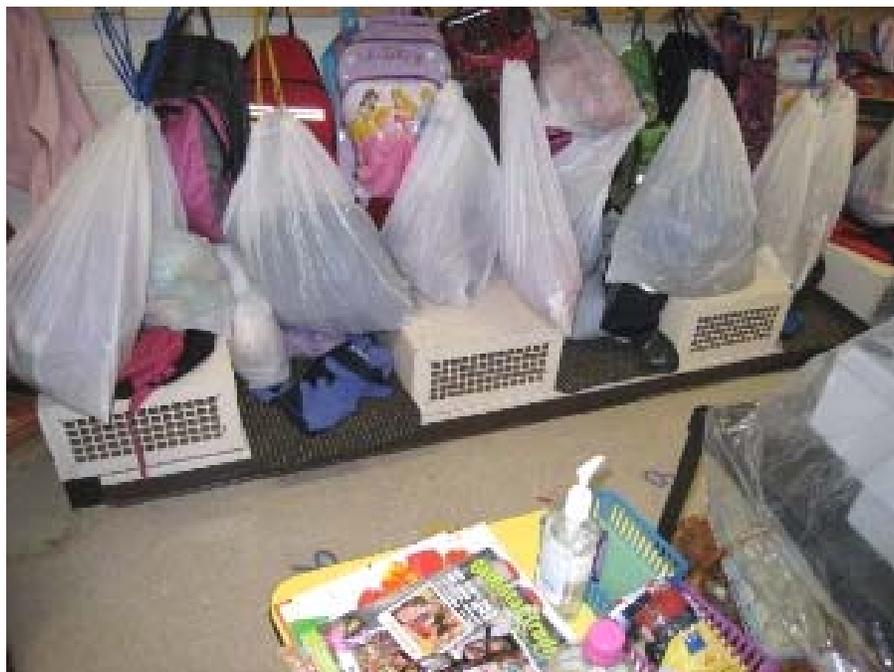
Picture 2

Exhaust Vents Leading to Plenum

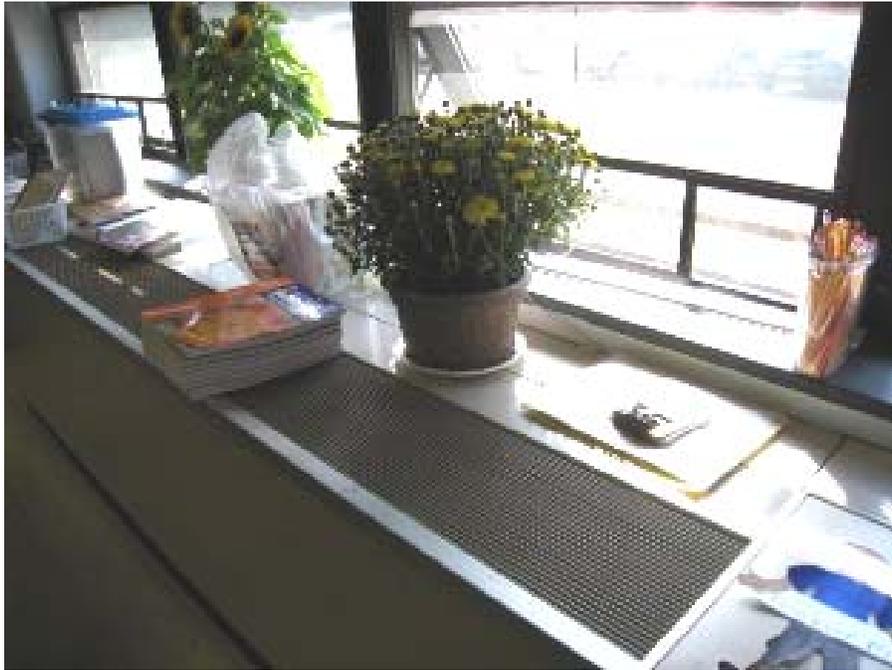
Picture 3

Unit Ventilator

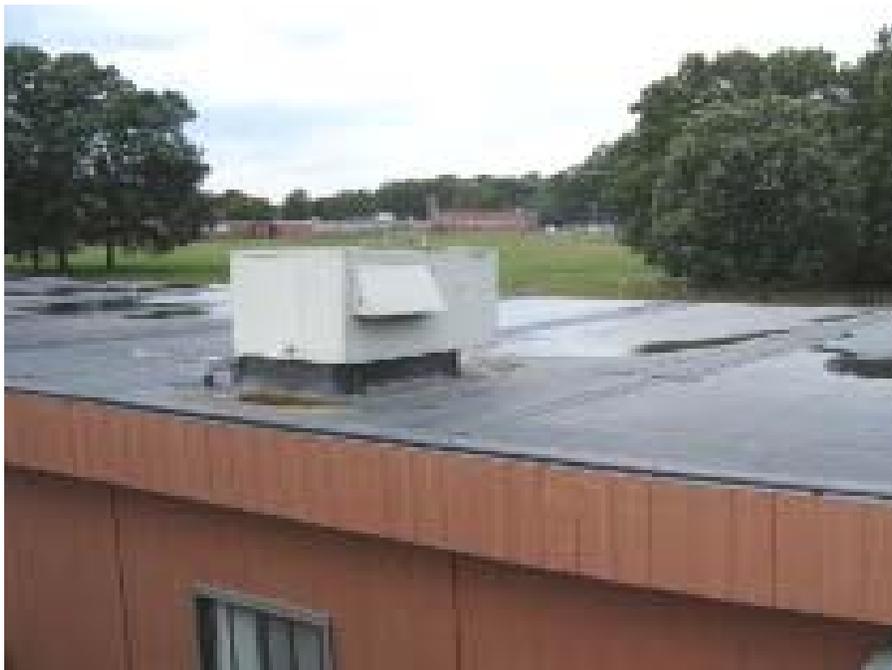
Picture 4

The three modular classrooms are ventilated by means of separate roof mounted AHUs (Picture 4). At least one modular classroom contained a thermostat set to the “auto” position. The automatic setting on the thermostat activates the HVAC system at a preset temperature. Once a preset temperature is measured by the thermostat, the HVAC system is deactivated. Therefore no mechanical ventilation is provided until the thermostat re-activates the system. Spacers were lacking between filters in the AHUs. The existence of space between the filters allows for air to by-pass the installed filters, resulting in aerosolization of materials (e.g. dust).

Air Handling Unit on Roof of Modular Classroom

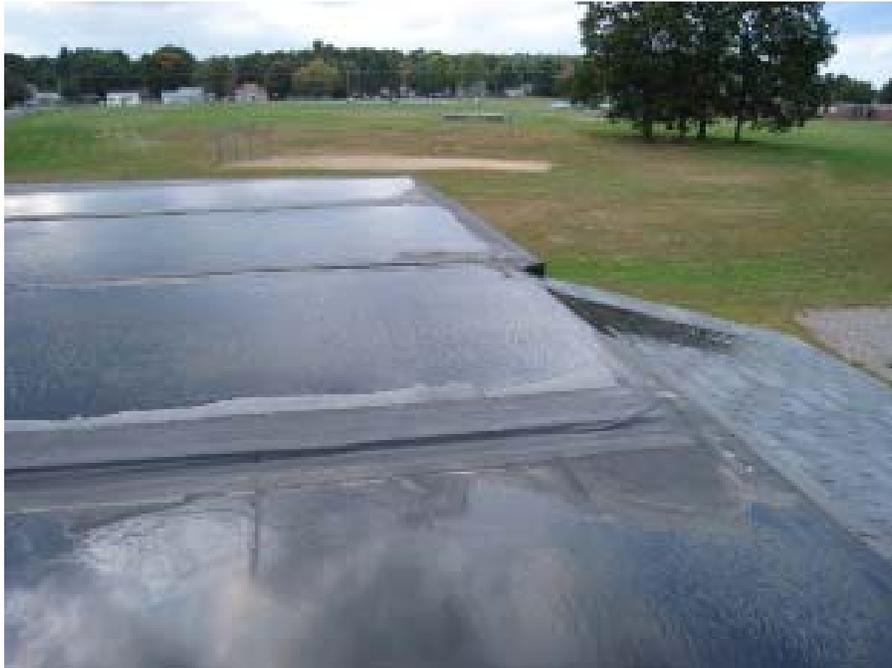
Picture 5

- Standing water was noted on all areas of the roof, but was particularly evident on the roof of the modular classrooms (Picture 5). A portion of the standing water drains off of the flat roof and onto the pitched roof of the hallway that runs outside of the modular units. From there, the water spills onto the pavement and splashes up onto the exterior walls of the modular units. Portions of the units exhibited buckled, water damaged exterior siding (Picture 6).
- Deterioration was observed in sections of the roof membrane (Picture 7).
- Roof drains were obstructed by a heavy accumulation of moss and accumulated debris (Picture 8). Moss was also evident on areas of the roof proper, on the modular unit siding

Standing Water on Roof of Modular Classrooms

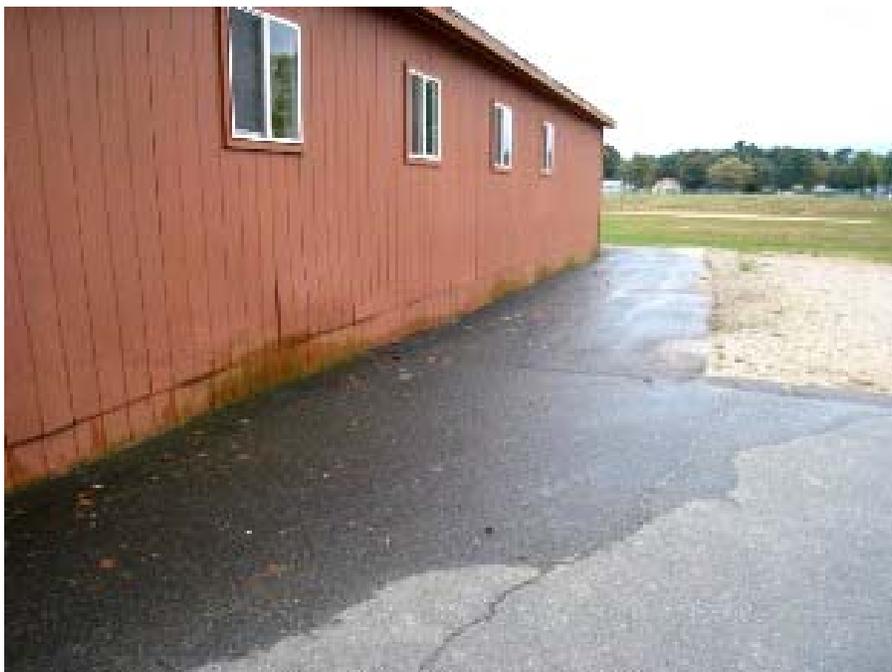
Picture 6

Buckled, Water Damaged Exterior Siding, Also Note Splashback on Base of Wall

6. Repair areas of roof that exhibit deterioration.
7. Repair/replace buckled water damaged exterior siding on modular classrooms.
8. Eliminate heavy moss growth from in front of roof drains and debris on roof.

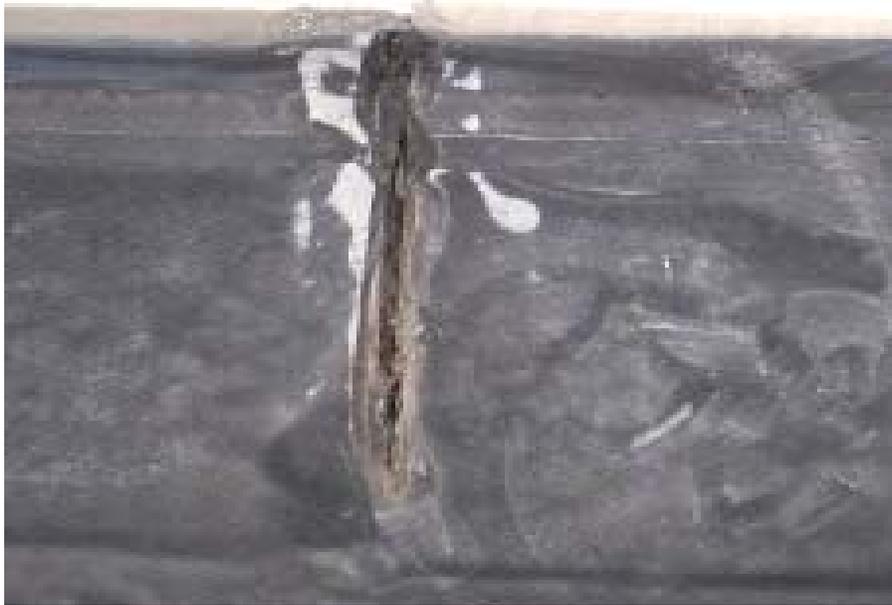
Picture 7

Deteriorated Rubber Membrane Roofing Material

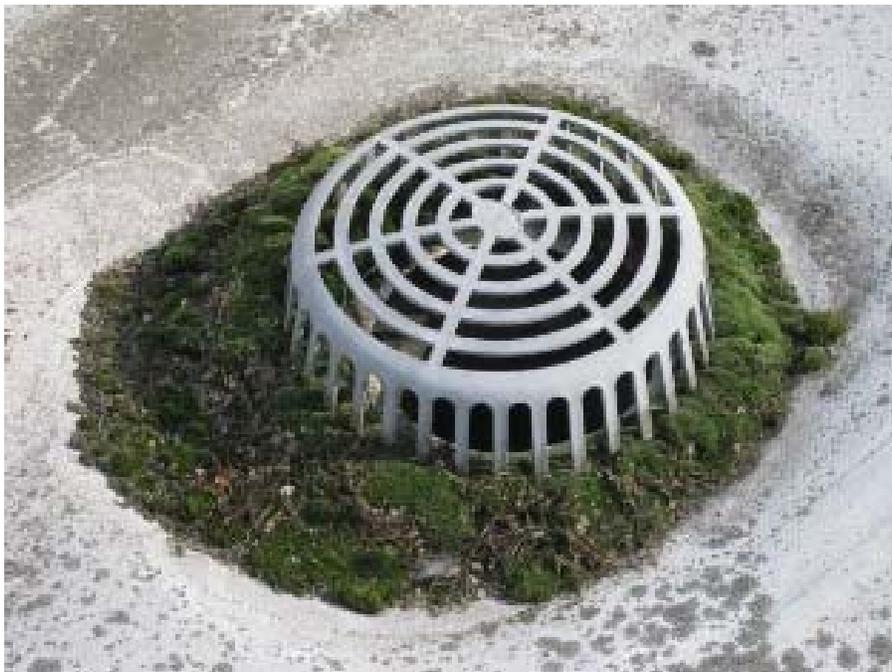
Picture 8

Heavy Moss Growth/Debris Clogging Roof Drain

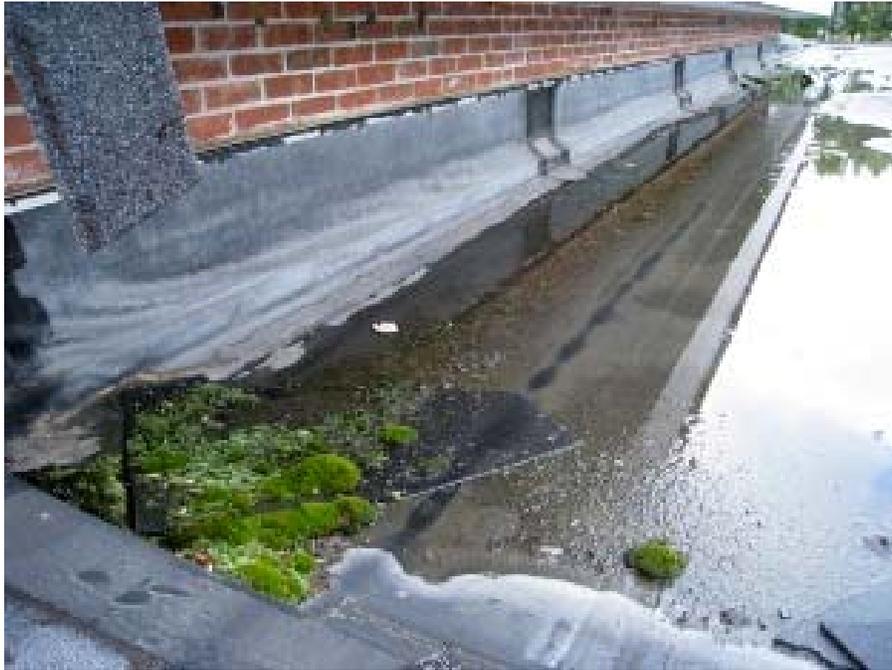
and at the juncture of the pavement and the building. The presence of moss on the roof shown in Picture 9 is indicative of repeated and sustained water exposure. The two main requirements of moss growth are substantial moisture and accessible nutrients. “For example, the moist environment of a rooftop shaded by trees seems just fine for mosses, [which] prefer to colonize shingles above the eaves, on detritus that builds up in the eaves' troughs or other depressions. Mosses will be at their best in the winter when there is plenty of water, little light, and low temperatures” (OSU, 2000).

Standing Water and Moss Growth on Roof

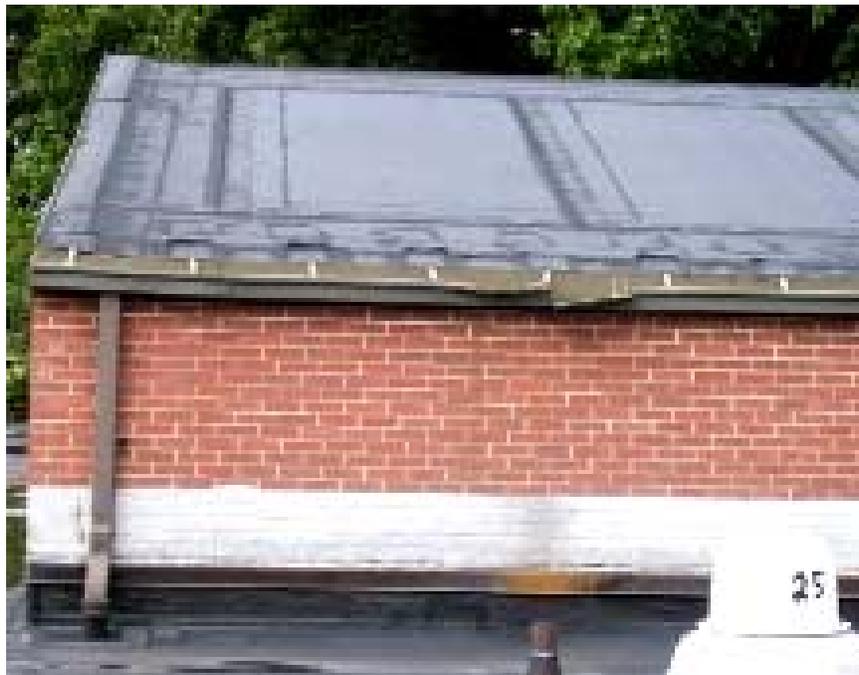
Picture 10

- Rooftop gutters are missing/in disrepair (Picture 10).
- A downspout missing its elbow extension terminates at the base of a modular classroom (Picture 11).

Gutter System in Disrepair

9. Repair deteriorated areas of gutter/downspout system. In addition, examine feasibility of engineering the downspout system in such a way as to prohibit rainwater from being deposited at the base of the building and splashing against the siding of the modular classrooms.

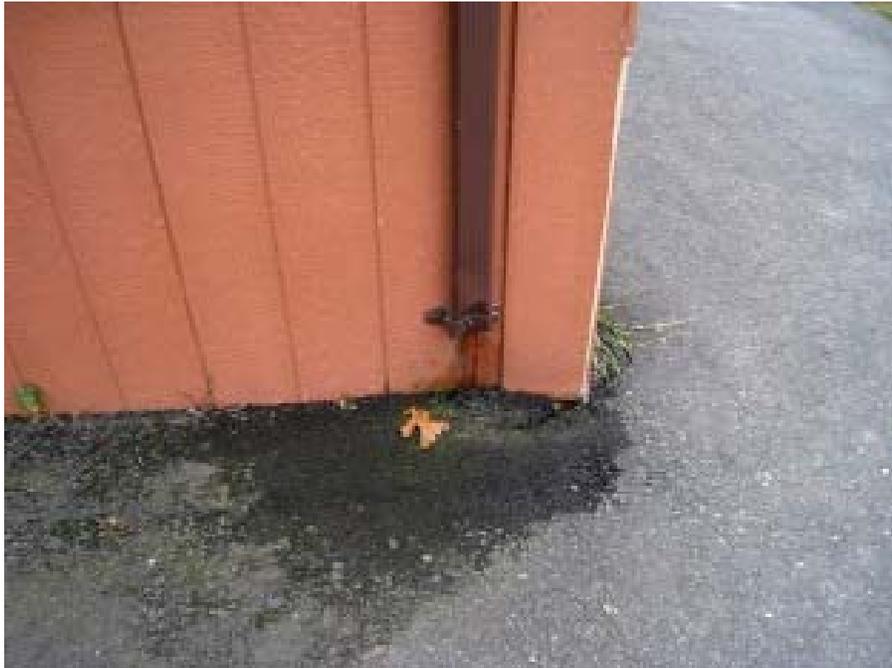
Picture 11

Downspout Terminates at Base of Building, Note Missing Elbow Extension

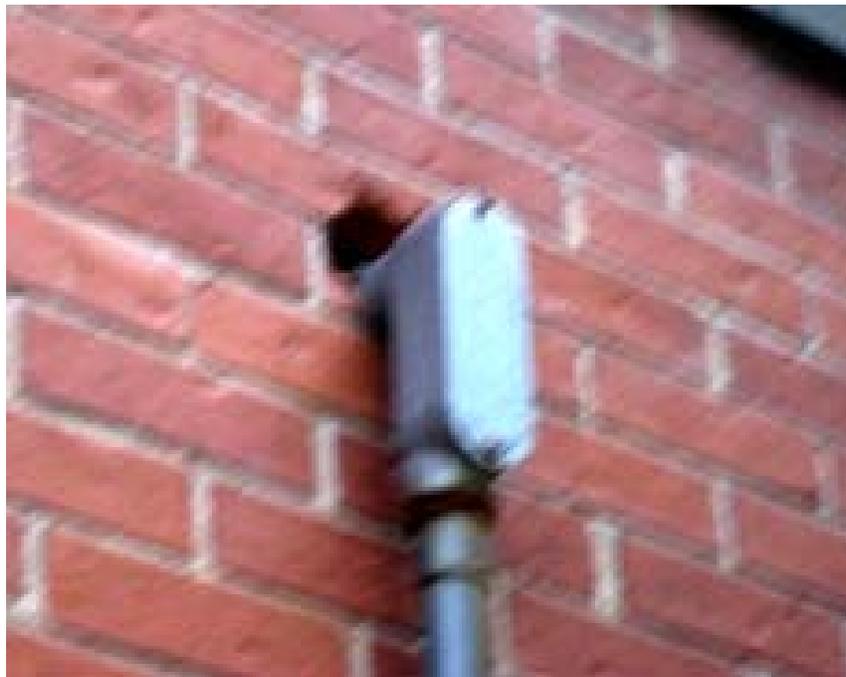
Picture 12

- An open utility hole was observed on the exterior of the building (Picture 12).
- Weep holes were observed to be obstructed (Picture 13). Exterior wall systems should be designed to prevent moisture penetration into the building interior. An exterior wall system should consist of an exterior curtain wall ([Figure 1](#)). Behind the curtain wall is an air space that allows for water to drain downward and for the exterior cladding system to dry. In order to allow for water to drain from the exterior brick system, a series of weep holes is customarily installed in the exterior wall, at or near the foundation slab/ exterior wall system junction. Weep holes allow for accumulated water to drain from a wall system (Dalzell, 1955). Opposite the exterior wall and across the air space is a continuous, water-resistant material adhered to the back up wall that forms the drainage plane. The purpose of the drainage plane is to prevent moisture that crosses the air space from penetrating the interior of the building. The plane also directs moisture downwards toward the weep holes. The drainage plane can consist of a number of water-resistant

Large Open Utility Hole on Exterior of Building

10. Seal all open utility holes (interior and exterior) throughout the building.
11. Remove debris from all obstructed weep holes.
12. Repair damaged/missing mortar.

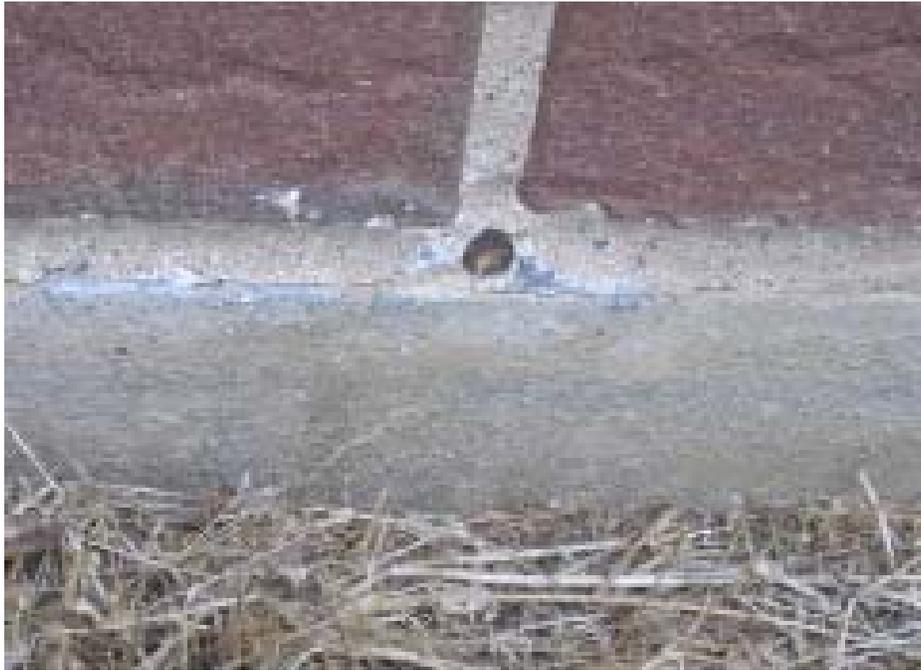
Picture 13

Obstructed Weep hole

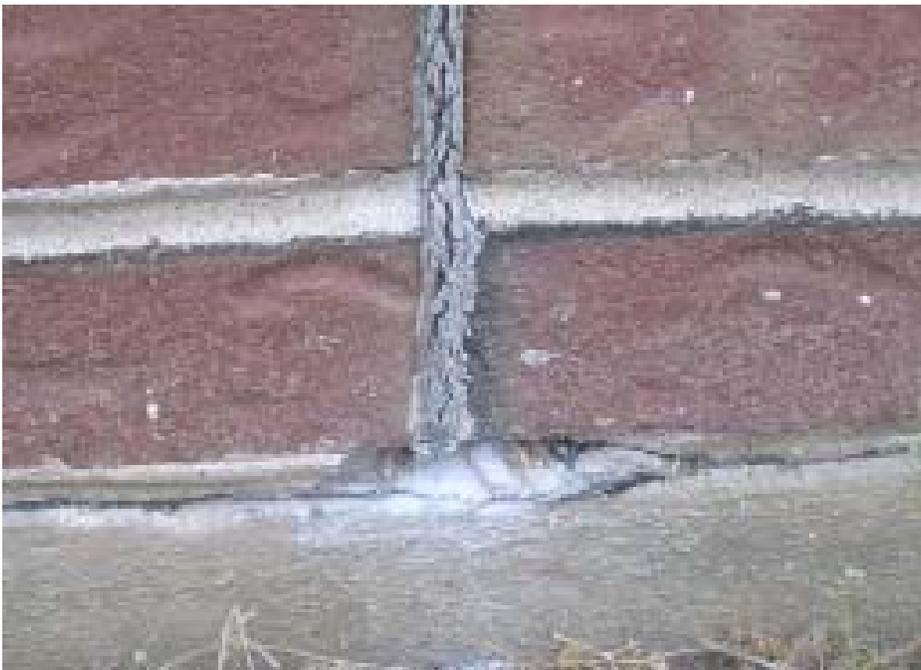
Picture 14

- Efflorescence was observed on portions of exterior brick (Picture 14). Efflorescence is a characteristic sign of water intrusion. As penetrating moisture works its way through mortar around brick, it leaves behind characteristic mineral deposits. (It is important to stress that while efflorescence is an important sign of water intrusion, it is not mold growth).

**Efflorescence on Mortar and Concrete
Note Deteriorated Expansion Joint**

13. Repair deteriorated caulking and expansion joint sealant in accordance with EPA guidelines.
14. Repair leaking exterior faucet.
15. Trim trees and plants to within five feet of building envelope.

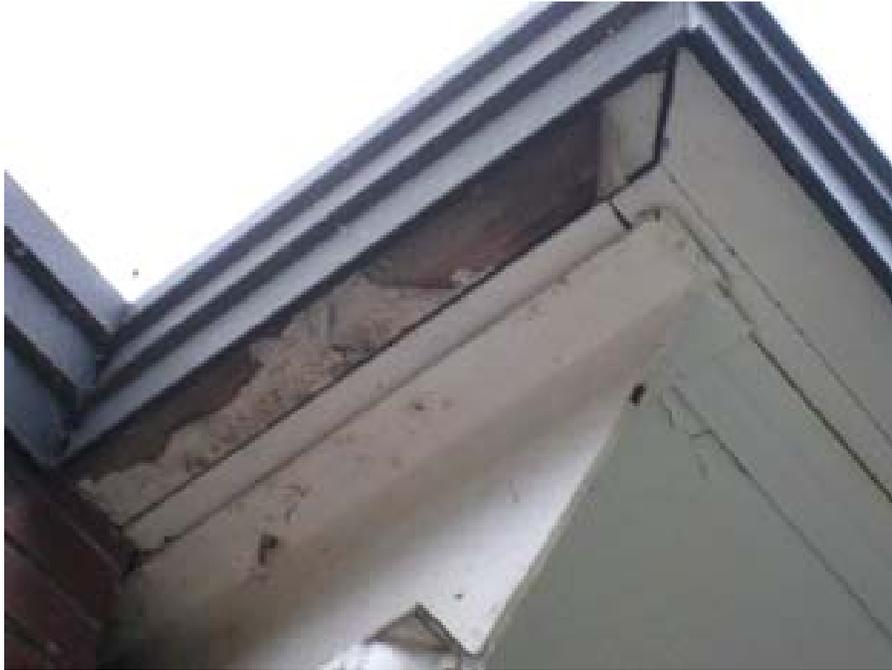
Picture 15

- Some mortar around exterior brick was missing and/or damaged.
- Caulking is damaged and deteriorated on windows and in expansion joints.
- Peeling paint was observed on the soffit (Picture 15). This condition allows moisture to enter the building envelope.

Peeling Paint on Soffit

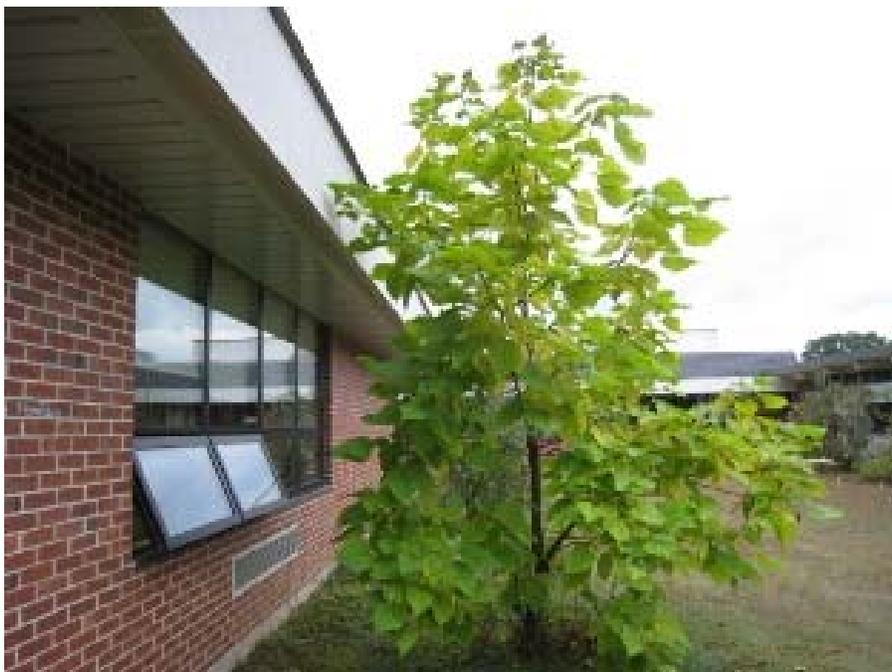
Picture 16

- A leaking faucet was observed on the exterior of the building.
- Trees and plants were observed growing in close proximity to the building (Pictures 16 and 17). The growth of roots against exterior walls can bring moisture in contact with the foundation. Plant roots can eventually penetrate, leading to cracks and/or fissures in the sublevel foundation.

Plant Growth Adjacent to Building

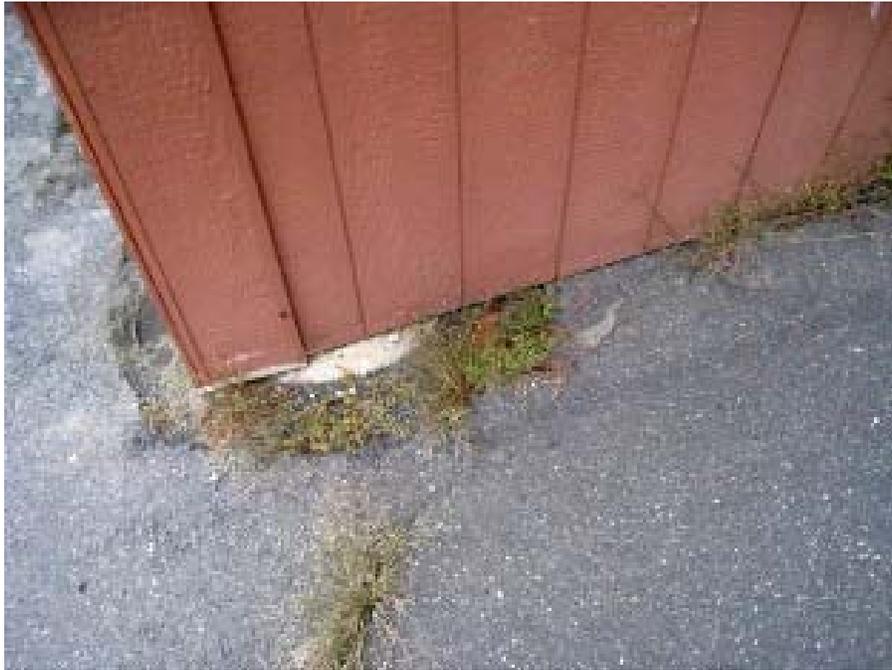
Picture 17

Plant Growth at Base of Modular Classrooms

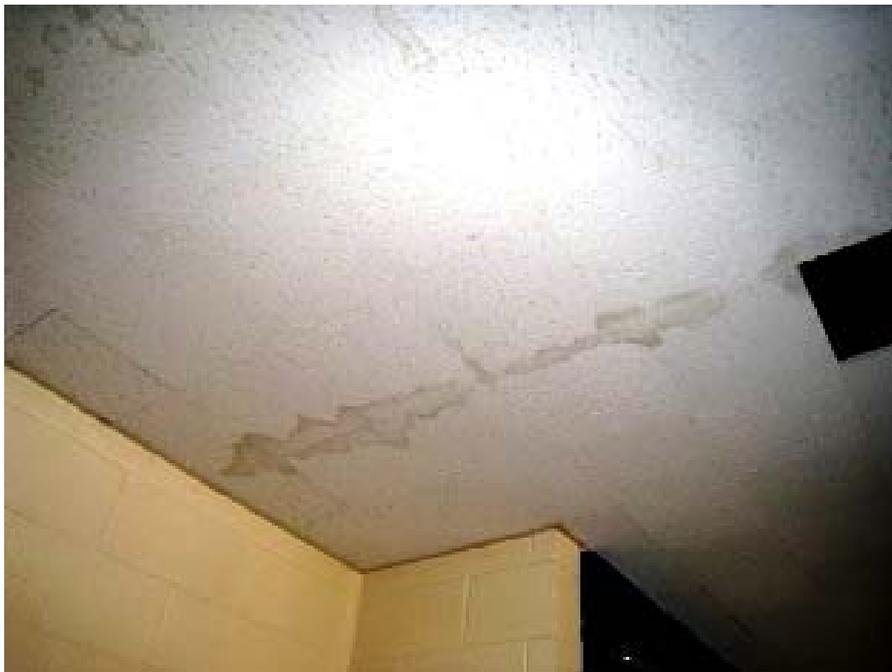
Picture 18

Several potential sources of water damage and/or mold growth were observed indoors at the WES. Water damaged ceiling tiles were observed throughout the WES (Table 1/Picture 18). Some of these tiles appeared to have been painted over rather than replaced. Water-damaged ceiling tiles can provide a source of mold and should be replaced after a water leak is discovered and repaired.

Water Damaged Ceiling Tiles

16. Ensure leaks are repaired and replace water damaged or missing ceiling tiles. Examine the area above and around these areas for mold growth. Disinfect areas of water leaks with an appropriate antimicrobial.

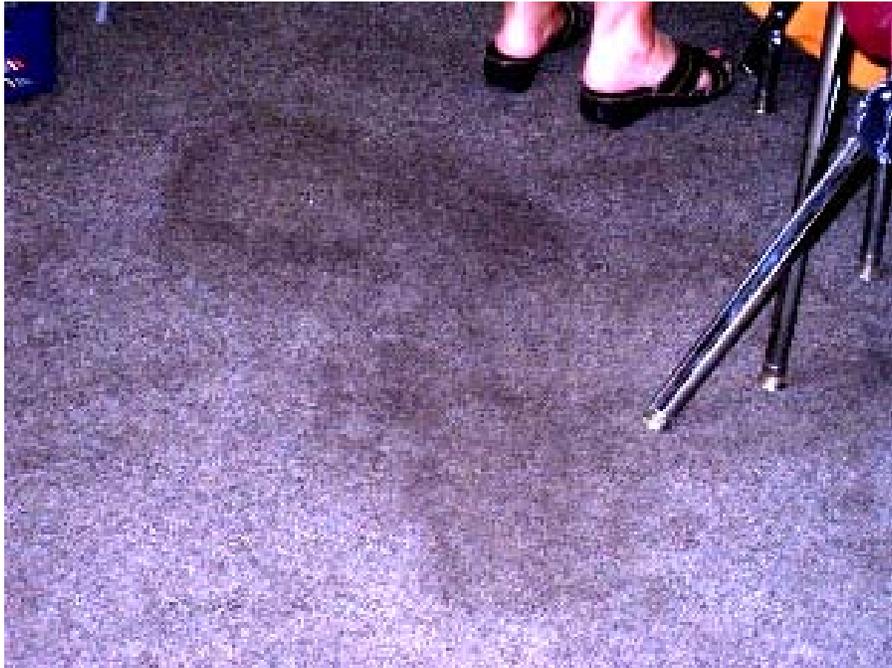
Picture 19

It was reported by WES staff that the carpets located in the modular classrooms were wet cleaned during the late summer; however, they do not appear to have been properly dried. As a result, two days prior to school opening, musty odors were discovered in these classrooms. BEH staff observed darkened surfaces on some areas of carpet (Picture 19). In an effort to ascertain moisture content of carpeting within these classrooms, moisture content was measured with a Delmhorst Moisture Detector equipped with a Delmhorst Standard Probe. The Delmhorst probe is equipped with three lights that function as visual aids that indicate moisture level. Readings that activate the green light indicate a sufficiently dry or low moisture level, those that activate the yellow light indicate borderline conditions and those that activate the red light indicate elevated moisture content.

Darkened Area of Carpet

1. Remove water damaged carpeting from modular classrooms and replace with impervious floor covering. Prior to installing new floor covering, ensure sub-floor is free from mold colonization and that it has been adequately dried.
2. Use openable windows in conjunction with mechanical ventilation to facilitate air exchange. Care should be taken to ensure windows are properly closed at night and weekends to avoid the freezing of pipes and potential flooding.
3. Consider adopting a balancing schedule of every 5 years for all mechanical ventilation systems, as recommended by ventilation industrial standards (SMACNA, 1994).
Maintain ventilation equipment in accordance with manufacturers' instructions.
4. Change filters for air-handling equipment (e.g., univents, AHUs and ACs) as per the manufacturer's instructions or more frequently if needed. Vacuum interior of units prior

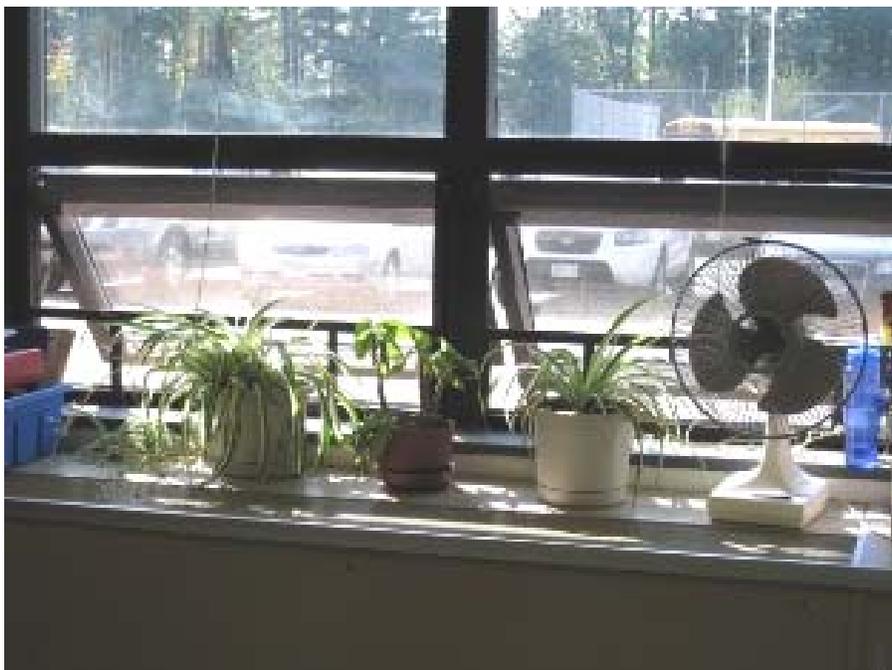
Picture 20

Plants were observed throughout the WES, many of which were located on unit ventilators (Picture 20). Plant soil and drip pans can serve as a source of mold growth. Plants should be properly maintained and be equipped with drip pans. Plants should also be located away from the air stream of mechanical ventilation to prevent aerosolization of dirt, pollen or mold.

Plants Located on Unit Ventilator

17. Clean and maintain aquariums, water fountains and terrariums to prevent mold growth and associated odors.
18. Examine plant drip pans periodically for mold growth. Disinfect with an appropriate antimicrobial where necessary.

19. Locate plants away from the airstream of mechanical ventilation to prevent aerosolization of dirt, pollen or mold.
20. Eliminate the use of latex tennis balls on chair legs. Consider replacing with latex-free tennis balls or alternative “glides”.

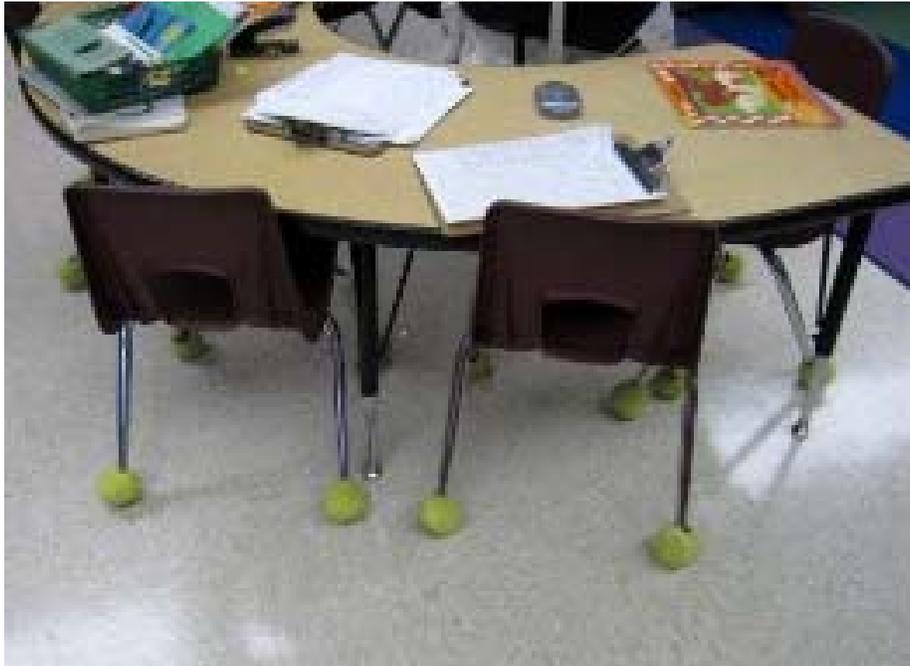
Picture 21

In an effort to reduce noise from sliding chairs and tables, tennis balls were sliced open and placed on chair legs (Picture 21). Tennis balls are made of a number of materials that are a source of respiratory irritants. Constant wearing of tennis balls can produce fibers and off-gas VOCs. Tennis balls are made with a natural rubber latex bladder, which becomes abraded when used as a chair leg pad. Use of tennis balls in this manner may introduce latex dust into the school environment. Some individuals are highly allergic to latex (e.g. spina bifida patients) (SBAA, 2001). It is recommended that the use of materials containing latex be limited in buildings to reduce the likelihood of symptoms in sensitive individuals (NIOSH, 1997).

Tennis Balls on Chair Legs

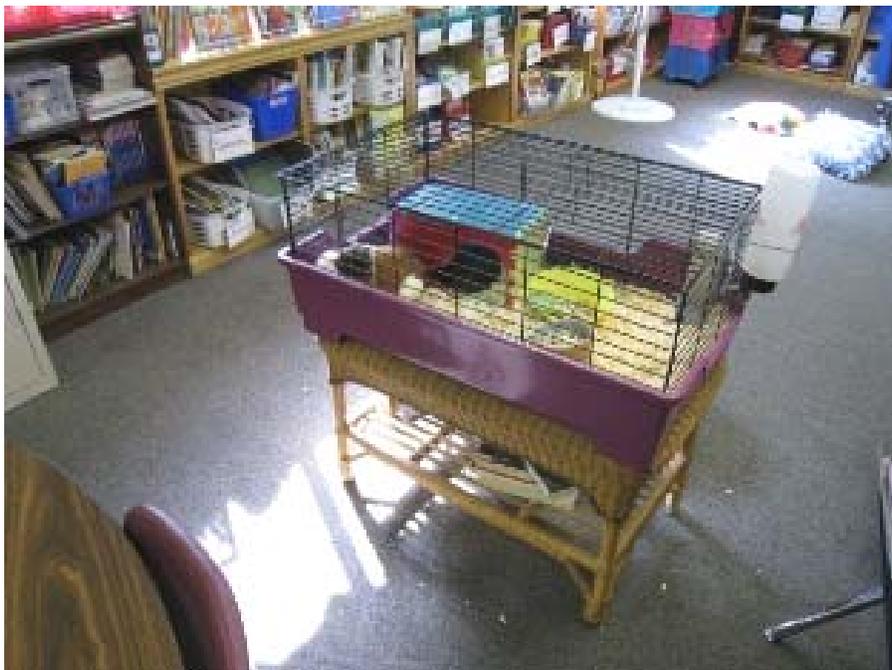
Picture 22

Pet bedding was observed on the carpet in one of the classrooms beside an animal cage (Picture 22). Porous materials (i.e., wood shavings) can absorb animal wastes and can be a reservoir for mold and bacterial growth. Animal dander, fur and wastes can all be sources of respiratory irritants. Animals and animal cages should be cleaned regularly to avoid the aerosolization of allergenic materials and/or odors.

Animal Bedding on Carpet

25. Clean animal cages regularly to avoid the aerosolization of allergenic materials and to prevent odors.
26. Frequently vacuum upholstered furniture and pillows. Ensure upholstered furniture is professionally cleaned on an annual basis. If not possible/practical consider removal.

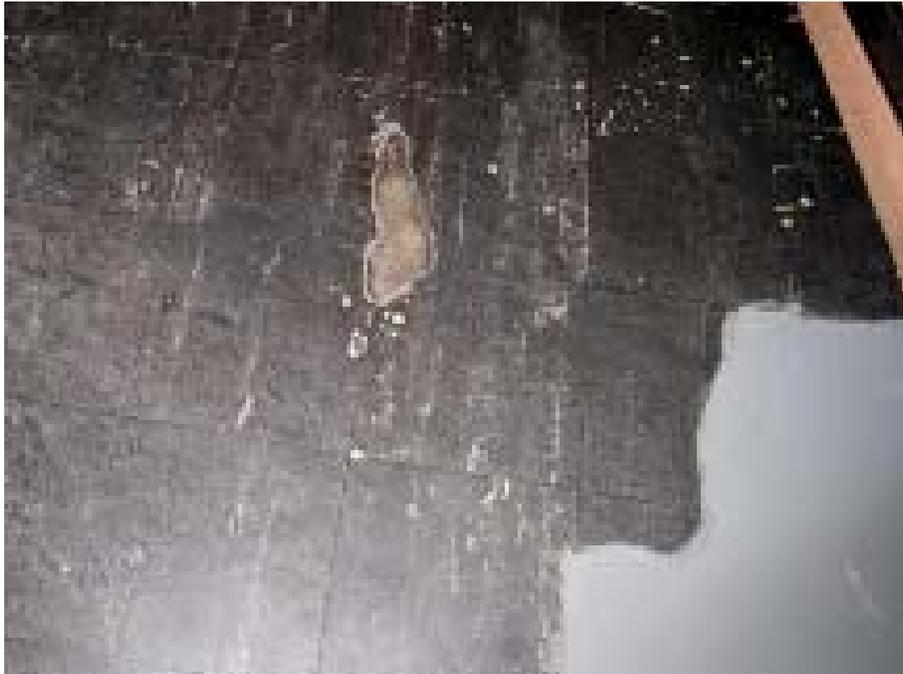
Picture 23

Damaged or missing floor tiles were observed in some areas (Picture 23). These floor tiles may contain asbestos. Intact asbestos-containing materials do not pose a health hazard. If damaged, asbestos-containing materials can be rendered friable and become aerosolized. Friable asbestos is a chronic (long-term) health hazard, but will not produce acute (short-term) health effects (e.g., headaches) typically associated with buildings believed to have indoor air quality problems. Where asbestos-containing materials are found damaged, these materials should be

Worn Floor Tiles

27. Determine composition of damaged floor tiles. If found to contain asbestos, remediate damaged floor tiles in conformance with Massachusetts asbestos remediation and hazardous waste disposal laws (MDLI, 1993).
