# **INDOOR AIR QUALITY ASSESSMENT**

**Registry of Motor Vehicles  
1 Washington Street  
Taunton, Massachusetts**

Prepared by:  
Massachusetts Department of Public Health  
Bureau of Environmental Health  
Indoor Air Quality Program  
June 2010

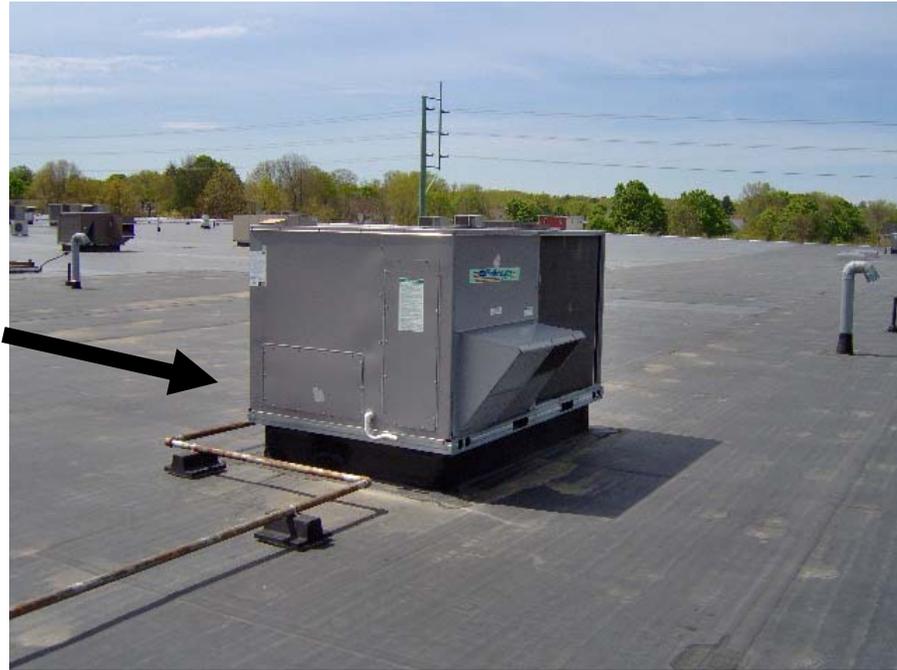
**Picture 1**

Mechanical ventilation is provided by rooftop air-handling units (AHUs) (Picture 1). Fresh air is drawn into the AHUs and delivered to occupied areas via ductwork. Recirculated air is directed into the office space by ceiling-mounted fresh air diffusers. Return air is drawn into an open ceiling plenum (Picture 2), which is returned to the rooftop AHU by a duct in the ceiling plenum. No means to exhaust stale air exists (Picture 1). In this configuration, ordinary indoor pollutants can build up over the course of the business day and lead to IAQ/comfort complaints. The only form of exhaust ventilation for the office space appears to be the exhaust vents in the restrooms. In order

**Rooftop AHU, Note Sheet Metal over Exhaust Vent (Arrow)**

1. Examine methods to improve exhaust ventilation. Adding exhaust vents to the rooftop AHUs should be considered.
2. Set the thermostat to the fan “on” position to operate the ventilation system continuously during business hours.
3. In order to increase air circulation, consideration should be given to replacing six ceiling tiles with “egg crates” in the public waiting area (Area 23) to allow for waste heat to vent into the ceiling plenum.
4. Consideration should be give to installing restroom exhaust motors in place of the cane-shape vents on the roof.

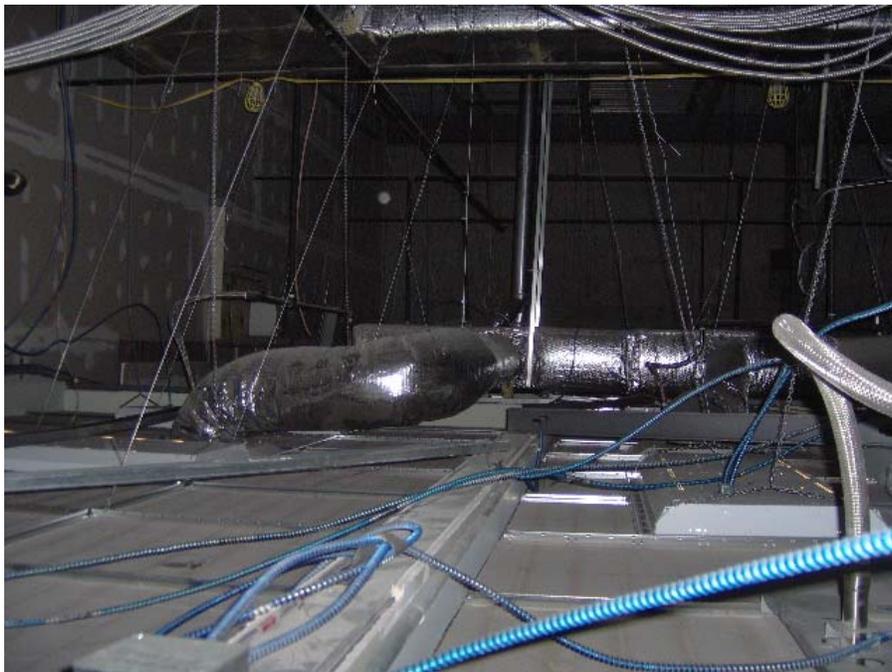
**Picture 2**

**Ceiling Plenum Above Office Space, Note Large Volume (+8 Feet)**

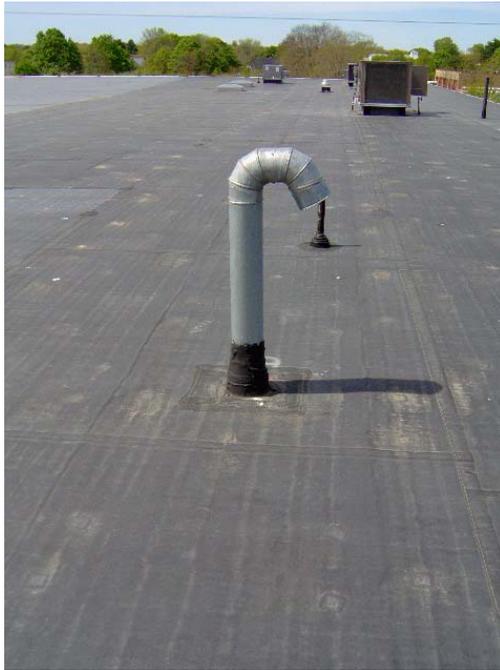
**Picture 3**

to maximize exhaust ventilation, exhaust fans in commercial settings are usually located at the roof level. The restroom exhaust vent fans for the RMV space (Picture 3) are located in the suspended ceiling and are connected to the roof via flexible ducts (Picture 4). The placement of exhaust in this manner will reduce air velocity to decrease draw of air, which in turn serves to increase carbon dioxide levels. Unfortunately, these vents are also activated by restroom light switches. The fans were deactivated at the time of the assessment because the lights were not on.

**Restroom Exhaust Vents on Roof**

5. Install timer to operate restroom exhaust vents continuously during business hours.
6. For buildings in New England, periods of low relative humidity during the winter are often unavoidable. Therefore, scrupulous cleaning practices should be adopted to minimize common indoor air contaminants whose irritant effects can be enhanced when the relative humidity is low. To control for dusts, a high efficiency particulate arrestance (HEPA) filter equipped vacuum cleaner in conjunction with wet wiping of all surfaces is recommended. Drinking water during the day can help ease some symptoms associated with a dry environment (throat and sinus irritations).

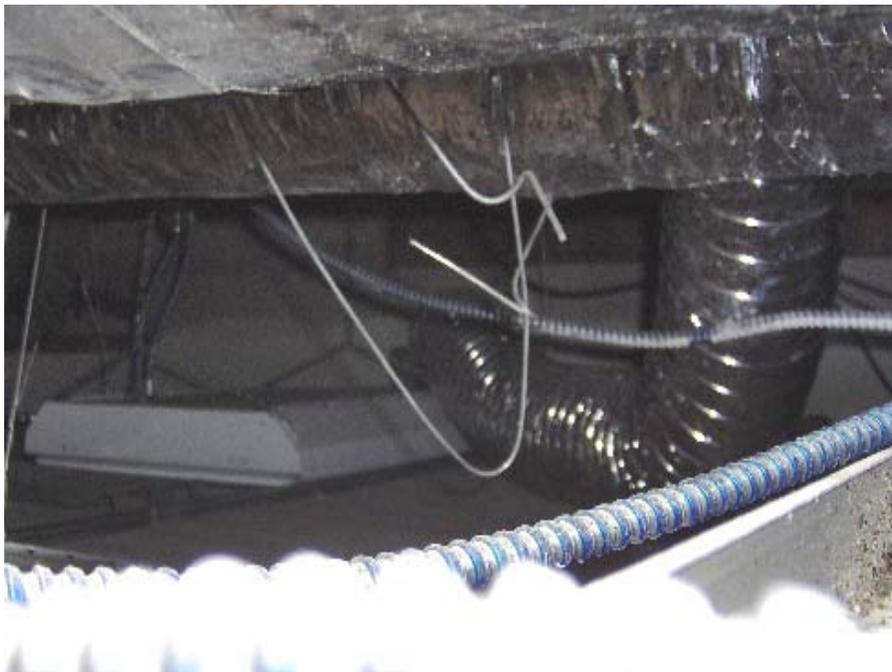
**Picture 4**

**Flexible Duct Connected to Restroom Vent**
