INDOOR AIR QUALITY REASSESSMENT

**Registry of Motor Vehicles
1 Washington Street
Taunton, Massachusetts**

Prepared by:
Massachusetts Department of Public Health
Bureau of Environmental Health
Indoor Air Quality Program
November 2010

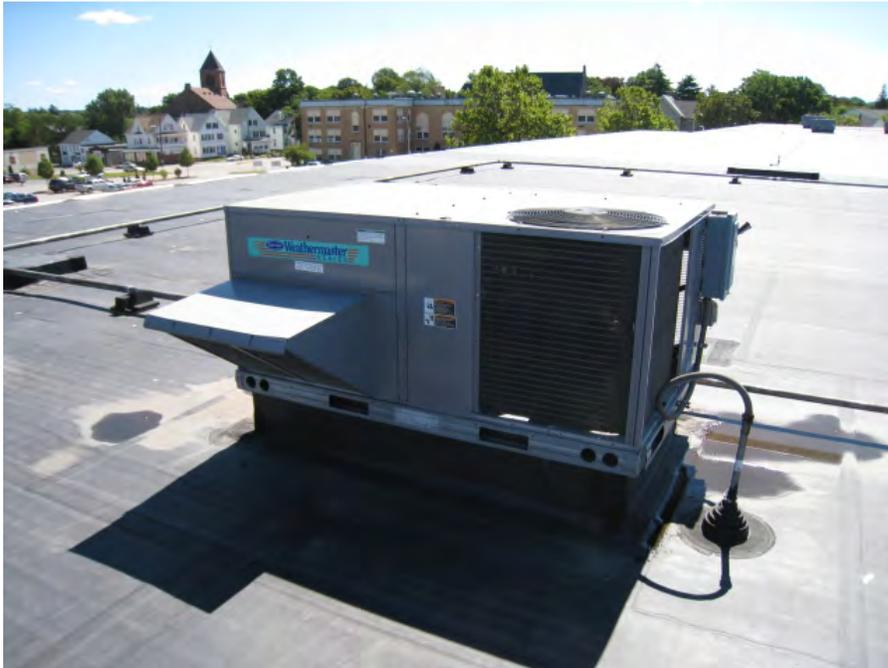
Picture 1

It can be seen from Table 1 that carbon dioxide levels were below 800 parts per million (ppm) in all areas, indicating adequate air exchange at the time of the assessment. Mechanical ventilation is provided by rooftop air-handling units (AHUs) (Picture 1). Fresh air is drawn into the AHU through a bank of pleated air filters (Picture 2); and is heated/cooled; and delivered to occupied areas via ducted supply diffusers. Return air is drawn into the ceiling plenum and ducted back to rooftop AHUs. Rooftop AHU filters were clean at the time of the assessment (Picture 2). Restroom exhaust vents provide general exhaust for the RMV space. As recommended in the previous MDPH report, they were on a timer to provide continuous exhaust during business hours (Appendix A), as recommended previously.

Rooftop Air Handling Unit

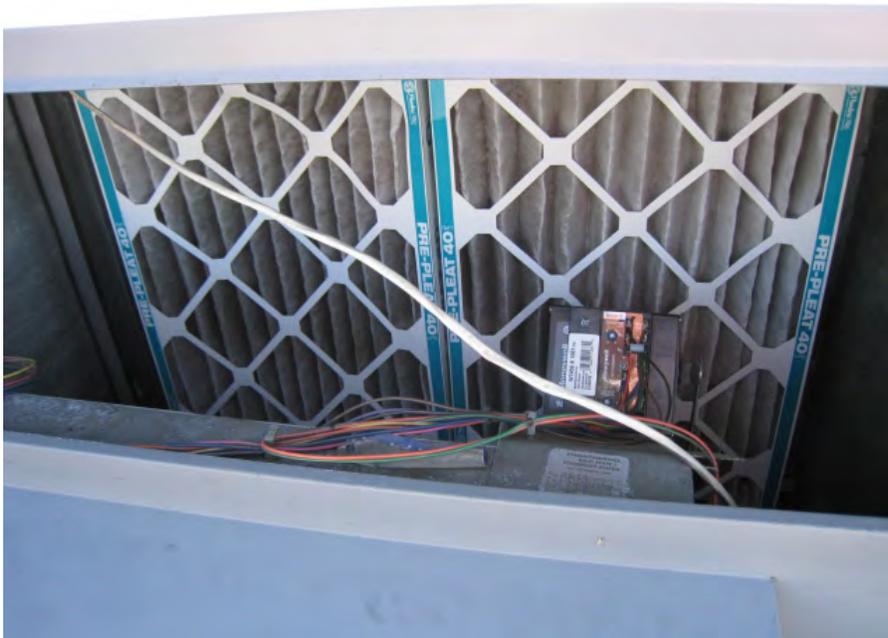
Picture 2

Pleated Filters Installed in Rooftop Air Handling Units

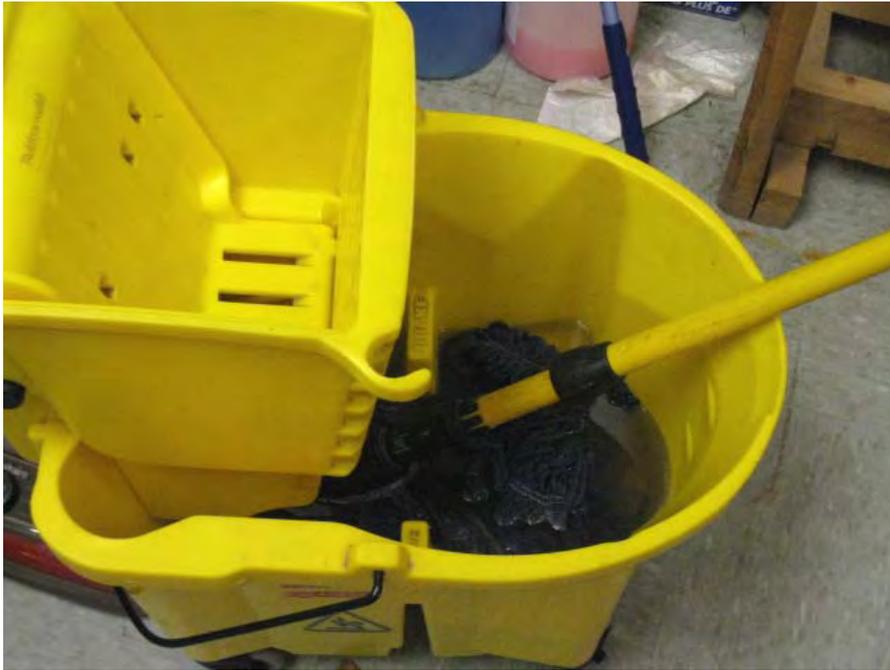
Picture 3

Other conditions that can affect indoor air quality were observed during the assessment. A wet mop and bucket with standing water was observed in the plate storage room (Picture 3). Mops should be dried and buckets should be emptied after use to prevent mold growth and associated odors.

Wet Mop and Bucket with Standing Water in Storage Room

6. Ensure mops are dried and buckets are emptied and cleaned after use.
7. Continue with plans to install filter media above egg crates to prevent dust/debris from the ceiling plenum into occupied areas.
8. Refer to resource manuals and other related indoor air quality documents for further building-wide evaluations and advice on maintaining public buildings. Copies of these materials are located on the MDPH's website: http://mass.gov/dph/indoor_air.

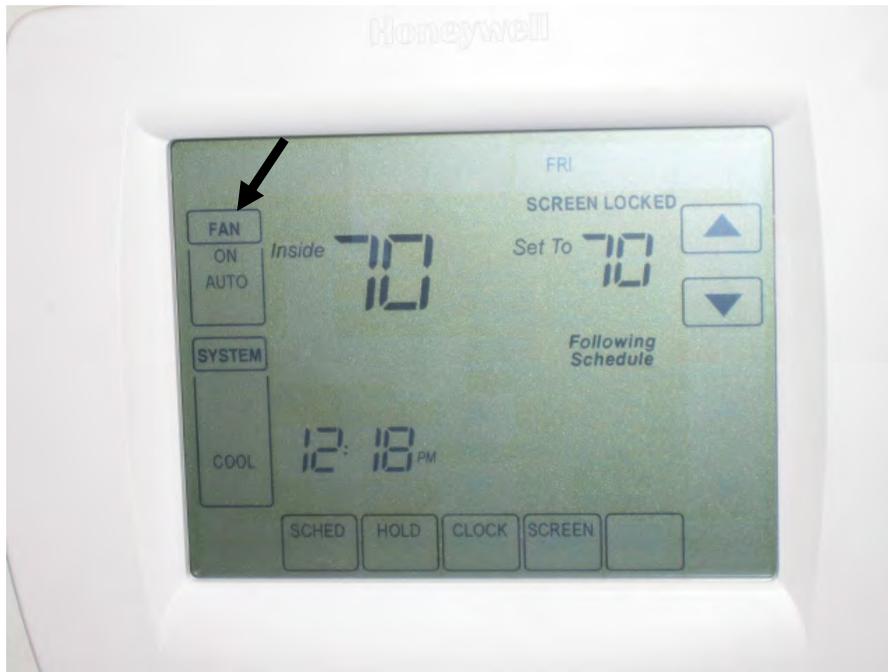
Picture A-1

- **Set the thermostat to the fan “on” position to operate the ventilation system continuously during business hours.**
- **Action:** Thermostats were set to the fan “on” position and were running continuously at the time of the IAQ assessment (Picture A-1).

Digital Thermostat Set to Fan “On” to Provide Continuous Air Exchange

2. Continue to operate thermostats in the fan "on" position to operate the ventilation system continuously during business hours.
3. In order to increase air exchange and control comfort, ensure all exterior doors are closed (e.g., auxiliary waiting room).

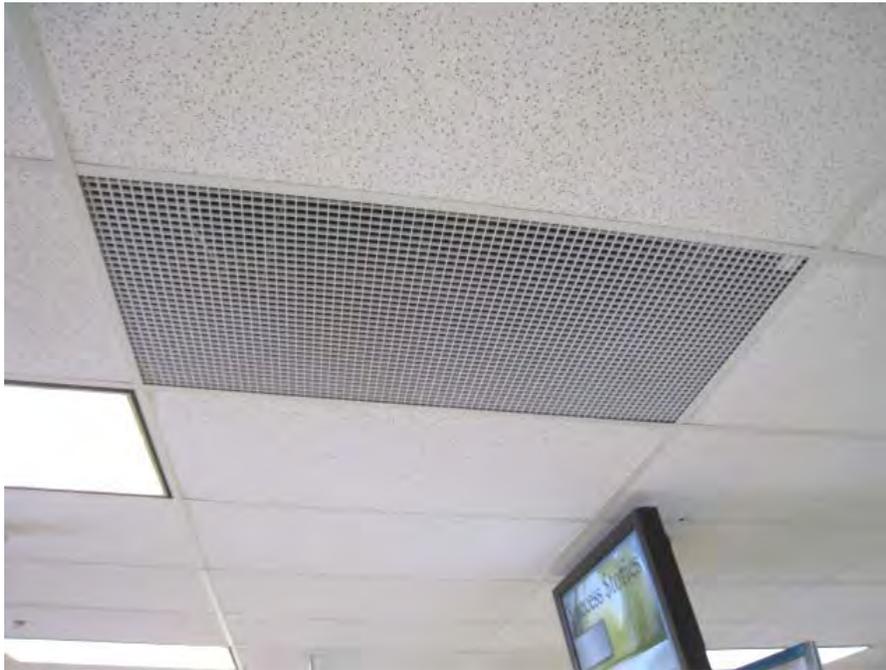
Picture A-2

In response to BEH previous recommendations, “egg crate” vents were installed in ceiling tiles in the waiting room to increase air circulation and remove waste heat. Occupants reported that dirt, dust and debris from the ceiling plenum had fallen into the RMV onto flat surfaces, most likely due to vibration from adjacent construction. Dirt, dust and particulates can provide a source of eye and respiratory irritation. At the time of the assessment no such dust/debris was observed; however, it was reported that building management had ordered a filter media to install above the egg crates which would let air pass through while catching dust and debris that might be present. MDPH believes this is a prudent measure.

- **Action:** Egg crates were installed in the waiting area (Picture A-2).
- **Consideration should be give to installing restroom exhaust motors in place of the cane-shape vents on the roof.**

One of Several Egg Crates Installed in Ceiling of Waiting Room

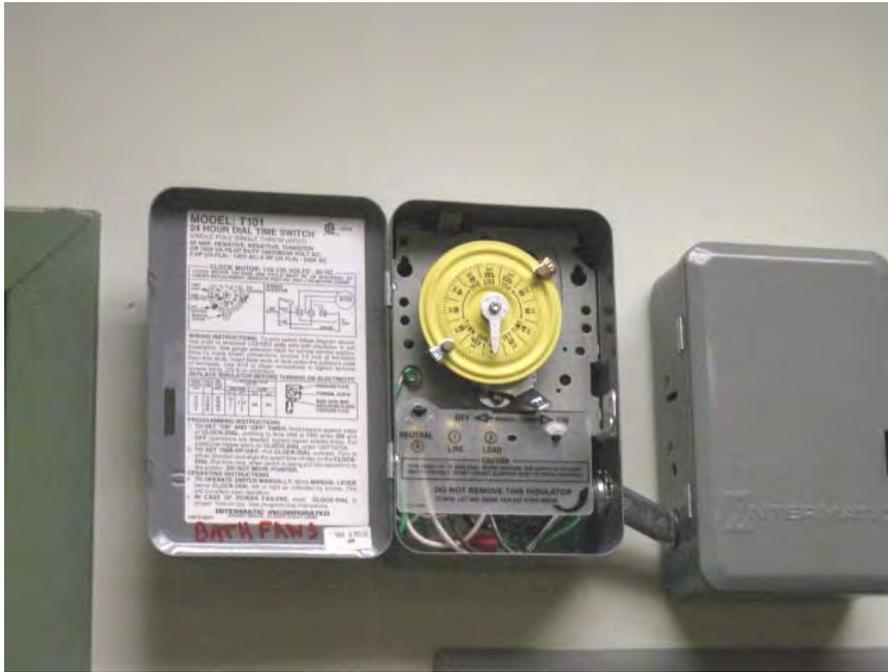
Picture A-3

Action: Timers were installed for exhaust vents and has improved air exchange (Picture A-3).

Timer Installed for Restroom Exhaust Vents

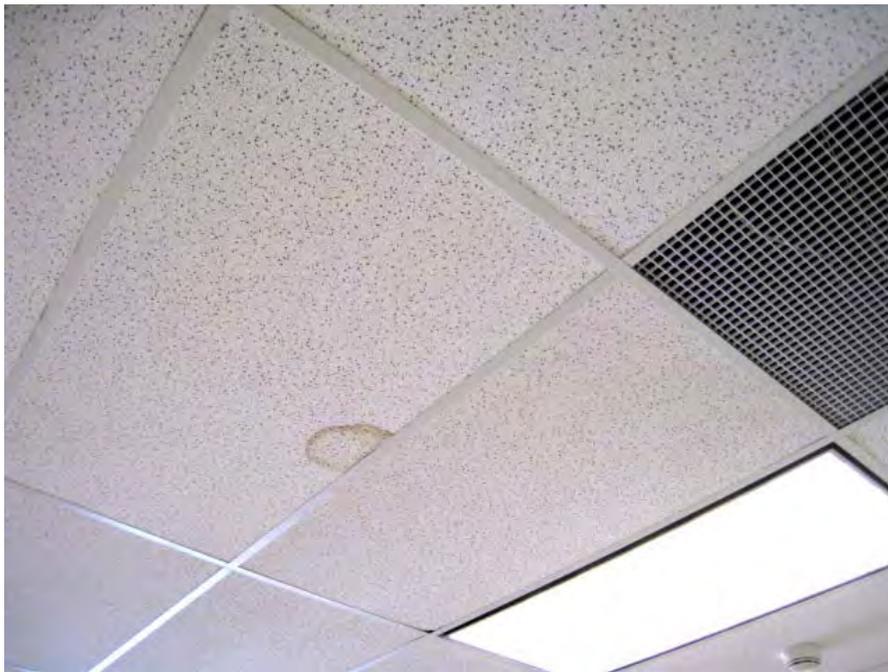
Picture A-4

Action: One water-damaged ceiling tile was observed in the waiting area (Picture A-4). At the time of the MDPH IAQ assessment, maintenance staff reported that their HVAC vendor was scheduled to be on-site to examine the rooftop air handling unit in this area for leakage and that the ceiling tile was left in place to identify the location of the leak.

Water-Damaged Ceiling Tile in Waiting Area

- **Ensure leaks are repaired and replace water-damaged ceiling tiles. Examine the area above and around these areas for mold growth. Disinfect areas of water leaks with an appropriate antimicrobial as needed.**
