# **INDOOR AIR QUALITY ASSESSMENT**

**Galvin Middle School  
525 Main St  
Wakefield, MA**

Prepared by:  
The Massachusetts Department of Public Health  
Bureau of Environmental Health  
August 2010

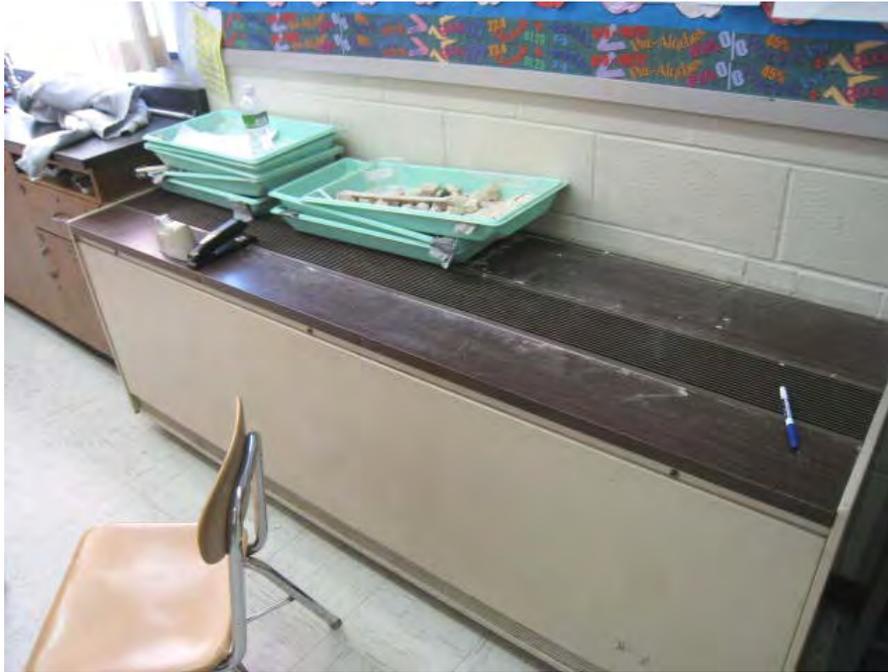
**Picture 1**

**Classroom univent (early 1970s vintage), note chalk dust**

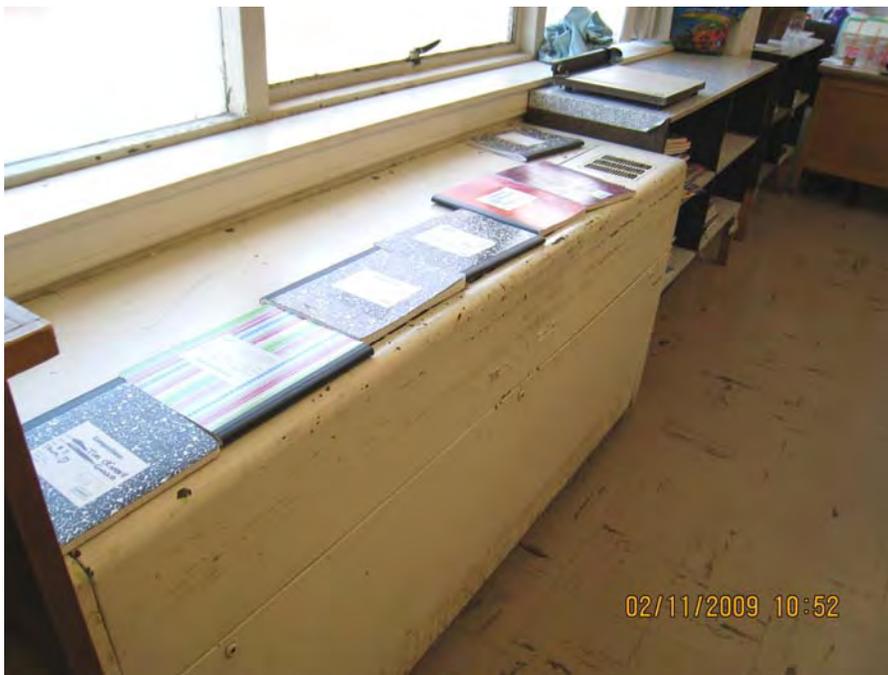
**Picture 2**

Exhaust ventilation is provided by two different systems. The older wing consists of ducted wall vents. Airflow is controlled by a flue which is opened by a draw chain-pulley system. The flue is positioned at a desired angle by setting the draw chain into a locking mechanism. This system was found to be functional in most classrooms surveyed; however, several flues, chains and pulleys were found in disrepair. The chain pulley system must be repaired in order to control airflow into the exhaust system. In addition, several classrooms had exhaust vents that were shut or obstructed by papers, posters, bookcases and furniture (Picture 3). Blockages must be removed to allow for proper removal of air in classrooms.

**Univent (1950s vintage) fresh air intake blocked by notebooks**

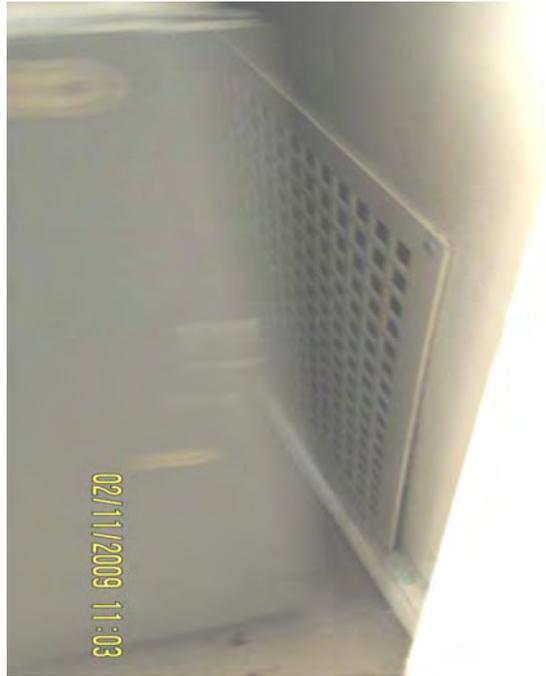
**Picture 3**

**Wall-mounted exhaust vent blocked by bookcase**

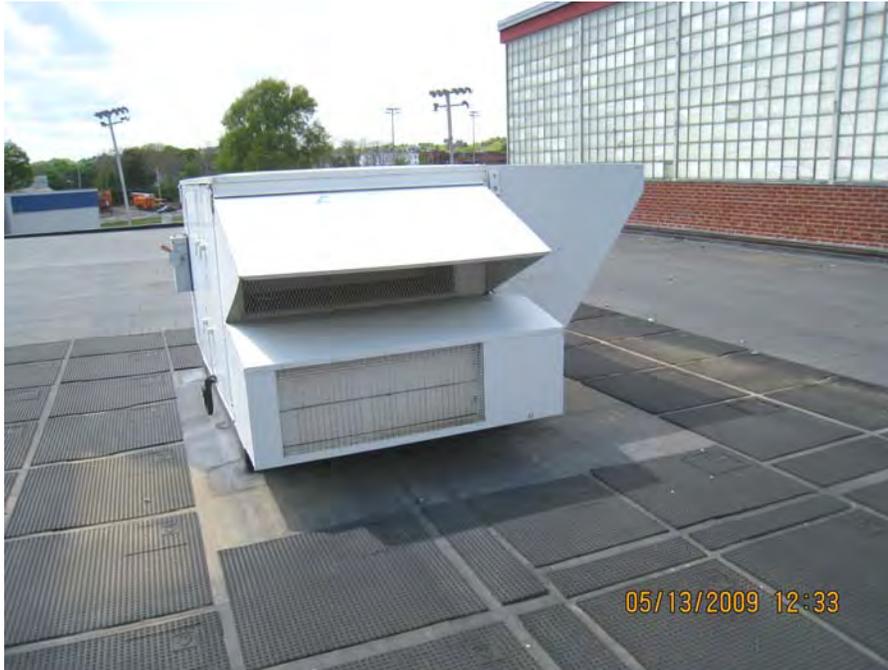
**Picture 5**

Mechanical ventilation for large/common areas such as the gymnasium, cafeteria and auditorium is provided by rooftop AHUs (Picture 5) or AHUs (Picture 6) in mechanical rooms. BEH staff observed conditions of these AHUs and noted breaches in flexible casing for one of the units (Picture 7). Airflow could be detected from this hole; such breaches should be sealed.

**Rooftop AHU**

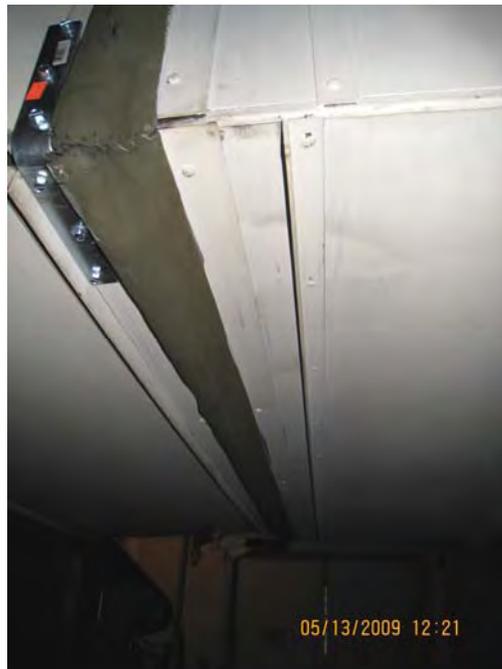
**Picture 6**

**AHU in mechanical room**

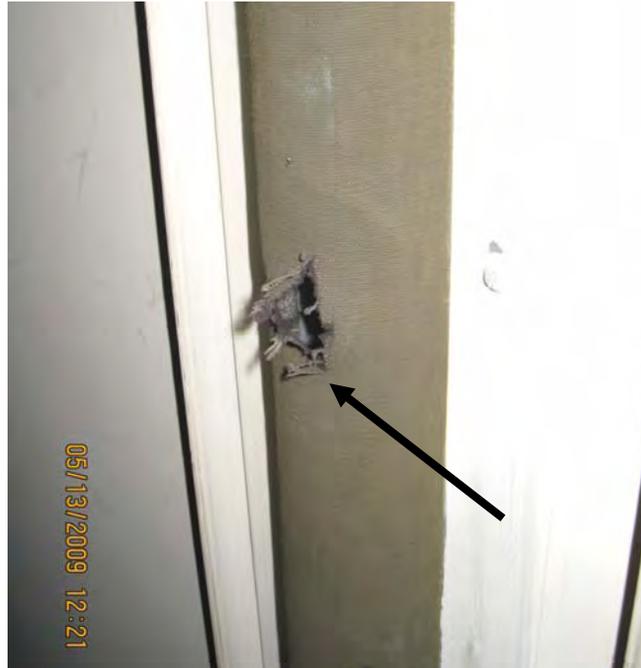
**Picture 7**

**Breach in casing to AHU**

4. Repair breach in AHU casing shown in Picture 7.
5. Close classroom doors to facilitate air exchange.
6. Inspect exhaust motors and belts for proper function. Repair and replace as necessary.

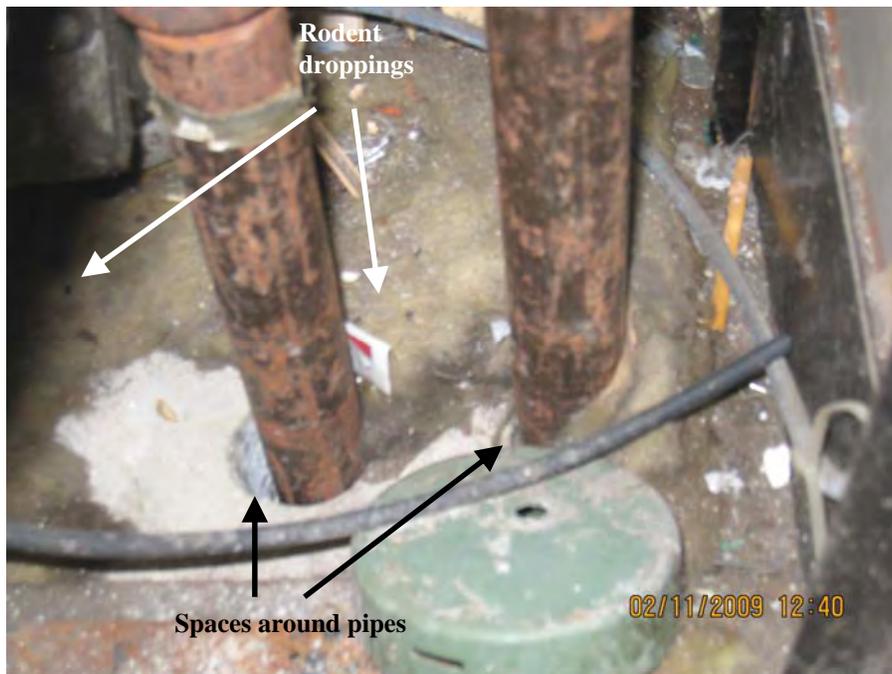
**Picture 8**

Spaces and breaches were observed around pipes in the interior cabinet of classroom univents (Picture 8). Holes were also observed between the cabinet wall and the fan compartment, which is above the filter bank (Picture 9). As the univent operates, air can be drawn through these holes instead of through the filter, allowing for particulates in the cabinet to become aerosolized. Since there are dirt crawlspaces below the building (Figure 3), odors, particulates and moisture from the crawlspace can be drawn into univents through spaces around the pipes and subsequently distributed to classrooms. The unit ventilator cabinet walls should be airtight and breaches around pipes should be sealed to allow filtration of air and prevent draw of odors, moisture and materials from the crawlspace.

**Breaches around pipes in univent cabinet, note rodent droppings**

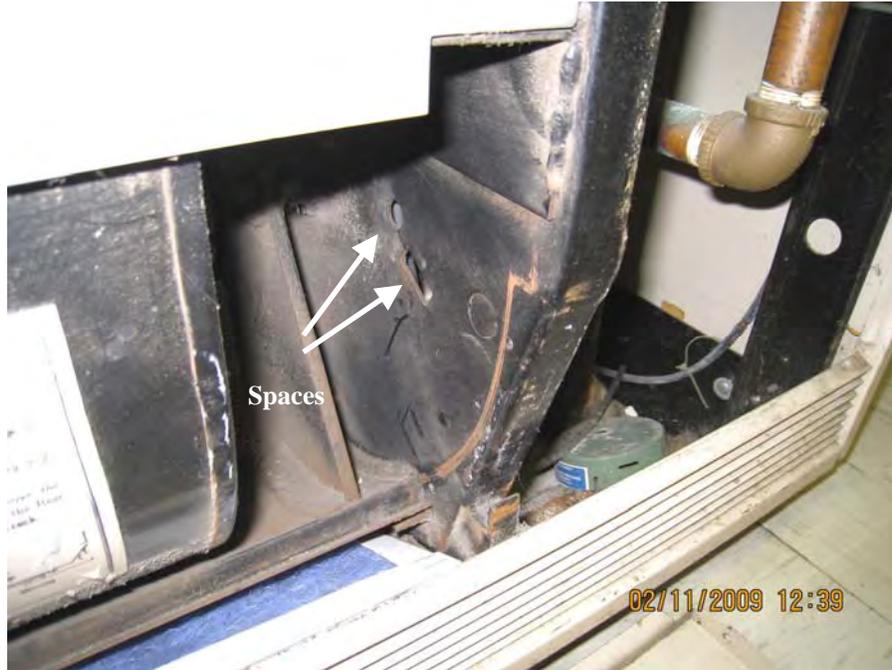
**Picture 9**

**Spaces in univent cabinet, post filter**

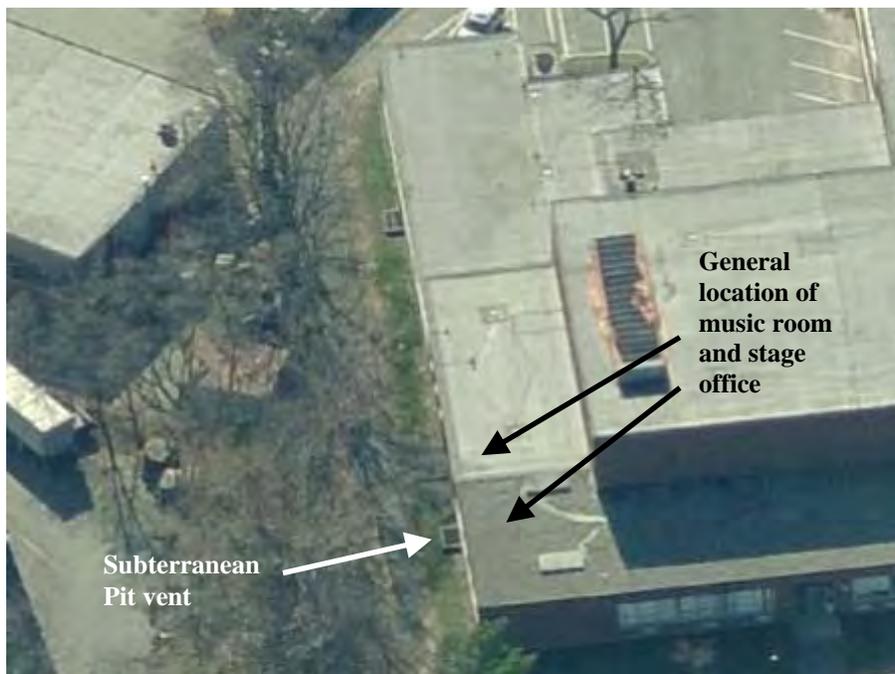
**Picture 10**

Considering the location of the music room, stage office and office 140 (above a dirt crawlspace) and the presence of crawlspace pits located outside the building in close proximity to these areas (Picture 10), it is possible that air penetrating these pits is creating temperature differences between the classroom air and the floor. Under certain conditions, such differences in temperature can result in condensation and moistening of materials. Repeated exposure of non-porous materials (i.e. carpet) and dust/debris can result in mold growth. Carpets in these areas should be removed and rooms should be cleaned thoroughly to prevent mold growth where dirt/dust can accumulate.

**Approximate location of music room and stage office relative to subterranean pit vent**

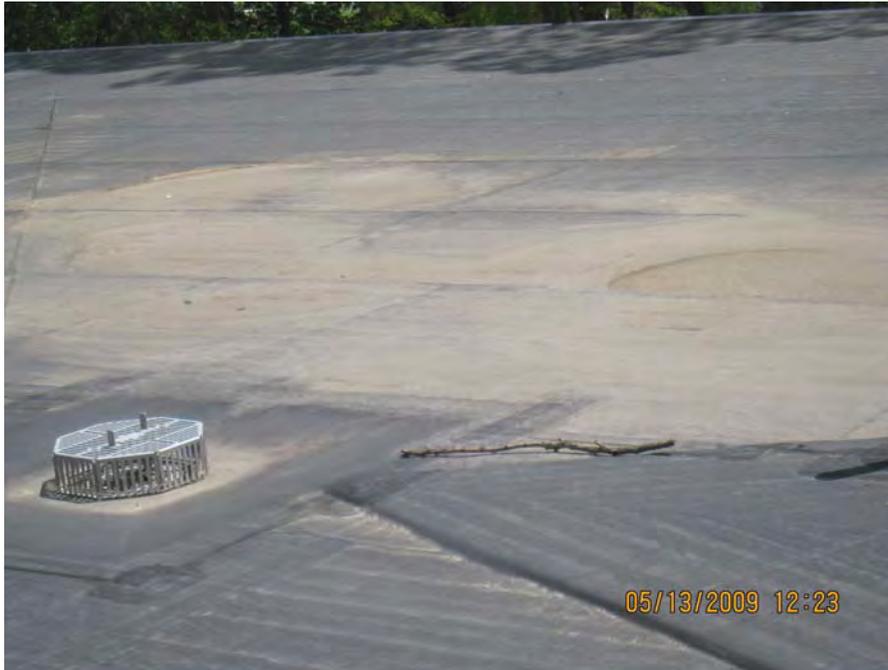
**Picture 11**

The GMS appears to have a number of water penetration issues related to the roof. It was reported that numerous of attempts to patch the roof have been made (Picture 11). BEH staff observed damaged roof flashing (Pictures 12 and 13). The purpose of flashing is to create a surface that allows water to roll down and away from the building. Where flashing is damaged, water can collect and penetrate in the building. In addition, since the building appears to be multiple joined sections (Picture 14), the roof of the building consists of a number of surfaces that are not level. The discontinuous roof surfaces can allow water to pool on the roof. Damage to the roof and flashing and the building exterior may be the cause of water damage/penetration to a number of areas, including the following:

**Roof patches**

13. Repair any existing water leaks (roof, windows, exterior walls) and replace any remaining water-damaged ceiling tiles. Examine the area above these tiles for mold growth. Disinfect areas of water leaks with an appropriate antimicrobial, as needed.

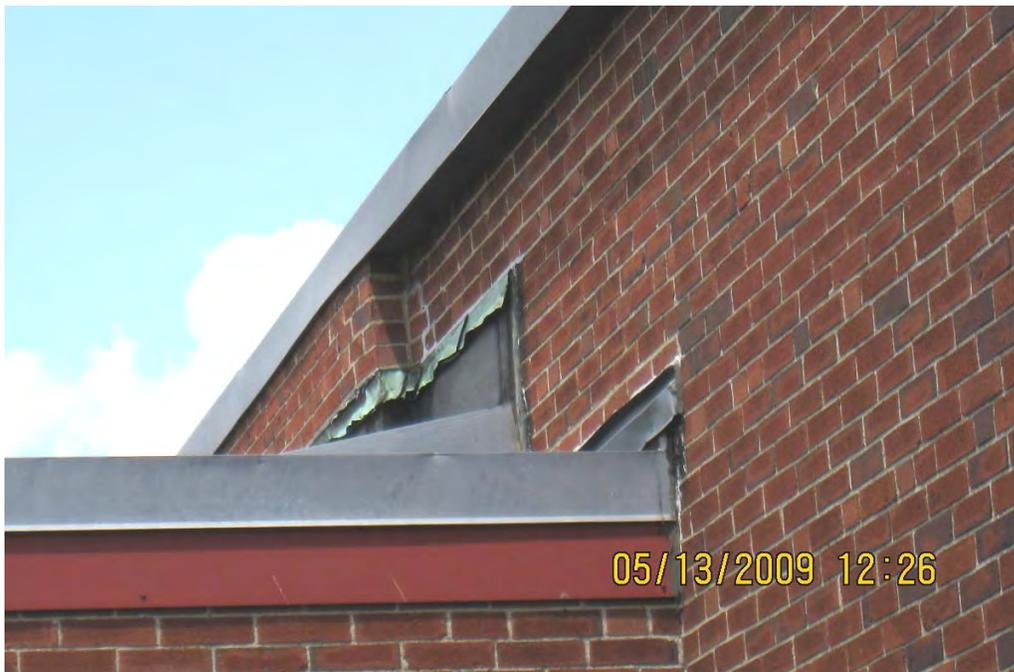
**Picture 12**

**Damaged flashing**

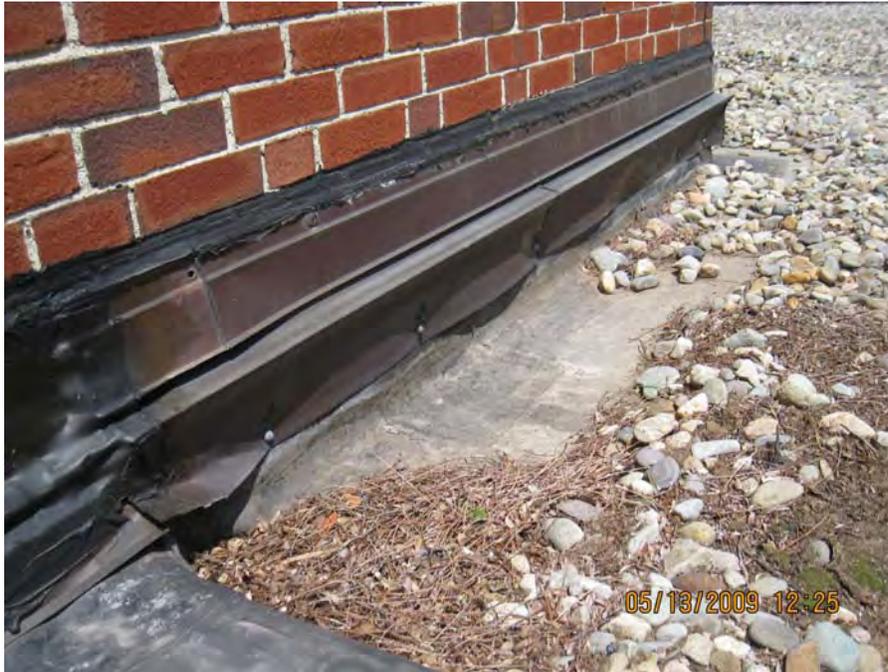
**Picture 13**

**Damaged flashing, note debris and moss growth on roof**

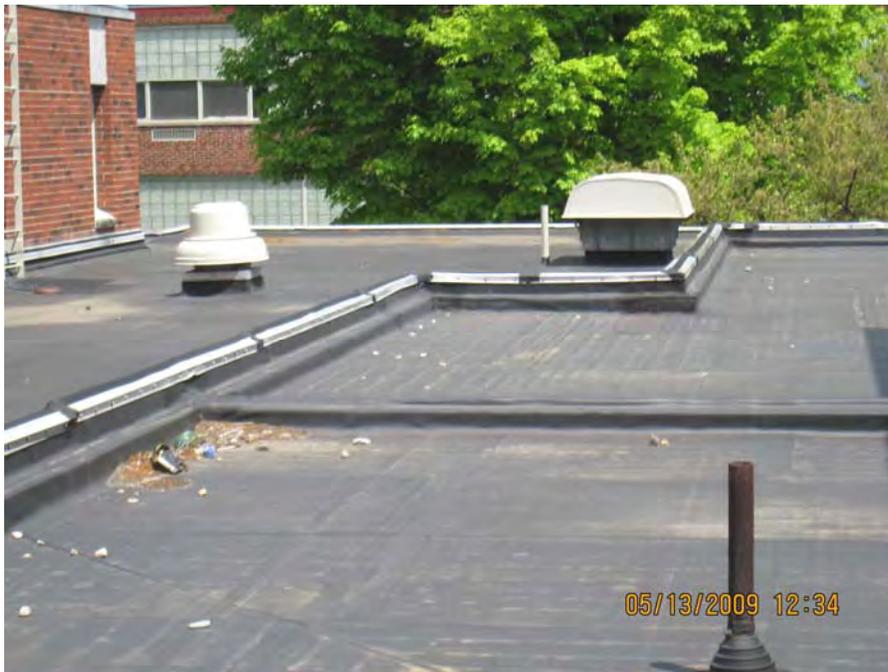
**Picture 14**

**Discontinuous flat roof surface**

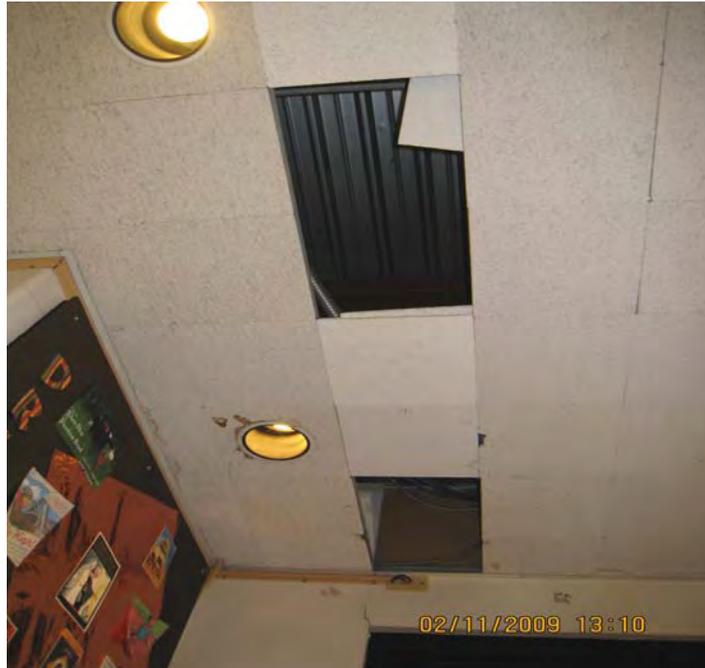
**Picture 15**

- **Library:** GMS staff reported concerns regarding water penetration and leaks in the library. BEH staff observed a number of water-damaged and missing ceiling tiles in this area (Picture 15). Water stains observed on the carpet indicate repeated moistening of the carpeting in this area. BEH staff did not detect any odors from the carpet; however, carpeting that is wet repeatedly can be a source of mold growth if it is not dried properly.

**Missing tiles in library**

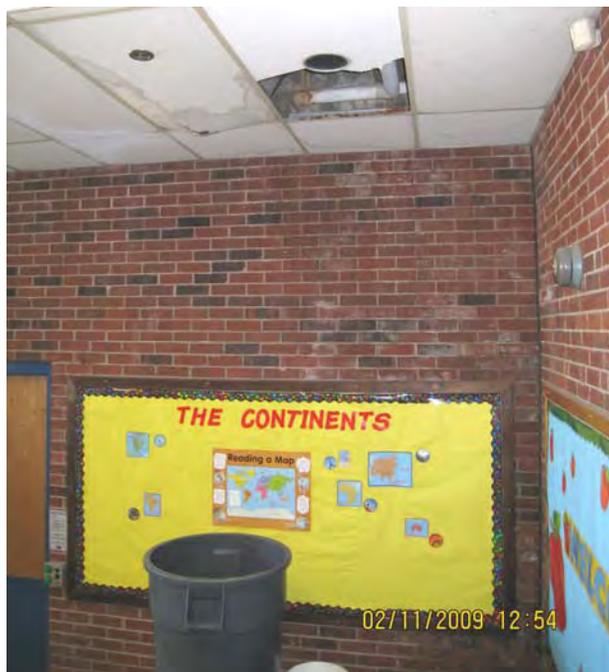
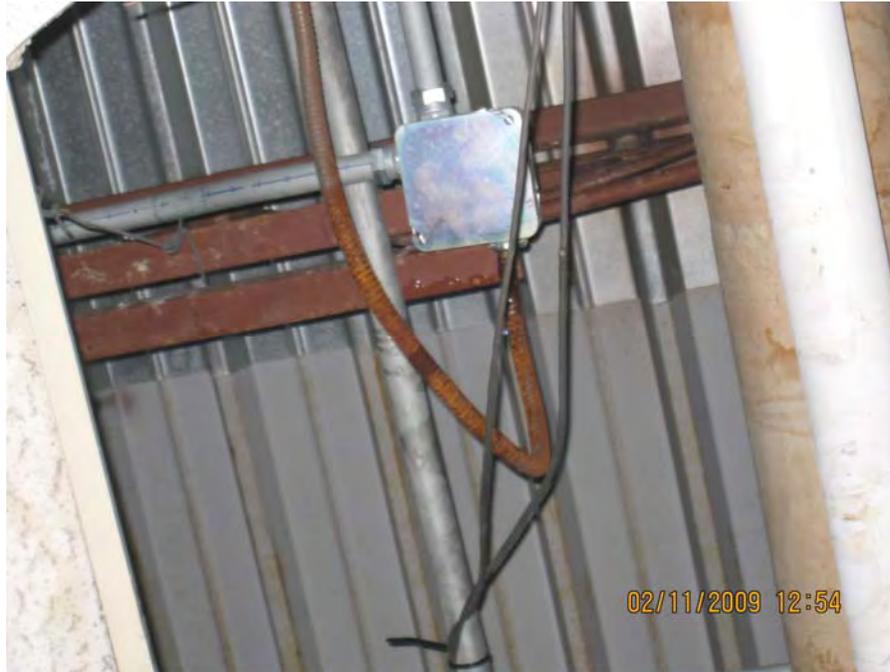
- **Hallway:** A trash barrel catching water was observed in the hallway near classroom 163. BEH staff observed water dripping from a roof beam in this area (Pictures 16 and 17).

**Water-damaged ceiling tiles, note barrel catching water**

**Water dripping from roof beams in hallway**

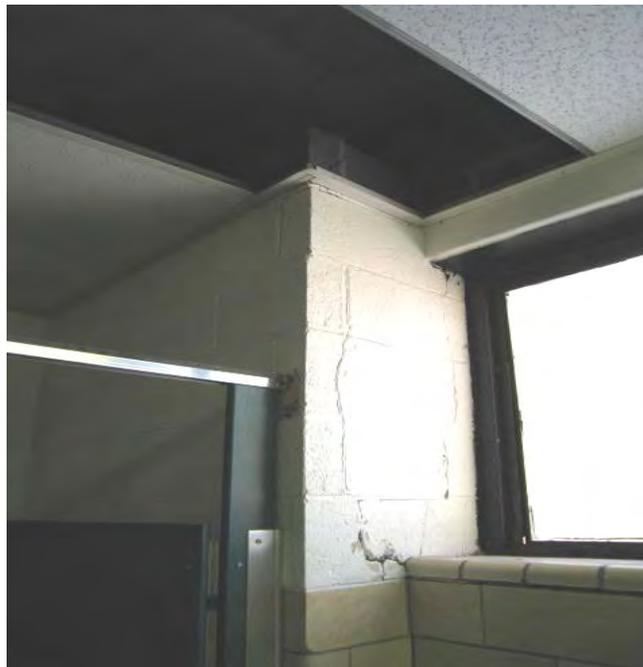
**Picture 18**

- **Building envelope:** Leaks were observed from windows. In some areas, breaches and cracks were observed in cement around windows (Picture 18).

**Missing ceiling tile reportedly from leaks, note damage to cement**

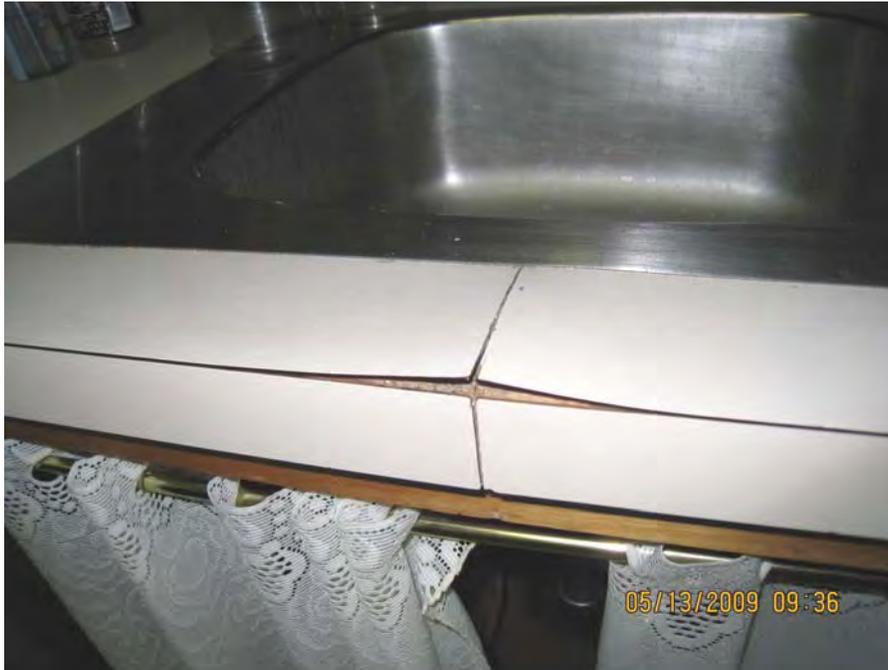
**Picture 19**

Other potential moisture/mold growth issues were observed throughout the building. Open seams between sink countertops and backsplashes were observed. If not watertight, water can penetrate through the seam, causing damage. Improper drainage or sink overflow can lead to water penetration into the countertop, cabinet interiors and areas behind cabinets. Water penetration and chronic exposure of porous and wood-based materials can cause these materials to swell and show signs of water damage, as observed in one classroom (Picture 19). Repeated moistening of porous materials can result in mold growth.

**Damaged sink countertop**

18. Seal areas around sinks to prevent water damage to the interior of cabinets and adjacent wallboard. Repair/replace damaged countertop shown in Picture 19.

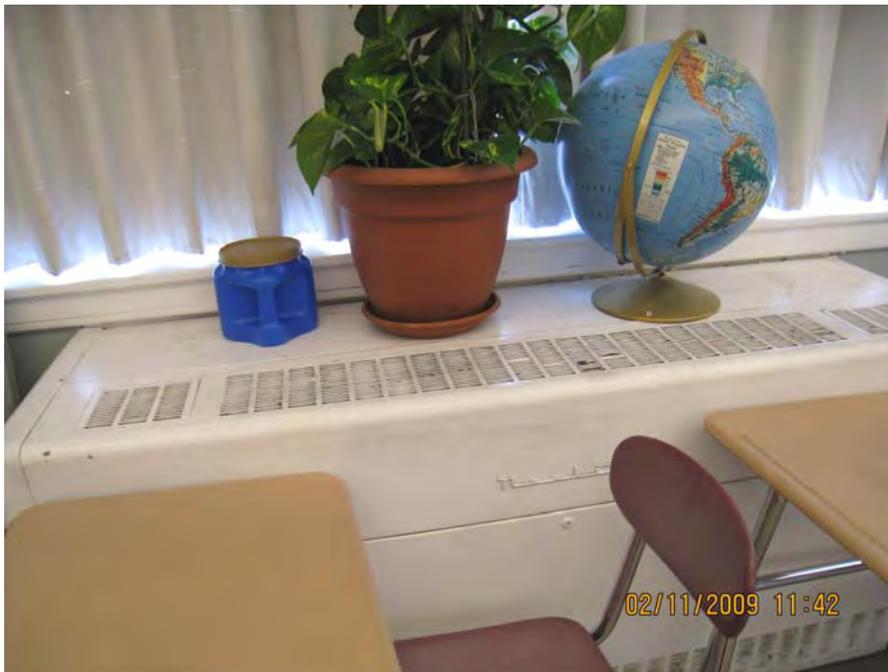
**Picture 20**

Plants were noted in several classrooms. In some instances, plants were located on univents (Picture 20). Plants can be a source of pollen and mold which can be respiratory irritants to some individuals. Plants should be properly maintained and equipped with drip pans and should be located away from univents to prevent the aerosolization of dirt, pollen and mold. Plants should also be located away from ventilation sources to prevent aerosolization of irritants.

**Plant on univent**

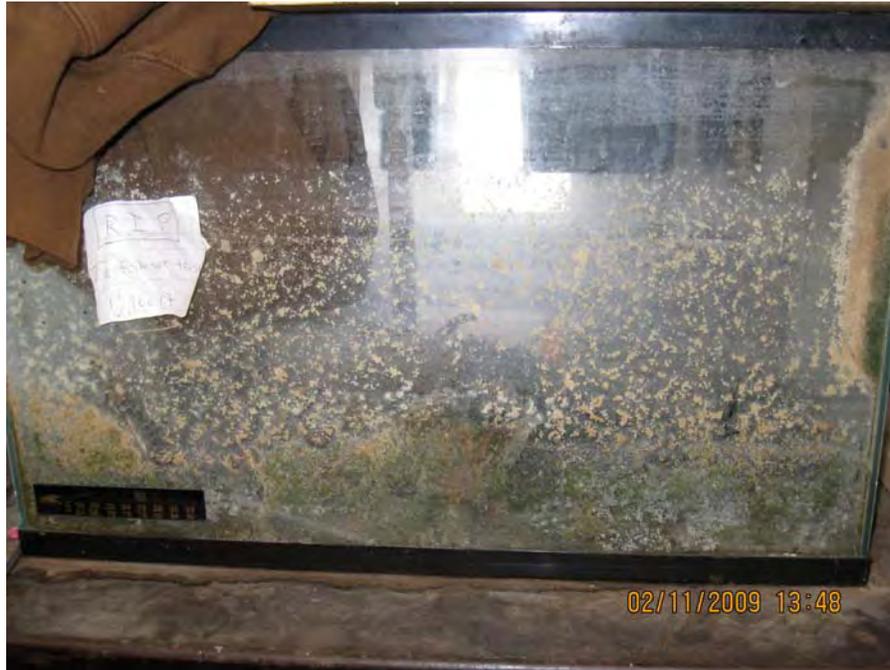
**Picture 21**

An aquarium tank was observed with microbial/algal growth (Picture 21). Aquariums should be properly maintained to prevent microbial/algal growth as they can emit unpleasant odors into the classroom.

**Microbial/algal growth in fish tank**

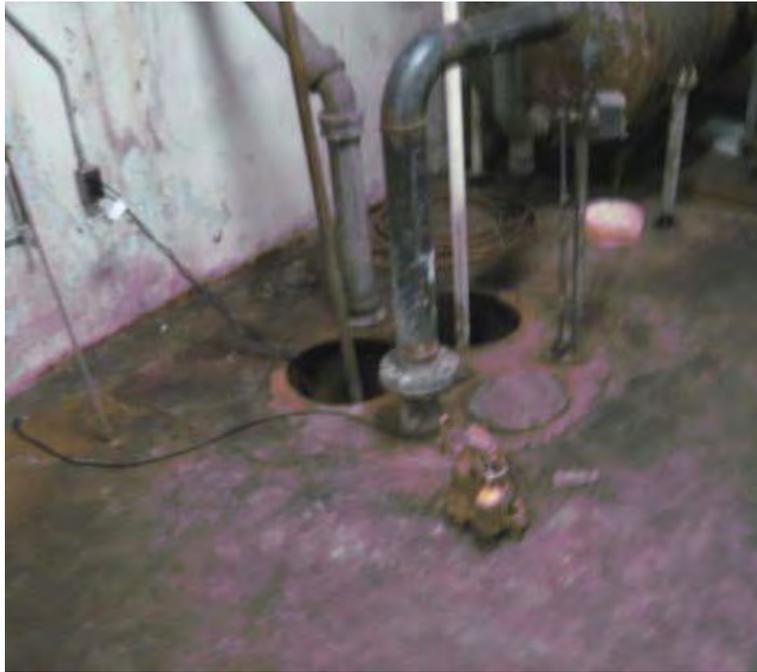
**Picture 23**

According to Wakefield town officials, a branch of the stream travels northwest under the portion of the building that contains the boiler room. BEH staff examined the interior of the boiler room and found a sump pump that had churning water that appears to be the branch of underground water reported by Wakefield officials (Pictures 23 and 24). This sump pump is located in the floor of the furnace room approximately 30 feet below the ceiling of the furnace room (above which is the floor for the hallway leading to the gymnasium). During the course of this assessment no measurable levels of volatile organic compounds (VOCs) were measured in the building, including the boiler room (Tables 1 and 2). These results would suggest that it is unlikely that the GMS were affected by contaminated flood water at the time of assessment. Please note, however, air measurements are only reflective of the indoor air concentrations present at the time of sampling.

**Sump pump in boiler room**

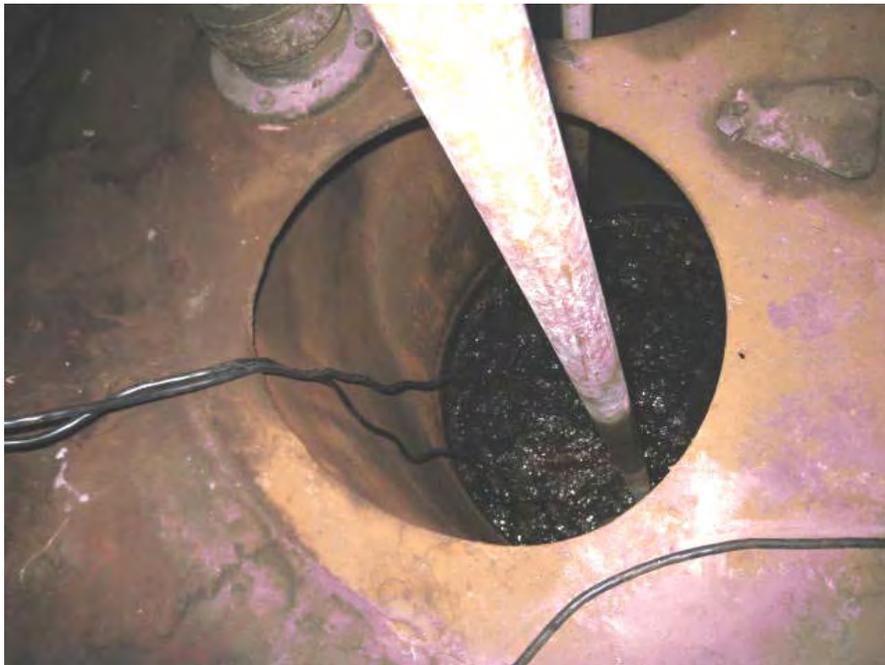
**Picture 24**

**Bottom of sump pump in boiler room**

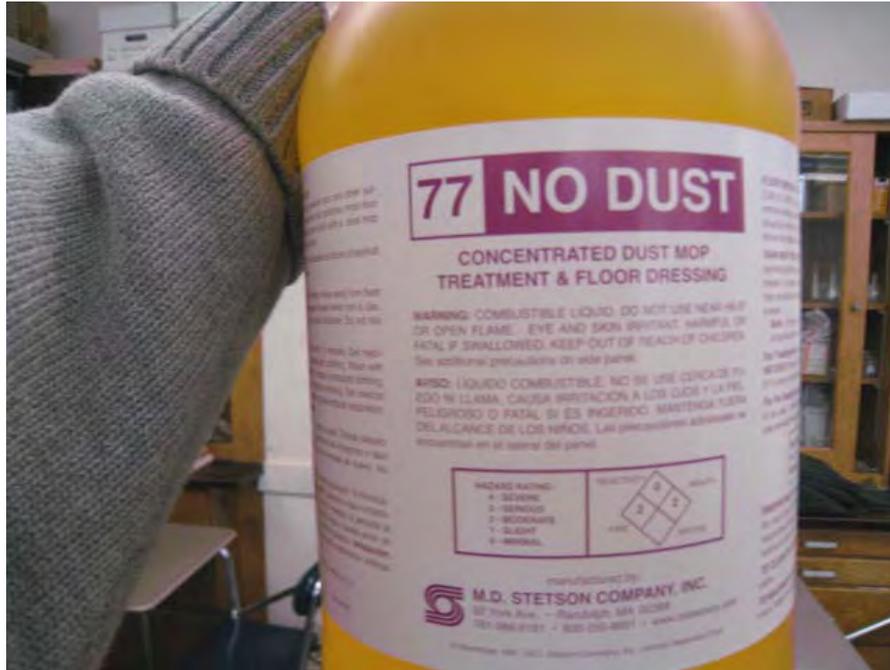
Picture 25

During the course of this assessment, it was noted that the custodial staff use a dust mop treatment called “77 No Dust” (Picture 25). This product includes Stoddard solvent and mineral

oil, which contain VOCs. As the mops are used on the floor, residue from the dust mop treatment is left on the floor which then evaporates. If used on a regular basis, this product can provide a source of additional air pollutants to the indoor environment. The constituents of Stoddard solvent and mineral oil can cause eye, nose, throat and respiratory system irritation.

Dust mop treatment

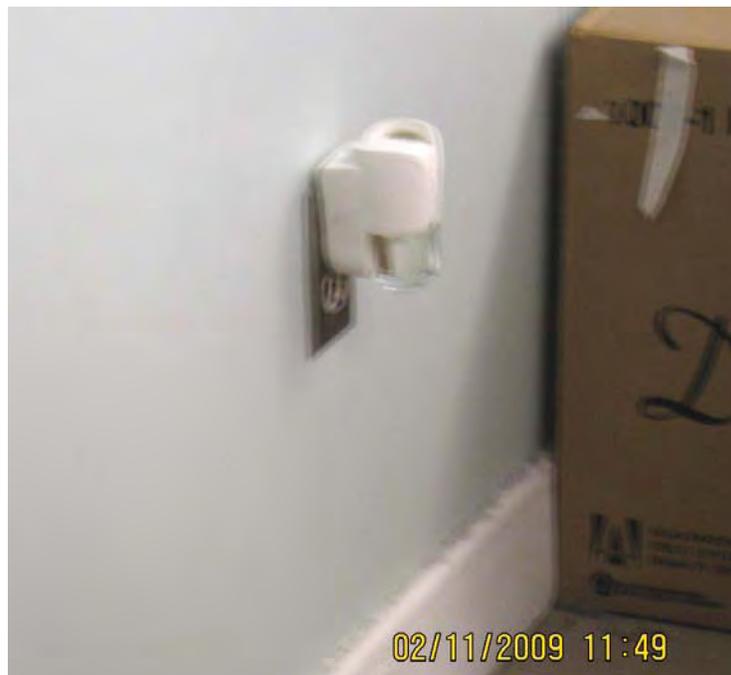
Picture 26

An assortment of air fresheners and deodorizing materials (i.e. fragrant oil reed diffusers, plug-ins and spray canisters) were observed in a number of areas (Picture 26). Air deodorizers contain chemicals that can be irritating to the eyes, nose and throat of sensitive individuals. Many air fresheners contain 1,4-dichlorobenzene, a VOC which may cause reductions in lung function (NIH, 2006). Furthermore, deodorizing agents do not remove materials causing odors, but rather mask odors that may be present in the area.

Plug-in air deodorizer

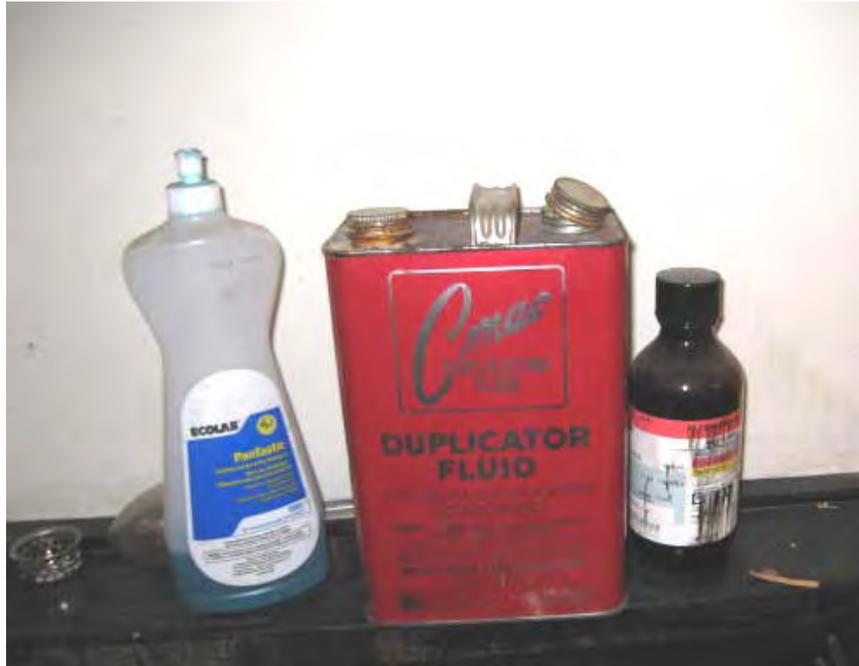
**Picture 27**

Flammable materials were observed on countertops in occupied areas (Picture 27). Flammable materials should be stored in flammable storage cabinets that meet the specifications

of the National Fire Protection Association (NFPA) (NFPA, 1996). No flameproof cabinet observed.

**Flammables placed on counter**

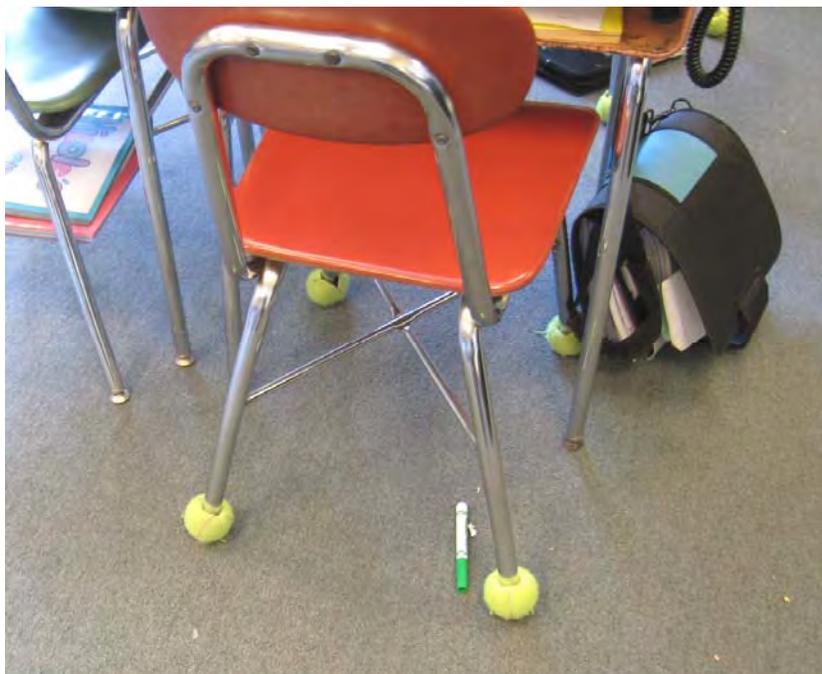
**Picture 28**

BEH staff also observed tennis balls which had been sliced open and placed on chair and/or table legs presumably to reduce noise (Picture 28). Tennis balls are made of a number of materials that are a source of respiratory irritants. Constant wearing of tennis balls can produce fibers and cause VOCs to off-gas. Tennis balls are made with a natural rubber latex bladder, which becomes abraded when used as a chair leg pad. Use of tennis balls in this manner may introduce latex dust into the school environment. Some individuals are highly allergic to latex (e.g., spina bifida patients) (SBAA, 2001). It is recommended that the use of materials containing latex be limited in buildings to reduce the likelihood of symptoms in sensitive individuals (NIOSH, 1997).

**Tennis balls on chair legs**

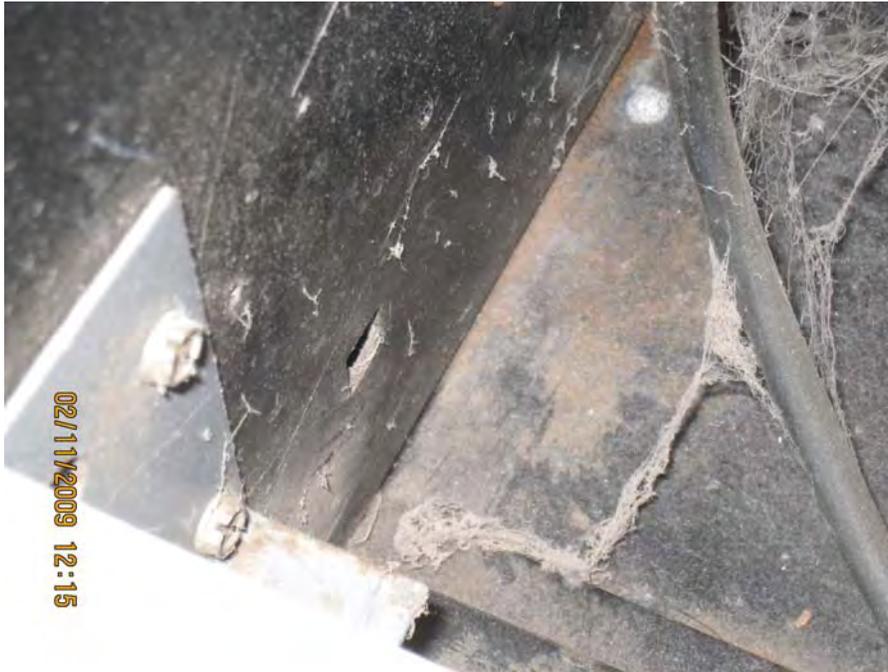
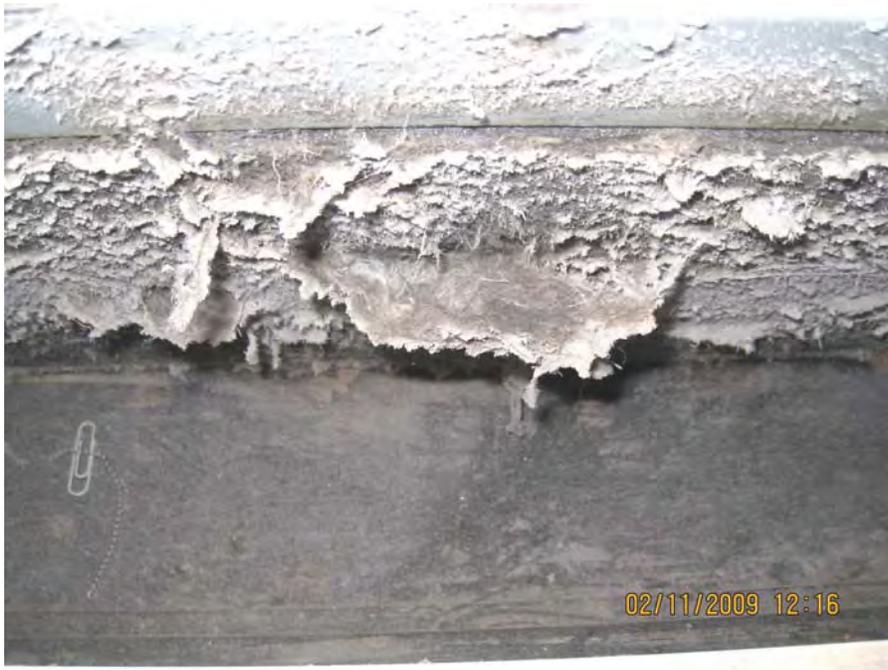
Dust was observed in univent cabinets, and filters were occluded with dust (Pictures 29 and 30). The univent filters installed in the building offer minimal filtration. The purpose of a filter is to provide filtration of respirable dusts. In order to decrease aerosolized particulates, disposable filters with an increased dust spot efficiency should be installed in place of current filter media. The dust spot efficiency is the ability of a filter to remove particulates of a certain diameter from air passing through the filter. Filters that have been determined by ASHRAE to meet its standard for a dust spot efficiency of a minimum of 40 percent (Minimum Efficiency

**Dust accumulated in univent**

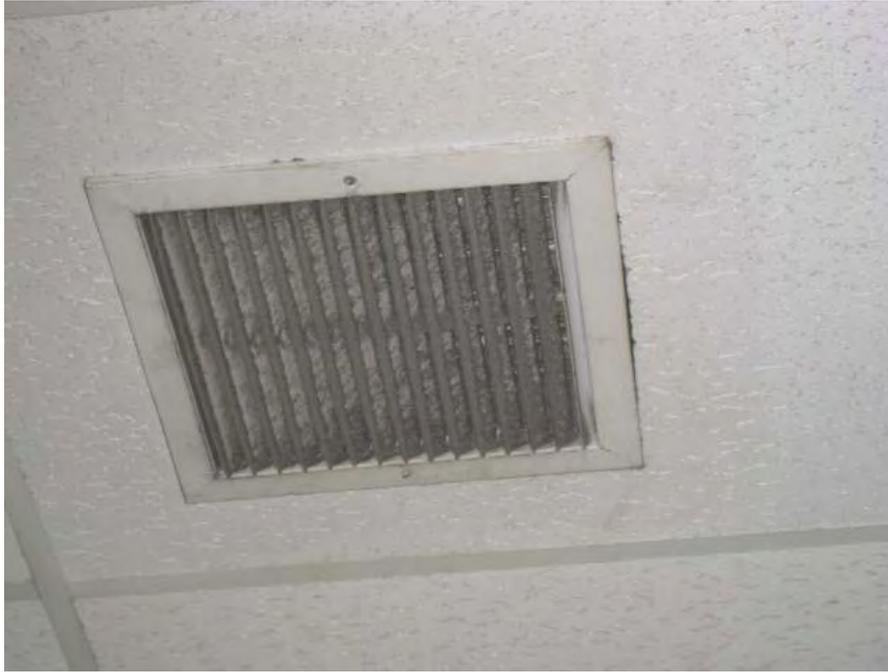
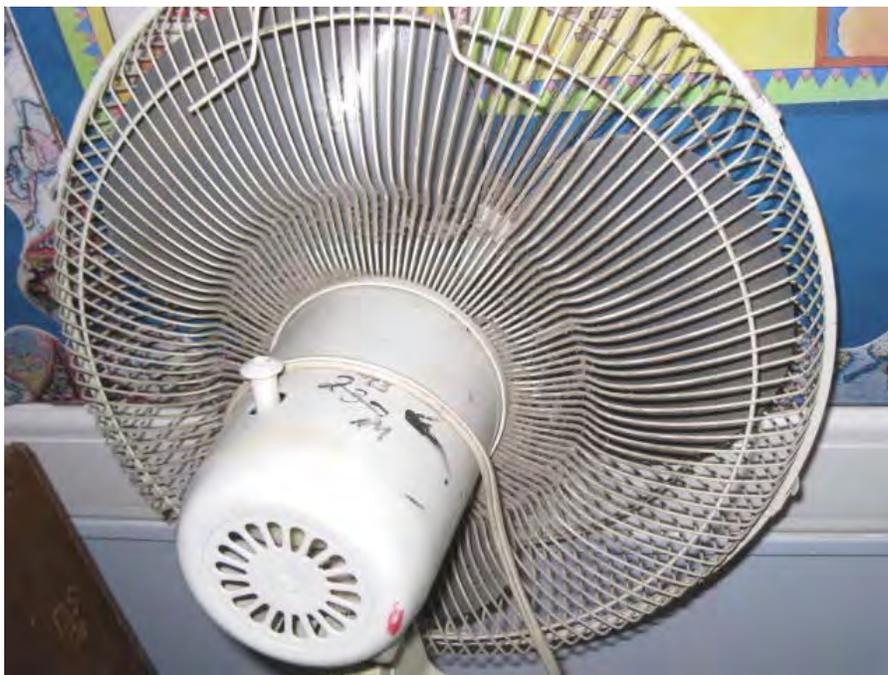
A number of air diffusers, exhaust vents and personal fans were observed to have accumulated dust/debris (Pictures 31 and 32). These diffusers, vents and fans should be cleaned periodically in order to prevent dust/debris from being aerosolized and redistributed throughout the room.

**Exhaust vent occluded with dust**

**Personal fan occluded with dust**

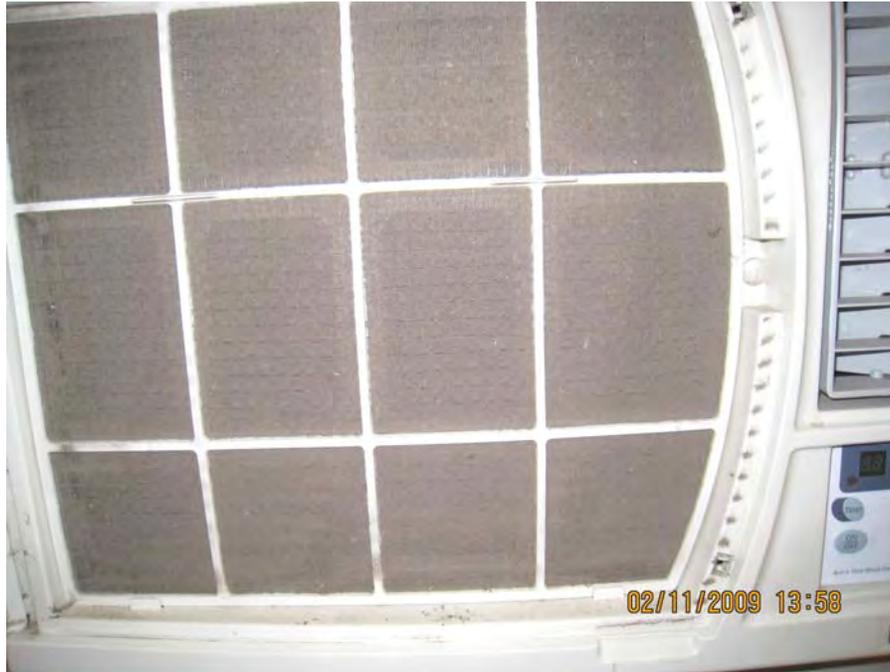
**Picture 33**

Window-mounted air conditioners (ACs) were observed in some areas (Picture 33/Table 1). These units are normally equipped with filters, which should be cleaned or changed as per manufacturer's instructions. AC filters had dirt, dust and debris accumulation. Accumulated chalk dust was observed on a classroom univent (Picture 1). Chalk dust is a fine particulate that can easily become airborne, irritating the eyes and respiratory system.

**Air-conditioner filter occluded with dust**

9. Clean/change filters for ACs as per the manufacturer's instructions or more frequently if needed.
10. Use openable windows in conjunction with classroom univents and exhaust vents to facilitate air exchange until repairs that are more permanent can be made. Care should be taken to ensure windows are properly closed at night and weekends to avoid the freezing of pipes and potential flooding.

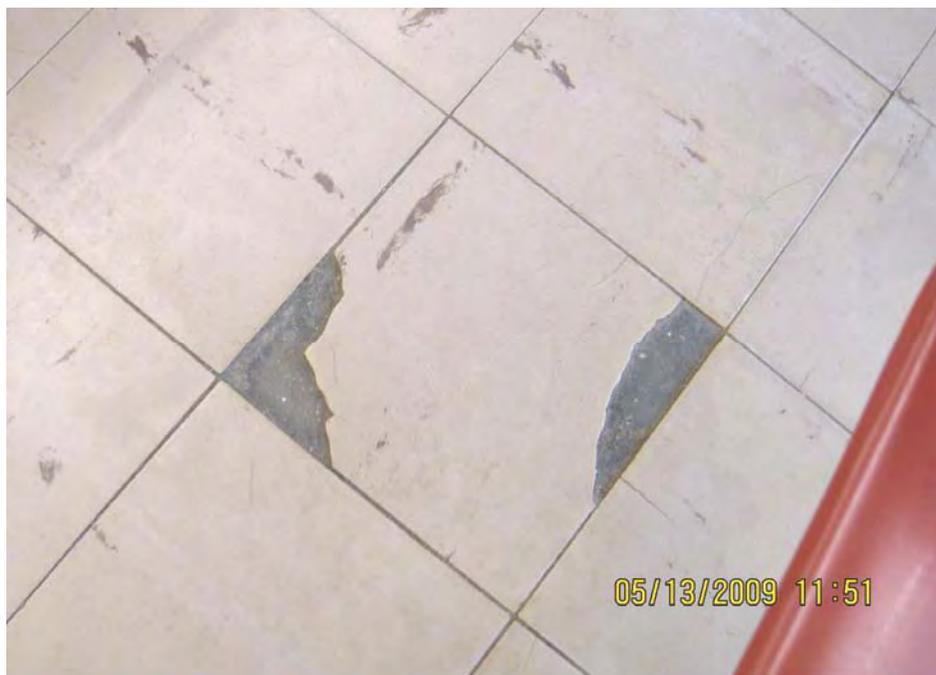
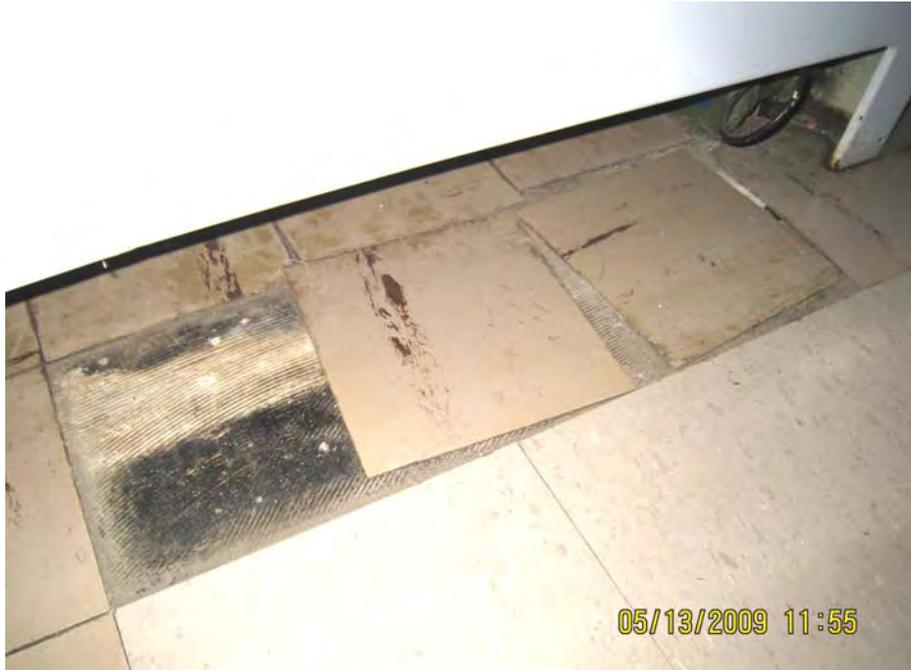
Damaged and loose floor tiles were observed in some areas (Pictures 34 and 35). Given the age of the building, these floor tiles may contain asbestos. Intact asbestos-containing materials do not pose a health hazard. If damaged, asbestos-containing materials can be rendered friable and become aerosolized. Friable asbestos is a chronic (long-term) health hazard, but will not produce acute (short-term) health effects (e.g., headaches) typically associated with buildings believed to have indoor air quality problems. Where asbestos-containing materials are found damaged, these materials should be removed or remediated in a manner consistent with Massachusetts asbestos remediation laws (MDLI, 1993).

**Damaged floor tiles**

**Floor tiles no longer adhering to floor**

30. Determine whether floor tiles in question contain asbestos. If so, remediate damaged floor tiles in conformance with Massachusetts asbestos remediation and hazardous waste disposal laws.
