INDOOR AIR QUALITY ASSESSMENT

**Westford Parks, Recreation & Cemetery Department
35 Town Farm Road
Westford, Massachusetts**

Prepared by:
Massachusetts Department of Public Health
Bureau of Environmental Health
Indoor Air Quality Program
July 2010

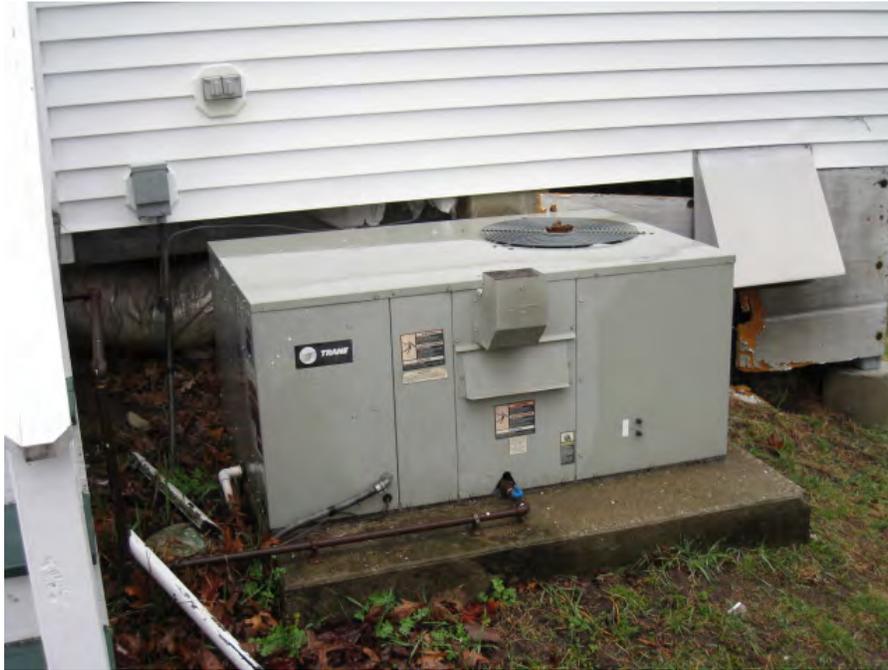
Picture 1

The HVAC system for the main building consists of an air handling unit (AHU) located at the exterior of the building (Picture 1). Conditioned air is distributed to occupied areas via ducted supply diffusers and returned to the AHU by return vents. Digital wall-mounted thermostats control the heating, ventilating and air-conditioning (HVAC) system and have fan settings of “on” and “automatic”. Thermostats were set to the “automatic” setting during the assessment. The automatic setting on the thermostat activates the HVAC system at a preset temperature. Once the preset temperature is reached, the HVAC system is deactivated. Therefore, no mechanical ventilation is provided until the thermostat re-activates the system. In the fan “on” mode air will be continuously circulated and filtered, which should improve temperature/comfort control.

AHU for HVAC System

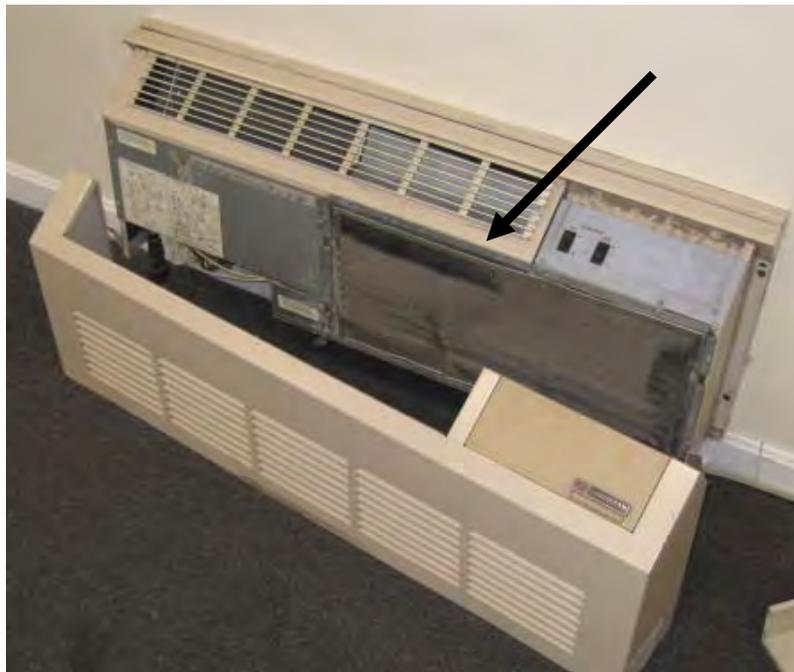
Picture 2

A separate AHU is located in the community room. BEH staff inspected the filter for this unit and found it to be occluded with dust and debris (Picture 2). Once a filter becomes saturated with debris, it can serve as a source of particulates that may become re-aerosolized into the airstream by the AHU. Lack of proper filtration can accelerate the degradation of HVAC equipment, making the equipment work harder to draw air through clogged filters.

AHU for Community Room, Note Filter Clogged with Dust/Debris

6. Change filters for air-handling equipment (e.g., AHUs and ACs) as per the manufacturers’ instructions or more frequently if needed. Vacuum interior of units prior to activation to prevent the aerosolization of dirt, dust and particulate matter. Ensure filters fit flush in their racks with no spaces in between allowing bypass of unfiltered air into the unit.

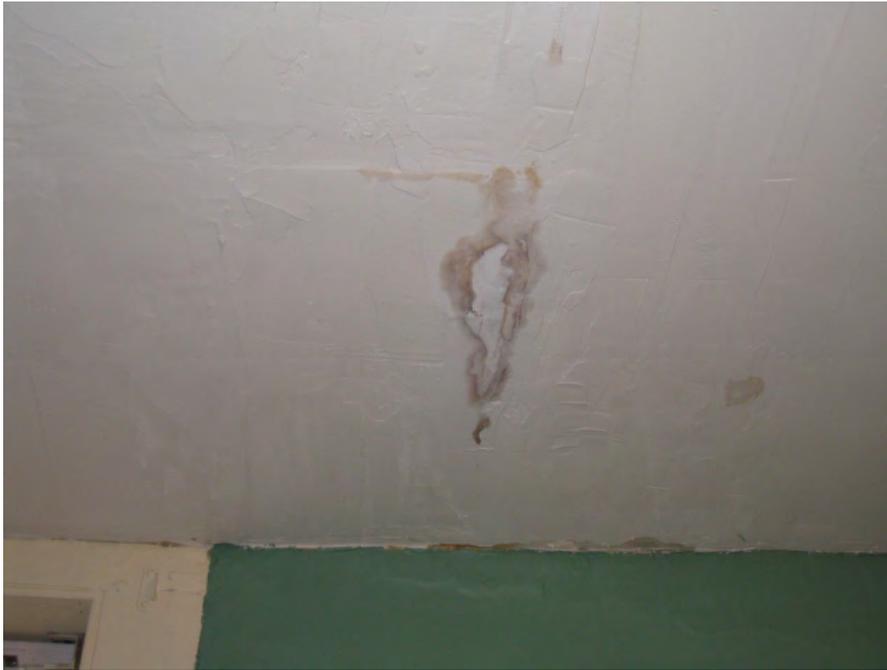
Picture 3

Elevated moisture measurements were detected on ceiling plaster in the 1st floor restroom (Table 1). BEH staff examined conditions in the 2nd floor restroom above this area and found that the toilet was leaking wetting the plaster below (Pictures 3 and 4).

Water-Damaged Ceiling Plaster in 1st Floor Restroom

9. Ensure toilet leak in 2nd floor restroom is repaired.
10. Make repairs to water-damaged ceiling plaster. Seal and repaint to prevent flaking.
11. Ensure all leaks in the building are repaired.

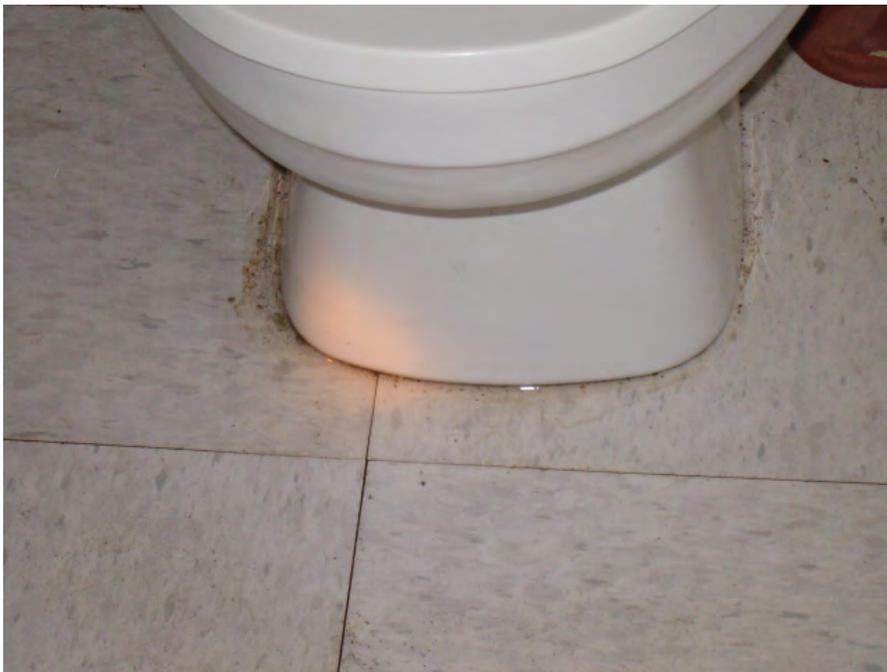
Picture 4

Leaking Toilet in 2nd Floor Bathroom

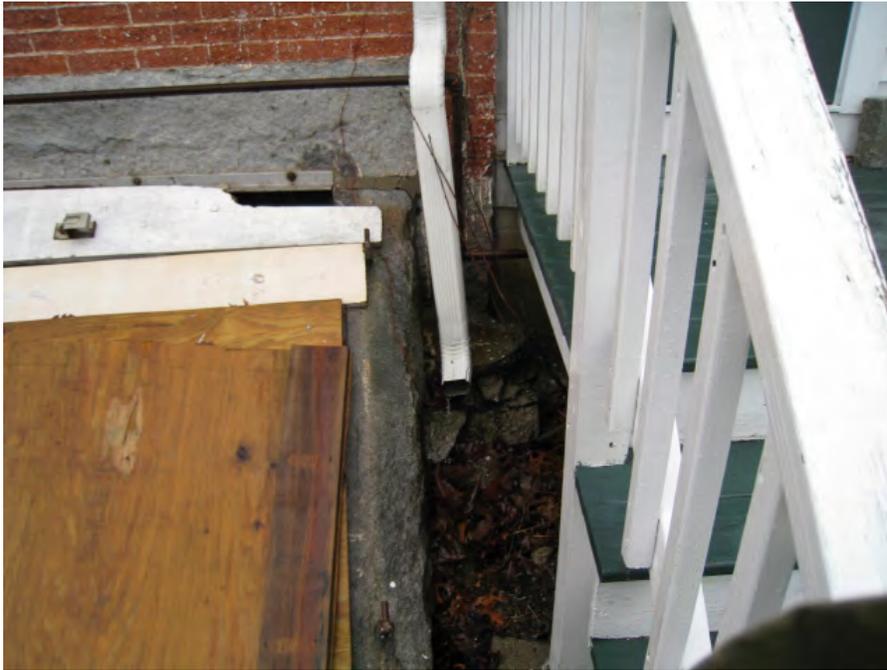
Picture 5

- Damaged bulkhead (Picture 5);
- Gutters/downspouts emptying against foundation (Pictures 5 and 6);
- Missing/damaged mortar around exterior brick and foundation stone (Pictures 7 and 8);
- Missing/damaged basement windows sealed with plywood (Picture 9); and
- Missing/damaged window caulking, joint sealant and damage/breaches in wooden window frames (Pictures 10 and 11). Window and expansion joint sealant may be composed of regulated materials [(e.g., asbestos, polychlorinated biphenyls (PCBs))].

Damaged Bulkhead and Downspout Emptying Water against Foundation

8. Make temporary repairs to seal breaches in building envelope (e.g., around windows, bulkhead) to prevent drafts, access by pests/rodents and further water penetration and damage to building materials. Address deteriorated window/joint sealant in accordance with EPA regulations/MDPH guidance.

12. Extend downspouts to empty at least 5 feet away from the foundation (if possible).
13. Consider removing carpeting from around radiators and replace with tile, to prevent chronic moistening of porous materials and potential mold growth conditions.

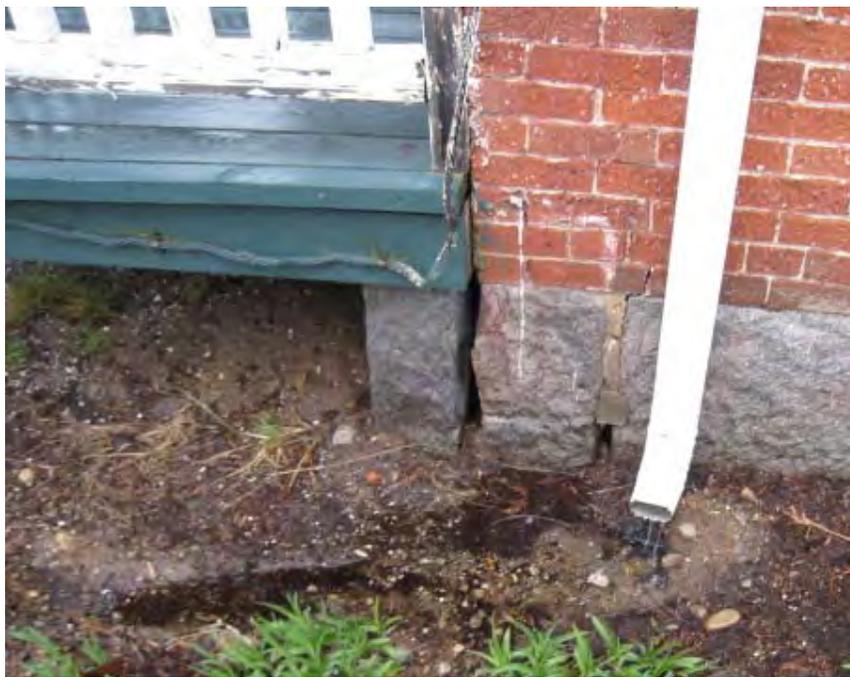
Picture 6

Downspout Emptying Water against Foundation, Note Spaces in Foundation

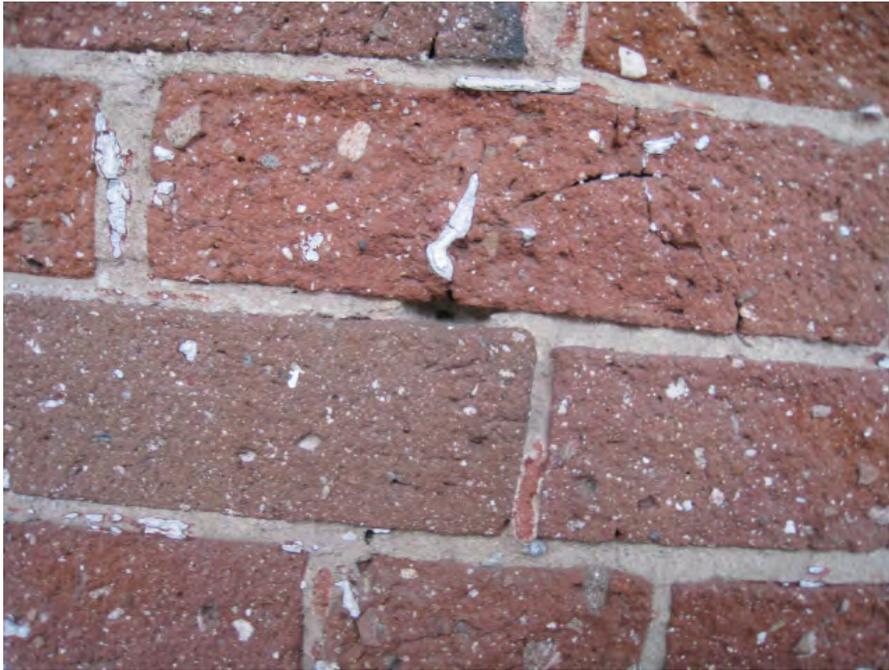
Picture 7

These conditions can undermine the integrity of the building envelope and provide a means of water entry by capillary action into the building through exterior walls, foundation concrete and masonry (Lstiburek & Brennan, 2001). In addition, these breaches in exterior areas can provide a means of drafts and pest entry into the building.

Damaged Exterior Brick

1. Consider consulting with an architect, masonry firm or general contractor regarding the integrity of the building envelope, primarily concerning water penetration through the roof/exterior walls.
2. Consider a long-term plan to replace all windows in the building as funds become available.

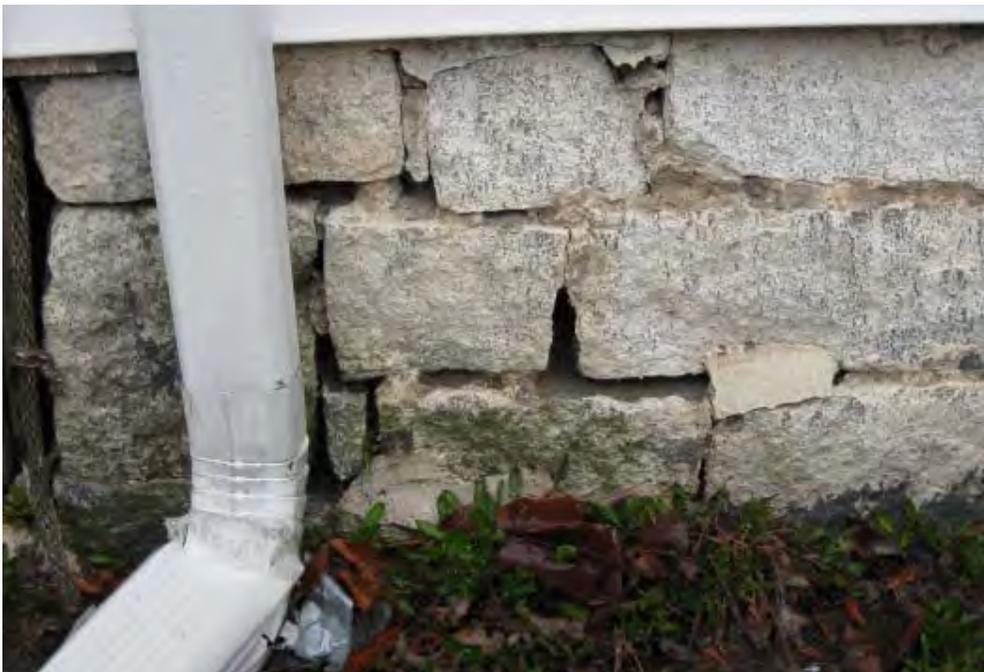
Picture 8

Missing/Damaged Mortar around Foundation Stone

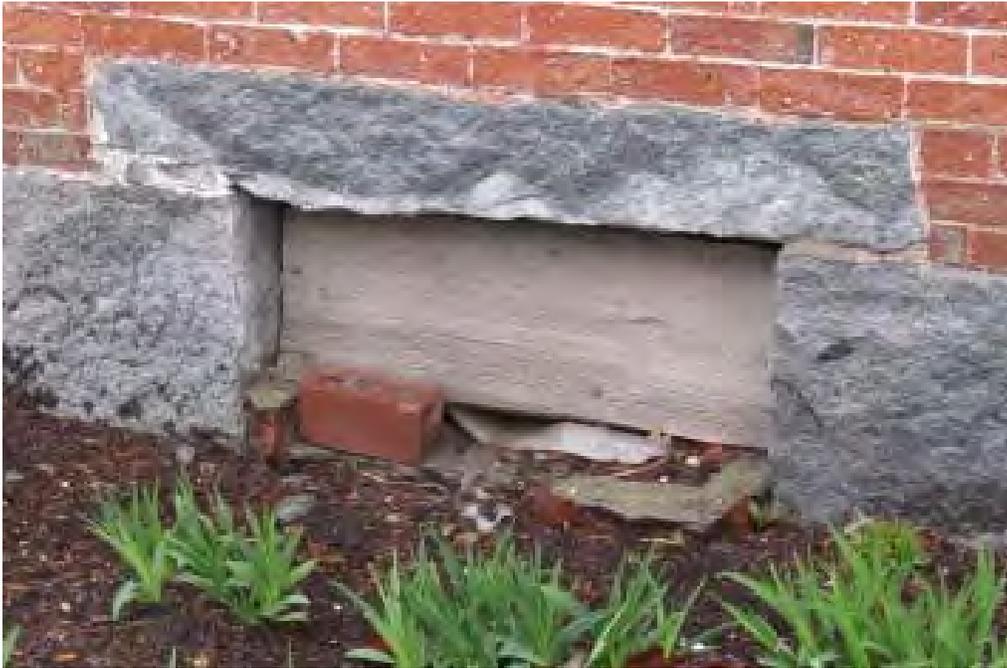
Picture 9

Window Sealed with Plywood, Note Spaces around Wood

14. Seal basement windows to prevent water penetration and rodent/pest entry.
15. Remove rodent/animal droppings and clean/disinfect interior of kitchen cabinets and basement.

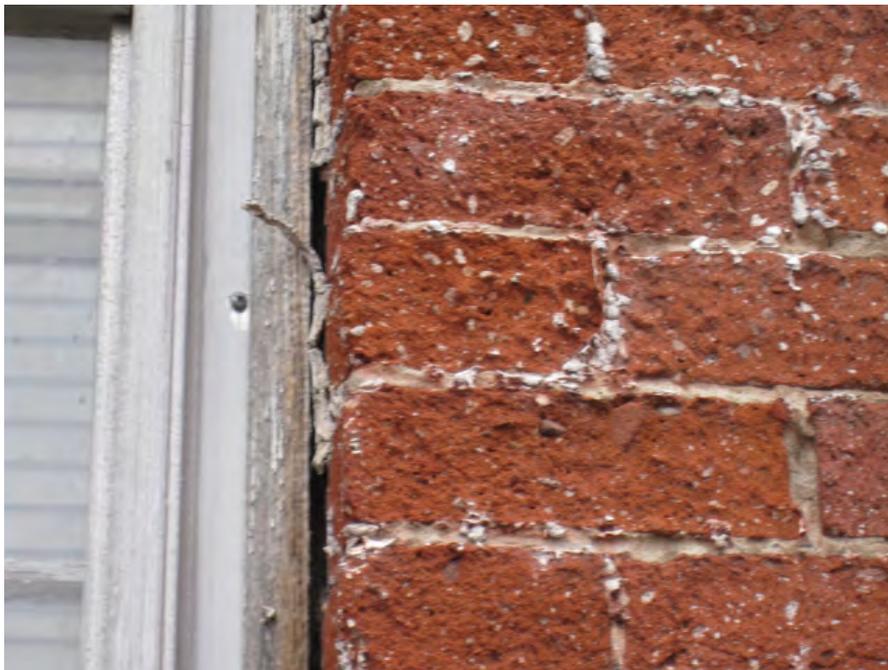
Picture 10

Missing/Damaged Caulking around Window Frame

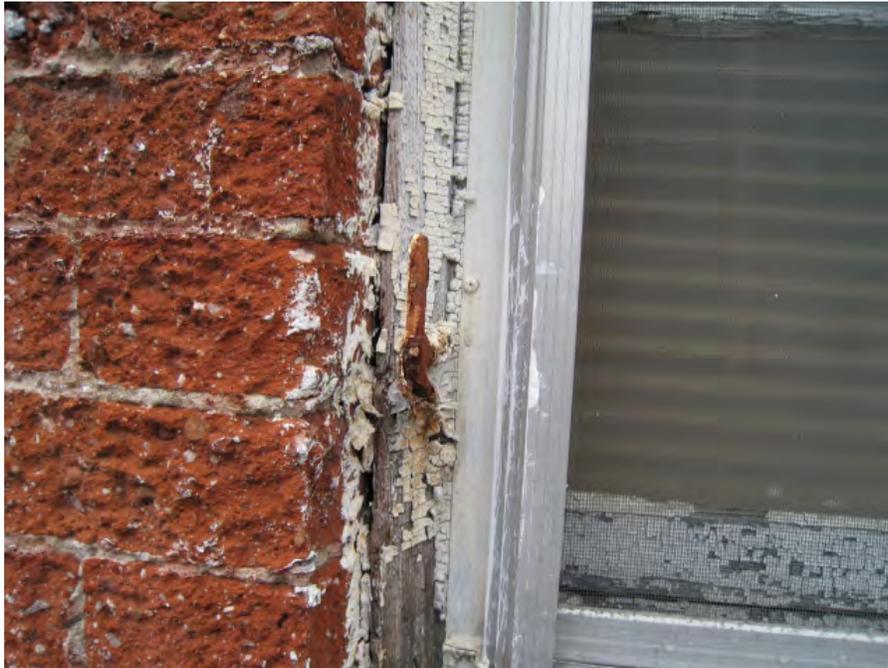
Picture 11

Missing/Damaged Caulking around Window Frame

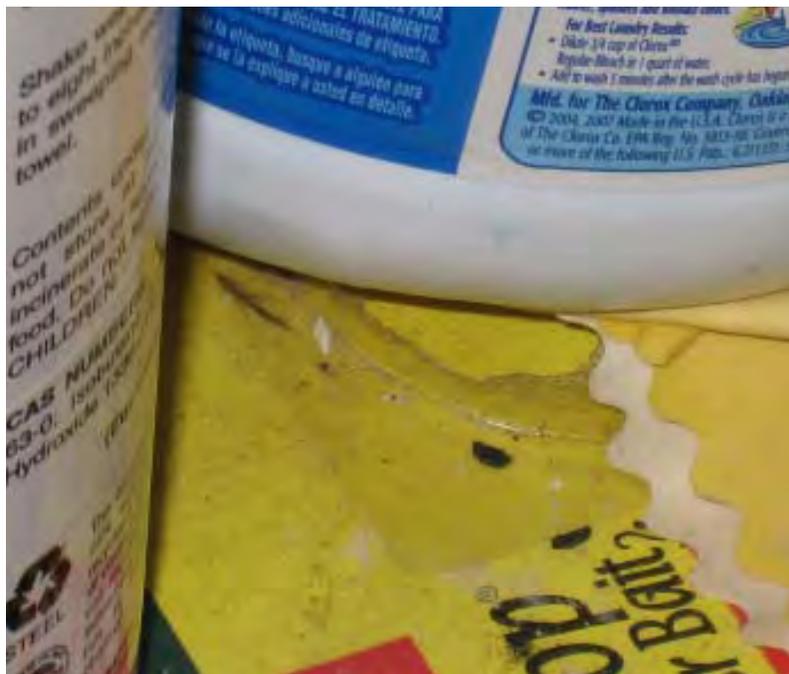
Picture 12

Other conditions that can affect indoor air quality were observed during the assessment. Evidence of rodent/pest infestation was observed in the form of mice droppings under the cabinet in the kitchen (Picture 12) and large deposits of fecal matter in the basement

Mice Droppings beneath Kitchen Sink

20. Contract with a licensed pest control firm to eliminate rodents from the building. For additional advice regarding pest control contact the Massachusetts Department of Agricultural Resources, Pesticide/IPM Program at (617) 626-1700
<http://www.mass.gov/agr/>

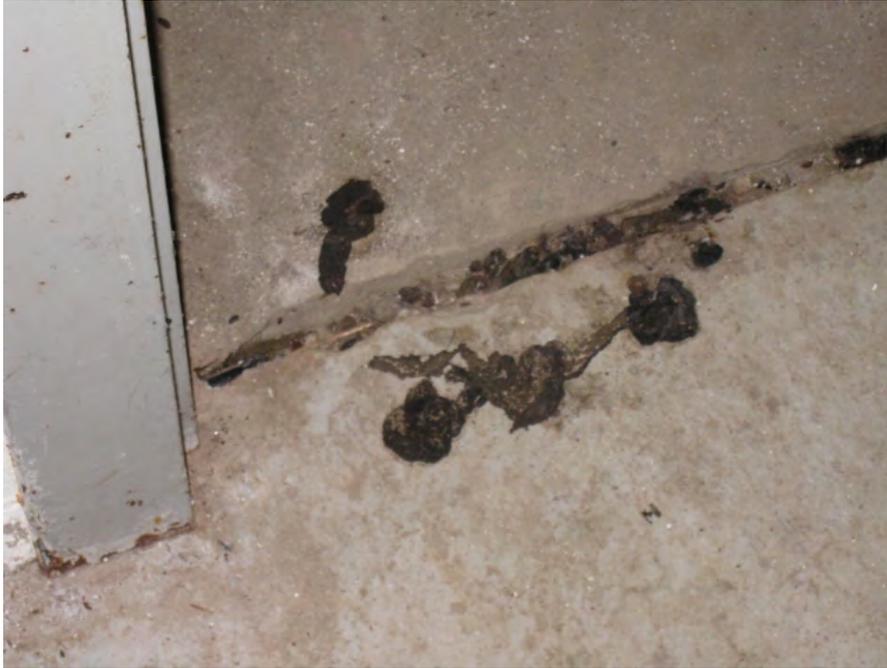
Picture 13

(Picture 13). The waste products in the basement appeared to be from an animal larger than mice, such as a feral cat, raccoon or possum. Rodent infestation can result in indoor air quality related symptoms due to materials in their wastes. Mouse urine contains a protein that is a known sensitizer (US EPA, 1992). A three-step approach is necessary to eliminate rodent infestation:

Large Deposits of Fecal Matter in Basement

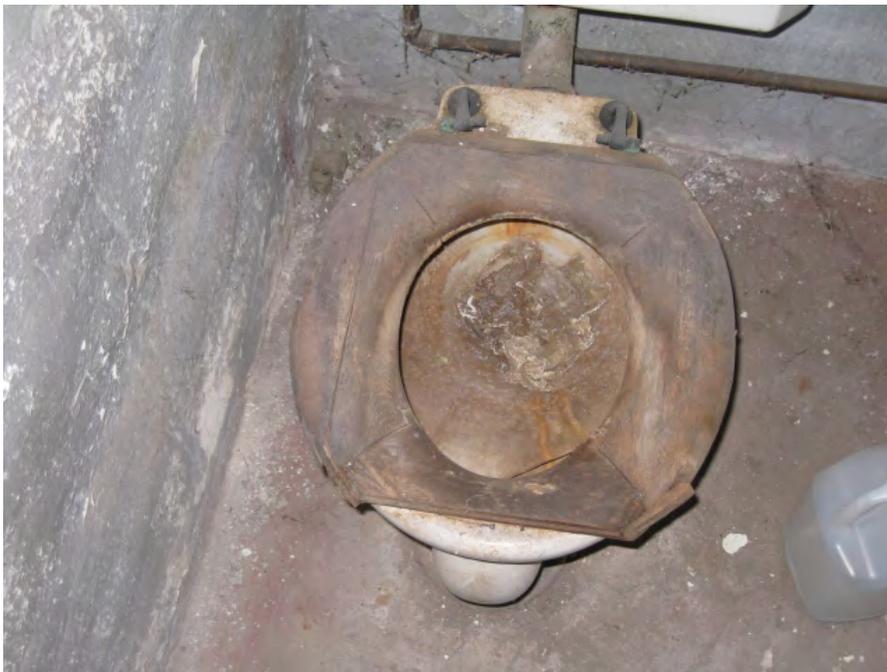
Picture 14

Finally, an abandoned toilet and urinal were observed in the basement, which formerly served as a jail cell for the police department. Instead of properly sealing the drain (or removing the toilet) rags were inserted into the drain (Picture 14). Drains are usually designed with traps in order to prevent sewer odors/gases from penetrating into occupied spaces. When water enters a drain, the trap fills and forms a watertight seal. Without a periodic input of water (e.g., every other day), traps can dry, breaking the watertight seal. Without a watertight seal, odors or other material can travel up the drain and enter the occupied space.

Abandoned Toilet in Basement, Note Rags Stuffed into Drain

18. Seal all open utility holes and breaches in interior spaces (e.g., around radiator pipes).
19. Remove or properly seal drains for abandoned toilets in the basement.
