# **Mold/Water Damage Investigation**

**Winchester High School  
80 Skillings Road  
Winchester, Massachusetts**

Prepared by:  
Massachusetts Department of Public Health  
Bureau of Environmental Health  
Indoor Air Quality Program  
August 2010

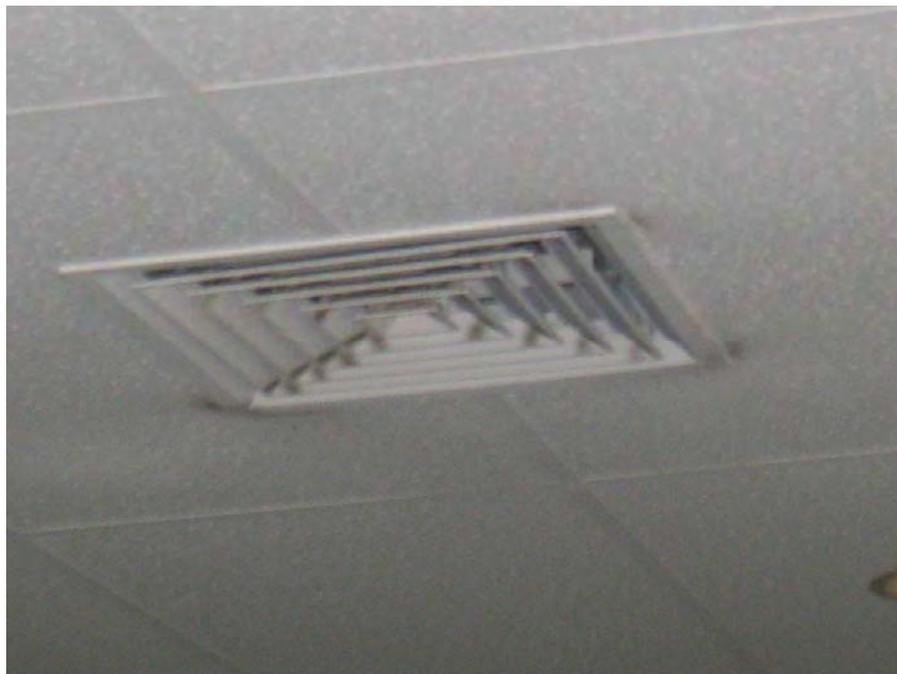
**Picture 2**

As discussed, concerns of mold growth in the cafeteria were also raised. BEH staff examined conditions in the cafeteria and did not observe water damage or mold growth in the area. However, accumulated dust/debris was observed on/around ceiling supply vents in the cafeteria and in other areas (Picture 2). Dust/debris will occasionally accumulate on supply vents due to charges created by the flow of air attracting these particles. Vents should be cleaned periodically to prevent dust from becoming a mold growth medium during periods of elevated humidity/condensation.

**Dust/Debris Accumulation on/around Vent**

4. Clean supply, exhaust/return vents periodically of accumulated dust.
5. Seal any/all utility holes and other potential pathways to eliminate pollutant paths of migration from the basement/crawlspace to the first floor. Ensure tightness by monitoring for light penetration and drafts.

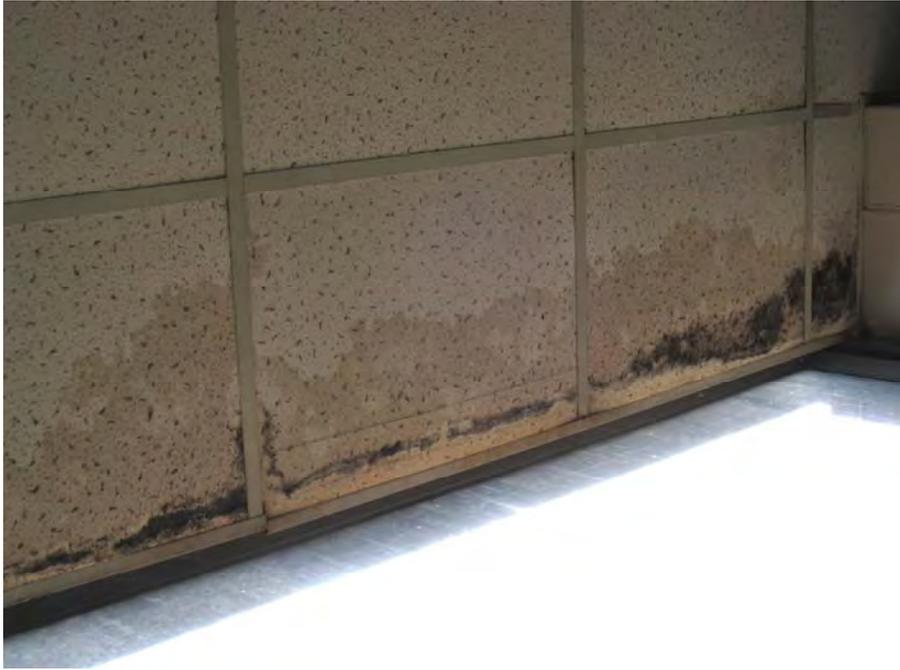
**Picture 3**

BEH staff found the exterior door propped open to the TV studio/wood shop wing during a perimeter examination of the building. Directly inside the hallway, water-damaged/mold-colonized ceiling tiles were observed and a strong musty/mold odor was detected (Picture 3). This condition was reported to Mr. Lawson, who indicated that immediate corrective actions would be taken.

**Water-Damaged/Mold-Colonized Ceiling Tiles in TV Studio/Wood Shop Hallway**

1. Remove water-damaged/mold-colonized ceiling tiles in TV studio/shop hallway as well as any damaged insulation material that may be above ceiling tiles. This measure will remove actively growing mold colonies that may be present. Remove mold contaminated

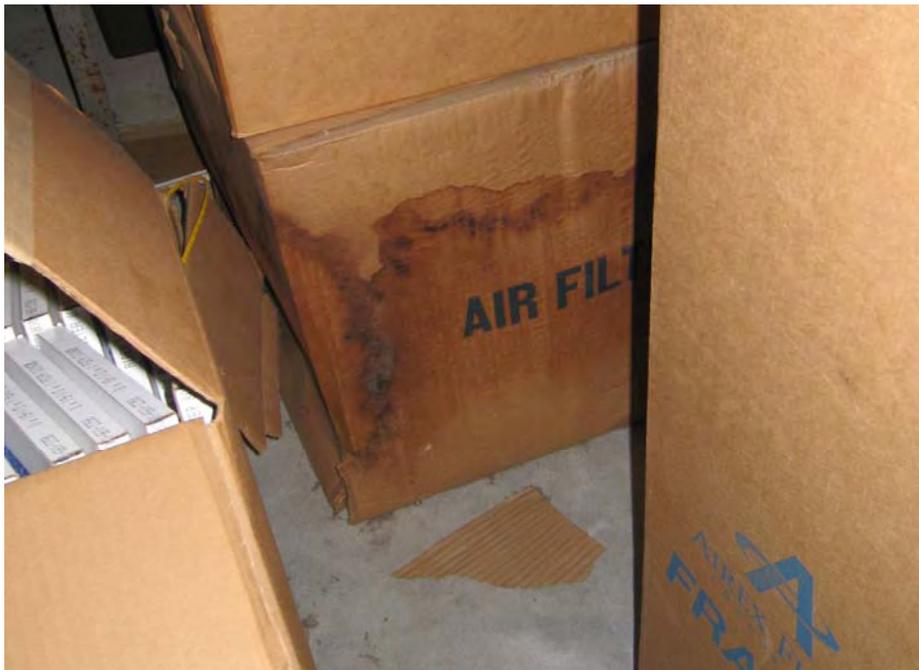
**Picture 4**

Water-damaged/mold-colonized cardboard boxes containing air filters were also observed in the basement (Picture 4). At the time of the assessment BEH staff recommended to Mr. O'Brien that the box and its contents be discarded.

**Water-Damaged/Mold-Colonized Box Containing Filters in Basement**

2. Discard water-damaged/mold-colonized boxes and their materials located in basement mechanical room. Clean and disinfect floor as needed.
3. Store cardboard boxes on pallets or other means to prevent direct contact with floor.

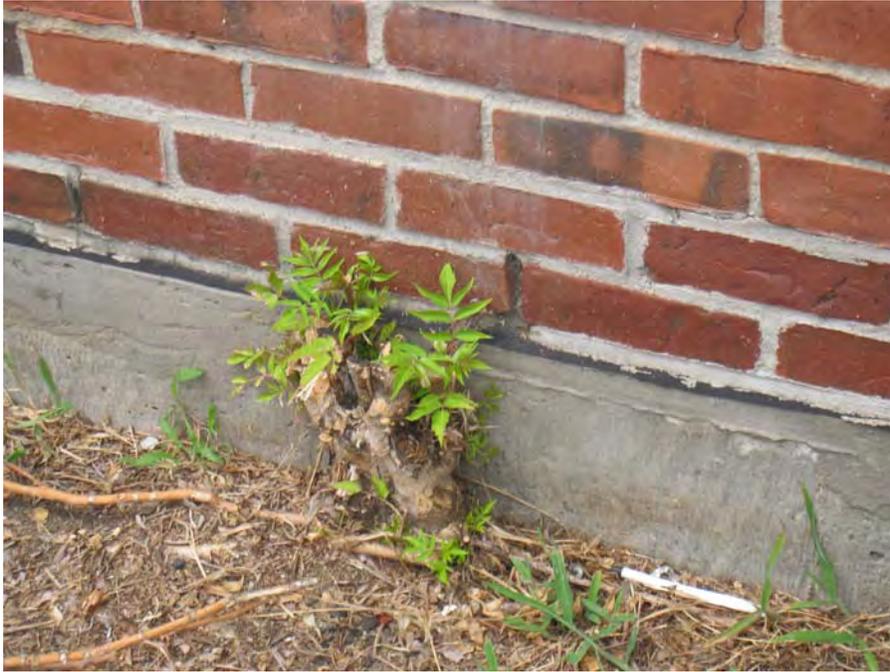
**Picture 5**

- Plants/trees growing in close proximity to exterior walls, which can hold moisture against the building and prevent drying (Pictures 5 and 6). In addition, roots of trees can damage the buildings foundation;
- Damaged concrete foundation/masonry (Picture 7);
- Broken window panes sealed with plywood or other material (Picture 8);
- Damaged vents containing trash/debris (Picture 9);
- Subterranean air intake pits with pine needles/leaves and debris (Picture 10).

**Tree Stump Growing against Foundation**

6. Remove plants/stumps in close proximity to the foundation. Trim trees back from exterior walls.
7. Repair cracked, broken foundation masonry.
8. Repair/replace damaged windows and exterior wall panels.

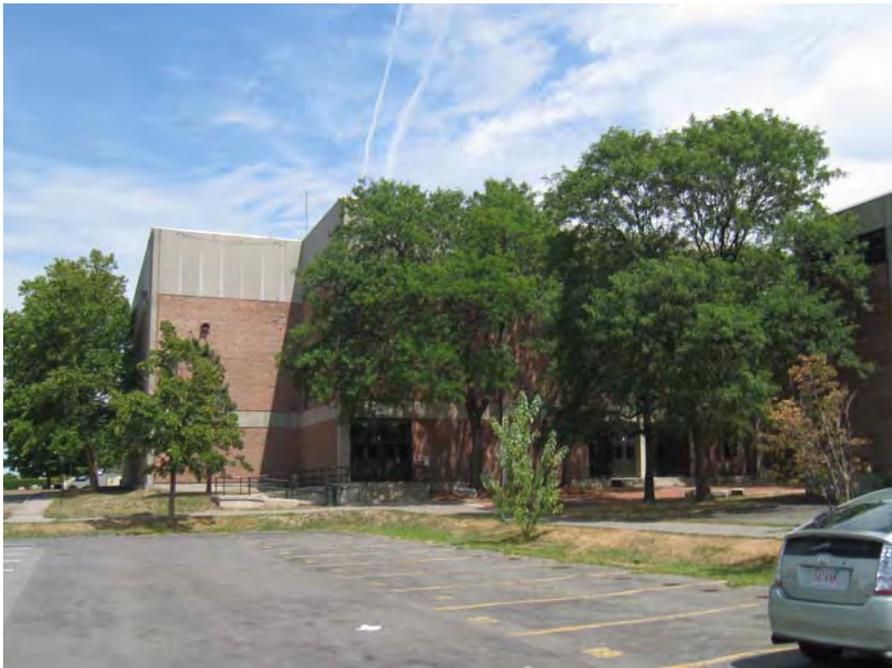
**Picture 6**

**Trees/Branches in Close Proximity to Exterior Walls**

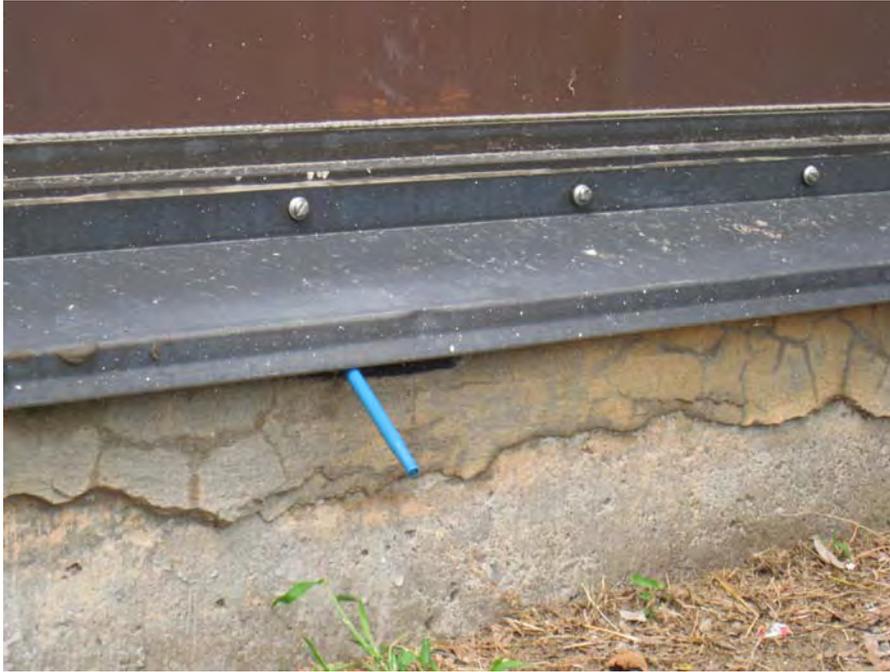
**Picture 7**

**Damaged Concrete Foundation Masonry, Pen Inserted by BEH Staff to Show Depth**

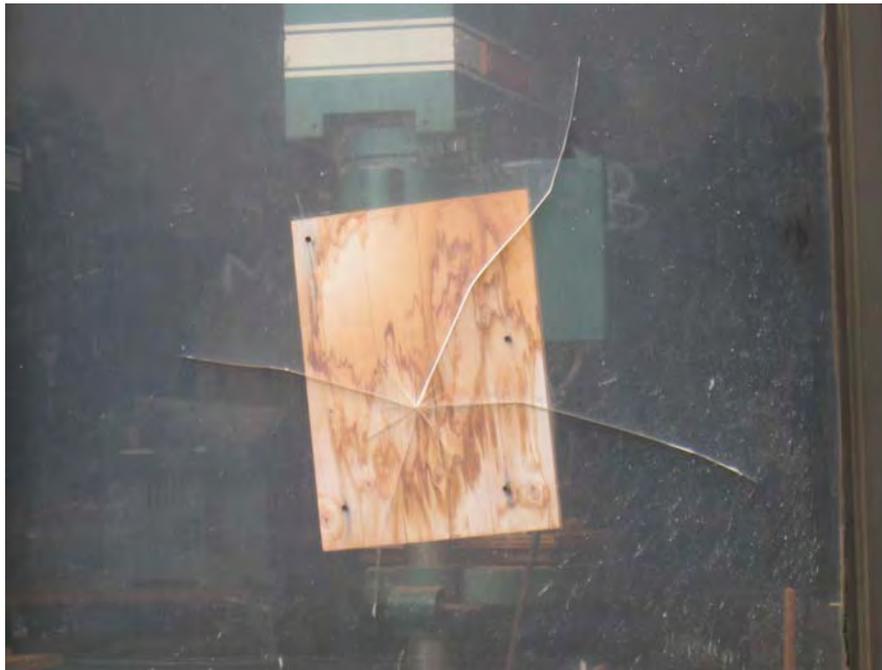
**Picture 8**

**Broken Window Sealed with Plywood**

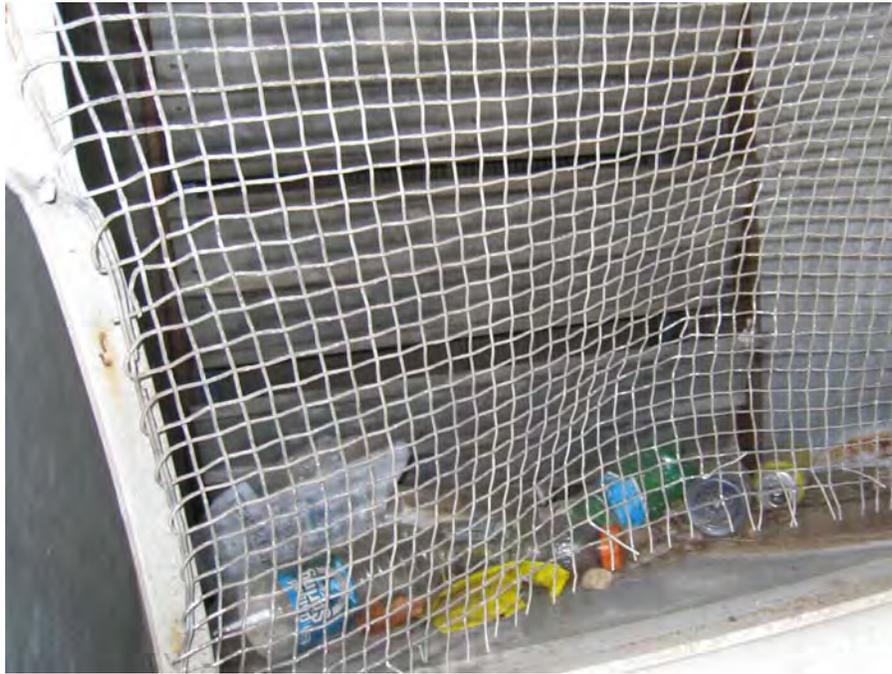
**Picture 9**

**Damaged Vent, Note Trash and Debris**

9. Clean trash/debris from exterior vent shown in Picture 9. Make repairs to bird screen to prevent reoccurrence.
10. Clean out subterranean pits periodically of accumulated debris.

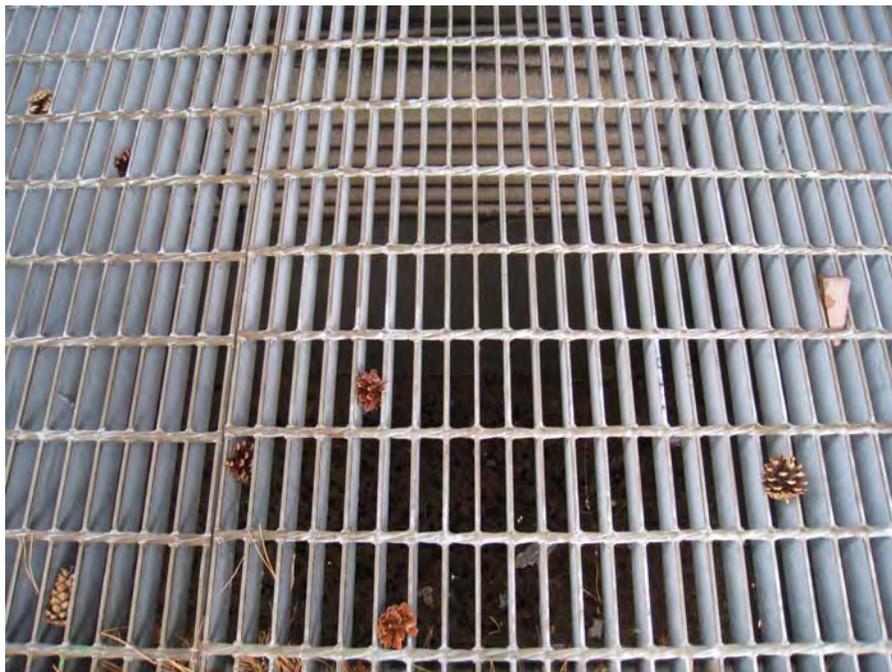
**Picture 10**

Accumulated debris in the pits can collect moisture and become a source of mold growth and associated odors;

**Subterranean Air Intake Pit**

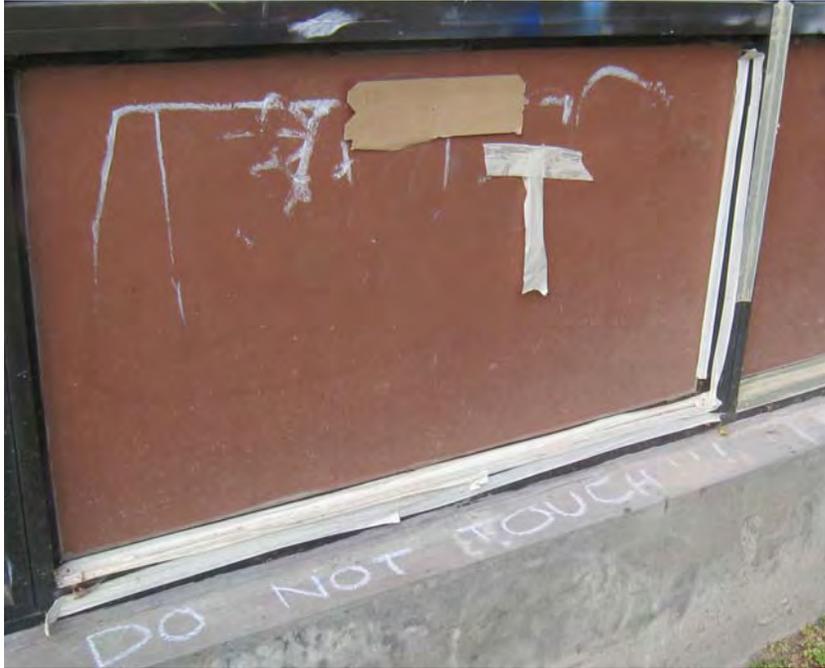
**Picture 11**

- Exterior wall panels sealed with masking tape (Picture 11); and
- Missing/damaged window caulking and joint sealant (Pictures 12 through 14). Window and expansion joint sealant may be composed of regulated materials [(e.g., asbestos,

**Exterior Wall Panels Sealed With Masking Tape**

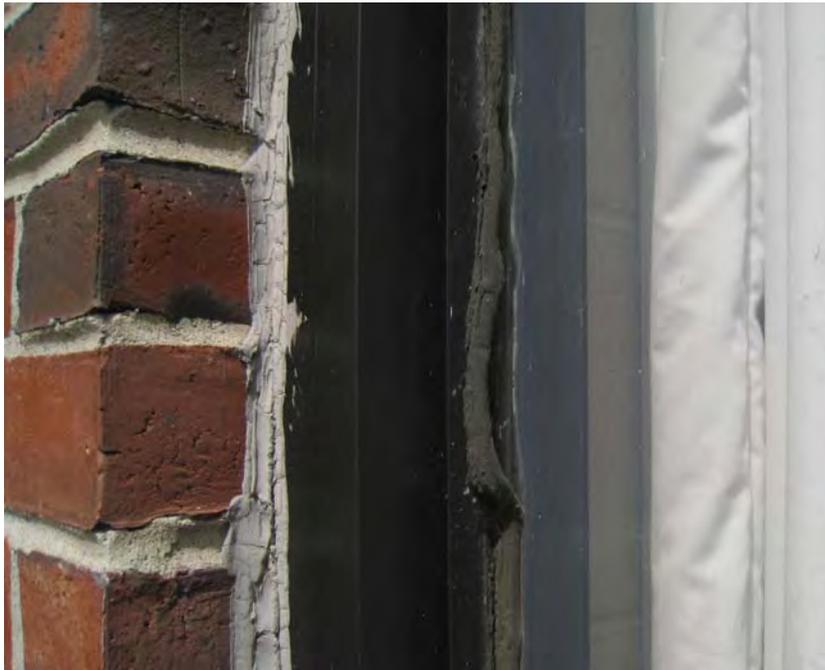
**Picture 12**

**Damaged/Failing Window Caulking**

11. Seal window panes and frames to prevent water penetration drafts and pest entry. Address deteriorated window sealant in accordance with EPA regulations/MDPH guidance.

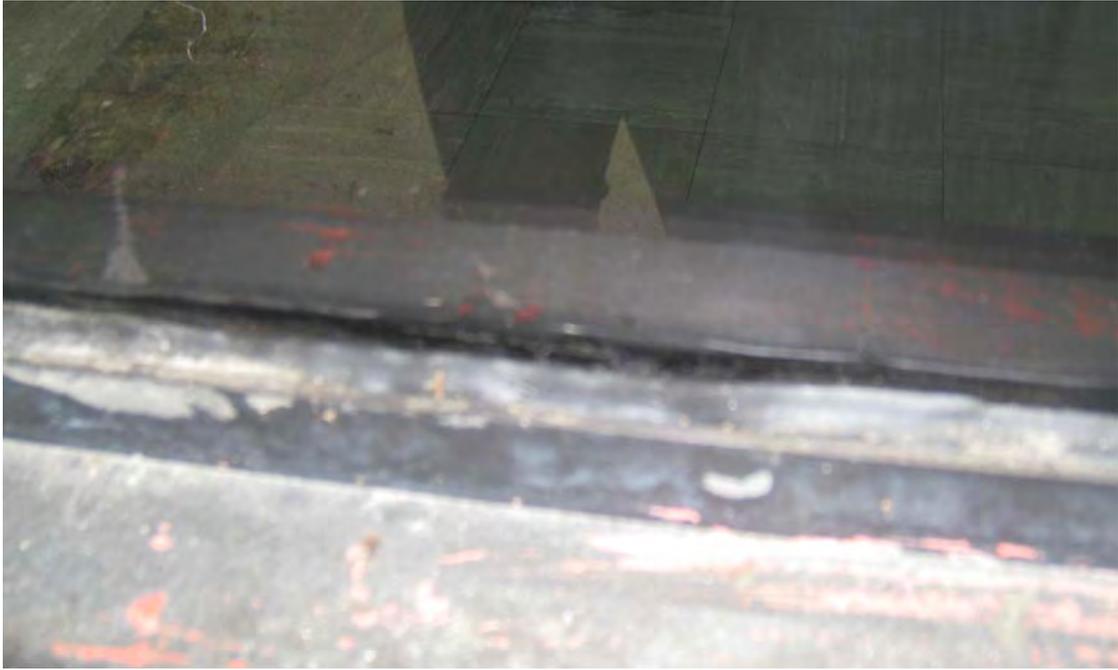
**Picture 13**

**Missing/Damaged Window Caulking**

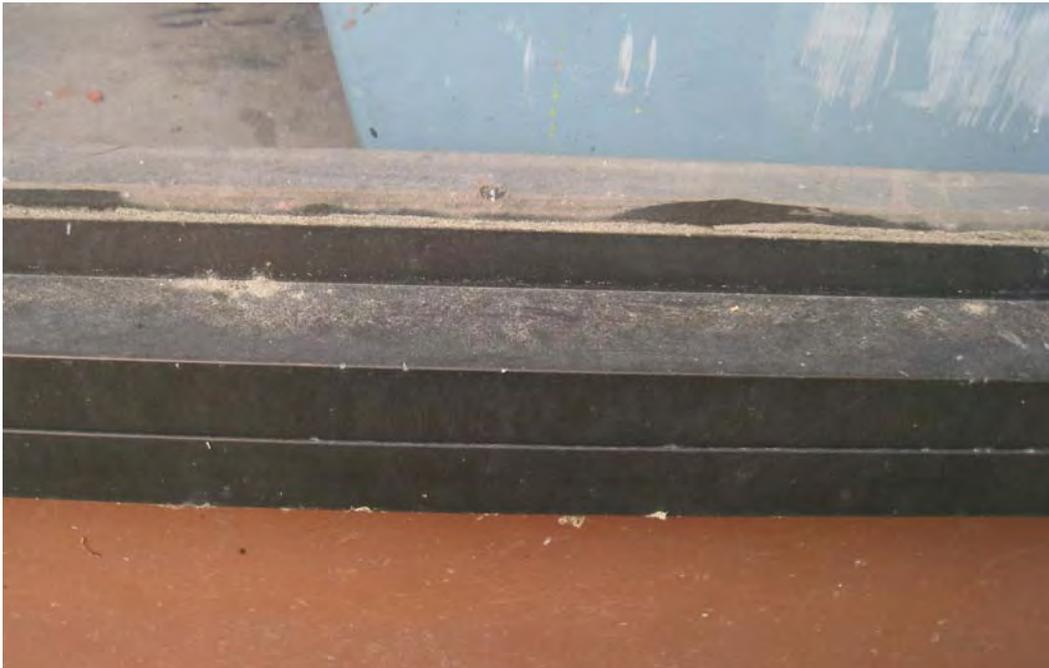
**Picture 14**

**Missing/Damaged Window Caulking**

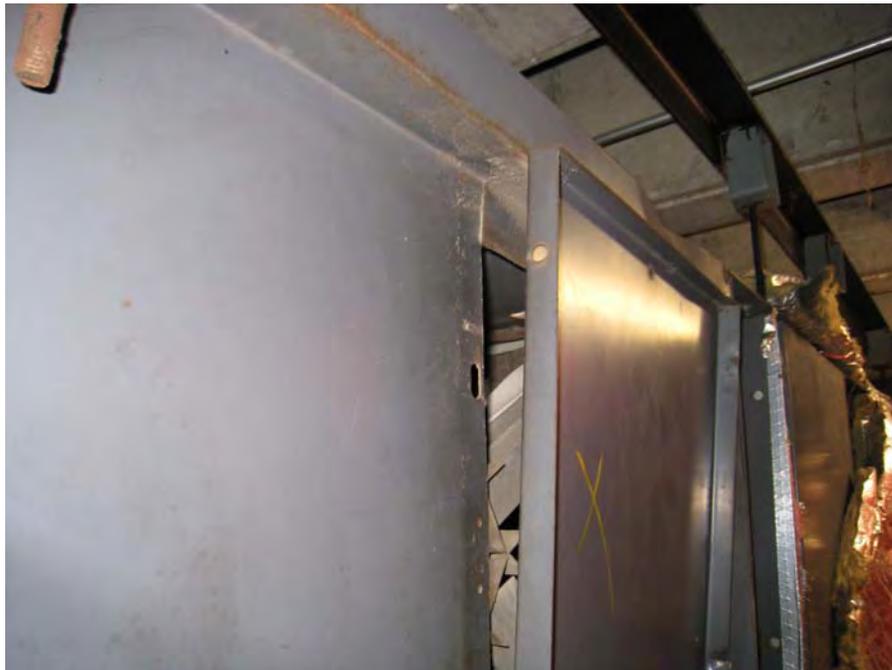
**Picture 16**

BEH staff inspected air-handling units (AHUs) in the basement mechanical room. One of the units had a damaged filter access panel (Picture 16). Under these conditions, the damaged access panel prevents the AHU casing from being airtight, which can result in the draw air from the mechanical room into the unit. In this condition, the opportunity exists for airborne dirt, dust,

odors and particulates to be drawn into the HVAC system and be distributed to occupied areas. Aerosolized dusts and particulates can provide a source of eye, skin and respiratory irritation to certain individuals.

**Damaged Filter Access Panel, Note Space/Opening**

13. Identify vents shown in Picture 15 as either supply or exhaust. Extend the supply vent at least 5-feet away from the exhaust vent to prevent entrainment.
14. Repair/replace filter access panel on AHU shown in Picture 16.
15. Consider adopting the US EPA (2000) document, “Tools for Schools”, as an instrument for maintaining a good indoor air quality environment in the building. This document is available at: <http://www.epa.gov/iaq/schools/index.html>.
16. Refer to resource manual and other related indoor air quality documents located on the MDPH’s website for further building-wide evaluations and advice on maintaining public buildings. These documents are available at: <http://mass.gov/dph/iaq>.
