INDOOR AIR QUALITY ASSESSMENT

**Windsor Town Hall
1927 Route 9
Windsor, Massachusetts**

Prepared by:
Massachusetts Department of Public Health
Bureau of Environmental Health
Indoor Air Quality Program
January 2010

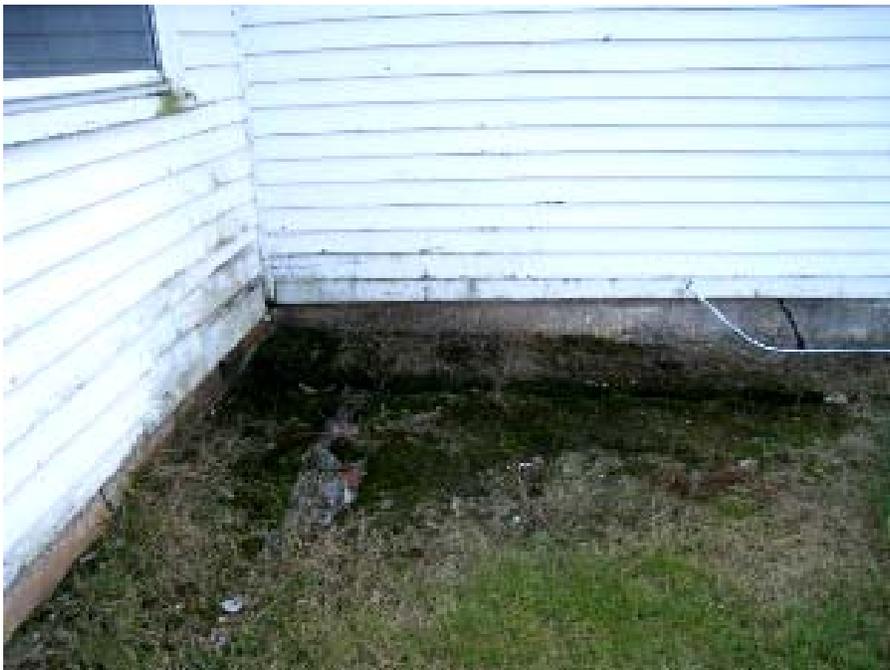
Picture 4

Sustained moisture at the base of the building is evident by heavy moss growth on the west side of the building (Picture 4). The presence of moss on the ground against the foundation is indicative of repeated water exposure. Moss is a sign of chronic dampness and can hold moisture against building surfaces which accelerates decomposition of building components. Additionally, since the building lacks a gutter/downspout system, rainwater from two sections of roofing converge in the northwest corner and deposit water onto the ground. Over time, this condition creates troughs adjacent to the foundation. These troughs collect and subsequently hold water close to the building's foundation. As water splashes up from the troughs, clapboards are exposed to moisture. As can be seen in Picture 4, clapboards in this corner are showing signs of prolonged contact with water. Over time, these clapboards will deteriorate if current conditions remain.

**Moss Growth on Ground Adjacent to Building
Note Water Damaged Clapboards**

3. Improve the grading of the ground away from the foundation in order to eliminate troughs and sink holes from the base of the building.
4. Repair rotted, cracked and broken clapboards.

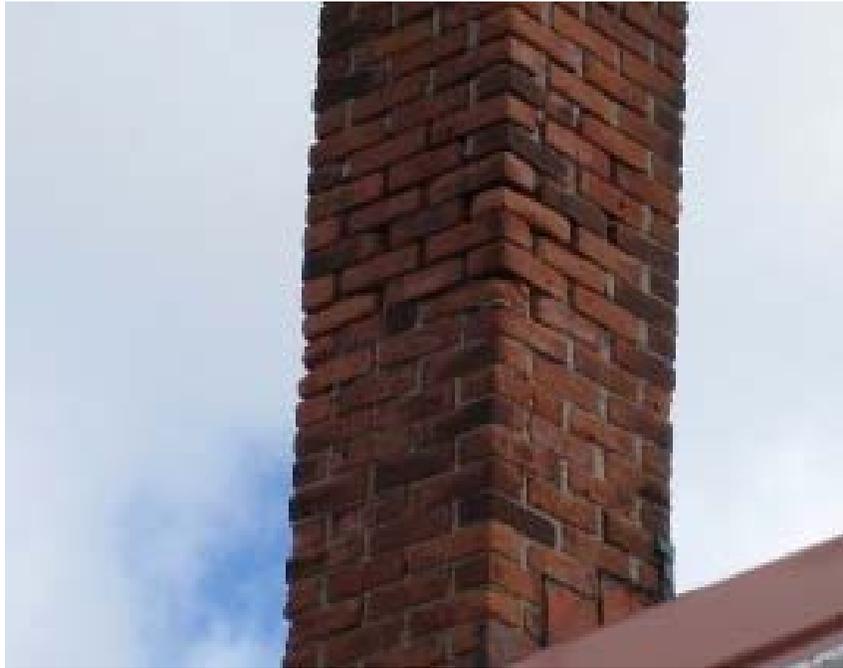
Picture 5

Missing Mortar on Chimney

5. Repaint surfaces that exhibit peeling paint.
6. Contact a mason to re-point the chimney to eliminate leakage into the building.
7. Repair missing, deteriorated glazing and broken windows.

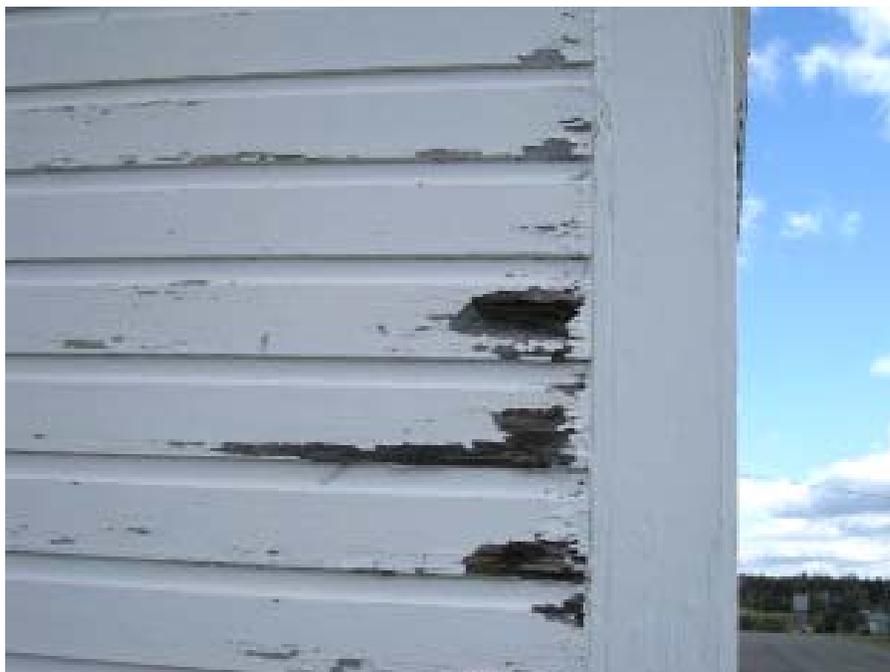
Picture 6

Peeling Paint Exposes Saturated Wood

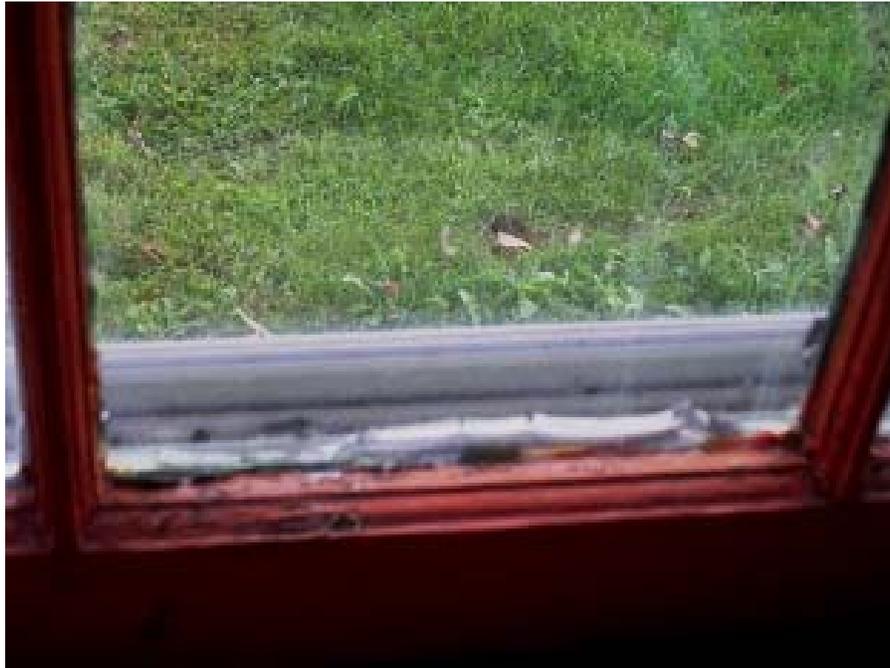
Picture 7

Deteriorated Glazing in Window

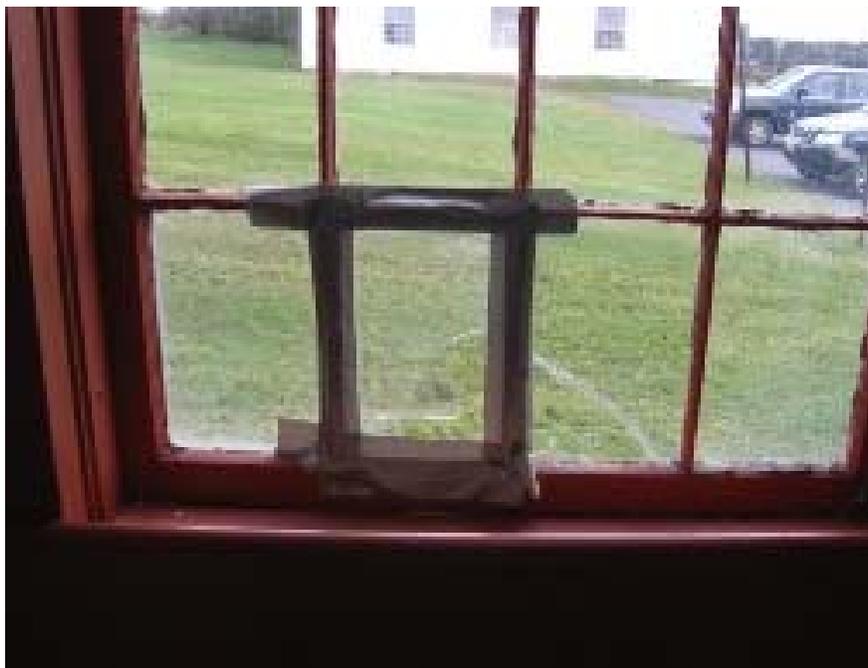
Picture 8

Broken Panes of Glass

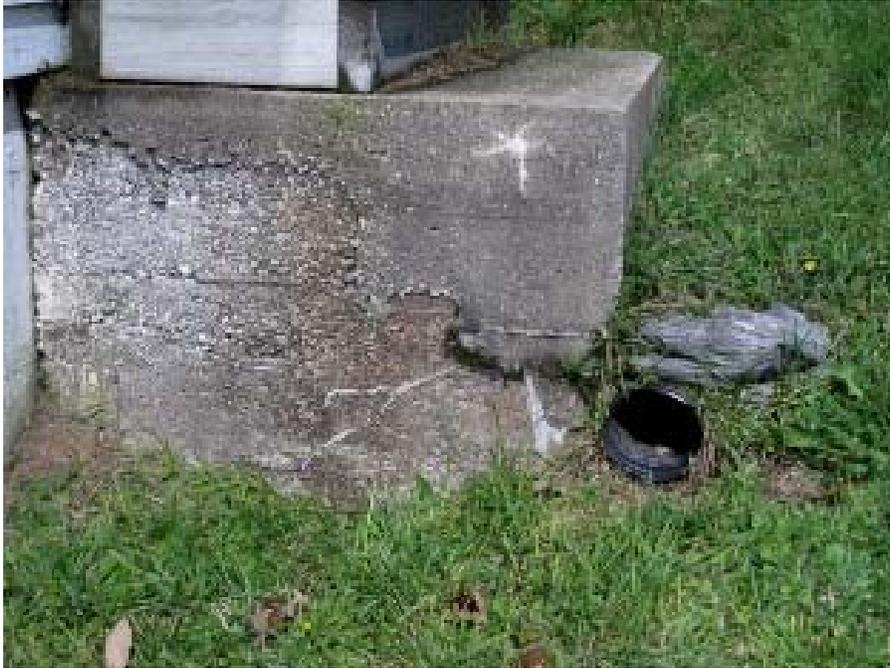
Picture 9

Drain Deposits Water Close to Foundation

8. Repair cracks, holes in foundation to reduce access points for rodents.
9. Assess exterior drain to determine if it is feasible to extend it further away from the building.

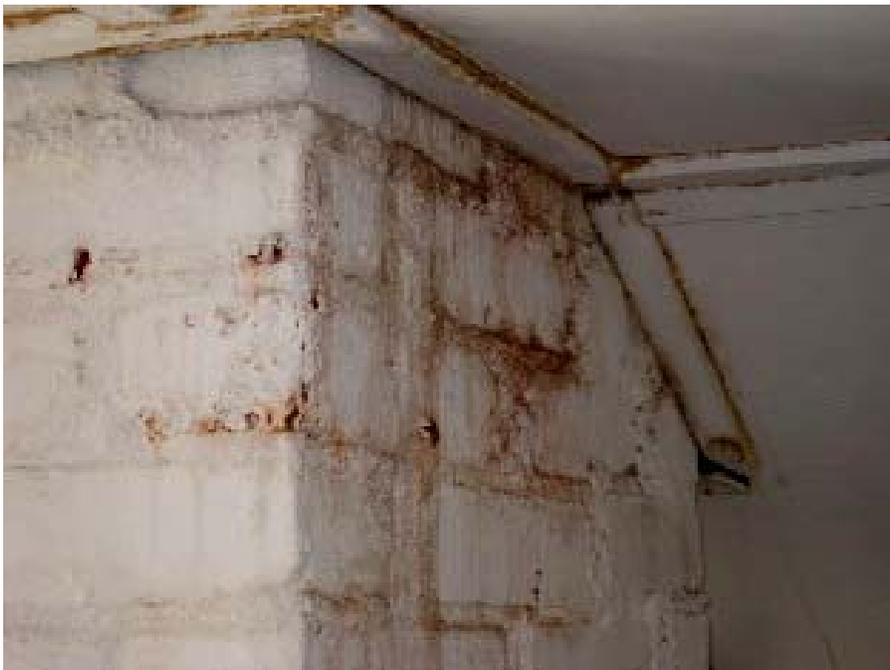
Picture 10

Numerous conditions were also observed on the interior of the building that may indicate that moisture is entering/has entered the building. Water damage was observed on the ceiling of the second floor storage room, particularly adjacent to the chimney (Picture 10). Attic joists exhibit water damage. Ceiling panels are buckled in some areas of the main hall and do not touch the walls in some areas. Water damaged wood was observed in the kitchen ceiling as well.

Water Damage to Ceiling Adjacent to Chimney

10. Repair/replace water damaged ceiling materials on the second floor adjacent to the chimney as well as in the main hall.
11. Documents, files and books stored in the attic should be reviewed and nonessential items discarded. Items which must be kept should be cleaned and properly stored.

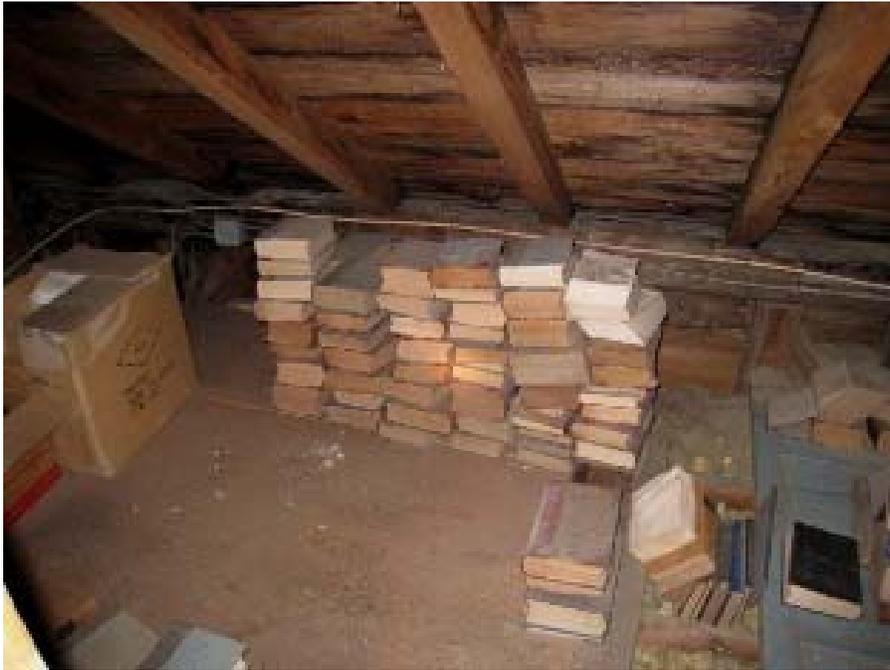
Picture 11

Porous materials, such as cardboard boxes, books, files and documents are stored in the attic (Pictures 11 through 13). Many of the materials appear water damaged and possibly mold colonized. These materials are covered with dust and attic insulation. Additionally, rodents

Books Stored in Attic

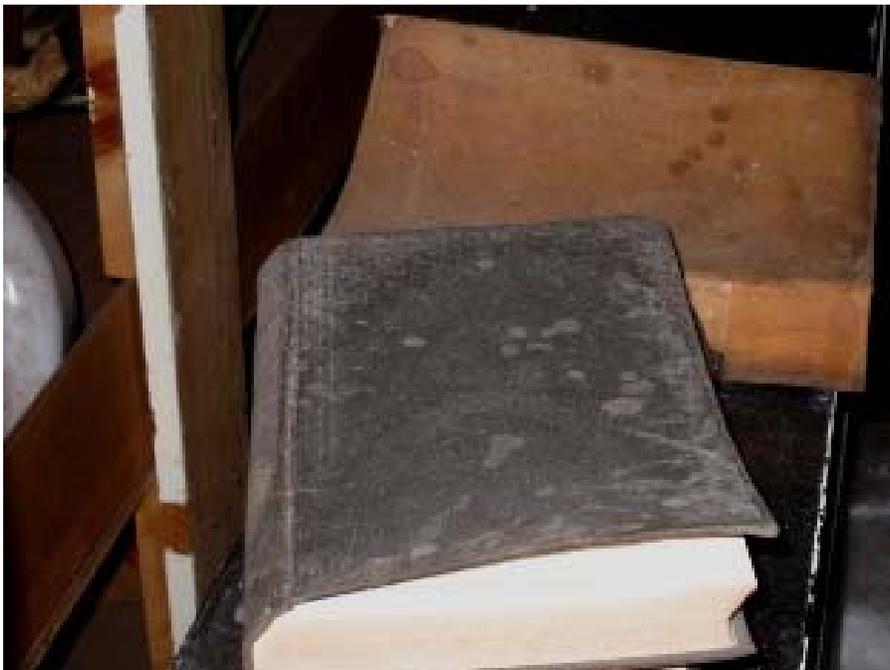
Picture 12

Water Damaged Books

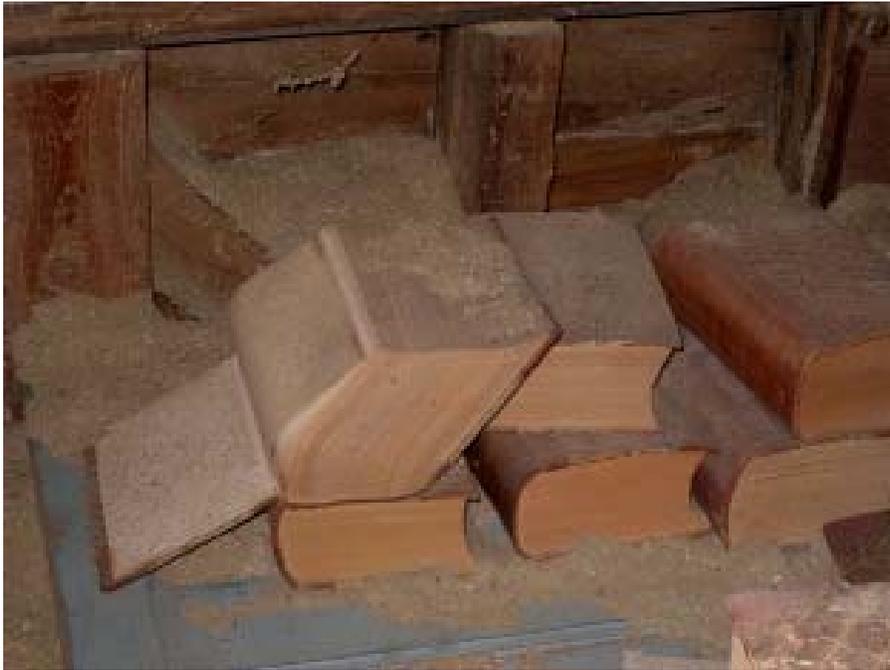
Picture 13

Books Covered With Insulation

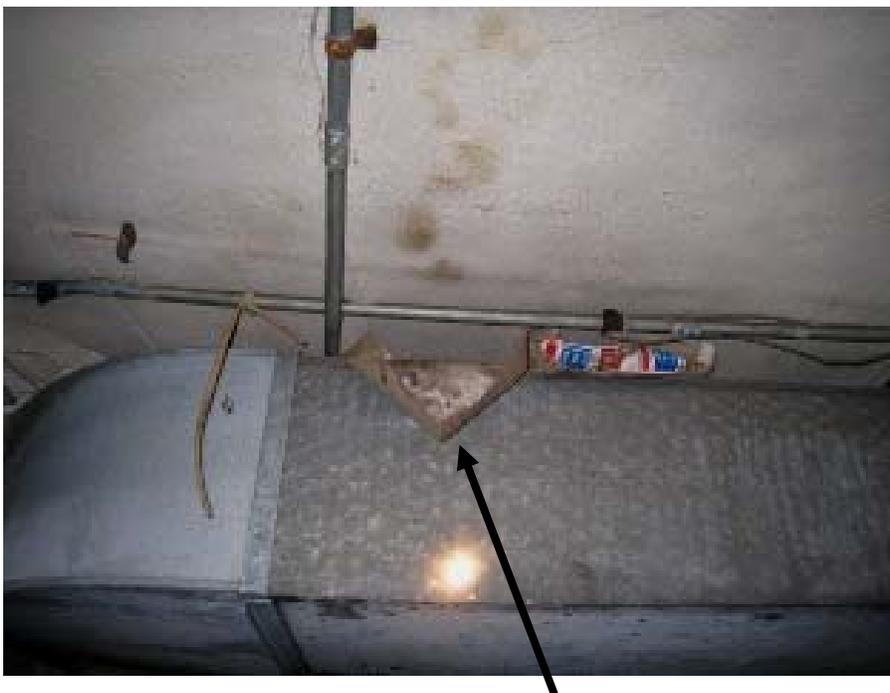
Picture 14

within the building appear to have been gnawing on book bindings. Porous materials stored in unconditioned spaces are subject to the absorption of moisture, which can subsequently lead to mold colonization. Mold colonized cardboard was found in the basement (Picture 14).

Mold Colonized Cardboard

12. Remove and properly dispose of mold colonized cardboard from basement.
13. Contact a heating technician to assess the furnace and to repair all conditions associated with the furnace/ductwork, which may allow carbon monoxide to enter the building.

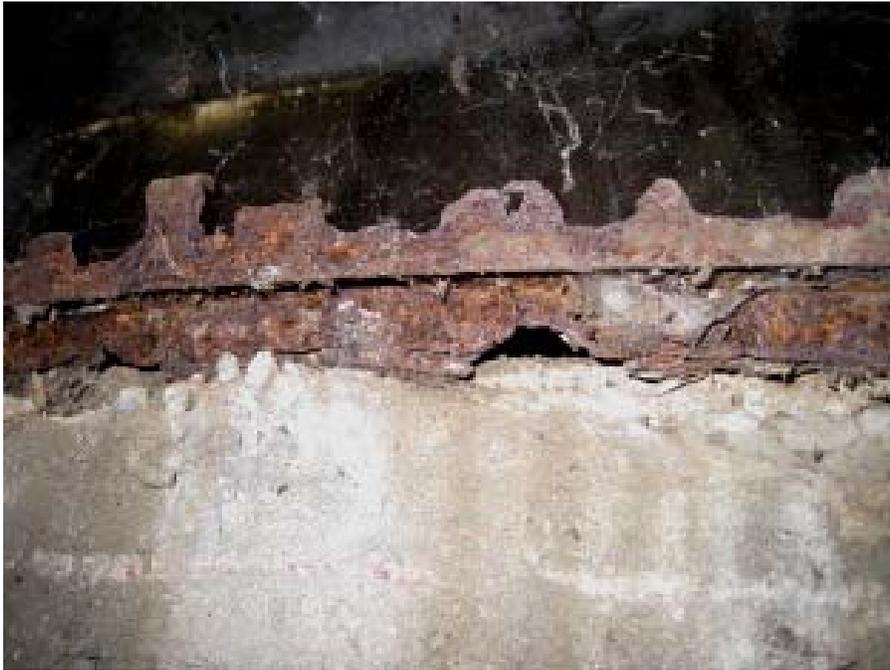
Picture 15

Indications of chronic moisture were evident throughout the basement. Metal window frames were severely oxidized, to the point where they were no longer weathertight (Picture 15). Metal surfaces of equipment throughout the basement were also observed to be heavily rusted (Picture 16). In addition, a sizable hole was observed in a concrete foundation wall in the basement.

Section of Oxidized Window Frame

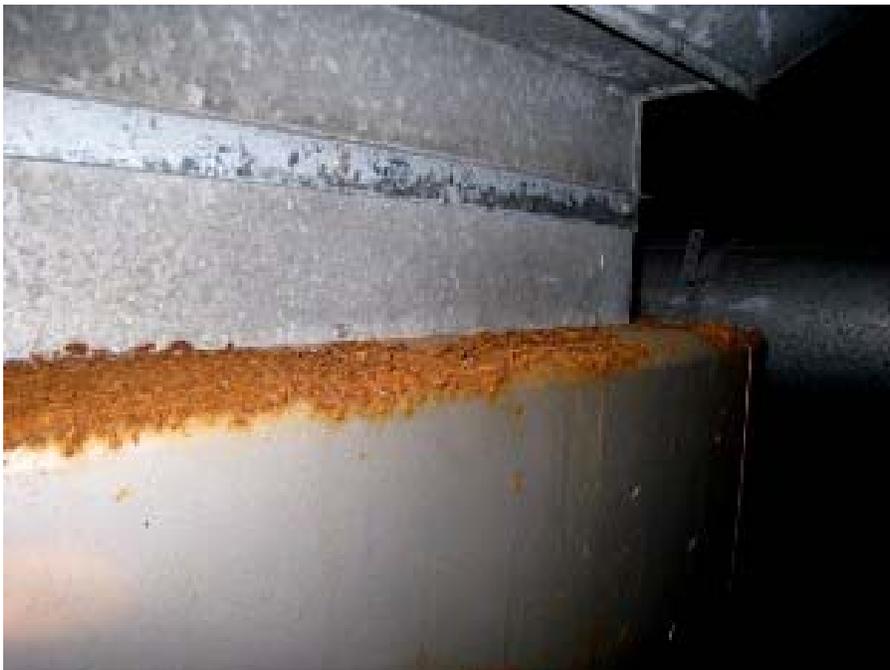
Picture 16

Although carbon monoxide was not detected at the time of the assessment, potential sources of carbon monoxide in the building were observed. As previously described, oxidation was observed on metal surfaces in the basement. One of these surfaces was the exhaust duct from the furnace to the chimney, which was rusted through in several areas. The interior of the duct was heavily rusted as well, which may be an indication that condensation is occurring within the exhaust duct. In addition, an improperly sealed pipe was protruding from the basement chimney. On the second floor, an old outlet in the chimney was also not adequately sealed (Pictures 18 through 21). These conditions may allow carbon monoxide to enter the WTH. BEH informed Ms. Giusti that the repairs should be made as soon as possible and suggested that a carbon monoxide detector be installed in the building immediately.

Top of Furnace Exhibits Rust

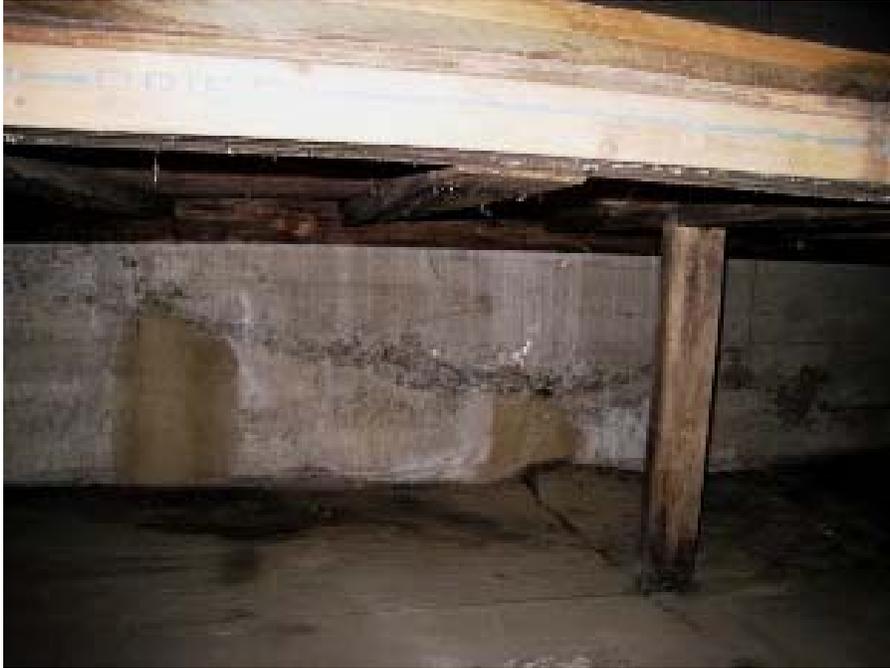
Picture 17

Efflorescence was observed on the concrete walls of the basement. Efflorescence is a characteristic sign of water intrusion. As penetrating moisture works its way through concrete, it leaves behind characteristic mineral deposits. Efflorescence is a characteristic sign of water damage to building materials, but it is not mold growth. As moisture penetrates and works its way through building materials (e.g., concrete), water-soluble compounds dissolve, creating a solution. As this solution moves to the surface, the water evaporates, leaving behind white, powdery mineral deposits (Picture 17). The plywood base of the storage area that abuts the concrete wall was moist to the touch and was buckled and separated in some areas from repeated moisture exposure.

**Efflorescence on Concrete Wall
Note Wet, Buckled Plywood Below**

16. Consider removing water damaged plywood from basement.
17. Remove visible rodent carcasses.
18. Due to the relatively large rodent population in the building, contact a licensed pest control firm to address the current rodent infestation.

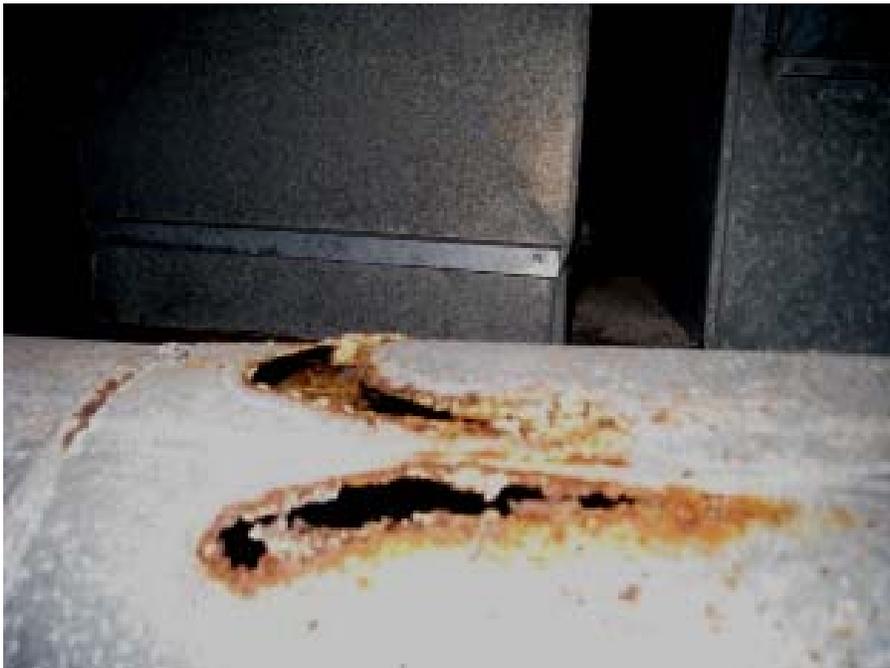
Picture 18

Holes in Exhaust Duct to Chimney

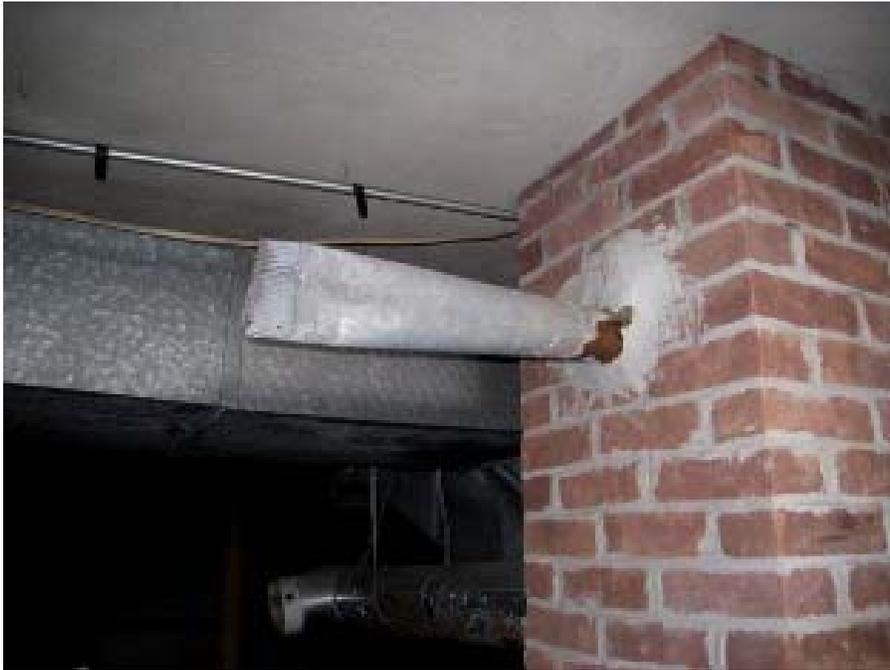
Picture 19

Abandoned Exhaust Duct in Chimney

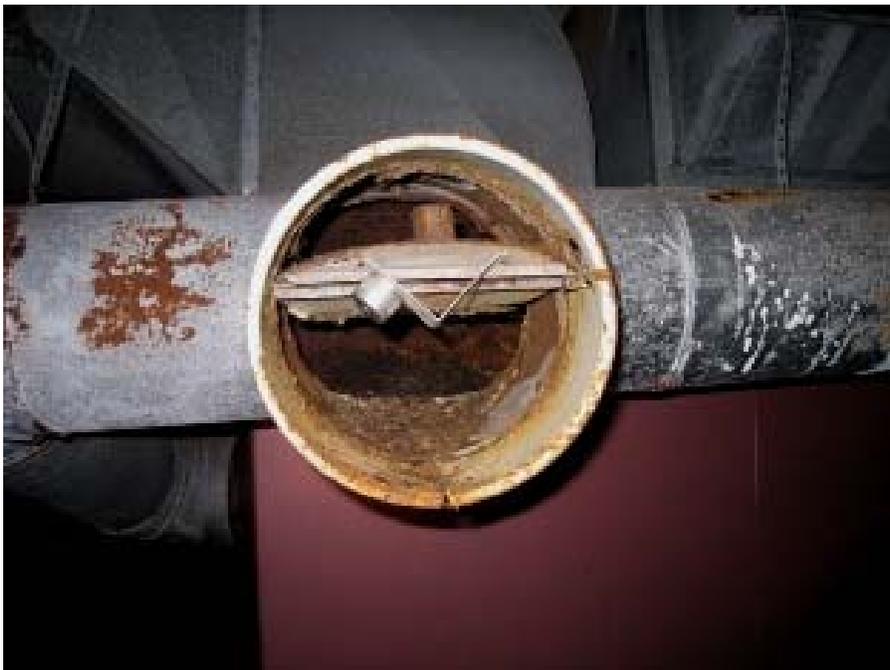
Picture 20

Heavy Oxidation of Interior Duct

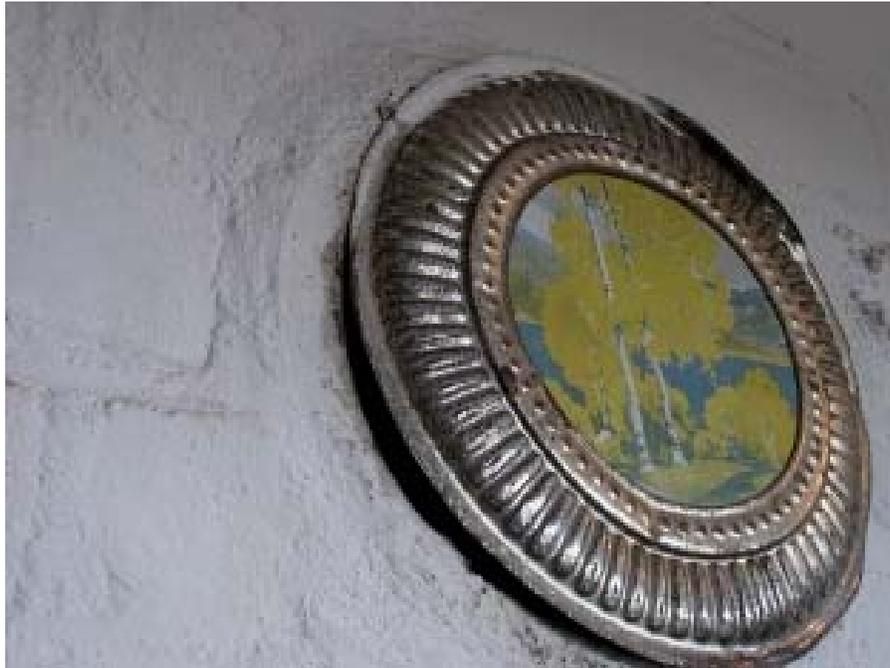
Picture 21

Ill-Fitting Cover to Chimney on Second Floor, Note Spaces around Cover

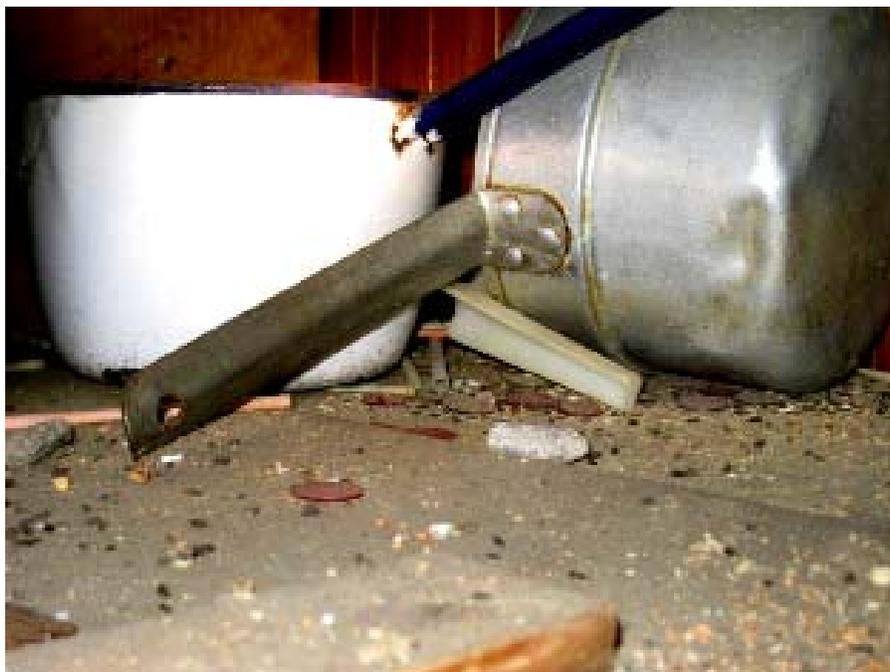
Picture 22

infestation were visible in the kitchen cabinets and behind the stove (Pictures 22 and 23). Two nearly empty boxes of rodent bait were also observed in the kitchen, and numerous rodent and mole carcasses were observed throughout the building as well as shredded paper and cardboard indicative of rodent activity (Picture 24). It is likely that a good number of them died within the walls as well.

Rodent Droppings in Kitchen Cabinet

19. Clean rodent feces from throughout the building, particularly the kitchen cabinets and behind the stove. Disinfect surfaces and rinse with clean water.

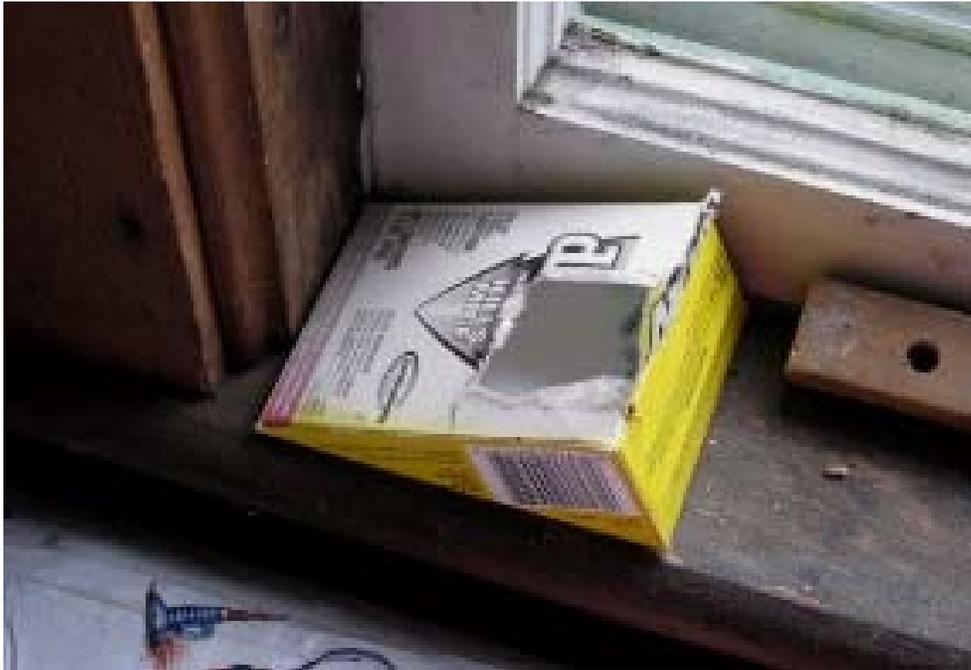
Picture 23

Nearly Empty Container of Rodent Bait

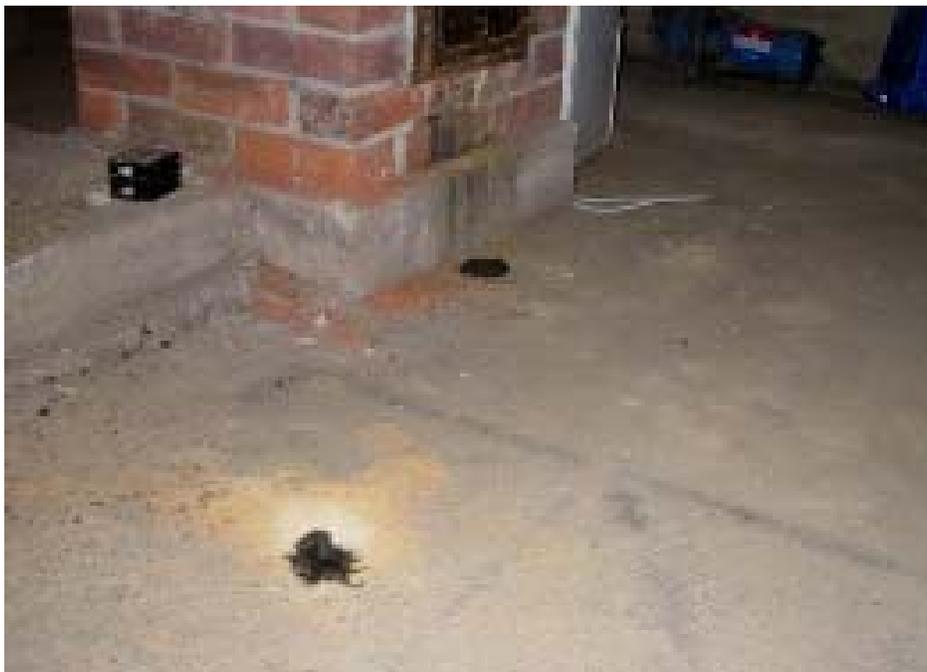
Picture 24

Rodent Carcasses in Basement

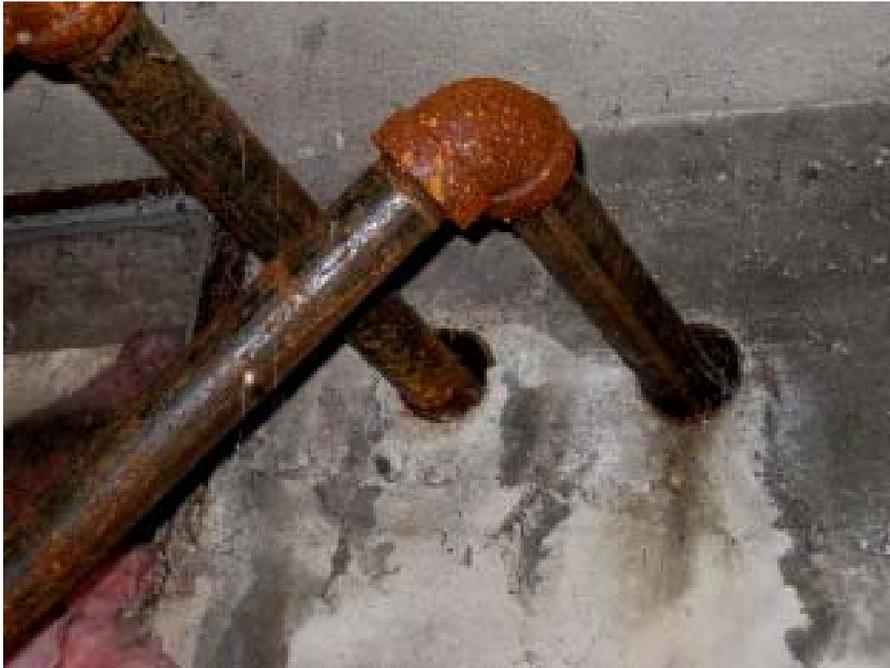
Picture 25

Open Utility Holes around Pipes

20. Seal numerous open utility holes throughout the building.
21. Ensure food products are stored in containers with tight-fitting lids.
22. Investigate purpose of the open duct in the attic. If it is not in use at the present time, it should be appropriately sealed.

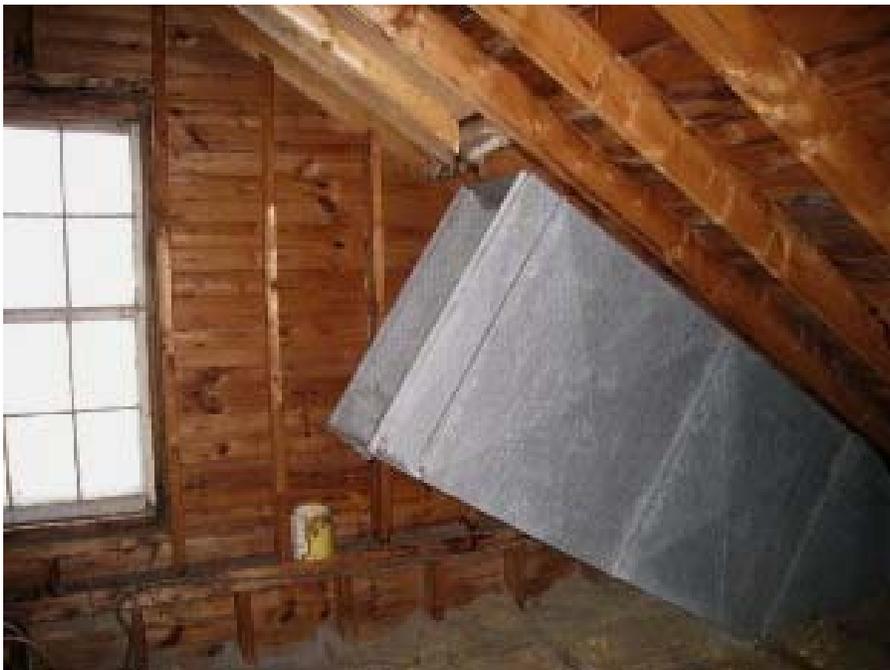
Picture 26

A large open duct was observed in the attic which appears to travel down through the

main floor at the back of the stage and which may be either part of the existing heating system or may possibly terminate in the crawlspace (Picture 26). The purpose of this duct should be investigated and identified. If it is a duct that has been abandoned, then it should be appropriately sealed.

Open Duct in Attic

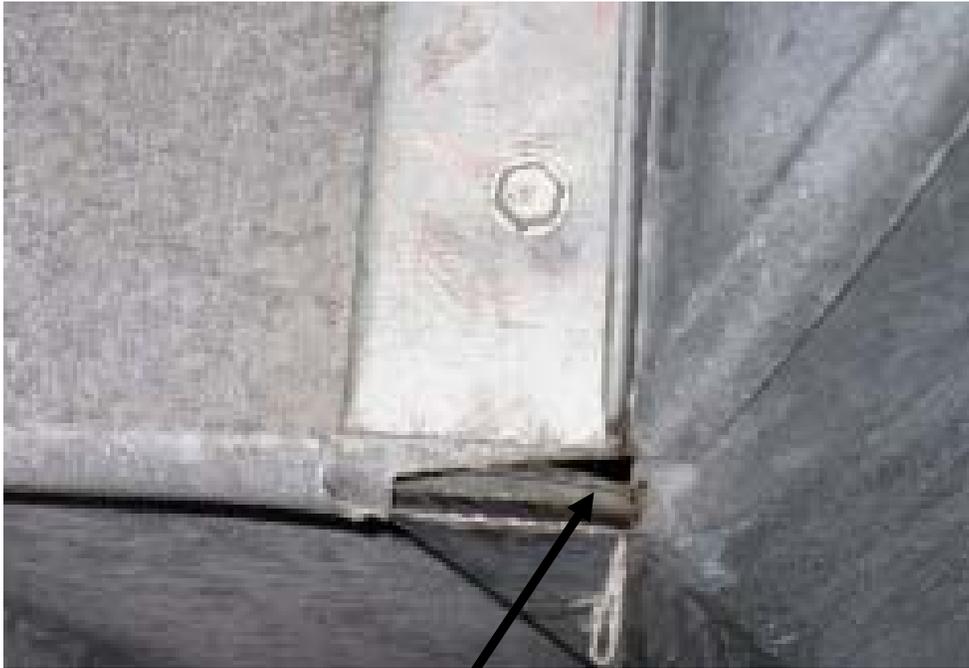
Picture 27

Breaches were observed in basement ducts (Picture 27). They should be sealed with appropriate sealant in order to increase the efficiency of the heating system and to eliminate the possibility of entrainment of particulates from the basement and distribution to the occupied space.

Breach in Duct

23. Seal breaches in heating ducts.
24. Seal seams/edges of linoleum floor in kitchen to prevent moisture infiltration.
25. Determine composition of damaged floor tiles. If found to contain asbestos, remediate damaged floor tiles in conformance with Massachusetts asbestos remediation and hazardous waste disposal laws (MDLI, 1993).

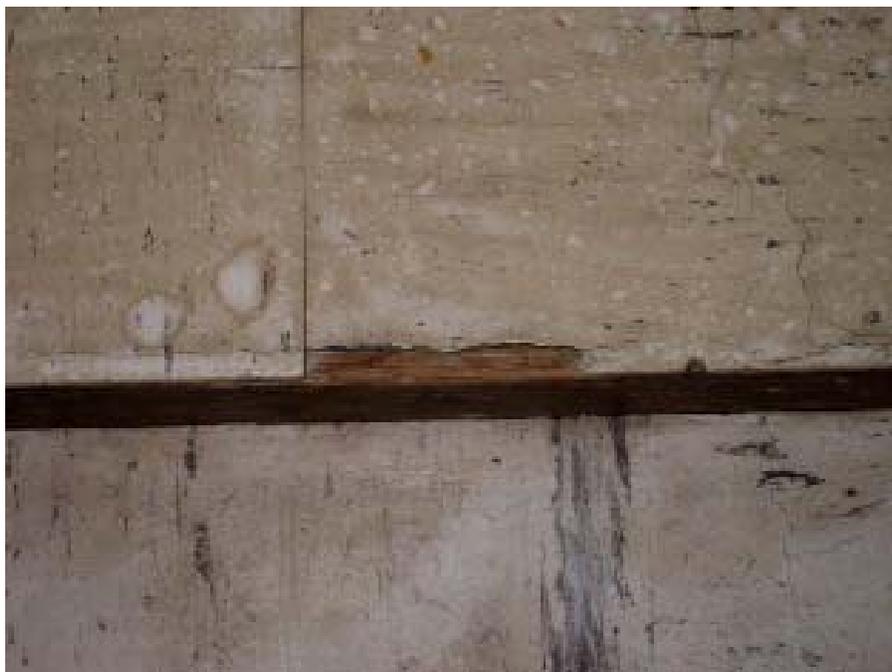
Picture 28

Damaged floor tiles were observed in some areas (Picture 28). These floor tiles may contain asbestos. Intact asbestos-containing materials do not pose a health hazard. If damaged, asbestos-containing materials can be rendered friable and become aerosolized. Friable asbestos is a chronic (long-term) health hazard, but will not produce acute (short-term) health effects (e.g., headaches) typically associated with buildings believed to have indoor air quality problems. Where asbestos-containing materials are found damaged, these materials should be removed or remediated in a manner consistent with Massachusetts asbestos remediation laws (MDLI, 1993).

Cracked, Broken Floor Tile
