INDOOR AIR QUALITY ASSESSMENT

**Massachusetts Department of Environmental Protection
Central Regional Office, 627 Main Street
Worcester, Massachusetts**

Prepared by:
Massachusetts Department of Public Health
Bureau of Environmental Health
Indoor Air Quality Program
June 2010

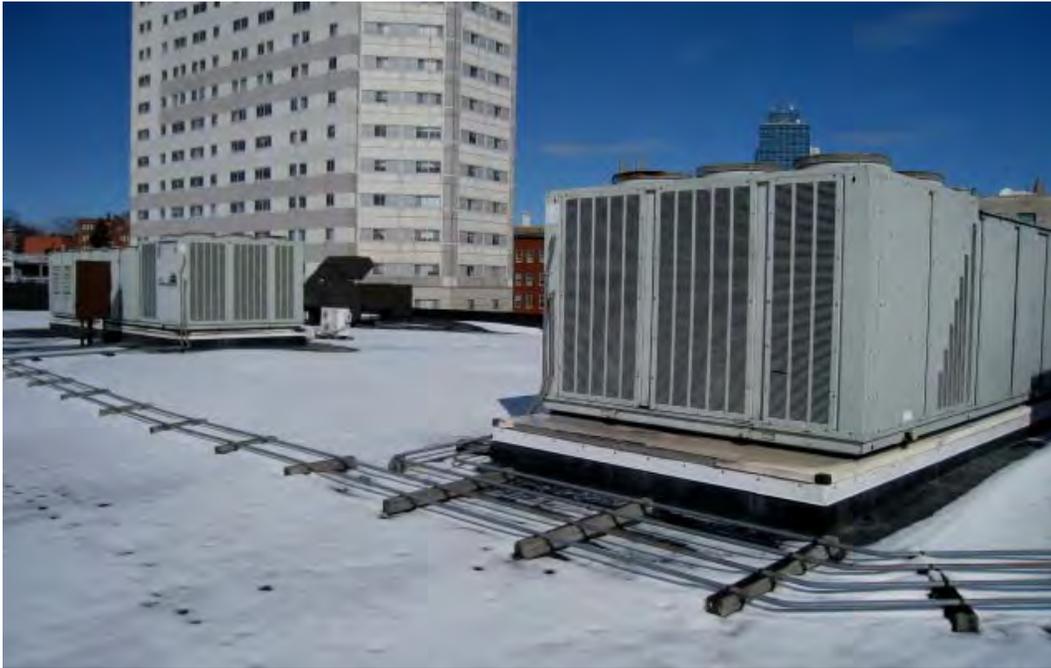
Picture 1

It can be seen from Table 1 that carbon dioxide levels were below 800 parts per million (ppm) in all areas surveyed, indicating adequate air exchange throughout the building at the time of the assessment. The heating, ventilation and air conditioning (HVAC) system, is a computer controlled system consisting of a two large rooftop air handling units (AHUs) (Picture 1). Rooftop units draw fresh outside air in through a bank of pleated filters (Picture 2), which are reportedly changed 3 times a year. AHU filters appeared clean at the time of the assessment. The air is heated/cooled and ducted to a series of variable air volume (VAV) boxes, which control temperature/airflow at remote locations throughout the building. Fresh air is distributed via ceiling or wall-mounted air diffusers (Pictures 3 and 4). Exhaust air is drawn into the ceiling plenum via grates and returned back to the AHUs via ductwork (Picture 5).

Rooftop Air Handling Units

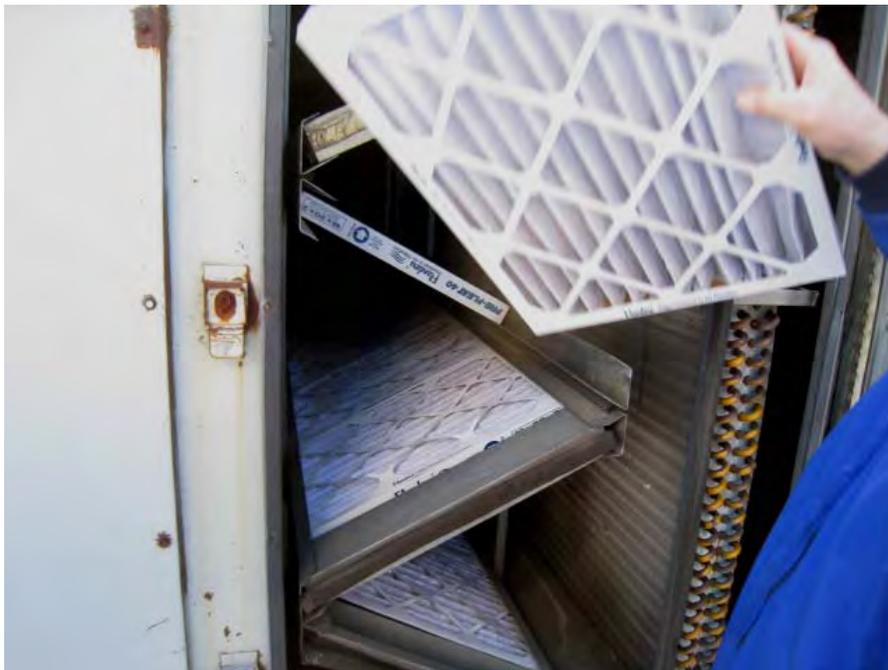
Picture 2

Pleated Filters Installed in Rooftop Air Handling Units

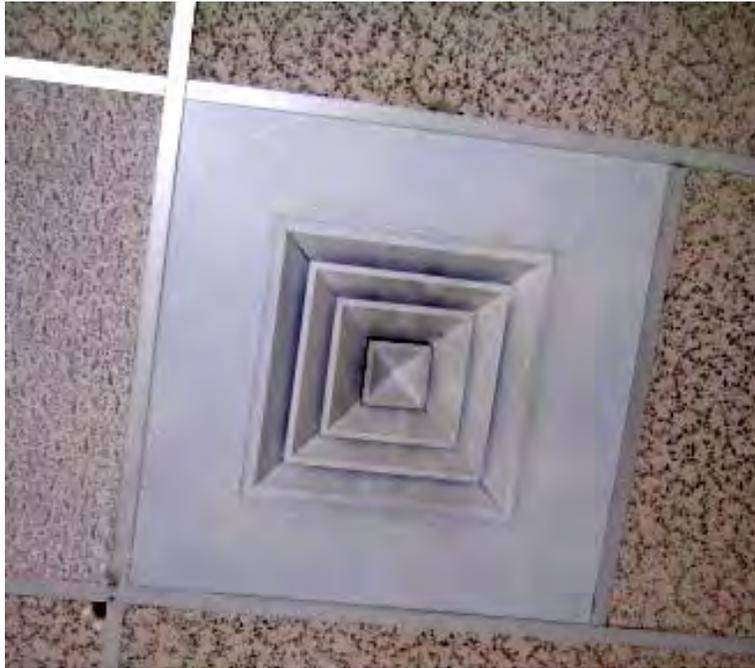
Picture 3

Ceiling-Mounted Supply Diffuser

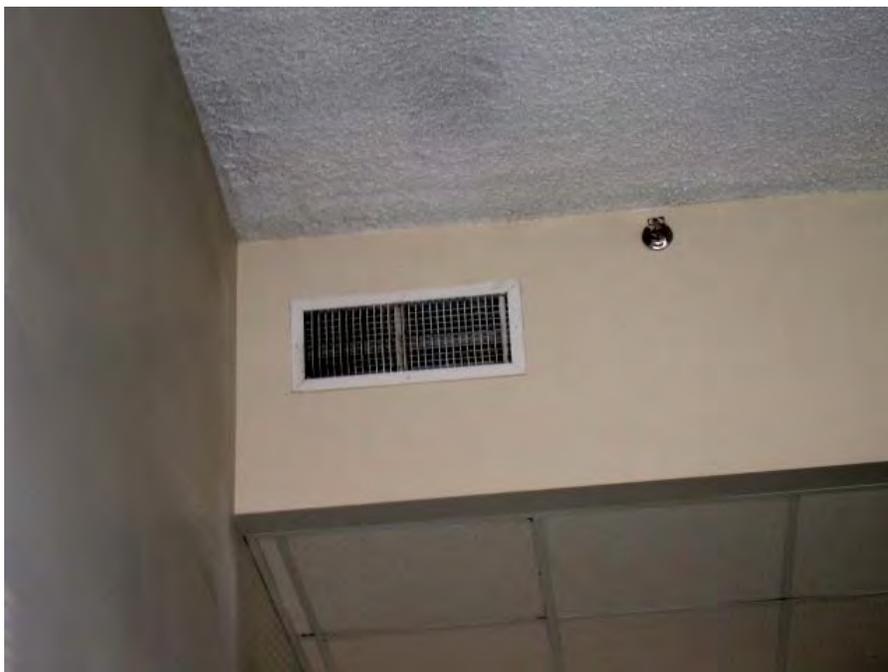
Picture 4

Wall-Mounted Supply Diffuser

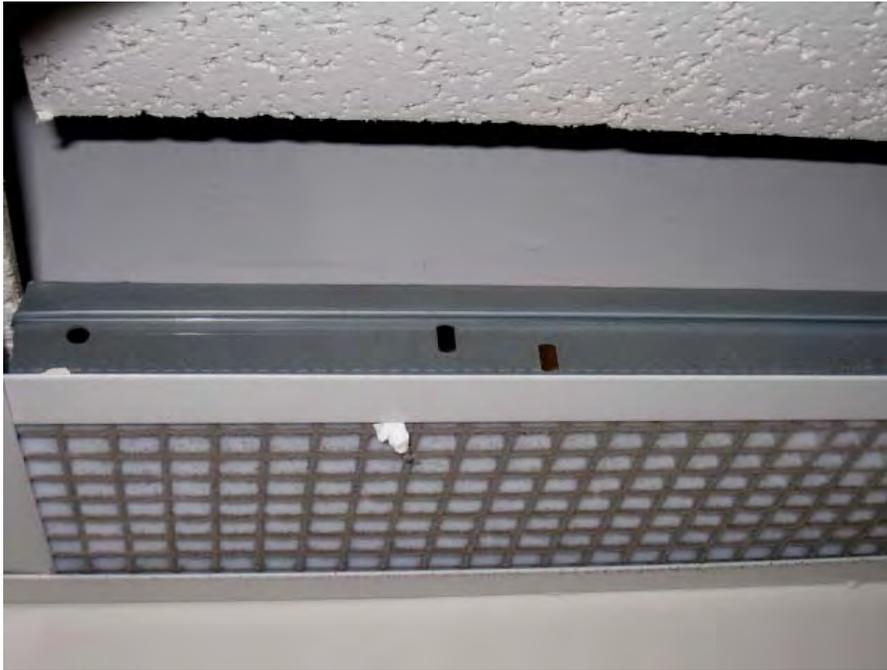
Picture 5

Ceiling-Mounted Return Grill

9. Clean supply, exhaust and return vents periodically of accumulated dust.
10. Replace all covers for fluorescent light fixtures.
11. Refer to resource manuals and other related indoor air quality documents for further building-wide evaluations and advice on maintaining public buildings. Copies of these materials are located on the MDPH's website: <http://mass.gov/dph/iaq>.

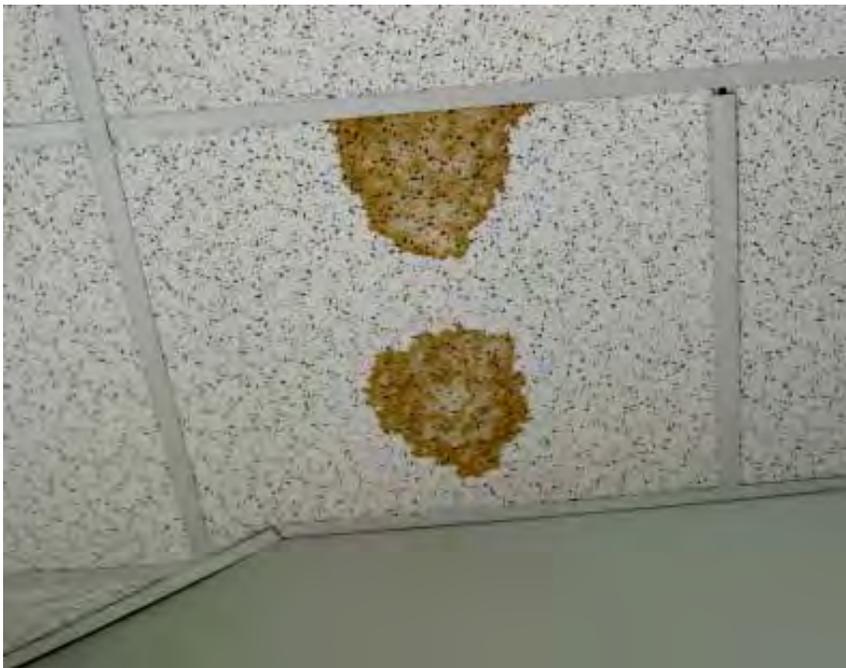
Picture 6

In order for building materials to support mold growth, a source of water exposure is necessary. Water-damaged ceiling tiles were observed in several areas (Pictures 6 and 7/Table 1). Water damaged tiles in the 1st floor men's room, reportedly resulted from a flooding event in the 2nd floor kitchen. Water damaged ceiling tiles can provide a source of mold and should be replaced after a leak is discovered and repaired.

Water Damaged Ceiling Tiles

5. Ensure (roof/plumbing) leaks are repaired and replace water damaged ceiling tiles. Examine the area above and around these areas for mold growth. Disinfect areas of water leaks with an appropriate antimicrobial.

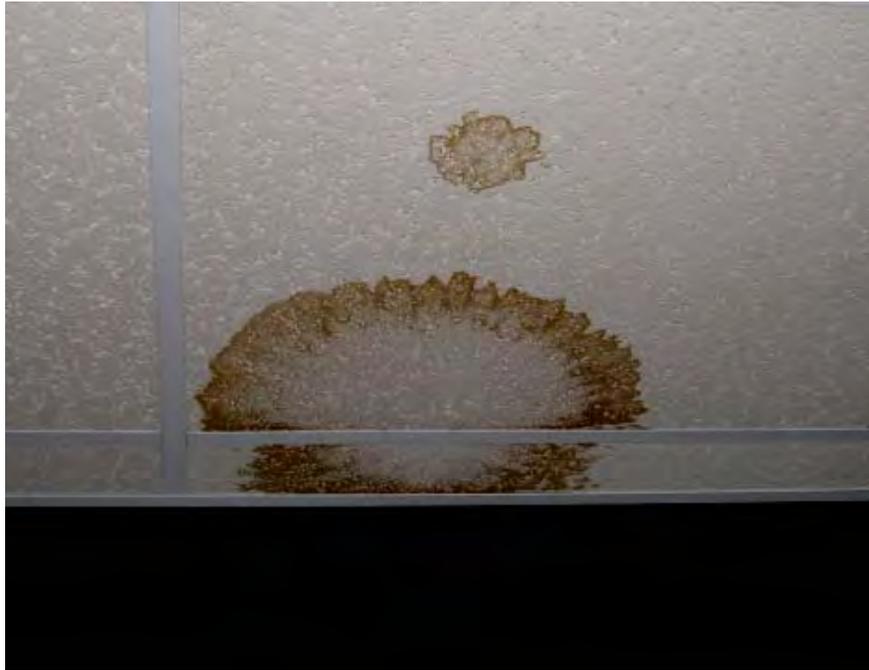
Picture 7

Water Damaged Ceiling Tiles in 1st Floor Men's Room

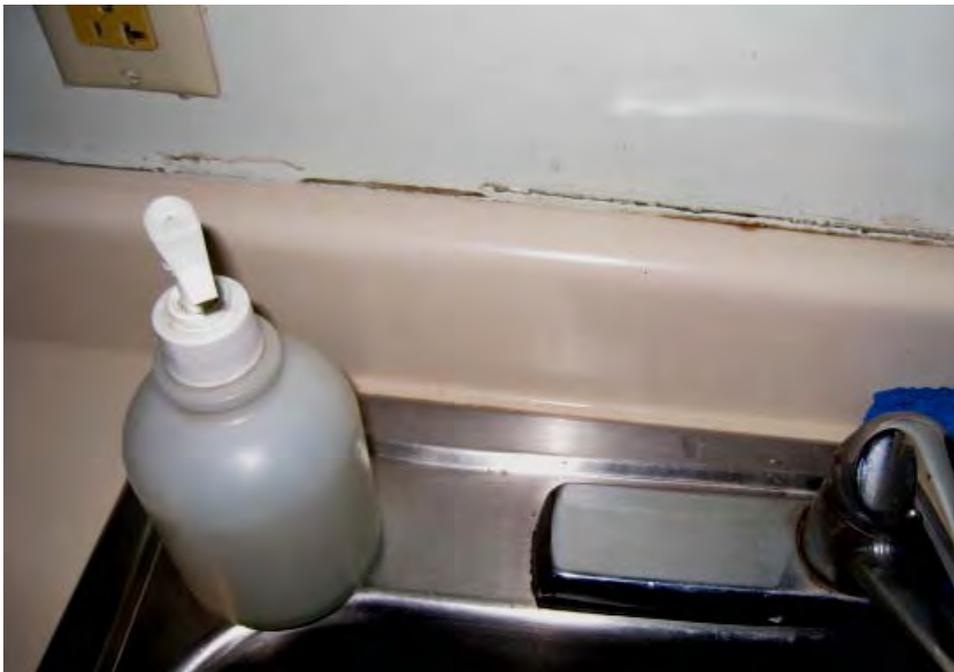
Picture 8

An open seam between the sink backsplash and wall was observed in the 2nd floor kitchen (Picture 8). If not watertight, water can penetrate through the seam, causing damage. Improper drainage or sink overflow can lead to water penetration into the countertop, cabinet interiors and areas behind cabinets. Water penetration and chronic exposure of porous and wood-based materials can cause these materials to swell and show signs of water damage. Repeated moistening of porous materials can result in mold growth.

Space between Sink Backsplash and Wall in 2nd Floor Kitchen

7. Seal areas around sink in kitchen to prevent water damage to the interior of cabinets and adjacent wallboard.
8. Relocate or consider reducing the amount of materials stored in offices, work stations and common areas to allow for more thorough cleaning. Clean items regularly with a wet cloth or sponge to prevent excessive dust build-up.

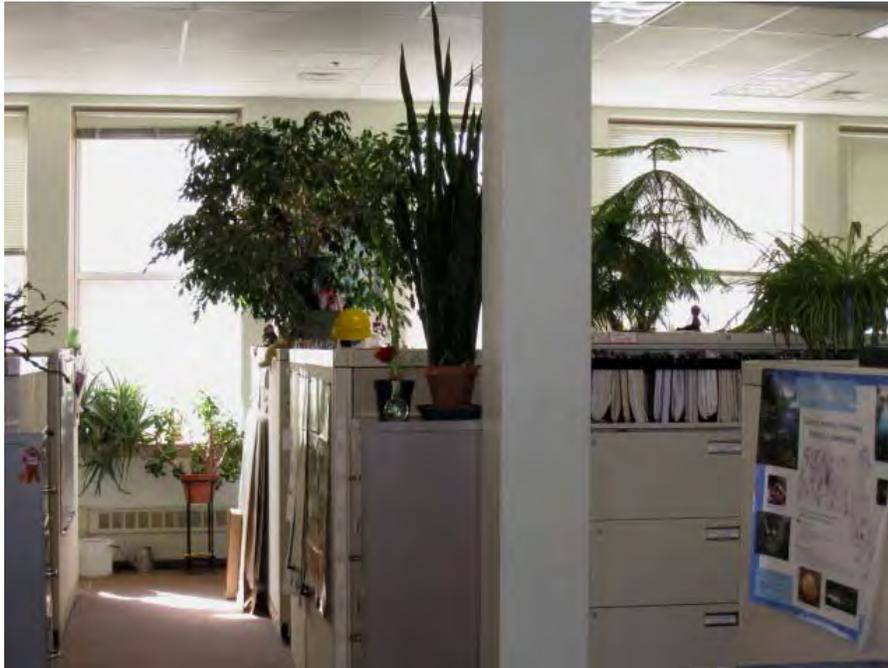
Picture 9

Plants were noted in several areas (Picture 9/Table 1). Plants should be properly maintained and equipped with drip pans. Plants should be located away from ventilation sources to prevent aerosolization of dirt, pollen or mold. Plants should also not be placed on porous materials (Picture 10), since water damage to porous materials may lead to microbial growth.

Plants in Cubicle Areas

6. Ensure plants have drip pans and avoid over-watering. Examine drip pans periodically for mold growth. Disinfect with an appropriate antimicrobial where necessary. Remove plants from porous materials, discard if moldy.

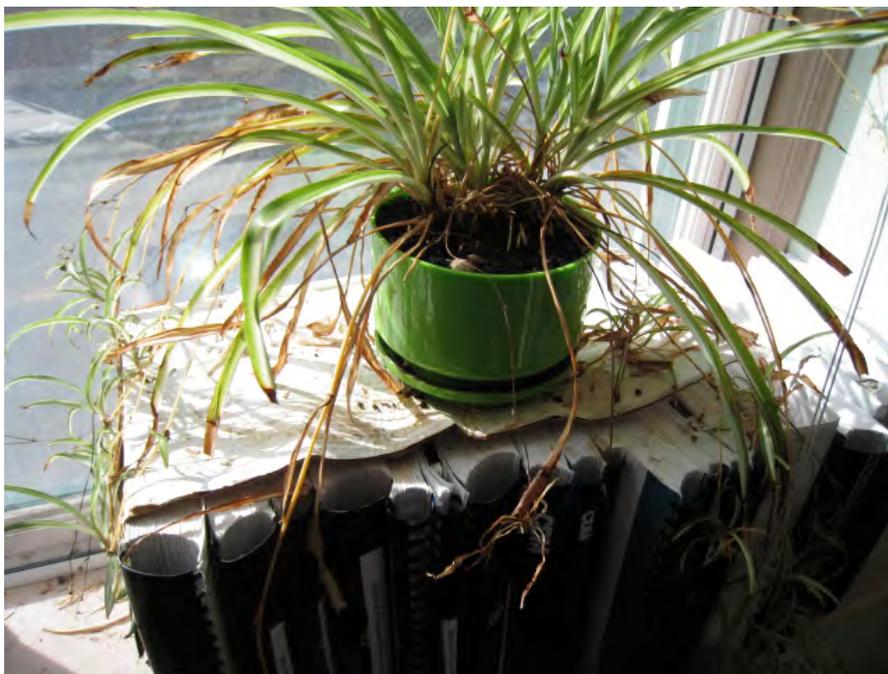
Picture 10

Plants on Porous Materials

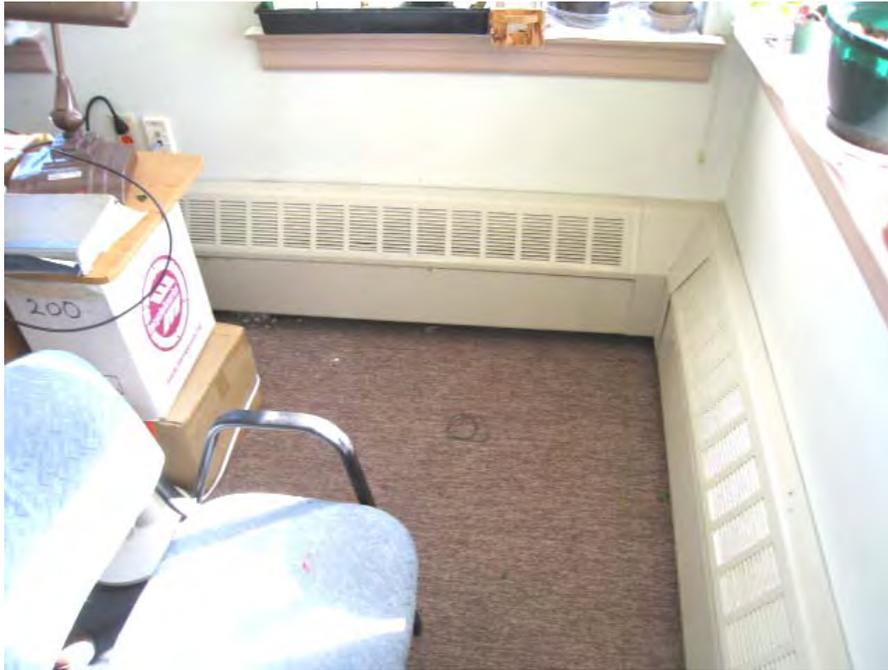
Picture 11

During the course of the assessment a CERO employee reported that the suspect odor was detectable along the baseboard of the exterior wall of work area 200. Although no obvious source of leaks was observed, a distinguishable sweet, maple-like odor was identified along the floor/baseboard in this area. Immediately above the baseboard is a large radiator style heating

unit (Pictures 11 and 12), that appears to operate separate from the HVAC system. It is likely that this radiator system predates the installation of the HVAC system in the building.

Each of these concepts has influence on the movement of odors from radiators into adjacent areas. In subsequent correspondence with building management, it was reported that a propylene glycol-based antifreeze/coolant had been added to the boiler system most recently in December, 2009, which roughly coincides with reports of maple odor in the office space (MDEP, 2010).

Baseboard Heating Elements in Work Area 200

1. Examine the necessity of adding propylene glycol to a heating system that has likely operated without such an additive during its operational lifespan. If necessary, have propylene glycol drained from the system.

2. Remove covers to baseboard heating units in areas where odors typically occur (e.g., 200) and thoroughly examine pipes/fixtures for leakage and/or evidence of leakage in the form of residual fluid or staining. Make repairs and conduct cleaning as necessary. Consider contacting a licensed plumber or HVAC technician to inspect/test for leaks throughout the building.

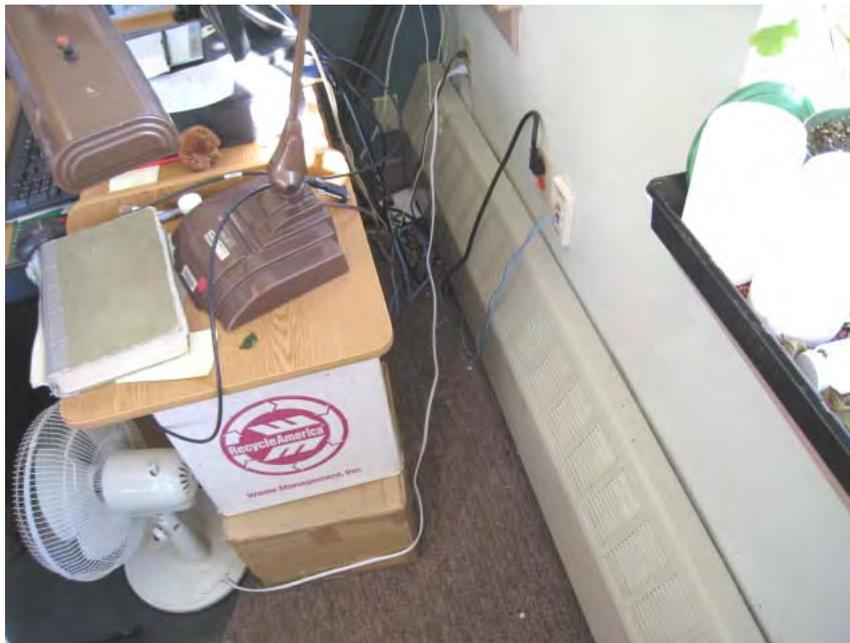
Picture 12

Baseboard Heating Elements in Work Area 200, From Which the Maple Smell Originated

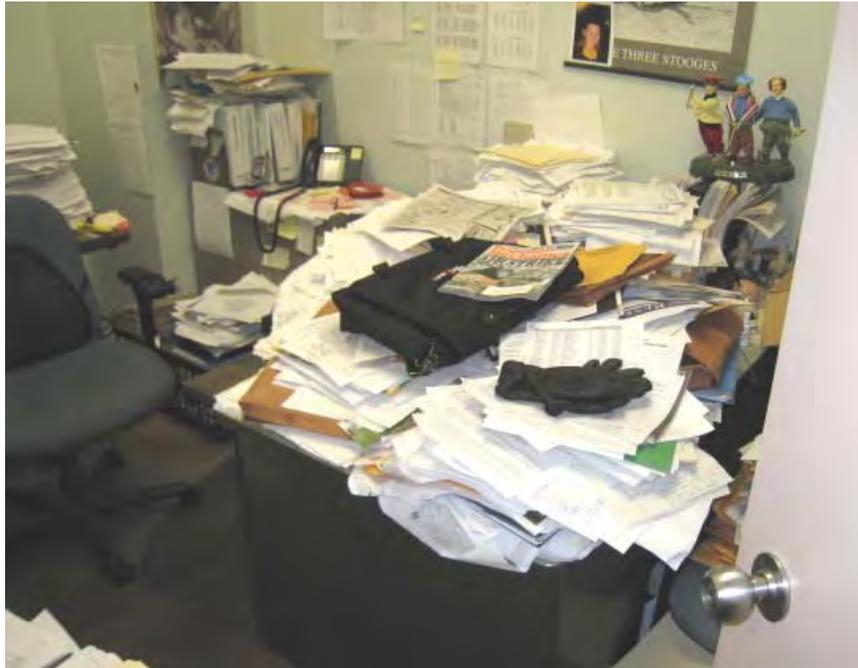
Picture 13

Other conditions that can affect indoor air quality were observed during the assessment. In several areas, items were observed on windowsills, tabletops, counters, bookcases and desks (Picture 13). The large number of items stored provides a source for dusts to accumulate. These items (e.g., papers, folders, boxes) make it difficult for maintenance staff to clean. Items should be relocated and/or be cleaned periodically to avoid excessive dust build up.

Accumulated Items on Flat Surfaces in Office

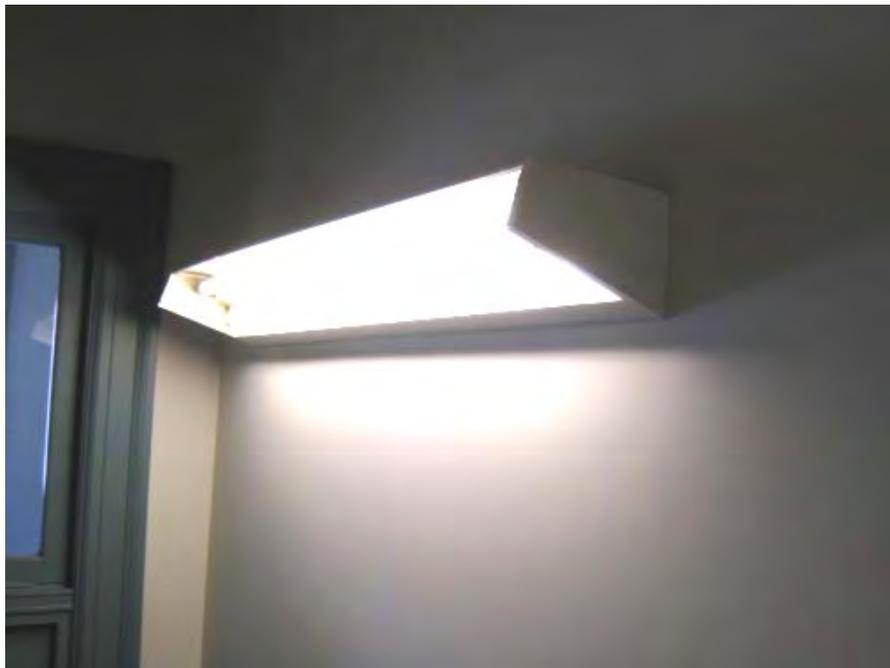
Picture 14

Finally, fluorescent light fixtures were missing covers in stairwells (Picture 14). Fixtures should be equipped with access covers installed with bulbs fully secured in their sockets. Breakage of glass can cause injuries and may release mercury and/or other hazardous compounds.

Fluorescent Light Fixture Missing Cover in Stairwell
