# **INDOOR AIR QUALITY ASSESSMENT**

**University of Massachusetts Amherst  
Health Services Building  
150 Infirmary Way  
Amherst, Massachusetts**

Prepared by:  
Massachusetts Department of Public Health  
Bureau of Environmental Health  
Indoor Air Quality Program  
November 2011

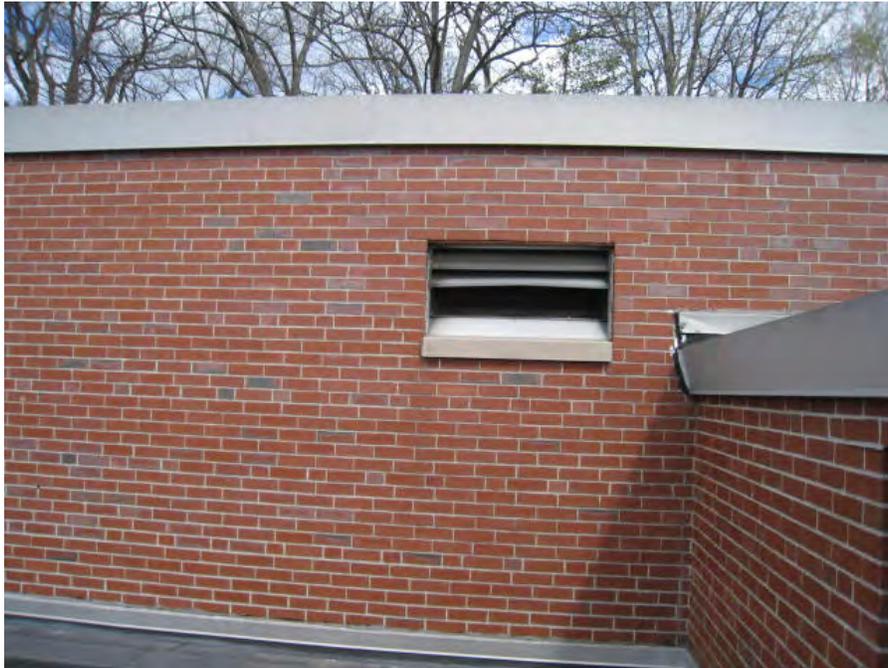
**Picture 1**

**4<sup>th</sup> Floor Penthouse Housing AHUs for 1960s Portion**

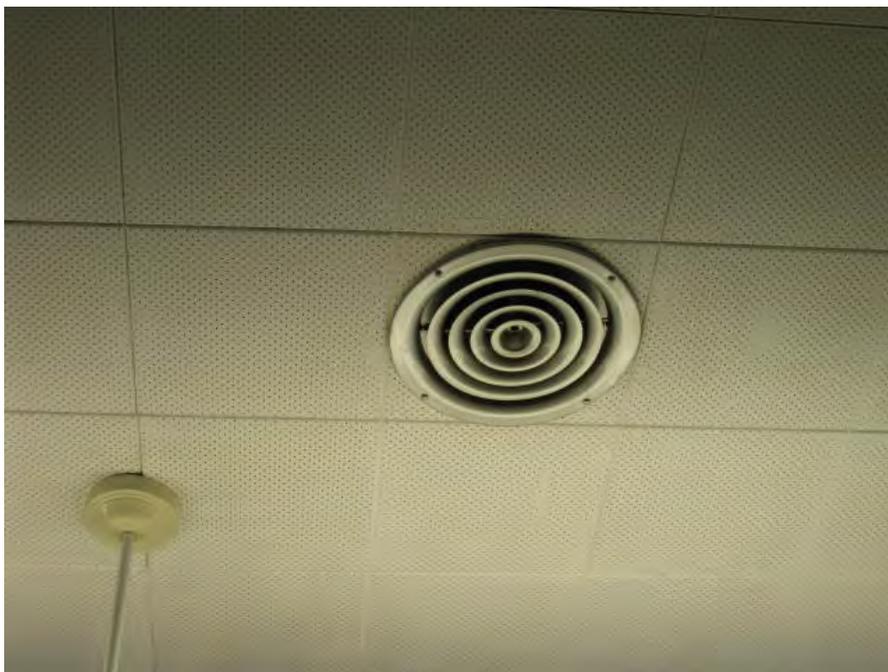
**Picture 2**

areas via individual supply vents (Picture 2). The ductwork, vents and pneumatic controls are reportedly original to the building and thus are greater than 50 years old.

**Supply Vent in the 1960s Section**

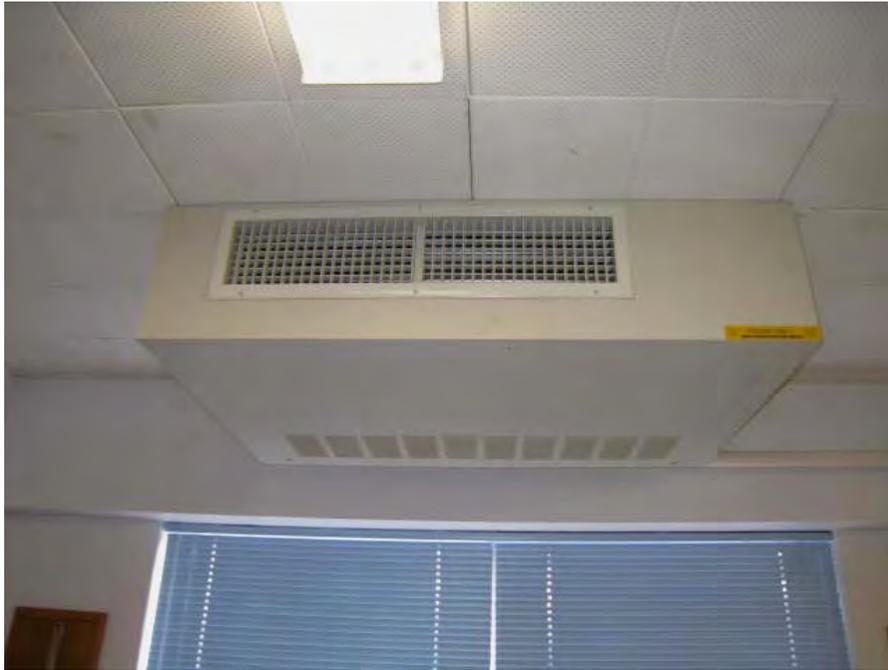
**Picture 3**

Additional heating in this section of the building is provided by radiant metal ceiling tiles and supplemental equipment (Picture 3) using steam originating from the central campus steam plant. Cooling in this area is provided by individual window air conditioners (Picture 4) and ceiling-hung fan coil units (FCUs) installed during the 1970s construction of the new wing. FCUs do not provide fresh air to rooms; rather, FCUs re-circulate air and provide auxiliary heating and/or cooling. FCUs are adjusted individually via control knobs on the front of the units or via wall-mounted thermostats.

**Radiant Metal Ceiling Tiles and Fan Coil Unit (FCU)**

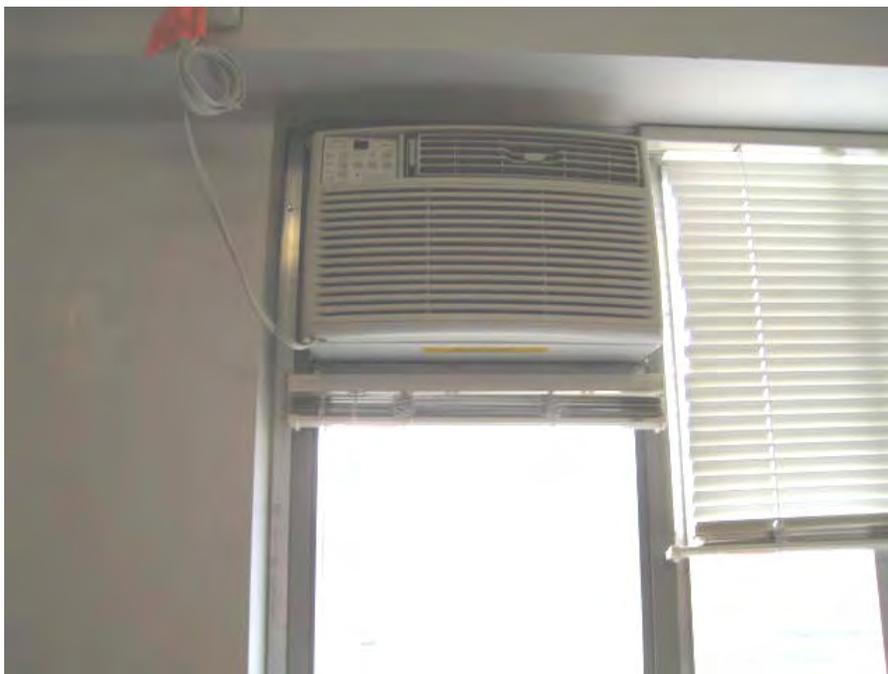
**Picture 4**

**One of the Types of Window Air Conditioners Used**

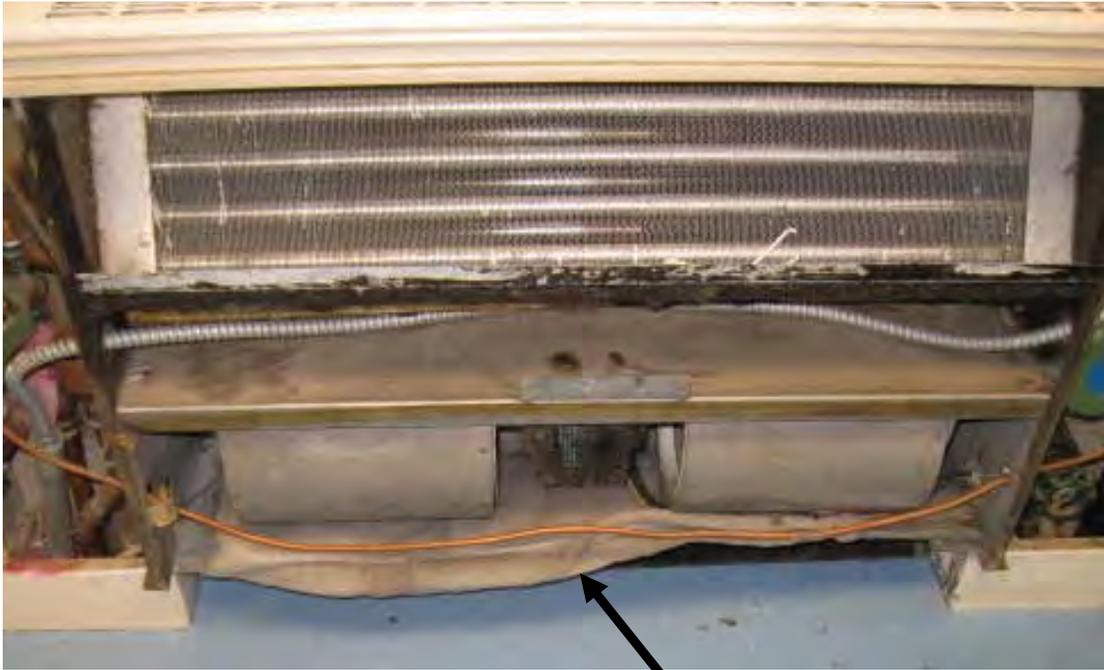
**Picture 5**

Air is drawn into a vent at the base of the FCU and is heated or cooled and provided to rooms by a diffuser on the side of the unit (Figure 1). These units are normally equipped with filters, which should be cleaned or changed as per the manufacturer's instructions to avoid the build-up and re-aerosolization of dirt, dust and particulate matter. Without proper filtration, the heating/cooling fins can become occluded with dust and debris, which can provide a mold growth media when moistened. In addition, poor filtration can accelerate the degradation of HVAC equipment by making the equipment work harder to draw air through clogged heating/cooling fins. Although filters were found in these units, they appeared to be of poor quality and poorly fitted (Picture 5).

**Poorly Fitted Filter in FCU**

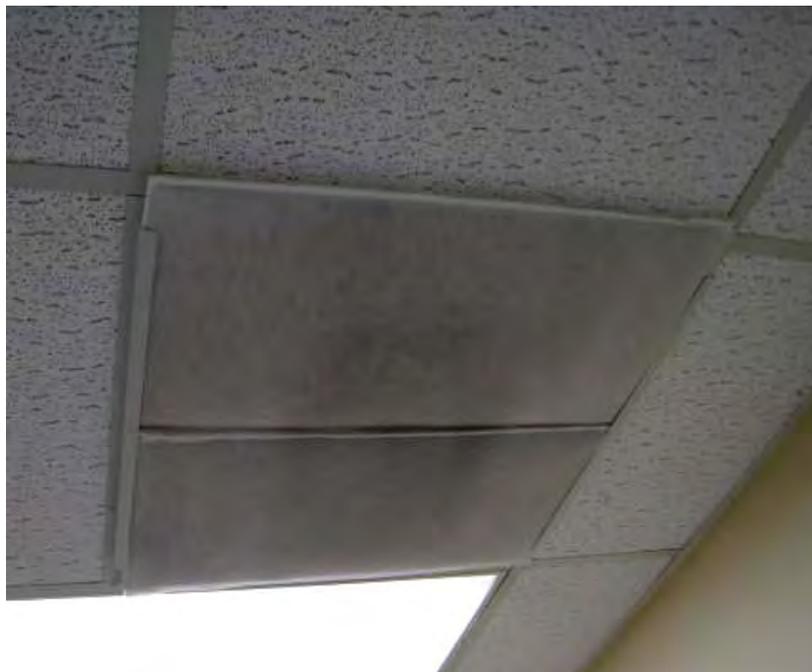
**Picture 6**

In the 1970s portion of the building, mechanical ventilation is provided by an HVAC unit located in the basement mechanical room, which draws in outside air via a cement-lined subterranean pit located on the west exterior wall of the building (Map 1). Outside air is filtered, conditioned (heated or cooled), and distributed via ducted supply vents. Many of these supply vents were found to be covered with a white filter-type material (Picture 6). As mentioned, the

**Filter Material Covering Supply Vent in General Medicine Area  
(Note Dirt on Material)**

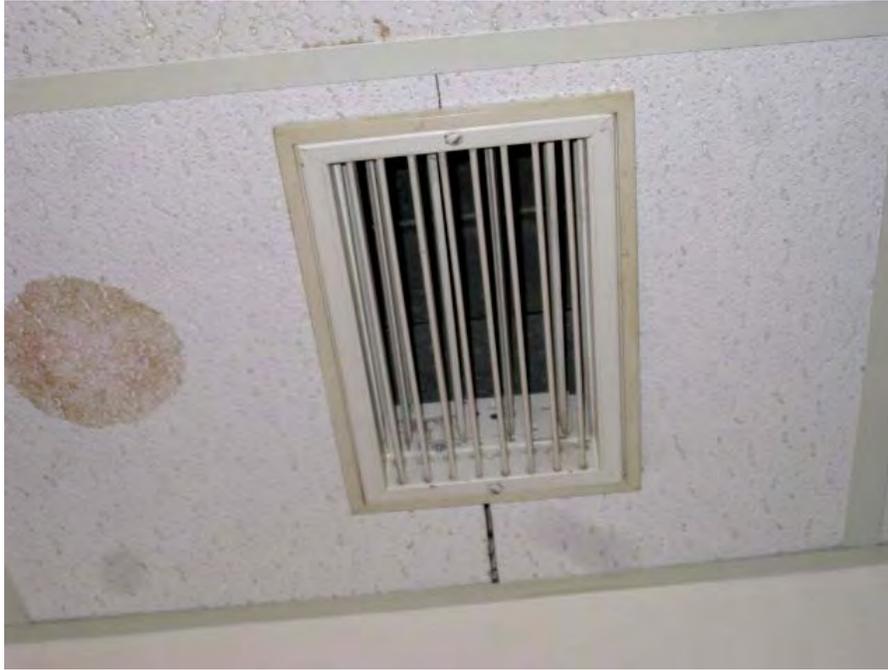
**Picture 7**

The HSB appears to have a significant problem with water damage to interior components of the building. Evidence of water damage and mold colonization were observed throughout the HSB, including water-damaged ceiling tiles (Picture 7), stained carpets and filters inside FCUs. In order for mold to colonize these materials, chronic exposure to moisture must occur.

**Water-Damaged Ceiling Tile**

3. Remove mold-colonized and water-damaged building materials (e.g., pipe insulation, ceiling tiles, gypsum wallboard and carpeting under FCUs) in a manner consistent with *Mold Remediation in Schools and Commercial Buildings* published by the US Environmental Protection Agency (US EPA) (US EPA, 2001). Copies of this document can be downloaded from the US EPA website at:  
[http://www.epa.gov/iaq/molds/mold\\_remediation.html](http://www.epa.gov/iaq/molds/mold_remediation.html).

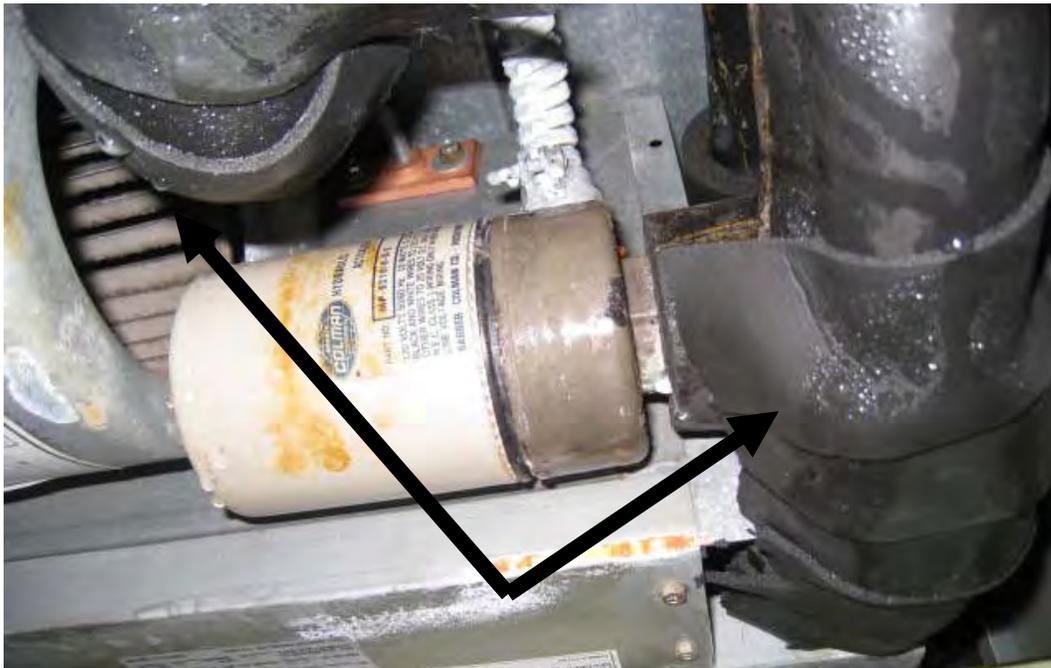
**Picture 8**

**Water Droplets due to Condensation between Insulation Sections**

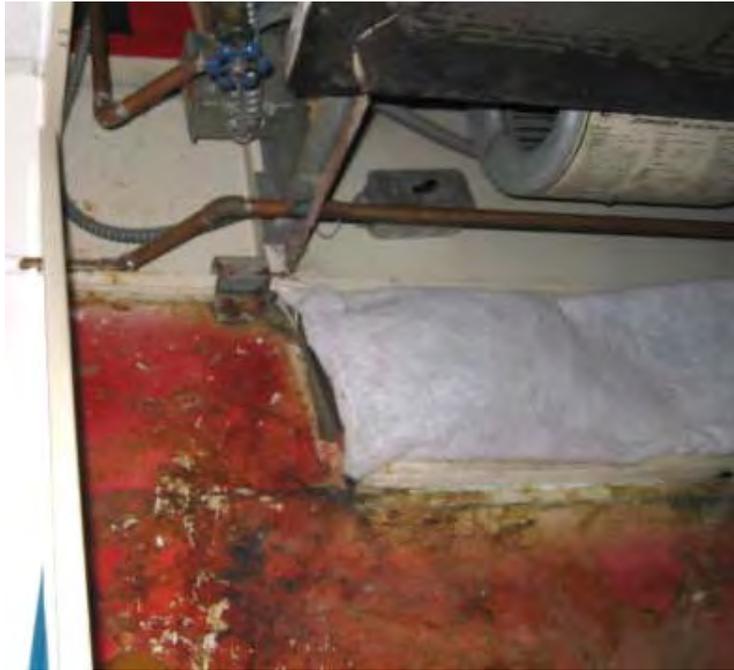
**Picture 9**

BEH staff examined ceiling mounted FCUs which were found to have signs of significant and repeated water damage to the interior of their cabinets (Picture 9). During both the July 29, 2011, and September 30, 2011, visits BEH staff opened FCUs which had standing water inside due to condensation from inadequately insulated pipes. This resulted in wet filters that were found in a number of FCUs. Repeated water damage can lead to mold growth inside the FCUs and on filters. Standing water was noted in the drip pans of some FCUs, indicating both poor drainage and likely insufficient capacity to drain condensation (Picture 10). Inadequately draining drip pans may also serve as a source of microbial/bacterial growth and associated odors.

**Moisture Damage to FCU Cabinet**

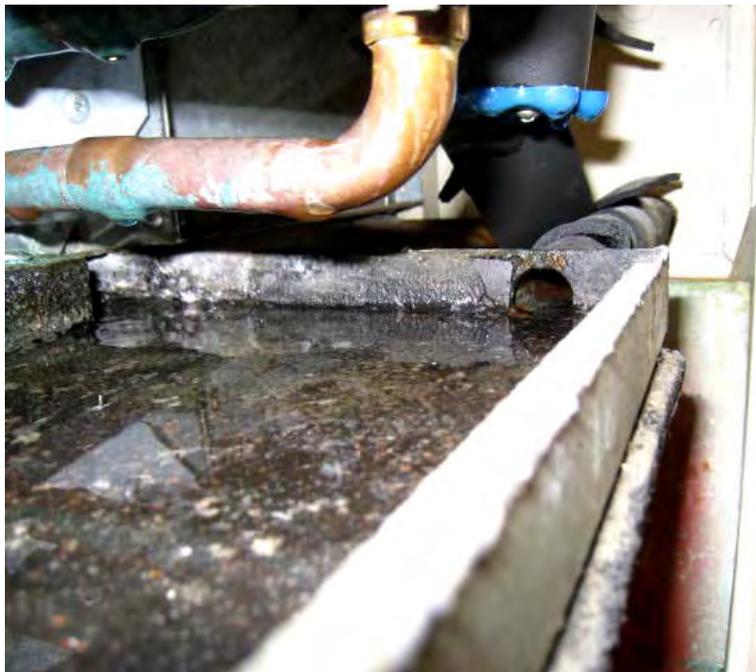
**Picture 10**

**FCU Drip Pan Filled With Water**

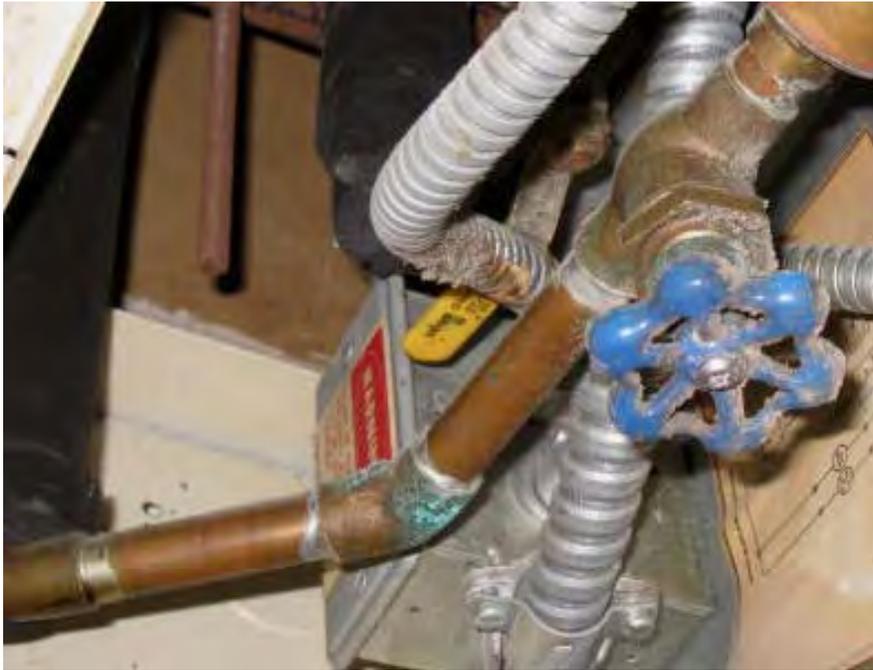
**Picture 11**

building and/or the lack of maintenance of the HVAC system. As previously mentioned, the UMA has a steam plant that supplies heat to campus buildings, including the HSB. It is customary to use either steel-fitted pipes or brazed copper pipes. Solder joints can be used if the steam provided to the building has a pressure less than 15 pounds per square inch and a temperature of 250° F (CDA, 2011). If the pressure or temperature parameters are exceeded, leaks can develop due to different rates of expansion between the copper and solder. Joints in FCUs examined appeared to have soldered joints (Picture 11), which may explain the proliferation of leaks throughout the HSB.

**FCUs Appeared to Have Soldered Joints**

1. Identify whether the heating system has proper joints for use in a steam-supplied heating system. If not, replacement of all leaking joints should be considered.

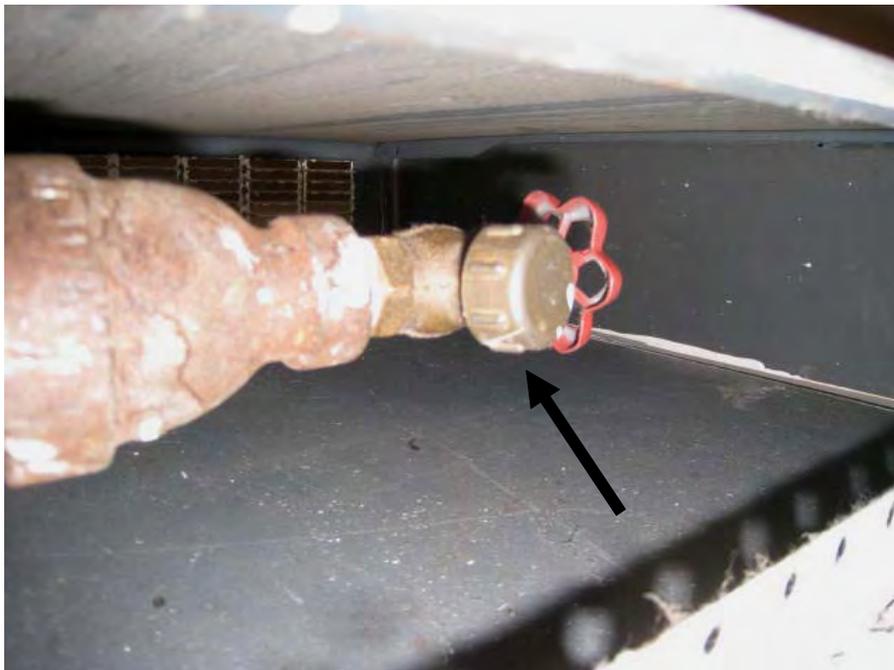
**Picture 12**

Another factor may be a lack of routine maintenance. The steam system may not be self-draining. This is likely due to the presence of stopcocks observed in radiators in the lowest part of the building (Picture 12). A non-self-draining system would require manual draining to prevent standing water in the system when the steam supply is turned off. Standing water should be drained from steam systems to prevent corrosion. Of note is the presence of red dye from a radiator leak, which may indicate that this heater may be *connected to the chilled water system* (Picture 13). Radiators should not be attached to the cooling system since chilling below the dew point can be a source of condensation.

**Stopcock on Radiator**

8. Drain the heating system as needed. This action should happen when the HVAC system switches between heating and cooling modes (twice a year). Inspect drain stopcocks and repair or replace as needed.

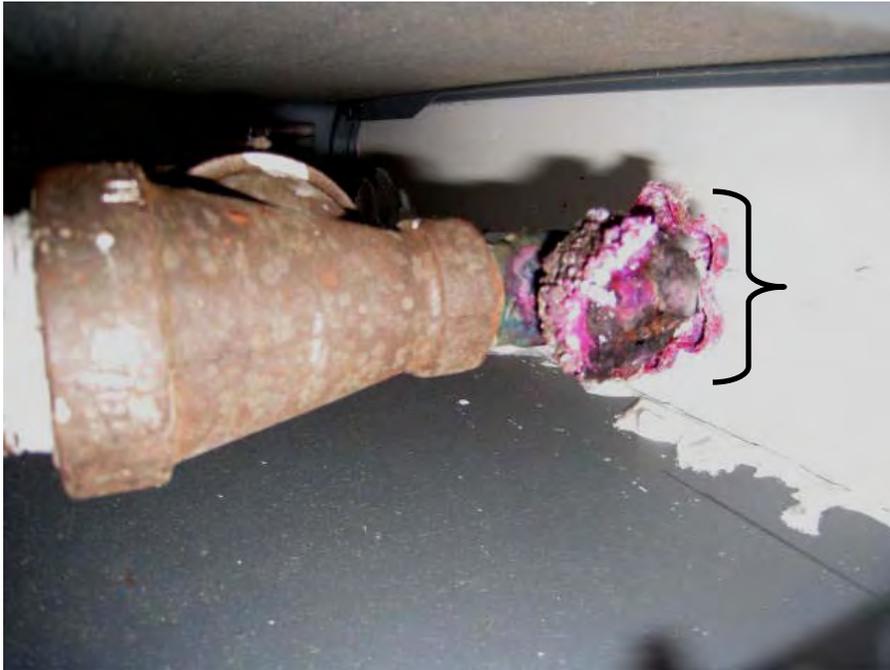
**Picture 13**

**Leaking Stopcock, Note Corrosion and Red Dye (highlighted by bracket)**

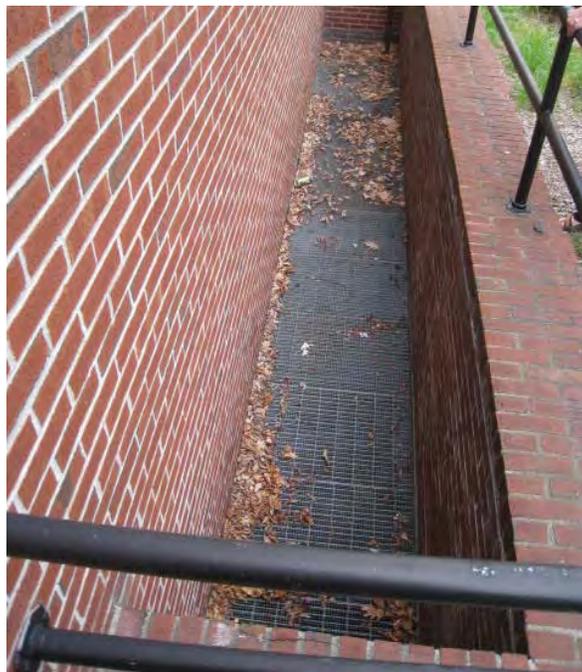
**Picture 14**

fresh air intakes for this section of the building are below grade, which allows the grills to be covered with leaves and other debris, inhibiting the draw of fresh air. In addition, this condition allows snow to accumulate during winter months, further blocking air intake and providing a source of moisture to be drawn into the building.

**Debris on Fresh Air Intake**

4. Repair drain in the floor of the 1975 mechanical room.
5. Routinely inspect and remove accumulated debris from the bird screen of the HVAC system subterranean pit.

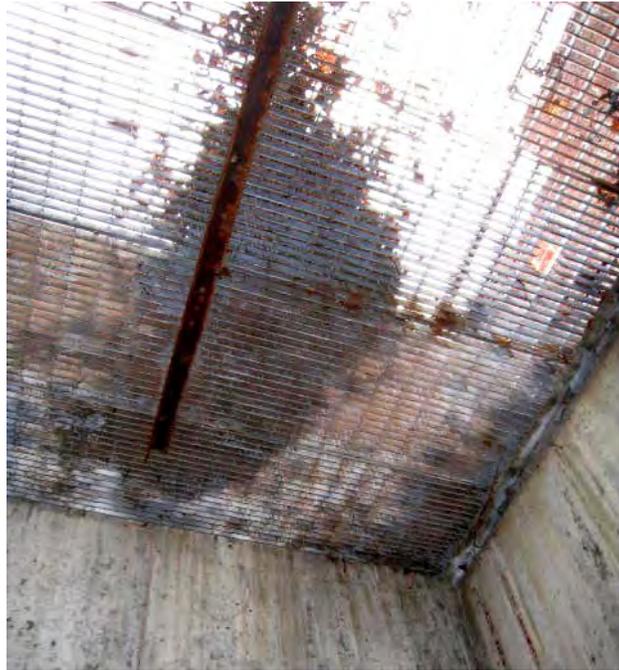
**Picture 15**

**Fresh Air Intake (Underside View)**

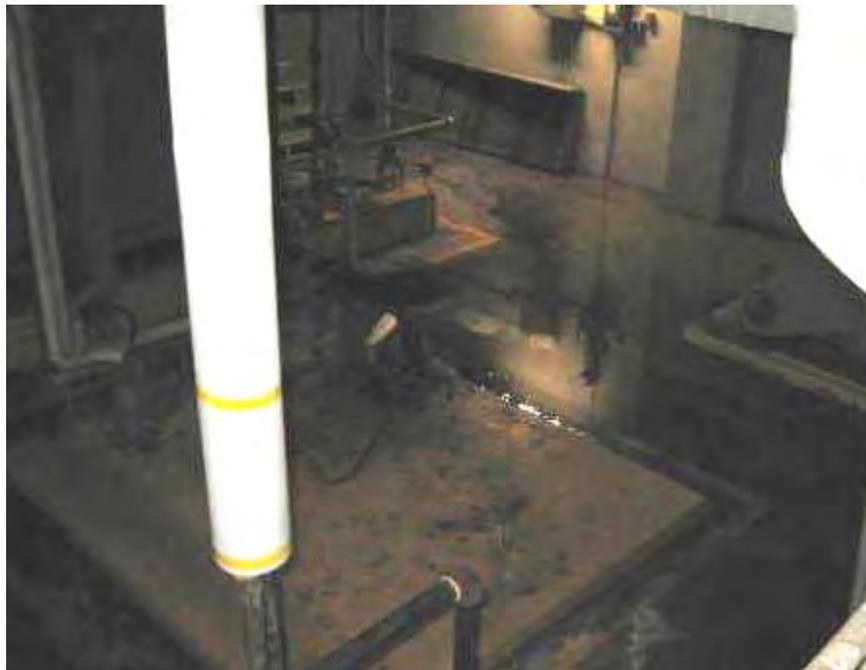
**Picture 16**

The floor of the mechanical room had standing water, due to a non-functioning floor drain (Picture 16). Water vapor from this pooling water can then be drawn into the HVAC system through breaches in the ductwork, such as one seen around an access door (Picture 17). Failure to drain water from the mechanical room floor and water vapor retention in the fresh air intake pit can lead to increased water vapor levels in the HSB.

**Flooded Mechanical Room Floor beneath HVAC Equipment**

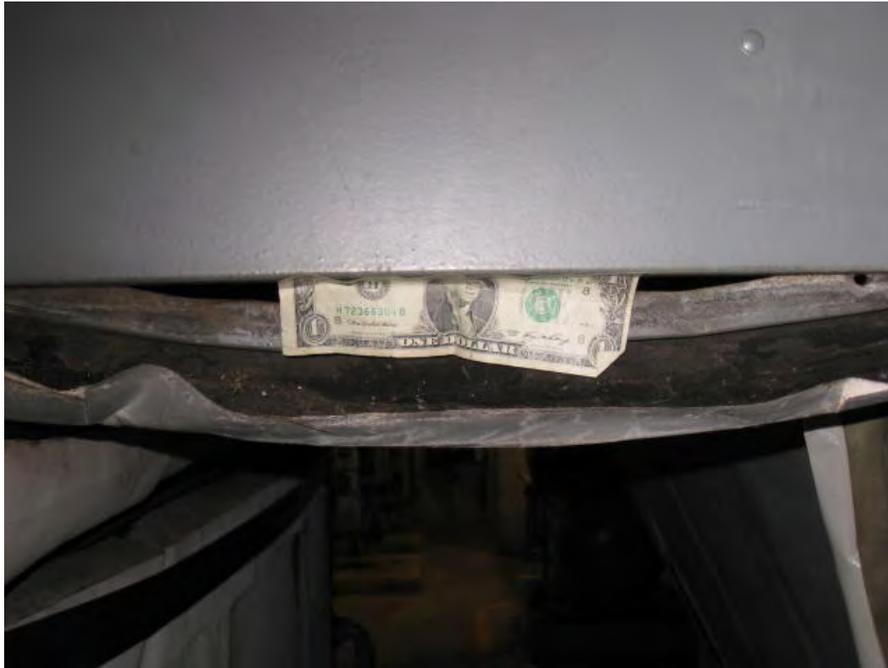
**Picture 17**

**Large Gap in AHU Ducting for the 1970s Section (Dollar Used to Depict Scale of Breach)**

13. Repair breaches identified in AHUs, fix any holes found around pipe penetrations, replace missing or damaged ceiling tiles, and close any other holes or penetrations allowing unwanted air exchange.

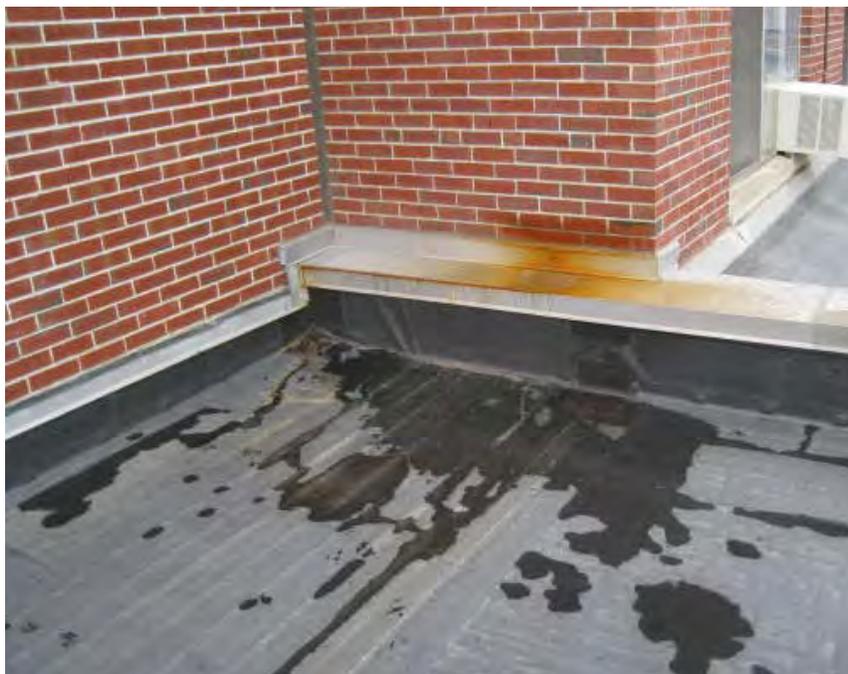
**Picture 18**

Water damage to ceiling tiles in the main lobby were attributed to roof leaks. The area of water damage occurs below the junction where the 1960s wing meets the 1970s wing (Picture 18). While the roof appears to be intact, the windowsills above this area have significant mortar erosion which can allow rainwater to penetrate into the exterior wall, bypassing the roof membrane (Picture 19). Since the roof is held in place by strapping with mortar bolts, no flashing or weep holes were installed in the 1960s wing wall to transfer water from the brick wall interior onto the roof membrane. Without flashing and weep holes, moisture penetrating the brick cannot exit the building envelope, and therefore can cause water damage to ceiling tiles in the main lobby. In addition, low points on the roof were identified by accumulation of plant debris (Pictures 20 and 21), which can hold moisture against the roof membrane causing damage in freezing temperatures.

**The Junction Where the 1960s Wing Meets the 1970s Wing**

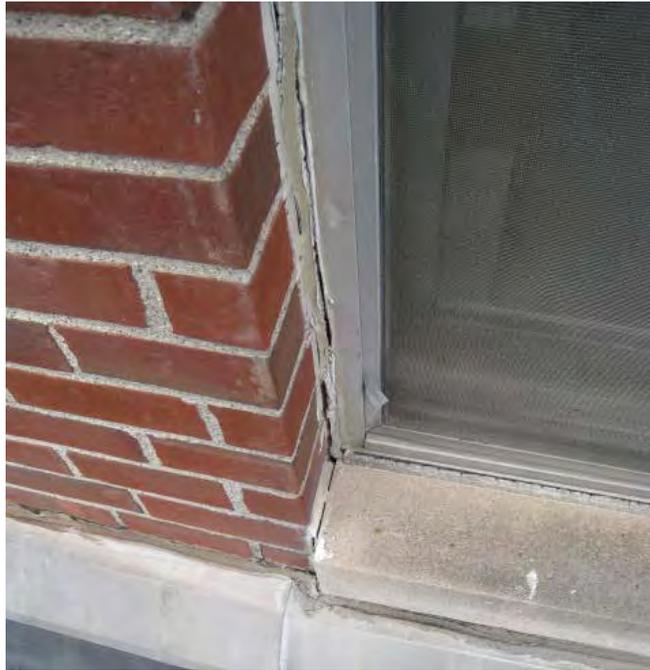
**Picture 19**

- Some windows and sills were reported to leak during heavy rain events. Damaged windowsills and related flashing were found during the investigation (Pictures 19 and 23).

**Cracks around Sills and Window Frame**

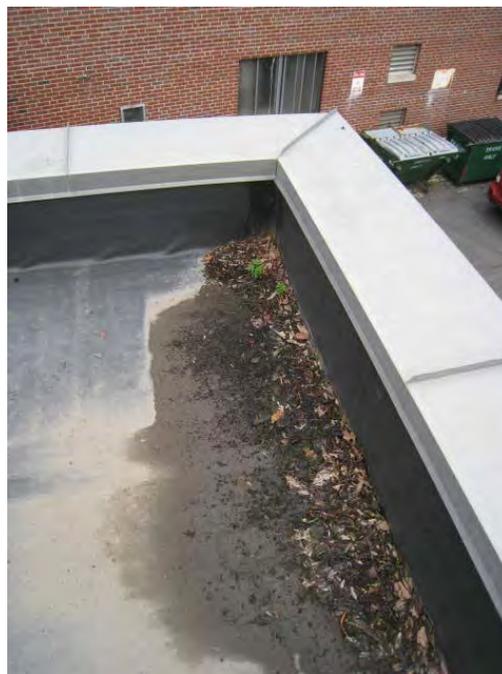
**Picture 20**

**Debris on Roof**

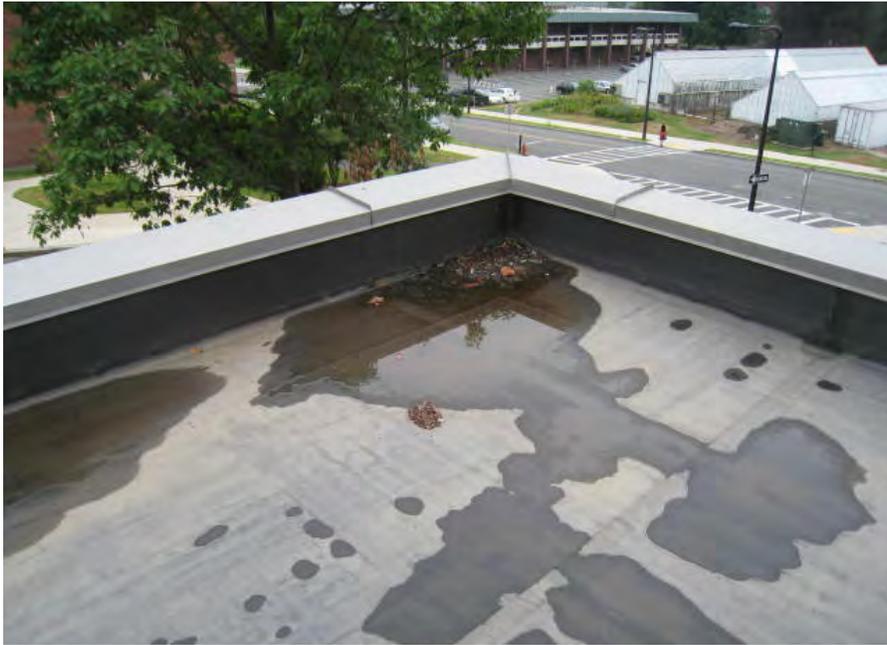
**Picture 21**

- Roof leaks were reported and water was noted pooling in areas on the roof (Picture 21).
- During a period of heavy rain prior to one of the BEH visits, the back door of the pharmacy area was reportedly forced open by a flood of water causing significant water damage. Although evidence of water damage had been repaired, conditions along the

**Additional Debris on Roof**

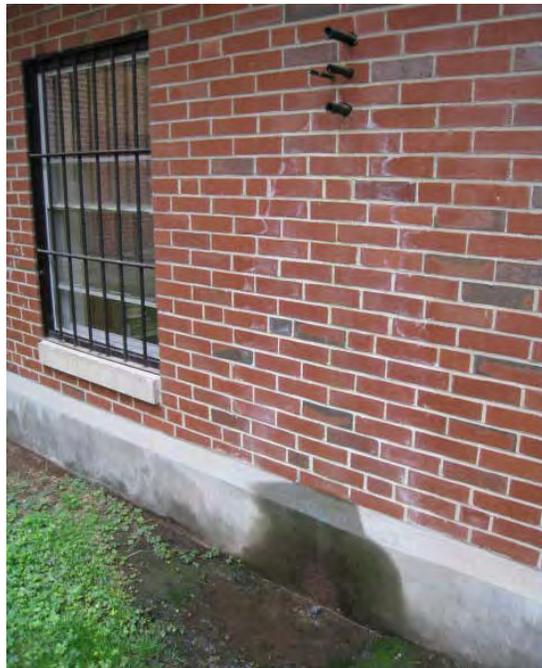
**Picture 22**

- Groundwater and storm water infiltration in the lower levels, particularly in the 1970s building.
- Some of what were assumed to be FCU condensation drain lines were draining directly against the building where the water can infiltrate via exterior brick and/or the foundation (Picture 22).

- Efflorescence was noted on exterior brickwork (Picture 22). Efflorescence is a characteristic sign of water damage to brick and mortar, but it is not mold growth. As moisture penetrates and works its way through mortar, brick or plaster, water-soluble compounds dissolve, creating a solution. As the solution moves to the surface of the material, the water evaporates, leaving behind white, powdery mineral deposits.

**Drain Presumed to be From FCU Condensate Discharges to Side of Building  
(Note Efflorescence on Brickwork and Staining/Puddle below)**

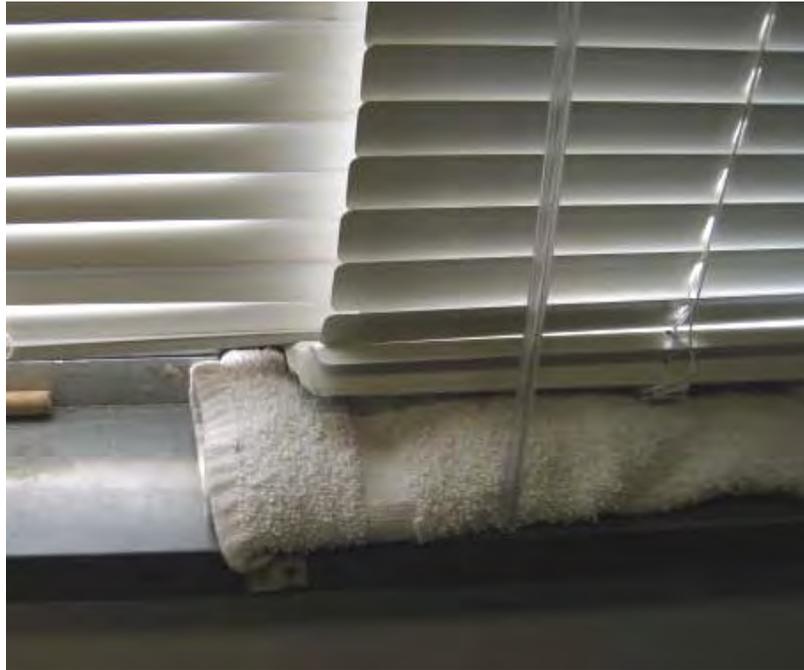
**Picture 23**

**Towel under Leaking Window**

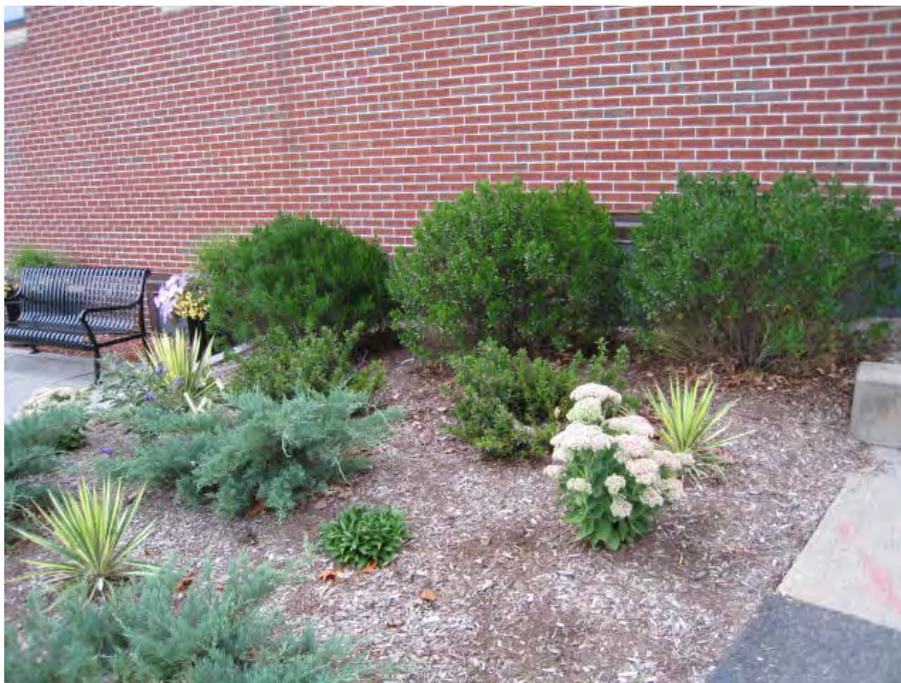
**Picture 24**

- Plants were noted close to or in contact with exterior walls (Picture 24). The growth of roots against exterior walls can bring moisture in contact with the foundation. Plant roots can eventually penetrate the wall, leading to cracks and/or fissures in the sublevel foundation. The freezing and thawing action of water during the winter months can also create cracks and fissures in the foundation resulting in additional penetration points for both water and pests. These conditions can undermine the integrity of the building envelope and provide a means of water entry by capillary action into the building through exterior walls, foundation concrete and masonry (Lstiburek & Brennan, 2001).

**Plants Growing Close to Base of Building**

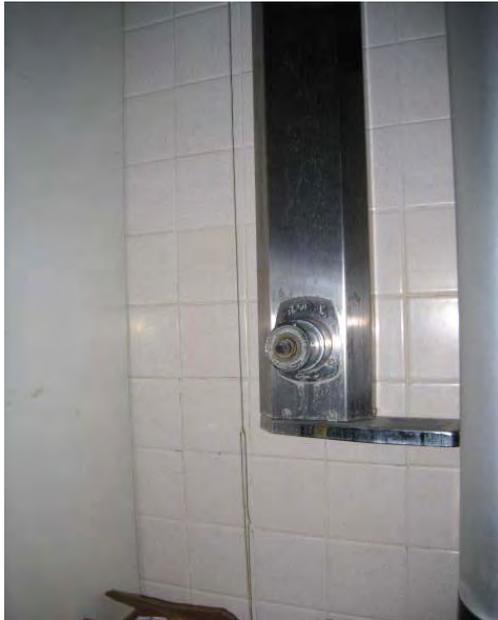
**Picture 25**

Due to the changes from previous use, particularly in the former infirmary sections of the 1960s building, there are many areas which still contain plumbing and fixtures which are used irregularly or not at all. Old shower rooms are used for storage, with the original fixtures still in place (Picture 25). These may be subject to leaks and should be shut off and properly capped. In addition, the drains in unused showers can be a source of infiltration of moist air and odorous sewer gases that should be removed or capped.

**Shower Fixtures in Old Shower Room Currently Used for Storage  
(Note stored boxes)**

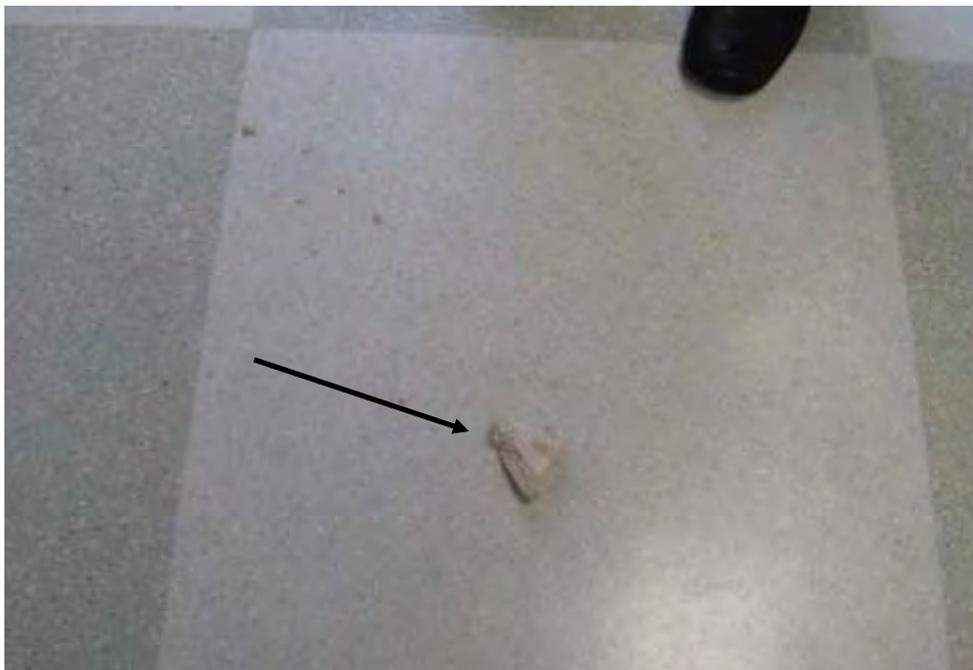
**Picture 26**

During the September 30, 2011 assessment, the FCU in Room 167 was opened. As the unit was opened, a piece of loose pipe insulation fell from the FCU onto the floor. Unlike other fiberglass insulation and foam pipe wrap installed on pipes in the FCU, the hand-sized piece of insulation appeared to be cementitious (Picture 26). Based on its appearance and the date of construction of the 1960s wing, BEH staff advised the occupants to discontinue the use of the room until properly cleaned and to have the debris tested for asbestos. According to a laboratory analysis report, the pipe insulation contained five percent chrysotile asbestos (PAS, Inc., 2011).

**Hand-Sized Piece of Insulation (arrow), Appeared to be Cementitious**

1. All penetrations in the ceiling where FCUs are installed should be examined for the presence of discarded asbestos pipe insulation. Where asbestos-containing materials are found damaged, these materials should be removed or remediated in a manner consistent with Massachusetts asbestos remediation laws (MDLI, 1993).
