INDOOR AIR QUALITY ASSESSMENT

**Executive Office of Health and Human Services
One Ashburton Place, 11th Floor
Boston, Massachusetts**

Prepared by:
Massachusetts Department of Public Health
Bureau of Environmental Health
Indoor Air Quality Program
April 2011

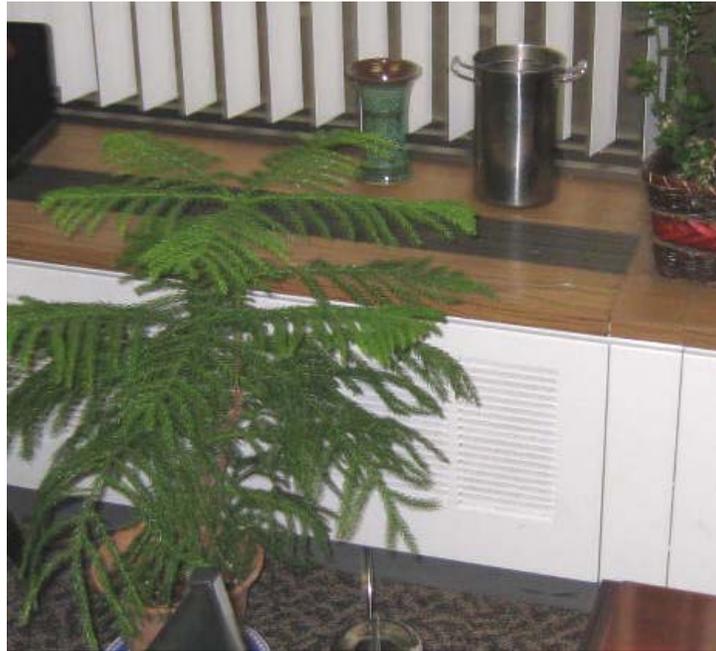
Picture 1

It can be seen from Table 1 that carbon dioxide levels were below 800 parts per million (ppm) in all of the 61 areas surveyed indicating optimal air exchange at the time of testing (Table 1). Fresh air is provided by air handling units (AHU) via ducted vents around light fixtures. Return air is drawn back into ducted vents around light fixtures, which is returned to the AHUs. Air circulation in perimeter offices is provided by wall-mounted induction units (Picture 1).

Wall-Mounted Induction Units in Perimeter Offices

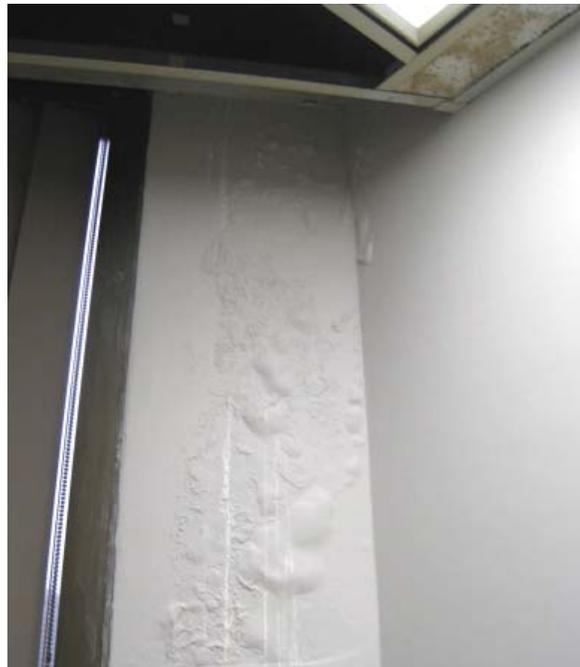
Picture 2

In order for building materials to support mold growth, a source of water exposure is necessary. Identification and elimination of the source of water moistening building materials is necessary to control mold growth. Occupants in several exterior offices (11041, 11084, and 11101) indicated that windows had water leaks during heavy northeastern wind/weather patterns. Each of these offices had water-damaged ceiling tiles, peeling/bubbling paint and efflorescence

on plasterboard (Pictures 2 and 3) all of which indicate water penetration. Efflorescence is a characteristic sign of water damage but it is not mold growth. As moisture penetrates and works its way through mortar, brick or plaster, water-soluble compounds dissolve, creating a solution. As the solution moves to the surface of the material, the water evaporates, leaving behind white, powdery mineral deposits. Water-damaged ceiling tiles can provide a source of mold and should be replaced after a water leak is discovered and repaired. These windows should be monitored and occupants should report leaks to the building's maintenance liaison/department for further evaluation/repair as necessary.

Water-Damaged Ceiling Tiles, Plasterboard, Peeling/Bubbling Paint and Efflorescence in Exterior Office

8. Investigate and make repairs to windows/exterior flashing/caulking along exterior offices (11041, 11084, and 11101). In the interim, efflorescence, loose paint and plaster debris should be scraped and cleaned using a vacuum with a brush attachment. Once repairs to windows are completed, water-damaged plasterboard and walls should be prepped and refinished.

9. Do not store porous items (cardboard, paper, etc.) in areas of known leaks to prevent water damage/mold growth.
10. Replace water-damaged ceiling tiles. Examine the area above and around these areas for mold growth. Disinfect areas of water leaks with an appropriate antimicrobial as needed.

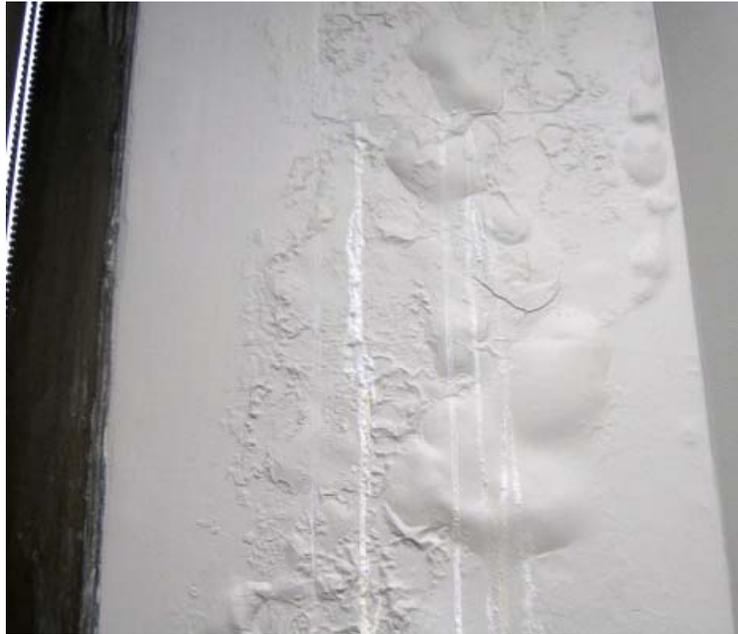
Picture 3

Close-Up of Water-Damaged Plasterboard, Peeling/Bubbling Paint and Efflorescence in Exterior Office

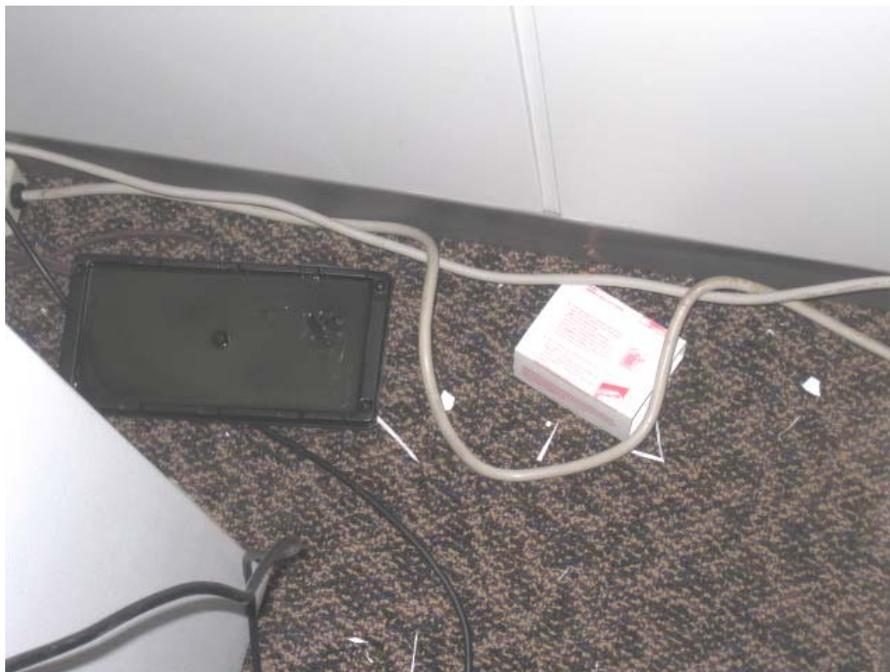
Picture 4

Other conditions that can affect indoor environmental conditions were observed during the assessment. Occupants reported rodent sightings and other signs of infestation in the EOHHS floor space, including on the day of the assessment. Numerous “sticky” traps and boxes of rodent bait were observed on the 11th floor (Pictures 4 and 5). There appear to be two

“Sticky” Type Rodent Traps

1. Relocate all bait and sticky traps into unoccupied spaces in the building's core.
2. Seal all holes in the floor and ceiling decking with rodent-proof, fire-rated expandable foam to eliminate rodent access.

- a. Keep list/inventory of location of all rodent bait/sticky traps, monitor on a regular basis and replace as needed to prevent odors from rodent die off.

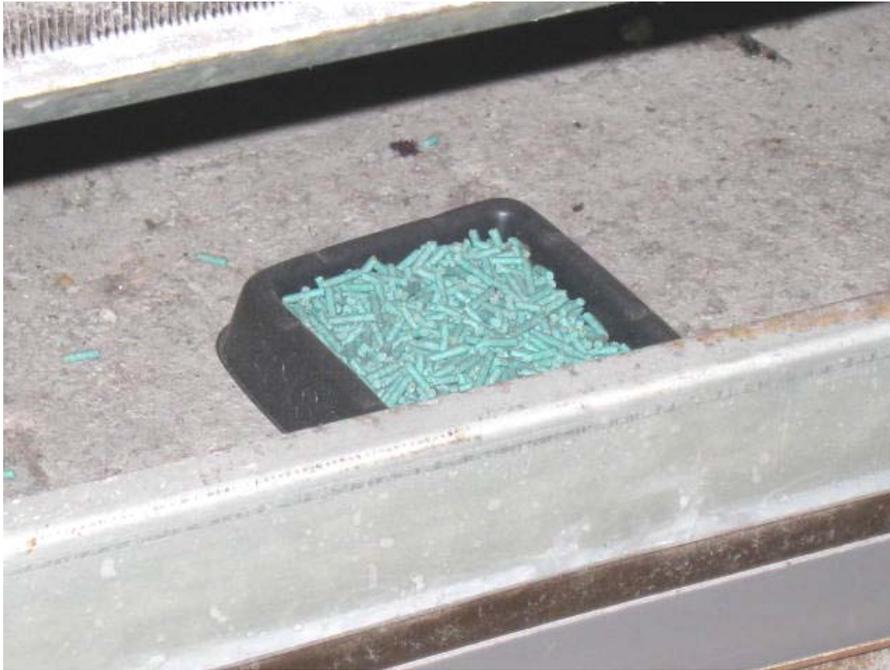
Picture 5

pathways for rodents to enter the EOHHS offices: the induction units that line the perimeter of the 11th floor, and spaces in the ceiling tile system. Offices/meeting spaces have induction units that supply airflow and heat at the base of exterior windows (Picture 1). The induction units are connected in series to ducts that are contained in an open chase that runs along the exterior wall below windows (Picture 6). If any penetrations exist in the floor decking of a size of ¼ inch or greater (MDFA, 1996), mice can readily enter this space. Building maintenance staff have reportedly placed bait traps in the induction unit chase on previous occasions (Pictures 5 and 7). The use of bait traps in induction units and sticky traps in office space will tend *to attract* rodents into the occupied space. Rodenticides are formulated to attract and induce rodents to eat the bait, which is why such devices should not be located in occupied areas. In addition, BEH staff found the bait traps in an office with the induction unit cover ajar, which gave rodent easy access into the occupied space from the chase. All induction unit covers should be secured to prevent rodent access.

Rodent Bait inside Air Handling Chamber of Induction Unit

3. Ensure that all induction unit covers are in place.
4. Replace/properly seal all holes in the suspended ceiling system.
5. Due to the reported prevalence of rodent infestation in the building, consider contacting a licensed pest control firm to design and implement an integrated pest management (IPM) plan. At a minimum:

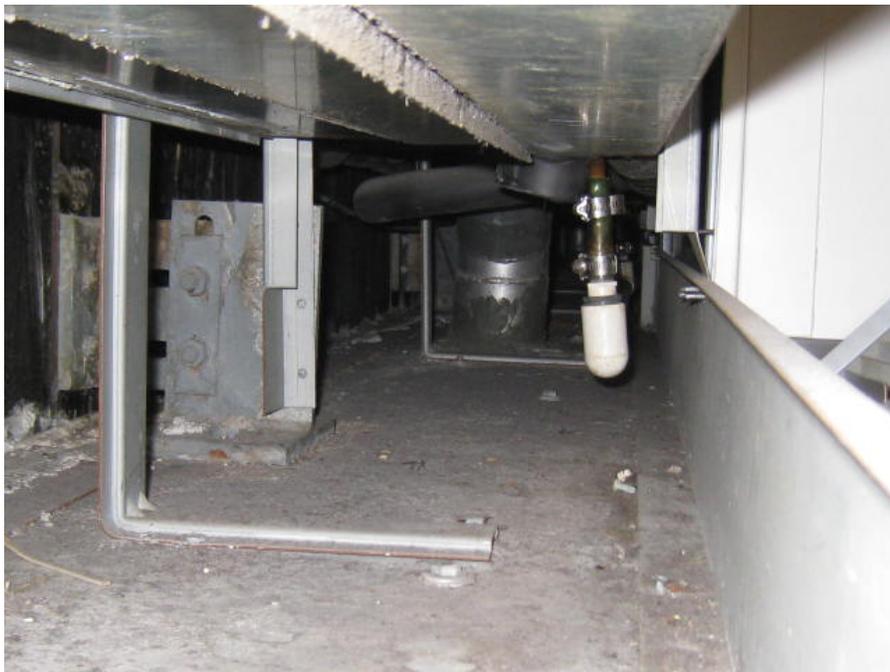
Picture 6

Induction Unit Pipe Chase

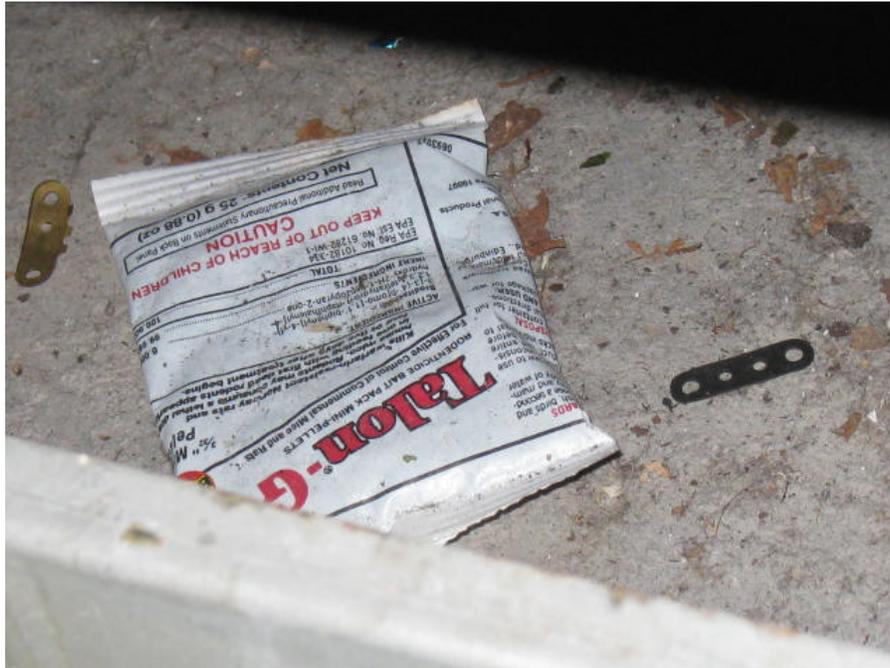
Picture 7

Package of Bait Trap Found in Induction Unit Chase

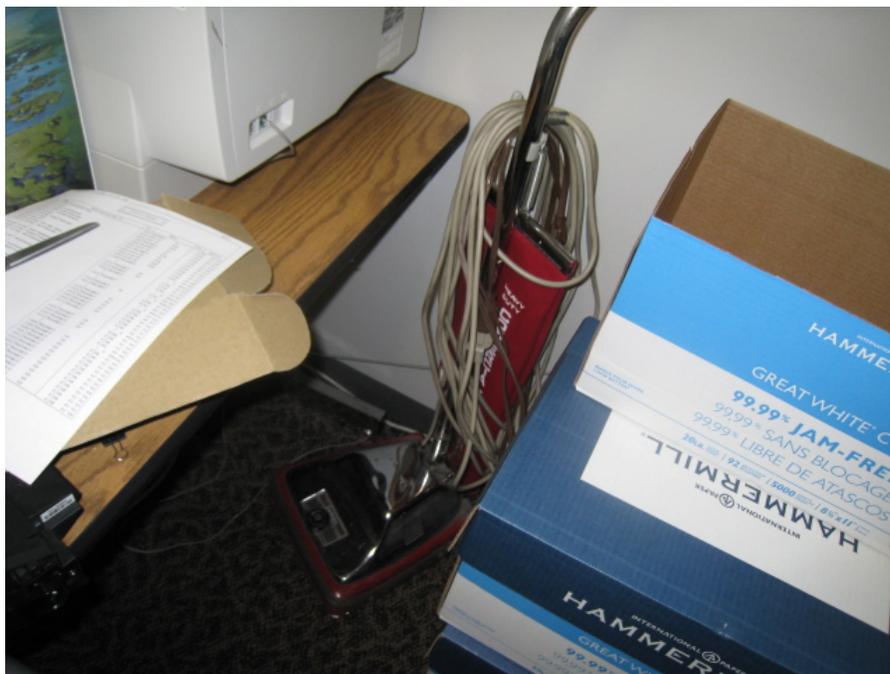
Picture 8

Of particular note was the vacuum cleaner found in the EOHHS offices (Picture 8). This type of vacuum cleaner is not equipped with a high efficiency particulate arrestance (HEPA) filter, and would likely aerosolize respirable dust if used. If the vacuum cleaner is used prior to the beginning of the workday, rodent droppings can be aerosolized and cause symptoms in sensitive individuals. The Institute of Inspection, Cleaning and Restoration Certification (IICRC), recommends that carpeting be cleaned annually (or semi-annually in soiled high traffic areas) (IICRC, 2005). EOHHS representatives did not know if a regular carpet cleaning program was in place.

Bag-Type Vacuum Cleaner Observed in the Kitchen

- d. Ensure food products are stored in containers with tight-fitting lids.
6. Discontinue the use of the current vacuum cleaner and upgrade to a high efficiency particulate arrestance (HEPA) filter equipped vacuum cleaner.

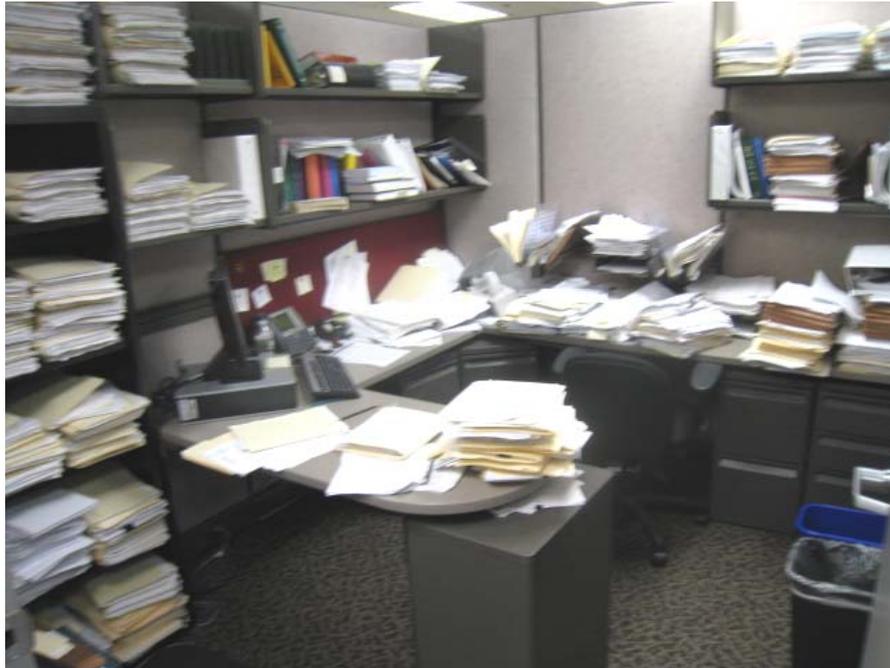
Picture 9

Finally, in several areas, items were observed on windowsills, tabletops, counters, bookcases and desks (Picture 9). The large number of items stored provides a source for dusts to accumulate. These items (e.g., papers, folders, boxes) make it difficult for maintenance staff to clean. Items should be relocated and/or be cleaned periodically to avoid excessive dust build up. Particular attention should be made to flat surfaces throughout the space (Picture 10).

Accumulated Items in Office

11. Relocate or consider reducing the amount of materials stored in cubicles, offices and common areas to allow for more thorough cleaning. Clean items regularly with a wet cloth or sponge to prevent excessive dust build-up. Explore the options of additional storage space, cabinets and/or off-site storage options. Particular attention should be made to the IT network room.

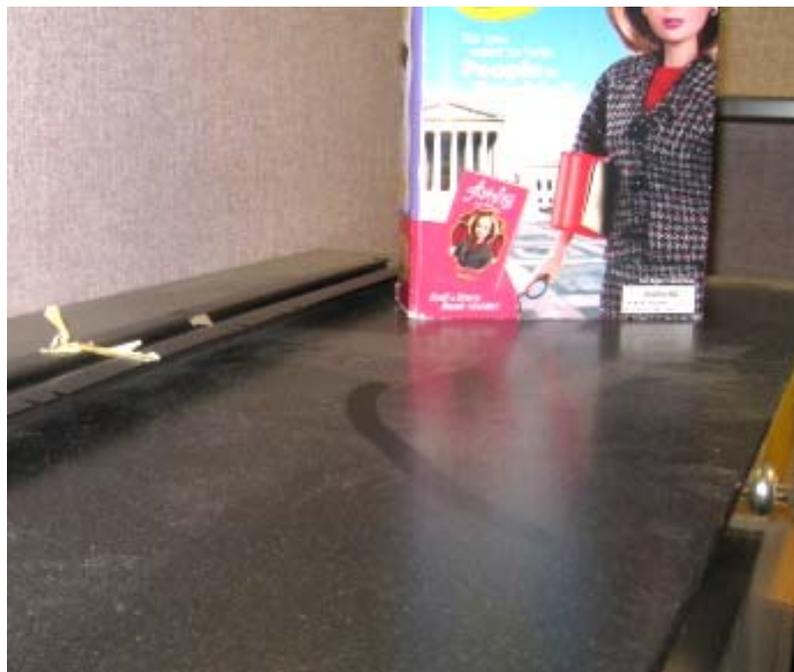
Picture 10

Dust Accumulation on Flat Surfaces

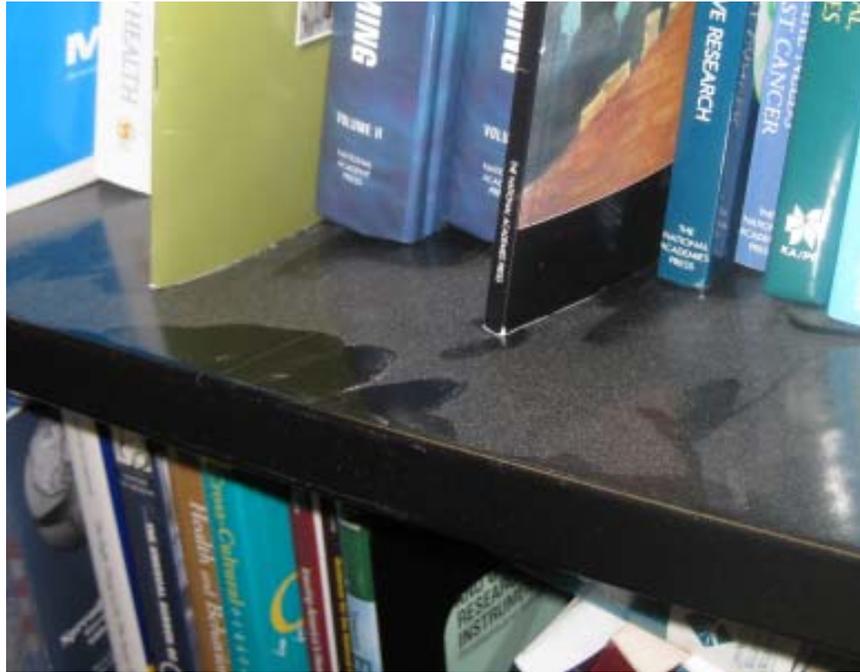
Picture 11

Dust Accumulation on Flat Surfaces
