INDOOR AIR QUALITY ASSESSMENT

**Raymond K-8 Elementary School
125 Oak Street
Brockton, Massachusetts**

Prepared by:
Massachusetts Department of Public Health
Bureau of Environmental Health
Indoor Air Quality Program
March 2011

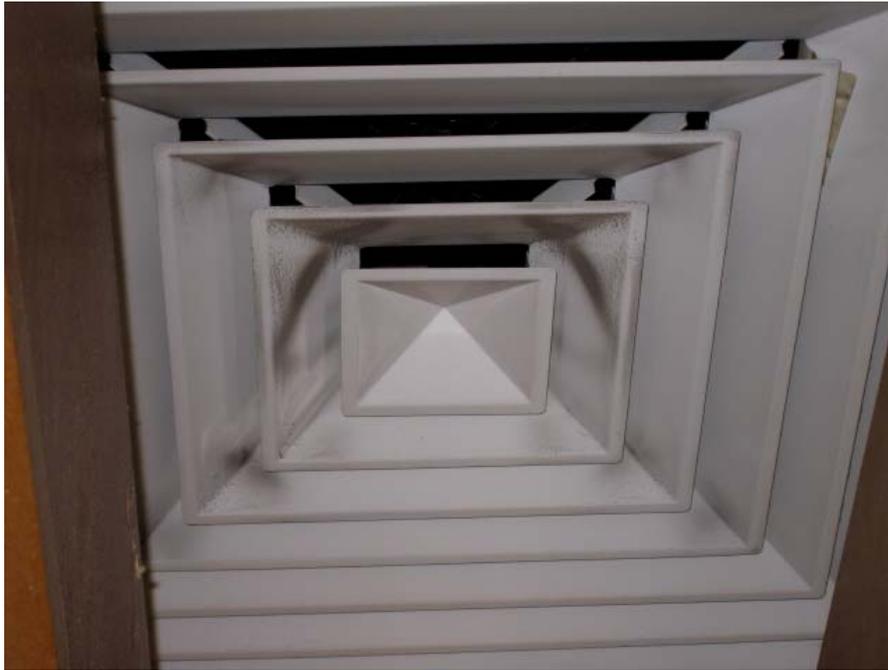
Picture 1

A number of air diffusers, exhaust/return vents and personal fans were observed to have accumulated dust/debris (Pictures 1, 3 and 4). If exhaust vents are not functioning, backdrafting can occur, which can re-aerosolize accumulated dust particles. Re-activated supply vents and fans can also aerosolize dust accumulated on vents/fan blades.

Ceiling-Mounted Supply Diffuser, Note Dust/Debris Accumulation on Louvers

14. Clean accumulated dust and debris periodically from the surface of air diffusers, exhaust vents and blades of personal and ceiling fans.
15. Repair/replace damaged fiberglass duct insulation in Pod 1 Room 106.

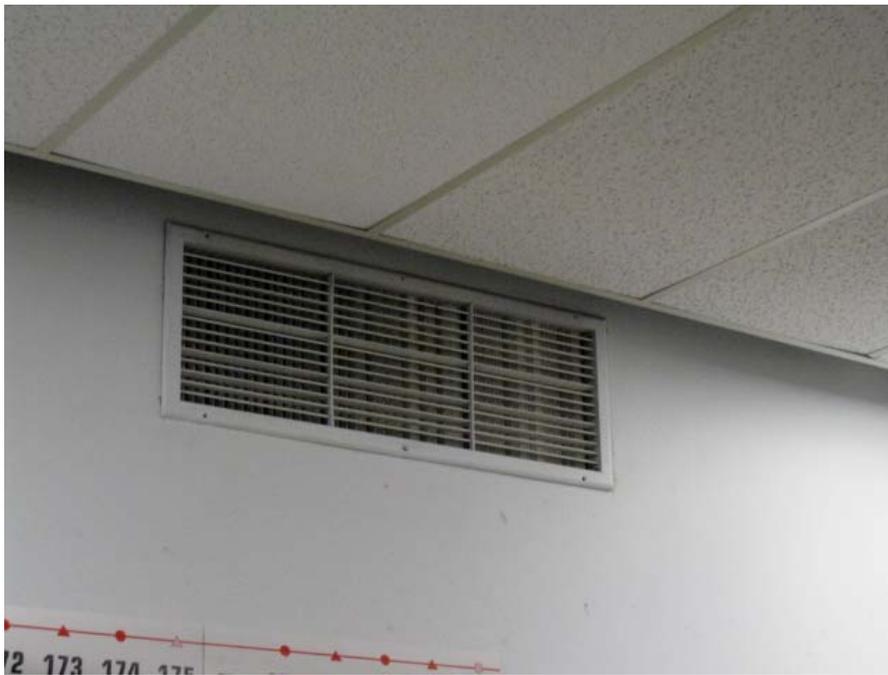
Picture 2

Wall-Mounted Supply Diffuser

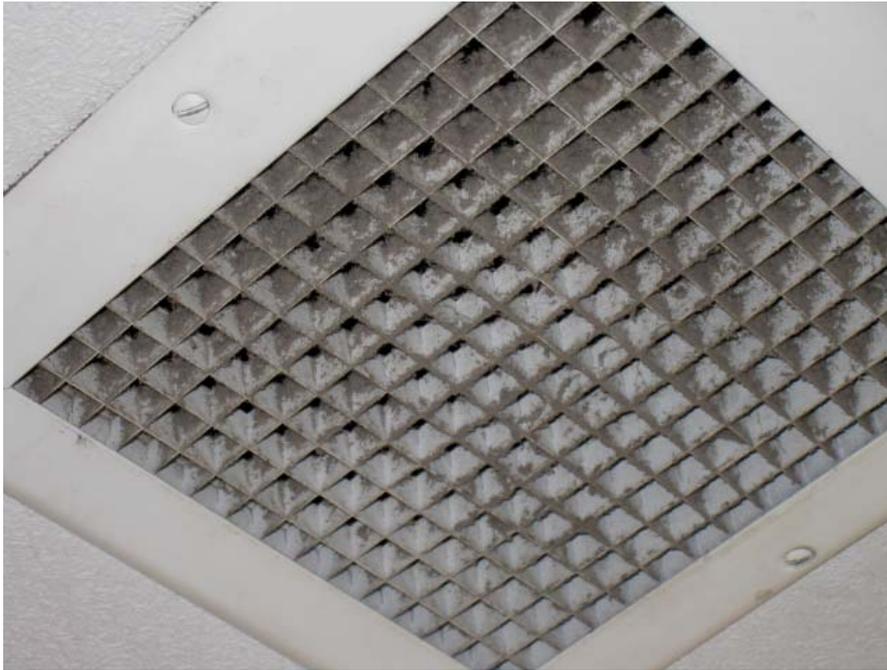
Picture 3

Ceiling-Mounted Exhaust/Return Vent, Note Dust/Debris Accumulation on Grate

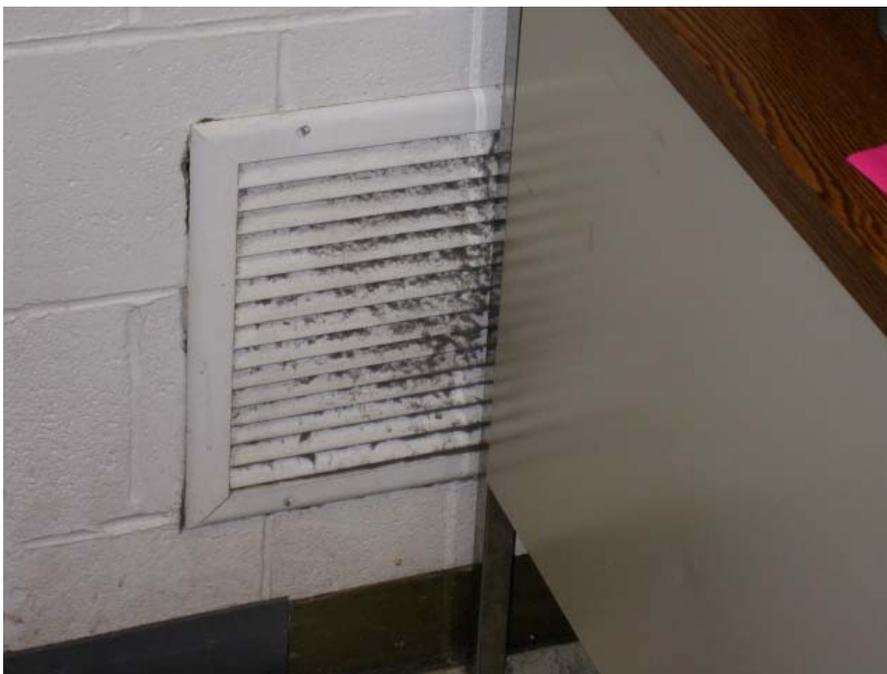
Picture 4

Wall-Mounted Exhaust/Return Vent, Note Dust/Debris Accumulation on Louvers

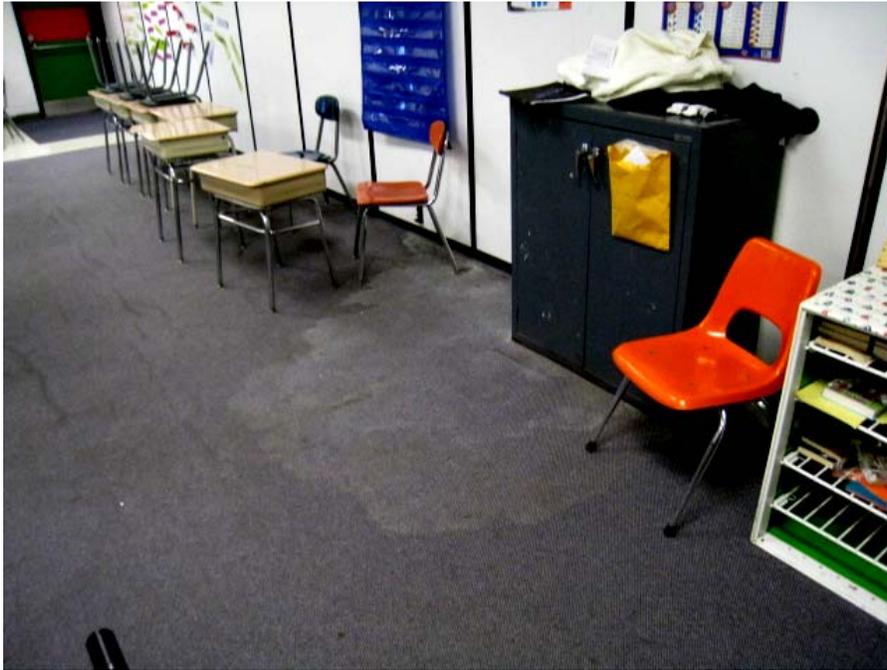
Picture 5

Water-Damaged Carpeting in Pod 1

1. In addition to carpeting removal that occurred over February vacation in Pod 1, carpeting in areas of chronic leakage should also be removed including the center of the library and corner of quiet room.
 - a. Deactivate mechanical ventilation system and seal vents during carpet removal.
 - b. Water-damaged carpeting should be removed and sealed in plastic bags for transport through the building.
 - c. If mold is present, clean concrete flooring with anti-microbial agent or mild detergent followed by rinse with clean water.
2. Remove carpeting in close proximity to restrooms and beneath water fountains to prevent damage due to flooding/back-ups and/or plumbing failures.
3. Remove/discard any water-damaged/mold-colonized ceiling tiles. Examine the area above these tiles for mold growth. Disinfect areas of water leaks with a mild detergent or an appropriate antimicrobial, as needed.

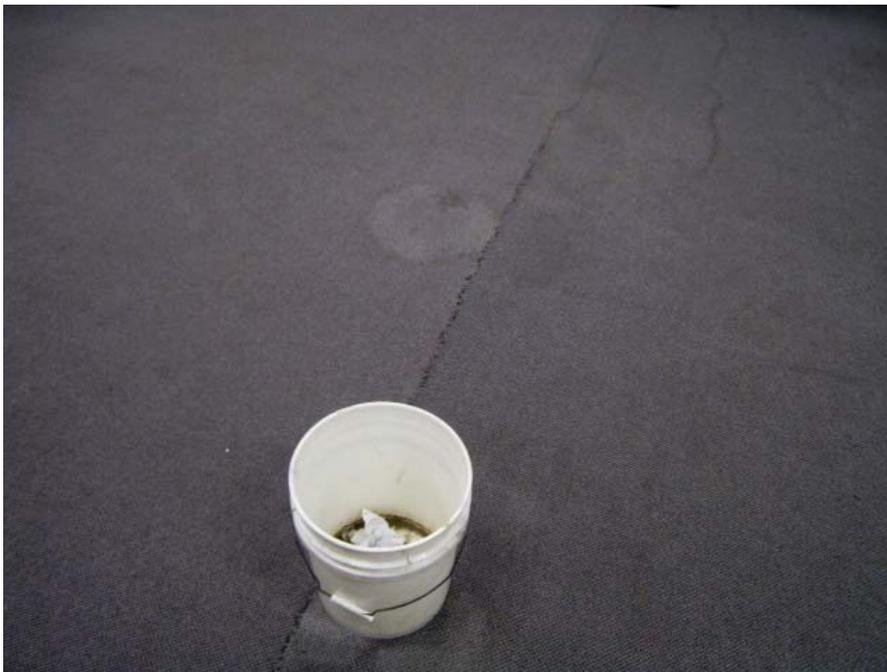
Picture 6

Water-Damaged Carpeting and Bucket Used to Catch Leaks in Pod 1

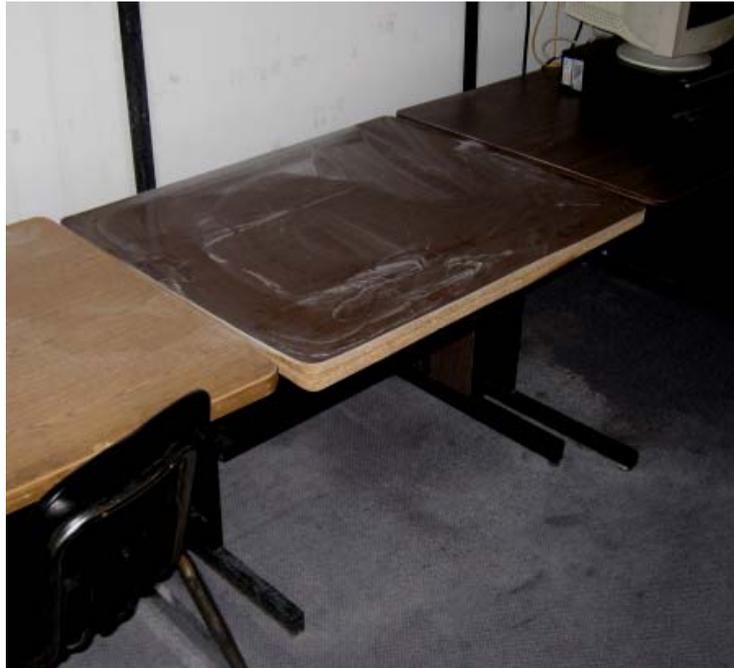
Picture 7

Water-Damaged Furniture in Pod 1

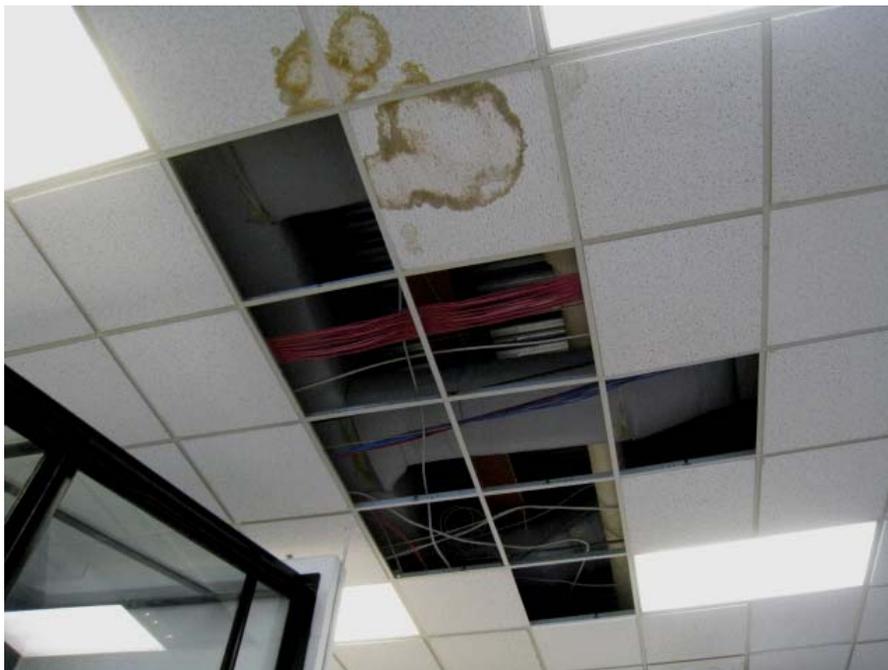
Picture 8

Missing/Water-Damaged Ceiling Tiles

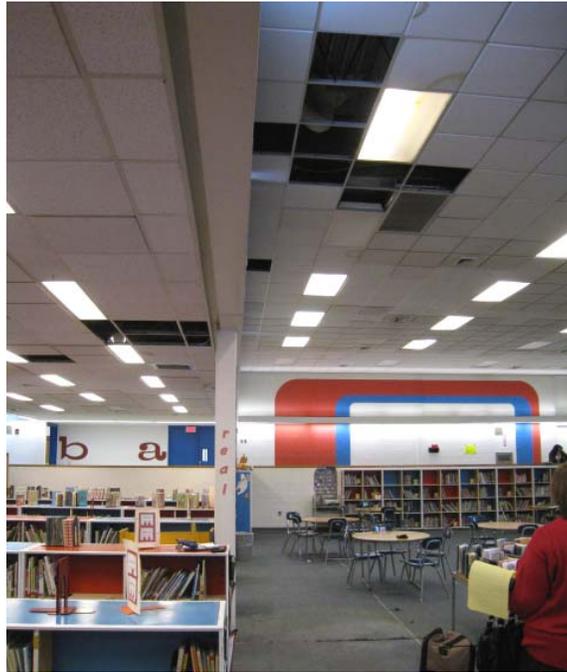
Picture 9

In order for building materials to support mold growth, a source of water exposure is necessary. Identification and elimination of the source of water moistening building materials is necessary to control mold growth. Signs of roof leaks were observed in many areas throughout the school (primarily in Pod 1) as evidenced by severely water-damaged carpeting, ceiling tiles and stains on walls and furnishings (Pictures 5 through 8/Table 1). As stated, this water-damaged carpeting was scheduled for removal over the February 2011 vacation break. Other areas of chronic leaks and water-damaged carpet should be removed including the center of the library (Pictures 9 and 10) and the corner of the “Quiet Room” (Picture 11).

Missing/Water-Damaged Ceiling Tiles and Carpeting in Center of Library

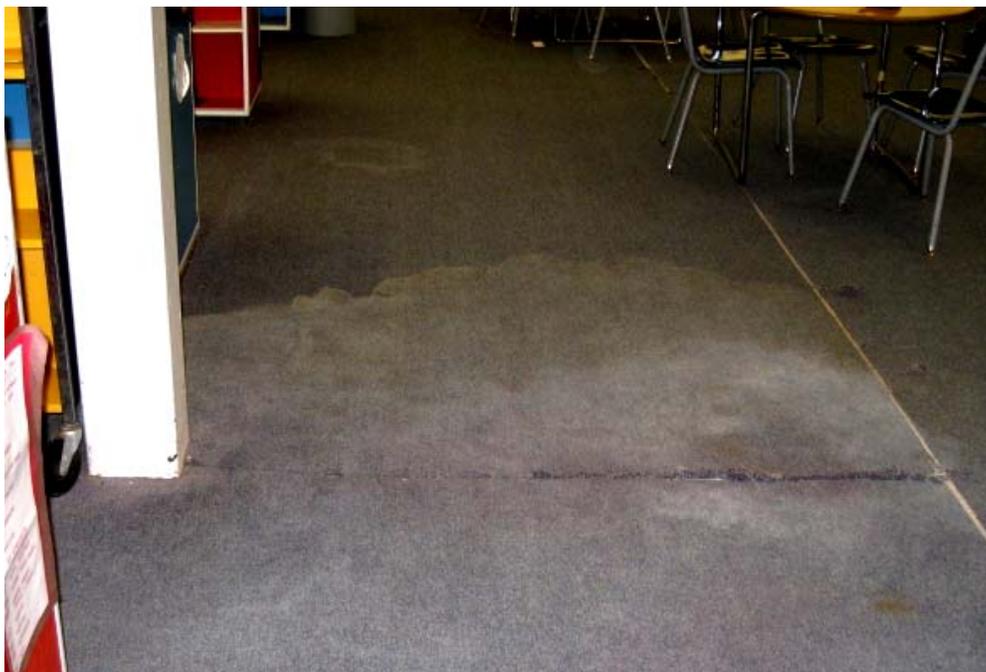
Picture 10

Water-Damaged Carpeting in Center of Library

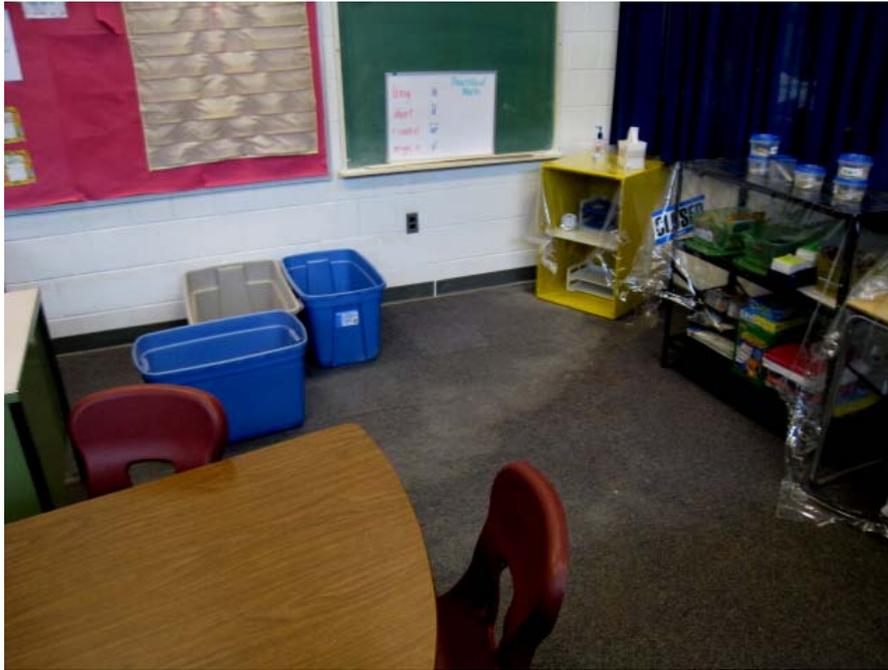
Picture 11

Water-Damaged Carpeting in Quiet Room

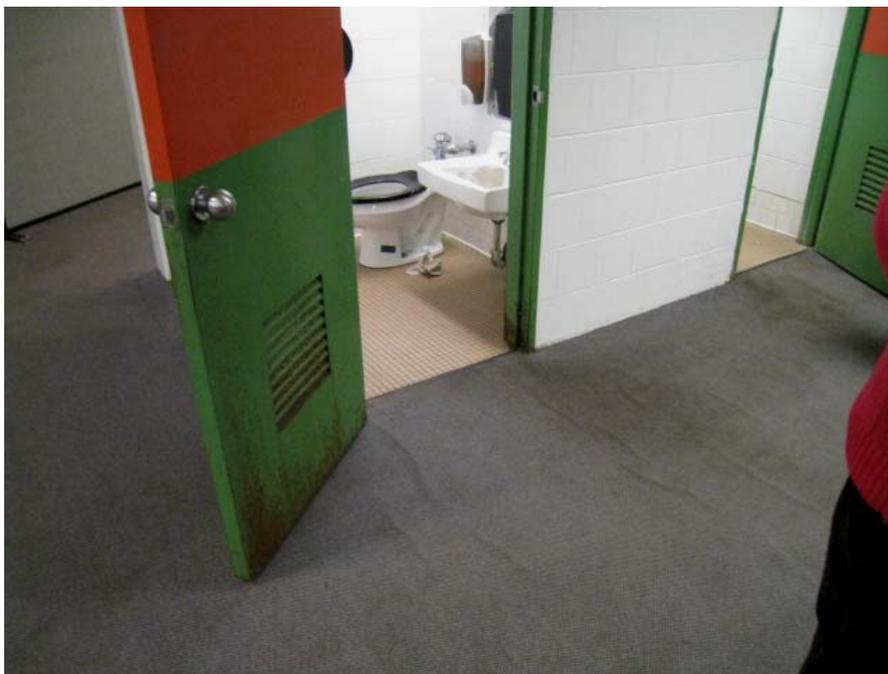
Picture 12

Carpeting was noted in close proximity to restrooms and beneath water fountains in hallways (Pictures 12 and 13). Overflow of toilets, sinks and/or water fountains that often occur can moisten carpeting and be a source of mold growth.

Wall-to-Wall Carpeting Directly outside Restrooms

17. Consider a long-term plan to replace all carpeting in the building as funds become available. Consider replacing carpeting with a non-porous surface such as vinyl tile.

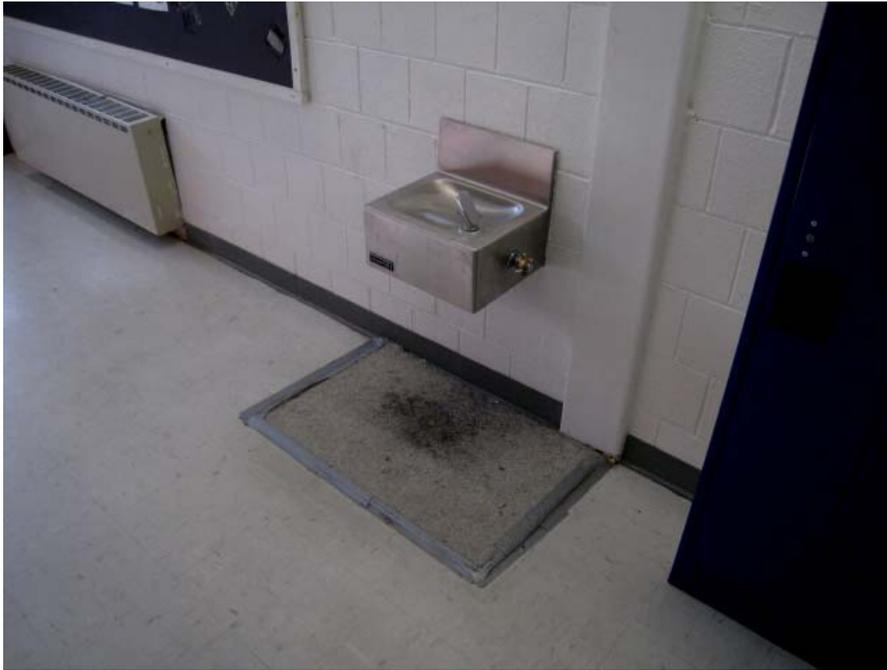
Picture 13

Carpet Square beneath Water Fountain

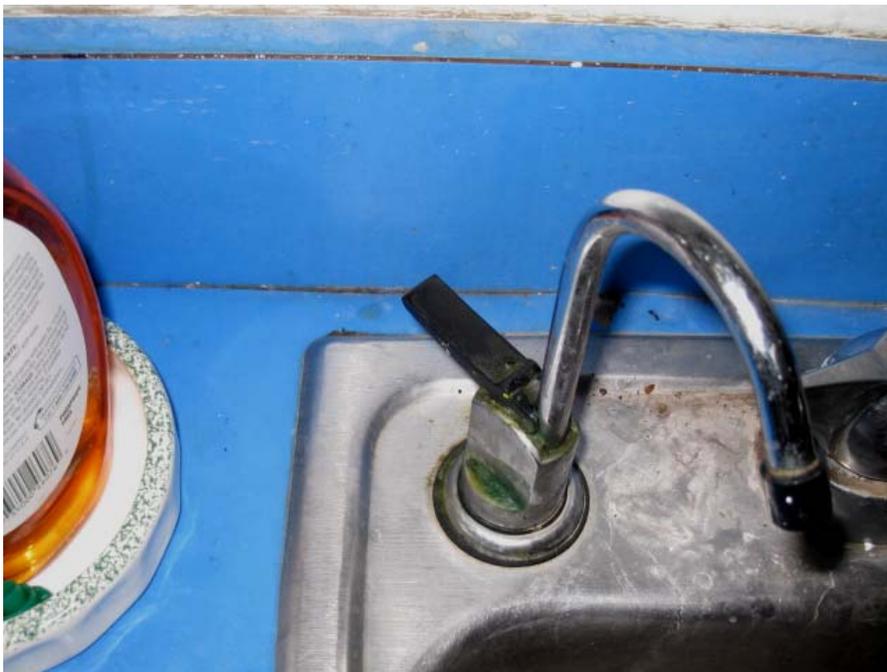
Picture 14

Open seams between sink countertops and backsplashes were observed in some rooms (Picture 14/Table 1). If not watertight, moisture can penetrate through seams, causing damage. Improper drainage or sink overflow can lead to water penetration into countertops, cabinet interiors and areas behind cabinets. Water penetration and chronic exposure of porous and wood-based materials can cause these materials to swell and show signs of water damage. Repeated moistening of porous materials can result in mold growth.

Open Seam between Sink Countertop and Backsplash

9. Refrain from storing porous items (boxes, papers, books, etc.) in areas prone to water leaks.
10. Seal areas around sinks to prevent water damage to the interior of cabinets and adjacent wallboard.

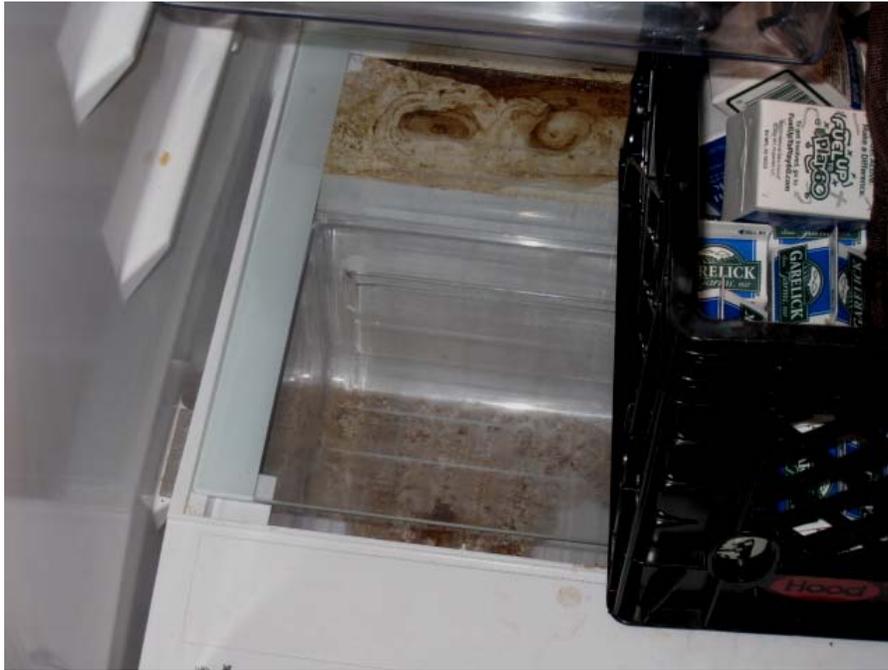
Picture 15

The teachers' faculty lunch room contained two refrigerators that appeared to have not been cleaned for some time, as evidenced by expired food/milk. Visible mold growth and food spillage was observed within the refrigerators (Pictures 15 and 16).

Mold Growth and Food Spillage in Teachers' Lounge Refrigerator

11. Clean food spillage and mold growth from faculty refrigerator with mild detergent or antimicrobial agent. Discard expired food items and clean out on a regular schedule.

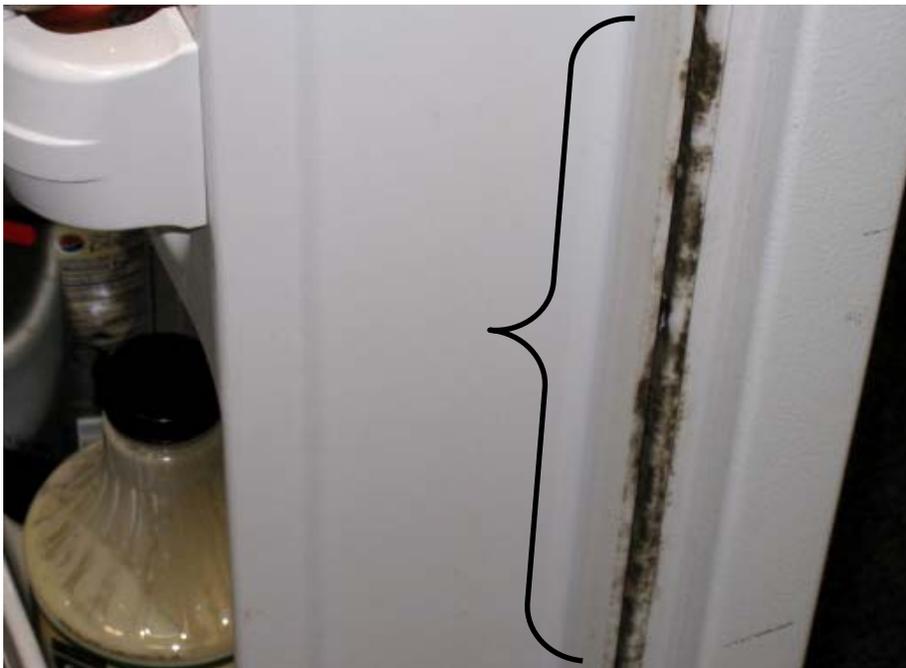
Picture 16

Mold Growth on Door/Gasket in Teachers' Lounge Refrigerator

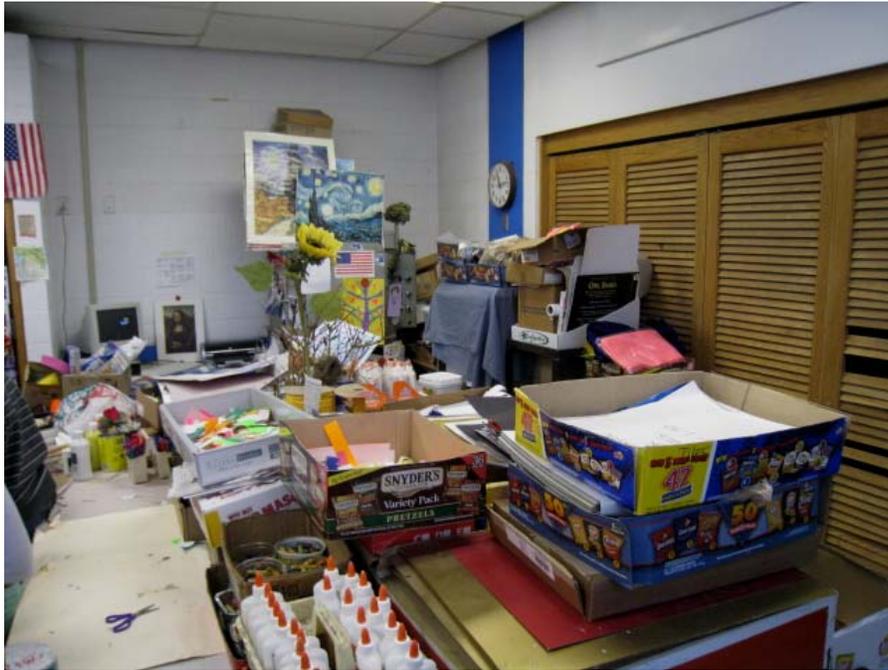
Picture 17

Other conditions that can affect indoor air quality were observed during the assessment. In many classrooms, items were observed on the floor, windowsills, tabletops, counters, bookcases and desks (Picture 17). The large number of items stored in classrooms provides a

Accumulated Classroom Items

13. Relocate or consider reducing the amount of materials stored in classrooms to allow for more thorough cleaning of classrooms. Clean items regularly with a wet cloth or sponge to prevent excessive dust build-up.

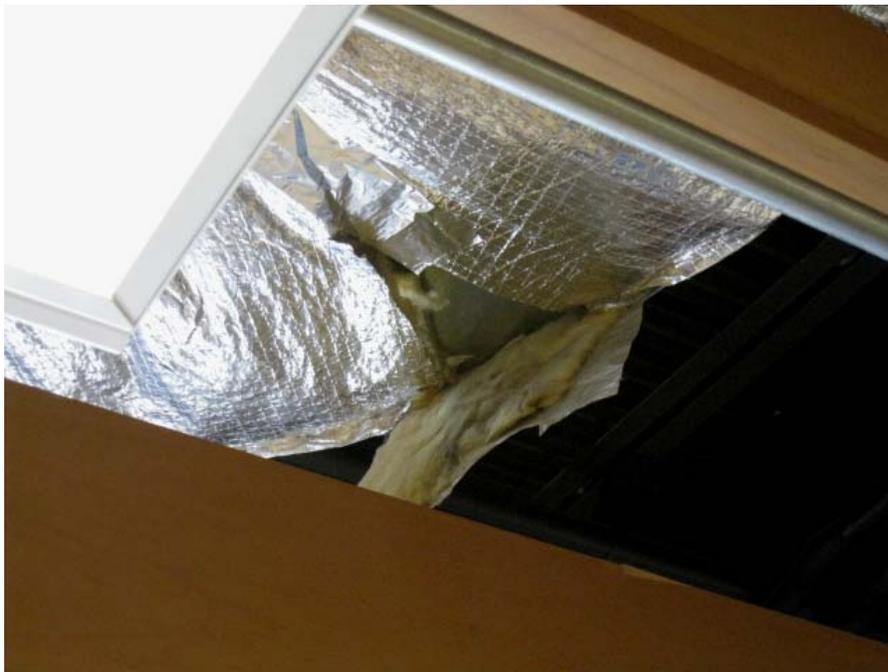
Picture 18

Missing/damaged fiberglass insulation was observed along ceiling-mounted ductwork in Pod 1 Room 106 (Picture 18). Fiberglass insulation can provide a source of skin, eye and respiratory irritation.

Missing/Damaged Fiberglass Insulation around Ductwork in Pod 1 Room 106

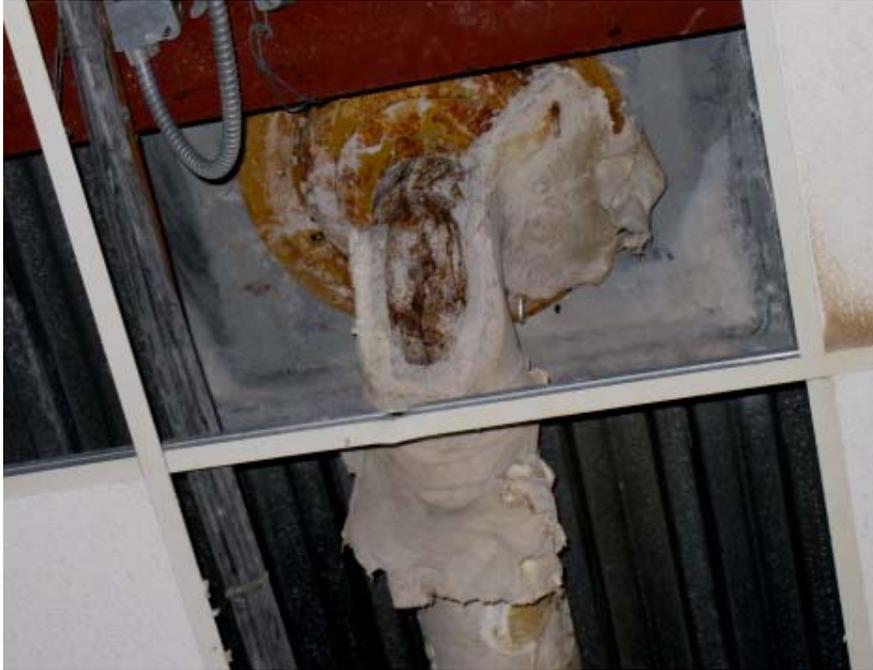
Picture 19

Finally, pipe insulation around a roof drain in the cafeteria was found damaged, exposing a white chalky material that may be asbestos (Picture 19). Upon discovery, BEH staff recommended that the insulation be inspected and remediated by a licensed member of the Brockton Public Works Department or an asbestos abatement contractor. In subsequent correspondence with Mr. Suarez, it was reported that the material was confirmed to be asbestos

Damaged Insulation Material in Cafeteria (Removed by Licensed Asbestos Remediation Firm on January 13, 2011)

and was remediated by New England Surface Maintenance, LLP, a licensed asbestos abatement contractor.
