INDOOR AIR QUALITY ASSESSMENT

**Northern Essex Community College
360 Merrimack Street
Lawrence, Massachusetts**

Prepared by:
Massachusetts Department of Public Health
Bureau of Environmental Health
Indoor Air Quality Program
March 2011

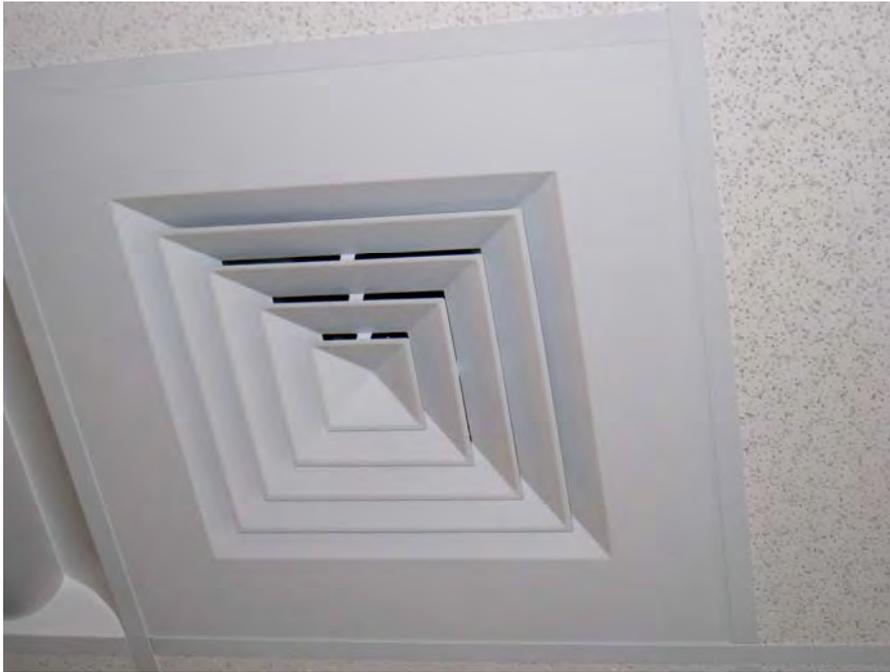
Picture 1

Fresh air is provided by three air handling units (AHUs) located in mechanical rooms or on the building's rooftop. Air is heated or cooled and delivered to occupied areas via ducted air diffusers (Picture 1) and returned to the AHU via wall- or ceiling-mounted return vents (Picture 2). Airflow to the space is regulated by thermostats that are connected to variable air volume boxes. Please note, in some areas, supply diffusers were adjacent to return vents (Picture 3). The efficacy of the ventilation system to dilute/remove pollutants is reduced due to the proximity of these vents to each other. Furthermore, some return vents were located near hallway doors (Picture 4). When the hallway door is left open, the exhaust vent tends to draw air from the hallway, thereby reducing the effectiveness of the vents to remove common environmental pollutants from the room.

Ceiling-mounted supply diffuser

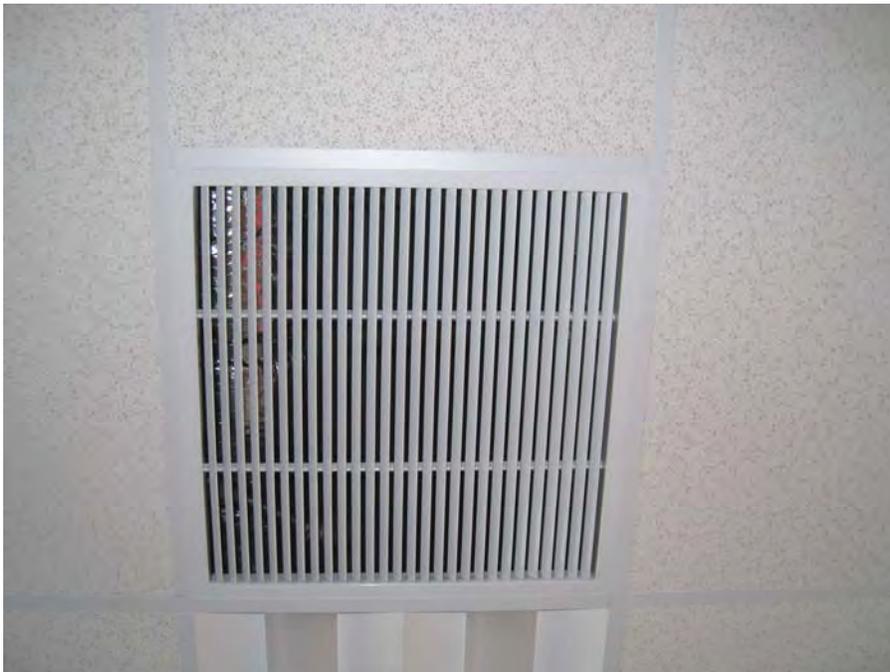
Picture 2

Ceiling-mounted return vent

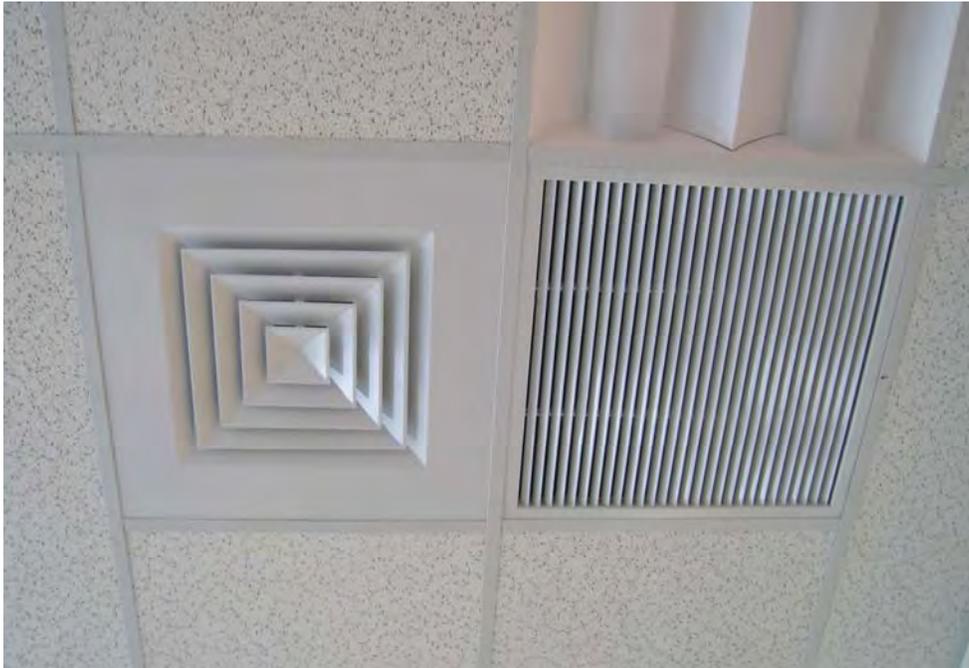
Picture 3

Ceiling-mounted supply diffuser adjacent to ceiling-mounted return vent

1. Consider re-locating return vents away from supply diffusers and doorways to increase efficiency/efficacy of pollutant removal/air exchange.
2. Close doors to facilitate exhaust ventilation/air exchange.

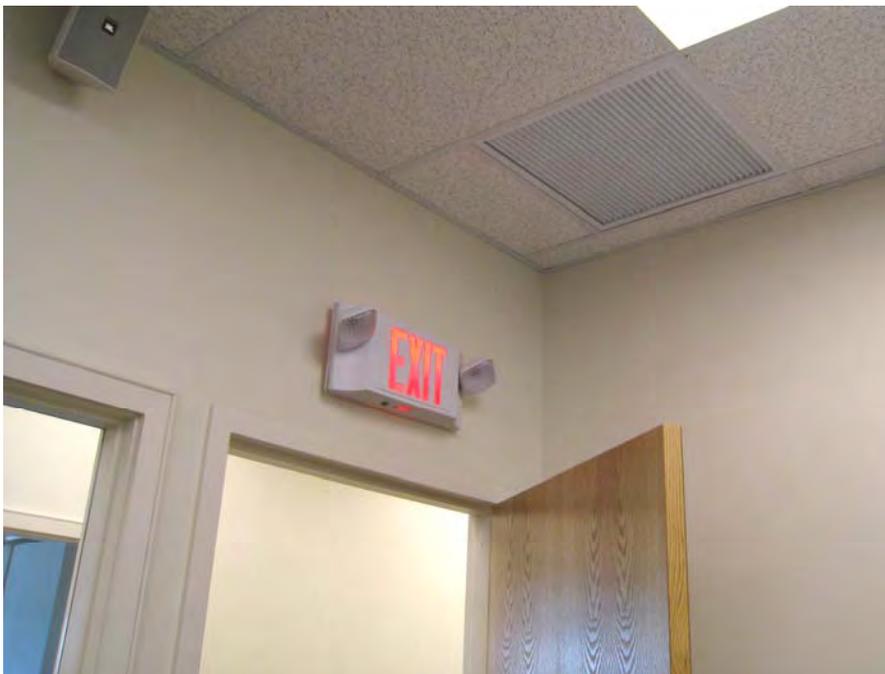
Picture 4

Ceiling-mounted return vent in close proximity to open hallway door

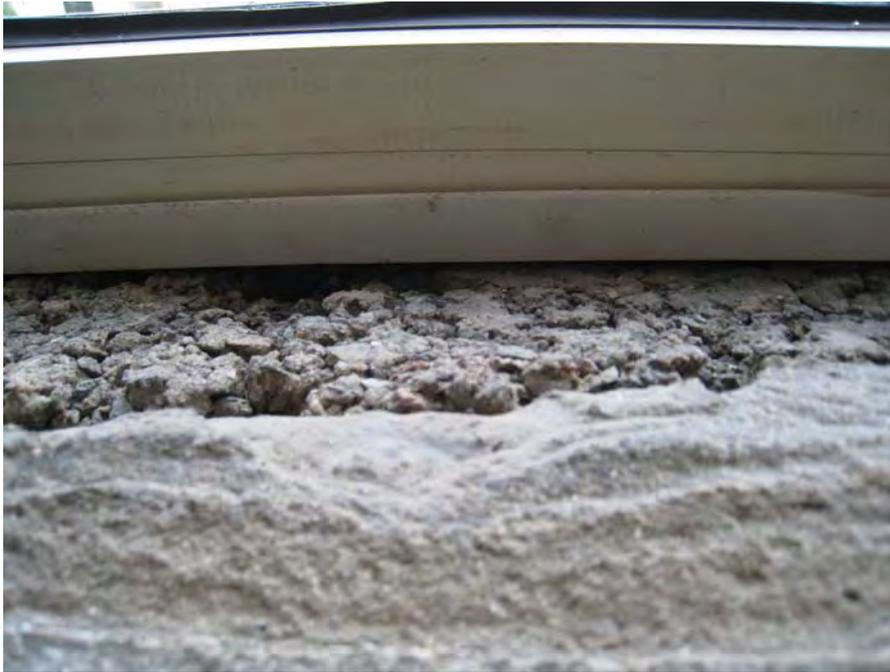
Picture 5

The condition of the window systems, including damaged concrete window ledges and missing window gaskets (Picture 5 and 6), can result in moisture and pests to penetrate the building. Plywood was observed in place of glass in one window (Picture 7). The integrity of the window system must be maintained in order to prevent damage to the building's interior. Measures should be taken to re-cement the window ledges and replace failing gaskets and the missing pane of glass.

Damaged concrete window ledge

5. Repair the window system (i.e., re-cement the ledge, replace gaskets, replace missing window pane) to prevent water/pest issues.

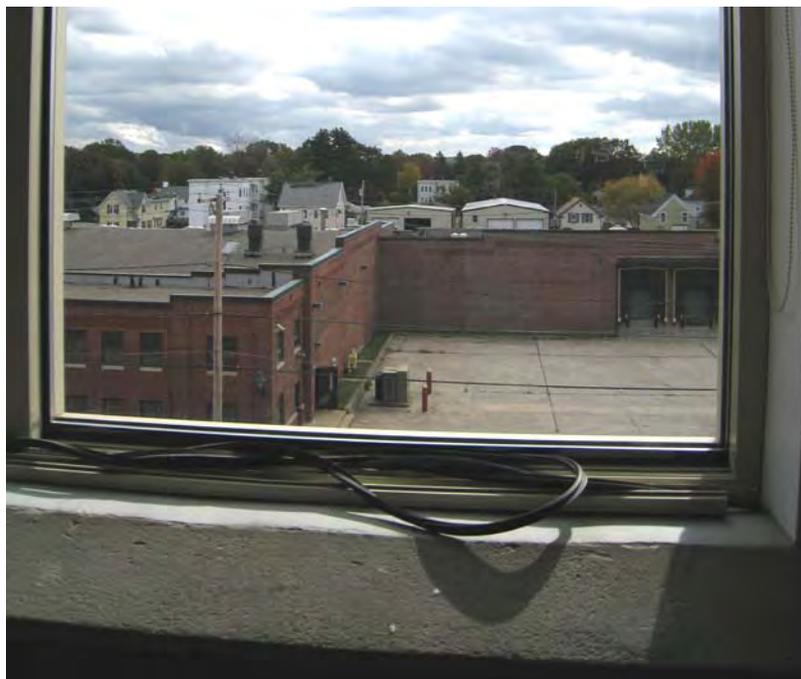
Picture 6

Damaged window gaskets

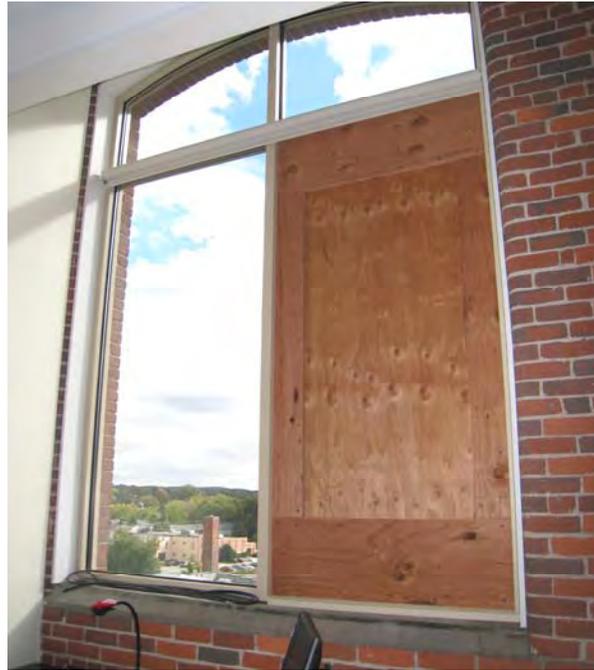
Picture 7

Plywood in place of glass window pane

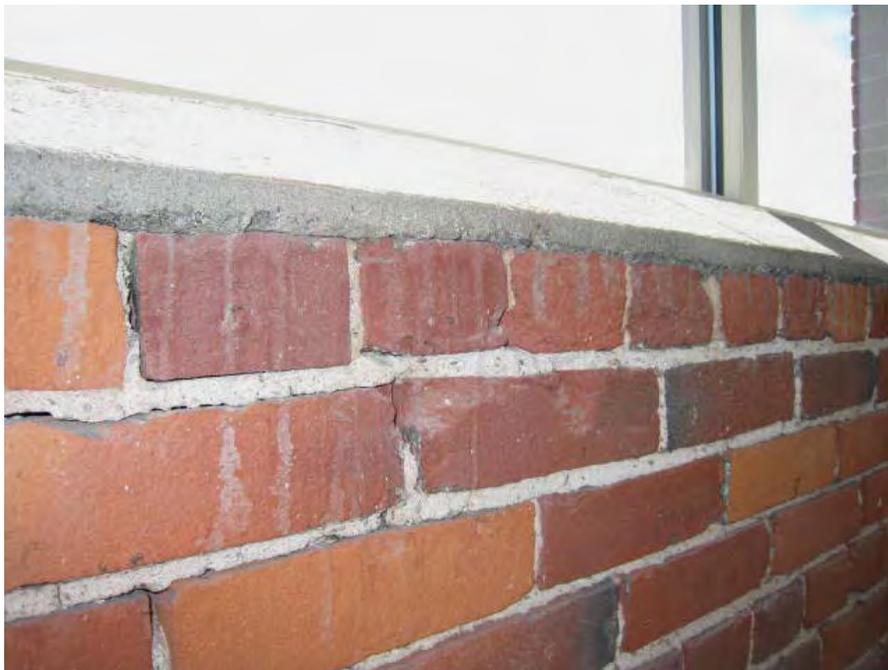
Picture 8

Some areas of interior brickwork showed signs of efflorescence near windows (Picture 8). Efflorescence is caused by water penetration dissolving minerals within the brick/mortar as it flows through. It is important to note that efflorescence is not mold. Rather, it results when water evaporates on the surface of the brick leaving behind a dry white residue. Efflorescence is

a characteristic sign of water penetration. Although some efflorescence was seen, water penetration issues appeared to be minimal.

Efflorescence on brick beneath window

6. Clean efflorescence from interior brick walls and monitor for further water penetration.
If further water penetration occurs, exterior brick may need re-pointing/waterproofing.
7. Ensure leaks are repaired and replace water-damaged ceiling tiles.
8. Finish ceiling system in room 310/312.
9. Seal all open abandoned pipes and utility holes.
10. Extend the water impermeable covering over all GW surfaces in the custodial closet.
11. Install mats beneath water coolers and refrigerators to prevent moistening of carpets.
12. Refer to resource manual and other related indoor air quality documents located on the MDPH's website for further building-wide evaluations and advice on maintaining public buildings. These documents are available at: <http://mass.gov/dph/iaq>.

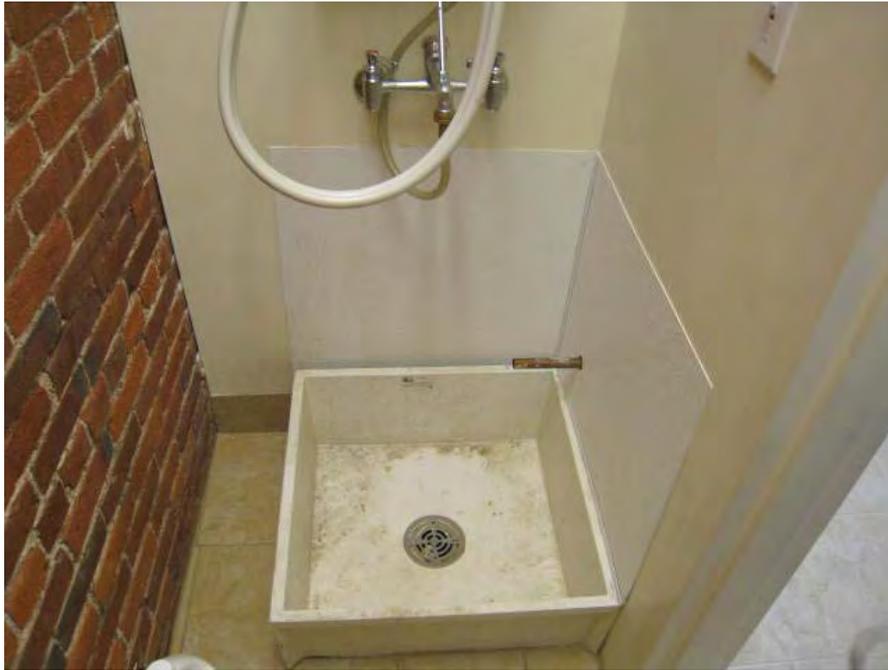
Picture 9

The custodial closet contains a large slop sink (Picture 9). A water impermeable surface installed around the sink does not extend beyond the sink to gypsum wallboard (GW) that can be readily moistened from normal use of this faucet. In order to prevent chronic exposure of GW, it is suggested that the water impermeable surface be extended from the sink to the brick wall, as depicted in Picture 9.

Exposed gypsum wallboard that may be prone to water exposure in sink closet

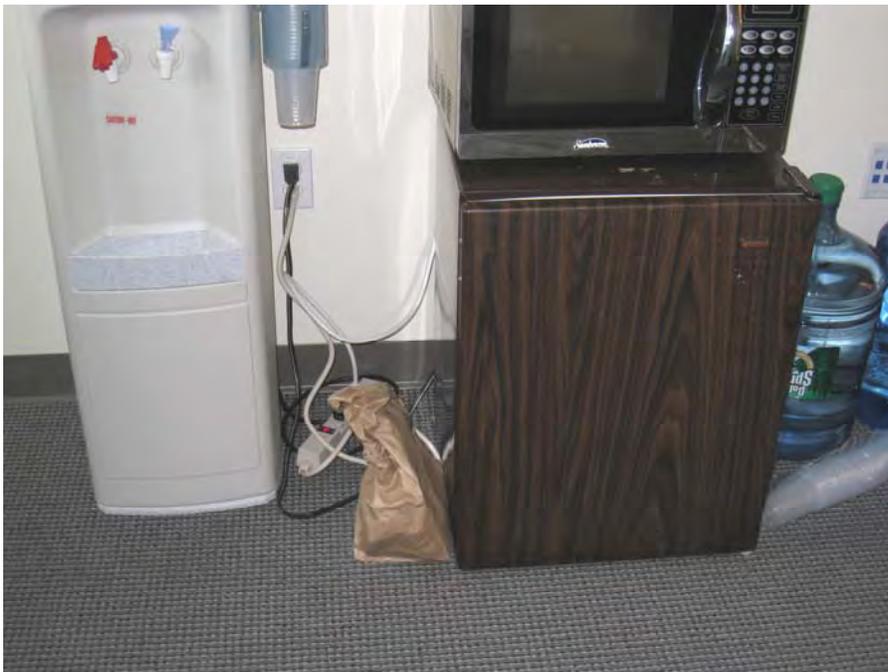
Picture 10

A water cooler and refrigerator were observed on carpeting (Picture 10). Overflow/leaks/spills that can occur around these appliances can result in the moistening of carpets. Consideration should be given to installing plastic mats beneath these appliances. In addition, the catch basins of water coolers should be cleaned regularly. Stagnant water that collects in basins can become a source of odors, and accumulated materials (i.e., dust/debris) can provide a medium for mold growth.

Water cooler and refrigerator on carpet

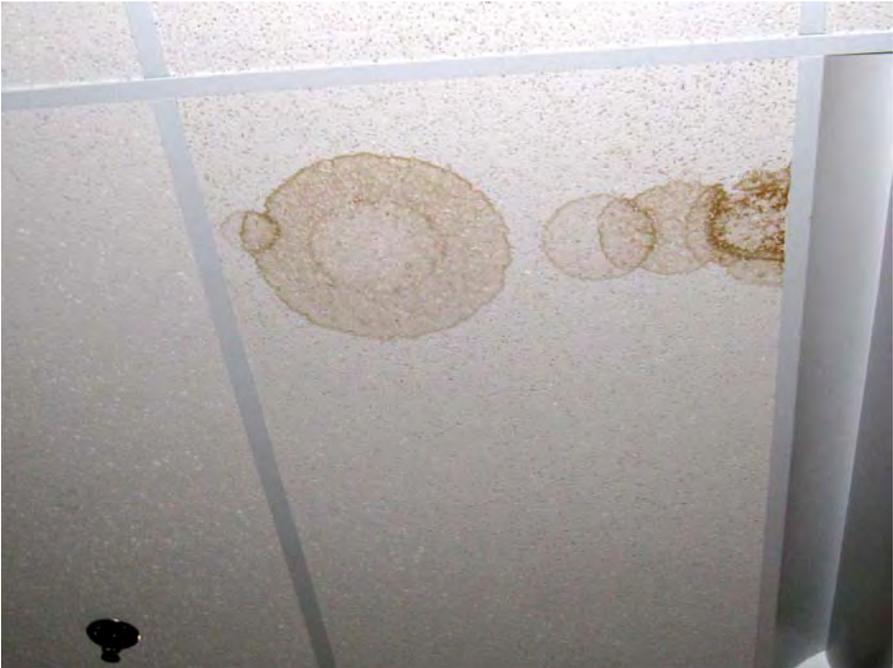
Picture 11

Water-damaged ceiling tiles were observed in one area of the building (Picture 11; Table 1). Water-damaged ceiling tiles can indicate sources of water penetration and provide a source of mold. Ceiling tiles should be replaced after a water leak is discovered and repaired.

Water-damaged ceiling tile

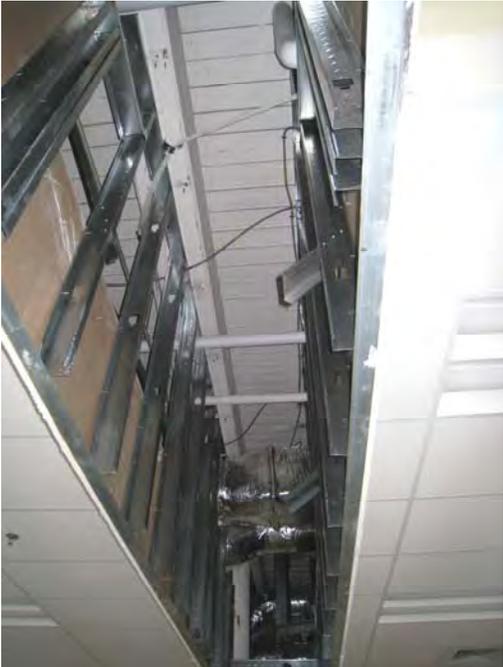
Picture 12

At the time of assessment, the ceiling system in one area was unfinished (Picture 12;

Table 1). Ceiling systems should be intact to prevent debris from entering occupied spaces.

Unfinished ceiling system

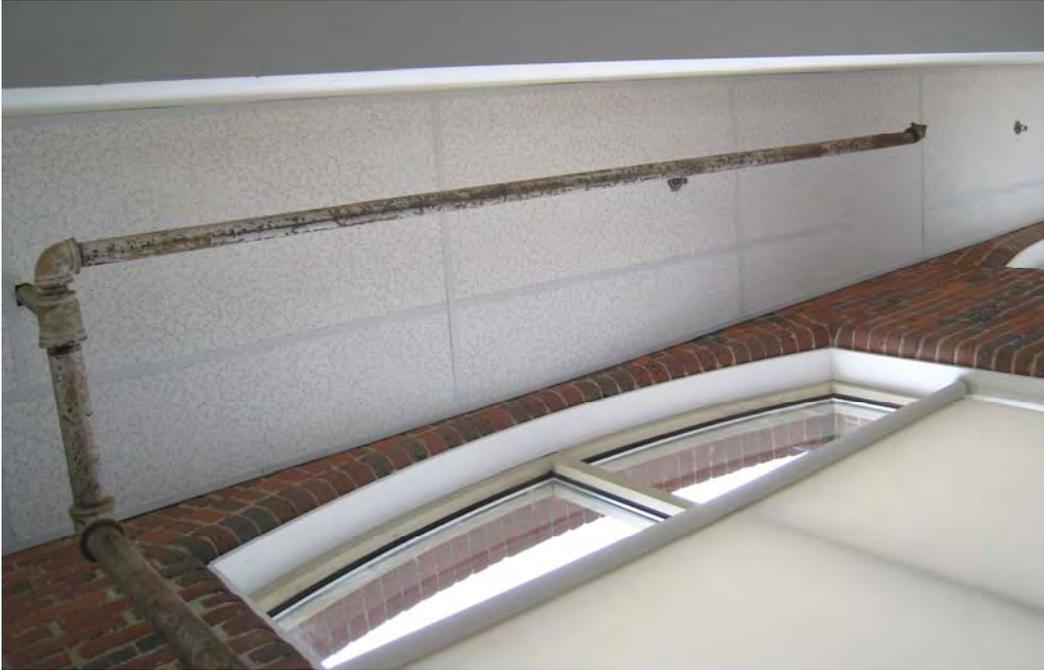
Picture 13

An open pipe and a number of utility holes were also observed in areas throughout the NECC (Pictures 13 and 14). Open pipes and breaches/chaseways can allow odors to move to occupied areas. In order to prevent possible odor migrations from one location to another in a retrofitted building; it is good practice to seal abandoned pipes.

Open pipe

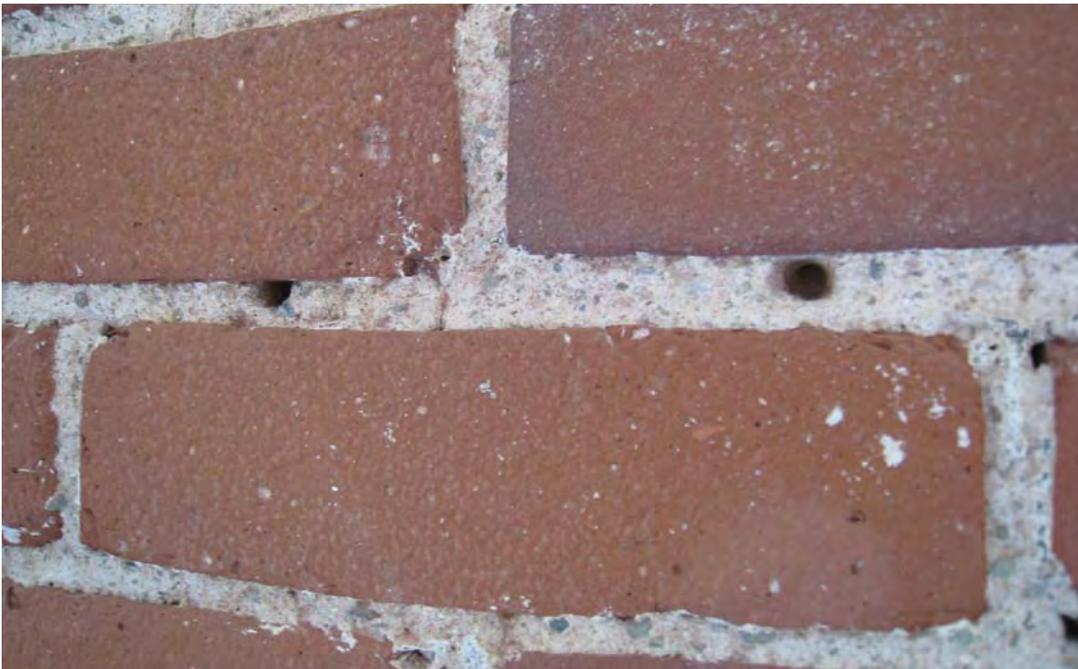
Picture 14

Utility holes in wall
