# **INDOOR AIR QUALITY ASSESSMENT**

**Memorial Elementary School  
11 Memorial School Drive  
Leicester, MA**

Prepared by:  
The Massachusetts Department of Public Health  
Bureau of Environmental Health  
Indoor Air Quality Program  
September 2011

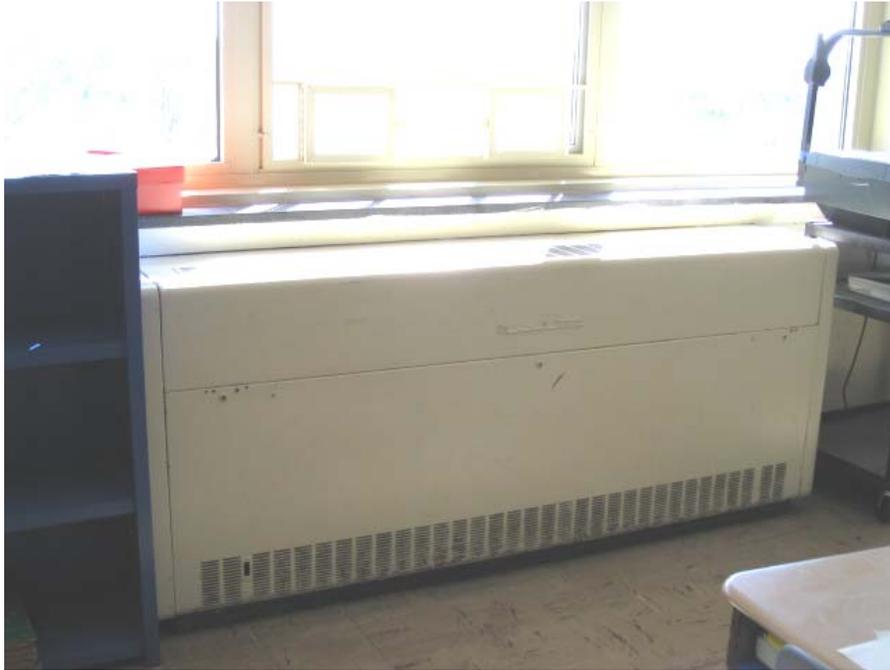
**Picture 1**

Fresh air in classrooms throughout the school is supplied by unit ventilator (univent) systems (Picture 1). A univent draws air from the outdoors through a fresh air intake located on the exterior wall of the building (Picture 2) and returns air through an air intake located at the base of the unit. Fresh and return air are mixed, filtered, heated and provided to classrooms through an air diffuser located in the top of the unit ([Figure 1](#)). Univents were found deactivated during the assessment, therefore no mechanical means of introduction of fresh air was being provided. Univents were also obstructed by items such as chairs, tables, desks, and books (Picture 3). In order to function as designed, univents must be activated and allowed to operate

Many of the univents at the LMS appeared to have been installed when the school was built in 1954. According to the American Society of Heating, Refrigeration and Air-Conditioning Engineers (ASHRAE), the service life<sup>1</sup> for a unit heater, hot water or steam is 20 years, assuming routine maintenance of the equipment (ASHRAE, 1991). The operational lifespan of this equipment has long passed. Given its age, continuing to maintain the balance of fresh air to exhaust air will be difficult at best.

**1950's Vintage Univent**

- 1. Contact an HVAC engineering firm for a building-wide ventilation systems assessment. Based on historical issues with air exchange/indoor air quality complaints, age, physical deterioration and availability of parts for ventilation components, such an evaluation is necessary to determine the operability and feasibility of replacing the equipment.
- 2. Strong consideration should be given to replacing univents in classrooms. Consideration should also be given to replacing exhaust units.
- 3. Consider replacing interlocking ceiling tile system.

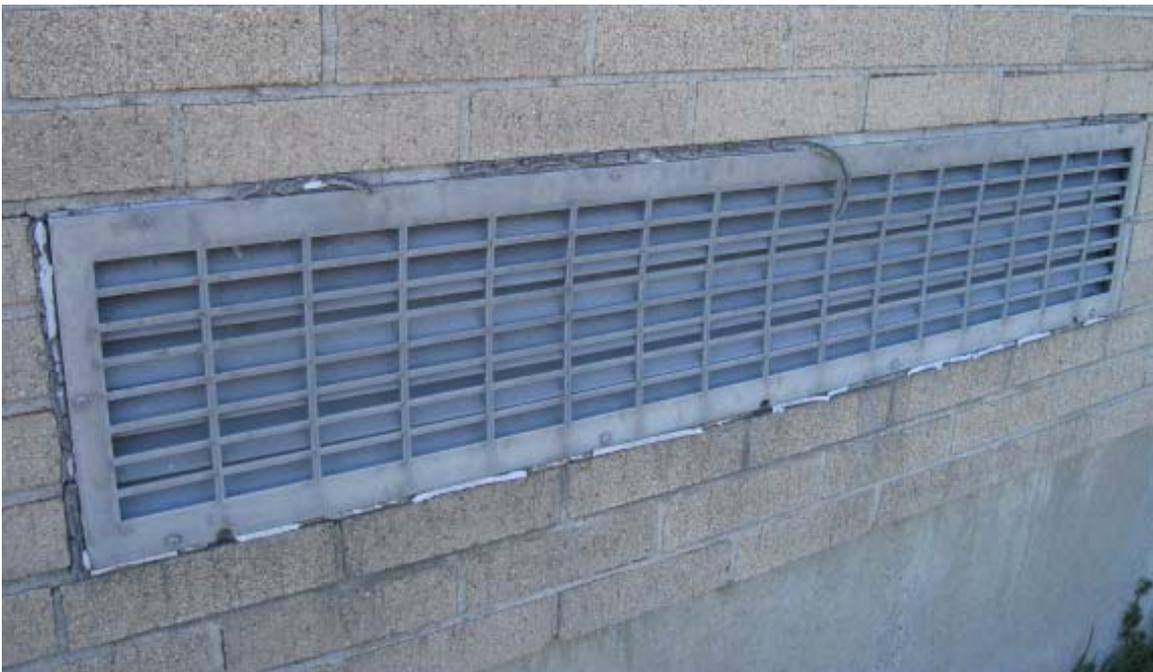
**Picture 2**

- Damaged/deteriorated brick and mortar (Pictures 12 through 14);
- Cracks were evident in the foundation (Pictures 15 and 16);
- Missing/damaged sealant around univent air intakes (Picture 2). Depending on its age, this sealant may contain regulated materials (e.g., asbestos, polychlorinated biphenyls or PCBs). If so, materials should be addressed in accordance with state and federal regulations/guidance. For further information on regulatory compliance with asbestos and/or PCBs, consult the US Environmental Protection Agency, Massachusetts Department of Environmental Protection and the Massachusetts Department of Occupational Safety. For guidance on addressing PCB-containing materials in schools, consult MDPH guidance (Appendix B);

**Univent Fresh Air Intake, Note Missing/Damaged Sealant around Grate**

- d. Repair or replace broken/leaking windows;
  - e. Determine if sealant around univent air intakes is composed of regulated materials, if so, consult EPA regulations and DPH guidance regarding PCBs in schools; and

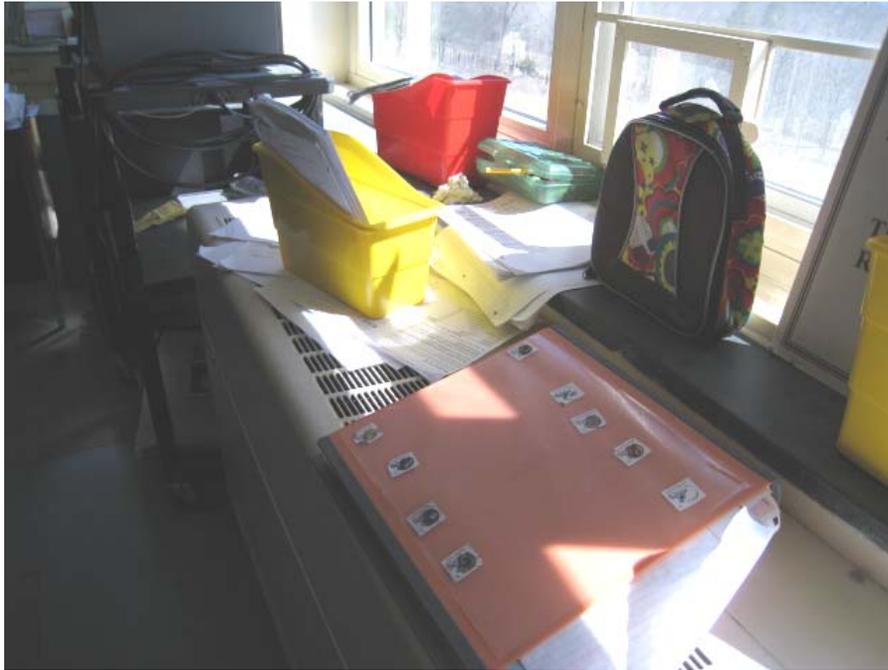
**Picture 3**

**Univent Air Diffuser Obstructed by Various Items**

3. Remove all blockages from univents and exhaust vents to ensure adequate airflow.
4. Consider adopting a balancing schedule of every 5 years for all mechanical ventilation systems, as recommended by ventilation industrial standards (SMACNA, 1994).

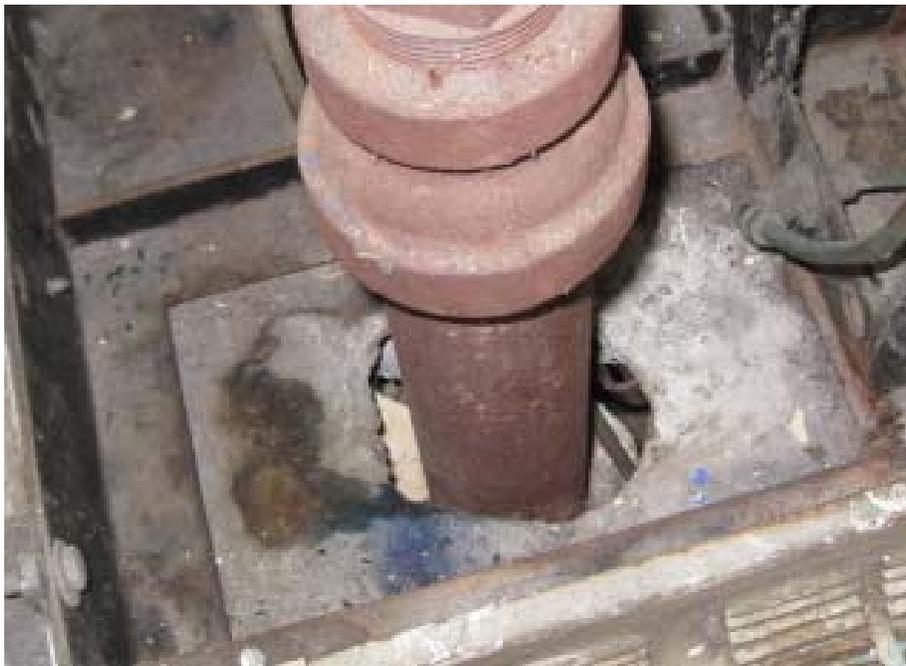
**Picture 4**

free of obstructions. Also noted within the air handling cabinets of univents were spaces through the concrete floor around utility pipes (Pictures 4 and 5). These breaches can create a pathway of migration for moisture, odors and/or particulates to be drawn from the crawlspace where it can be distributed by the univent into occupied areas.

**Spaces around Utility Pipes in Floor of Univent Cabinet**

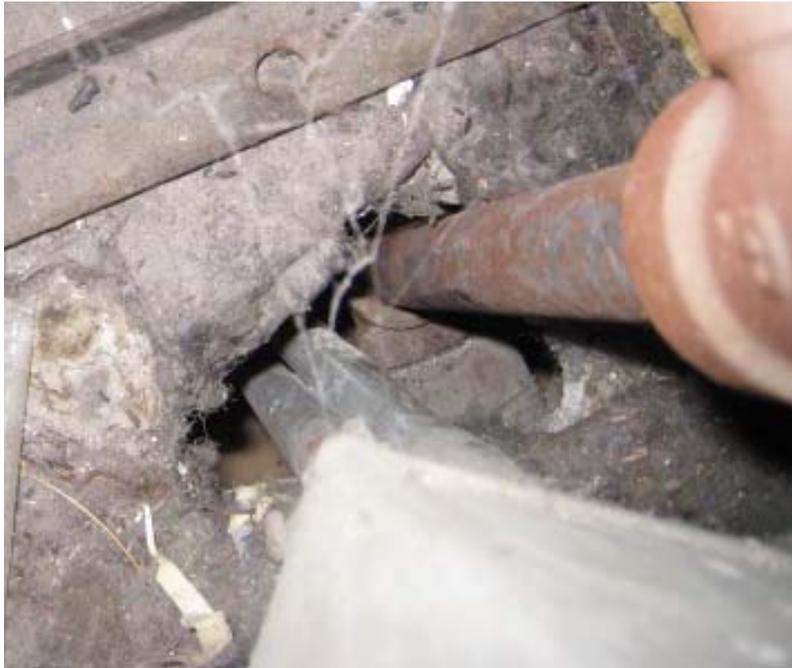
**Picture 5**

**Spaces around Utility Pipes in Floor of Univent Cabinet**

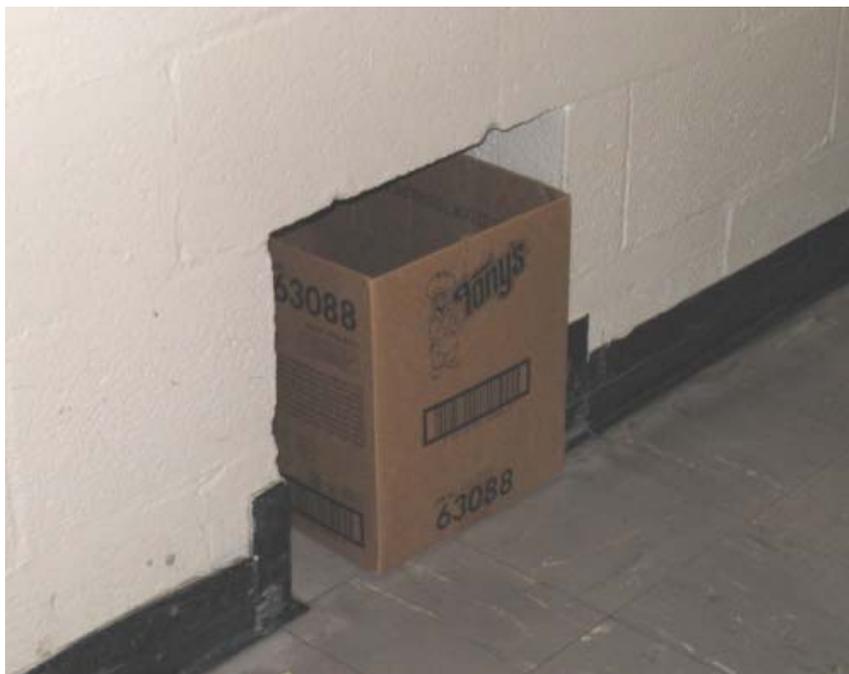
**Picture 6**

Exhaust ventilation in classrooms is provided by hearth-like structures at the base of walls that are connected to exhaust vents on the roof. At the time of the assessment, the exhaust system was found deactivated in many areas (Table 1). In addition, several classrooms had exhaust vents that were either shut or obstructed by various items (Picture 6). As with the univents, exhaust vents need to be activated and free from obstruction to function as designed. Without adequate supply and exhaust ventilation, excess heat and environmental pollutants can build up and lead to indoor air/comfort complaints.

**Classroom Exhaust Vent Obstructed by Box**

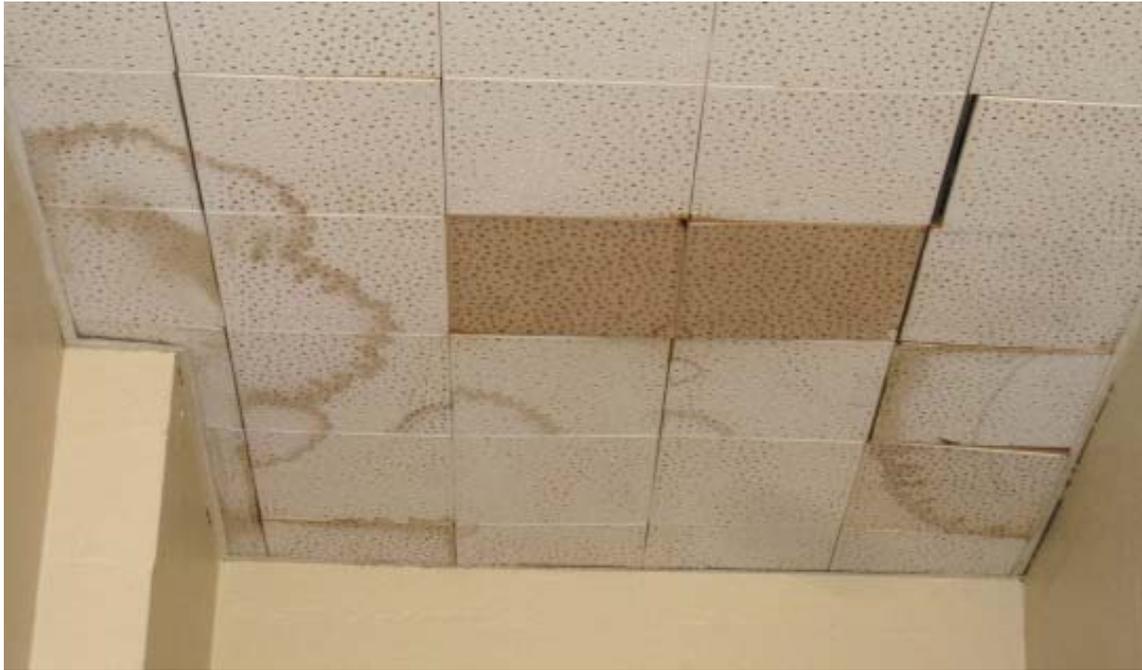
**Picture 7**

Chronic water damage was evident throughout the building in the form of water-damaged ceiling tiles, ceilings and walls throughout the building (Pictures 7 through 11; Table 1). The LMS appears to have a number of water penetration issues related to the building envelope (roof, windows and exterior walls). It was reported by school officials that the roof had been replaced approximately four years ago to limit water penetration. However, occupants reported active roof leaks in the library. Ceiling tiles should be replaced and water-damaged building materials should be repaired after a water leak is discovered and repaired.

**Water-Damaged Ceiling Tiles**

7. Work with staff to identify and repair any remaining leaks (e.g., library). Replace any water-damaged ceiling tiles. Examine the area above these tiles for mold growth.  
Disinfect areas of water leaks with an appropriate antimicrobial, as needed.

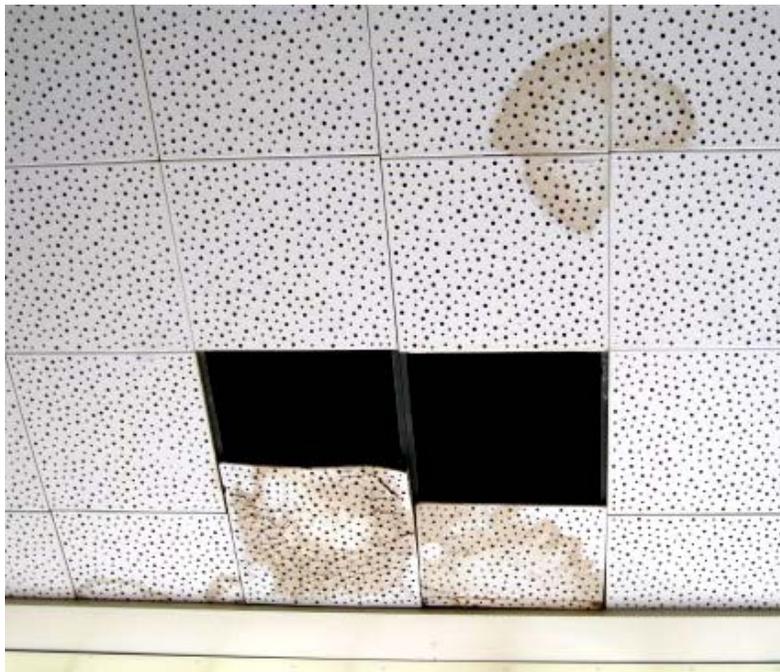
**Picture 8**

**Missing/Water Damaged Ceiling Tiles**

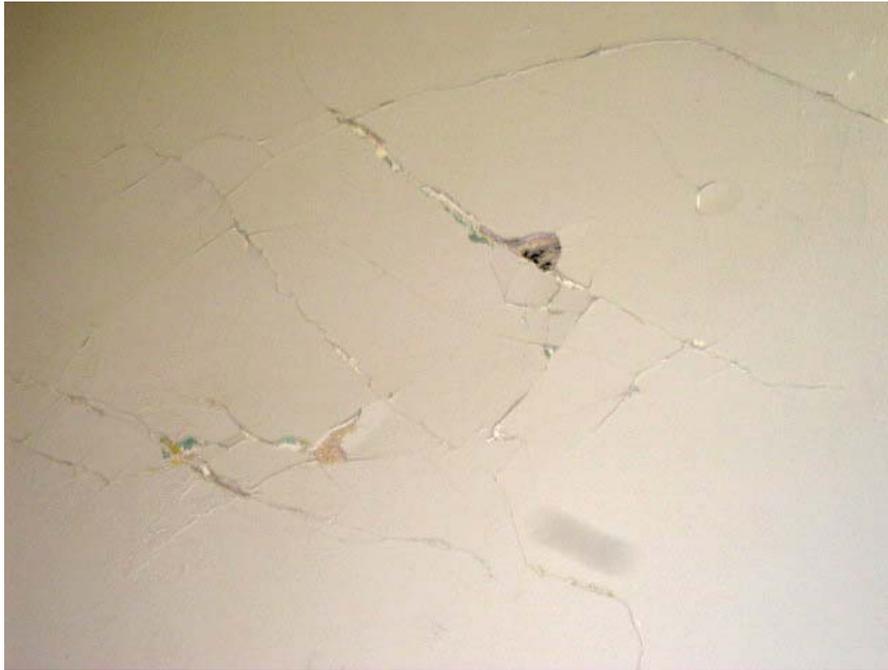
**Picture 9**

**Cracked/Damaged Ceiling Plaster**

8. Make repairs to water-damaged building materials throughout the building.
9. Remedy all exterior building envelope conditions that contribute to water infiltration into the building, such as:

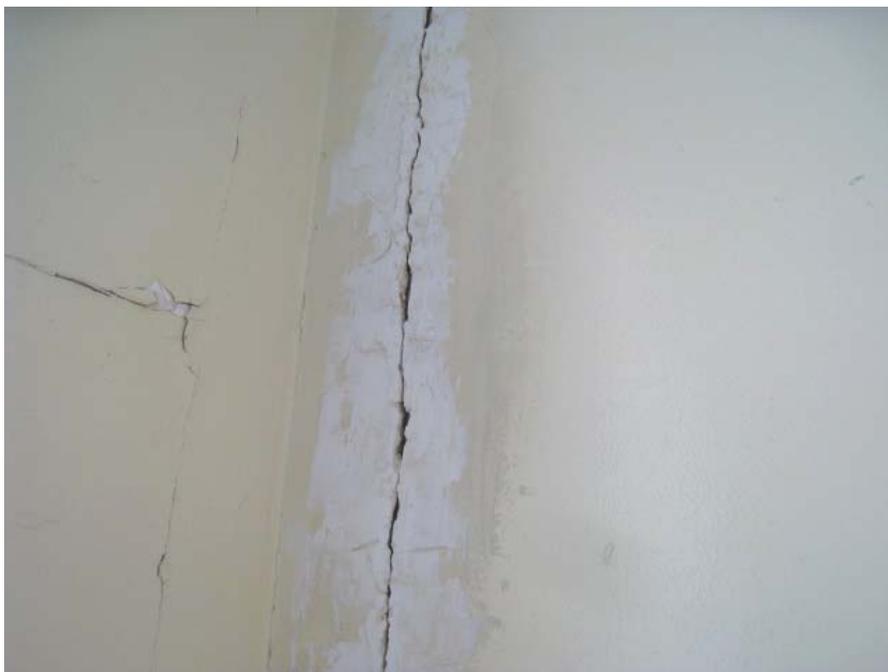
**Picture 10**

**Water-Damaged Wall Plaster**

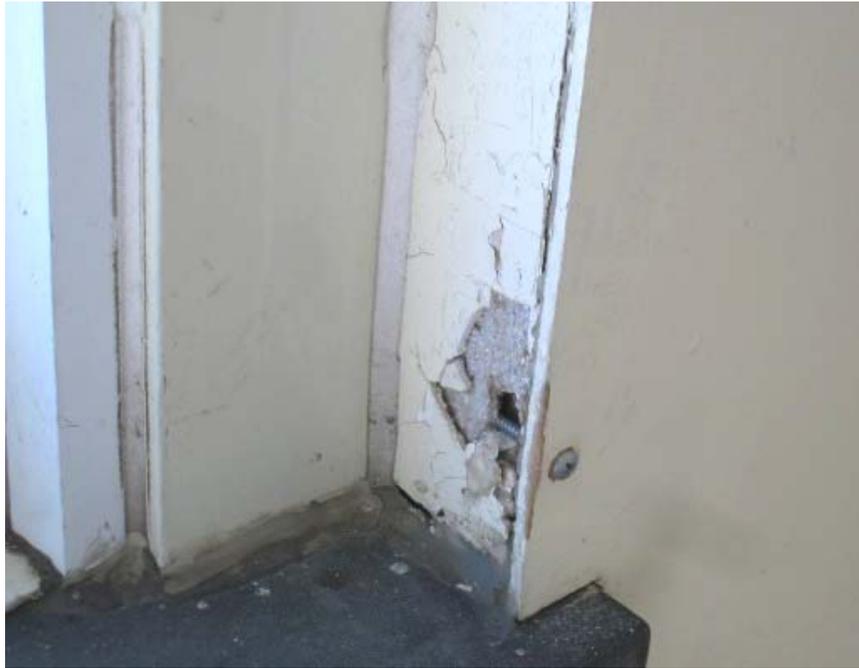
**Picture 11**

**Water-Damaged Window/Wall Plaster**

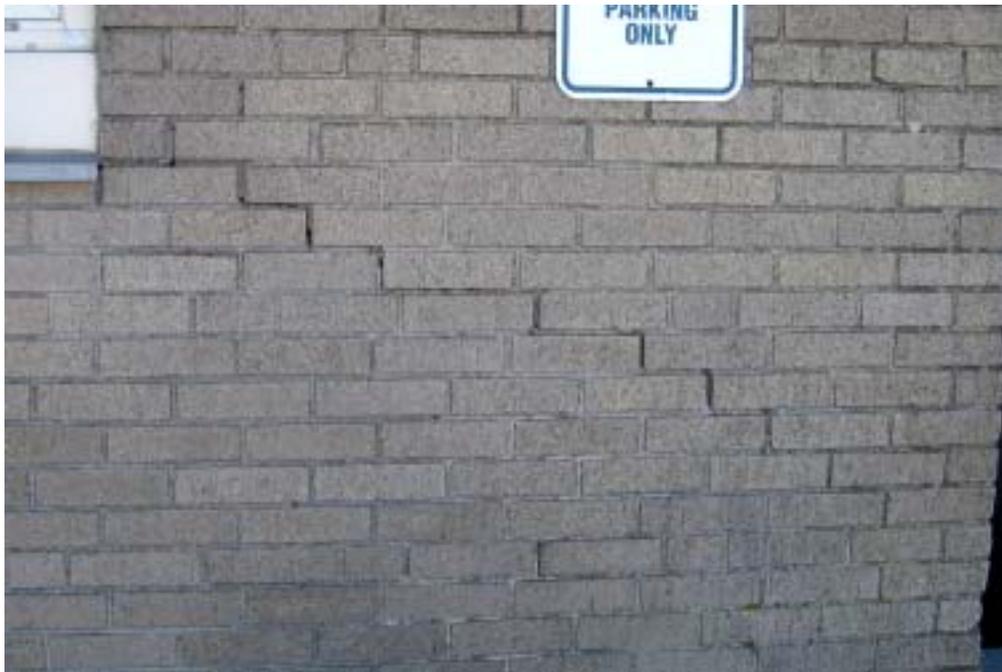
**Picture 12**

**Damaged Exterior Brickwork**

- a. Repair cracked masonry and broken, missing mortar in exterior brickwork;
  - b. Seal cracks in foundation;
  - c. Seal open penetrations into the building;

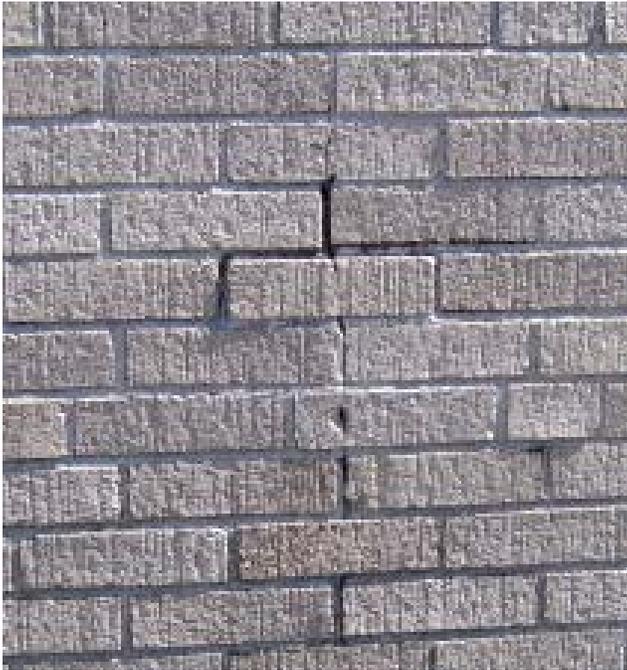
**Picture 13**

**Damaged Exterior Brickwork**

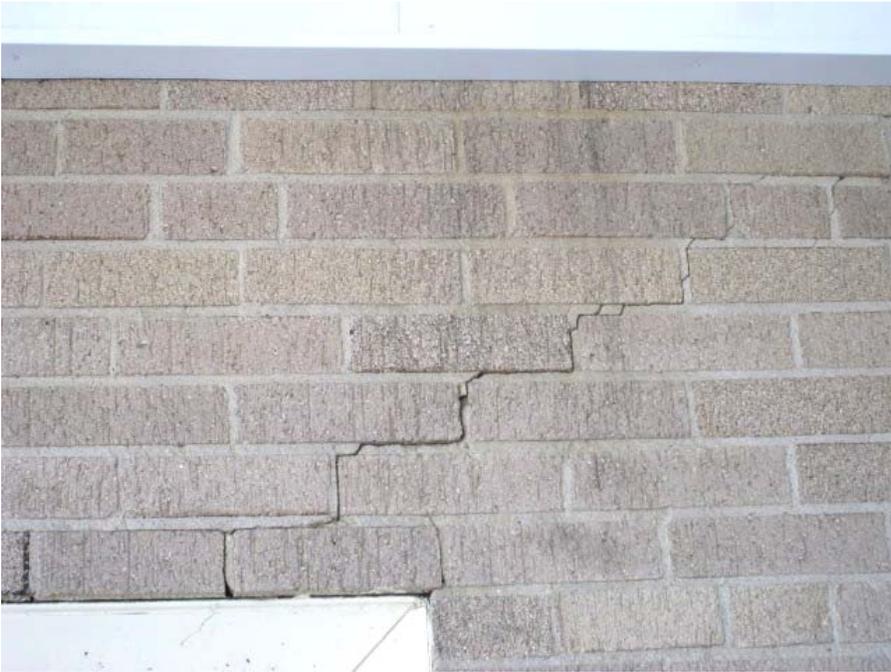
**Picture 14**

**Damaged Exterior Brickwork**

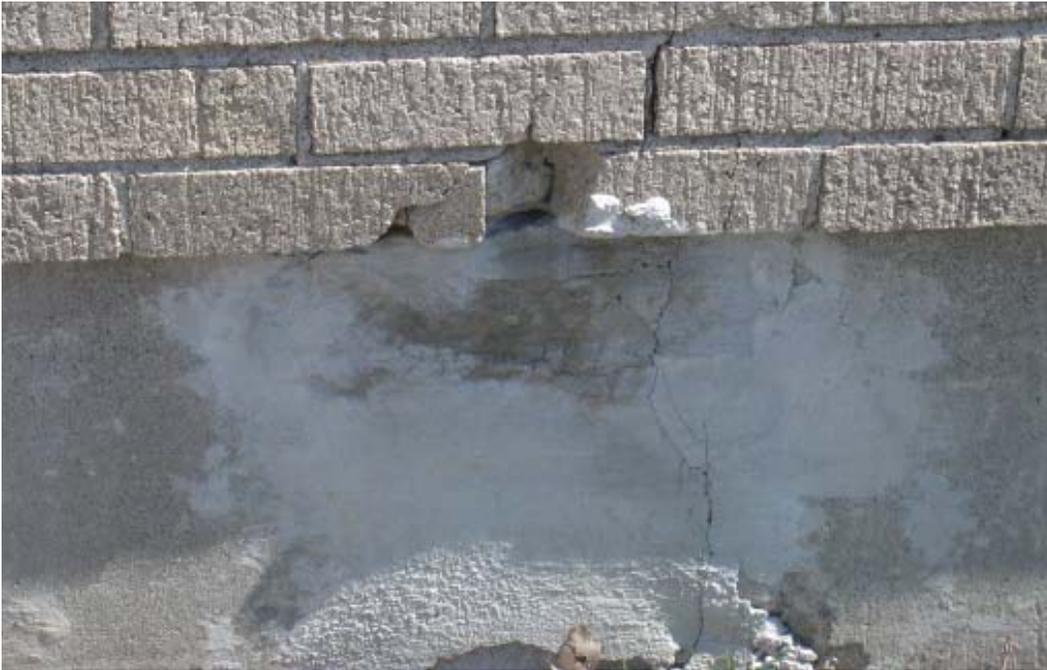
**Picture 15**

**Damaged Brickwork and Foundation**

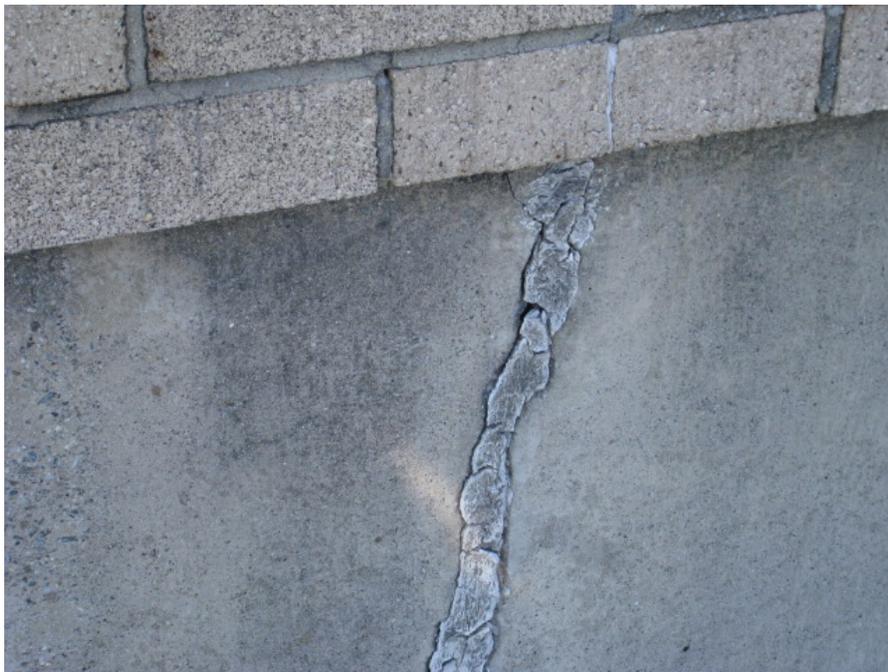
**Picture 16**

**Damaged Foundation**

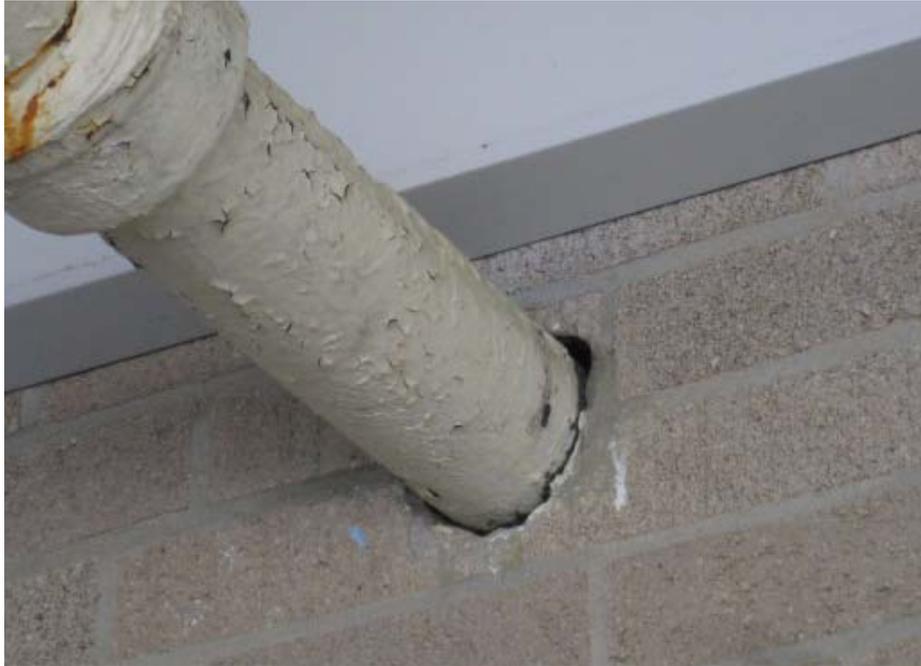
**Picture 17**

- Open spaces around utility pipes (Picture 17);
- Clinging plants on exterior walls, which holds moisture against the building (Picture 18); and
- Plant growth between foundation and tarmac (Picture 19).

**Open Spaces around Utility Pipes**

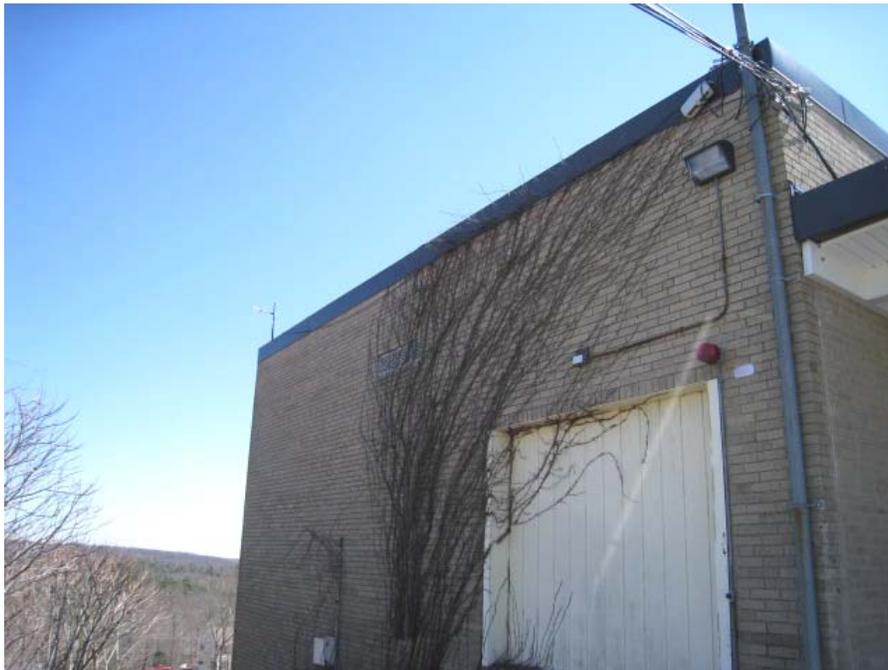
**Picture 18**

**Clinging Plants on Exterior Wall**

- f. Remove plants/trees/vines from impacting the building.
  - g. Reduce the amount of food/containers stored and/or prepared in classrooms.  
Stored and waste food products can be attractive to insect and rodent pests which can contribute to indoor air quality problems.

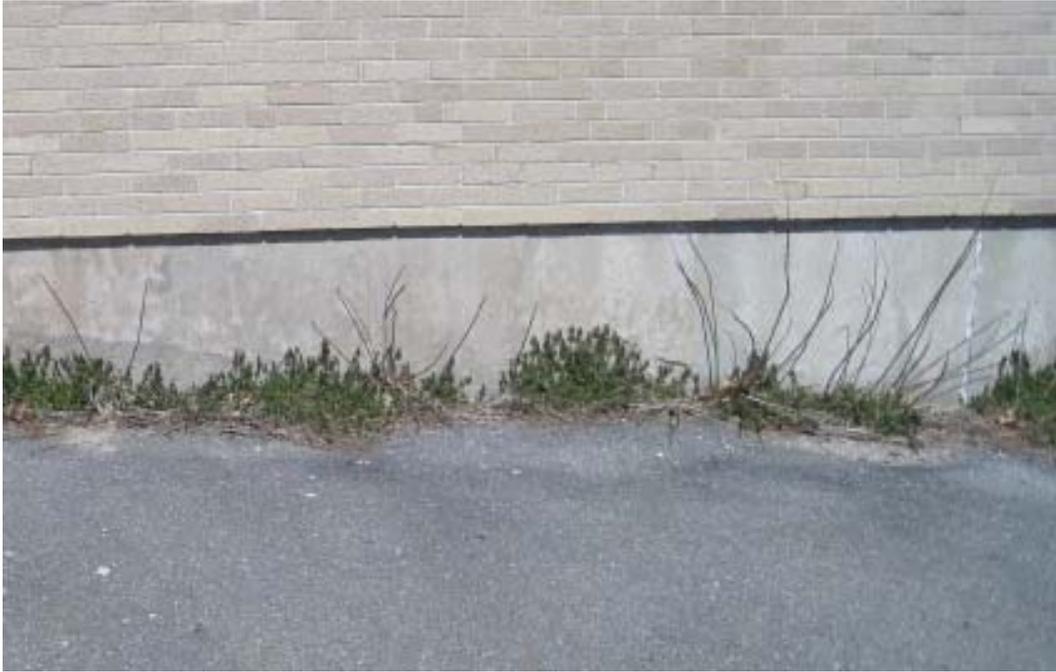
**Picture 19**

**Plant Growth between Foundation and Tarmac**

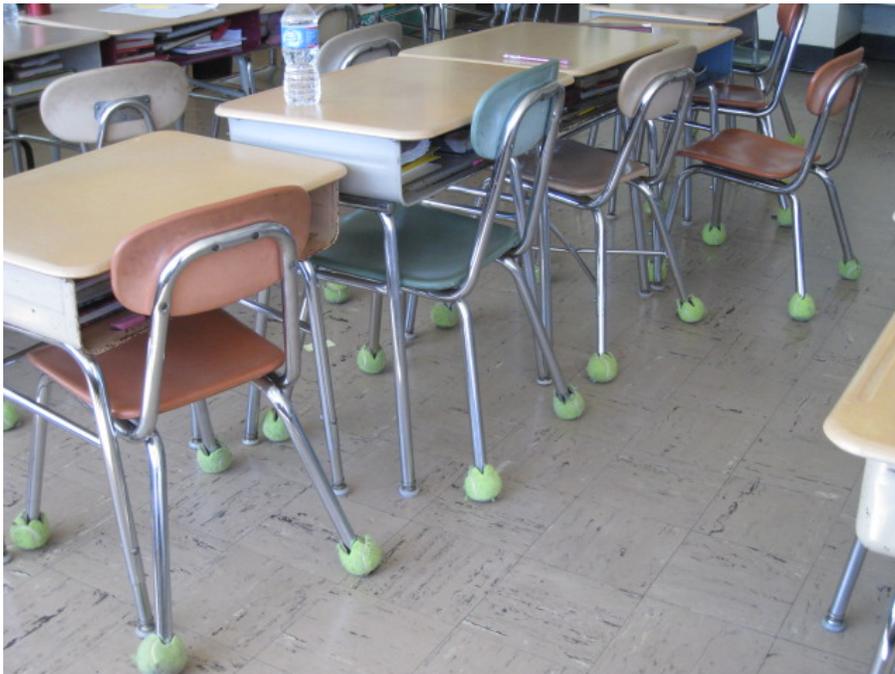
**Picture 20**

BEH staff observed tennis balls which had been sliced open and placed on chair and/or table legs presumably to reduce noise (Picture 20). Tennis balls are made of a number of materials that are a source of respiratory irritants. Constant wearing of tennis balls can produce fibers and cause volatile organic compounds (VOCs) to off-gas. Tennis balls are made with a natural rubber latex bladder, which becomes abraded when used as a chair leg pad. Use of tennis balls in this manner may introduce latex dust into the school environment. Some individuals are highly allergic to latex (e.g., spina bifida patients) (SBAA, 2001). It is recommended that the use of materials containing latex be limited in buildings to reduce the likelihood of symptoms in sensitive individuals (NIOSH, 1997).

**Tennis Balls on Chair Legs**

- j. Clean items, including chalk trays, pencil shaving trays and dry erase marker trays regularly with a wet cloth or sponge to prevent excessive build-up.
- 10. Consider replacing tennis balls with latex-free tennis balls or glides.
- 11. Properly seal abandoned plumbing pipes in teacher's lounge.
- 12. Repair hole near light fixture in ceiling over food prep area.
- 13. Consider adopting the US EPA (2000) document, "Tools for Schools", as an instrument for maintaining a good indoor air quality environment in the building. This document is available at: <http://www.epa.gov/iaq/schools/index.html>.
- 14. Refer to resource manual and other related indoor air quality documents located on the MDPH's website for further building-wide evaluations and advice on maintaining public buildings. These documents are available at: <http://mass.gov/dph/iaq>.
