INDOOR AIR QUALITY ASSESSMENT

**Leicester Primary School
170 Paxton Street
Leicester, MA**

Prepared by:
The Massachusetts Department of Public Health
Bureau of Environmental Health
Indoor Air Quality Program
December 2011

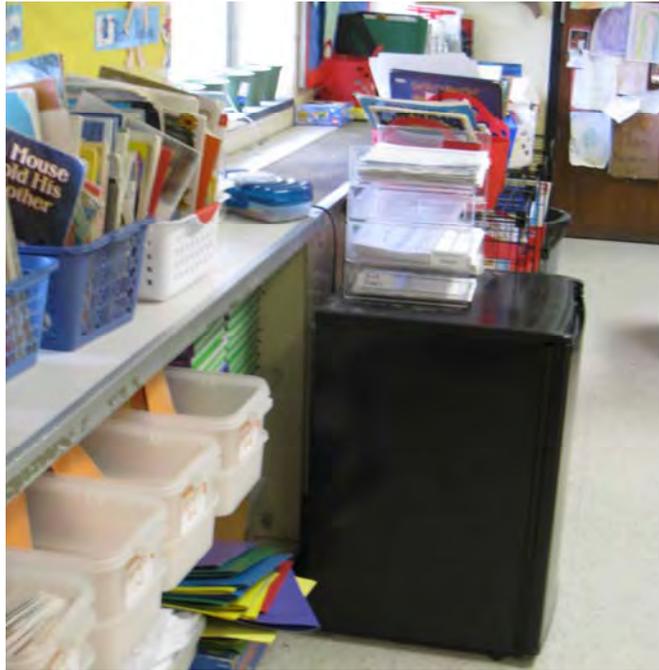
Picture 1

Classroom items obstructing airflow into univent return vent (bottom front)

3. Remove all blockages from univents and exhaust vents to ensure adequate airflow.
4. Make provisions for supply/make-up air for music and library offices either by ducting active supply ventilation or installing passive vent.

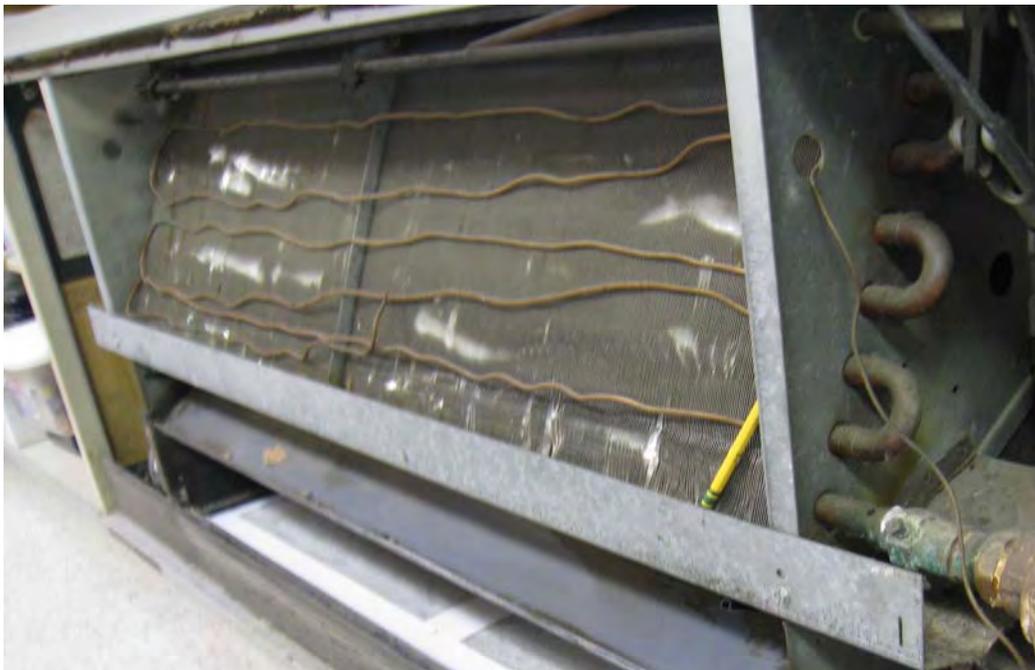
Picture 2

Also noted were dirt/dust covered air filters and accumulated material within the units (Pictures 2 and 3). Debris-saturated filters can decrease airflow and may serve as a reservoir of particulates that can be re-aerosolized and distributed to occupied areas.

Univent heating fins occluded with dust/debris

20. Ensure local exhaust is operating in the copy room and the library to remove odors and waste heat when operating the photocopiers and laminators.
21. Clean accumulated dust and debris periodically from the interior of univents, exhaust vents and blades of personal and ceiling fans.

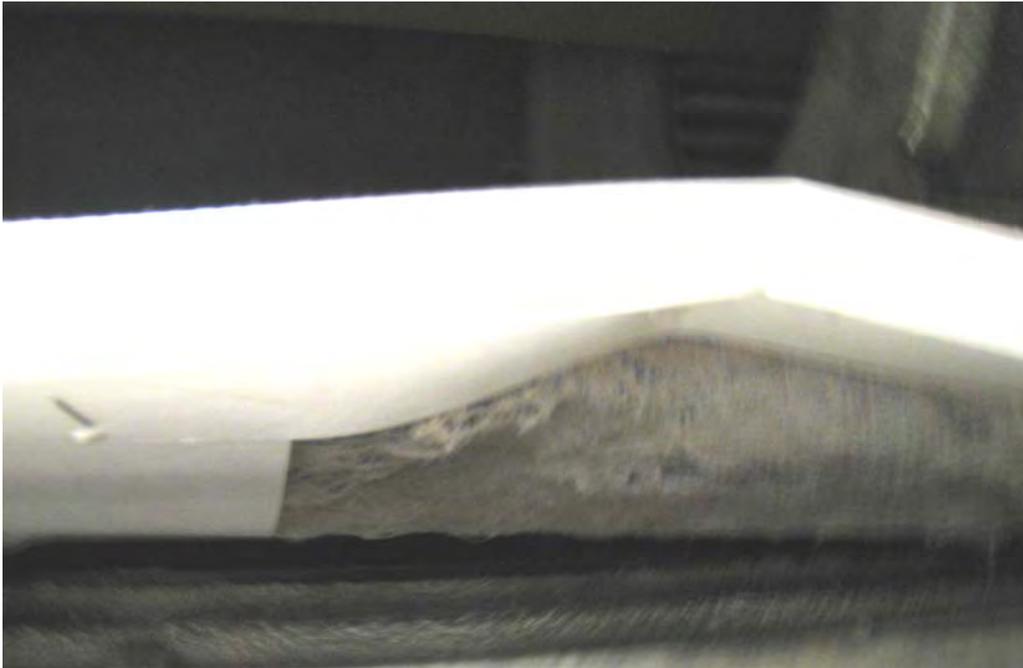
Picture 3

Close-up of univalent filter occluded with dust/debris

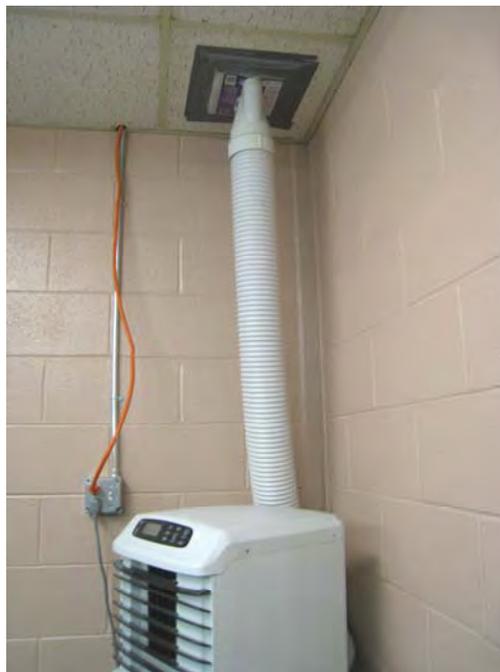
Picture 4

A number of areas are provided with window-mounted or portable air conditioners (ACs). Portable ACs were ducted directly to the general exhaust in offices where they were installed (Picture 4; Table 1). Although this configuration removes the excess heat and exhaust from the AC unit, it prohibits the ability of the general exhaust vent to remove environmental pollutants from the room. As a result, during the heating season, excess heat and odors can become trapped in these areas. As with all ventilation equipment, ACs are also equipped with filters that should be cleaned as directed by the manufacturer or more frequently if necessary.

Portable AC unit connected to general exhaust vent in Nurse's office

5. Disconnect portable AC units from general exhaust vents when the units are not in use. Ensure exhaust fans are operating at all times that the building is occupied to ensure pollutants, waste heat and moisture (generated from AC operation) are removed.

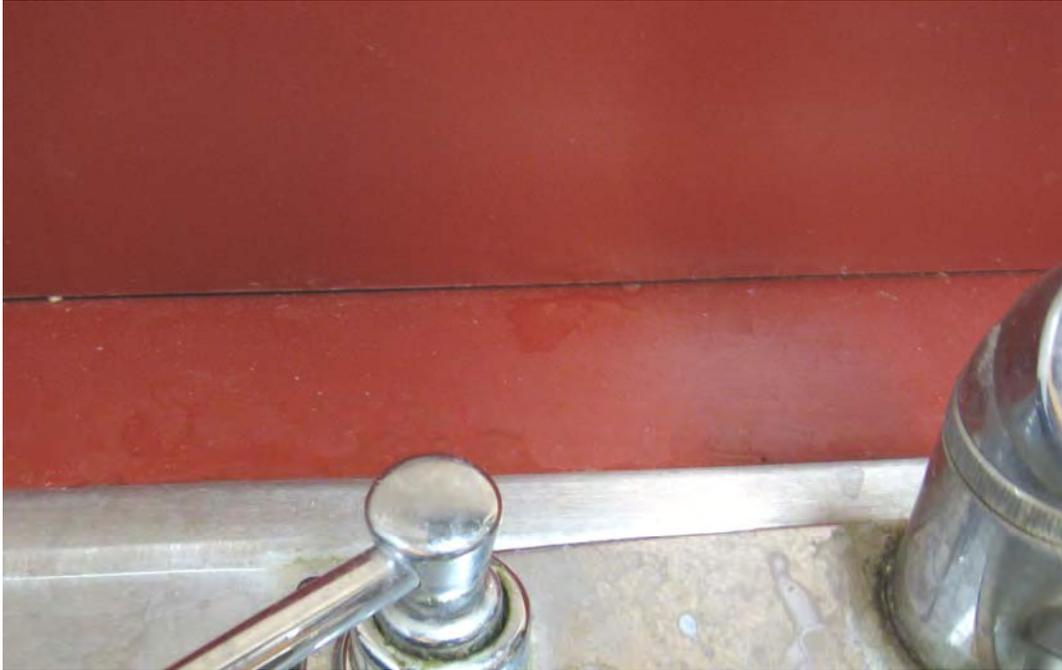
Picture 5

Water-damaged countertops were noted around sinks in some classrooms, particularly PS3 (Picture 5/Table 1). Spaces around sinks provide a means for water to penetrate into wooden countertops and cabinets. Over time, water-damaged wood can provide a medium for mold and mildew growth.

Space between sink countertop and backsplash

- d. Repair or replace broken/leaking windows.
12. Seal seams between counters and backsplashes in classrooms. Consider replacing with one-piece molded countertops as funds become available.

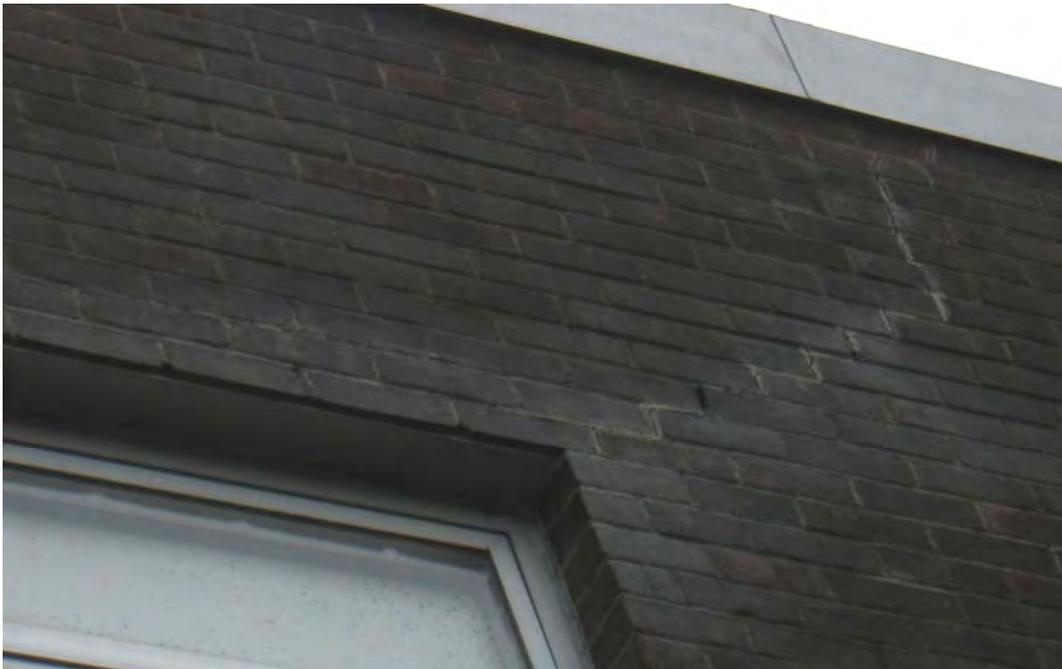
Picture 6

Efflorescence and missing/damaged mortar around brick

- a. Repair cracked masonry and broken, missing mortar in exterior brickwork;
 - b. Seal cracks in foundation;
 - c. Seal open penetrations into the building; and

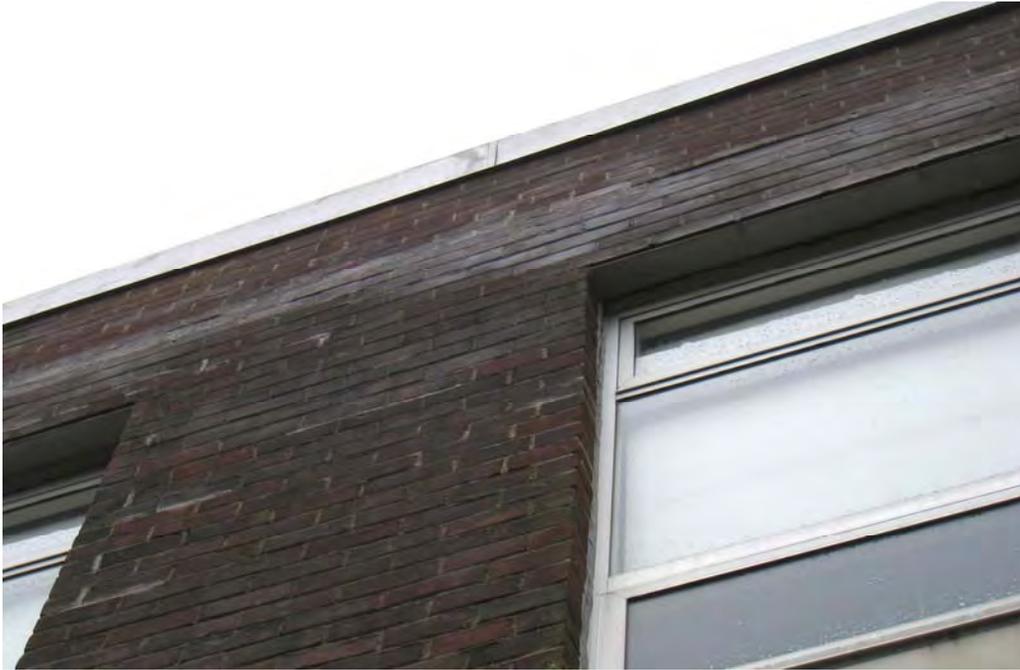
Picture 7

Efflorescence and missing/damaged mortar around brick

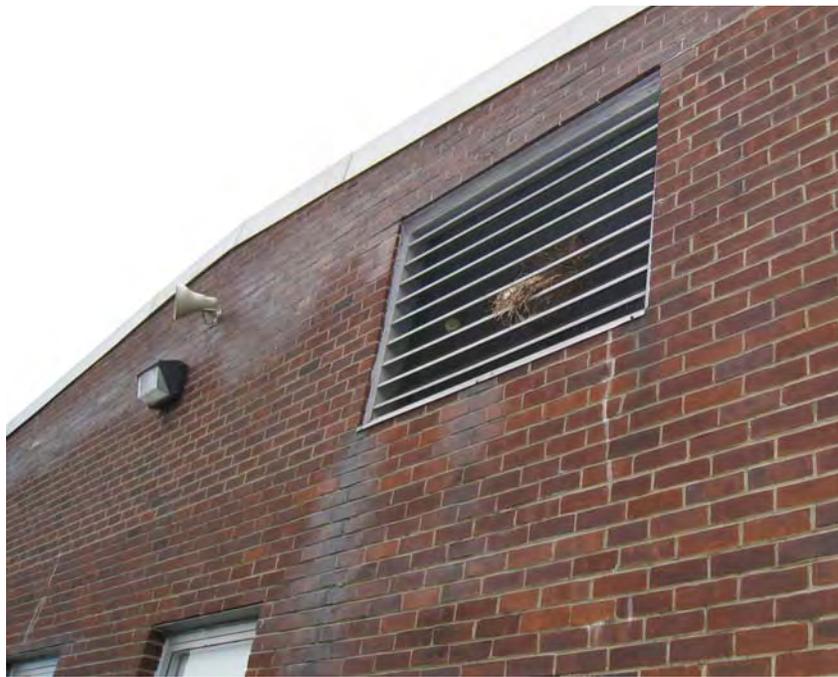
Picture 8

Finally, signs of bird roosting and nesting materials were observed in univent intake louvers (Picture 8). If the ventilation system is activated, the possibility exists for nesting materials, bird waste and other related particulate to be drawn into the system and be distributed to occupied areas. Birds can be a source of disease, and bird wastes and feathers can contain mold and mildew, which can be irritating to the respiratory system.

Efflorescence on exterior brickwork, also note bird nesting materials in vent

22. Remove bird nests from fresh air intake vent (Picture 8) and clean with an appropriate antimicrobial. Consider installing wire mesh bird screens over air intakes to prevent further roosting as necessary.

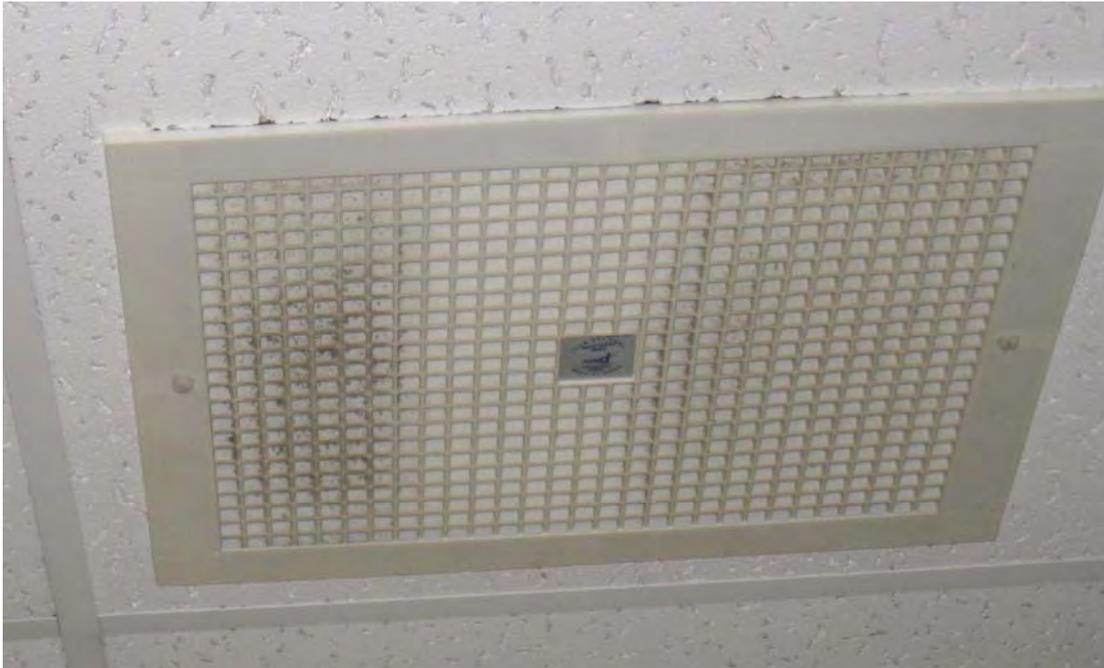
Picture 9

As mentioned, dust was observed accumulated in univent interiors, exhaust vents, and personal and ceiling fans (Pictures 2, 3, and 9). This equipment should be cleaned periodically in order to prevent dust/debris from being aerosolized and distributed throughout the room.

Dirt/dust accumulation on ceiling-mounted exhaust vent
