INDOOR AIR QUALITY REASSESSMENT

**Abbot Public Library
235 Pleasant Street
Marblehead, Massachusetts**

Prepared by:
Massachusetts Department of Public Health
Bureau of Environmental Health
Indoor Air Quality Program
October 2011

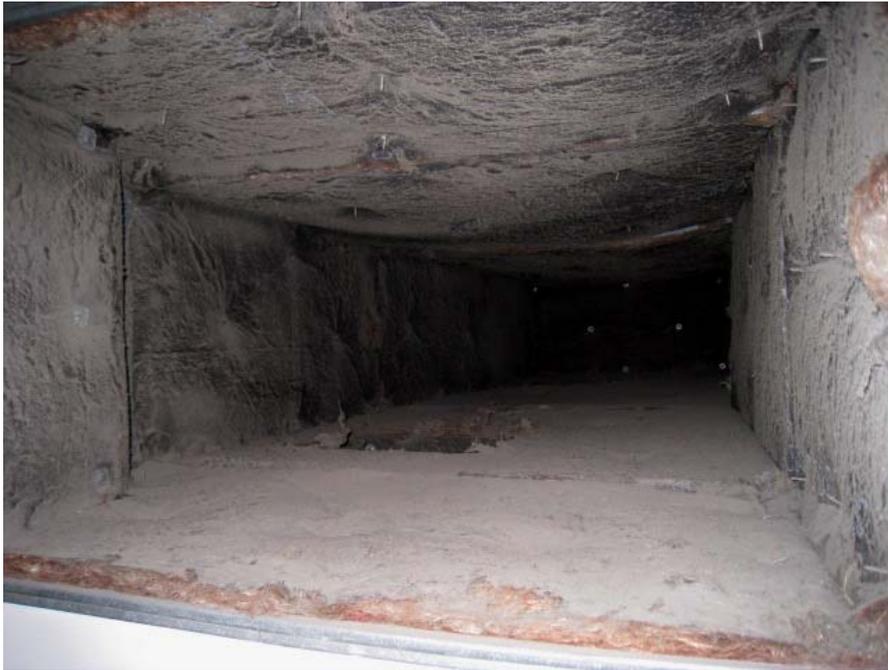
The return duct appeared to be lined with a fibrous material that is conducive to collecting dust and debris (Picture 5). It is unclear what the purpose of this material is. At the time of the assessment this material was completely occluded. In its current condition it can serve as a reservoir of airborne particulates in the air mixing room. BEH staff recommended that library officials contact their HVAC vendor to determine if the duct-lining material can be cleaned, or if deemed not necessary, removed.

**Fibrous Mesh-Lined Return Duct in HVAC Mechanical/Air Mixing Room
Covered with Dust/Debris**

4. Have HVAC vendor determine the function of duct shown in Picture 5 and whether the fibrous liner can be cleaned or removed if deemed not necessary. For additional information regarding duct cleaning, please consult the National Air Duct Cleaners Association guidance at <https://www.nadca.com/download/NADCA%20GENERAL%20SPECIFICATIONS%202006.pdf>

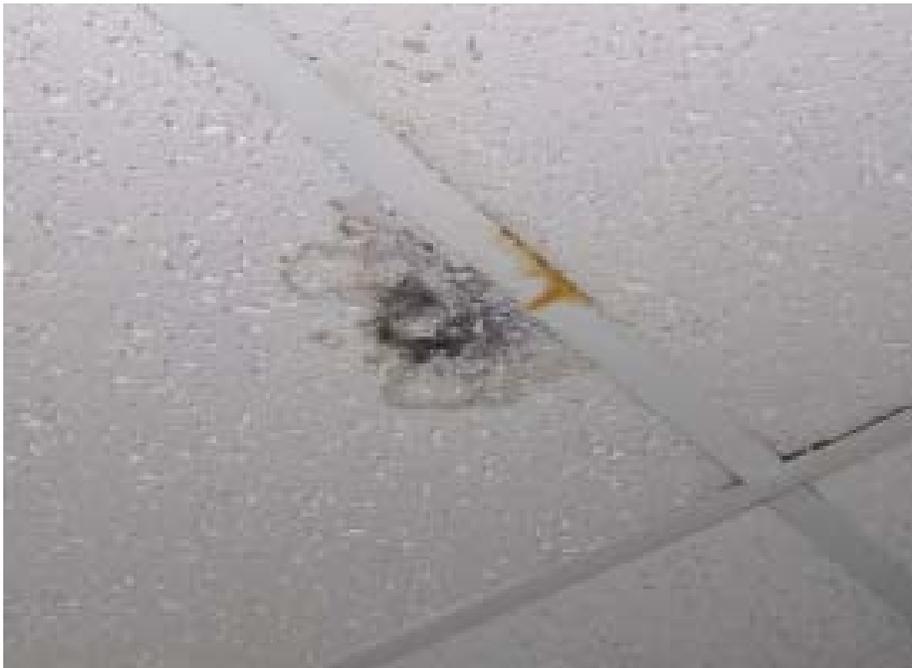
Picture 6

Water-damaged/mold-colonized ceiling tiles were seen, such as the 644-657 non fiction area on the main floor (Picture 6/Table 1). Water-damaged ceiling tiles indicate leaks from either the roof or plumbing system and can provide a source for mold growth. These tiles should be replaced after a water leak is discovered and repaired.

Mold-Colonized Ceiling Tile in the 644-657 Non-Fiction Area on Main Floor

12. Replace or make repairs to water-damaged materials in HVAC mechanical room.
13. Remove plant growth in downspout gutter system shown in Picture 12.
14. Remove/replace water-damaged ceiling tiles. Examine the area above and around these areas for mold growth. Disinfect areas of water leaks with an appropriate antimicrobial.

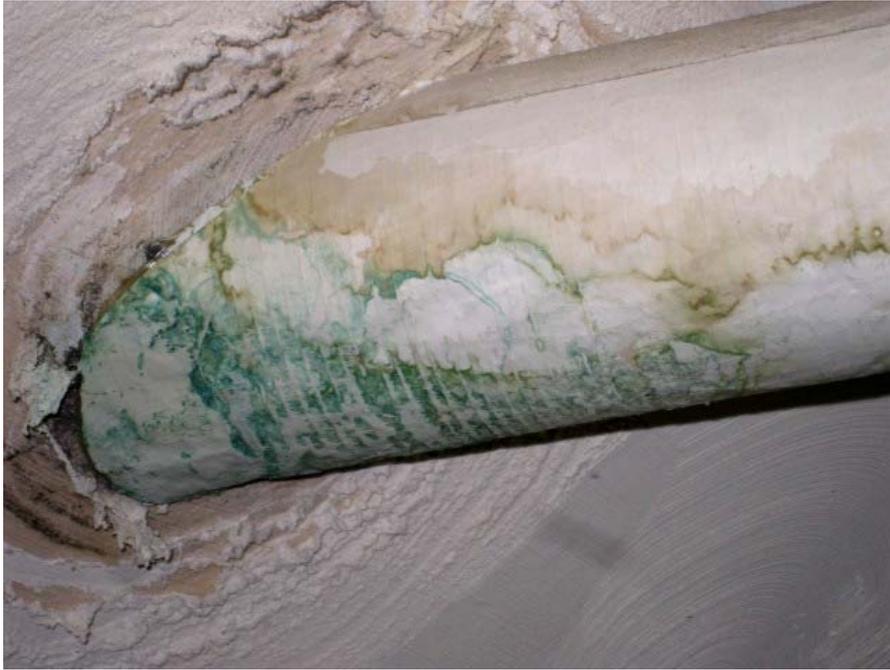
Picture 7

Water-damaged drywall, pipe insulation and efflorescence were observed in the 3rd floor mechanical room (Pictures 7 through 9). The mechanical room shares a common wall with the unconditioned attic space (Picture 10). The source of moisture causing this water damage appears to be condensation due to unconditioned air penetrating above the ceiling of the mechanical room, where the warm moist air comes in contact with a surface with a temperature below the dew point. In this case, chilled water pipes to the HVAC system (Picture 11).

Water-Damaged Ceiling and Pipe Insulation in HVAC Mechanical/Air Mixing Room

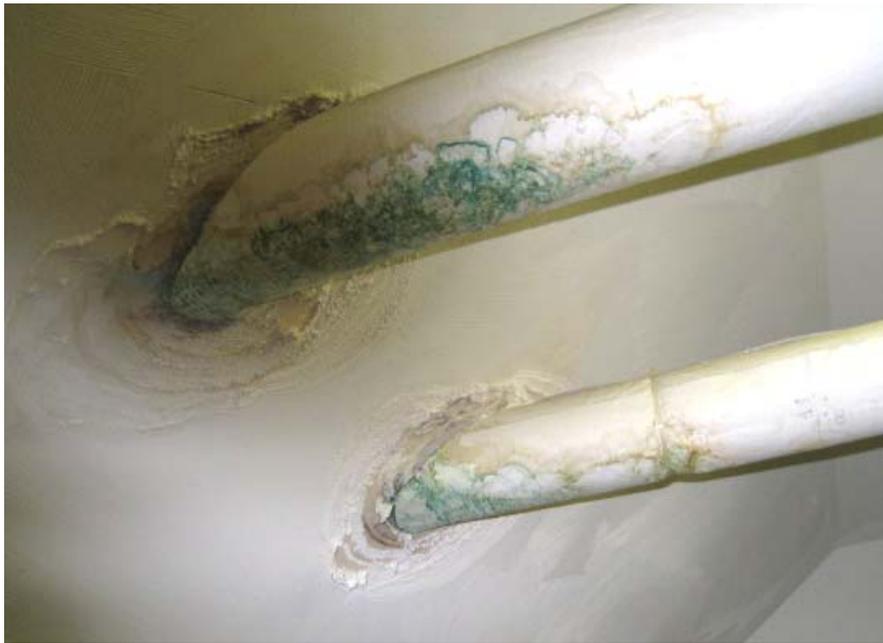
Picture 8

Efflorescence and Water Damaged Ceiling and Pipe Insulation in HVAC Mechanical/Air Mixing Room

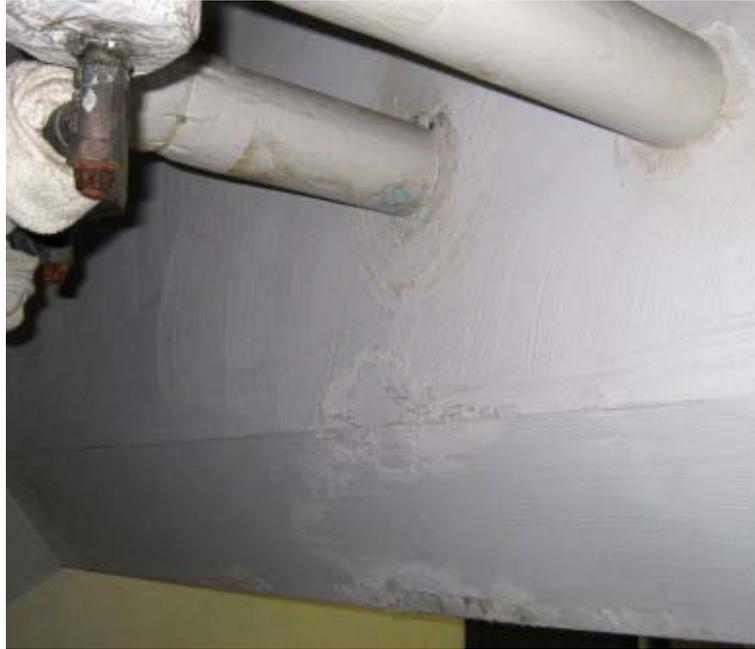
Picture 9

Efflorescence and Water-Damaged Ceiling and Pipe Insulation in HVAC Mechanical/Air Mixing Room

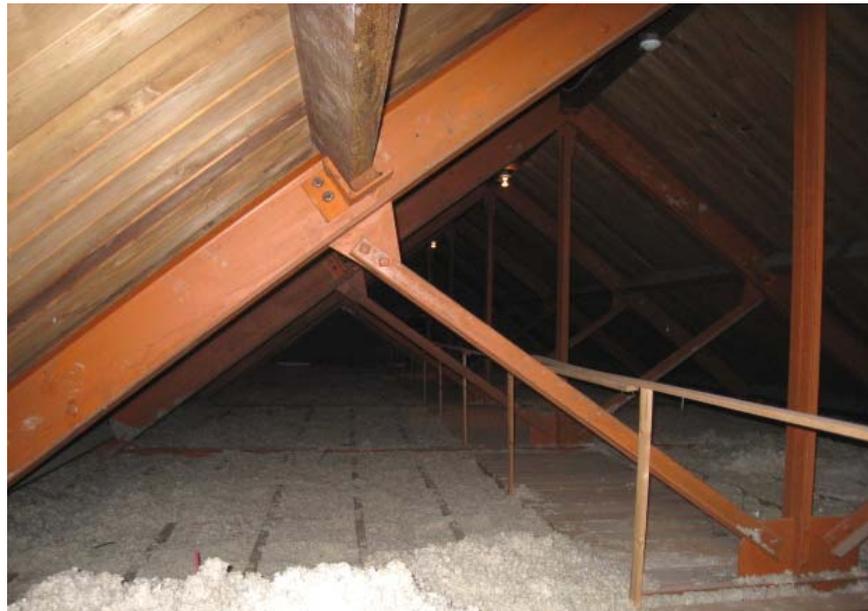
Picture 10

Unconditioned Attic

11. Seal above ceiling space between HVAC mechanical room and unconditioned attic (Pictures 10 and 11) to reduce/prevent condensation and further water damage.

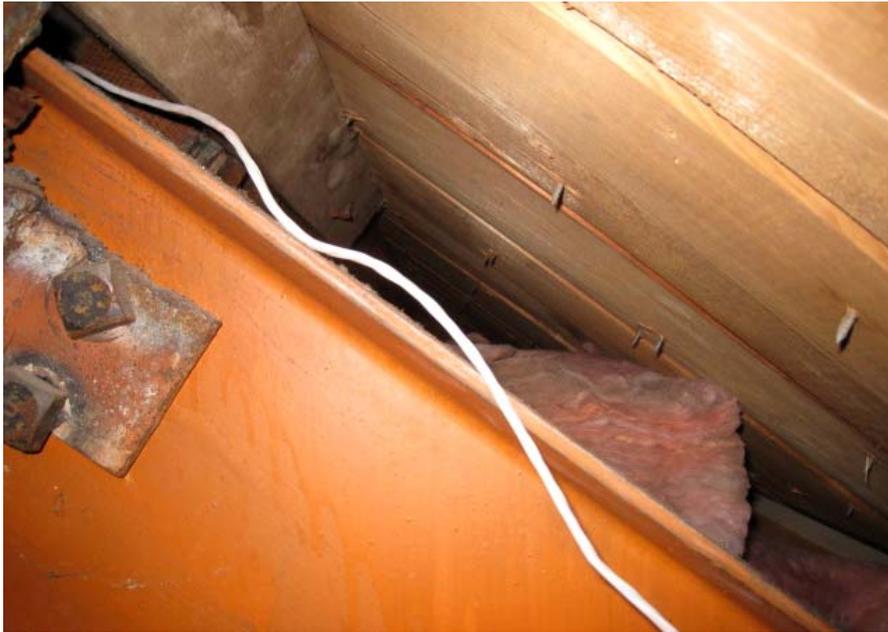
Picture 11

Air Space Where Unconditioned Attic Air Flows into Ceiling Plenum of HVAC Mechanical Room causing Condensation and Water Damage to Building Materials

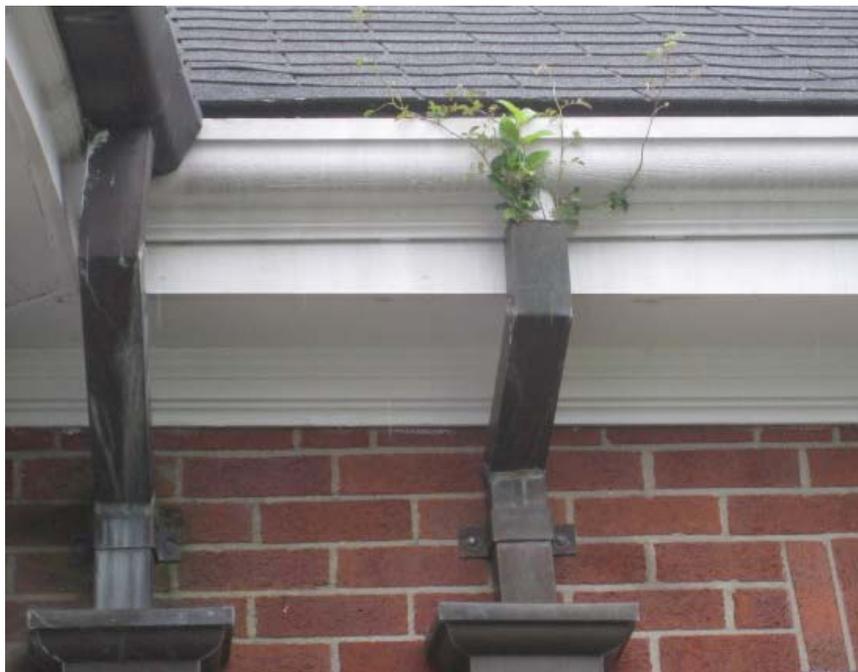
Picture 12

Although a number of improvements to the gutter/downspout system were made (Appendix A), a downspout at the front of the building appeared to be clogged with debris and plant growth (Picture 12). This equipment should be monitored on a regular basis to ensure proper drainage.

Debris/Plant Growth in Downspout at Front of Building

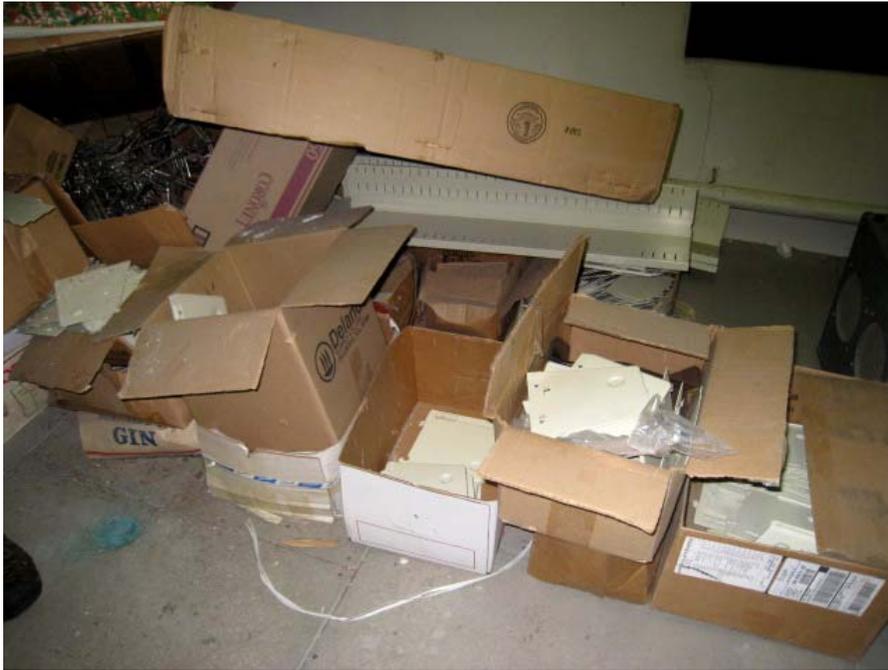
Picture 13

Lastly, a number of items were stored in the HVAC mechanical room, including a water-damaged/moldy cardboard box (Pictures 13 and 14). The air mixing room should be routinely cleaned and not used for storage.

Items Stored in HVAC Mechanical/Air Mixing Room

5. Remove stored items from HVAC mechanical room.
6. Remove carpeting in below grade areas (e.g., young adult library), replace with non-porous floor covering.

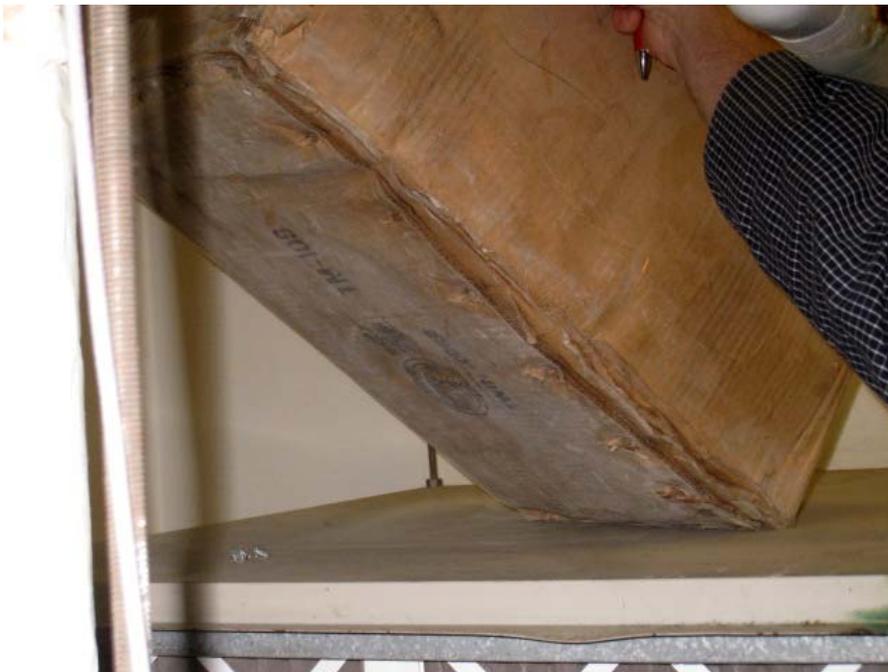
Picture 14

Water-Damaged/Mold-Colonized Box in HVAC Mechanical/Air Mixing Room

15. Ensure paper/cardboard materials are not stored directly on floors in unconditioned areas. Discard any water-damaged/mold colonized porous materials.
