# **INDOOR AIR QUALITY ASSESSMENT**

**Mashpee Middle/High School  
500 Old Barnstable Road  
Mashpee, Massachusetts**

Prepared by:  
Massachusetts Department of Public Health  
Bureau of Environmental Health  
Indoor Air Quality Program  
January 2011

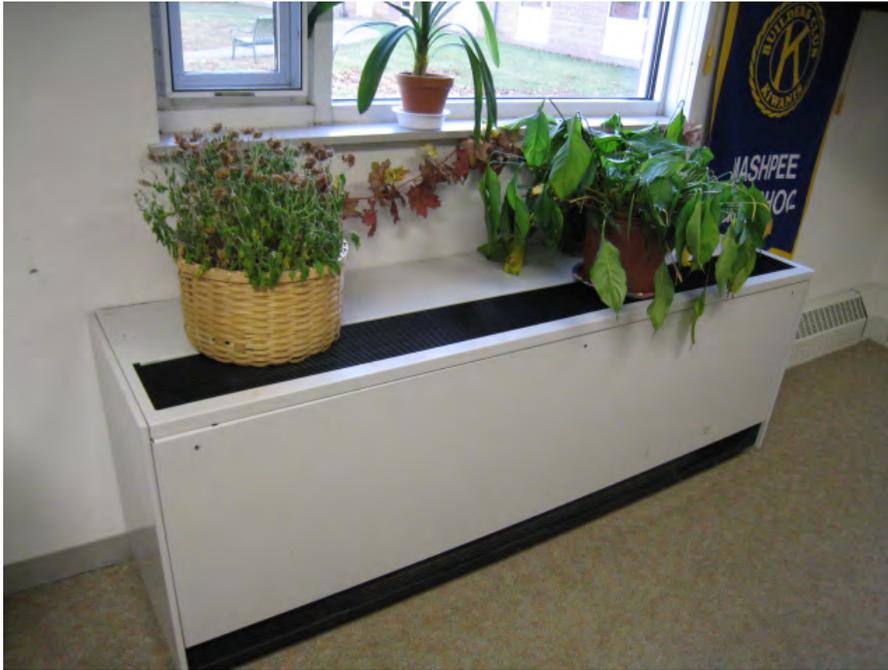
**Picture 1**

Plants were noted in several classrooms, in some instances on or near univent equipment (Picture 1). Plants can be a source of pollen and mold which can be respiratory irritants to some individuals. Plants should be properly maintained and equipped with drip pans. They should also be located away from univents to prevent the aerosolization of dirt, pollen and mold.

**Typical Classroom Univent, Note Plants on Top/Near Air Diffuser**

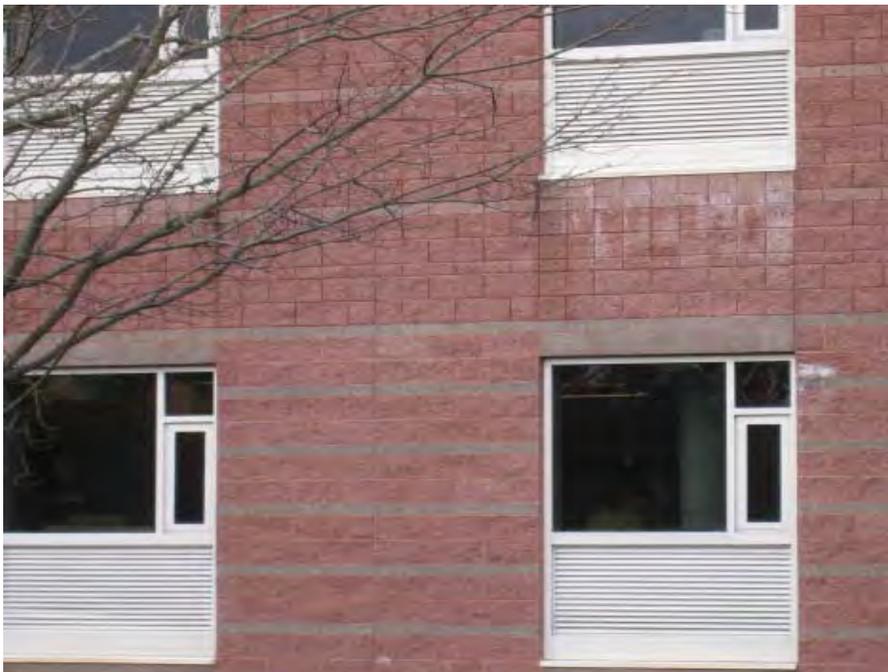
**Picture 2**

Fresh air is supplied to most classrooms by unit ventilator (univent) systems (Picture 1). A univent draws air from the outdoors through a fresh air intake located on the exterior wall of the building (Picture 2). Return air from the classroom is drawn through an air intake located at the base of the unit (Figure 1). Fresh and return air are mixed, filtered, heated and provided to classrooms through an air diffuser located in the top of the unit. At the time of the IAQ assessment, univents were operating in the large majority of the areas surveyed; however, some had been deactivated. Univents in some areas had items stored on top, which can restrict airflow (Picture 3; Table 1). In order for univents to provide fresh air as designed, intakes/diffusers must remain free of obstructions. Importantly, these units must remain 'on' and be allowed to operate while rooms are occupied.

**Univent Fresh Air Intakes below Windows**

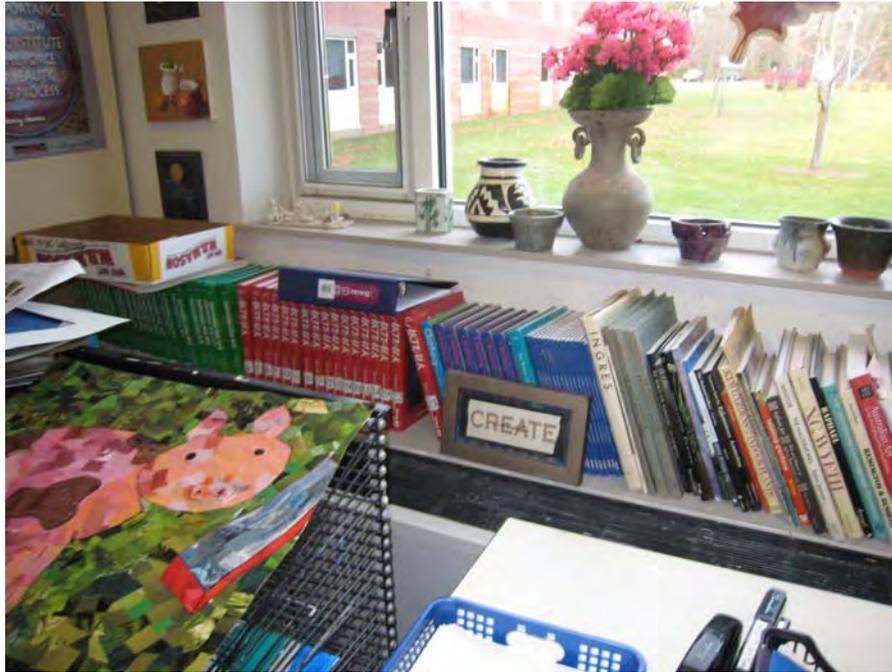
**Picture 3**

**Items placed on and in front of univent, note debris in diffuser**

4. Remove all blockages from univents to ensure adequate airflow.
5. Examine HVAC unit in B-112 for proper operation, make repairs as needed.
6. Examine if fresh air supply can be increased/intake adjusted in areas that measured over 800 ppm carbon dioxide.

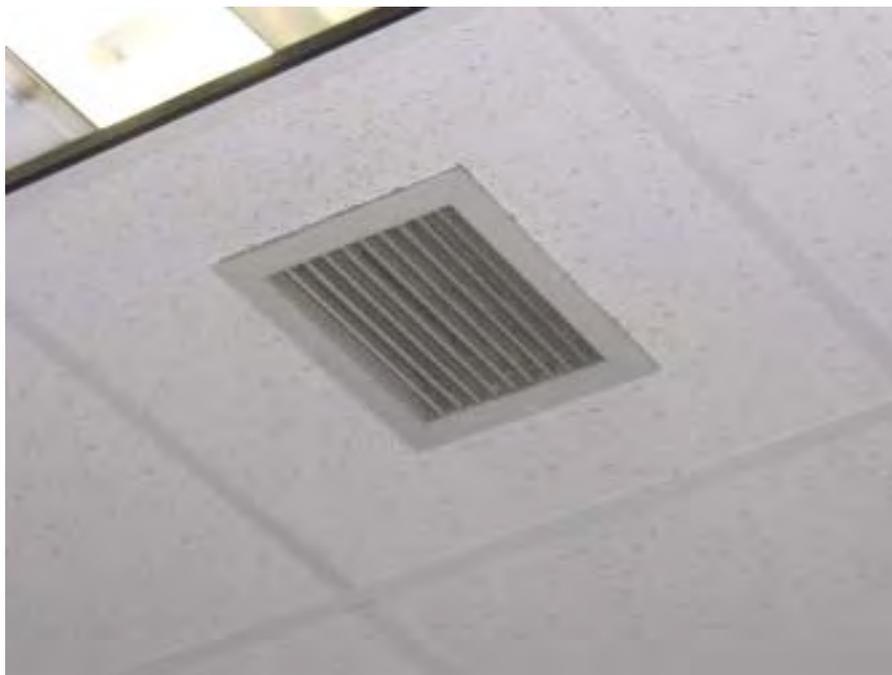
**Picture 4**

Exhaust ventilation for classrooms is provided by ceiling or wall-mounted vents powered by rooftop motors (Pictures 4 and 5). The exhaust system was operating at the time of assessment.

**Ceiling-Mounted Exhaust Vent**

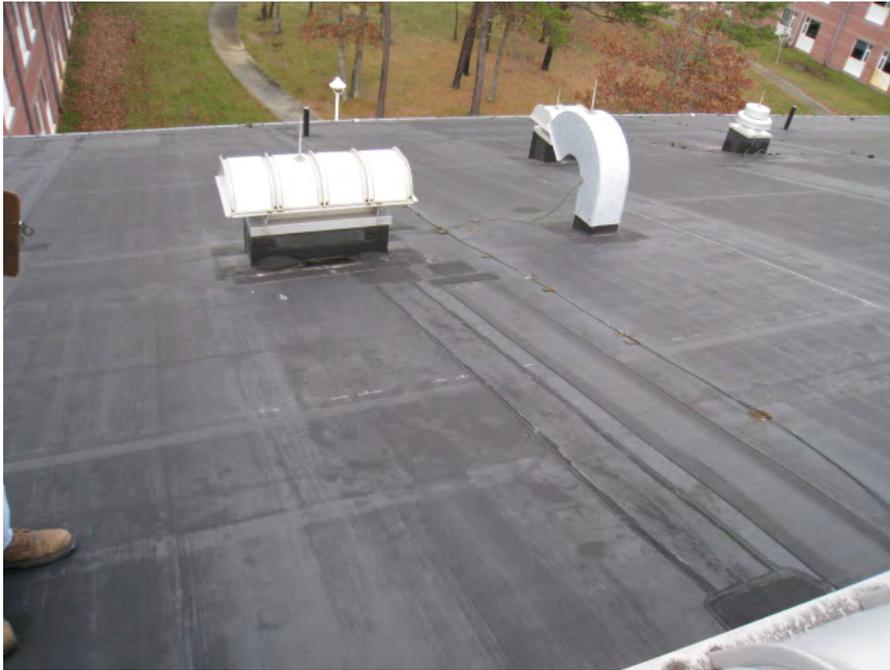
**Picture 5**

**Rooftop Exhaust Motors/Vents**

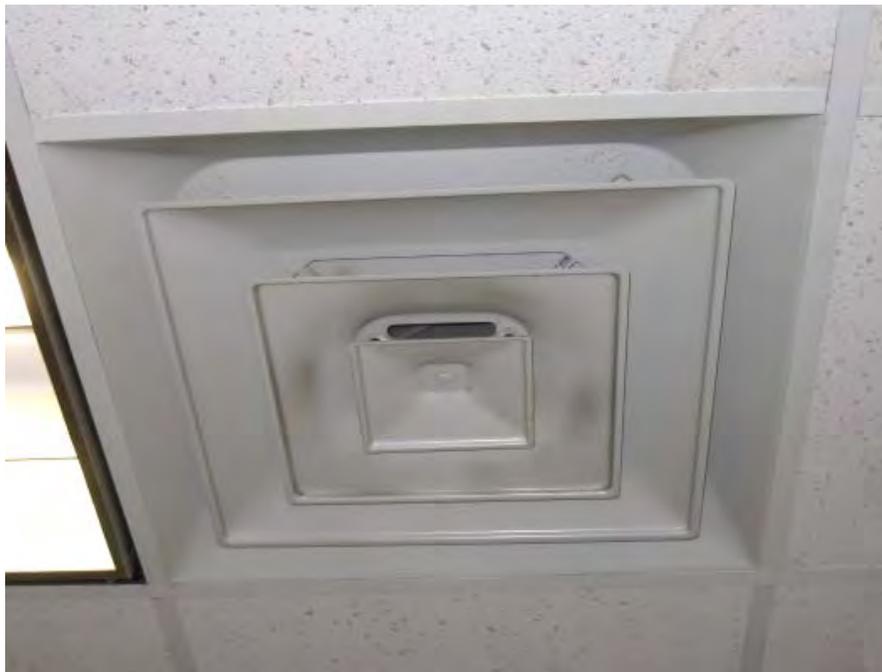
**Picture 6**

A number of air diffusers, exhaust/return vents and personal fans were observed with accumulated dust/debris (Pictures 6 and 27). If exhaust vents are not functioning, backdrafting can occur, which can re-aerosolize accumulated dust particles. Re-activated supply vents and fans can also aerosolize dust accumulated on vents/fan blades. Several rooms had various objects hung from the ceiling tile system (Picture 28). Building occupants should refrain from hanging objects to prevent damage to the ceiling tile system. Damaged/dislodged ceiling tiles can provide a pathway for the movement of drafts, dusts and particulate matter between rooms and floors.

**Ceiling-Mounted Supply Diffuser, Note Dust/Debris Accumulation on Louvers**

22. Clean accumulated dust and debris periodically from the surface of air diffusers, exhaust vents and blades of personal and ceiling fans.
23. Refrain from hanging objects from ceiling tile system. Ensure missing or ajar ceiling tiles are in place.

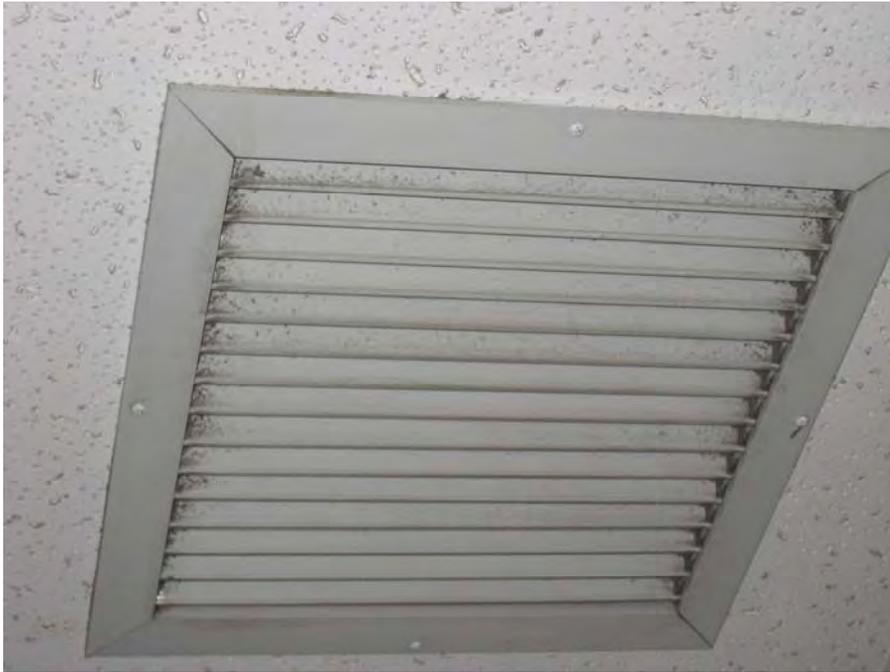
**Picture 7**

**Ceiling-Mounted Return Vent**

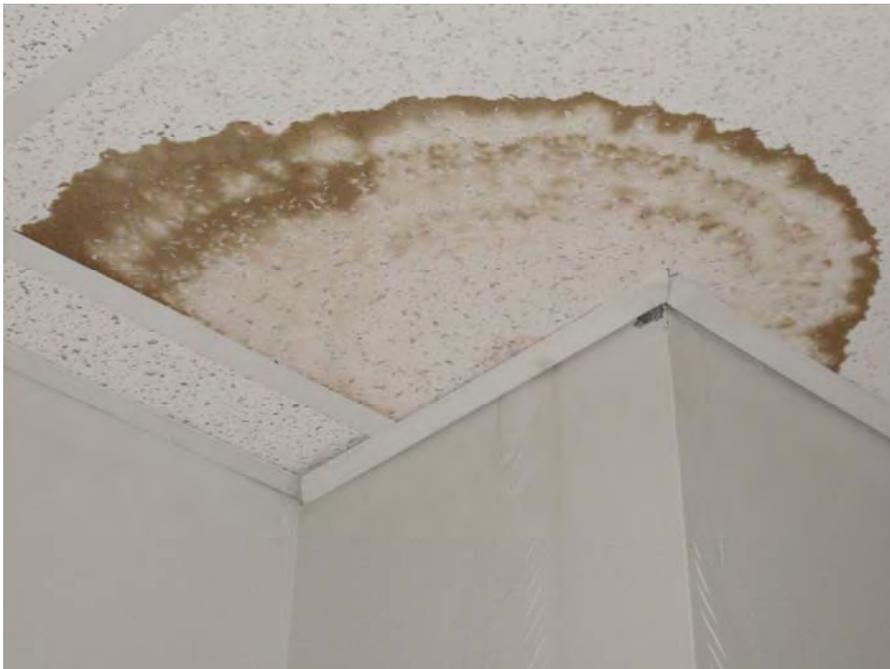
**Picture 8**

As indicated previously, the assessment was prompted by concerns of water damage/mold related to chronic roof leaks. Signs of roof leaks (e.g., water-damaged ceiling tiles and peeling paint) were observed in many areas throughout the school (Pictures 8 and 9/Table 1). Water-damaged ceiling tiles can provide a source of moisture/microbial growth and should be replaced after a water leak is discovered and repaired.

**Water-Damaged Ceiling Tile and Peeling Paint on Wall**

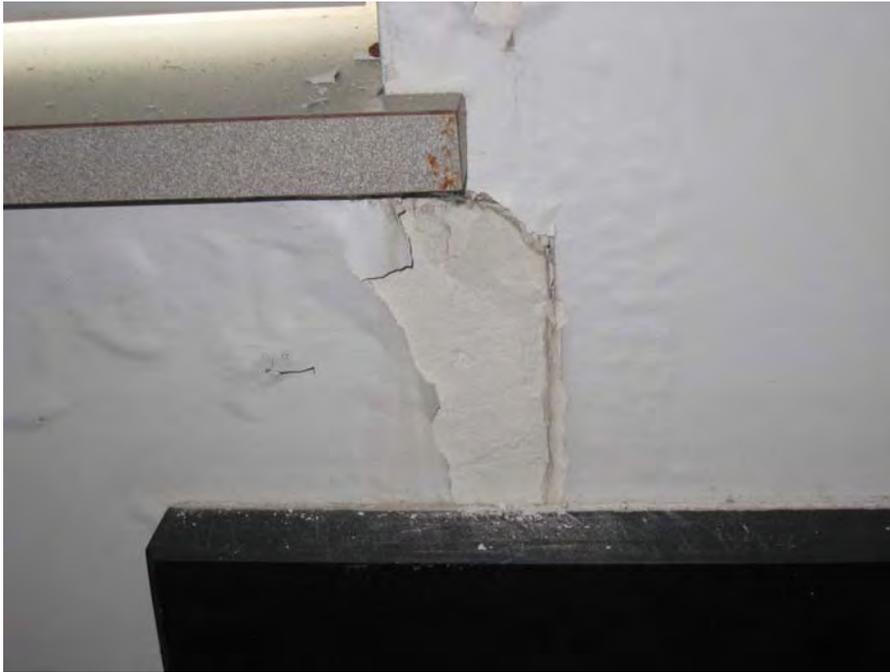
**Picture 9**

**Water-Damaged Gypsum Wallboard and Peeling Paint**

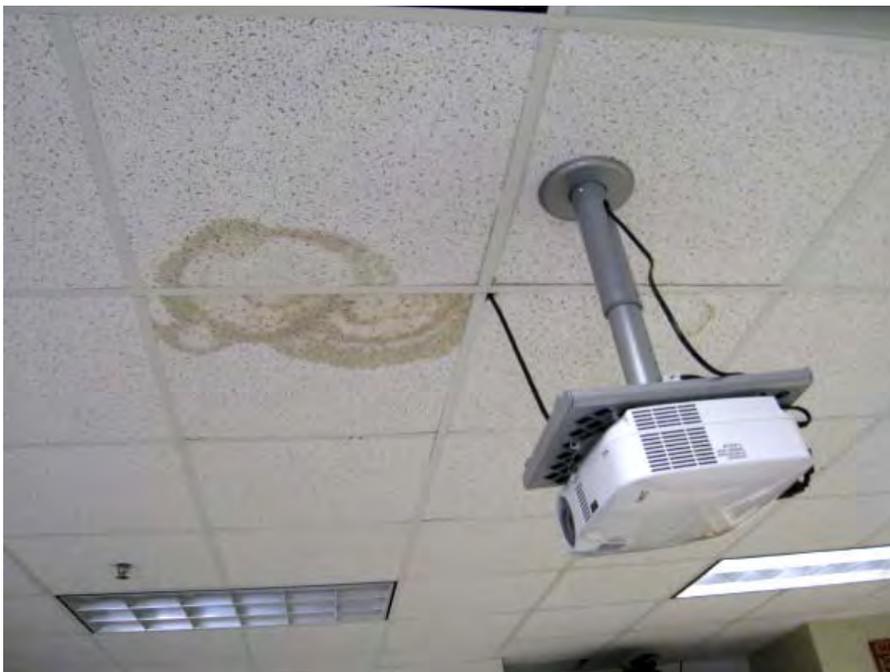
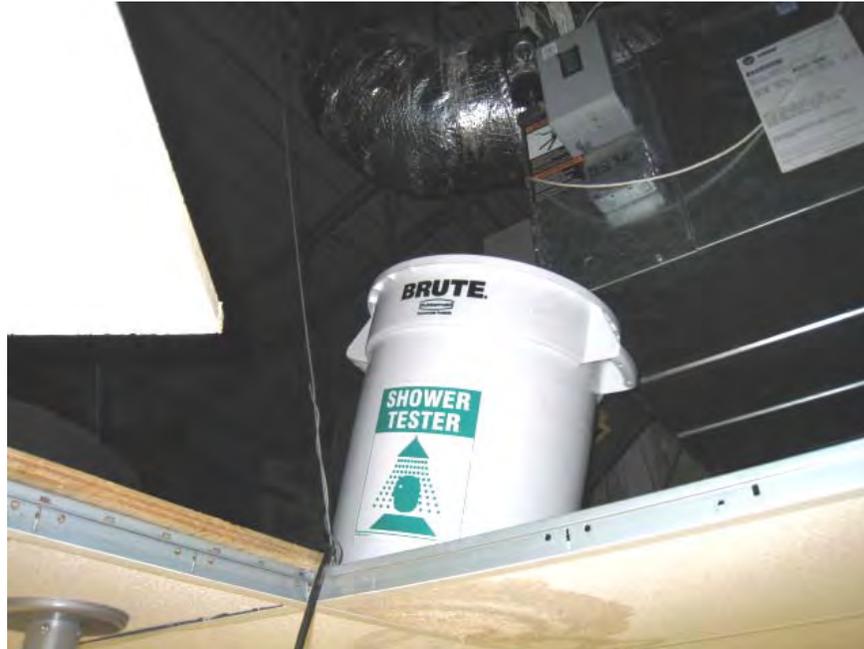
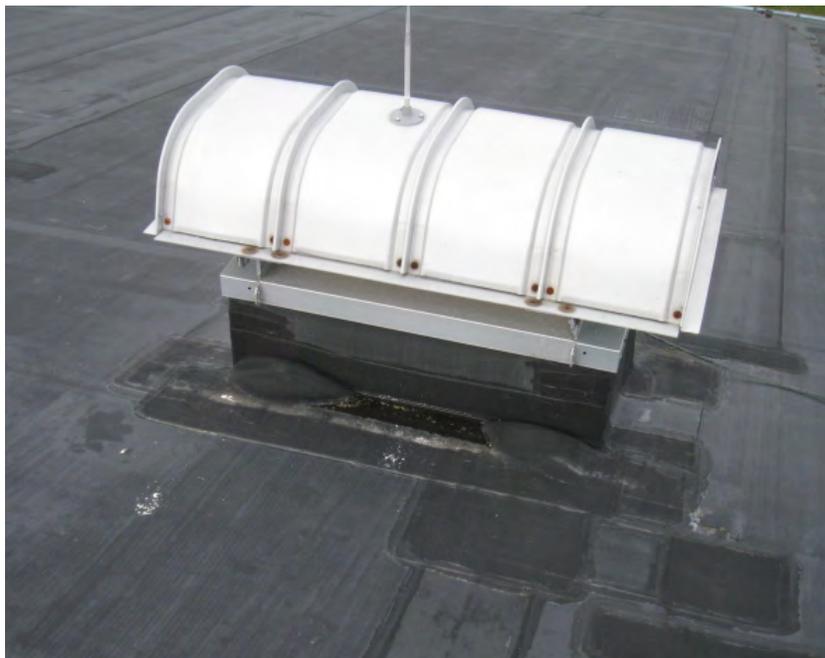
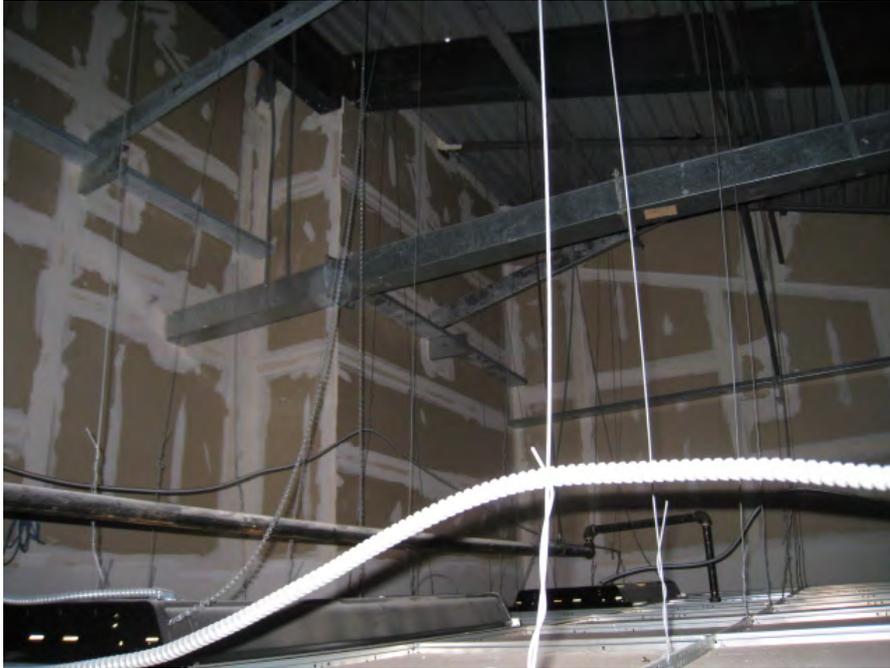
Science room B-236 was reported as an area impacted by recent roof leakage. As a temporary measure, a bucket was placed above the ceiling tile system to collect rainwater (Pictures 10 and 11). Mr. Tripp reported that the source of leakage was traced to damaged rubber membrane around the curb of a rooftop exhaust vent (Picture 12). Attempts have been made to repair the membrane in this area. Water-damaged ceiling tiles were noted throughout this room. MDPH/IAQ staff examined conditions above the ceiling tile system for water-damaged building materials that could provide a source for mold growth. No mold colonized materials were observed in this area at the time of the assessment. The ceiling plenum is an area that has a large volume for air movement, which aids in drying (Picture 13).

**Area of Recent Leakage Reported in Classroom B-236**

**Bucket Stationed above Ceiling Tiles as a Temporary Measure to Collect Water in Classroom B-236, Note Ductwork (Source of Leak) above Bucket**

**Rooftop Exhaust Motor above Classroom B-236, Note Numerous Roof Patches**

**Large Volume of Air Space above Ceiling Tile System in Classroom B-236**

1. Implement recommendations included in the BET report. Major roof repairs/replacement will require capital funding and planning. In the interim, maintenance staff should continue to make minor roof repairs and monitor building materials for water damage.

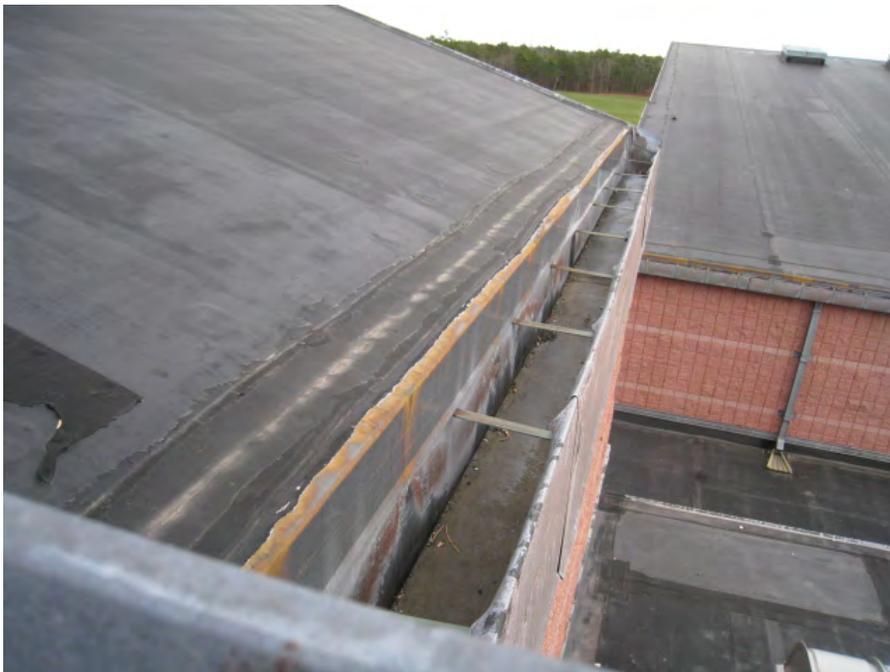
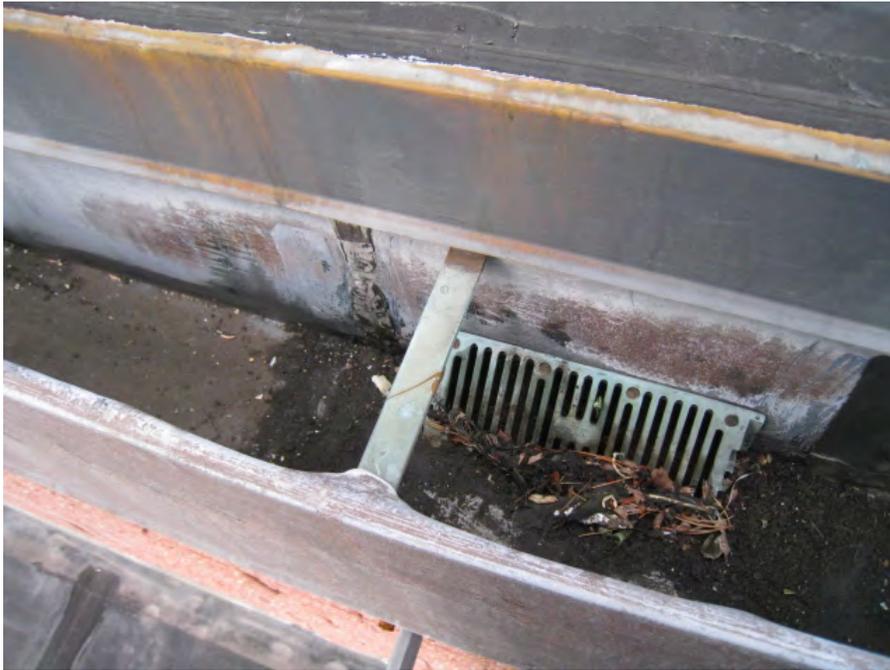
Water-damaged gypsum wallboard (GW) and peeling paint was observed in the first floor corridor outside of the main office. As identified in the BET report, this damage is related to the copper gutter system installed above this area (Pictures 14 and 15).

**Copper Gutter along Peaked Roof Detail**

**Close-Up of Copper Gutter along Peaked Roof Detail**

- Re-flash the entire length of the built-in copper gutter with a semi-cured self-adhering EPDM membrane and integrated connection with the throughwall scupper drains;
- Detailed cleaning of mechanical equipment housing;
- Patch failed seams near areas of leakage near the weight training room;
- Repair damage/seam failures in the roof membrane;
- Repair exposed concrete block masonry in the cooling tower enclosure and treat with an elastomeric masonry coating;
- Repair and recoat deteriorating exterior columns;
- Repair rooftop lightning arrestor system;
- Removal and replacement of all elastomeric sealings, including materials between metal-to-metal contact (e.g., window openings, mechanical equipment); and
- Refinish steel egress doors (BET, 2010).

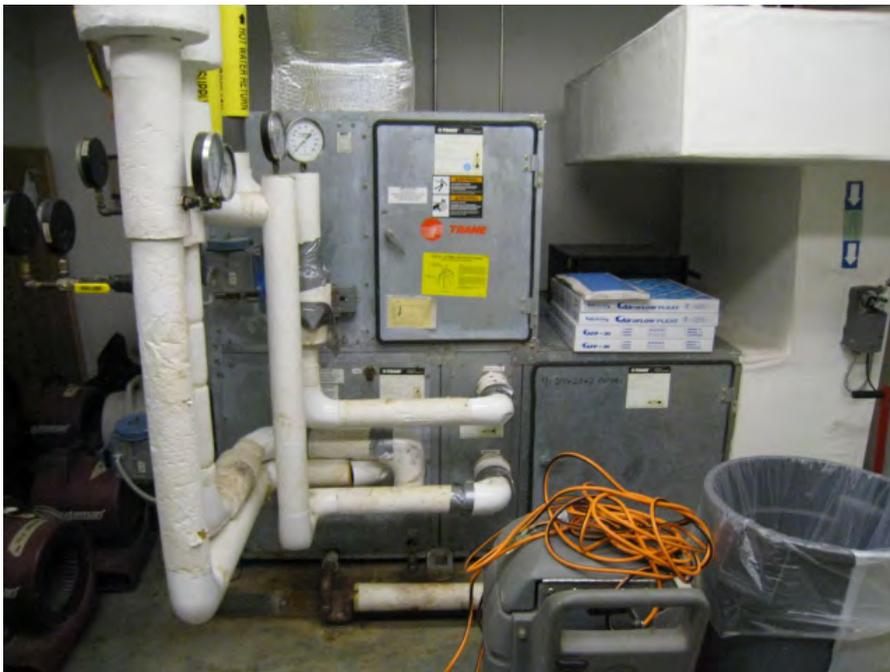
**Picture 16**

As reported by Mr. Tripp, a plumbing leak was discovered on Monday, November 29, 2010, the day prior to the MDPH assessment. The source of the leak was an HVAC unit (Picture 16) located in a mechanical room adjacent to the guidance area (specifically room B-115). As a result of the leak, which likely occurred over the previous weekend, GW and carpeting in the guidance area was moistened. At the time of the assessment, industrial fans were in use to dry carpet and GW (Picture 17).

**HVAC Unit in Mechanical Room adjacent to Room B-115**

12. To mitigate future water damage/mold issues in the guidance wing associated with the adjacent mechanical room consider the following:
  - a. Install a sheet metal drip pan underneath/around AHU;

- b. Replace water-damaged GW with green board or other water impervious material;  
and/or
  - c. Leave a small gap (~ 1/2 to 3/4-inch) beneath wallboard to prevent wicking in the event of flooding.

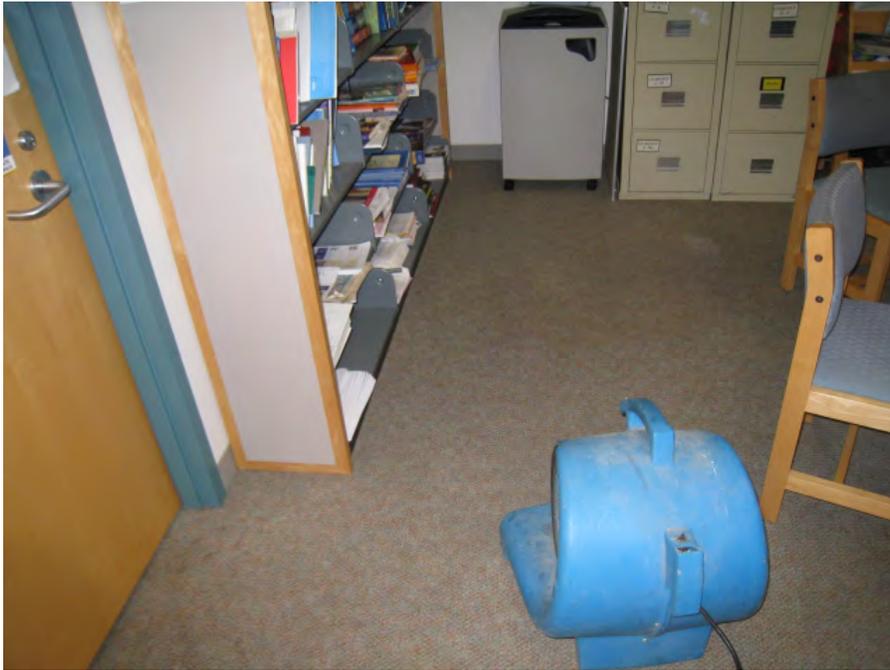
**Picture 17**

**Industrial Fan Drying Moistened Carpet**

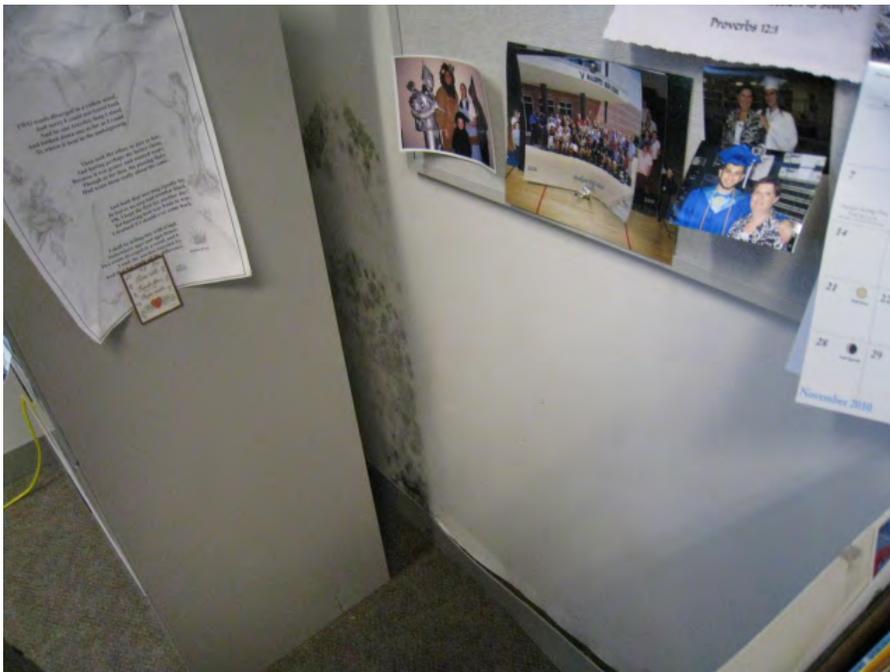
**Picture 18**

To determine if GW and carpeting had elevated moisture content that would be conducive to mold growth, MDPH/IAQ staff conducted moisture testing of these materials. Elevated moisture measurements were detected in rooms B-115 and B-113 (Table 1), indicating that materials were wet at the time of the assessment. In addition, visible mold growth was observed behind a file cabinet and vinyl base coving along the floor in B-115 (Picture 18).

The US Environmental Protection Agency (US EPA) and the American Conference of Governmental Industrial Hygienists (ACGIH) recommend that porous materials (e.g., GW) be dried with fans and heating within 24 to 48 hours of becoming wet (US EPA, 2001; ACGIH, 1989). If not dried within this time frame, mold growth may occur. Once mold has colonized porous materials, they are difficult to clean and should be removed.

**Mold Growth behind File Cabinet**

- Removal of all carpeting in B-115;
- Removal of moistened carpeting in B-113 approximately 10-feet from the shared wall between the mechanical room and guidance suite; and
- Removal of mold-colonized GW in B-115.

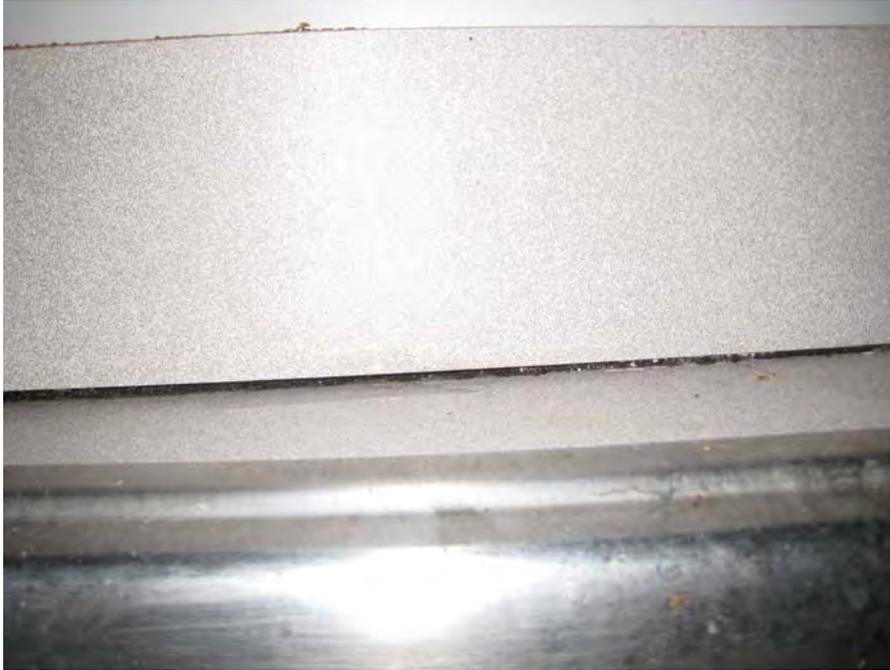
**Picture 19**

Open seams between sink countertops and backsplashes were observed in some rooms (Picture 19/Table 1). If not watertight, moisture can penetrate through seams, causing damage. Improper drainage or sink overflow can lead to water penetration into countertops, cabinet interiors and areas behind cabinets. Water penetration and chronic exposure of porous and wood-based materials can cause these materials to swell and show signs of water damage. Repeated moistening of porous materials can result in mold growth.

**Space between Sink Backsplash and Countertop**

15. Seal areas around sinks to prevent water damage to the interior of cabinets and adjacent wallboard.
16. Clean and maintain aquariums prevent bacterial/mold/algal growth and associated odors.

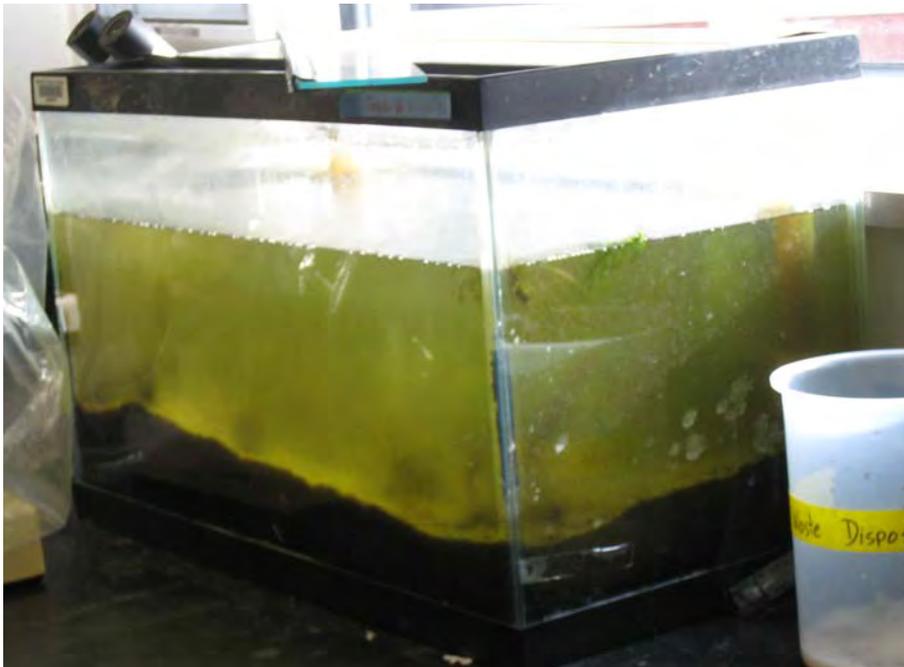
**Picture 20**

**Aquarium Green with Algal Growth**

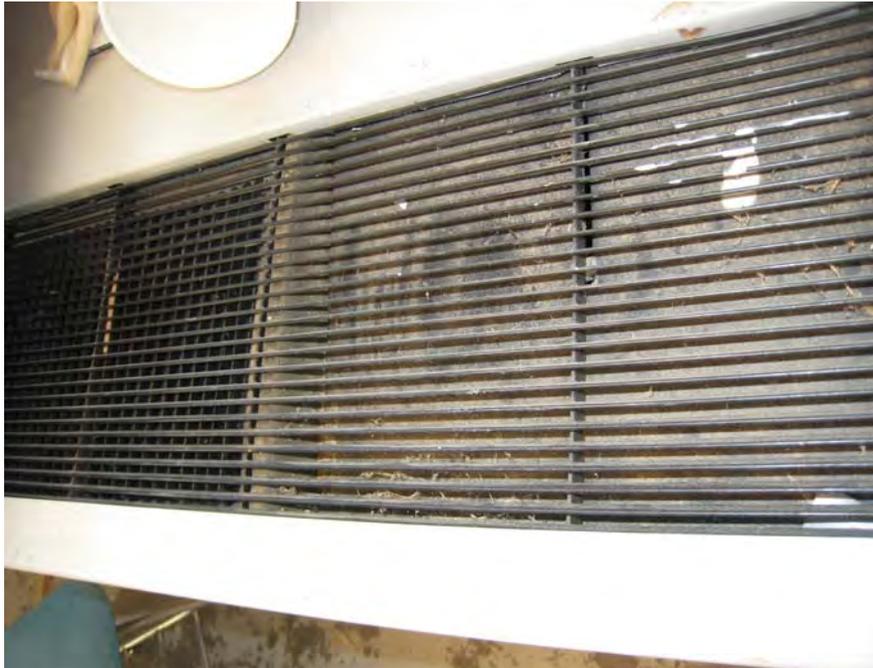
**Picture 21**

**Wood Dust Collected in Univent Diffuser**

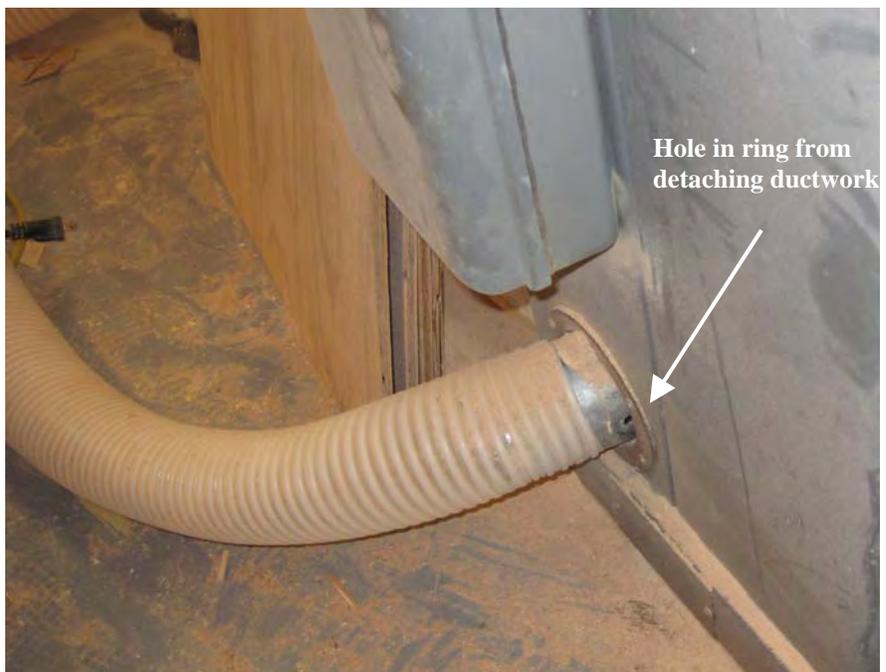
**Picture 22**

**Detaching Flexible Ductwork, note Wood Dust on Floor**

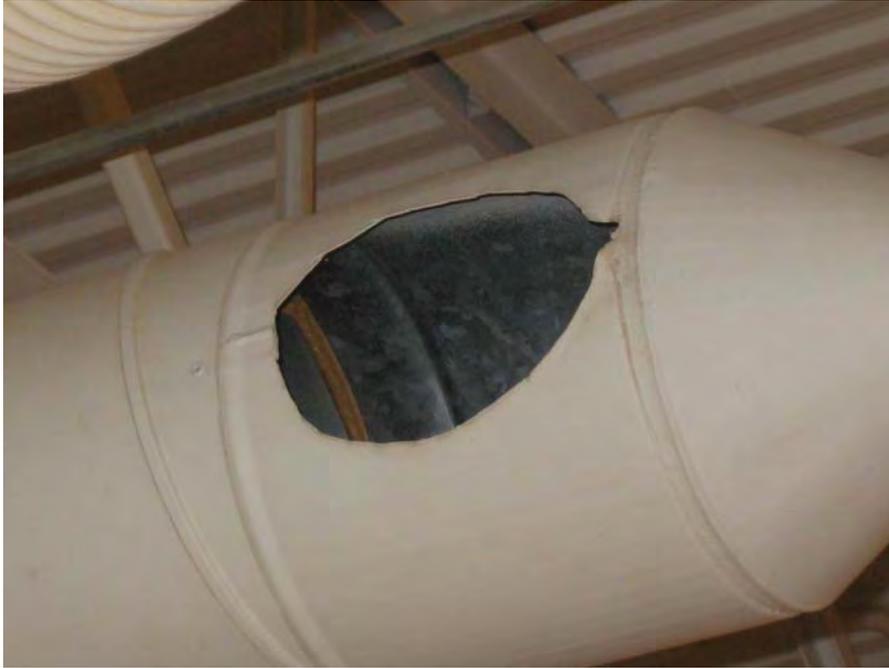
**Picture 23**

**Breach in Wood Dust Collection System Ductwork**

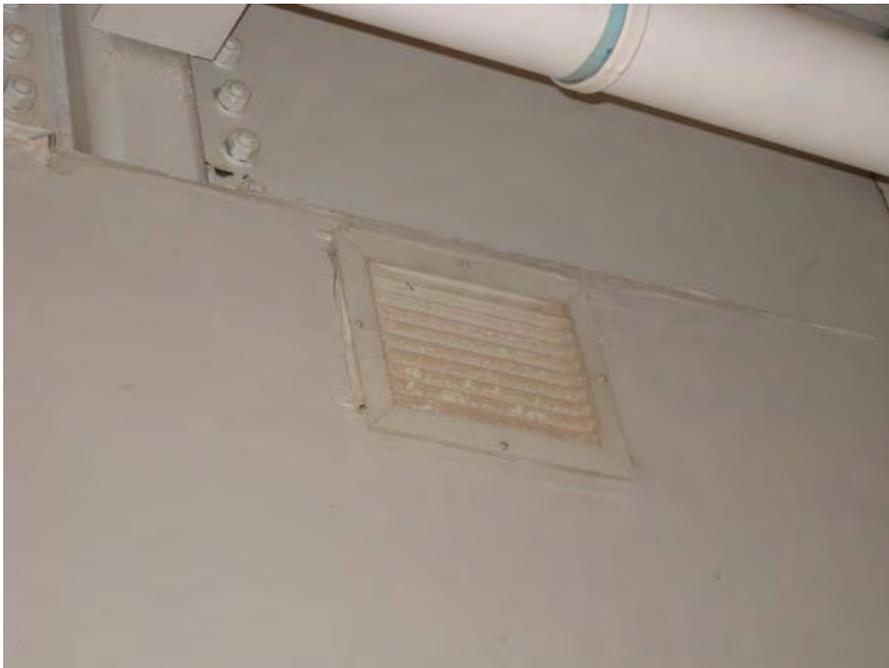
**Picture 24**

**General Exhaust Vent, note Accumulation of Dust**

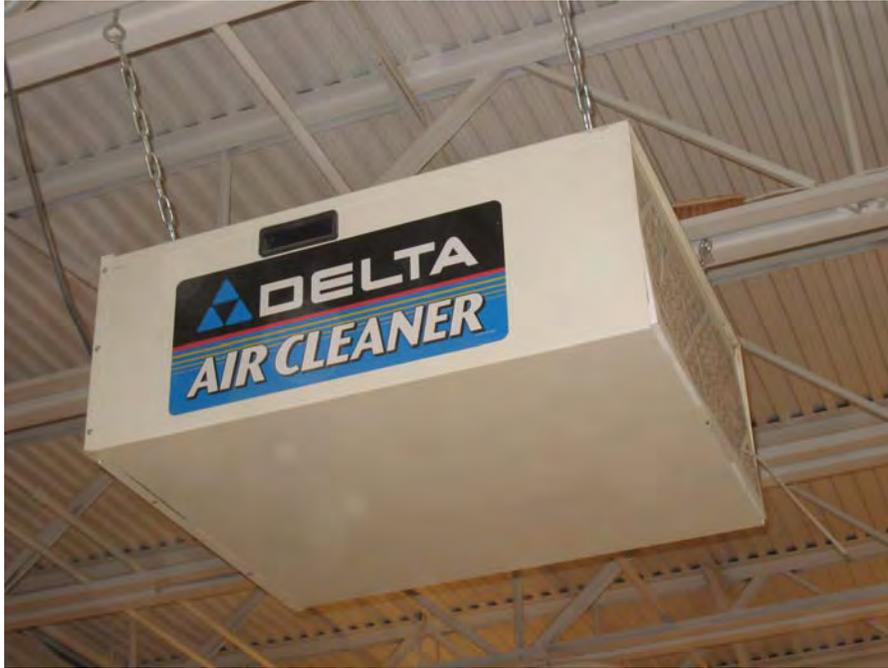
**Picture 25**

**Deactivated Air Cleaner, note Dust on Filter**

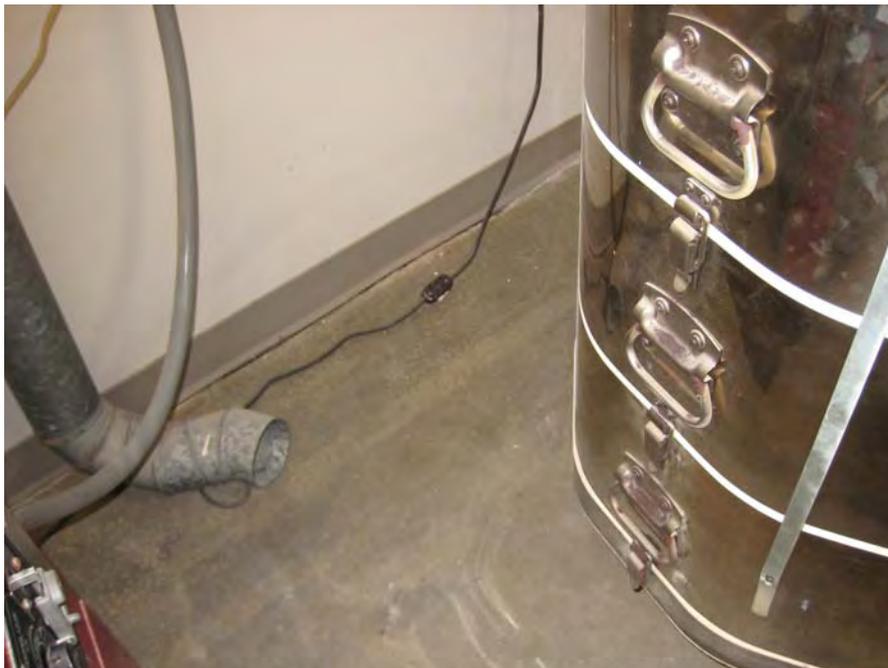
**Picture 26**

Two kilns were observed in the C wing of the school. A hood style and dedicated exhaust were observed for the kilns. At the time of assessment, the flexible ductwork for the dedicated exhaust was not attached to the kiln, which was operating at the time of assessment (Picture 26). While the hood exhaust can remove latent heat and dust expelled by the kiln, a dedicated system can capture these materials more effectively, especially since the second kiln was not located directly below the hood.

**Ductwork Detached from Kiln**

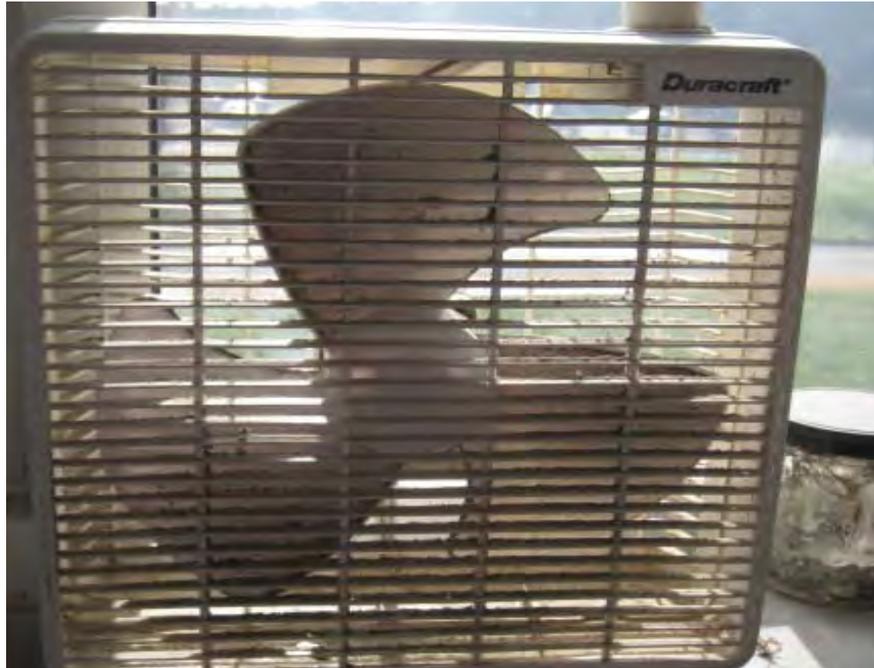
**Picture 27**

**Accumulated Dust/Debris on Box Fan in Classroom**

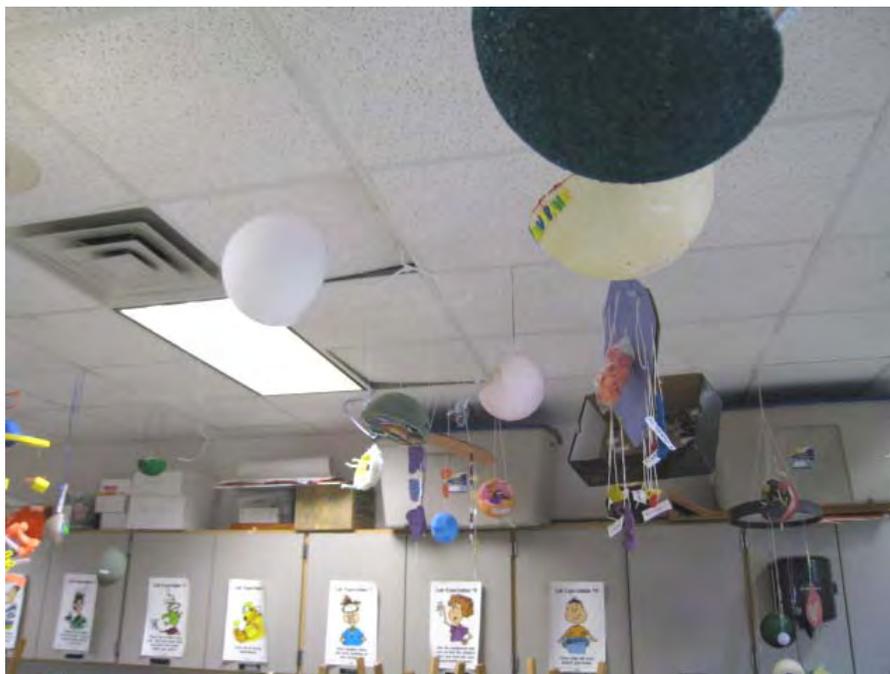
**Picture 28**

**Various Objects Hanging from Suspended Ceiling Tile System**
