# **Mold/Water Damage Remediation Assessment**

**North Reading Middle School  
Modular Buildings  
19 Sherman Road  
North Reading, Massachusetts**

Prepared by:  
Massachusetts Department of Public Health  
Bureau of Environmental Health  
Indoor Air Quality Program  
June 2011

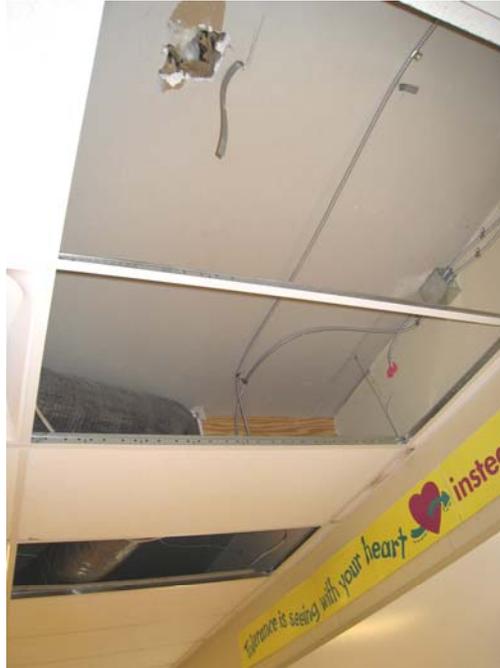
**Picture 1**

removed ceiling tiles in areas where leaks had occurred and GW and insulation was cut open (Pictures 1 through 3). MDPH staff observed conditions in the ceiling plenum and noted water staining on the wooden beams where the building is joined (Picture 2). Cross-sections of GW that had been cut appeared free of mold growth or water staining. Most of the remaining GW was free of stains and appeared intact. Where stains exist, measures should be taken to examine the paper backing of the GW for mold growth. Insulation appeared dry, free of stains and intact (Picture 3). BEH staff detected airflow from the space above the GW as well as within the plenum. As indicated previously, airflow from above and below the GW played a significant role in drying the material and preventing mold growth. Moisture measurements taken of the wooden beams, GW and insulation in the plenum space confirmed that these materials were dry.

**An area where roof leaks occurred**

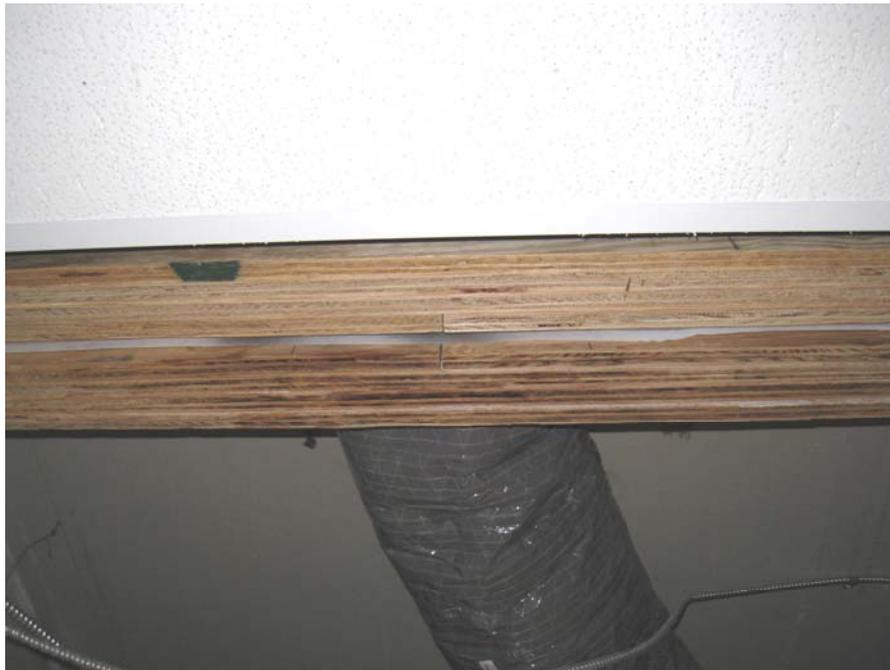
**Picture 2**

In the weeks prior to the MDPH assessment, Mr. Hardacker was able to determine the source of leaks. The roof leaks are reportedly the result of water penetrating through the beams where the two portions of the building are joined. Over the April vacation, work was conducted to seal/replace roofing materials around these areas to prevent further water penetration.

**Water-stained wooden beam**

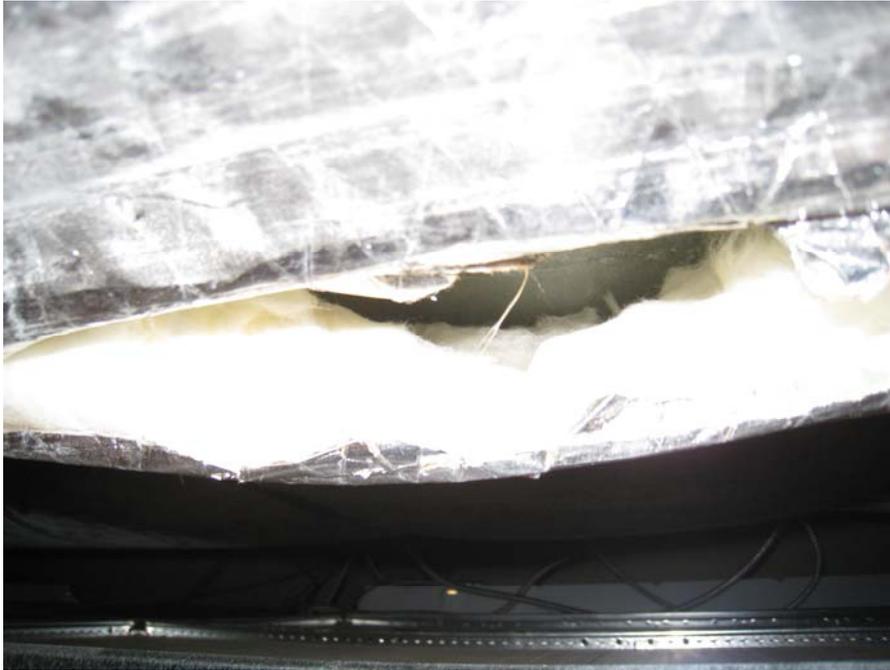
**Picture 3**

**Ductwork insulation**

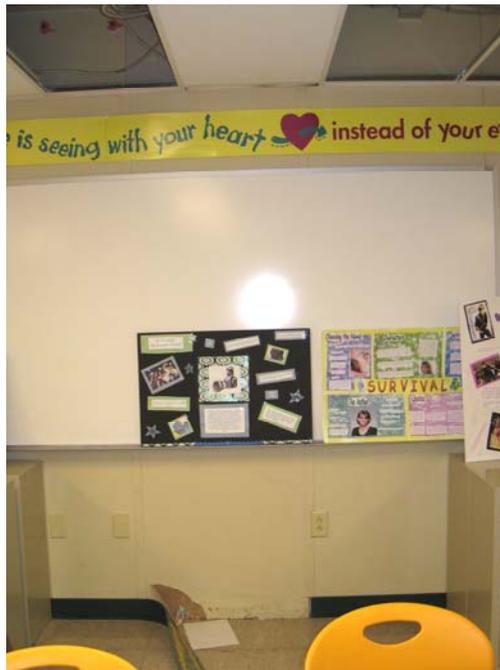
**Picture 4**

The exterior walls along the seam in these classrooms were also examined to determine whether draining water impacted GW. Vinyl coving removed from these areas showed some dark staining and potential mold growth on the GW around the seam (Pictures 4 and 5). Moisture measurements confirmed that GW in these areas was wet at the time of testing (Picture 6). An assessment of these classrooms showed that GW was only moist in classrooms (M5 and M7) where furniture (e.g., bookcases) was placed in front of this seam. The combination of furniture placed against exterior walls inhibiting airflow to the GW and vinyl trim can serve to trap moisture and preventing drying, and if not remediated, lead to mold growth.

Subsequent conversation with Mr. Hardacker revealed that the source of moisture is an open exterior trim strip that runs along the perimeter at the base of these modular classrooms (personal communication, May 4, 2011). While GW in these areas was moist, no other materials (e.g., insulation) were damaged. Mr. Hardacker reported that this void would be sealed with caulking.

**Area with water-damaged GW at wall base**

1. Examine exterior trim around the base perimeter of all modular classrooms. Seal voids with an appropriate caulking.
2. Remove furniture placed against the exterior wall in modular classrooms, remove vinyl coving and conduct moisture testing to determine whether any other classrooms were impacted by moisture penetrating through the exterior trim.
3. Remove and replace water-damaged/mold colonized GW in a manner consistent with US EPA's (2001) guidance.
4. Repair/seal GW and insulation wrap to prevent aerosolization of materials in the plenum space.
5. Replace any remaining water-damaged ceiling tiles.
- 6.** Refer to resource manual and other related indoor air quality documents located on the MDPH's website for further building-wide evaluations and advice on maintaining public buildings. These documents are available at: <http://mass.gov/dph/iaq>.

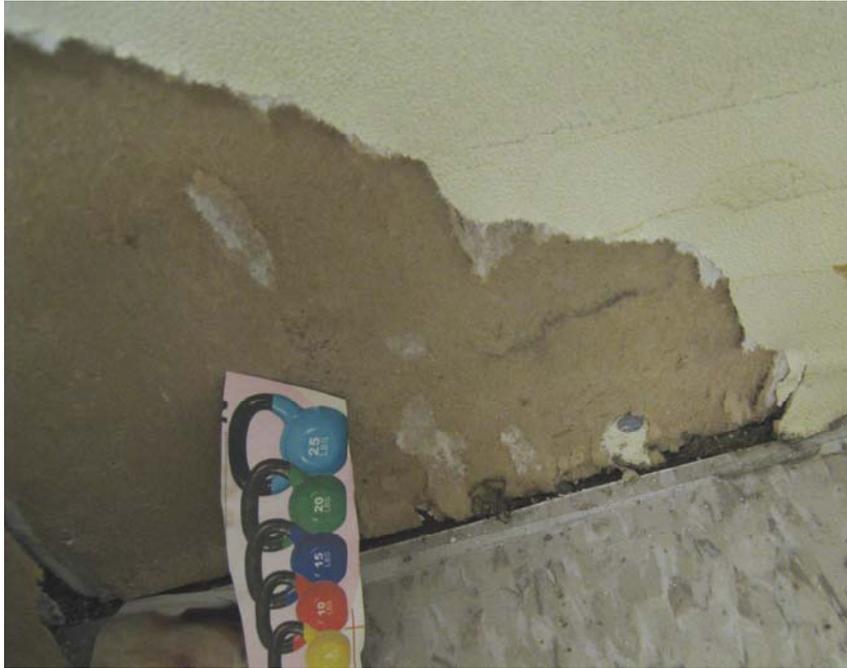
**Picture 5**

**Water damage/mold growth on GW**

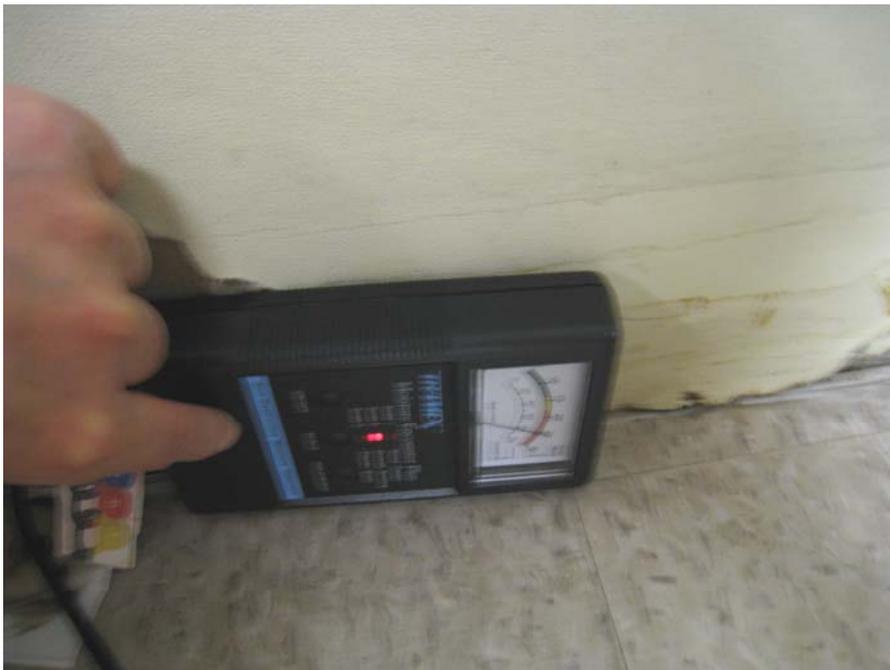
**Picture 6**

**Moisture meter indicating GW wet at time of assessment**
