# **Mold/Water Damage Investigation**

**Templeton Center School  
17 South Road  
Templeton, Massachusetts**

Prepared by:  
Massachusetts Department of Public Health  
Bureau of Environmental Health  
Indoor Air Quality Program  
March 2011

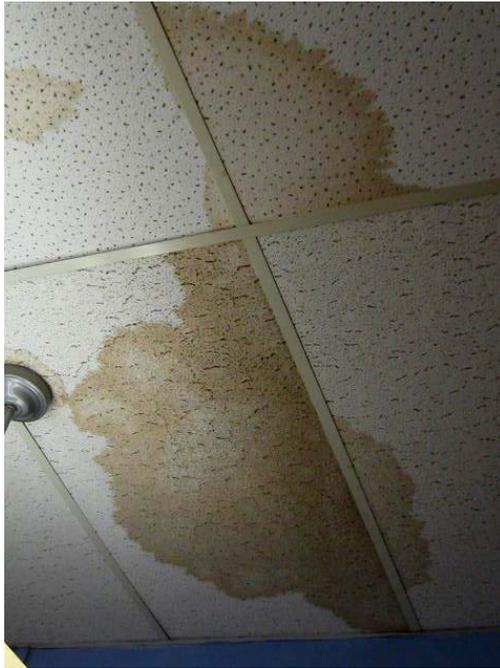
**Picture 1**

Both classroom 107 and the attic above did not appear to have mold colonization at the time of the IAQ Program's evaluation. Classroom 107 did, however, have some water-damaged ceiling tiles remaining (Picture 1). Water-damaged ceiling tiles can indicate sources of water penetration and provide a source of mold growth. Ceiling tiles should be replaced after a water leak is discovered and repaired. The US Environmental Protection Agency (US EPA) and the American Conference of Governmental Industrial Hygienists (ACGIH) recommends that porous materials (carpeting, ceiling tiles, etc.) be dried with fans and heating within 24 to 48 hours of becoming wet (US EPA, 2001; ACGIH, 1989). If porous materials are not dried within this time frame, mold growth may occur. Water-damaged porous materials cannot be adequately cleaned to remove mold growth. The application of a mildewcide to moldy porous materials is not recommended.

**Remaining Water-Damaged Ceiling Tiles in Classroom 107**

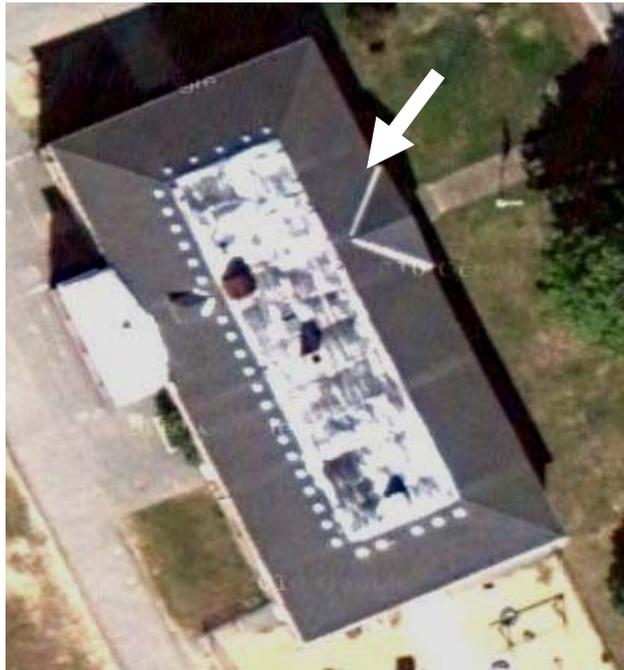
**Picture 2**

BEH staff examined the ceiling of classroom 107 as well as the attic area above the leak. The school has a hip roof *without* a peak/ridge, meaning the center of the roof is flat with sloped sides. The area where the roof leak occurred is near a roof valley, in a location that roughly faces northeast (Picture 2). The part of the roof would be highly prone to lingering snow accumulation during nor'easters. The orientation of the building also keeps this location shaded from direct sunlight, which inhibits melting. Therefore, it is highly likely the support structure of the roof would be subjected to prolonged snow loads, resulting in ice dams, chronic moisture, and exposure to roofing materials, all of which can result in roof leaks.

**Location of Roof Leak (Arrow)**

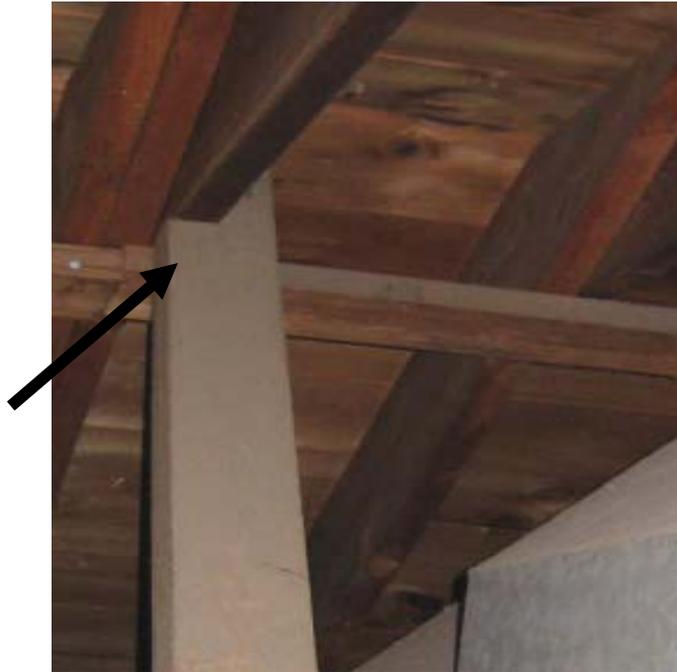
**Picture 3**

The area of the attic beneath the water leak was examined. Of note is the diagonal brace system, which appears to support the roof at the junction where the roof transfers from a flat to sloped plane. Each of these braces are notched and inserted beneath the roof rafter at the flat/slope roof junction (Picture 3). BEH staff observed that the diagonal brace beneath the area of the roof leak is split down the middle (Picture 4) and has shifted out of position where it connects to the floor joist (Picture 5). In this condition, the damaged diagonal beam likely cannot bear the same load as intact beams, which likely allowed the roof to sag under snow load, resulting in leaks.

**Diagonal Brace, Not Notch at End of Beam (Arrow)**

1. Repair roof braces to prevent further damage and roof leaks. Either replacement of the braces or repair by “sistering” the braces should be examined.
2. Replace all water-damaged ceiling tiles and wet insulation material.
3. The base of the diagonal brace in Picture 6 needs to be re-footed.
4. Continue to implement recommendations made in the Klienfelder/SEA Consultants report.

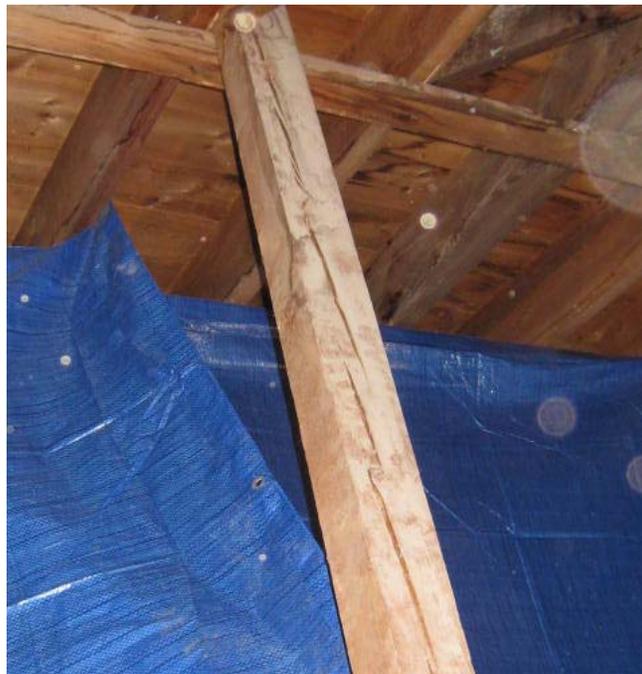
**Picture 4**

**Diagonal Brace Is Split Down the Middle**

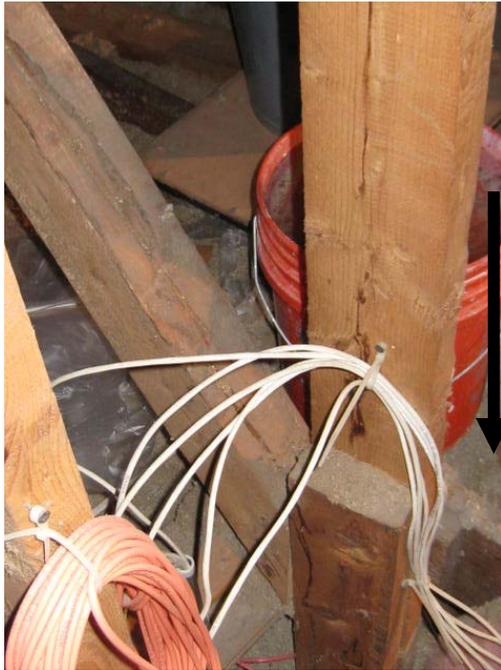
**Picture 5**

**Brace Holding the Base of the Diagonal Brace in Place was Kicked Outward (Arrow)**

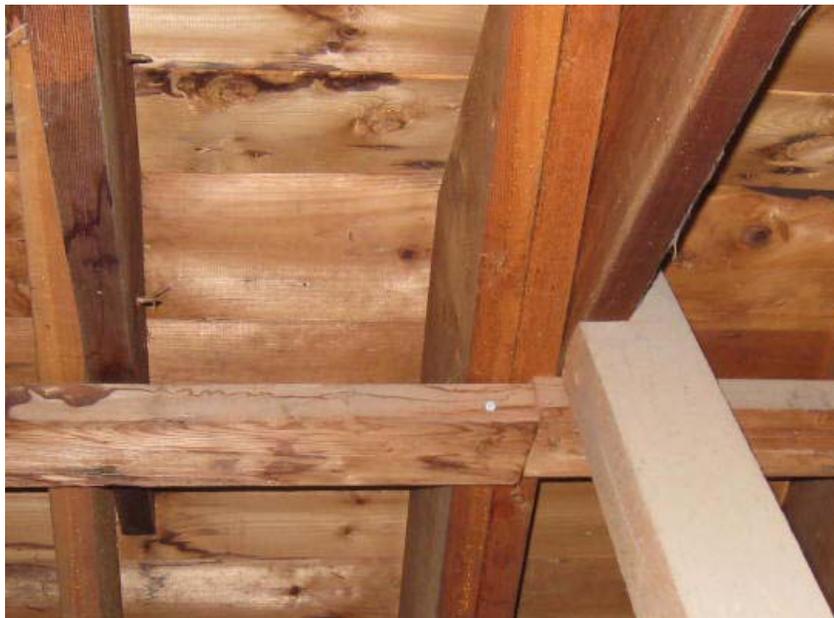
**Picture 6**

Another sign of roof movement beneath the leak location is the rotation of a brace connecting the diagonal roof rafters beneath the water leak. One end has rotated to split the end of the brace at its fastener (Picture 6). The condition of each of these braces appears to indicate that load was depressing the roof in this location, which can lead to roof damage and subsequent water leaks.

**Rotation of a Brace Connecting the Diagonal Roof Rafters beneath the Water Leak (Note Split at the Nail and that the Brace Junction Where the Brace Ends are no Longer Flush. Also Note Water Stains on the Braces and Adjacent Rafter on Left Side of Picture)**
