# **INDOOR AIR QUALITY ASSESSMENT**

**Massachusetts Department of Transitional Assistance  
Worcester Regional Office  
9 Walnut Street  
Worcester, Massachusetts**

Prepared by:  
Massachusetts Department of Public Health  
Bureau of Environmental Health  
Indoor Air Quality Program  
April 2011

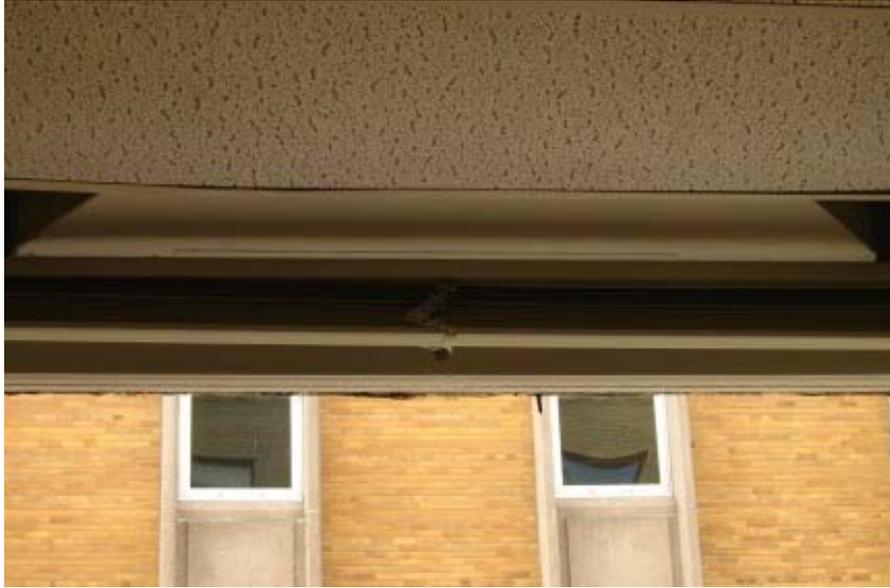
**Picture 1**

Mechanical ventilation is provided by a series of heating, ventilation and air conditioning (HVAC) air handling units (AHUs) located in closets throughout the floor. Fresh air is drawn through vents located above selected window frames (Picture 1). Ductwork connects the AHUs to ceiling-mounted supply diffusers. By design, air diffusers are equipped with fixed louvers that direct air along the ceiling to flow down walls and create airflow. Air is returned to the AHUs through the fixed louvers in the doors of the AHU closets (Picture 2). Several supply diffusers were found obstructed with manila folders reportedly by occupants in an attempt to obtain thermal comfort (Picture 3). Louvers in AHU closet doors were blocked by an insulating material, likely in an attempt to reduce sound generated by AHUs (Picture 4).

**Fresh Air Intake above Window**

4. Examine fresh air supply as needed.
5. Ensure ventilation components are operational and free from obstructions/ accessible for maintenance and repairs.

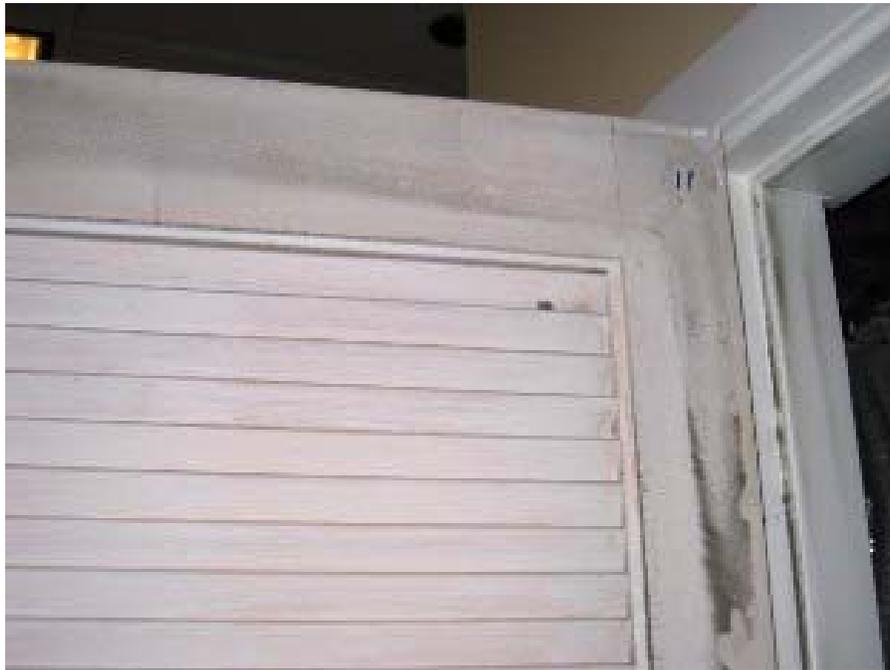
**Picture 2**

**AHU Closet with Fixed Louvered Doors  
Note Particulate Residue on Perimeter of Door and Casing**

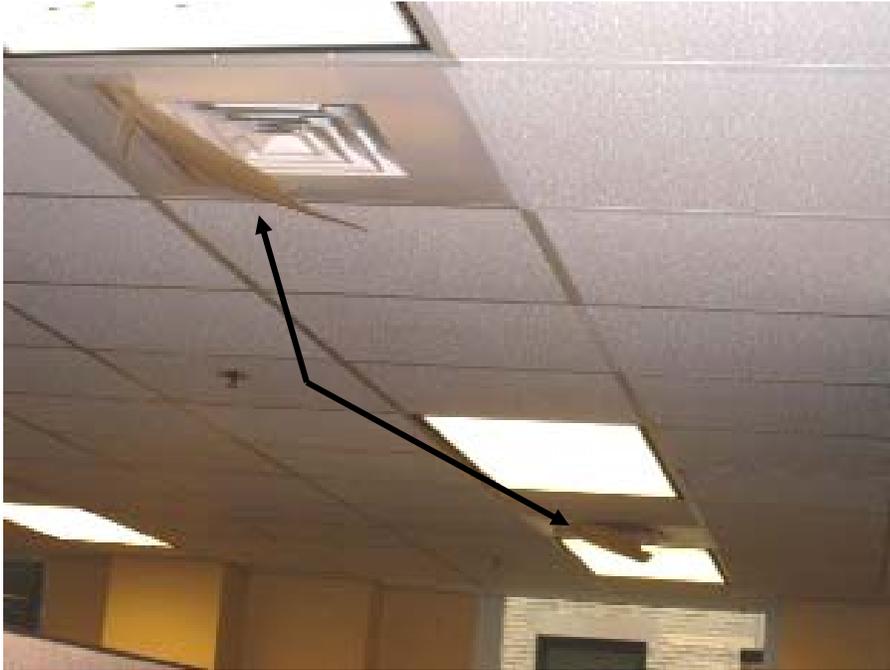
**Picture 3**

**Obstructions Taped to Fresh Air Supply Diffusers (Arrows)**

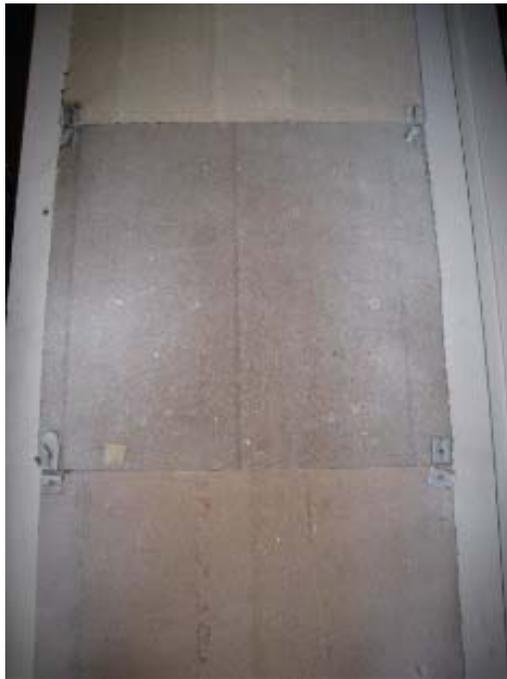
**Picture 4**

**Insulating Material on Interior of AHU Closet Door**

6. Consider adopting a balancing schedule of every 5 years for all mechanical ventilation systems, as recommended by ventilation industrial standards (SMACNA, 1994). This will eliminate the need for occupants to adjust airflow in the office environment to address thermal comfort issues. Remove insulating material from louvered AHU doors as needed if balancing not effective.

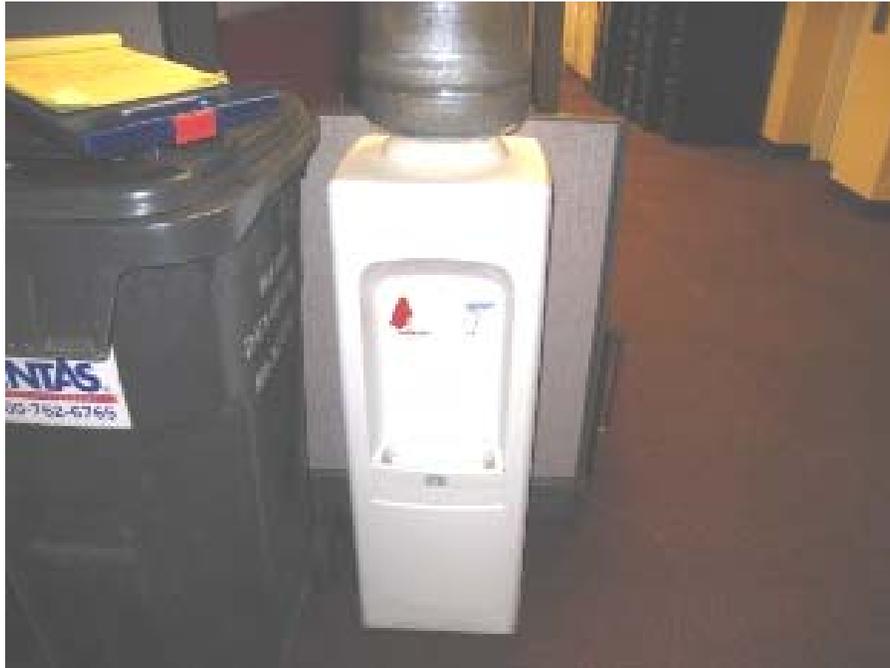
**Picture 5**

In addition to moisture issues previously outlined (MDPH letter, December, 2010), several other sources were observed. Water coolers were located directly on carpets. In addition, stagnant water was observed in one water cooler's overflow reservoir (Pictures 5 and 6). Overflow of the water basin or spills that often occur can moisten carpeting, which can lead to mold growth. It is important that the catch basin of a water cooler be cleaned regularly as stagnant water can be a source of odors, and materials (i.e., dust) collected in the water can provide a medium for mold growth.

**Water Cooler Located on Carpeting**

11. Provide impervious mats beneath water coolers, to eliminate/reduce the possibility of moistening carpeted areas.
12. Periodically empty and clean water cooler reservoirs.

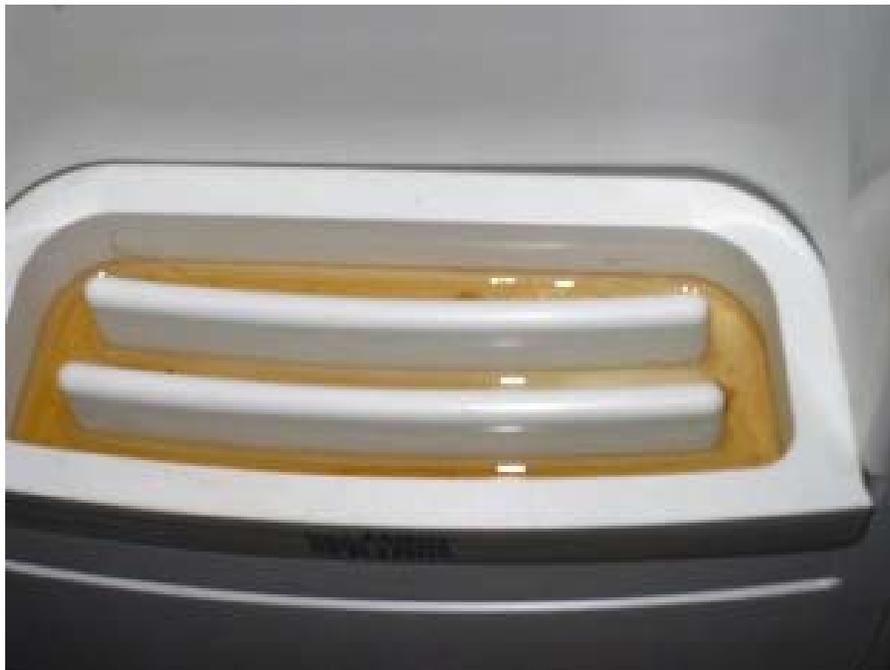
**Picture 6**

**Water Cooler Reservoir with Accumulated Water**

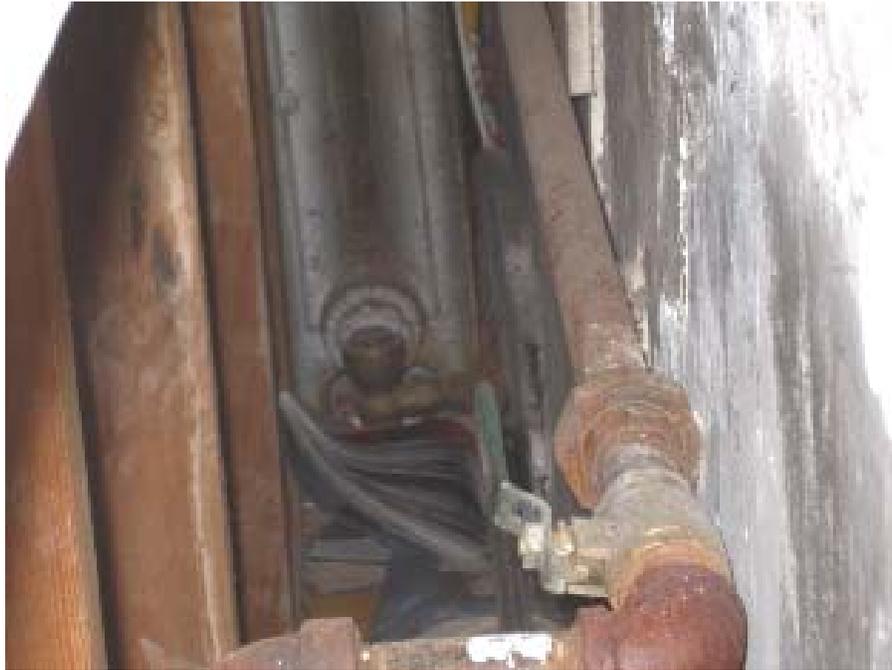
**Picture 7**

Numerous porous materials such as magazines, paper/paper towels as well as dried plant debris were observed within the exterior wall cavity adjacent to radiators and heating pipes (Pictures 7 and 8). If these materials become wet from condensation or pipe leakage, they have the ability to support mold colonization. These areas should be cleared of this debris.

**Paper, Magazines in Wall Cavity Adjacent to Radiator**

13. Remove and dispose of magazines, paper and debris that have fallen into the wall cavity surrounding the radiators.
14. Ensure plants are equipped with drip pans. Examine drip pans periodically for mold growth and disinfect with an appropriate antimicrobial, as needed. Ensure plants are not located on porous materials, and ensure that any spillage that occurs during plant watering is promptly dried in order to prevent water damage to windowsills. Repaint water-damaged window sills.

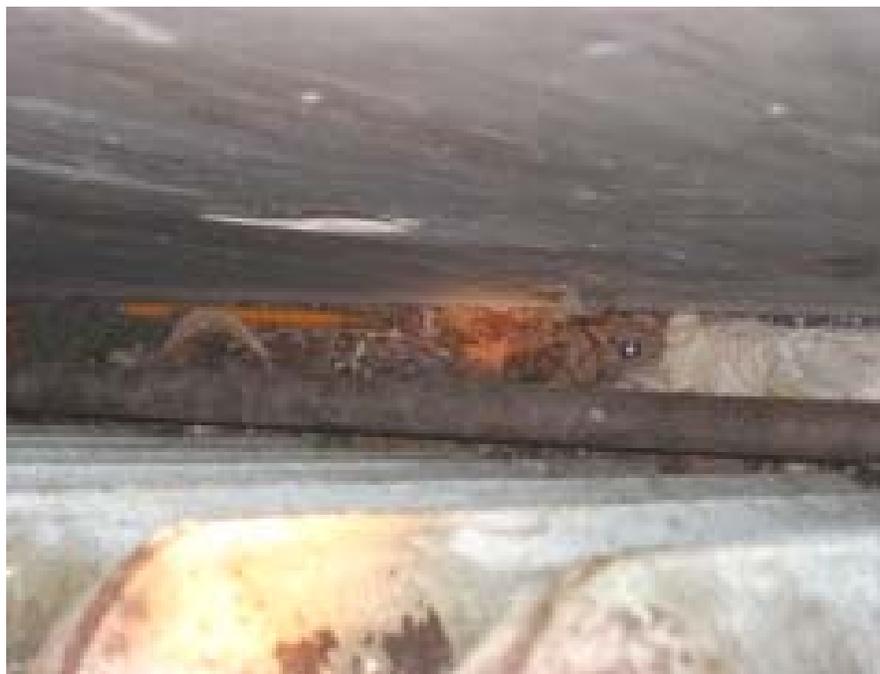
**Picture 8**

**Plant Material, Paper Towel Adjacent to Radiator**

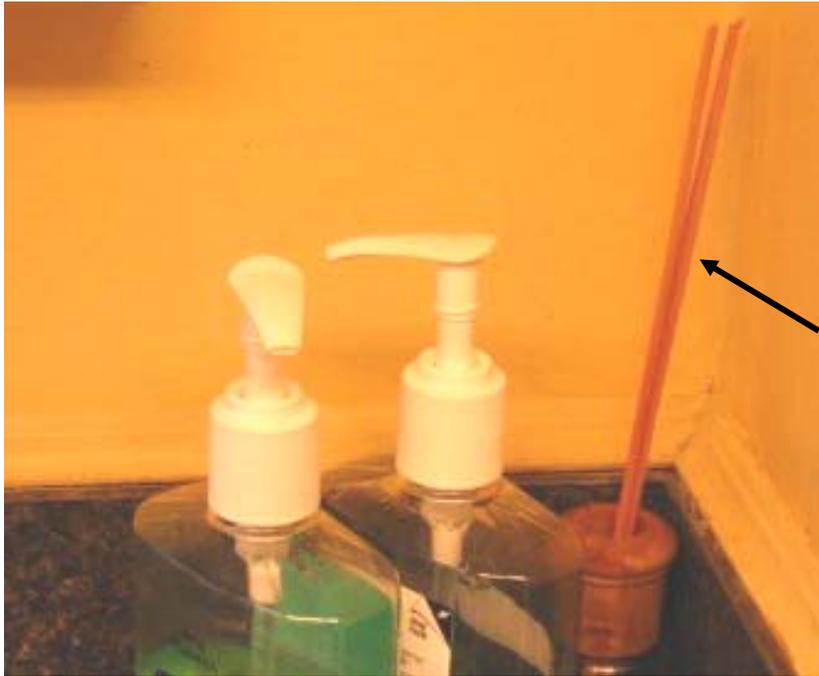
**Picture 9**

Reed diffusers/fragrance sticks were observed in the women's room (Picture 9). Air fresheners/deodorizers contain chemicals that can be irritating to the eyes, nose and throat of sensitive individuals. Many air fresheners contain 1,4-dichlorobenzene, a VOC that can cause reductions in lung function (NIH, 2006). Furthermore, deodorizing agents do not remove materials causing odors, but rather mask odors that may be present in the area.

**Reed Diffuser/Fragrance Sticks (Arrow)**

15. Repair any existing water leaks.
16. Replace water-damaged ceiling tiles as needed.
17. Refrain from using reed diffusers, fragrance sticks or other air deodorizers.

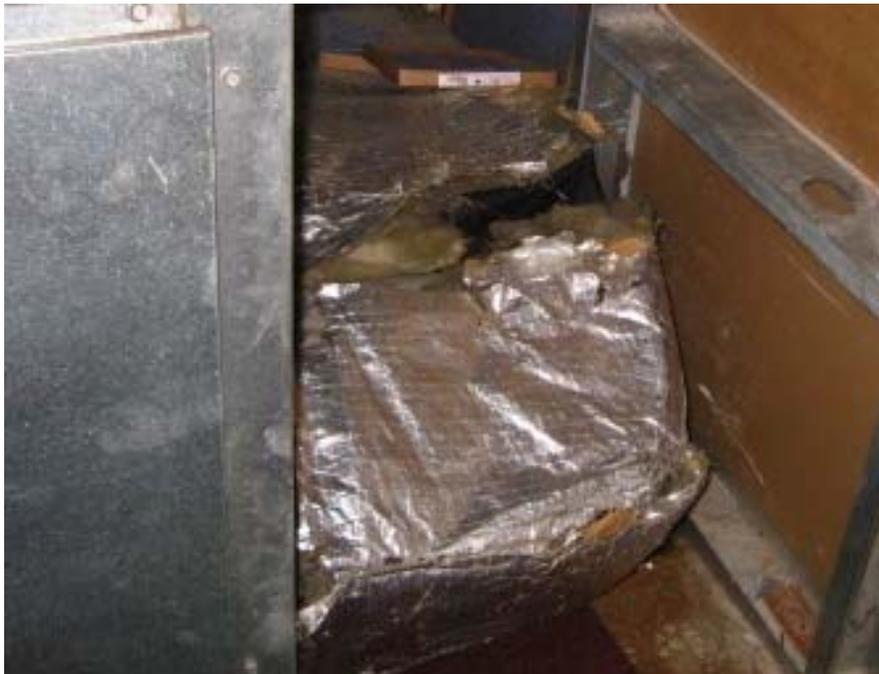
**Picture 10**

Other conditions that can affect indoor air quality were observed during the assessment. Damaged/deteriorated fiberglass insulation was observed on numerous AHUs. Fiberglass insulation can provide a source of skin, eye and respiratory irritation. Dusts, particulate and peeling/chipping paint were observed in several AHU closets, likely due to previous demolition of walls and ceilings (Pictures 10 through 13). If these particulates become aerosolized, they can cause respiratory irritation in sensitive individuals. Some AHU filters appeared to be ill-fitting, which can create filter bypass and lead to particulates being drawn into the AHUs and distributed to occupied areas. Paper, cardboard, plastic bags and various debris were also found stored in these closets. These materials provide surfaces on which dusts settle and accumulate. These

**Ripped, Exposed Fiberglass Insulation**

18. Repair/replace all damaged, missing fiberglass on AHU ducts.
19. Remove all paint chips, dust and particulate and stored materials from the interior of AHU closets.

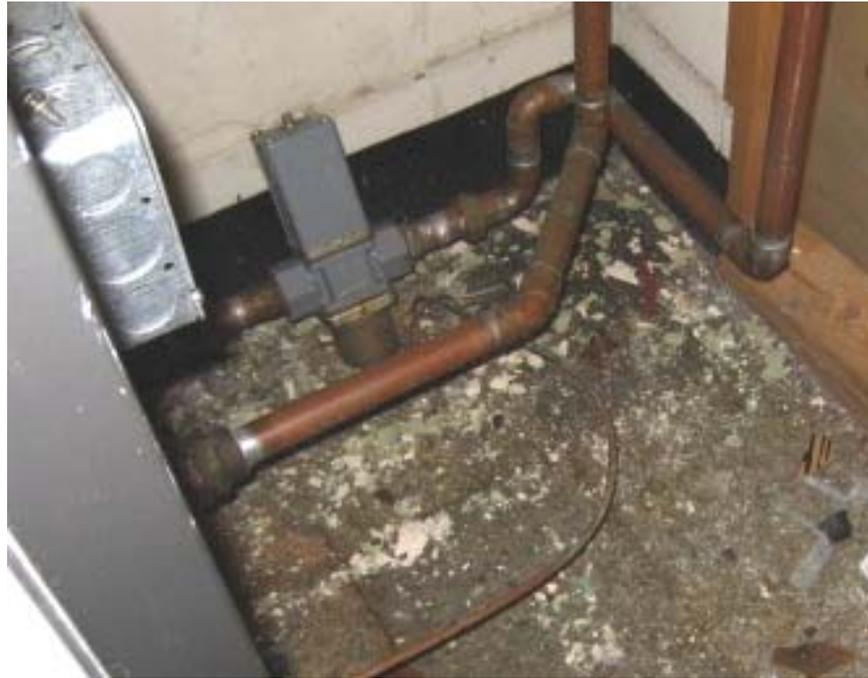
**Picture 11**

**Paint Chips and Debris on Floor of AHU Closet**

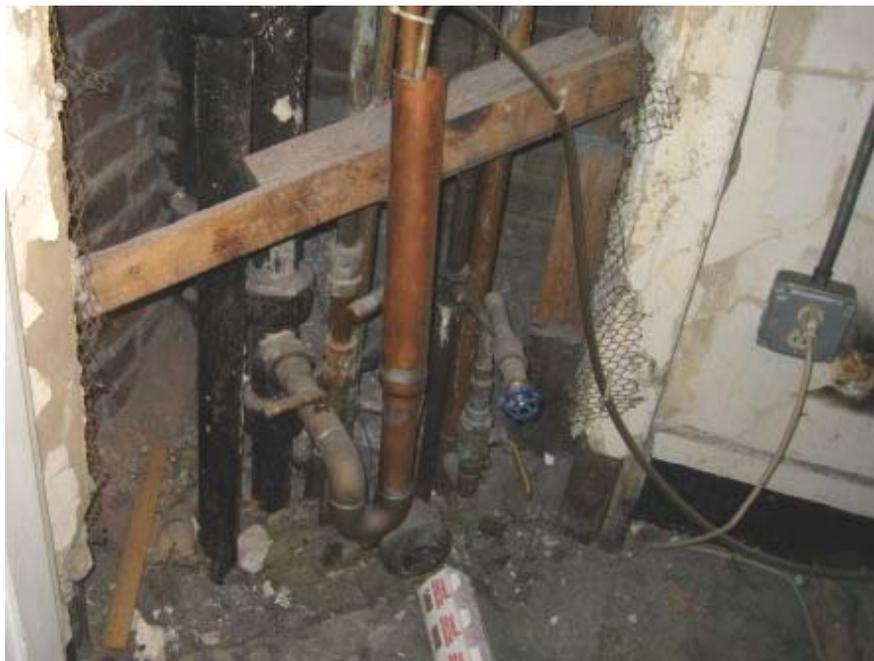
**Picture 12**

**Open Wall Cavity**

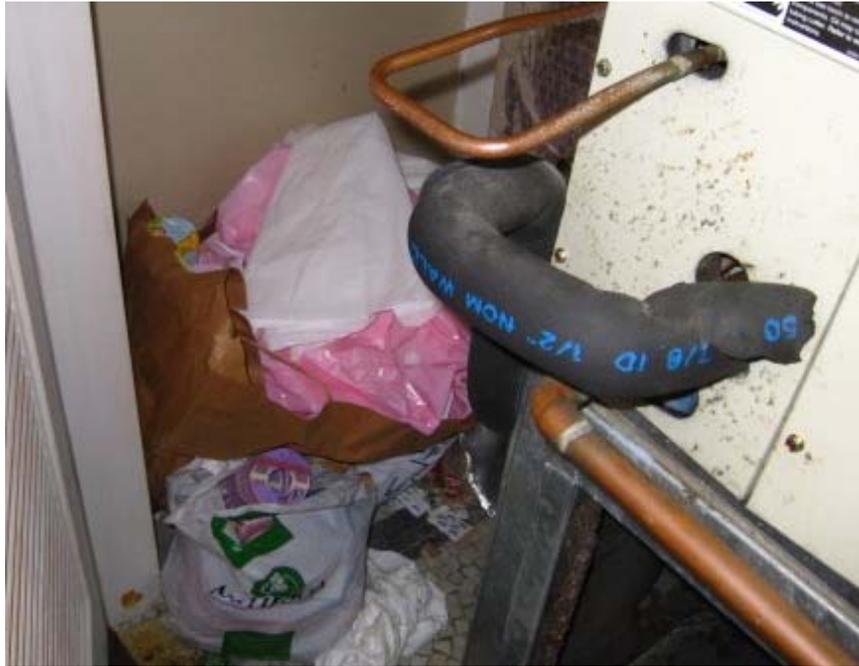
**Picture 13**

**Debris Stored in AHU Closet**

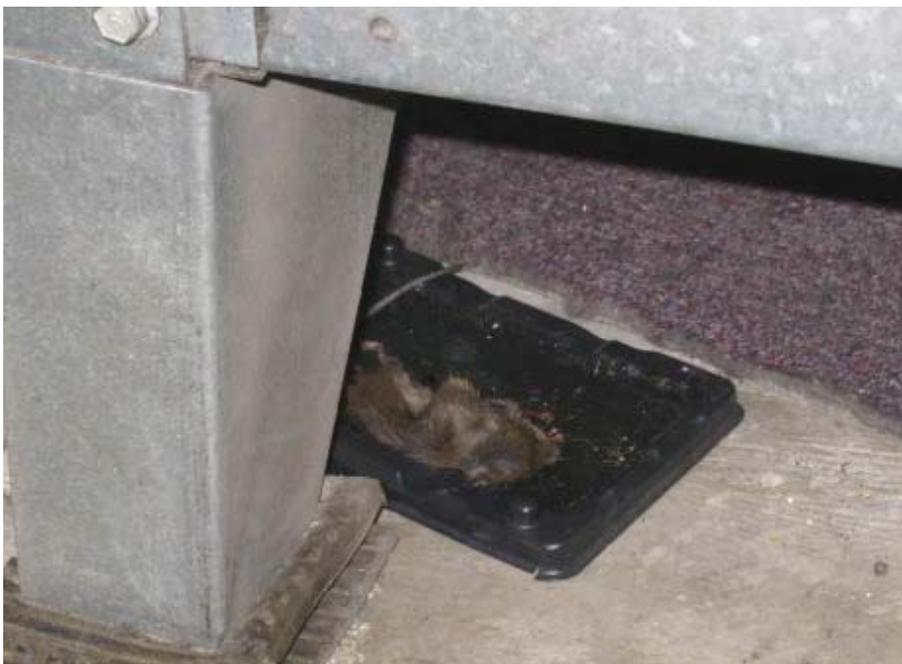
**Picture 14**

A dead rodent was observed on a sticky trap beneath an AHU; a dead cockroach was observed in an AHU closet (Pictures 14 and 15). To penetrate the exterior of a building, rodents require a minimal breach of ¼ inch (MDFA, 1996). The most likely route for pests to enter the DTA offices is via holes in the floors, walls and ceilings of AHU closets. Rodent and insect infestation results from easy access to food and water in a building. Rodent infestation can result in indoor air quality related symptoms due to materials in rodent wastes. Mouse urine and cockroach fragments contain a protein that is a known sensitizer (US EPA, 1992). A sensitizer is a material that can produce symptoms in exposed individuals, including runny nose or skin rashes. A three-step approach is necessary to eliminate pest infestation:

**Dead Mouse beneath AHU**

20. Consult with a licensed pest control agency regarding insect and rodent infestation. Use the principles of integrated pest management (IPM) to prevent infestation of pests, including **appropriate food handling storage in the DTA office**. A copy of the IPM recommendations from the Massachusetts Department of Food and Agriculture (MDFA, 1996) can be obtained at the following website:  
[http://www.state.ma.us/dfa/pesticides/publications/IPM\\_kit\\_for\\_bldg\\_mgrs.pdf](http://www.state.ma.us/dfa/pesticides/publications/IPM_kit_for_bldg_mgrs.pdf).

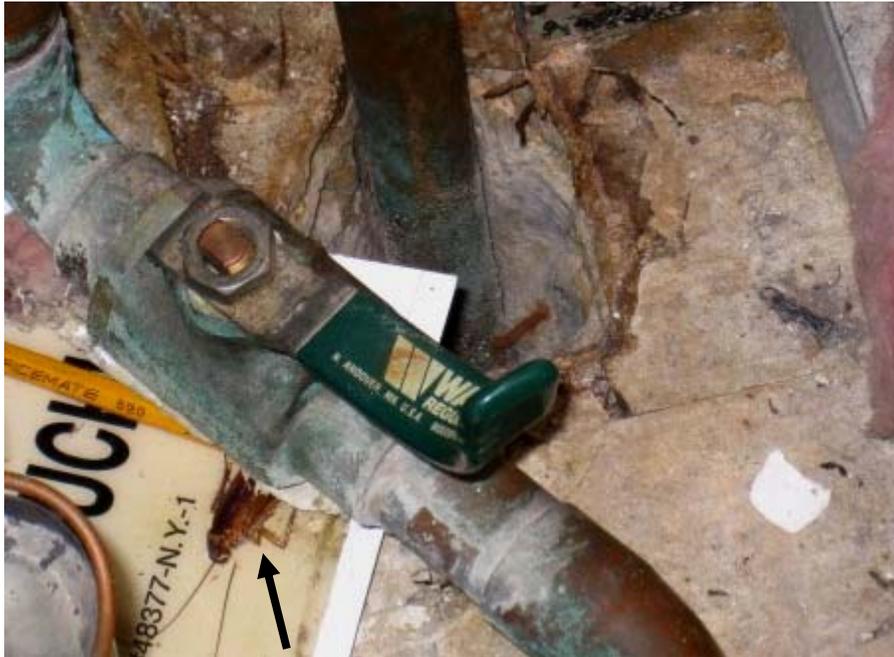
**Picture 15**

**Dead Insect in AHU Closet (Arrow)  
Note Fiberglass Insulation and Large Utility Hole in Floor**

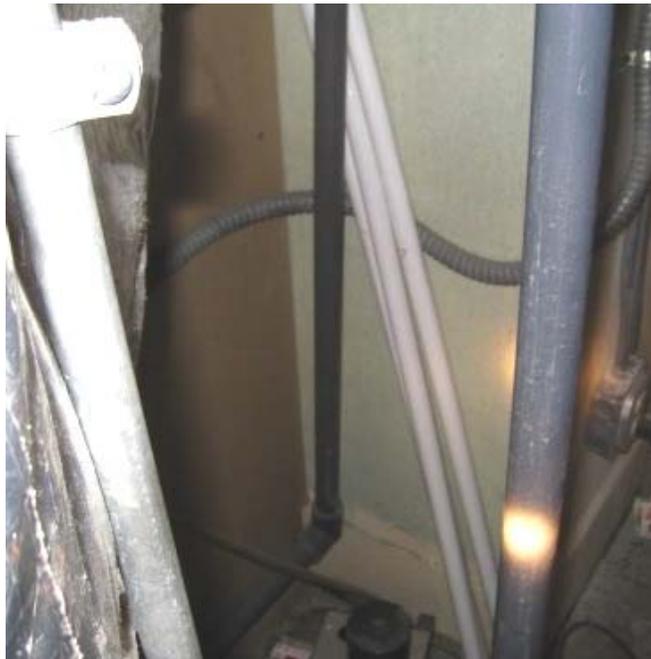
**Picture 16**

Fluorescent light bulbs were stored in a closet in a manner that could subject them to damage (Picture 16). Breakage of these glass bulbs can cause injuries and may release mercury and/or other hazardous compounds.

**Fluorescent Light Bulbs Leaning Against Wall**

21. Ensure fluorescent light bulb storage is in accordance with Massachusetts Department of Environmental Protection's Guidelines, which can be obtained at the following website:  
<http://www.mass.gov/dep/toxics/stypes/flampbiz.htm>.
