INDOOR AIR QUALITY ASSESSMENT

**Massachusetts Registry of Motor Vehicles
490 Forest Avenue
Brockton, Massachusetts**

Prepared by:
Massachusetts Department of Public Health
Bureau of Environmental Health
Indoor Air Quality Program
December 2012

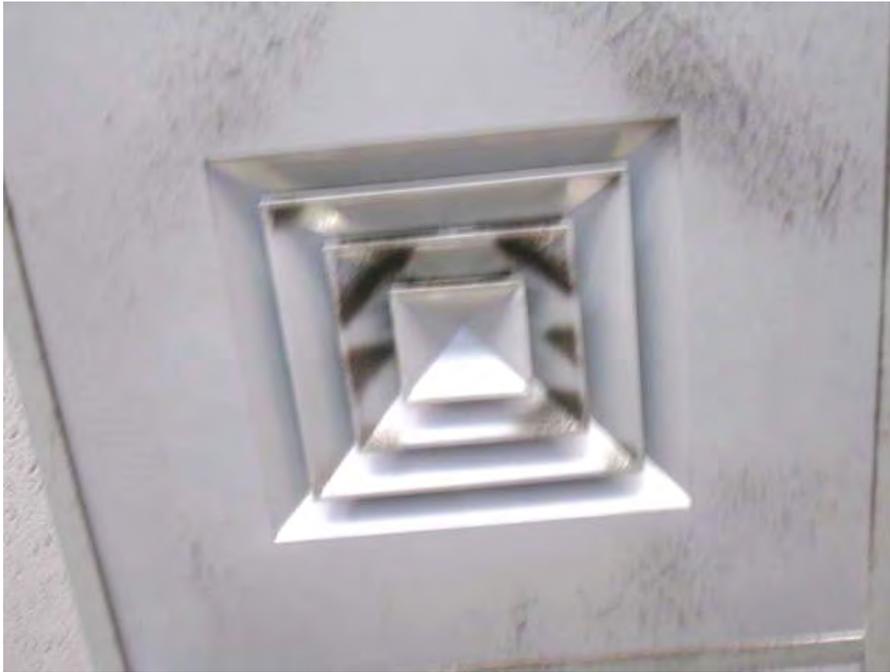
Picture 1

A number of air diffusers, exhaust/return vents and FCUs were observed to have accumulated dust (Pictures 1, 2, and 6). The exhaust vent in the women's restroom was severely occluded (Pictures 8 and 17), which inhibits its ability to function and may also lead to damage of the fan itself. If exhaust vents are not functioning, backdrafting can occur, which can re-

Ceiling-mounted supply vent, note dust/debris accumulation on louvers

15. Clean air diffusers, FCUs and return/exhaust vents periodically of accumulated dust/debris.

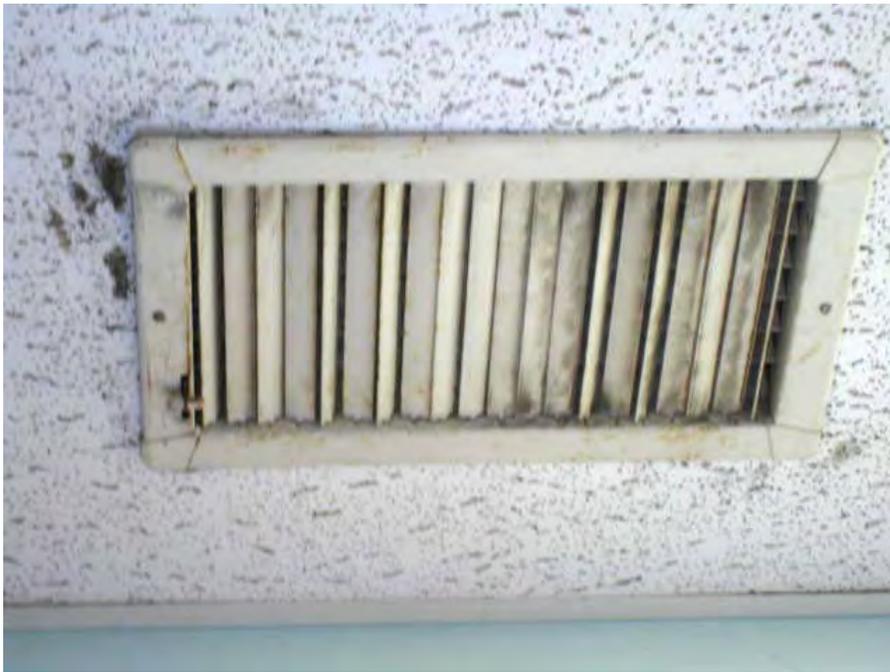
Picture 2

Ceiling-mounted supply vent, note dust/debris accumulation on louvers

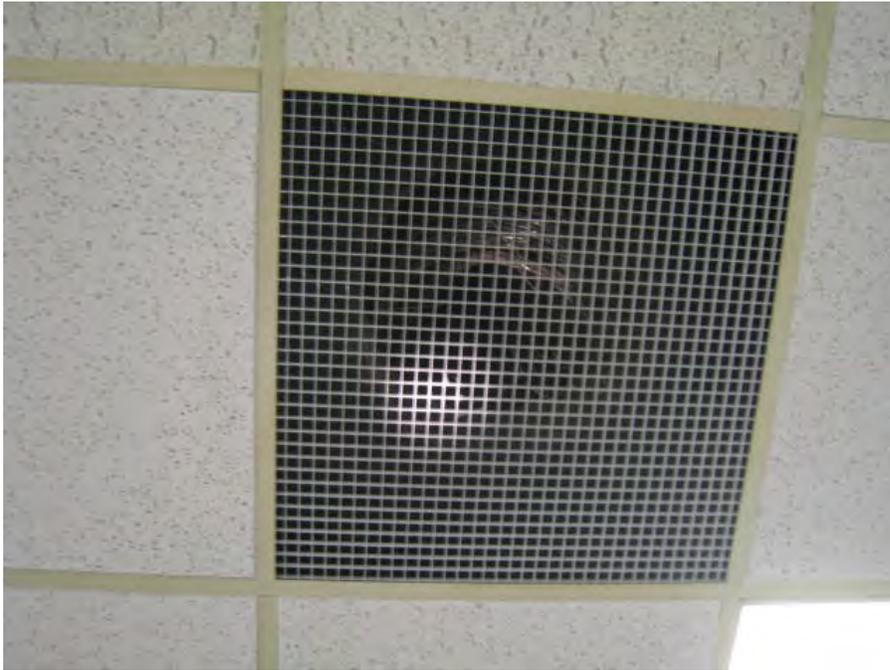
Picture 3

Ceiling-mounted return grill

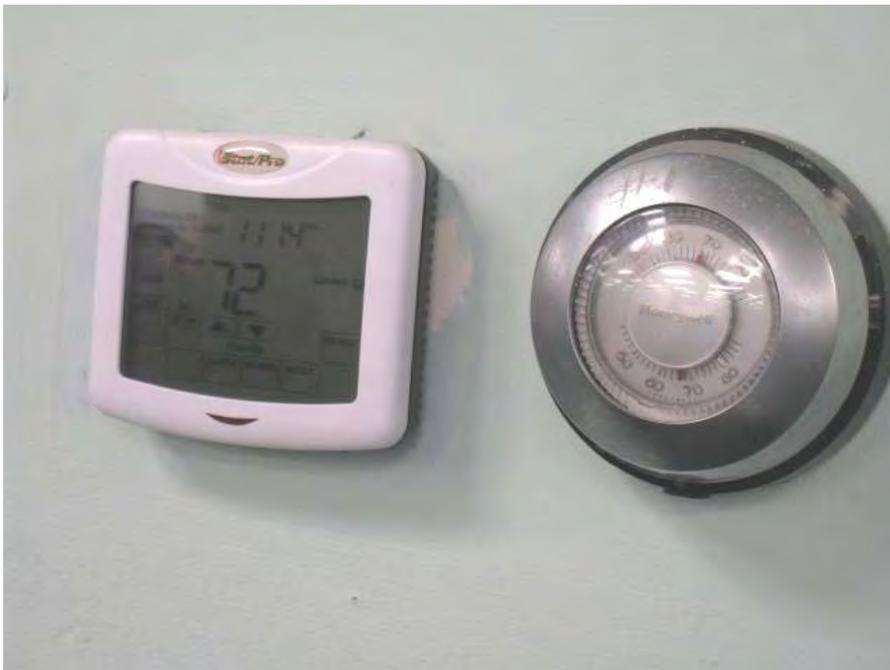
Picture 4

Digital wall thermostat, adjacent to old dial thermostat

improve temperature/comfort control. MDPH recommends that thermostats be set to the fan “on” setting during occupied periods to provide continuous air circulation and filtration.

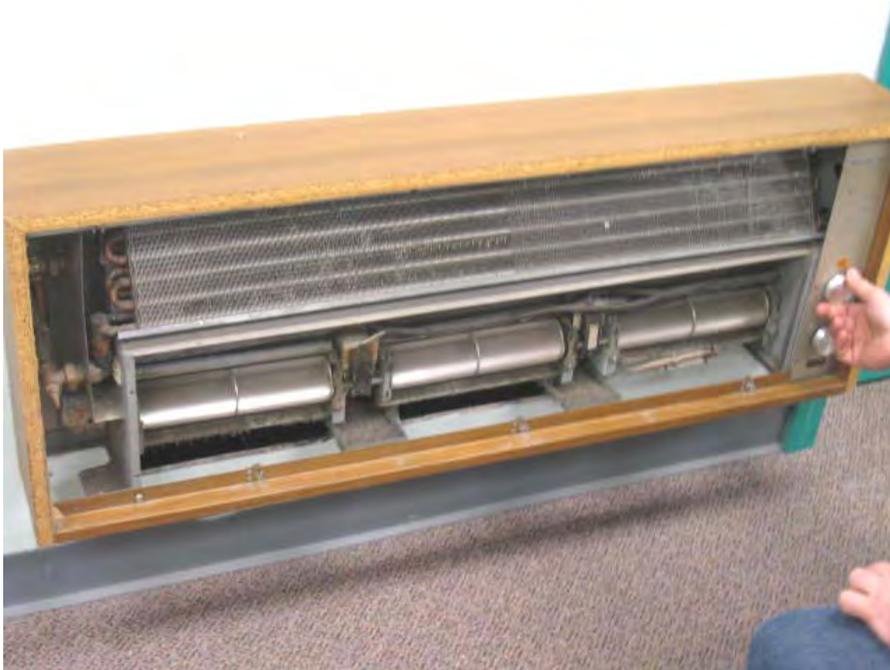
Picture 5

To supplement the HVAC system, the building utilizes fan coil units (FCUs) to provide heat. The FCUs throughout the building appeared to be outdated and in disrepair, several were missing covers, exposing moving fans (Picture 5), which could be a hazard. In addition, the interiors of the FCUs examined had accumulated dust and debris (Picture 6). FCUs are typically equipped with filters; no filters were installed in FCUs at the RMV.

Fan coil unit missing cover

4. Contact an HVAC engineering firm to have FCUs fully evaluated for proper operation (and replacement if needed), as well as possible retrofit of filter racks and missing panels. This measure is strongly recommended given the age and present condition of FCUs.

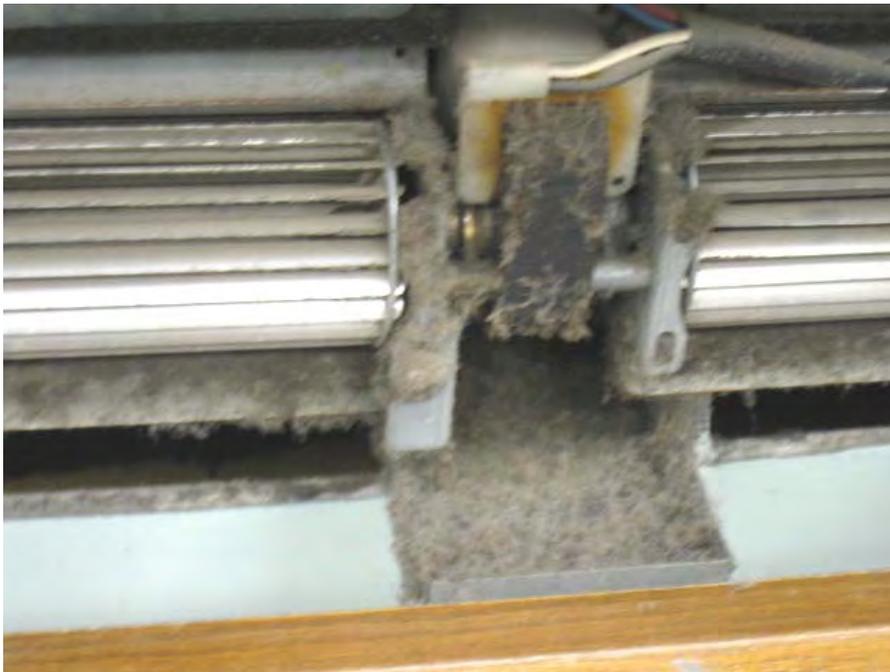
Picture 6

Accumulated dust/debris in fan coil unit

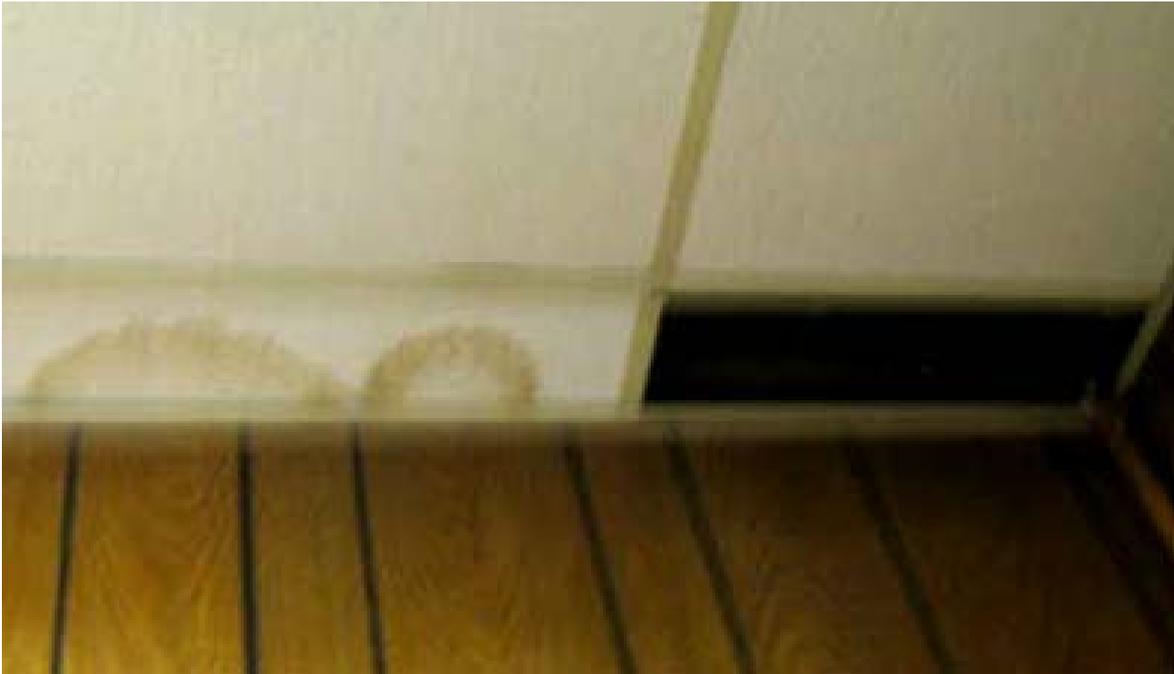
Picture 7

A number of areas had water-damaged ceiling tiles (Table 1; Pictures 7 through 11). Water-damaged ceiling tiles indicate leaks from either the roof or plumbing system and can provide a source for mold growth. Water-damaged ceiling tiles should be replaced after a water leak is discovered and repaired. Roof leaks were reported by occupants outside the Clerk 5 office, where the carpet was water-stained.

Missing ceiling tiles and open utility holes in walls were noted in several areas throughout the building (Pictures 7, 9, 21 and 22; Table 1). Missing ceiling tiles and open utility holes can provide a means of transport for odors, fumes, dusts and vapors between rooms and floors.

Missing/water-damaged ceiling tiles

- recommended. Drinking water during the day can help ease some symptoms associated with a dry environment (throat and sinus irritations).
7. Ensure leaks are repaired and replace water-damaged ceiling tiles (and light fixtures).
Examine the area above and around these areas for mold growth. Disinfect areas of water leaks with an appropriate antimicrobial as needed.

8. Ensure that all missing/damaged ceiling tiles are replaced and that they fit snugly within their frames.
 9. Install weather stripping around exterior doors (e.g., plate room) to prevent drafts, water penetration and pest entry.

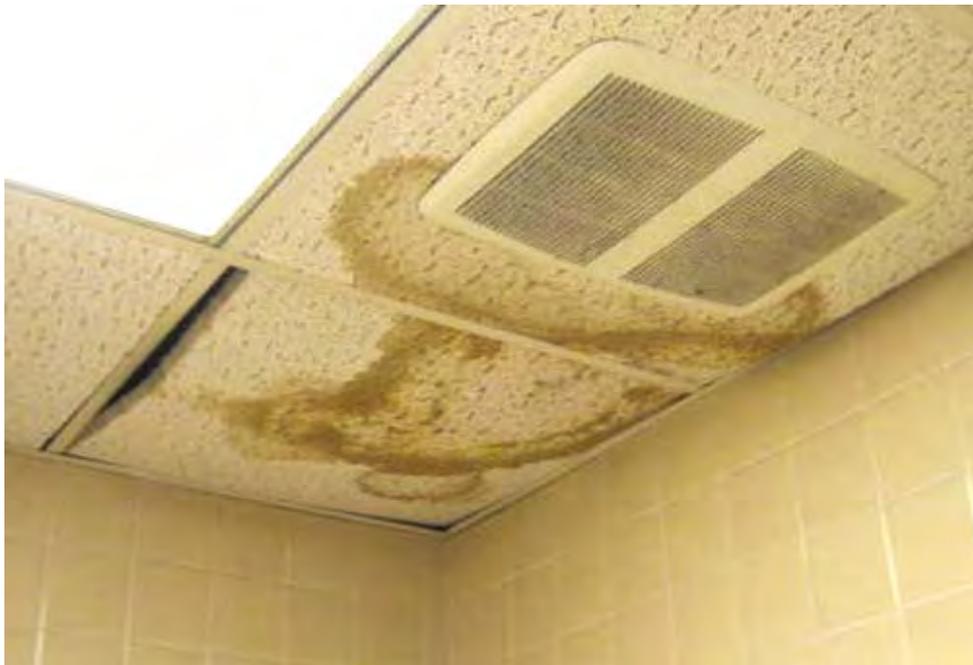
Picture 8

Water-damaged ceiling tiles in women's restroom, note dust/debris accumulation on vent

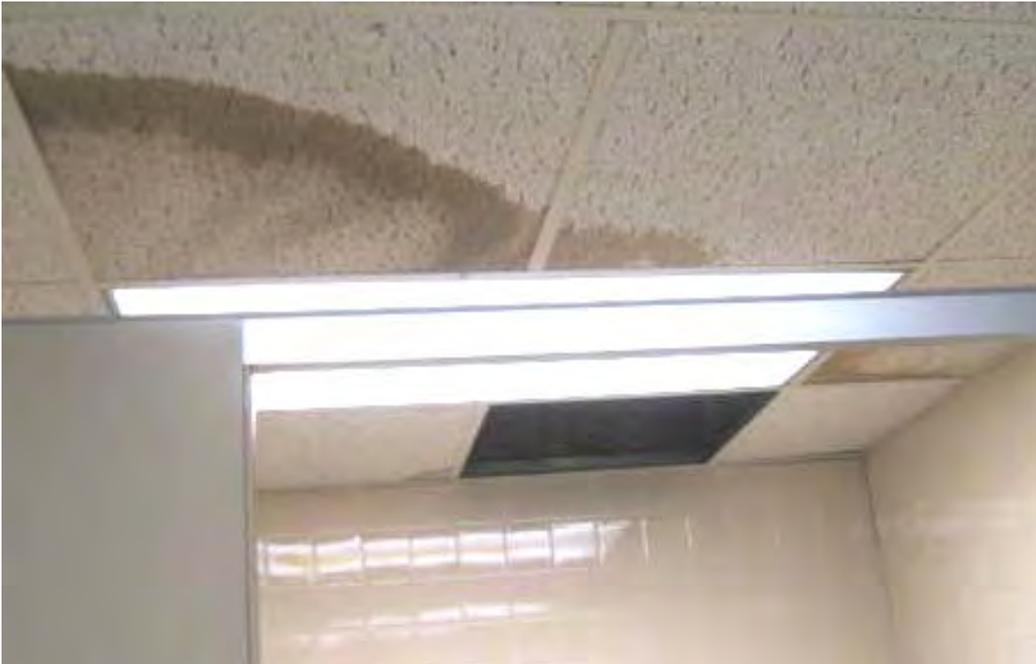
Picture 9

Missing/water-damaged ceiling tiles in men's restroom

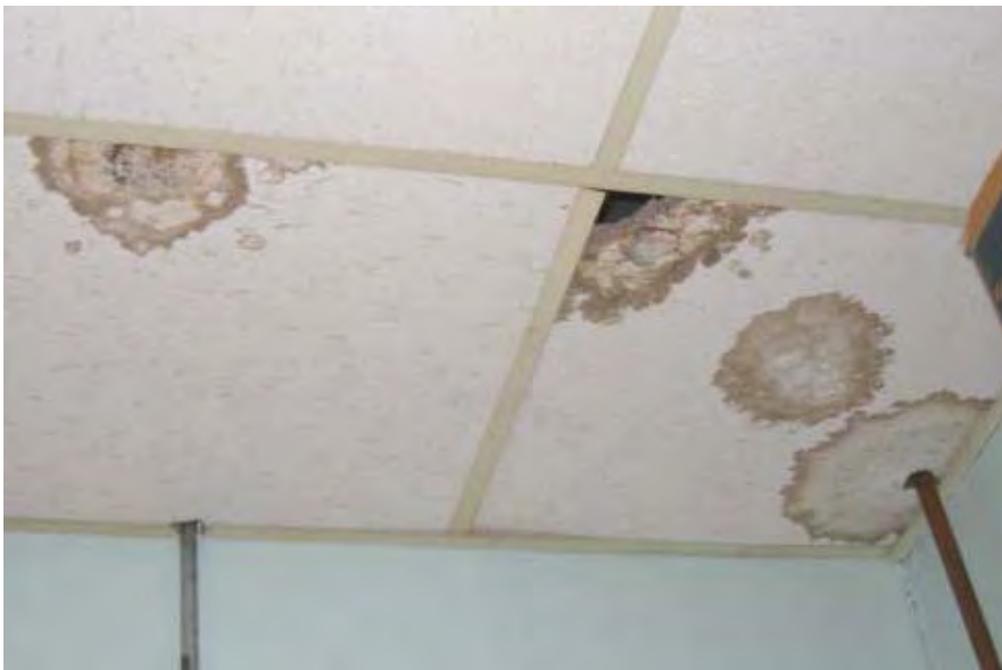
Picture 10

Water-damaged ceiling tiles in plate room

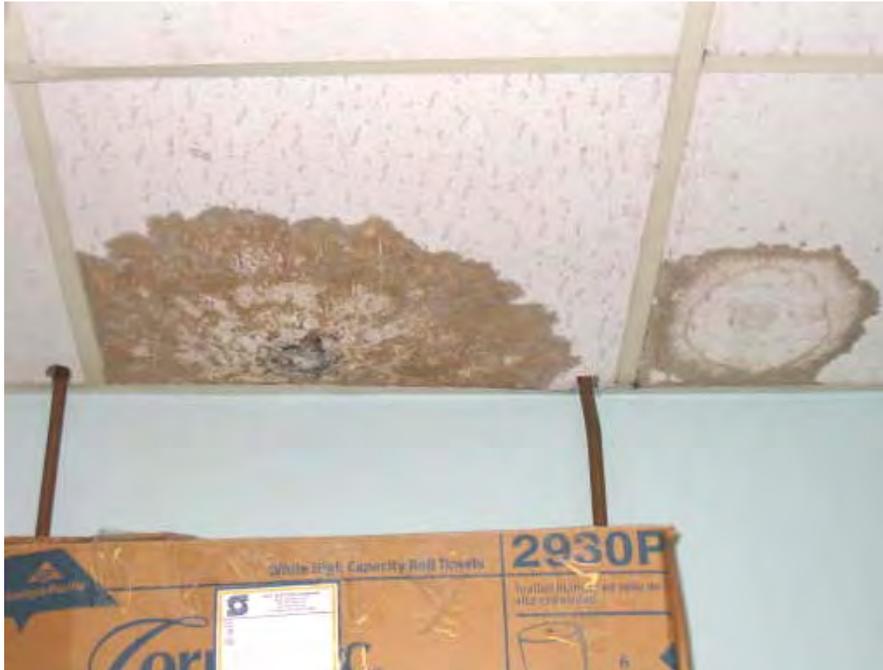
Picture 11

Water-damaged ceiling tiles in plate room

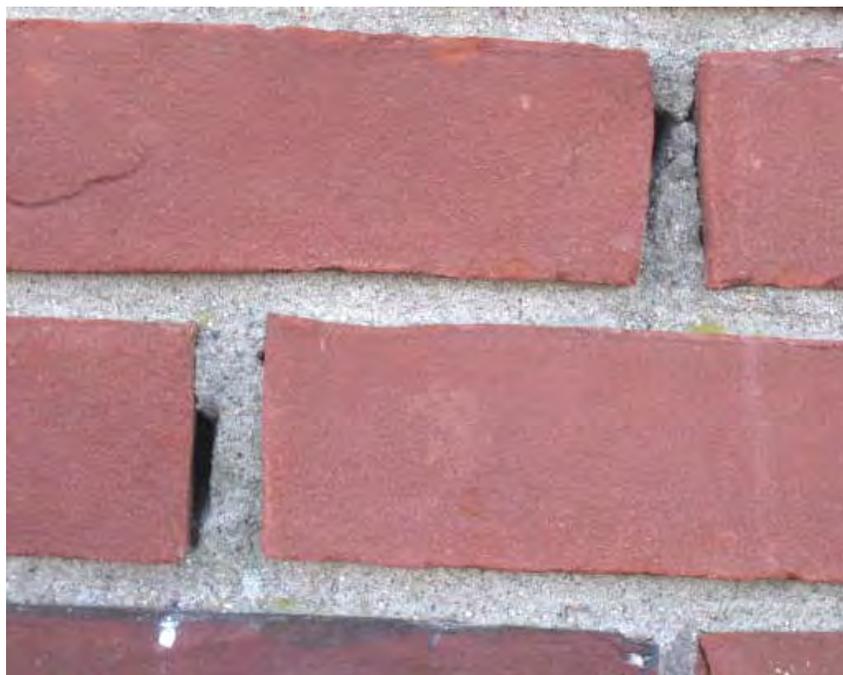
Picture 12

- Light penetrating through the spaces around/underneath the exterior door in the plate room, which can also serve as pathways for insects, rodents and other pests into the building;
- Missing/damaged mortar around exterior brick (Pictures 12 and 13);
- Damaged roof eaves (Pictures 14 and 15); and
- Damaged attic crawlspace vent/bird screen (Picture 16).

The aforementioned conditions represent potential water penetration sources. Over time, these conditions can undermine the integrity of the building envelope and provide a means of water entry into the building, including via capillary action through foundation concrete and masonry (Lstiburek & Brennan, 2001). In addition, these breaches may provide a means for pests such as rodents and, in the case of the damaged attic/crawlspace vent, birds to enter the building.

Missing/damaged mortar around exterior brick

10. Re-point missing/damaged mortar around exterior brick to prevent further damage and water intrusion.
 11. Repair/replace damaged attic/crawlspace vent/bird screen.

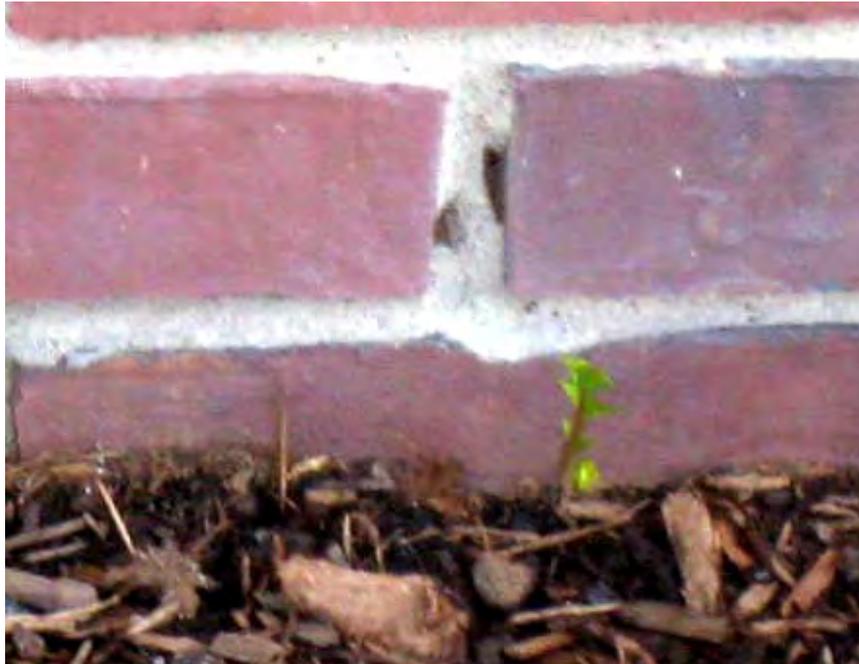
Picture 13

Missing/damaged mortar around exterior brick

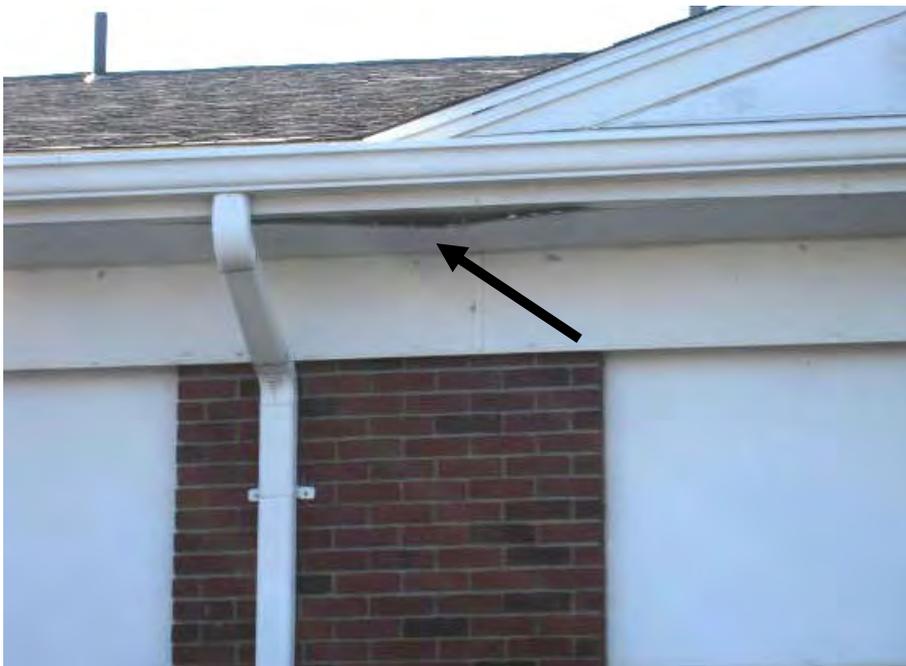
Picture 14

Damaged roof eave (arrow)

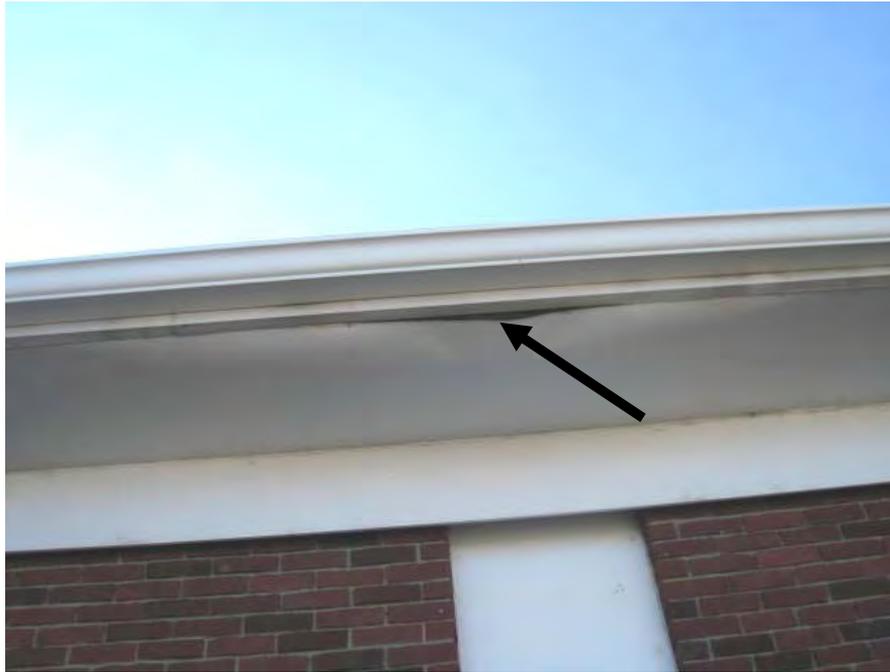
Picture 15

Damaged roof eave (arrow)

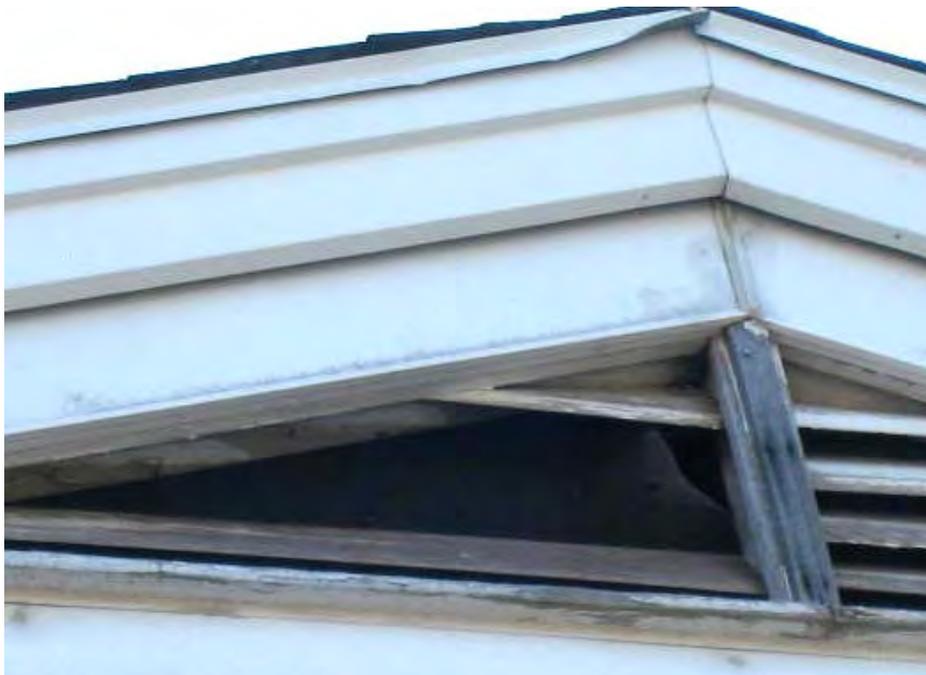
Picture 16

Damaged attic crawlspace vent/bird screen

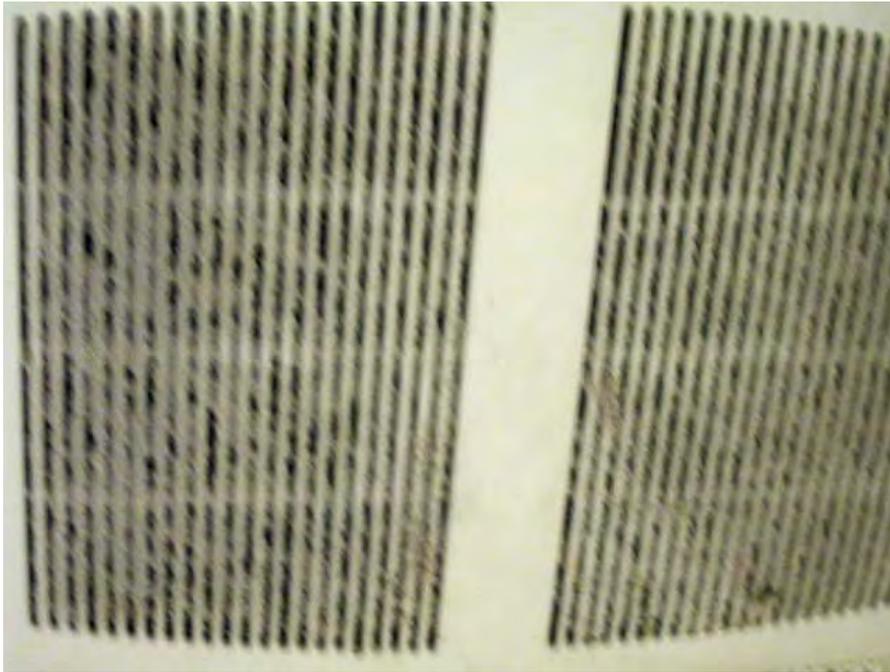
Picture 17

Close-up of occluded exhaust vent in women's employee restroom (Picture 8)

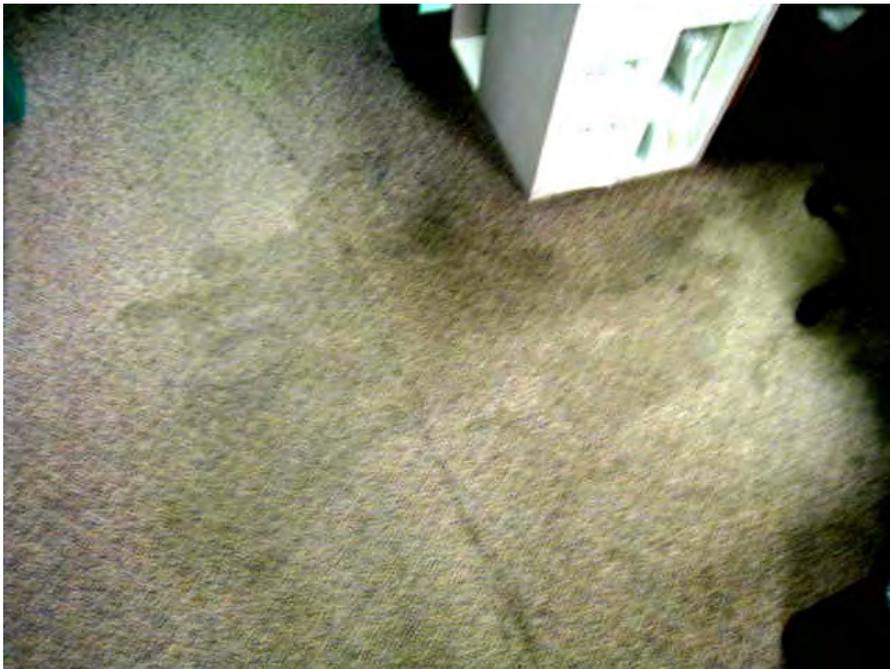
Picture 18

Many areas had water-damaged or soiled carpeting (Pictures 18 and 19). Mr. Clifford reported that carpets at the RMV were installed in 2003-2004 and are spot cleaned by in-house staff several times a year as needed. Additionally, all carpets are professionally cleaned once a year by a carpet cleaning vendor. The Institute of Inspection, Cleaning and Restoration Certification (IICRC), recommends that carpeting be cleaned annually (or semi-annually in soiled high traffic areas) (IICRC, 2005). Since the average lifespan of a carpet is approximately eleven years, consideration should be given to replacing flooring over the next few years (Bishop, 2002).

Soiled/stained carpeting

12. Continue to clean carpeting annually or semi-annually in soiled high traffic areas as per the recommendations of the Institute of Inspection, Cleaning and Restoration Certification (IICRC). Copies of the IICRC fact sheet can be downloaded at: http://1.cleancareseminars.net/?page_id=185 (IICRC, 2005)

13. Over the next several years, consider replacing carpeting as it nears the end of its useful lifespan with carpet squares or a non-porous surface such as vinyl tile.

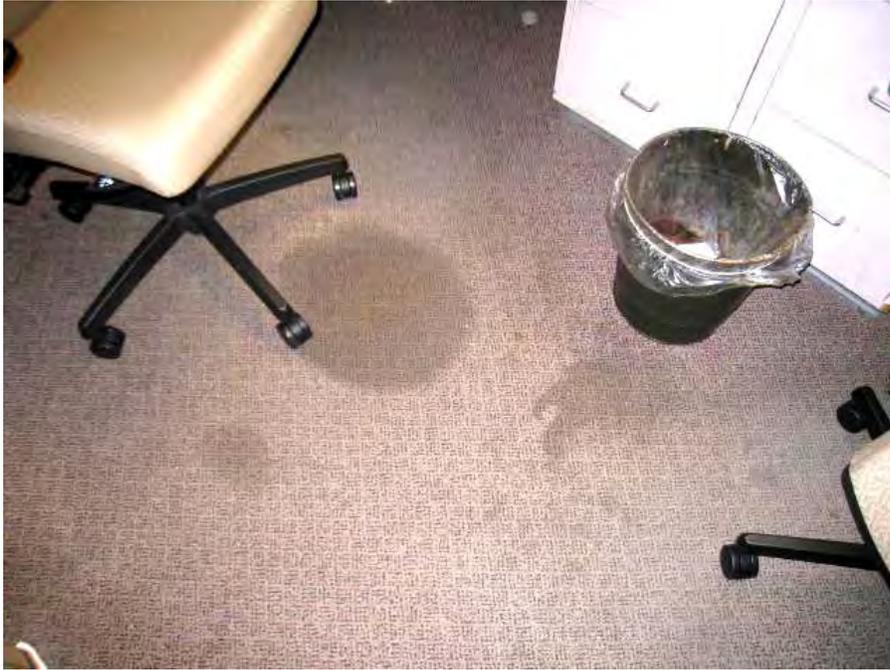
Picture 19

Soiled/stained carpeting

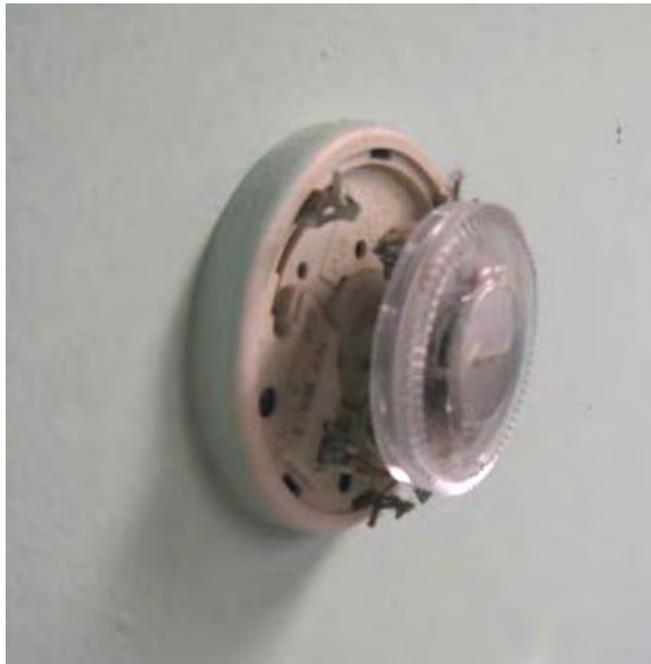
Picture 20

Of note are old mercury-containing thermostats located in several areas of the RMV (Picture 20). The mercury in these thermostats is in an airtight glass ampoule. While the mercury is not evaporating into the environment, these glass ampoules pose a hazard by accidental breakage. Accidental breakage could result in a costly hazardous material clean up/remediation.

Mercury-containing thermostat (cover removed by BEH/IAQ staff)

17. Consider replacing mercury containing thermostats with digital/programmable thermostats to improve temperature control. Have the mercury-containing items removed for proper disposal.

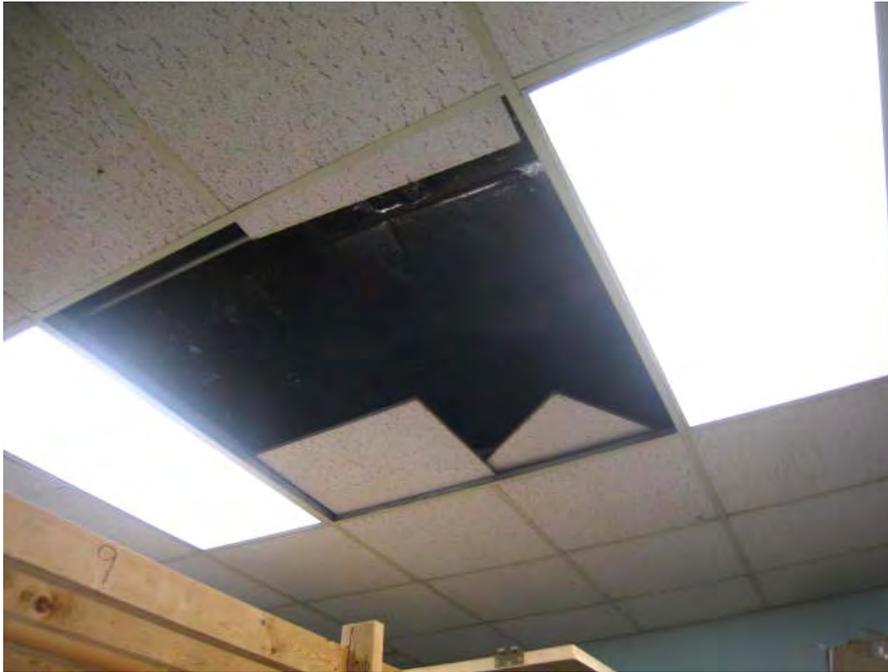
Picture 21

Missing ceiling tiles in plate room

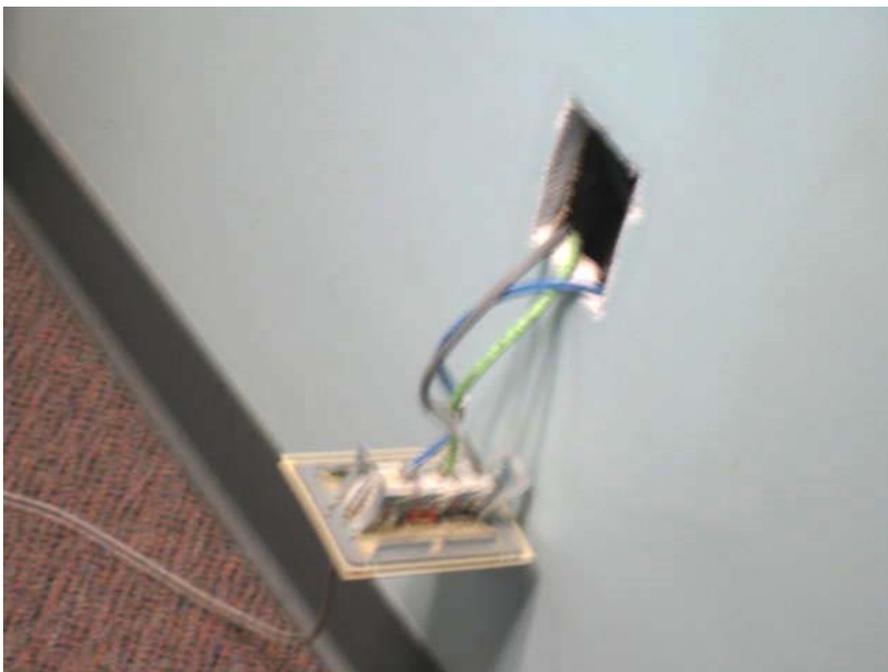
Picture 22

Wall socket removed from wall

14. Reinstall wall socket (Picture 22); ensure this and other breaches in wall cavities are sealed to eliminate potential pollutant paths of migration.

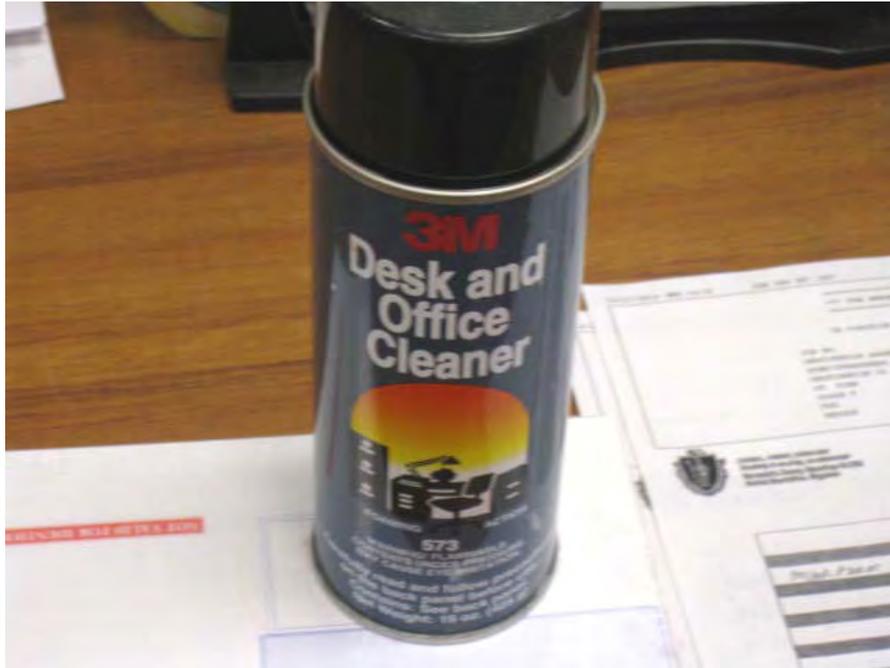
Picture 23

Lastly, RMV staff frequently use volatile organic compound (VOC)-containing cleaning materials (Picture 23) to clean personal work areas. These materials contain several VOCs (e.g., isopropyl alcohol and monoethanolamine) that can be irritating to the eyes, nose and throat (3M, 2000).

VOC-containing spray cleaner, note label warning: **flammable and may cause eye irritation**

18. Consider discontinuing the use of VOC-containing cleaners. Less irritating materials such as soap and water may be sufficient to clean in these areas.
