ODOR INVESTIGATION

**Mary L. Fonseca Elementary School
160 Wall Street
Fall River, Massachusetts**

Prepared by:
Massachusetts Department of Public Health
Bureau of Environmental Health
Indoor Air Quality Program
February 2012

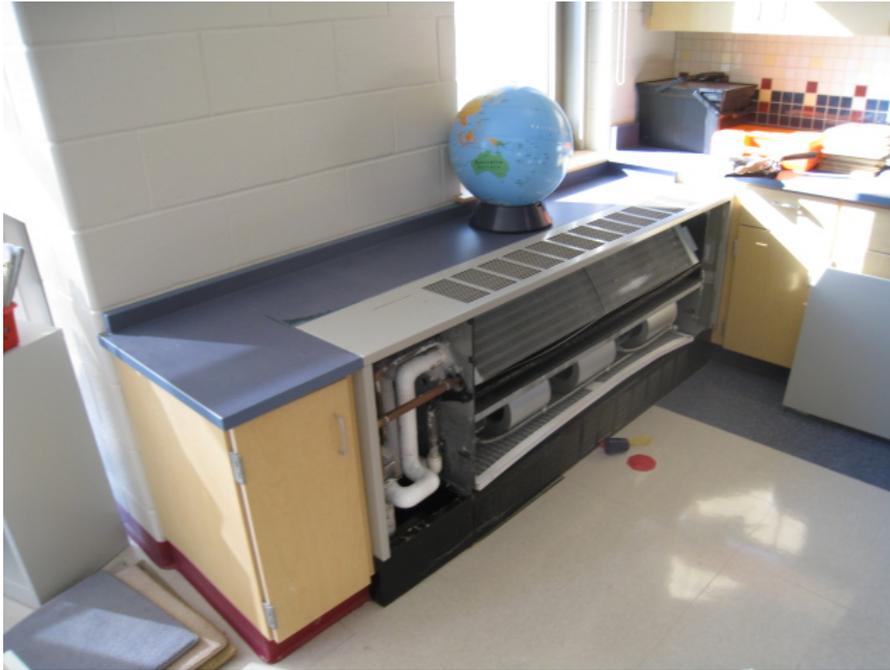
Picture 1

Upon entry into classroom 135 a slight musty odor could be detected. The odor was noticeably more potent towards the rear right corner of the classroom where the fan coil unit (FCU) was located (Picture 1). When a FCU is activated it draws air from the classroom,

Fan Coil Unit in Right Rear Corner of Classroom 135

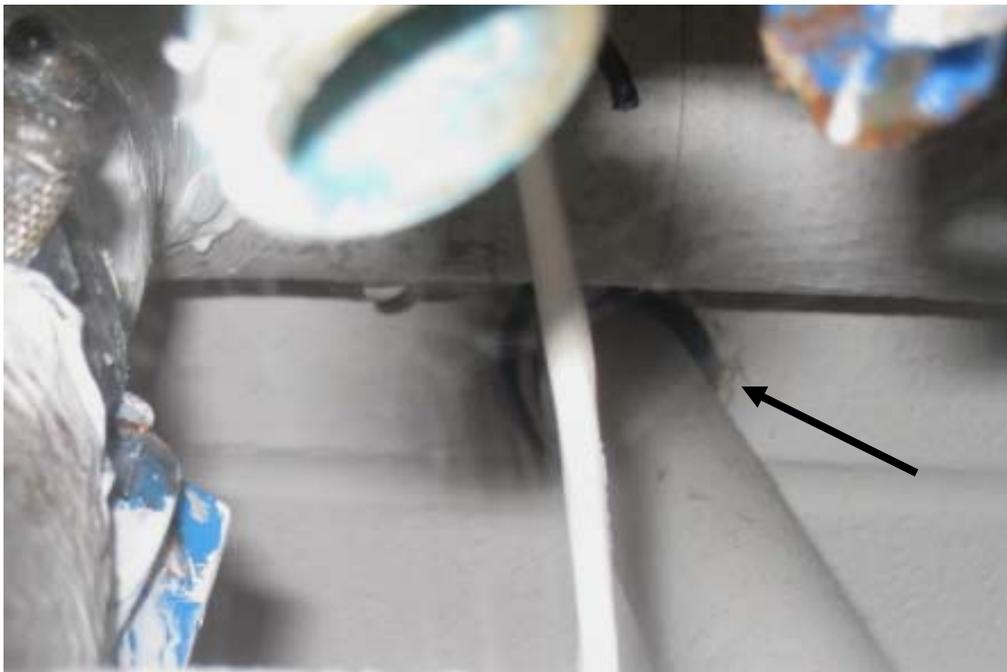
Picture 2

heats/cools, filters, and distributes the air back into the classroom ([Figure 1](#)). BEH noted a space around the condensation pipe in the rear wall behind the FCU cabinet (Picture 2), which could serve as a pathway for musty odors from the wall cavity into the FCU. At the time of the assessment, BEH recommended that this breach be sealed.

Space around Condensate Pipe in Rear Wall behind Fan Coil Unit Cabinet

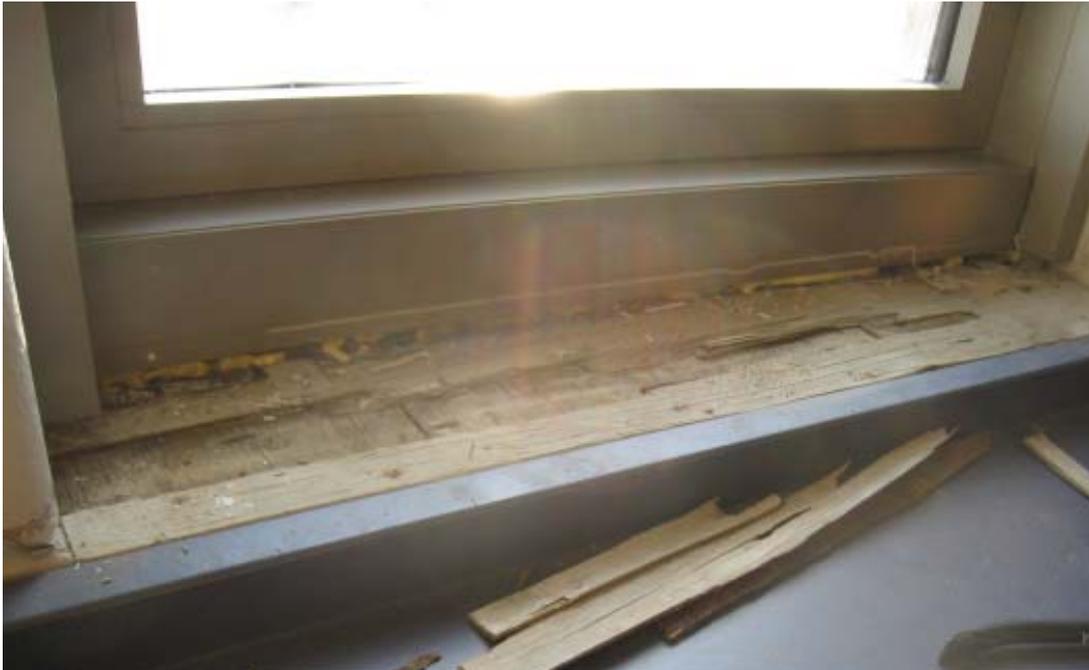
Picture 3

Although these breaches had been sealed, the odors reoccurred, prompting the second site visit from BEH staff. On December 30, 2011, Mr. Feeney and Mr. Holmes evaluated the FCU drainage pipes, as well as the rooftop drainage system, as potential causes of odors and eliminated them both as the source. The most likely source of moisture creating odors appeared to be related to window leaks. When the windowsill near the FCU was removed, water-damaged wood was observed (Picture 3). The water damage appeared to be the result of missing/damaged caulking around the window frame (Picture 4). If windows are not properly sealed they can allow wind-driven rain in and allow moisture infiltration during humid months. Also noted were dark spots, possibly mold growth, on the underside of particle board trim around the FCU (Picture 5), which may be a contributor to the odors noted.

Water-Damaged Wood beneath Window Sill in Classroom 135

1. Reseal around window pane/frame to prevent leaks/moisture infiltration.
2. Remove/replace all water-damaged wood around window and FCU.
3. Contact BEH IAQ Program if further investigation is needed.

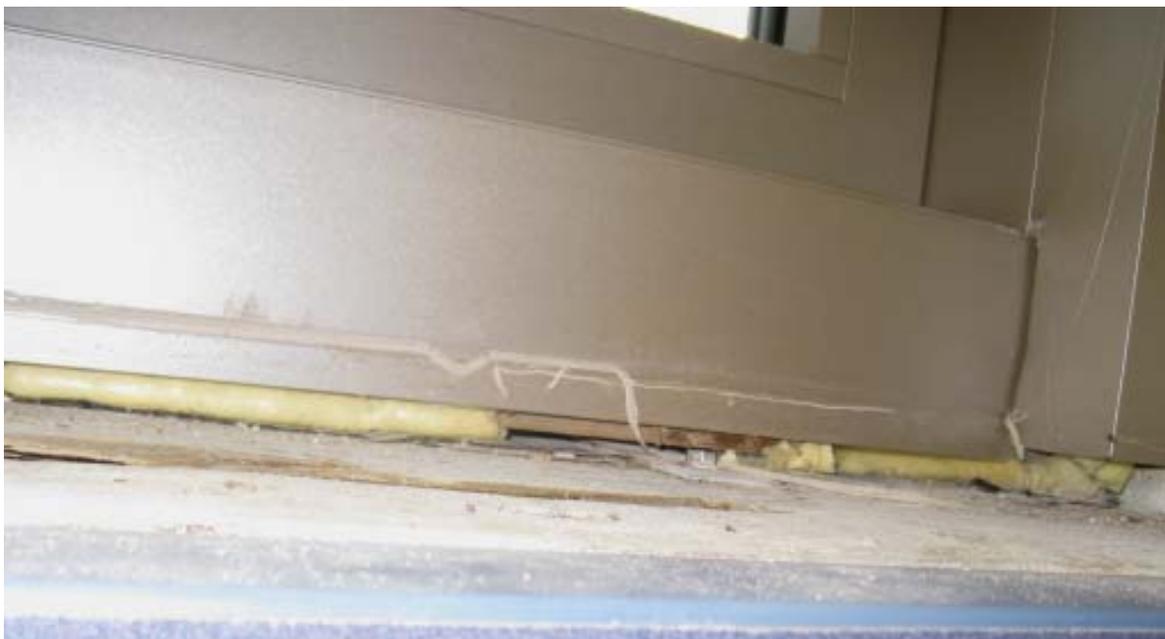
Picture 4

Window Sill Removed Exposing Missing/Damaged Sealant around Window Frame in Classroom 135

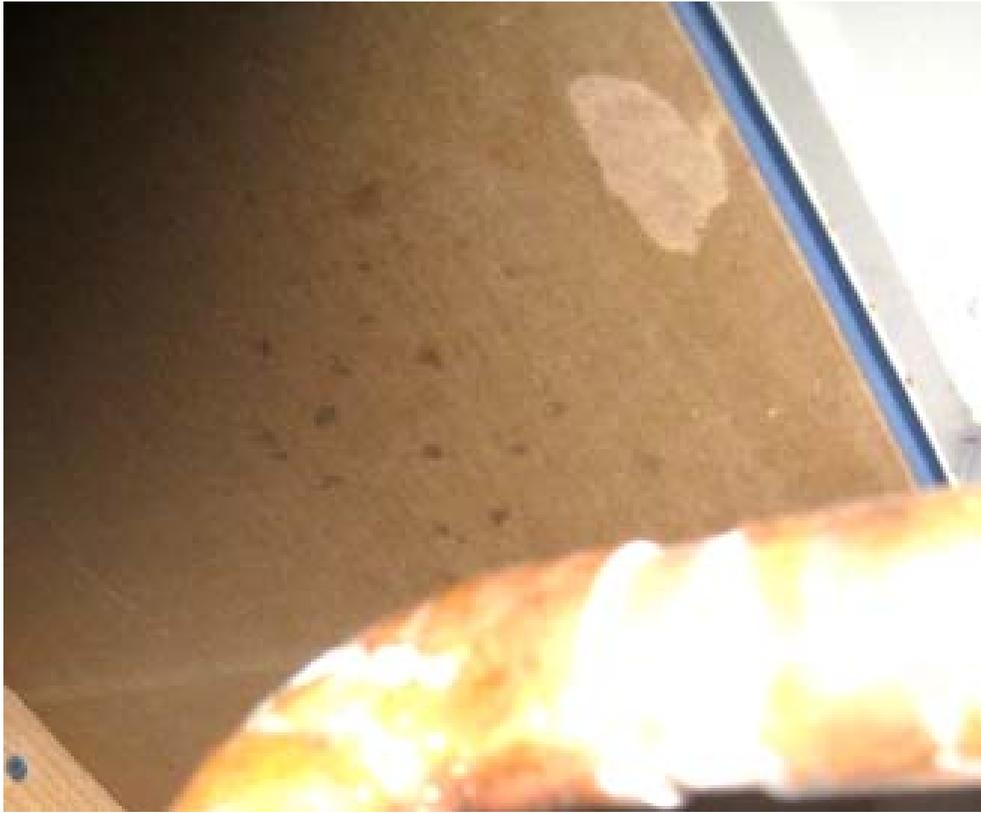
Picture 5

**Dark Spots Observed on the Underside of Particle Board Trim
Adjacent to Fan Coil Unit in Classroom 135**
