# **INDOOR AIR QUALITY INVESTIGATION**

**Gloucester High School  
Ceramic Program and Administrative Office  
32 Leslie O Johnson Road  
Gloucester, Massachusetts**

Prepared by:  
Massachusetts Department of Public Health  
Bureau of Environmental Health  
Indoor Air Quality Program  
April 2012

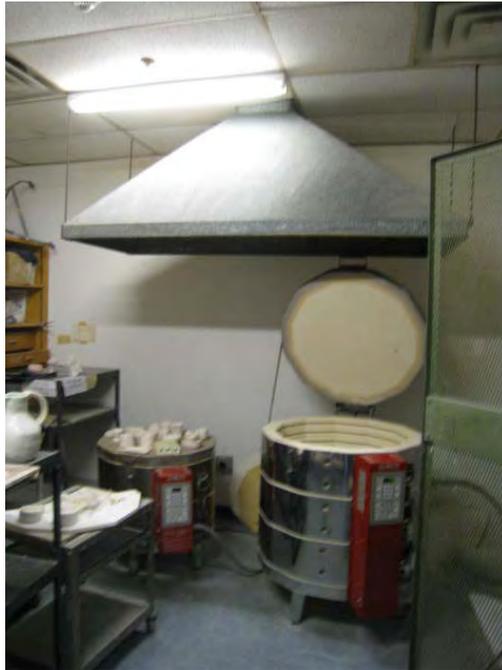
**Picture 1**

The clay art room is equipped with supply and exhaust ventilation as a part of the general heating, ventilation and air conditioning (HVAC) system of the school. It is also equipped with openable windows. The kiln room is separated from the rest of the art room by a door and contains two operable kilns, which were not in use at the time of the visit. The kilns are equipped with a large exhaust vent hood (Picture 1) operated by a switch. The exhaust from this vent goes directly to the outside. When turned on, the exhaust fan appeared to be noisy with minimal draw of air. It was also observed to be intermittently spinning, which can indicate a loose or slipping fan belt. In order to remove heat, gases, water vapor, and particulates generated by the use of the kiln, this fan needs to be repaired and operating. Of note is corrosion on the supports of the suspended ceiling in the kiln room, which may indicate that kiln pollutants were not being removed by the kiln hood exhaust system with the kilns firing. The kiln exhaust should operate at all times the kiln is in use and for a period following use.

**Kilns with exhaust hood**

- a. Ensure that the mechanical systems for the exhaust hood are operational. Make sure the vent is turned on at all times the kiln is in operation and for a period of time afterwards;

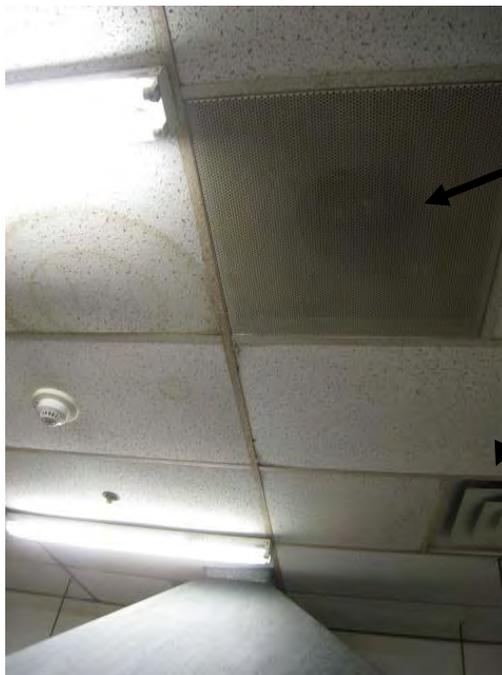
**Picture 2**

In addition, it was noted that both a supply vent and exhaust vent from the building's general HVAC system were located in this room (Picture 2). The presence and operation of

these vents would tend to compromise the effectiveness of the kiln exhaust ventilation and may either: 1) pressurize the room to drive aerosolized kiln waste products into the clay art classroom, or 2) entrain waste products from the use of the kiln into the general building exhaust where they can be transmitted to other areas. There was also a missing portion of ceiling tile in this room, which may allow kiln waste products to enter the ceiling plenum and impact other areas. It is recommended that both the supply and exhaust vents of the general ventilation systems in the kiln room be disconnected and sealed. In addition, to allow the kiln hood exhaust ventilation to operate, the kiln room door should be undercut by several inches, allowing space for air to flow from the classroom beneath the door to the exhaust hood.

**Supply and exhaust vent (arrows) from general HVAC system in kiln room**

- b. Remove or seal the general supply and exhaust vent in the kiln room. Supply make-up air for the room by undercutting the door from the classroom into the kiln room by 3 to 4 inches; and

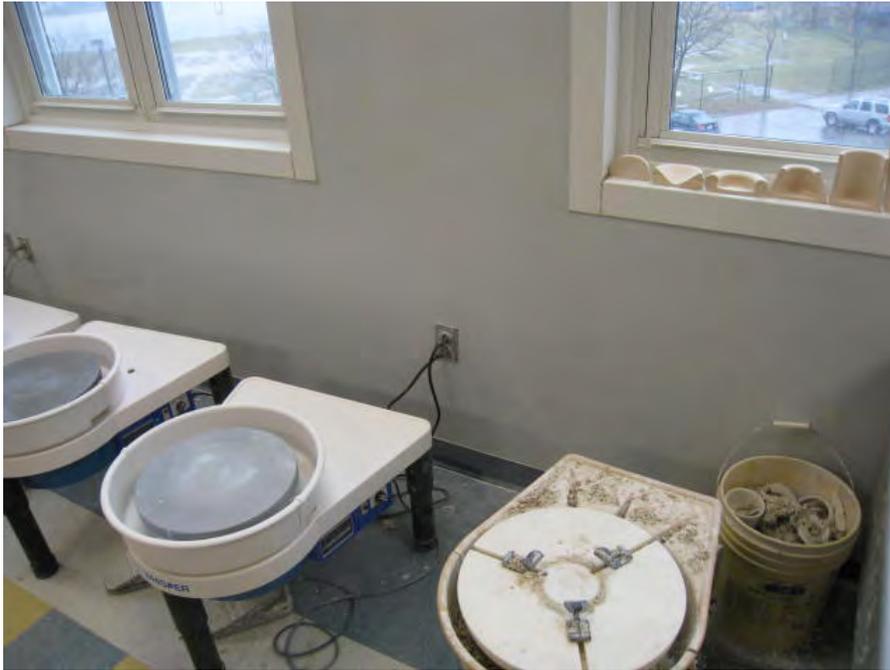
**Picture 3**

Activities that take place in this classroom include wheel throwing of clay. The pottery wheels are located next to the exterior wall of the classroom (Picture 3). It was noted that there were stains and signs of water that had splashed on this wall from pottery wheel use, including areas near electric outlets (Picture 4). Water can infiltrate the wall material, leading to damage and mold growth. It can also compromise the electrical outlets, leading to a shock or fire hazard.

**Location of pottery wheels next to wall**

It is recommended that either the pottery wheels be moved to an area as to not impact walls, or that the walls be covered with a plastic wallboard material to the level of the bottom of the windows to protect the wall surface. Electrical outlets should be moved up the wall out of the splash zone, or be replaced with ground-fault circuit interrupter (GFCI) outlets to protect against shorting-out due to dampness.

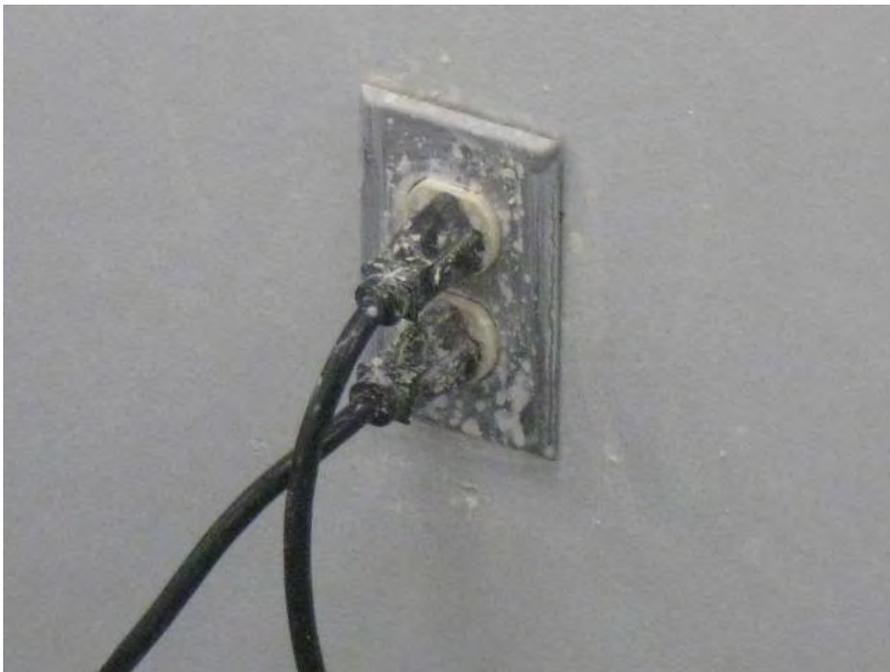
**Picture 4**

**Evidence of splashing on wall and electrical outlets**

- c. Replace missing/damaged ceiling tiles.
2. Move the pottery wheels away from the wall sufficiently far to prevent splashing on wall materials. Alternatively, protect the wall using plastic sheeting and move the electrical outlets up the wall out of the splash zone. Replace standard outlets with GFCI outlets to prevent shock/electrocution and fire hazards.

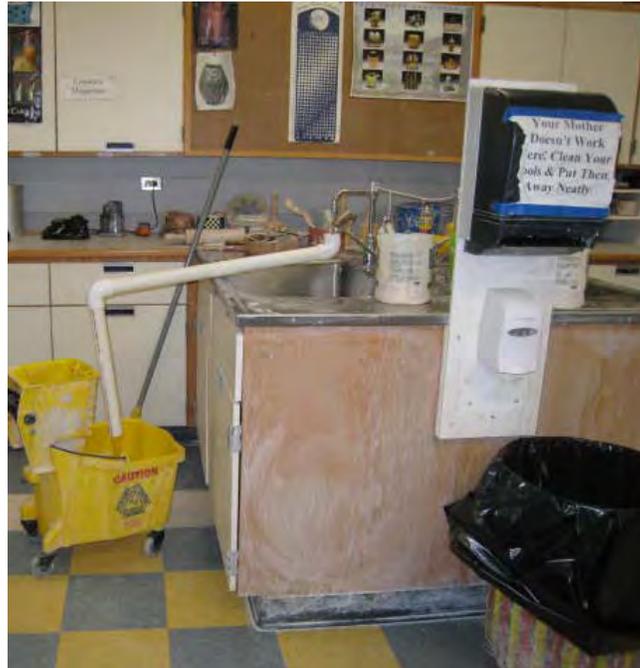
**Picture 5**

A variety of cleaning activities were observed including clay waste that was being removed from tables and other surfaces using sponges, and wet mopping which appeared to be ineffective at removing residue (Picture 5). Clay particles are composed in part of silica, which can harm the lungs when inhaled long term (US CPSC, 2012). Clay can also harbor mold and other microorganisms.

**Residue from clay on counters and surfaces (note conventional mop bucket on left)**

Clay studios should be cleaned often with a wet mop, wet-vacuum or a vacuum equipped with a high efficiency particulate arrestance (HEPA) filter (UMASS Dartmouth, 2012). Microfiber cleaning cloths and mops, which have a very high surface area of small fibers, can also be effective at containing and removing dusts from surfaces; they are recommended for use in hospitals and schools for infection control and may be useful in controlling other dusts (Rose, L. and Westinghouse C., 2010). Dry sweeping or use of an ordinary vacuum cleaner can increase the amount of airborne particulates and should not be used.

- d. Consider a trial use of microfiber cleaning cloths to capture dust on surfaces;
  - e. Using whichever method is chosen, remove as much clay residue from surfaces as possible to prevent reaerosolization of the material in subsequent classes; and

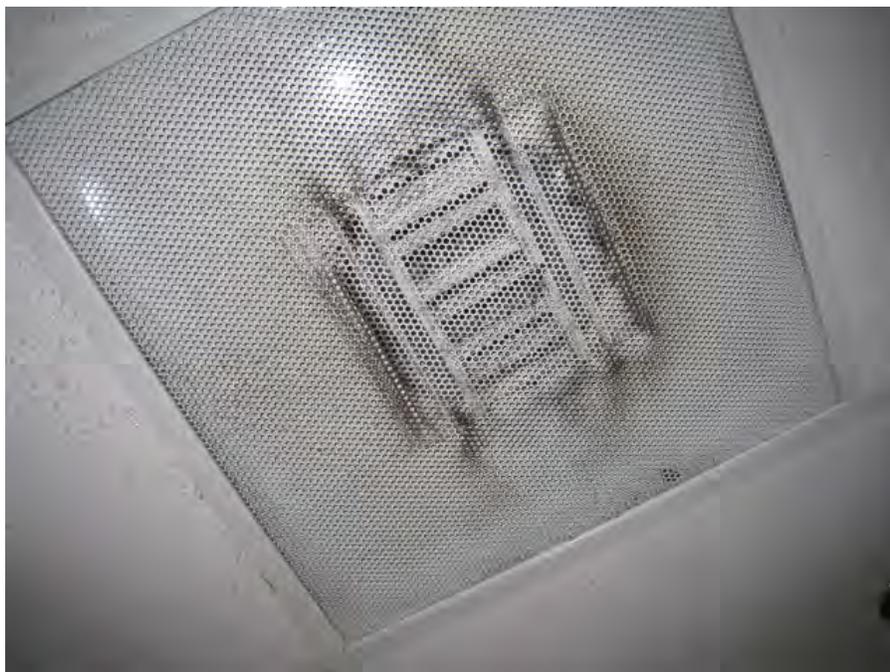
**Picture 6**

- Supply and exhaust vents in this area had accumulated dust/debris (Picture 6). Supply vents, exhaust vents and univent diffusers should be cleaned to prevent re-aerosolization of dust when equipment is activated.

**Dust/dirt accumulation on exhaust vent in MCAS office**

- f. Close art room doors whenever possible to prevent migration of clay dusts into the hallway.
- 4. Clean personal fans, univent air diffusers, return vents and exhaust vents in the administrative offices, as well as the art rooms, periodically of accumulated dust/debris.
- 5. Clean walls and floors of accumulated dust, soils and debris.
- 6. Continue to address any remaining recommendations made in the 2005 and 2008 MDPH reports on this building. These reports and other related indoor air quality documents are located on the MDPH's website and can be found at: <http://mass.gov/dph/iaq>.

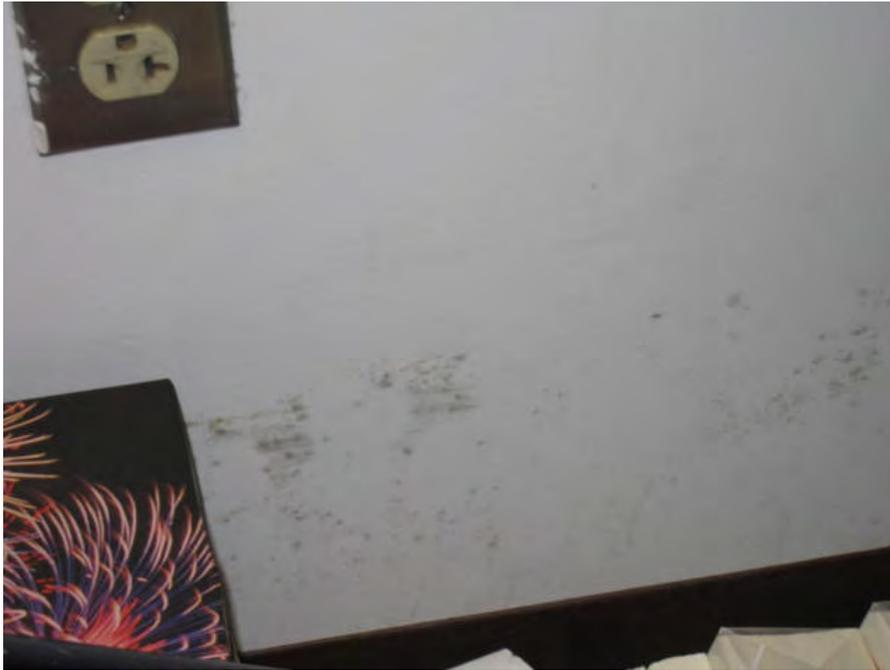
**Picture 7**

- Walls had accumulations of dark material in some locations (Picture 7). This material may be accumulated dust or surface mold. BEH staff readily removed the residue using an alcohol wipe, indicating the material was likely accumulated dust, dirt and other debris on the painted surface of the wall and not mold colonization of the gypsum wallboard. Thorough cleaning of this material is recommended as soon as it is noted.

**Dirt or surface mold on wall in Administrative area**
