# **INDOOR AIR QUALITY ASSESSMENT**

**Massachusetts Department of Public Health  
Southeast Regional Health Office  
1750 Purchase Street  
New Bedford, Massachusetts**

Prepared by:  
Massachusetts Department of Public Health  
Bureau of Environmental Health  
Indoor Air Quality Program  
April 2012

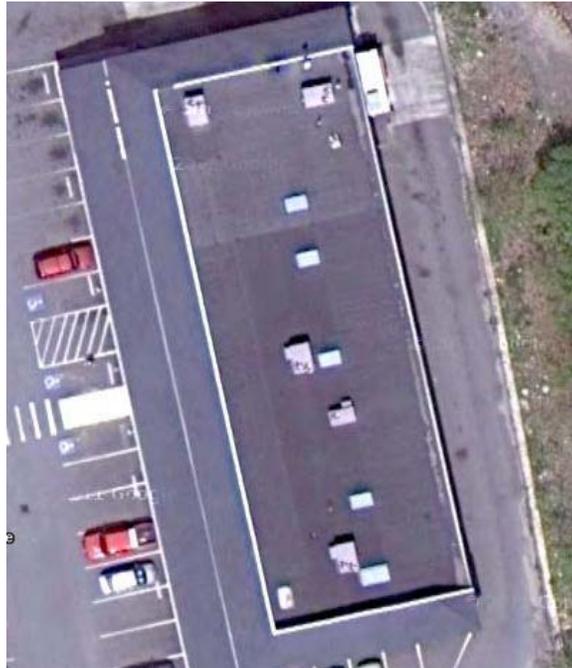
Picture 1

Rooftop Air Handling Units, 1750 Purchase Street

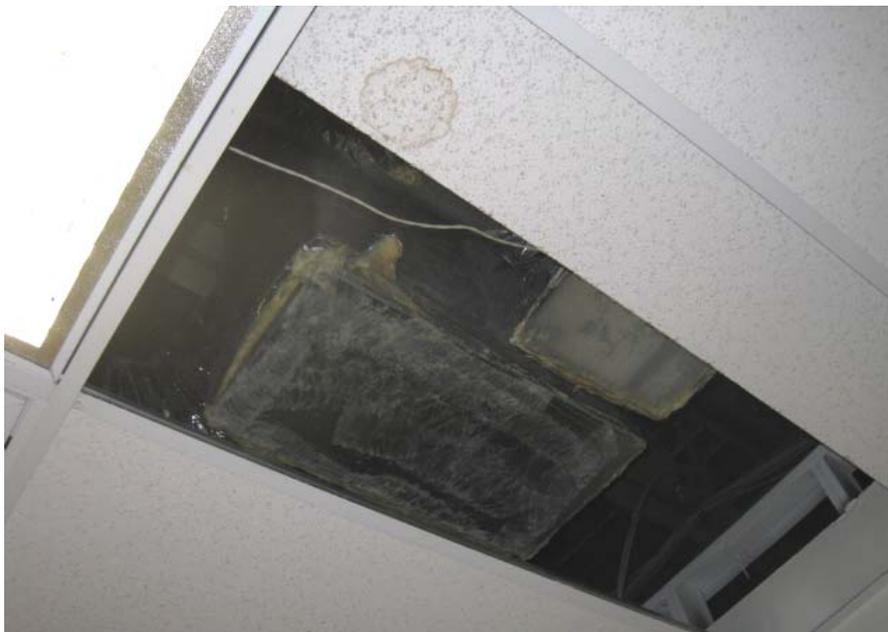
Picture 2

Water-Damaged Ceiling Tile in Vaccine Storage Room 134,  
also Note Insulation Removed from Base of Metal Ductwork

1. Remove/replace water-damaged ceiling tiles.

3. Replace missing insulation on bottom of ductwork in 134 vaccine room (Picture 2), to prevent condensation on metal surfaces and further water damage to ceiling tiles.

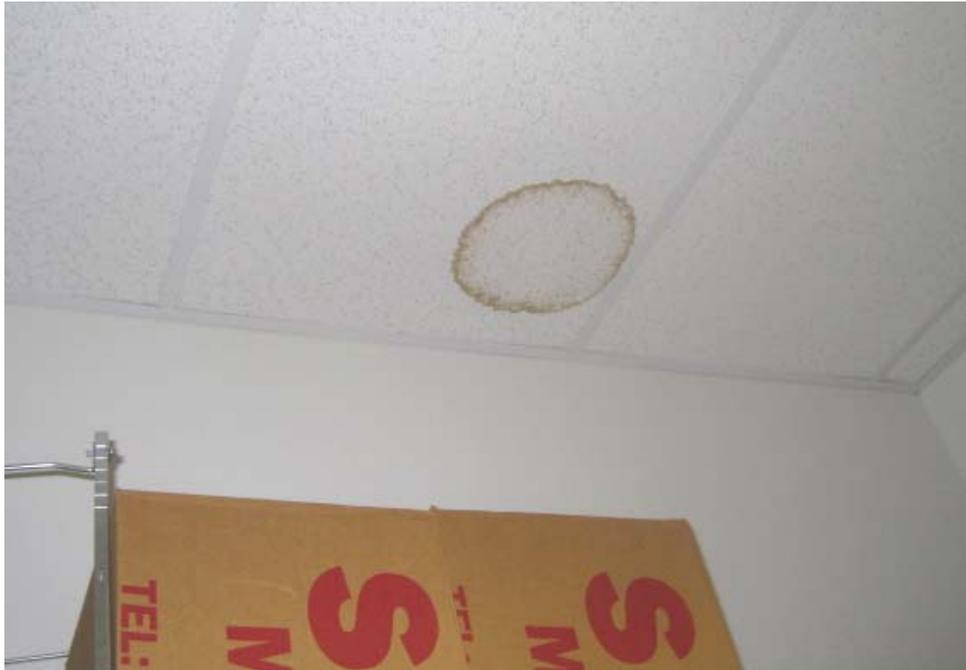
Picture 3

As mentioned previously, the assessment was prompted by the presence of water-damaged ceiling tiles that occupants believe to be associated with roof leaks. Mr. O'Connor reported that building maintenance personnel have been on-site several times over the past year to repair roof leaks, however, new damage continues to occur, usually after heavy wind-driven rain conditions. Three primary areas of leaks were listed as conference room 132, work area 117 and room 134 (the vaccine storage room). Of the three, only the vaccine storage room had current water damage in the form of a stained ceiling tile (Picture 2). BEH staff also observed a stained ceiling tile in the file room (Picture 3). Ceiling tiles were removed in each of these areas to examine conditions above the ceiling tile system for water-damaged building materials that could provide a source for mold growth. No mold-colonized materials were observed in any of the areas at the time of the assessment. The ceiling plenum mainly contains metal and concrete block materials, which are not conducive to mold growth. In addition, the ceiling plenum is an area that has a large volume of moving air, which aids in the drying of any moistened materials.

Water-Damaged Ceiling Tile in File Room

2. Continue to work with building management to address roof leaks. Consider contacting a roofing contractor to conduct high-pressure water testing and/or infra-red analysis to determine source of roof leaks.

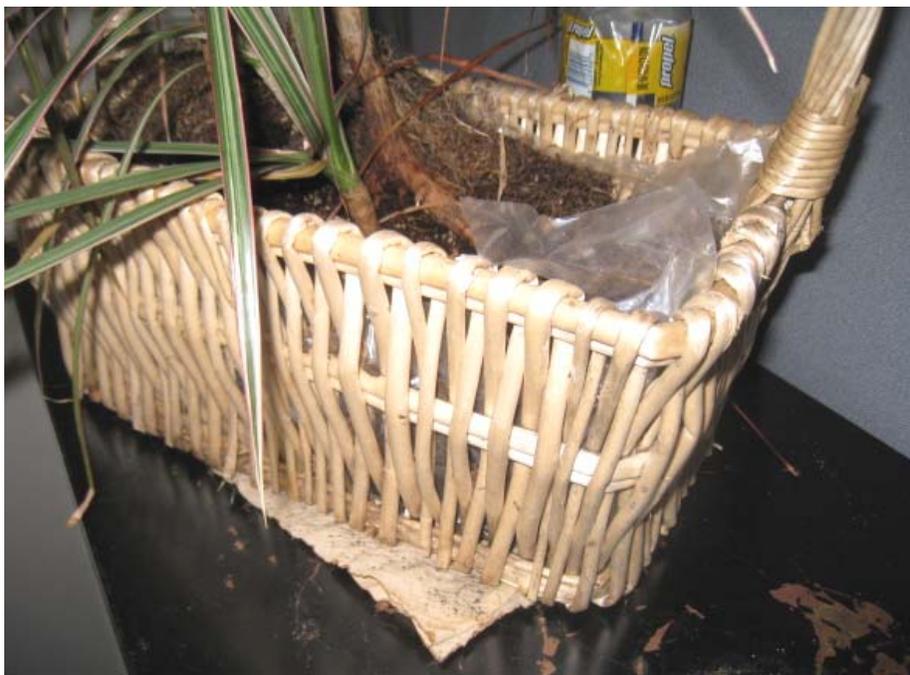
Picture 4

Several areas had plants (Table 1); in one case a plant was observed on paper towels (Picture 4), which is a porous material conducive to mold growth. Plants can be a source of

Plant on Paper Towels

4. Ensure all plants are equipped with non-porous drip pans. Examine drip pans for mold growth and disinfect areas of water leaks with an appropriate antimicrobial where necessary.

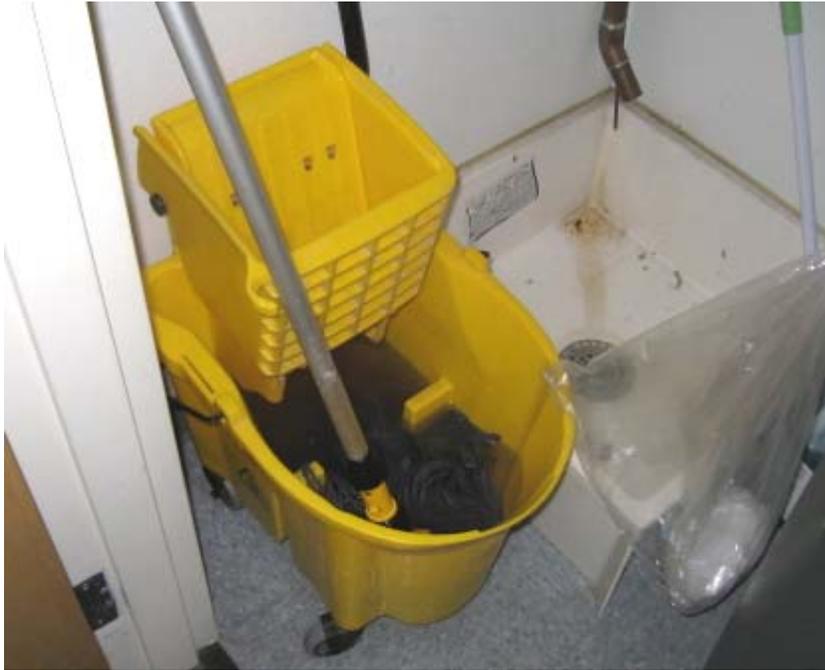
Picture 5

A mop bucket with dirty water was also observed in the custodial closet, which can provide a source of unpleasant odors and bacterial growth (Picture 5). After each use, buckets should be emptied/rinsed and mops set to dry.

Dirty Mop/Water in Bucket in Custodial Closet

5. Empty and rinse mop buckets after each use. Mops should be cleaned, disinfected and set up to dry between uses.
6. Consider adopting a balancing schedule of every 5 years for all mechanical ventilation systems, as recommended by ventilation industrial standards (SMACNA, 1994).
