INDOOR AIR QUALITY ASSESSMENT

**William Taylor Elementary School
620 Brock Avenue
New Bedford, Massachusetts**

Prepared by:
Massachusetts Department of Public Health
Bureau of Environmental Health
Indoor Air Quality Program
January 2012

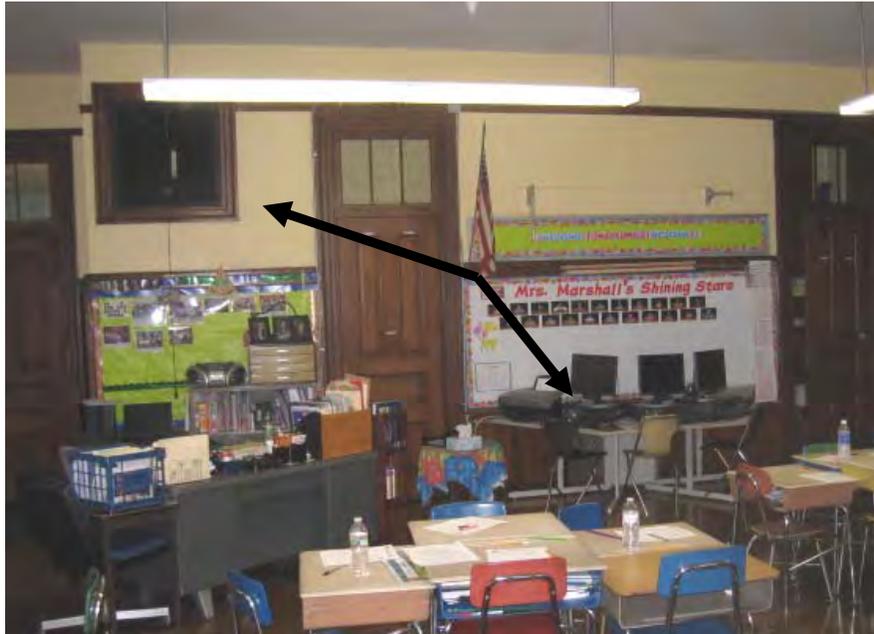
Picture 1

Originally, ventilation was provided by a series of louvered vents. Each classroom has an approximately 3' x 3' grated air vent in an interior wall near the ceiling (Pictures 1 and 2), which is connected by a ventilation shaft to a vault-like "air-mixing" room in the basement. A corresponding 3' x 3' vent exists in each room (Picture 3) near the floor that is connected to an exhaust ventilation shaft that runs from the basement to the roof (Pictures 4 through 6). Classrooms were constructed around these shafts to provide exhaust ventilation. The draw of air into these vents is controlled by a draw chain pulley system. The chains of the pulley system

**Typical Classroom Ventilation Configuration (as Indicated by Arrows):
Supply Vent (Top Left) Exhaust Vent (Bottom Right-Obstructed)**

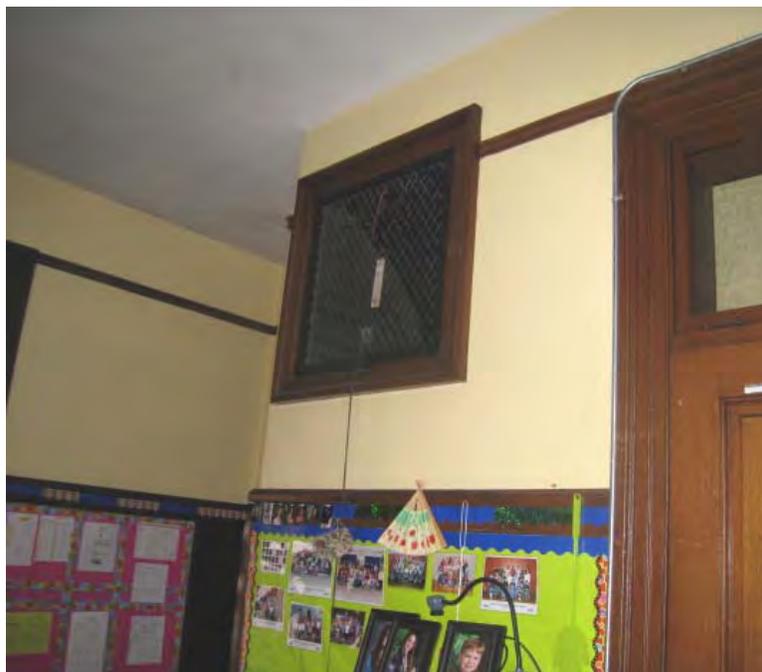
Picture 2

Supply Vent, Note Pull Chain to Adjust Airflow

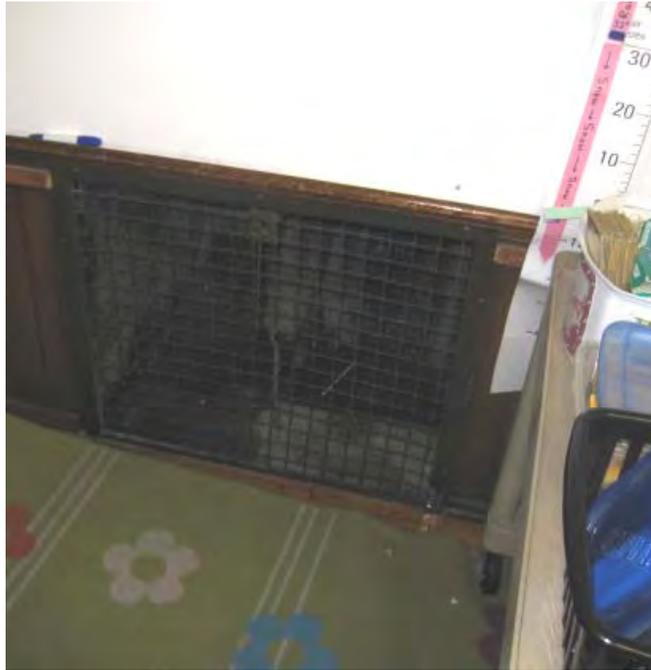
Picture 3

were designed to set the flue in the ventilation shaft at a desired angle to adjust airflow (Pictures 2, 3 and 5).

Exhaust Vent, Note Pull Chain to Adjust Airflow

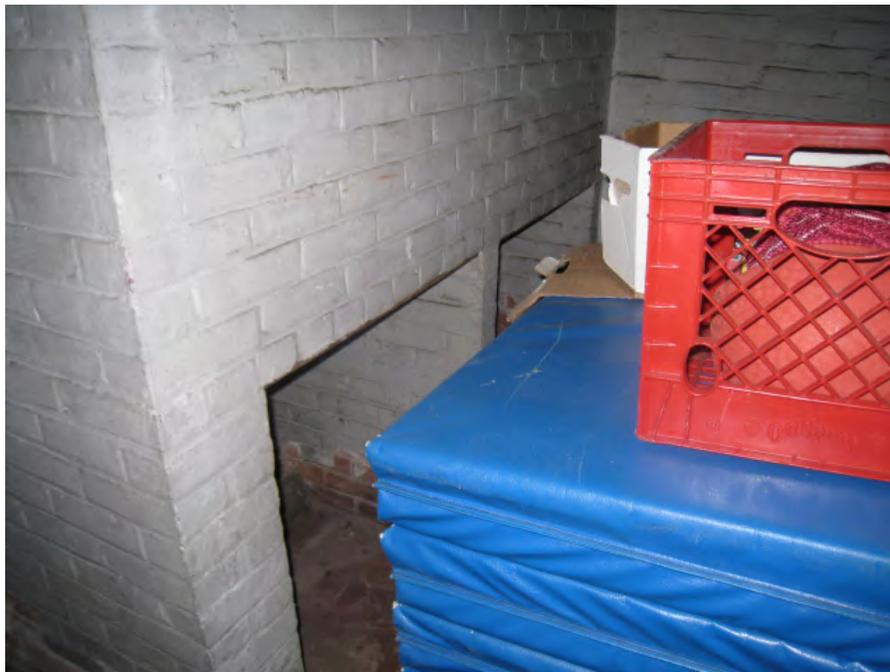
Picture 4

Openings for Ventilation Shafts in Air-Mixing Room

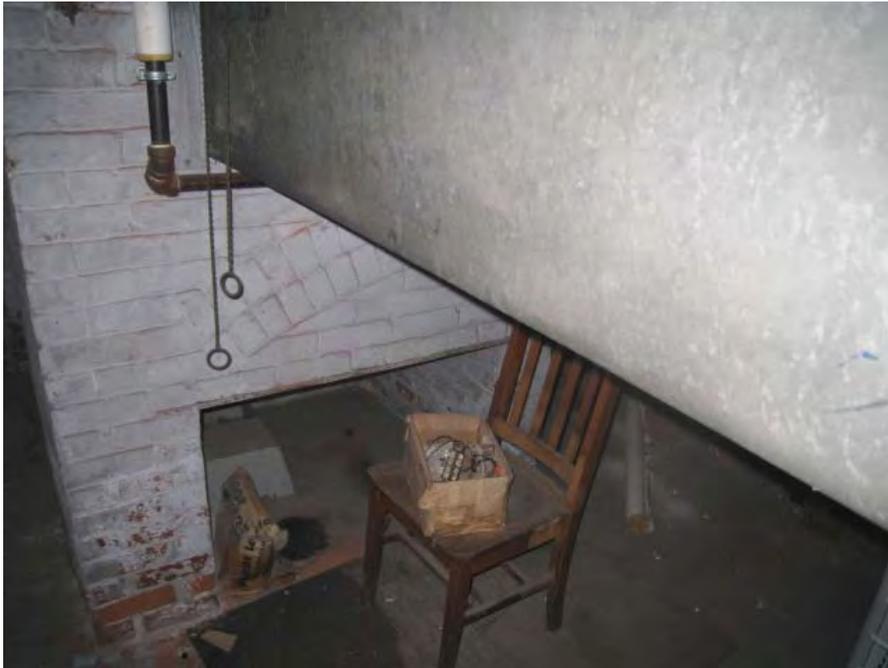
Picture 5

Openings for Ventilation Shafts in Air-Mixing Room, Note Hanging Pull Chains

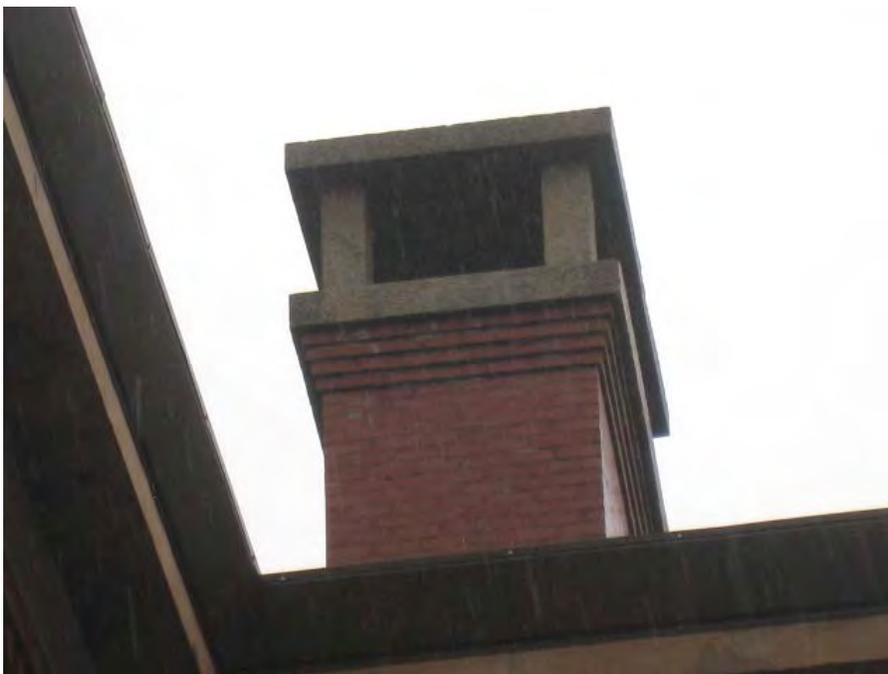
Picture 6

Ventilation Shaft Terminus on Roof

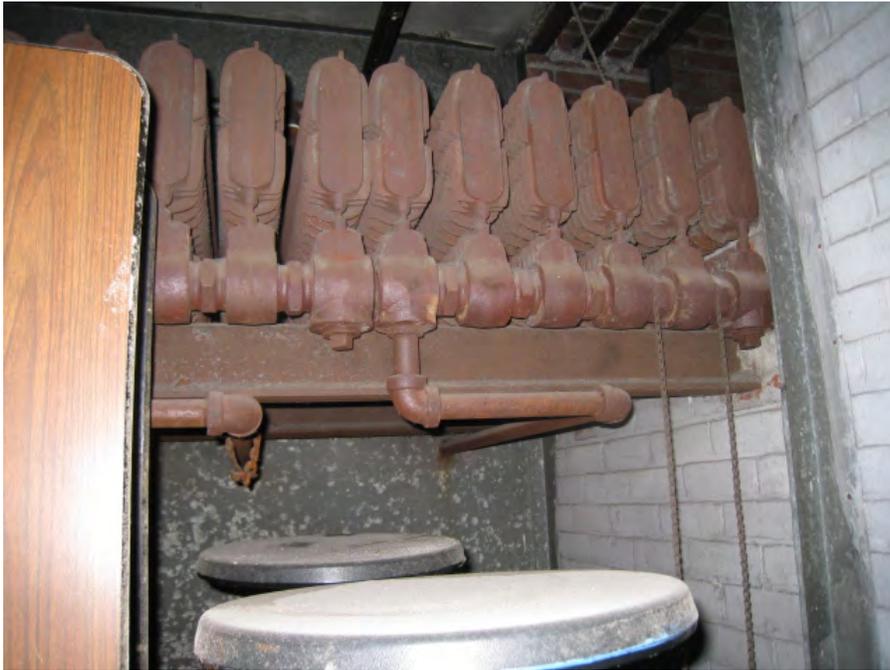
Picture 7

Air movement is provided by the stack effect. Heating elements located in the base of the ventilation shaft warm the air, which rises up the ventilation shaft (Picture 7). As the heated air rises, negative pressure is created, which draws cold air from the enclosed air-mixing room in the basement into the heating elements/ventilation shaft. This system was designed to draw in outside air from windows in the air-mixing room. The percentage of fresh air is controlled by a hinged window-pulley system (Picture 8).

Radiator/Heating Element in Ventilation Shaft

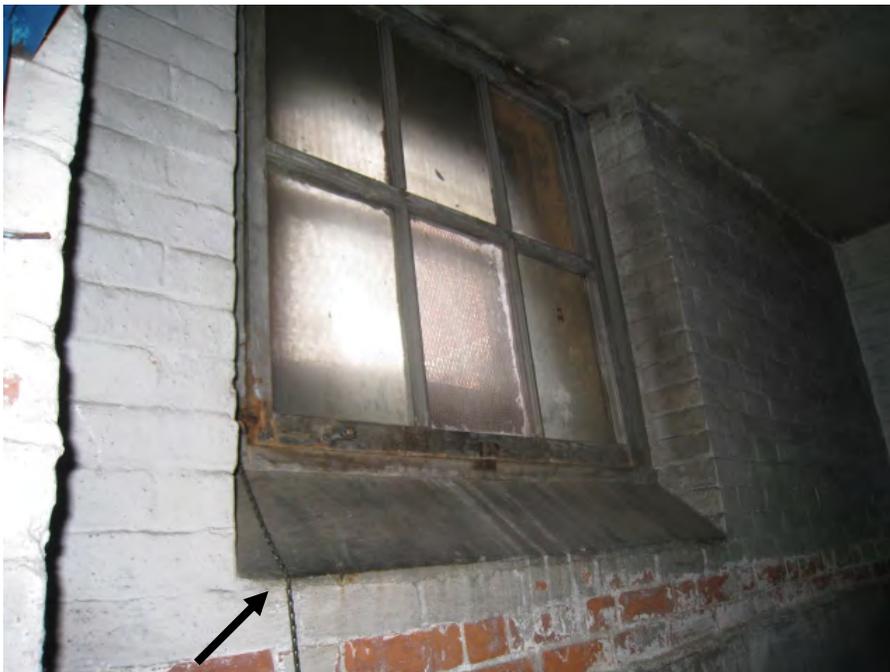
Picture 8

Basement Window in Air-Mixing Room, Note Pull Chain (Arrow)

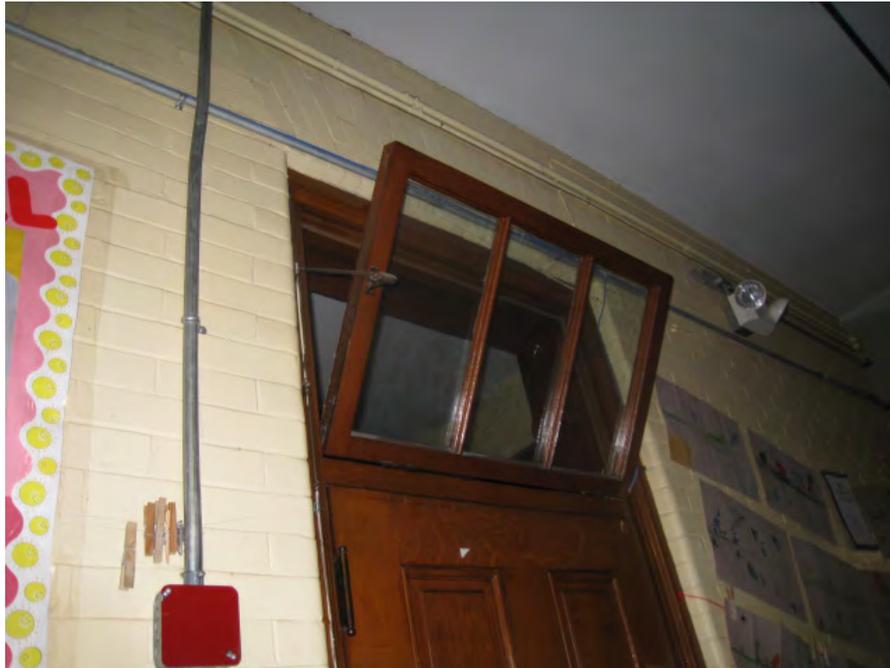
Picture 9

Open Transom above Classroom Door

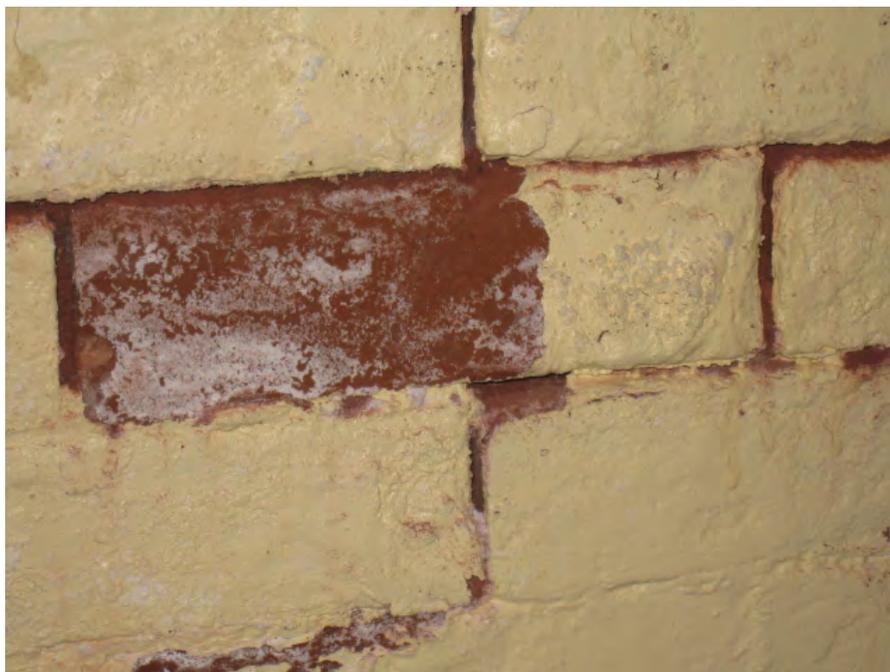
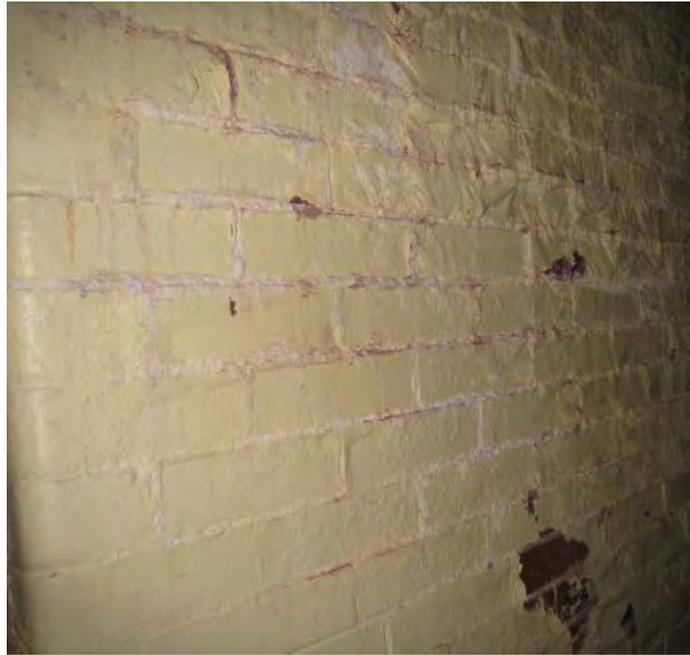
Water-damaged wall/ceiling plaster, peeling paint and efflorescence were observed in a number of areas throughout the building (Pictures 10 through 14, Table 1). Efflorescence is a characteristic sign of water damage to brick and mortar, but it is not mold growth. As moisture penetrates and works its way through mortar, brick or plaster, water-soluble compounds dissolve,

creating a solution. As the solution moves to the surface of the material, the water evaporates, leaving behind white, powdery mineral deposits. In addition, brick is a porous material that allows moisture to evaporate. Paint can serve as a water impermeable barrier, which can trap moisture and efflorescence causing bubbling and peeling (Pictures 10 and 11, Table 1). Without repointing and waterproofing of exterior masonry, peeling paint and efflorescence will continue to be a problem.

Peeling Paint and Efflorescence on Interior Brick

5. Make temporary roof repairs to prevent/reduce leaks.
6. Discard water-damaged porous materials in attic.
7. Replace water-damaged ceiling tiles.
8. Scrape and clean efflorescence and loose paint from ceiling/wall plaster and brick. Do not repaint brick.

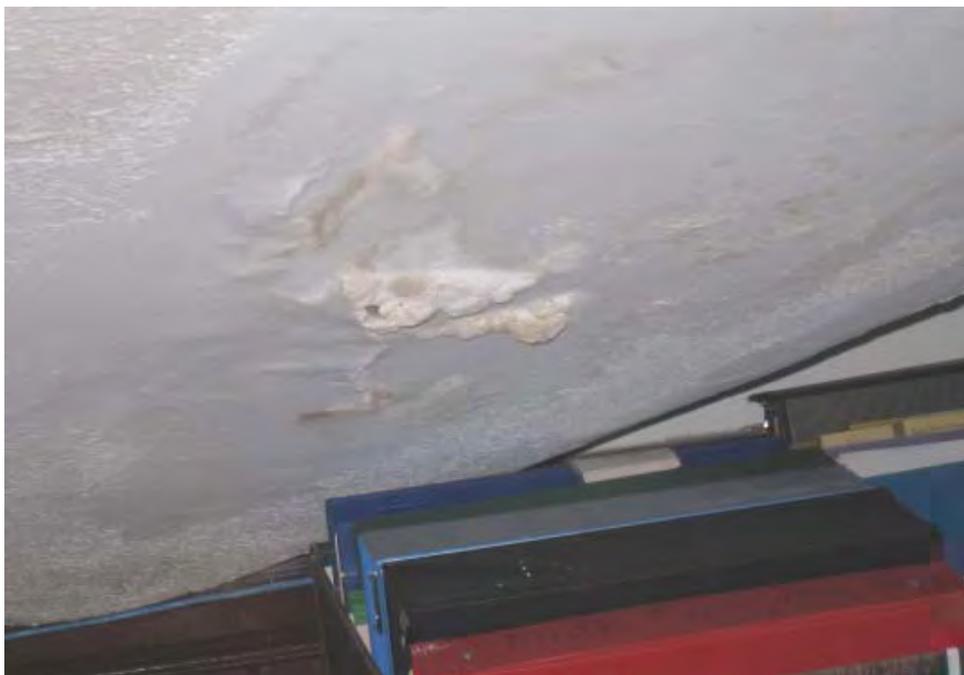
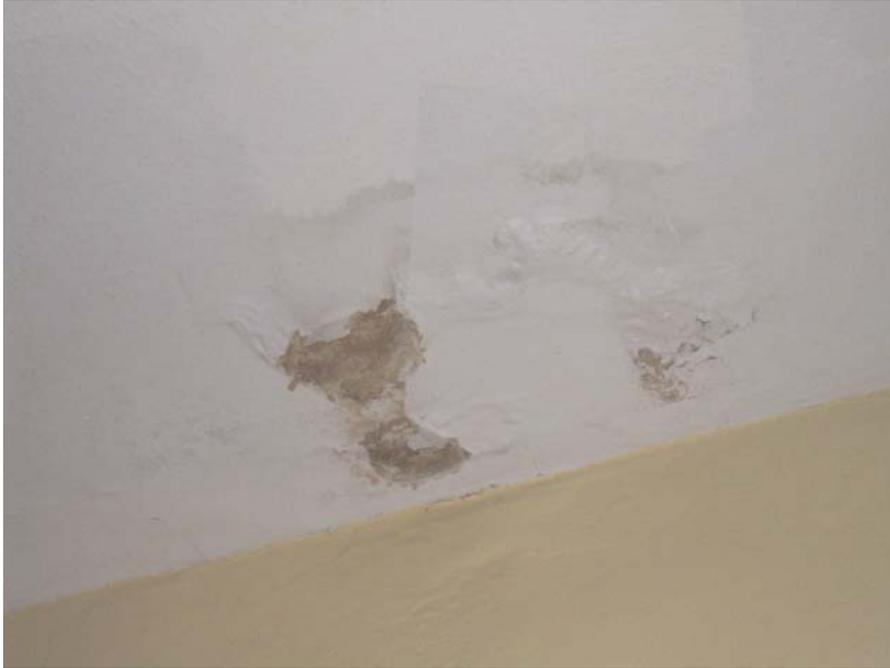
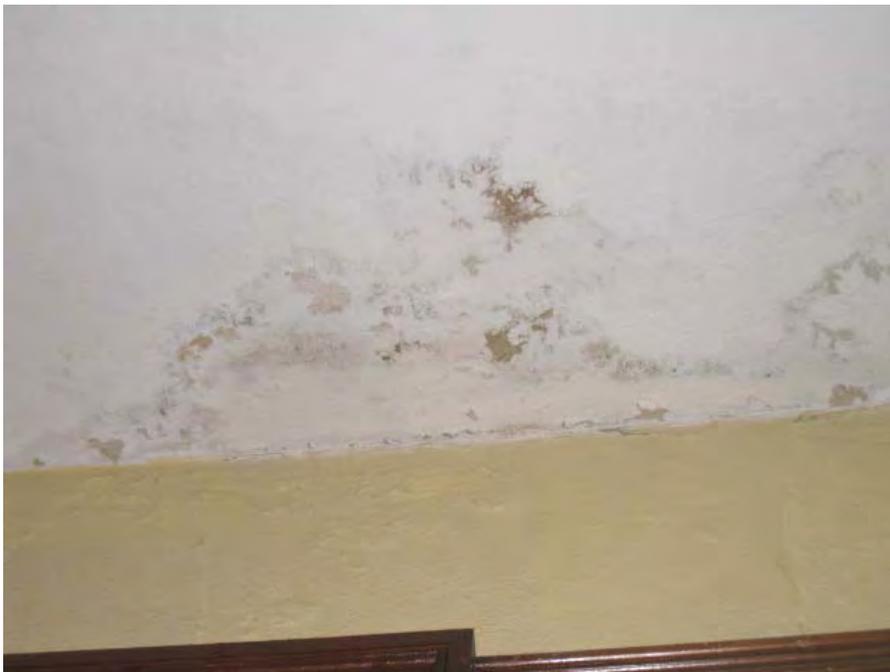
Water-Damaged Ceiling Plaster in Top Floor (Library Area)

Water-Damaged Ceiling Plaster and Peeling Paint in Classroom

3. Consider having exterior brick foundation re-pointed and waterproofed to prevent further water intrusion. Repair/replace water-damaged interior plaster.
4. Replace or make repairs to original slate roof. Once roof is repaired, repair/replace any remaining water-damaged building materials.

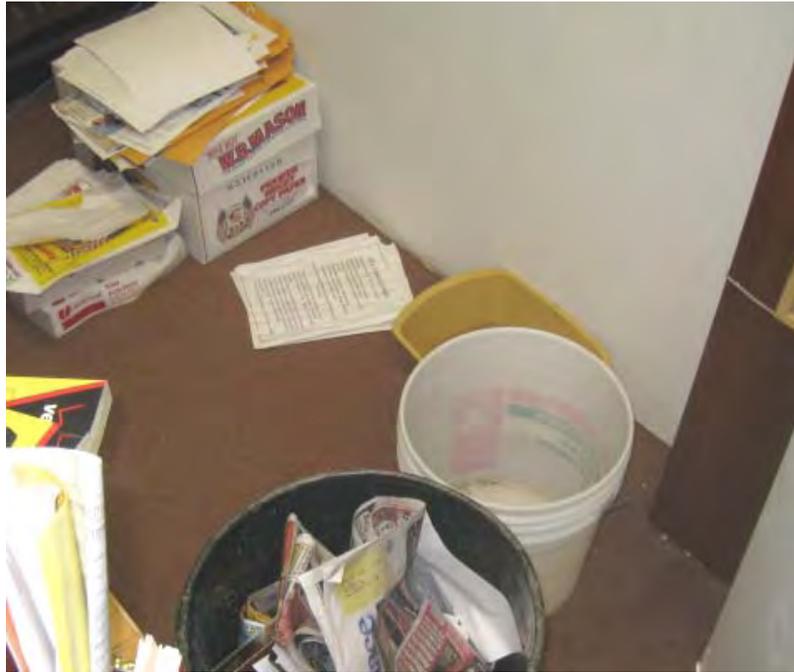
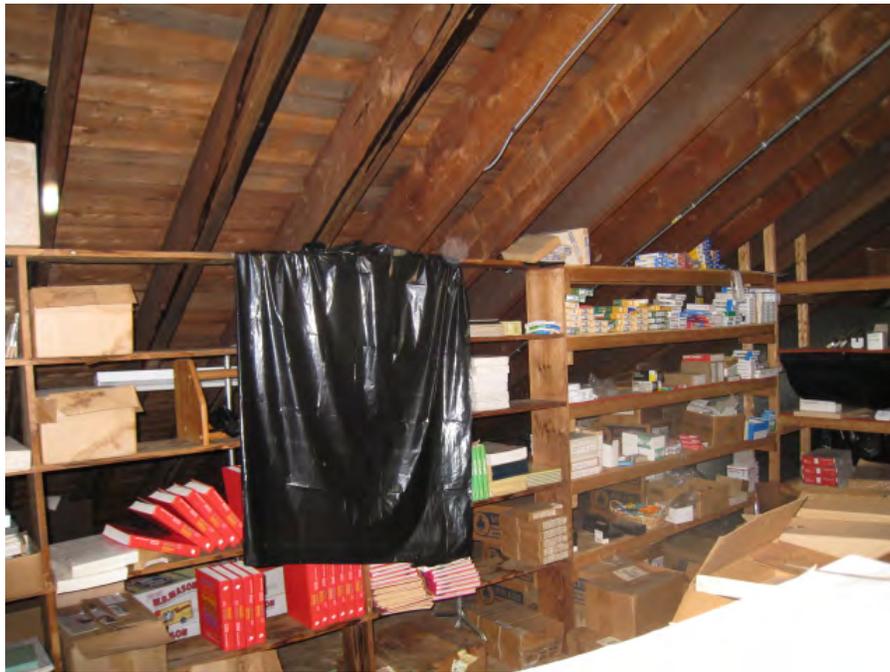
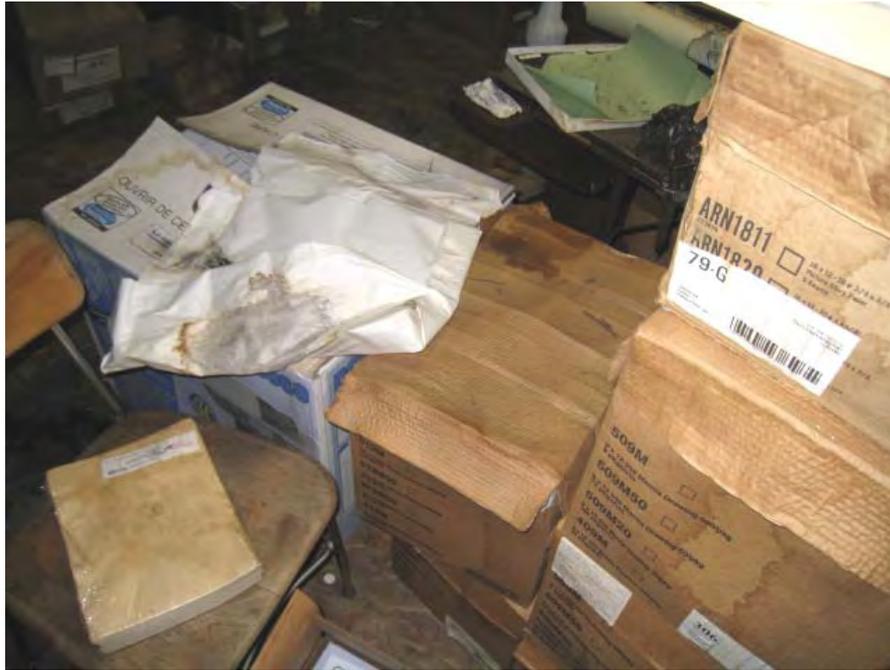
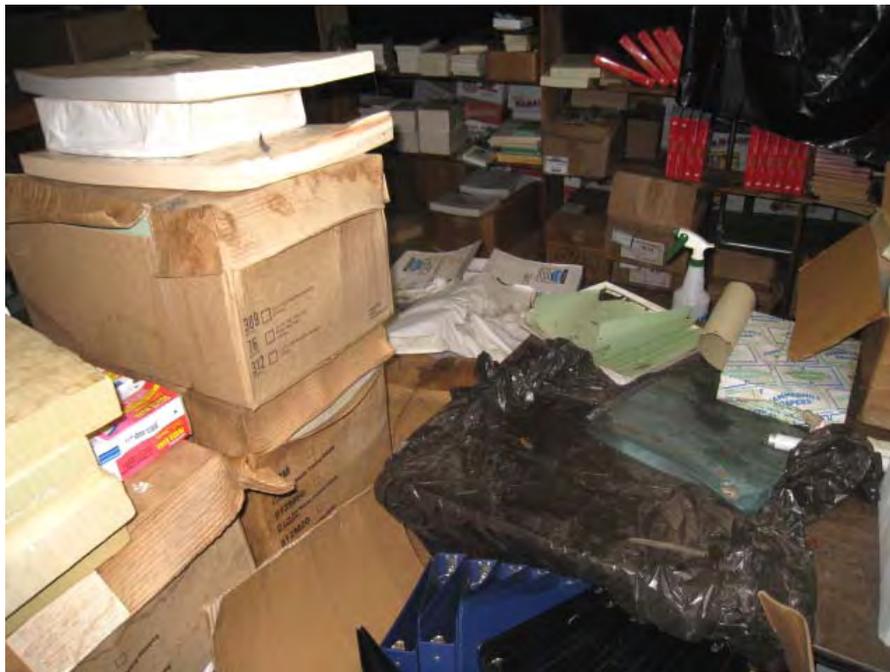
Water damage on the upper floors is most likely the result of water penetration through the original slate roof, as evidenced by numerous buckets and tarps to protect materials and catch water (Pictures 15 through 18). Water-damaged/mold colonized cardboard boxes and paper were observed in the attic storage room (Pictures 17 and 18). The US Environmental Protection Agency (US EPA) and the American Conference of Governmental Industrial Hygienists (ACGIH) recommend that porous materials be dried with fans and heating within 24 to 48 hours of becoming wet (US EPA, 2001; ACGIH, 1989). If not dried within this time frame, mold growth may occur. Once mold has colonized porous materials, they are difficult to clean and should be removed/discarded.

Buckets Used to Catch Rain Water from Roof Leaks

Plastic Tarp in Attic Protecting Materials from Leaks in Attic

Water-Damaged Porous Materials in Attic

Plastic Sheeting in Attic Protecting Materials from Leaks in Attic

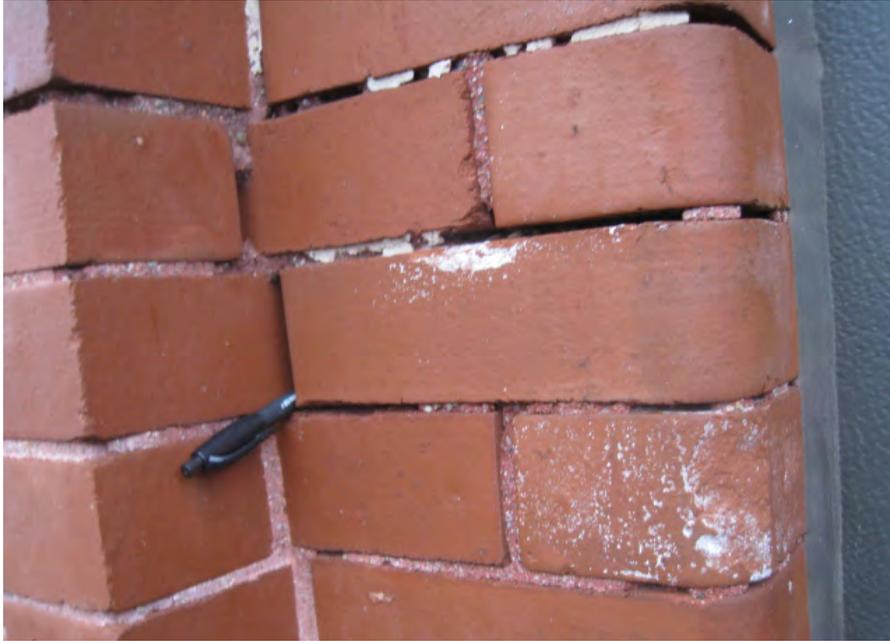
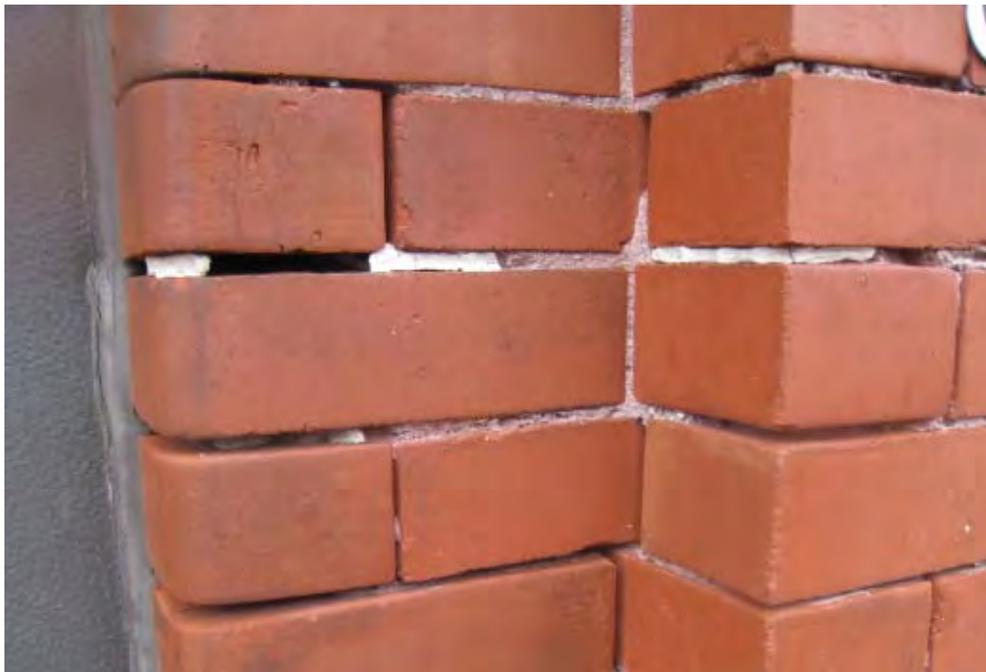
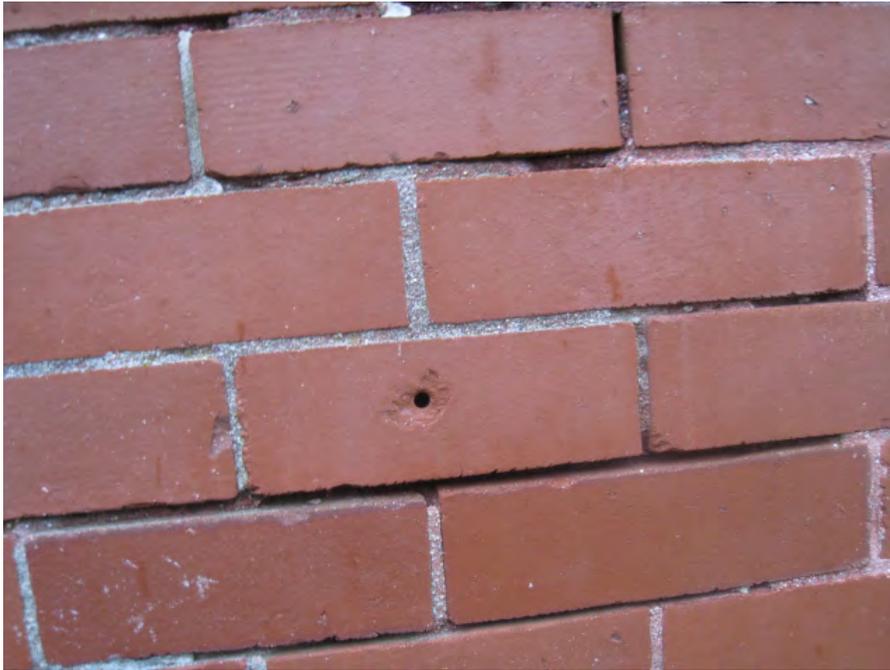
Another major source of water penetration is via missing/damaged mortar around exterior brick (Pictures 19 through 21). These conditions represent potential moisture penetration sources. Over time, these conditions can undermine the integrity of the building envelope and provide a means of water entry into the building via capillary action through foundation concrete and masonry (Lstiburek & Brennan, 2001). The freezing and thawing of water during winter months can lead to further damage and subsequent water penetration into the interior of the building. In addition, these breaches may provide a means for pests/rodents into the building.

Missing/Damaged Mortar around Exterior Brick, Pen Inserted by BEH Staff to Show Depth

Missing/Damaged Mortar around Exterior Brick

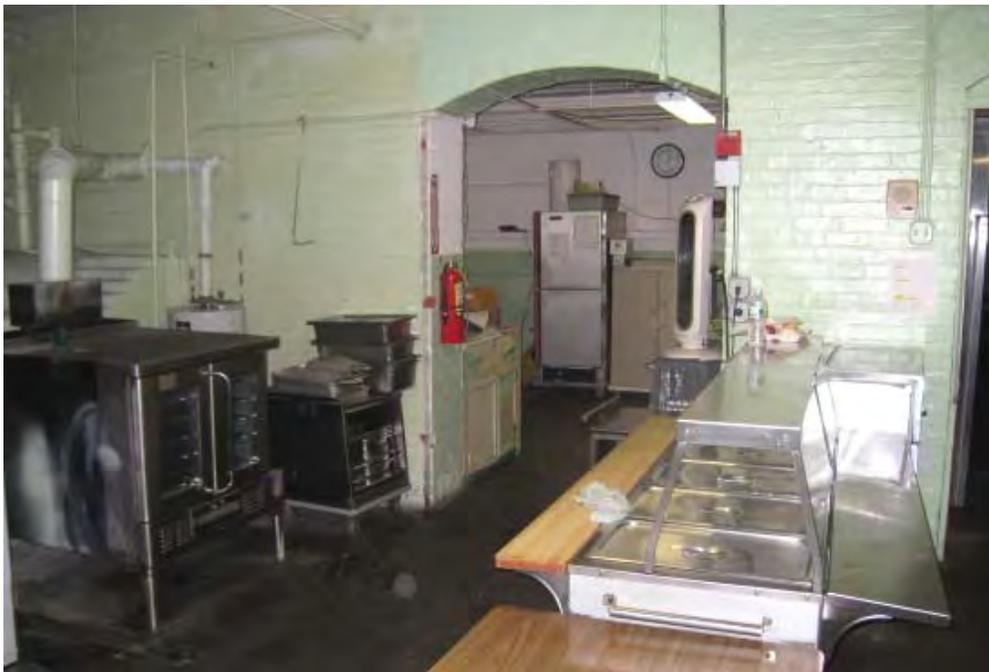
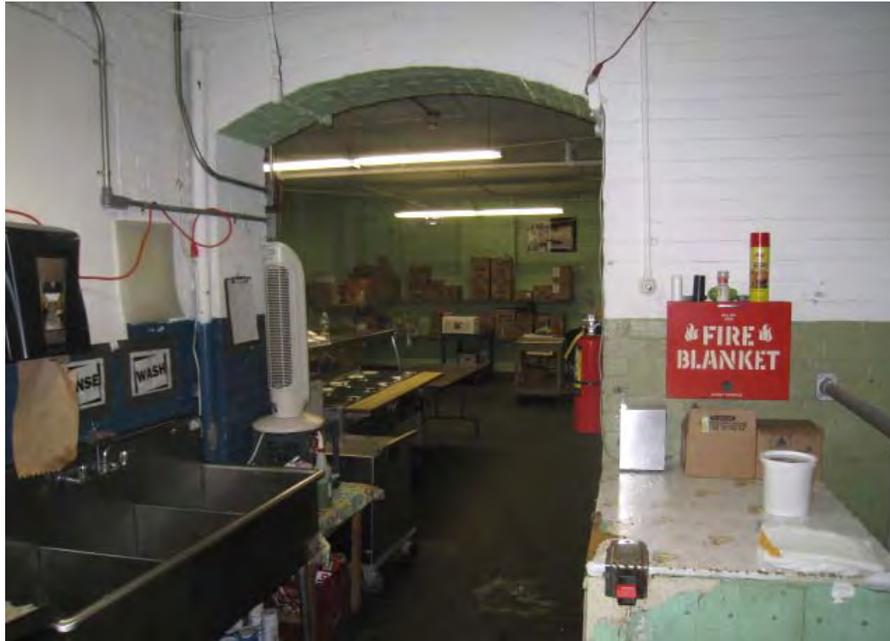
Although no measurable levels of carbon monoxide or elevated PM_{2.5} were detected, a potential source was identified. The boiler room lacked a door and was open to the kitchen/food prep area (Pictures 22 and 23). The lack of a boiler room door may result in combustion products migrating into occupied areas under certain wind/weather conditions. Boiler rooms are frequently sealed with a fire rated/airtight door to prevent odors from migrating into adjacent areas.

Kitchen Food Prep Area and Boiler Room, Note Archway to Boiler Room has no Door

View from inside Boiler Room to Kitchen Food Prep Area, Note Archway to Boiler Room has no Door

3. Install fire-rated doors to separate the boiler room from the kitchen/food prep area. Ensure doors meet local fire code and fit flush with threshold. Seal doors on all sides with foam tape and/or weather-stripping. Ensure tightness of door by monitoring for light penetration and drafts around doorframe.

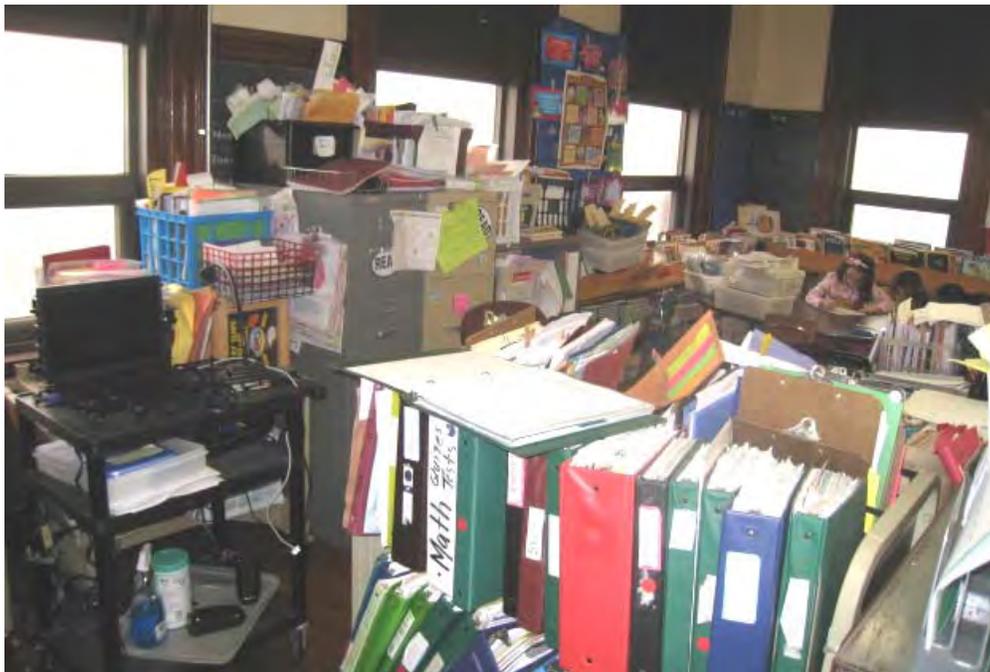
Picture 24

In several classrooms, items were observed on windowsills, tabletops, counters, bookcases and desks (Picture 24). The large number of items stored in classrooms provides a source for dusts to accumulate. These items (e.g., papers, folders, boxes) make it difficult for custodial staff to clean. Items should be relocated and/or be cleaned periodically to avoid excessive dust build up. In addition, these materials can accumulate on flat surfaces (e.g., desktops, shelving and carpets) in occupied areas and subsequently be re-aerosolized causing further irritation.

Accumulated Items in Classroom

9. Relocate or consider reducing the amount of materials stored in classrooms to allow for more thorough cleaning. Clean items regularly with a wet cloth or sponge to prevent excessive dust build-up.

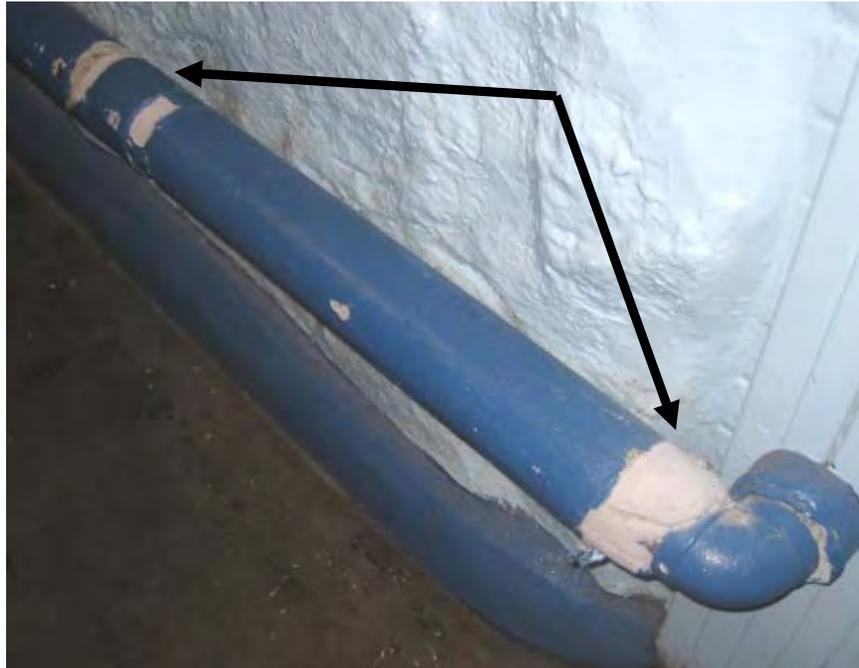
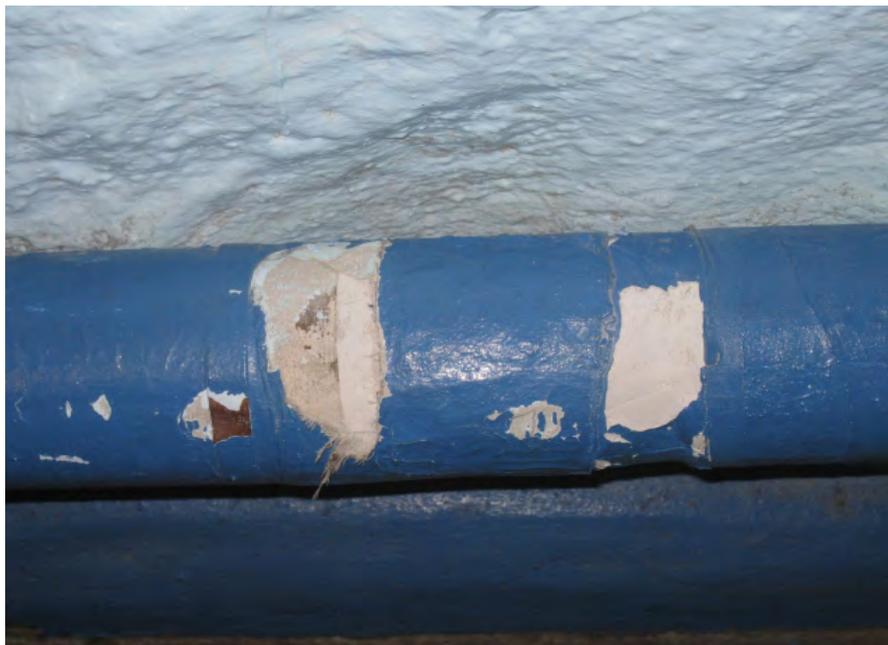
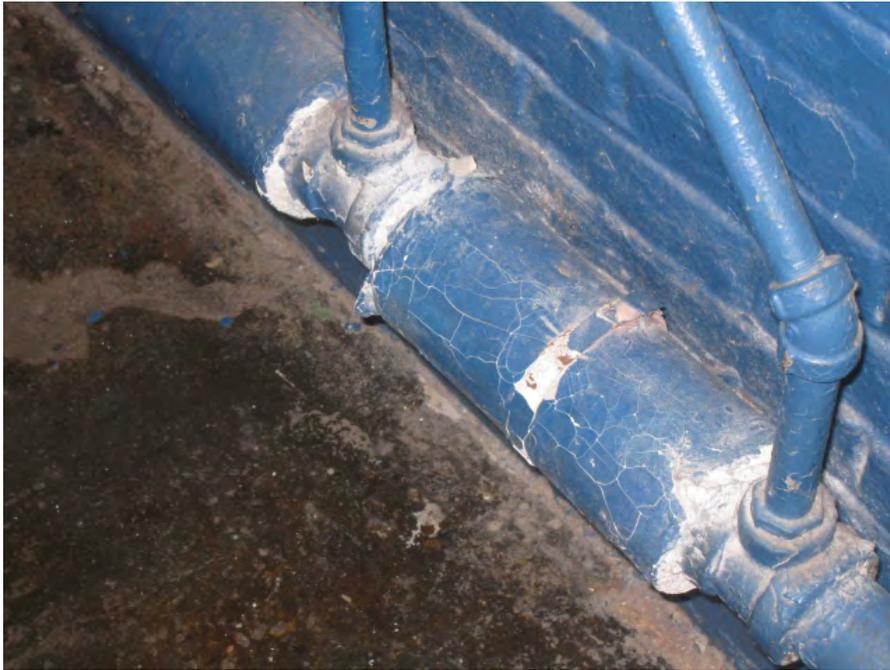
Finally, BEH staff observed damaged/exposed insulation that may contain asbestos around hot water pipes along the base of the wall in the basement boy's restroom (Pictures 25 and 26) and in the central cafeteria (Picture 27). Upon this discovery, BEH staff immediately reported the issue to Principal Matthew Riley. At the time of the assessment, BEH staff recommended that the insulation be evaluated and remediated by a licensed asbestos abatement contractor.

Exposed Pipe Insulation in Basement Boy's Restroom

Exposed Pipe Insulation in Central Cafeteria

were notified (Appendix B). The material in the central cafeteria was removed and the material in the boy's restroom was encapsulated (Appendix B).

10. Ensure federally required 6-month and 3-year inspections are conducted and document in accordance with asbestos management plan as required by the Asbestos Hazard Emergency Response Act (AHERA) (US EPA, 1986). AHERA outlines a detailed process aimed at ensuring the safe management of all asbestos-containing materials by a designated person for a local education agency. Where asbestos-containing materials are found and/or damaged, these materials should be removed, remediated or maintained in a manner consistent with Massachusetts asbestos remediation laws (MDLI, 1993).
