INDOOR AIR QUALITY ASSESSMENT

**Pembroke Community Center
128 Center Street
Pembroke, Massachusetts**

Prepared by:
Massachusetts Department of Public Health
Bureau of Environmental Health
Indoor Air Quality Program
June 2012

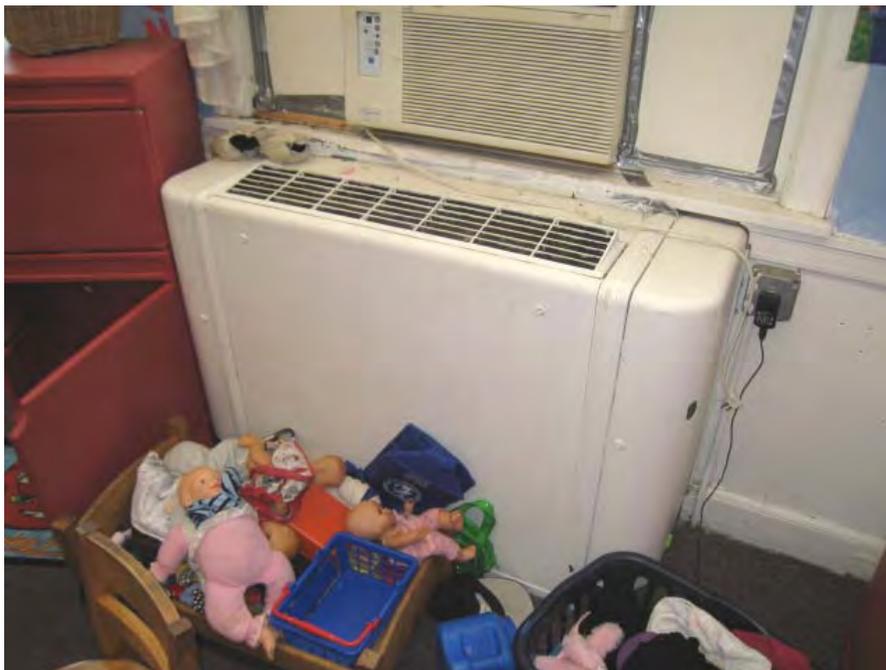
Picture 2

The building was originally designed to be ventilated via a mechanical ventilation system. Fresh air was supplied to classrooms by unit ventilator (univent) systems (Pictures 2 and 3). A univent is designed to draw air from outdoors through a fresh air intake located on the exterior wall of the building (Picture 4) and return air through an air intake located at the base of each unit ([Figure 1](#)). Fresh and return air are mixed, filtered, heated and provided to classrooms through a fresh air diffuser located in the top of the unit. Univents were found deactivated throughout the building; in addition, several air diffusers and outside intakes were also found sealed/blocked (Pictures 5 and 6).

1930s Vintage Univent

2. Based on the age, physical deterioration and availability of parts, the BEH recommends that an HVAC engineering firm evaluate options for providing adequate ventilation building-wide. Such an evaluation is necessary to determine the operability and feasibility of repairing/replacing the equipment.

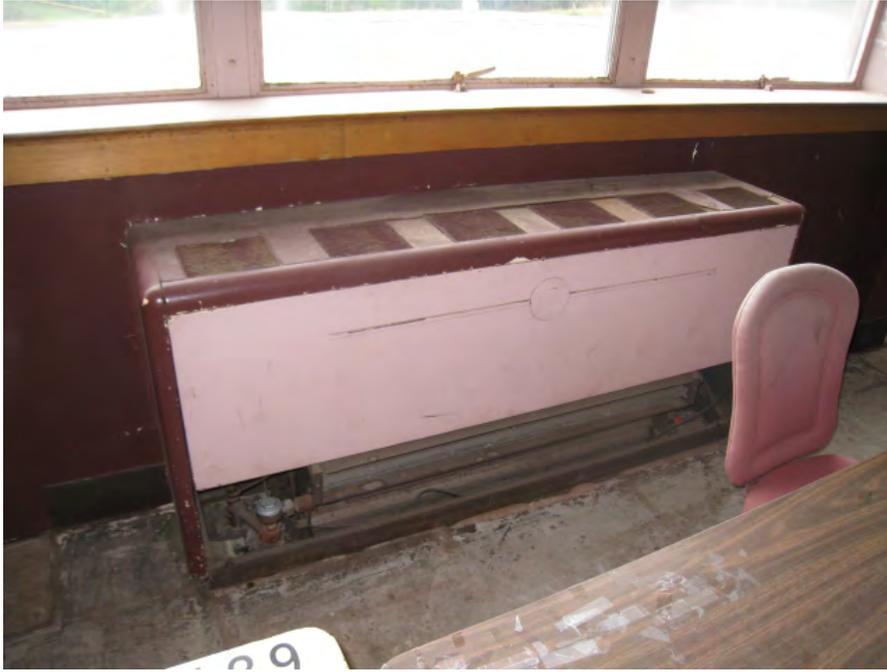
Picture 3

1950s Vintage Univent

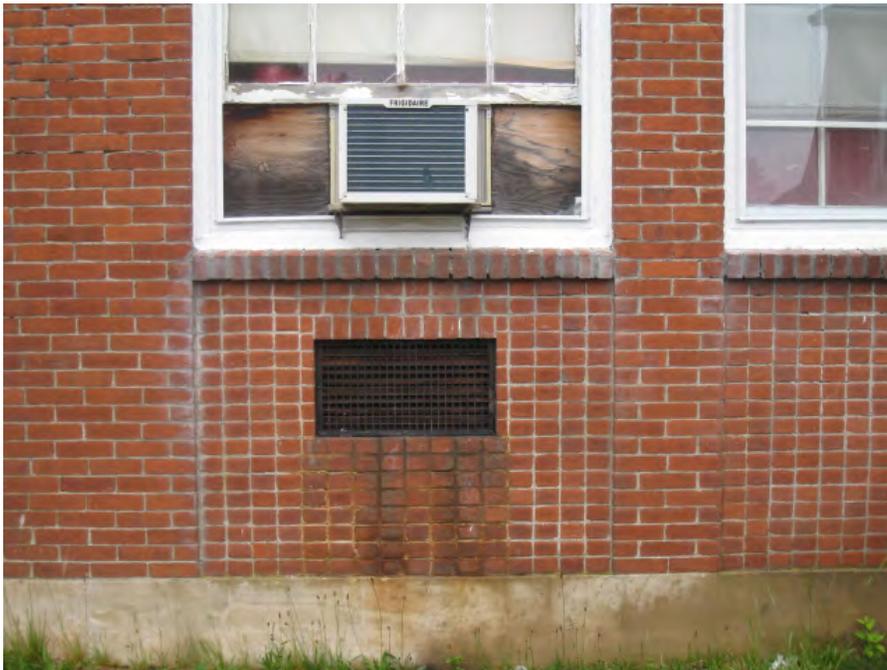
Picture 4

Univent Fresh Air Intake

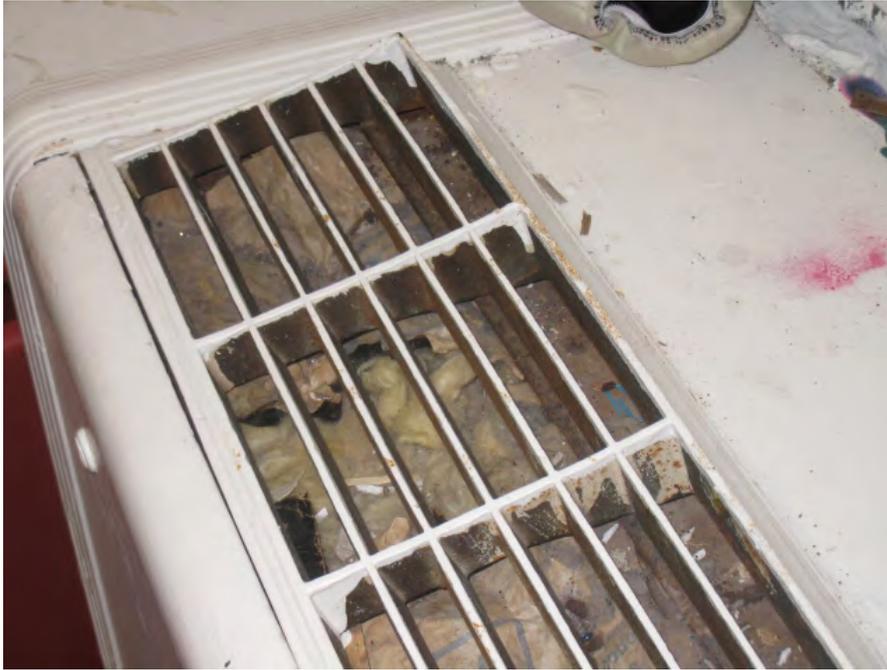
Picture 5

Finally, exposed fiberglass pipe insulation was observed in the upper bingo hall behind a loose ceiling tile (Picture 33) and inside univent air diffusers in classrooms (Picture 5).

Fiberglass insulation can provide a source of skin, eye and respiratory irritation.

Univent Air Diffuser Blocked with Fiberglass Insulation

15. Finish floors in the bingo halls to improve cleaning.
16. Replace loose ceiling tile in upper bingo hall (Picture 33) and seal univent diffusers that are stopped with fiberglass insulation (Picture 5).

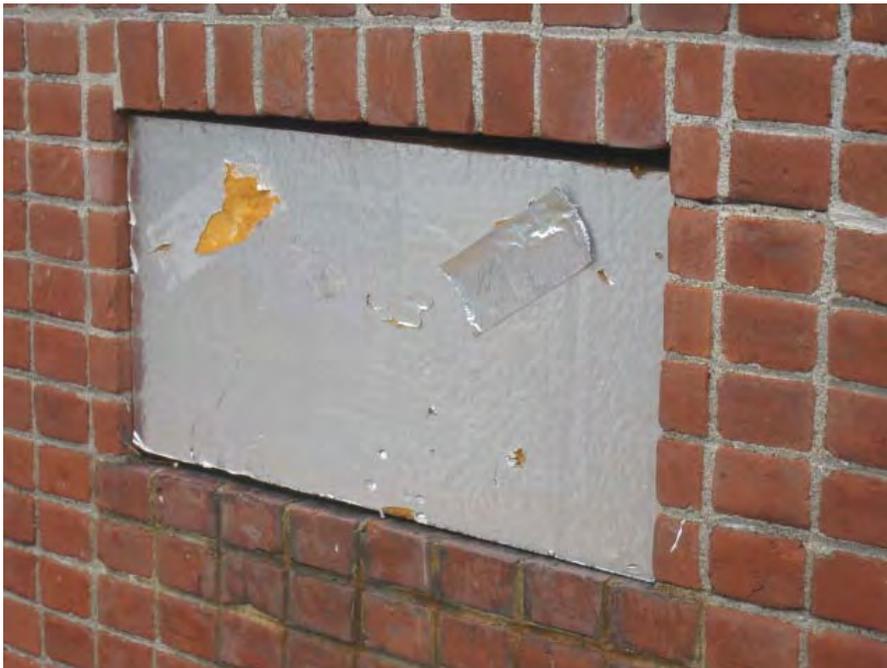
Picture 6

Univent Fresh Air Intake Blocked with Fiberboard

3. If the original ventilation components are not to be restored, seal abandoned supply and exhaust vents inside the building as well as on the roof to prevent drafts and the egress of odors, dust and particulate matter into occupied areas.

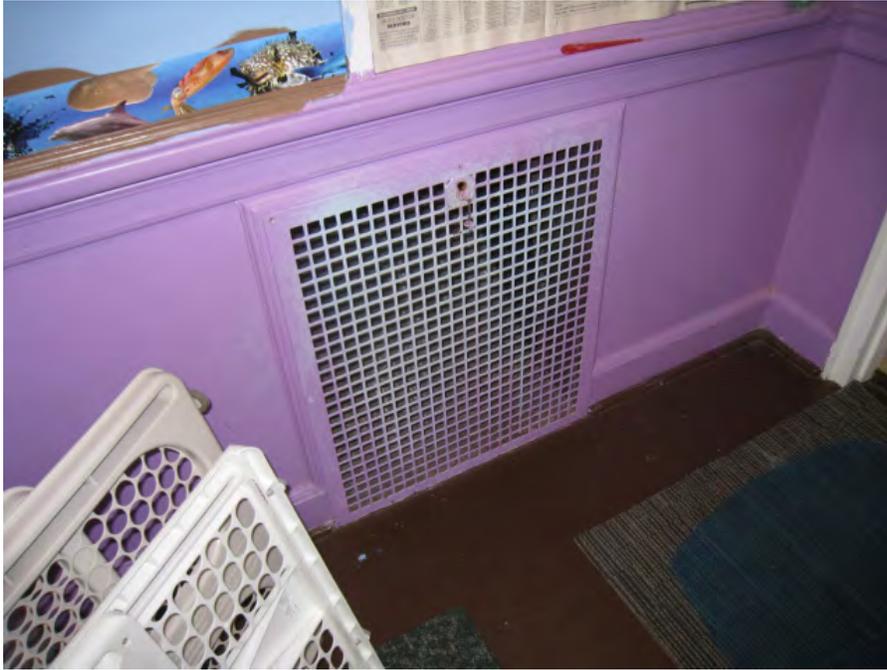
Picture 7

Exhaust ventilation was originally provided by vents located in cubby holes at the base of the wall (Pictures 7 and 8) and ducted to rooftop motors (Picture 9). None of these exhaust vents were operating at the time of the assessment.

Grated Exhaust Cubby

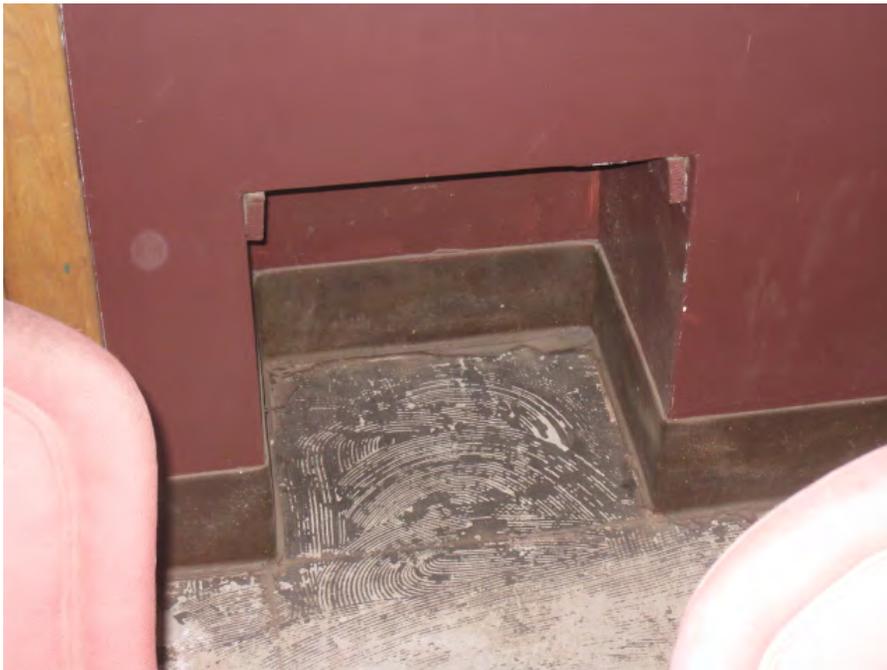
Picture 8

Ungrated Exhaust Cubby

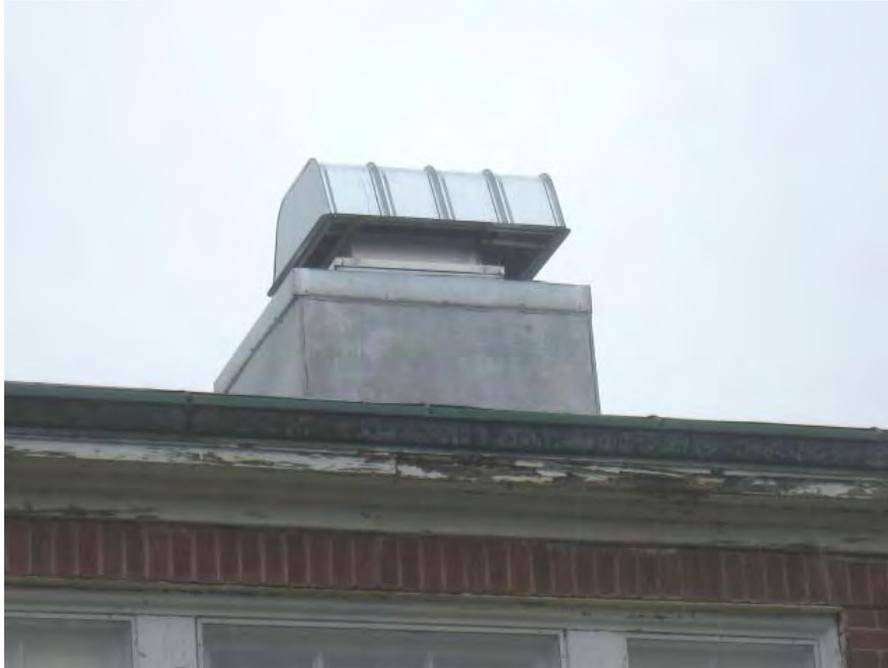
Picture 9

Rooftop Exhaust Motor

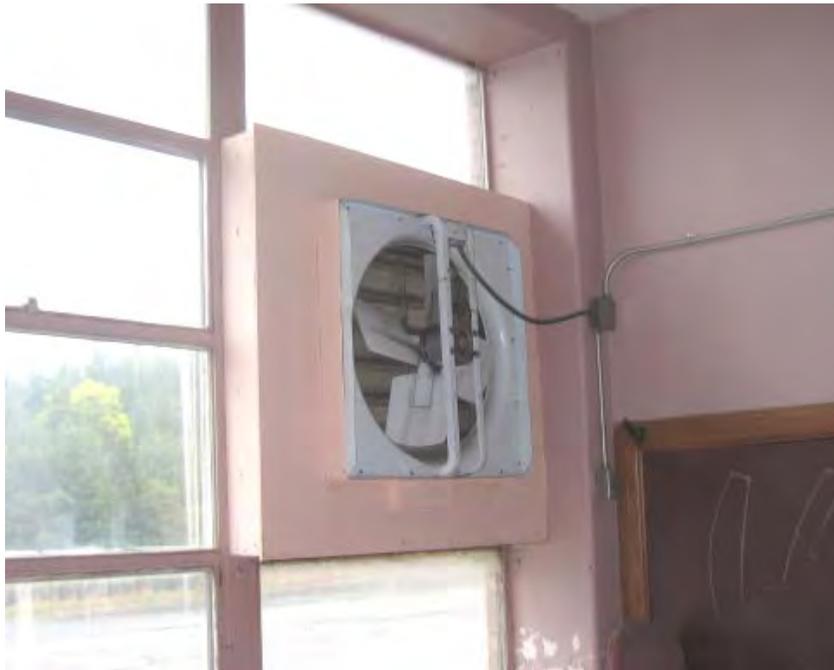
Picture 10

Supplemental ventilation was retro-fitted in the form of local exhaust motors and corresponding supply vents in the bingo halls (Pictures 10 and 11). These vents are manually operated; once the exhaust fans are activated the supply louvers for the intake vents open to create air exchange. The TV studio has been renovated and is equipped with a modern mechanical heating, ventilating and air-conditioning (HVAC) system that appeared to be operating at the time of the assessment. Window-mounted air conditioners were noted in some areas.

Local Exhaust Fan in Bingo Hall

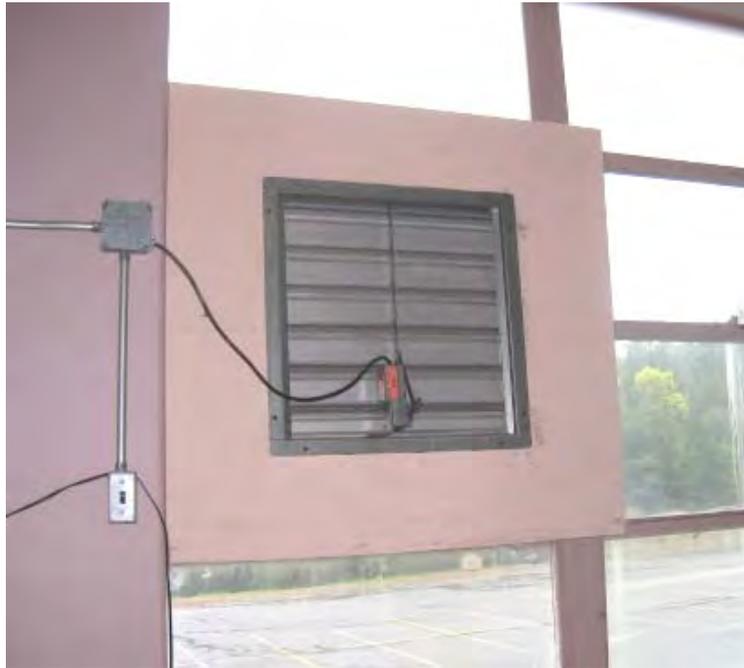
Picture 11

Louvered Supply Vent in Bingo Hall

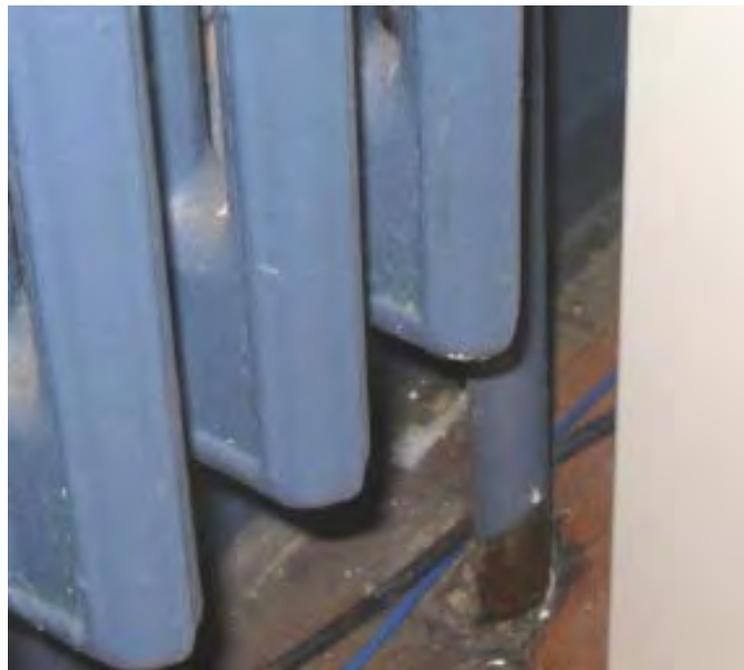
Picture 12

Concerns regarding mold growth in the crawlspace were expressed. Note that mold would be expected to be present in an unconditioned dirt crawlspace that is subjected to moisture. It is more prudent to make efforts to reduce moisture, circulate air and reduce/eliminate potential pathways for mold, spores, and associated odors to migrate into occupied areas. The most obvious pathways for communication between the crawlspace and occupied areas on the ground floor are through utility holes (e.g., radiators, univents) (Picture

12). Airflow tends to rise from lower to upper floors, a condition known as the stack effect. These holes should be sealed with a fire-rated foam or other material.

Radiator Pipe through Floor to Crawlspace

11. Seal utility holes (e.g., around radiator/univent pipes) and other potential pathways to eliminate pollutant paths of migration from the basement/crawlspace to the first floor. Ensure tightness by monitoring for light penetration and drafts.

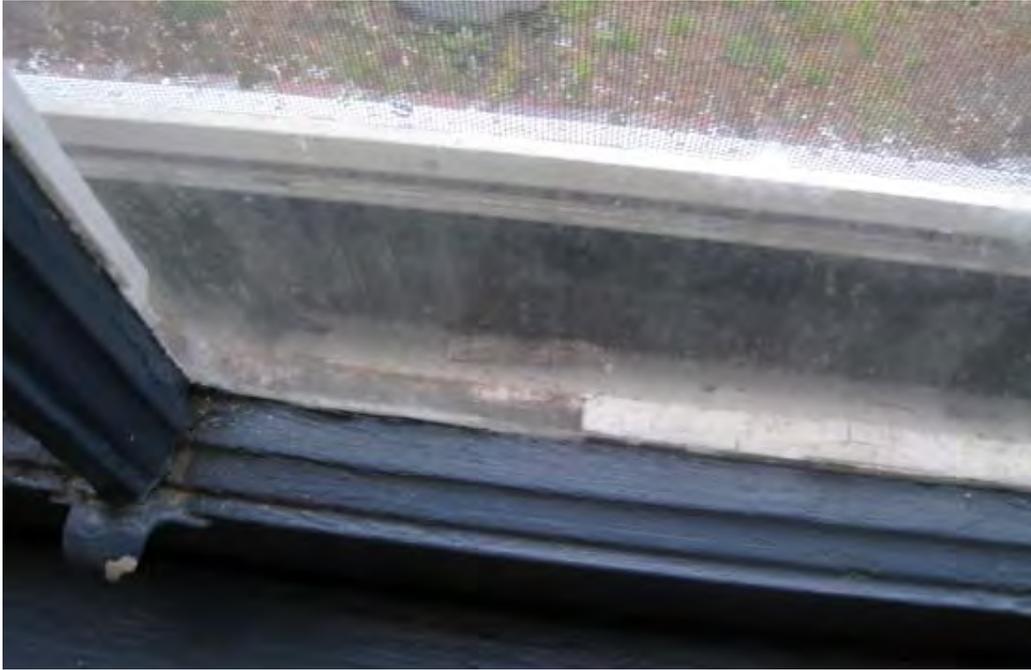
Picture 13

Missing/damaged caulking was observed around windows (Pictures 13 through 16), which can result in air/moisture infiltration and damage to interior building materials (e.g., wall/ceiling plaster, flooring) (Picture 17). Depending on its age, window (and joint) sealant may be composed of regulated materials [e.g., asbestos, polychlorinated biphenyls (PCBs)]. If so, materials should be addressed in accordance with US Environmental Protection Agency (US EPA) regulations. For additional information regarding PCBs, please consult MDPH guidance (Appendix B).

Missing/Damaged Window Caulking

10. Address deteriorating sealant/caulking materials on the interior and exterior of the building in accordance with EPA regulations/MDPH guidance (Appendix B).

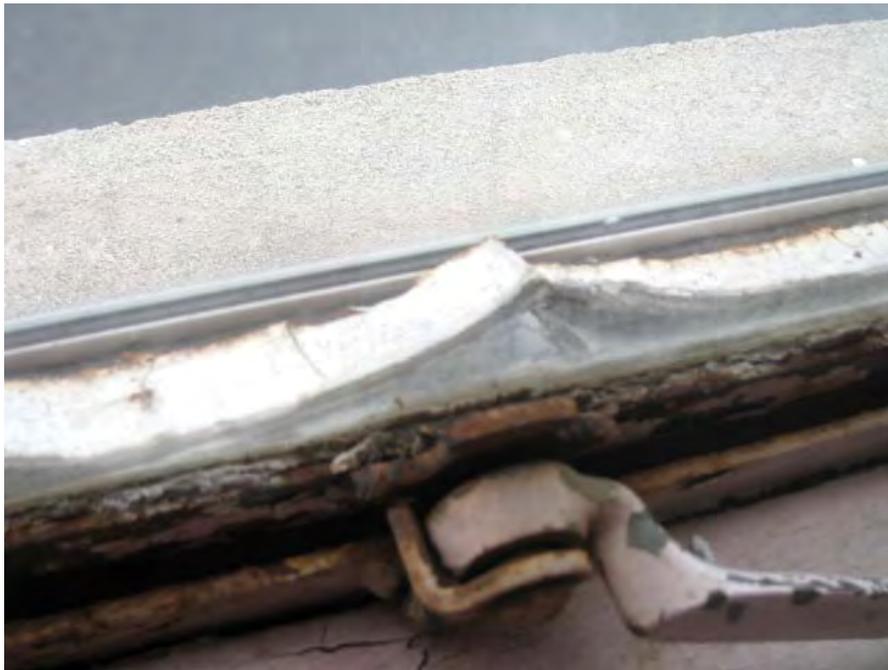
Picture 14

Missing/Damaged Window Caulking

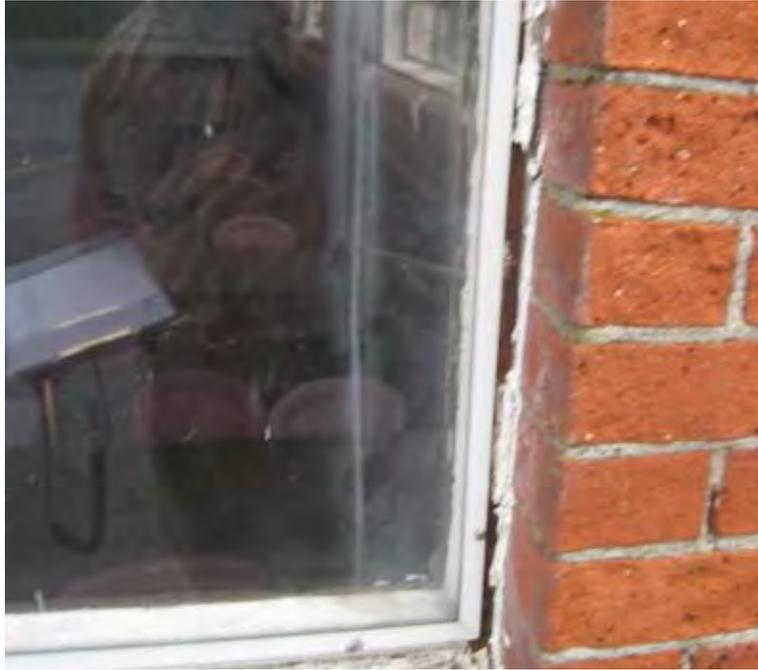
Picture 15

Missing/Damaged Caulking around Window Frames

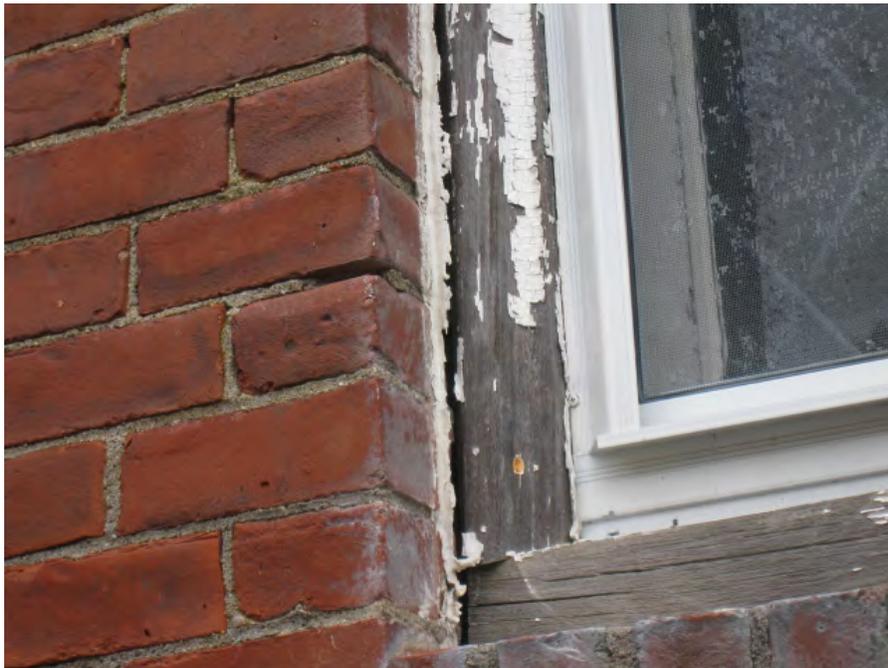
Picture 16

Missing/Damaged Window Caulking, Also Note Old Damaged Wooden Window Frames

4. Consider a long-term plan to replace windows (where needed) to prevent air/moisture infiltration.
5. Consider consulting with an HVAC engineering firm for best methods for installing a mechanical means to establish negative pressure conditions in the basement/crawlspace relative to the first floor.

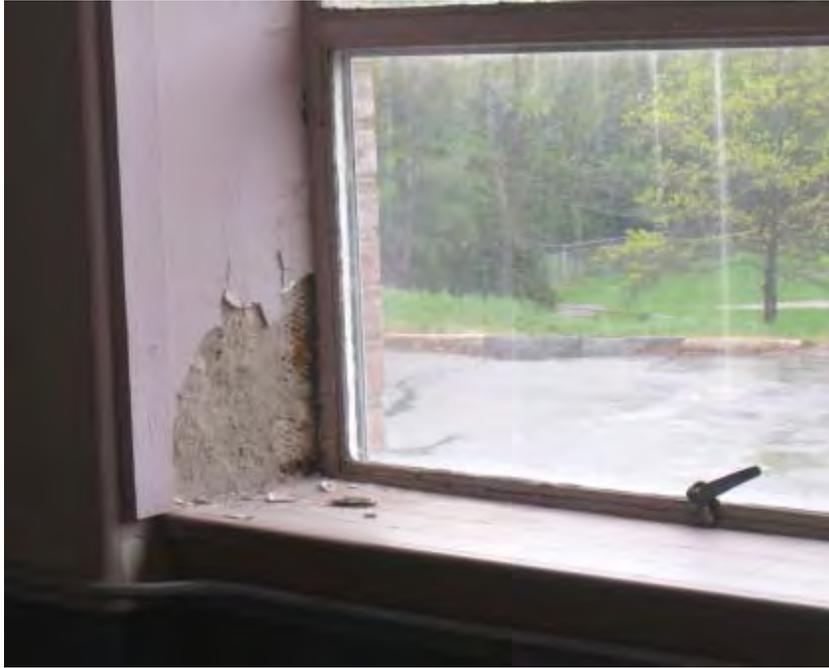
Picture 17

Water-Damaged Wall Plaster around Windows

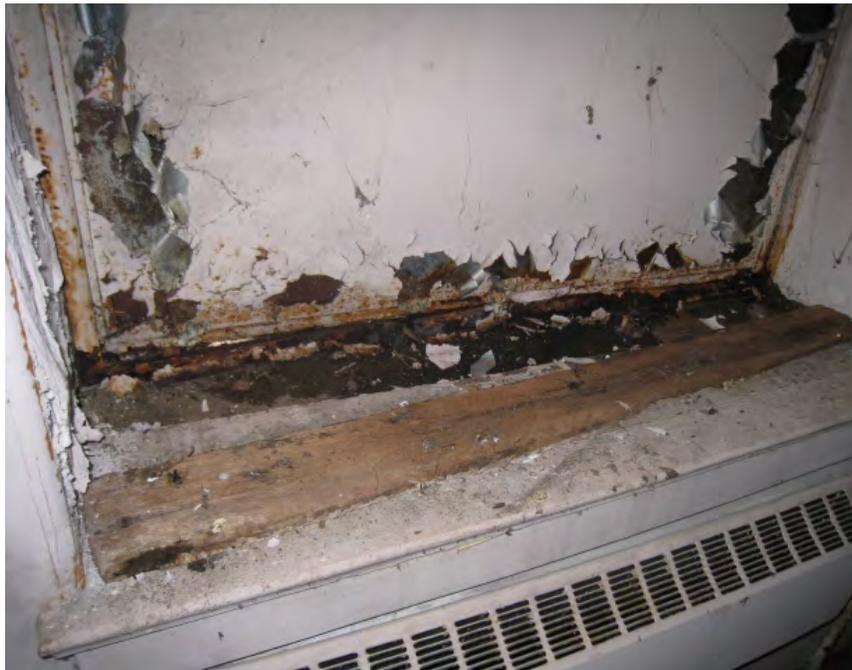
Picture 18

Wet/Moldy Debris inside First Floor Restroom Window

8. Ensure any roof/window leaks are repaired.
9. Clean mold/debris from around window in lower rest room; ensure window is properly sealed to prevent water infiltration.

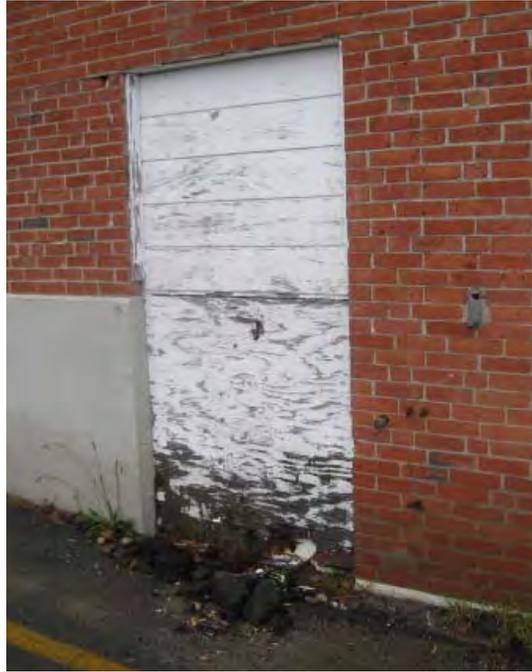
Picture 19

Leaking First Floor Restroom Window Sealed with Plywood

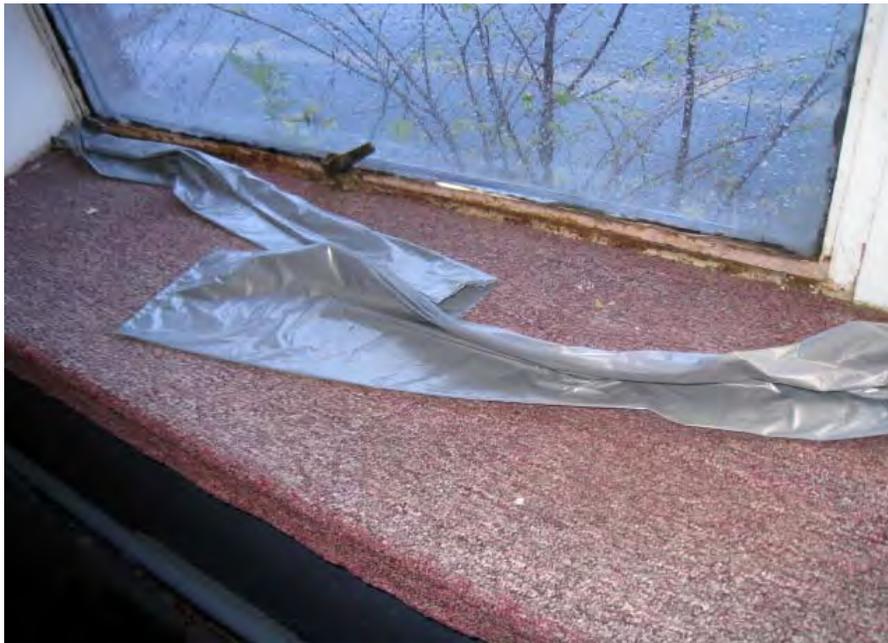
Picture 20

Carpeting along Windowsills in Lower Bingo Hall, Note Plastic Presumably to Keep out Drafts/Moisture

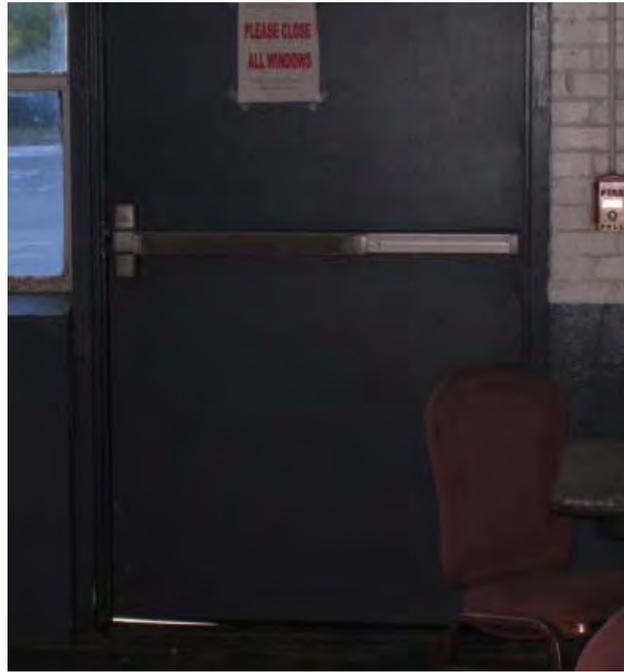
Picture 21

- A number of exterior doors had damaged weather-stripping and light could be seen penetrating through the spaces underneath the door from the outdoors (Picture 21).

Light Penetrating beneath Exterior Door

12. Periodically clean/pressure wash moss growth from exterior brickwork.
13. Take measures to tighten exterior doors (e.g., weather-stripping) to prevent drafts, moisture infiltration and pest/rodent entry. Ensure tightness of doors by monitoring for light penetration and drafts around doorframes.

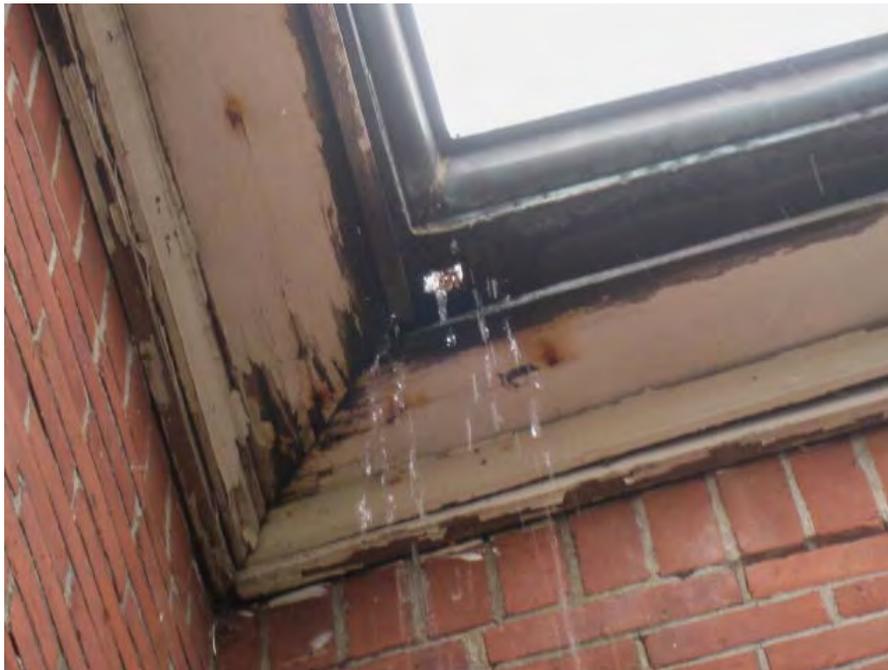
Picture 22

- Gutters/downspouts were damaged/missing and emptying against the exterior of the building, allowing rainwater to pool on the ground at the base of the building (Pictures 22 and 23).
- Moss growth was noted in several areas along exterior brickwork. A substantial source of water is needed for moss to grow. Moss growth is a sign of heavy/continuous water exposure which can threaten the structural integrity of the building.
- Exterior wall cracks and open utility holes penetrate through the exterior wall and are not properly sealed (Picture 24).
- Missing/damaged mortar around brickwork (Pictures 25 through 27), and
- Bowing of exterior walls (Pictures 28 and 29).

Hole in Gutter, Also Note Damaged/Rotted Woodwork

6. Consider having exterior walls re-pointed to prevent water intrusion.
7. Repair/replace missing/damaged sections of gutter/downspout system to direct water away from the foundation of the building.

8. Repair/replace missing/damaged sections of wooden trim along roof edge to prevent water infiltration.

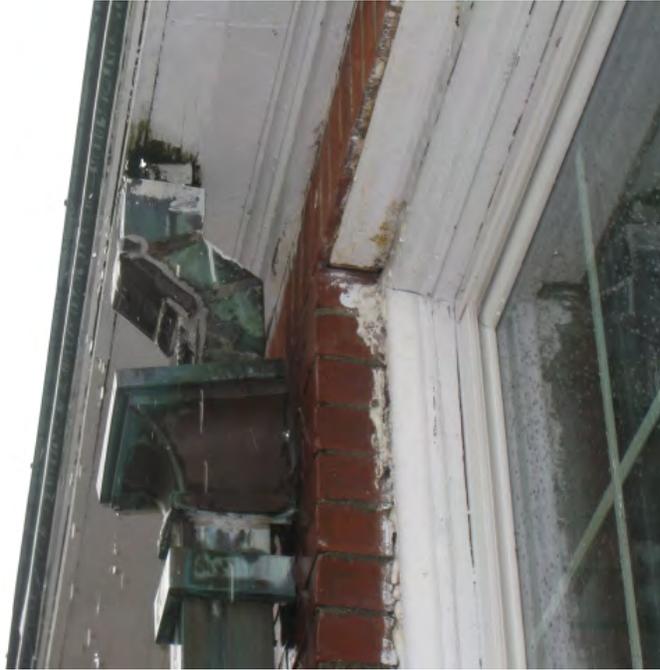
Picture 23

Damaged Downspout/Gutter System and Damaged/Rotted Woodwork

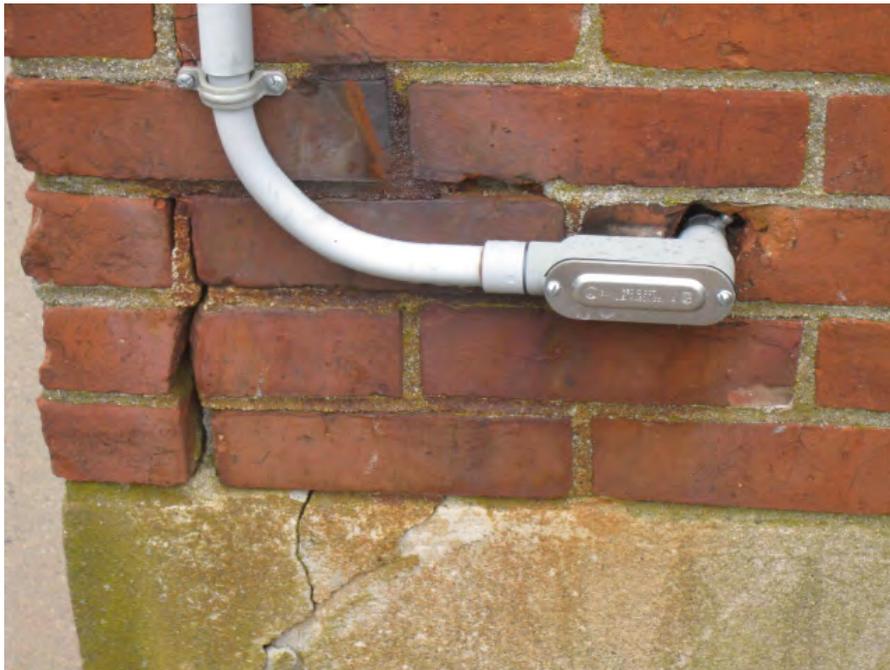
Picture 24

Exterior Wall Cracks and Open Utility Holes

7. Contact a masonry firm or general contractor to repair holes/breaches in exterior brick surfaces to prevent water penetration, drafts and pest entry.

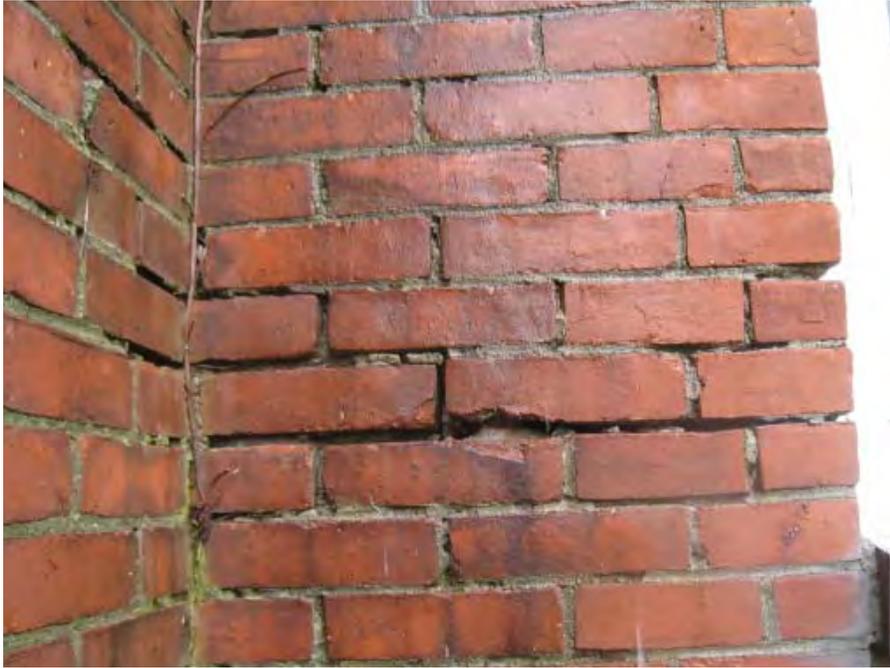
Picture 25

Missing/Damaged Mortar around Brickwork

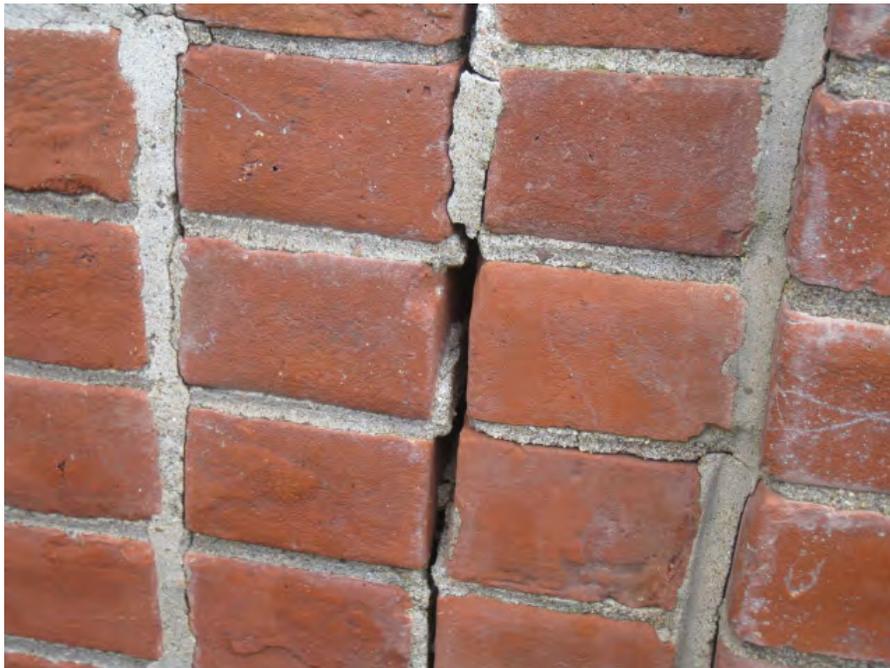
Picture 26

Missing/Damaged Mortar around Brickwork

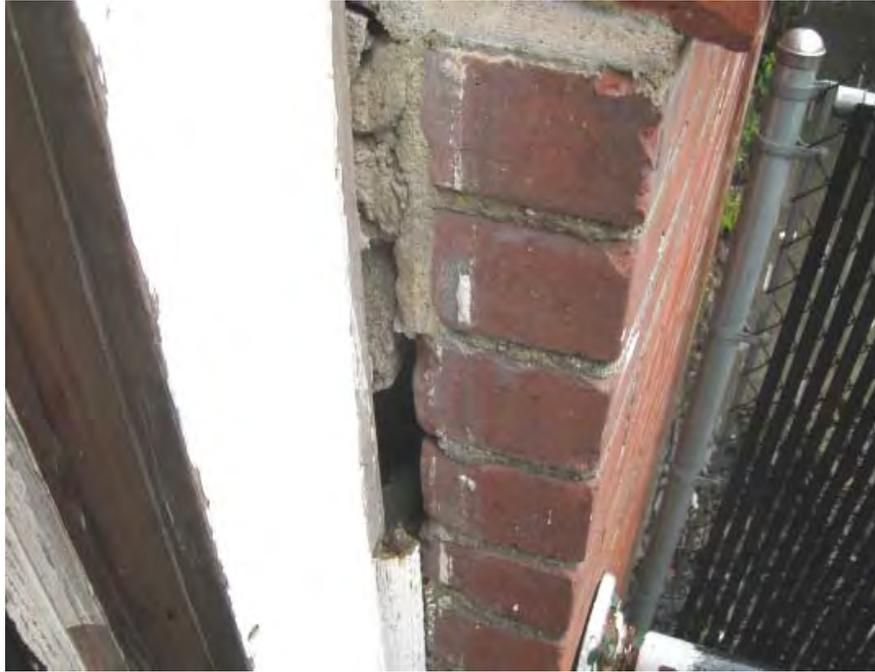
Picture 27

Missing/Damaged Mortar/Sealant around Brickwork and Wooden Door Frame

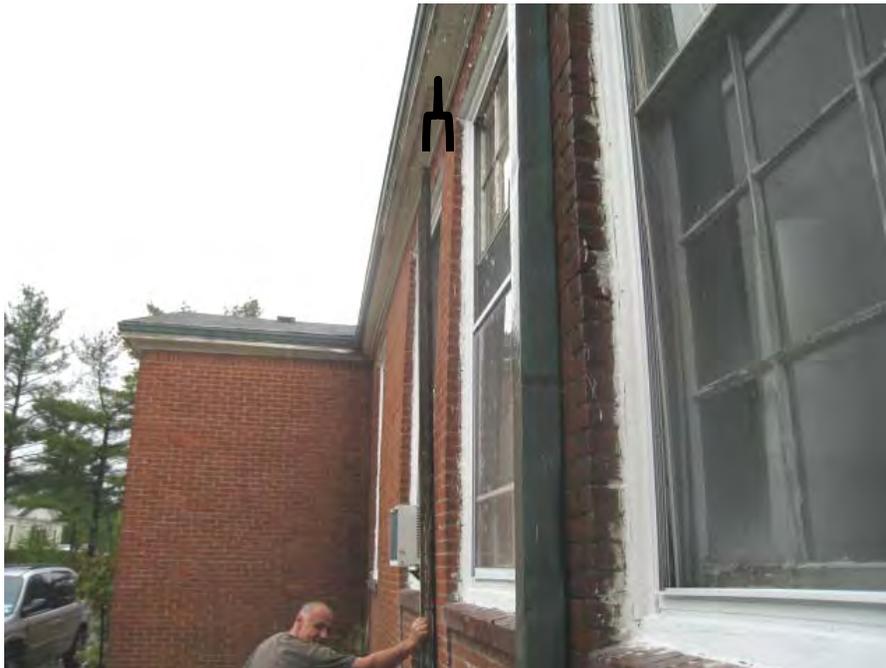
Picture 28

The aforementioned conditions represent potential water penetration sources. Over time, these conditions can undermine the integrity of the building envelope and provide a means of water entry into the building via capillary action through exterior walls, foundation concrete and masonry (Lstiburek & Brennan, 2001). The freezing and thawing action of water during the winter months can create cracks and fissures in the foundation. In addition, they can serve as pathways for insects, rodents and other pests into the building. Of particular note is the “bowing” of portions of the exterior wall in Pictures 28 and 29, which may raise questions regarding the building’s structural integrity.

“Bowling” Exterior Brickwork, Note Space between Straight Plank and Wall (Bracket)

1. Contact a structural engineer/building envelope specialist for an examination of the exterior brick work of the building, especially in areas where the exterior wall is “bowing” outwards. This measure should include a full building envelope evaluation.

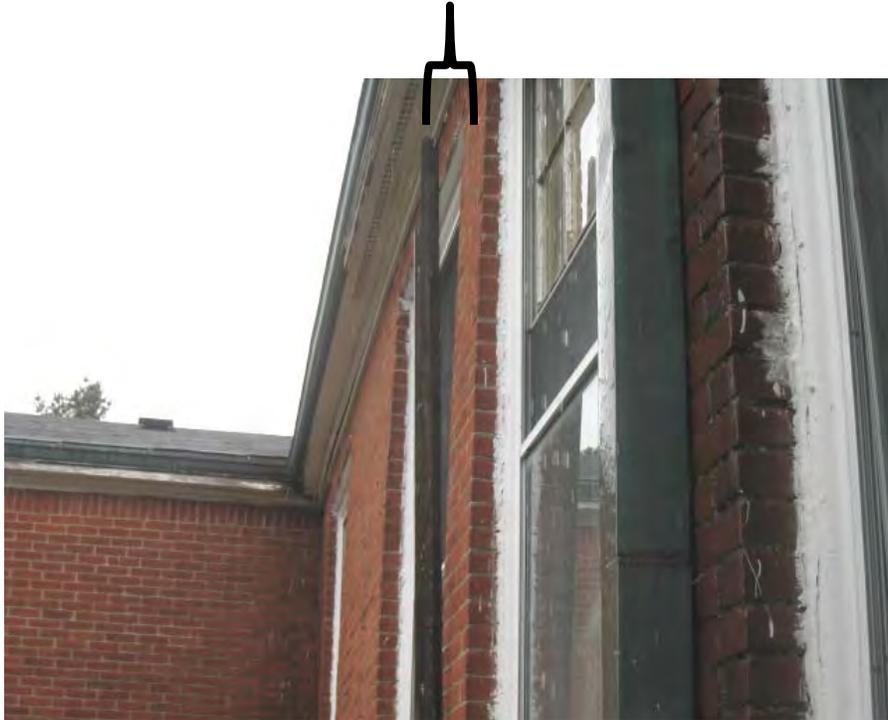
Picture 29

Close-up of “Bowling” Exterior Brickwork, Note Space between Straight Plank and Wall (Bracket)

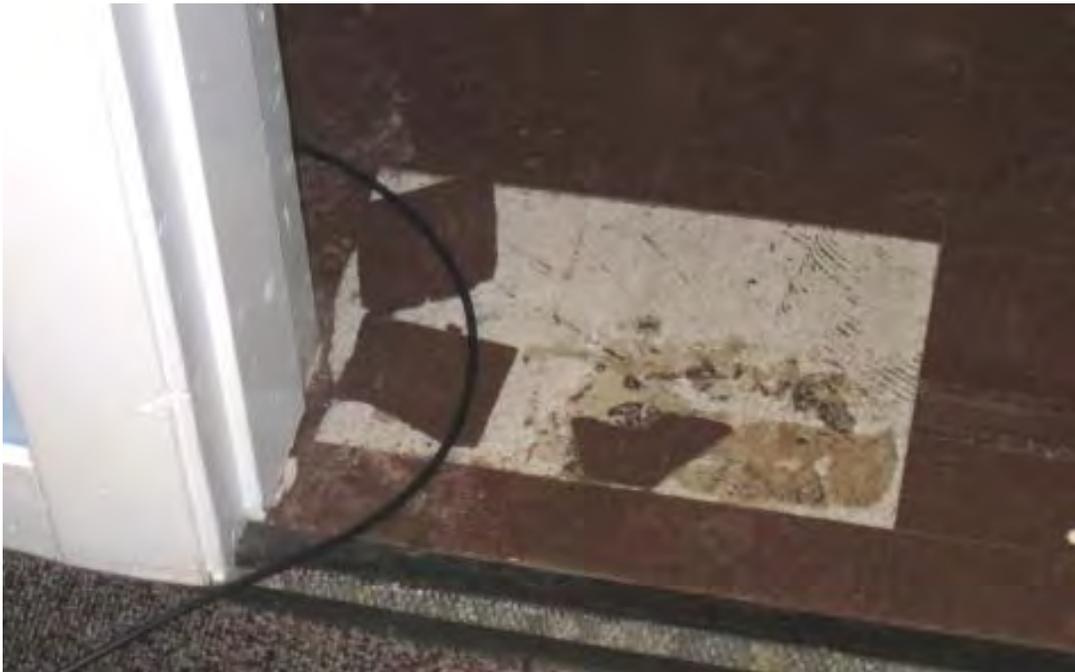
Picture 30

Damaged and/or missing floor tiles were observed in the TV studio and in both the lower and upper bingo halls (Pictures 30 through 32). These floor tiles may contain asbestos. Intact asbestos-containing material (ACM) does not pose a health hazard. If damaged, ACM can be rendered friable and become aerosolized. Friable asbestos is a chronic (long-term) health hazard, but will not produce acute (short-term) health effects (e.g., headaches) typically associated with buildings believed to have indoor air quality problems. Where asbestos-containing materials are found damaged, these materials should be removed or remediated in a manner consistent with Massachusetts asbestos remediation laws (MDLI, 1993).

Damaged Floor Tiles in TV Studio

14. Determine if damaged floor tiles contain ACM. Remediate damaged ACMs (e.g., floor tiles, pipe insulation) throughout the building in conformance with Massachusetts asbestos remediation and hazardous waste disposal laws and regulations. For further advice contact the Massachusetts Department of Labor Standards Asbestos Program at (508) 616-0461.

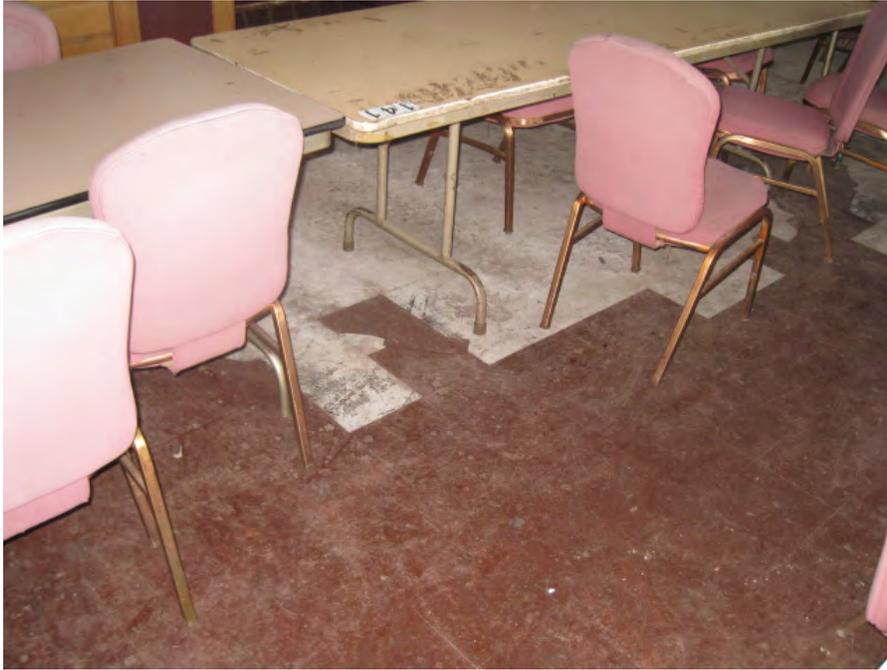
Picture 31

Damaged Floor Tiles in Upper Bingo Hall

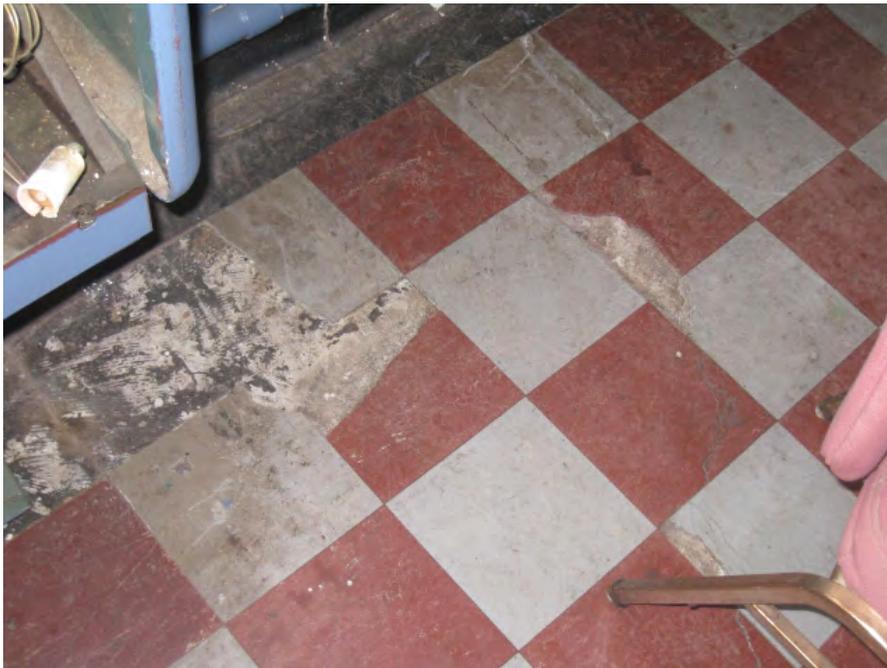
Picture 32

Damaged Floor Tiles in Lower Bingo Hall

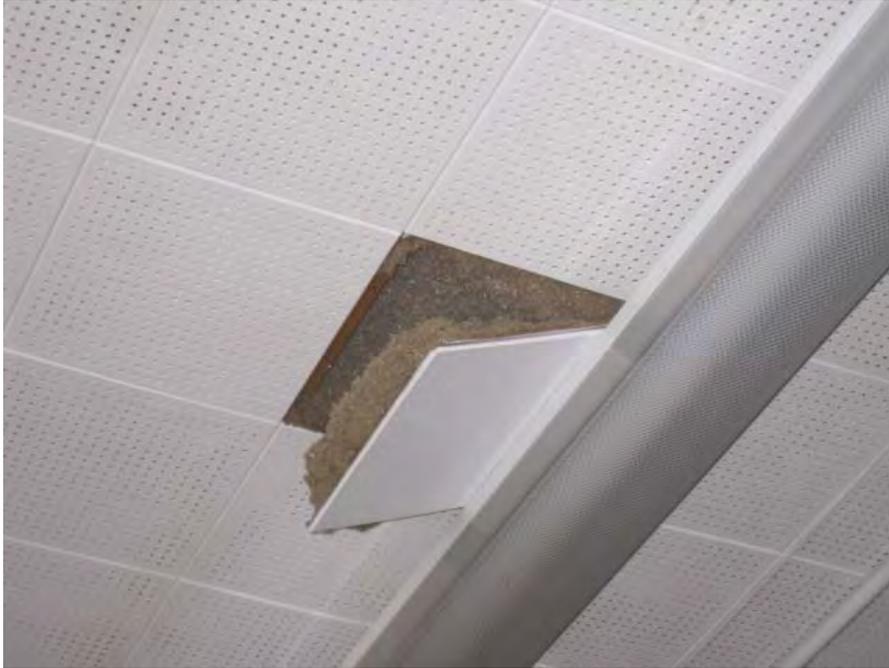
Picture 33

Loose Ceiling Tile Exposing Insulation in Upper Bingo Hall
