INDOOR AIR QUALITY ASSESSMENT

**McKinley Elementary School
65 Yeamans Street
Revere, Massachusetts**

Prepared by:
Massachusetts Department of Public Health
Bureau of Environmental Health
Indoor Air Quality Program
June 2012

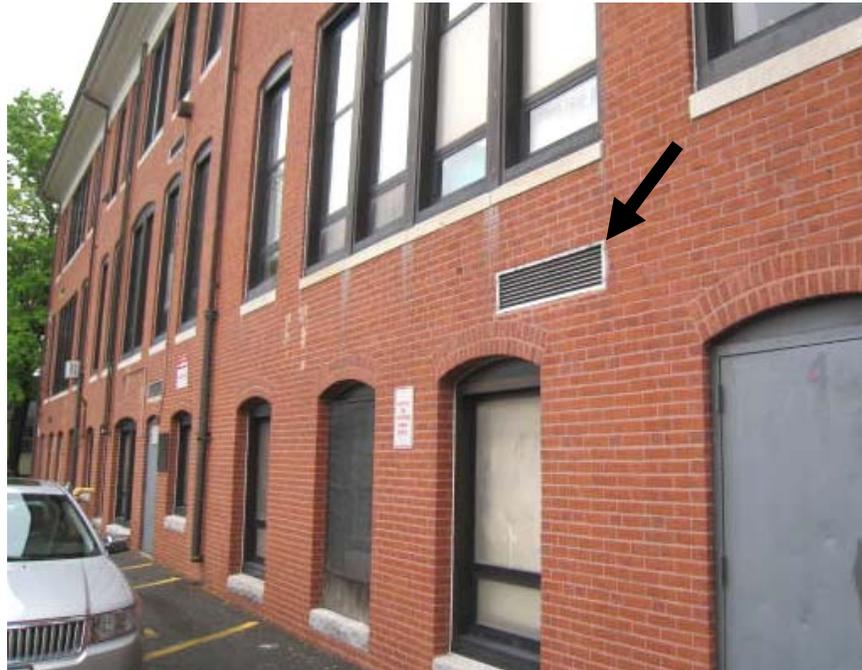
Picture 1

A fresh air source is necessary for the dilution of indoor air pollutants. The MES was designed with a natural/gravity ventilation system to provide airflow to most classrooms in combination with openable windows. With this design, ventilation is supplemented by open windows and cross ventilation through transoms. Many rooms are now served by unit ventilator (univent) systems. A univent is designed to draw air from outdoors through a fresh air intake located on the exterior wall of the building (Picture 1). Return air is drawn through an air intake located at the base of each unit where fresh and return air are mixed, filtered, heated and provided to classrooms through an air diffuser located in the top of the unit ([Figure 1](#)).

Air intake for univent (arrow)

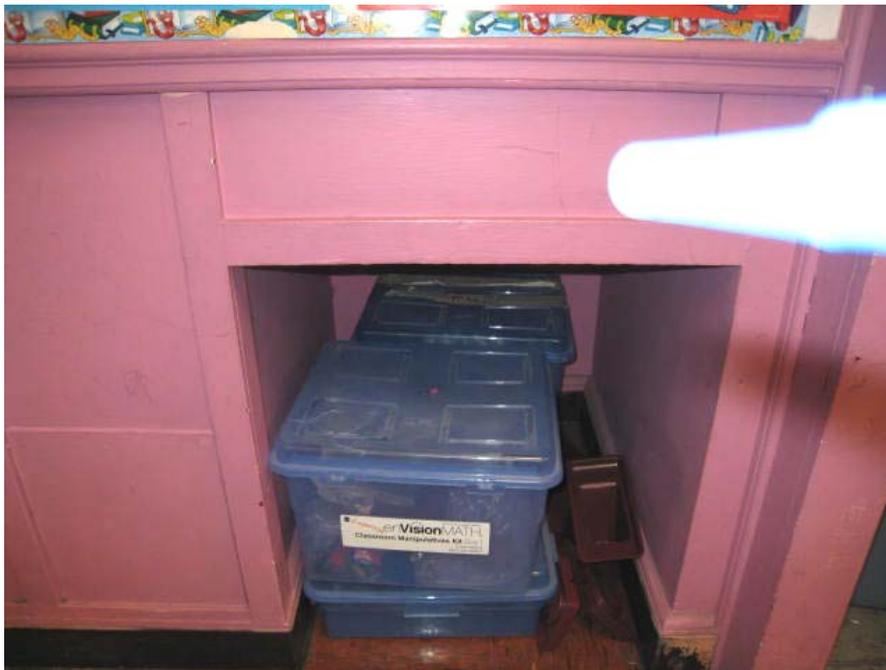
Picture 2

Exhaust ventilation in the 1902 sections of the school was originally provided by “cubbyhole” vents located near the floor in each room (Picture 2) connected to an exhaust ventilation shaft that runs to the roof. Whether these systems were still operational could not be determined, and most of the cubbyholes had materials stored in them which would obstruct flow through the vents. In the 1926 sections of the building, exhaust vents are located on the wall at floor level (Picture 3). As shown in Picture 3, some of these units were also found to be blocked by furniture and other items.

Cubby for old exhaust system, note items stored in it

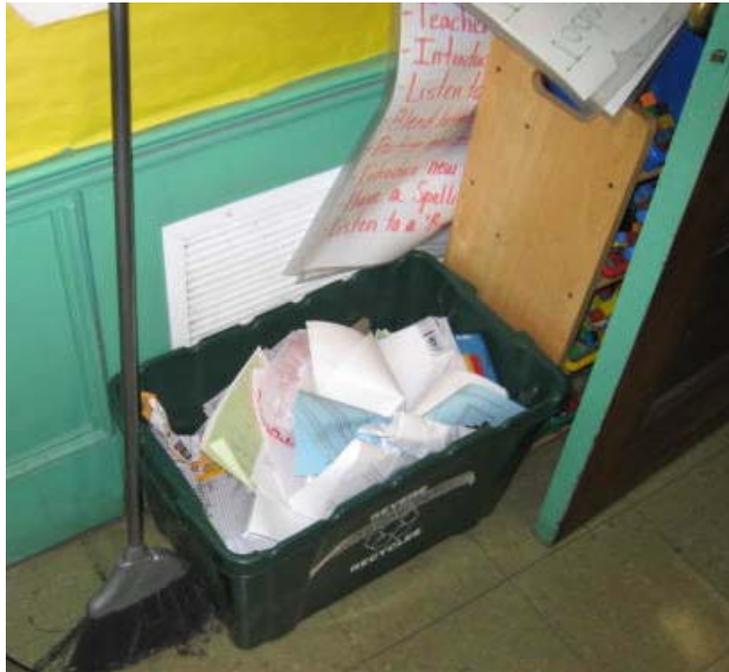
Picture 3

Exhaust vent in the 1924 section of the building; note partial blockage

1. To maximize air exchange operate existing ventilation equipment (in working order) continuously throughout the building (e.g., gym, auditorium, classrooms) during periods of school occupancy independent of thermostat control. Ensure all blockages to supply and exhaust vents are removed.

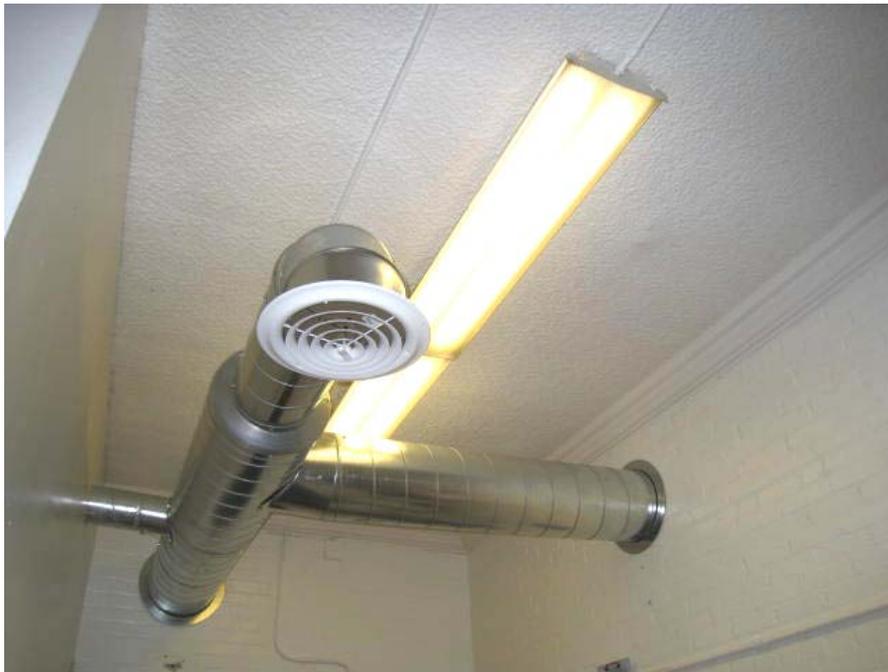
Picture 4

A new ventilation system which includes cooling has been installed in the basement, reportedly in 2011, consisting of an air handling unit (AHU) and ducted vents installed on the ceiling (Picture 4). However, not all rooms in the basement are served by this system. Of

New basement supply ducts and vent

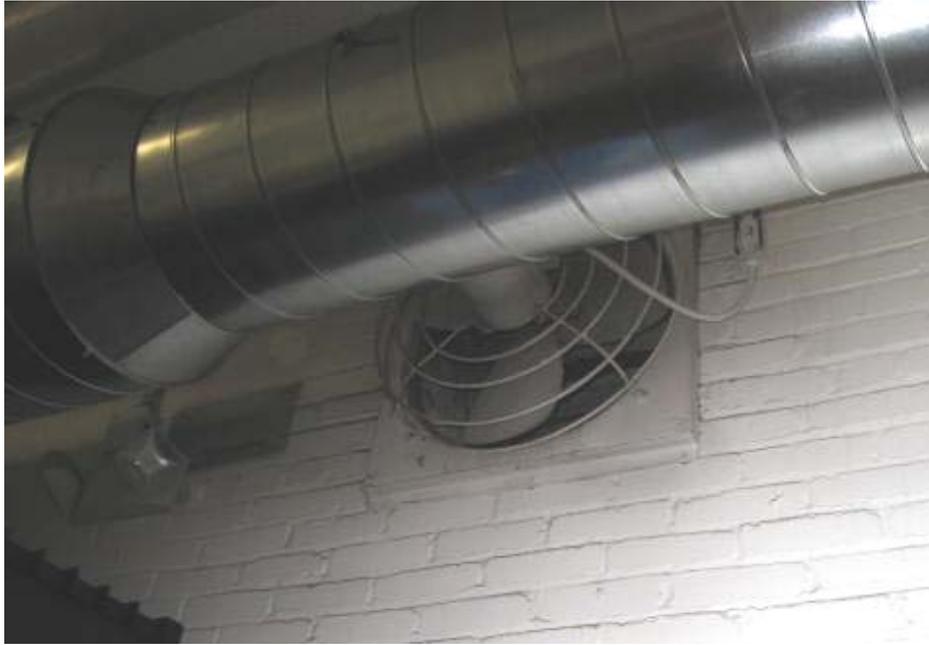
Picture 5

It was also noted that the basement hallway and corner room had exhaust fans mounted in the exterior wall (Picture 5). These fans were not in activation and outdoor light was visible through the louvers of these exhaust fans. In this configuration, unconditioned outdoor air can enter the building, resulting in increased humidity, as well as be an entry point for pests, pollen and dirt. The fans should be removed from these housings and the penetrations fully sealed.

Old basement exhaust fan alongside new ductwork; light could be seen between the vanes showing where unconditioned air can enter the basement

8. Seal penetrations for the old ventilation fans in the basement.
9. Monitor condensate lines from portable air conditioner in the computer lab for leaks and ensure that condensate drains away from the building.

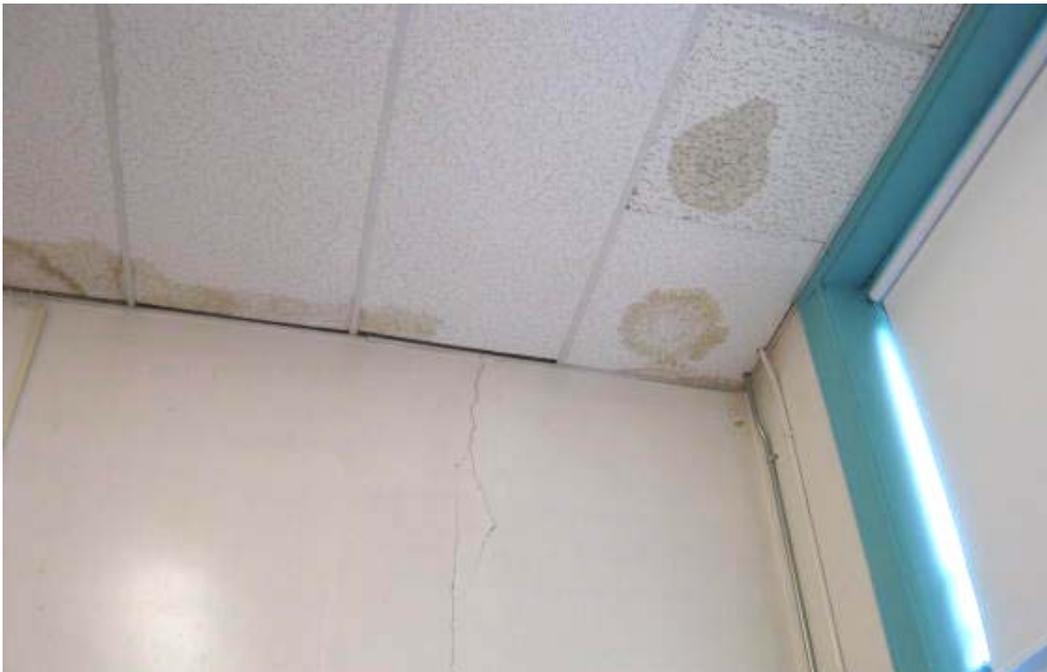
Picture 6

Water-damaged ceiling tiles were observed in some classrooms (Picture 6, Table 1). The large number of water-damaged ceiling tiles in room 16 were attributed to a historic leak from the kitchen/cafeteria level on the top floor. Other water-damaged ceiling tiles and a water-damaged windowsill were noted. Water-damaged ceiling tiles can provide a source for mold growth and should be replaced after a water leak is discovered and repaired.

Water-damaged ceiling tiles

3. Ensure any roof/exterior/plumbing leaks are repaired and replace water-damaged ceiling tiles and building materials. Examine the area above and around these areas for mold growth including the flashing. Disinfect areas of water leaks with an appropriate antimicrobial.

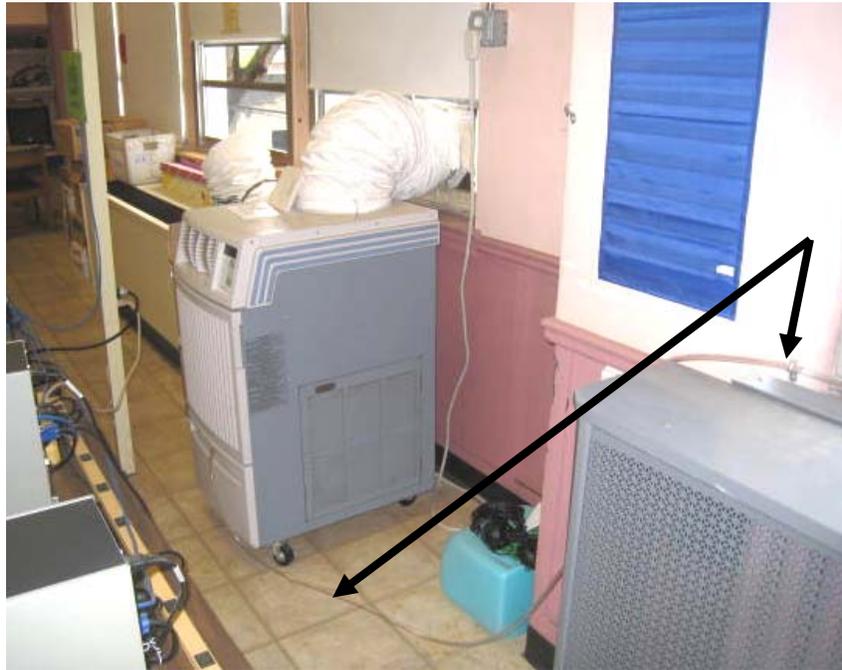
Picture 7

A portable air-conditioning unit was found in the computer lab (Room 11, Picture 7). These units generate condensate that needs to be properly drained. Drainage of the unit appeared to be through a long condensate drain line; this line needs to be monitored to make sure the water drains away from the building and does not leak and moisten the carpet or other porous building materials.

Portable air-conditioning unit in computer lab, note long condensate drain line (arrows)

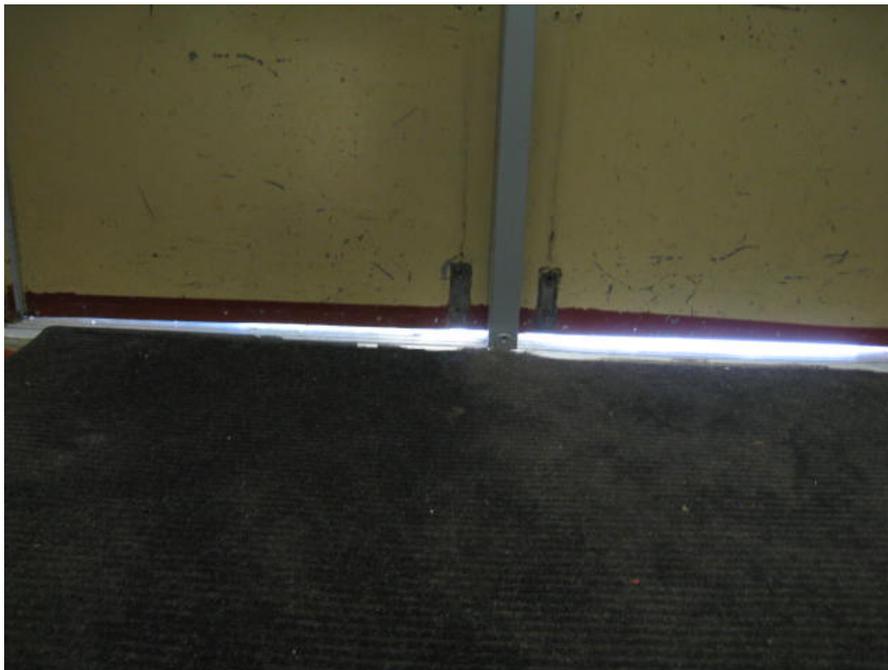
Picture 8

BEH staff examined the outside perimeter of the building to identify breaches in the building envelope and/or other conditions that could provide a source of water penetration. An exterior door had visible gaps beneath it (Picture 8), which can allow moisture to enter the building. In addition, these breaches can allow insects and rodents access to the building. A ¼-inch breach is enough space for rodents to enter a building (MDFFA, 1996). It was reported that this door was planned for replacement.

Light visible beneath an outside door

14. Take measures to tighten exterior doors (e.g., weather-stripping) to prevent drafts, moisture infiltration and pest/rodent entry. Ensure tightness of doors by monitoring for light penetration and drafts around doorframes.

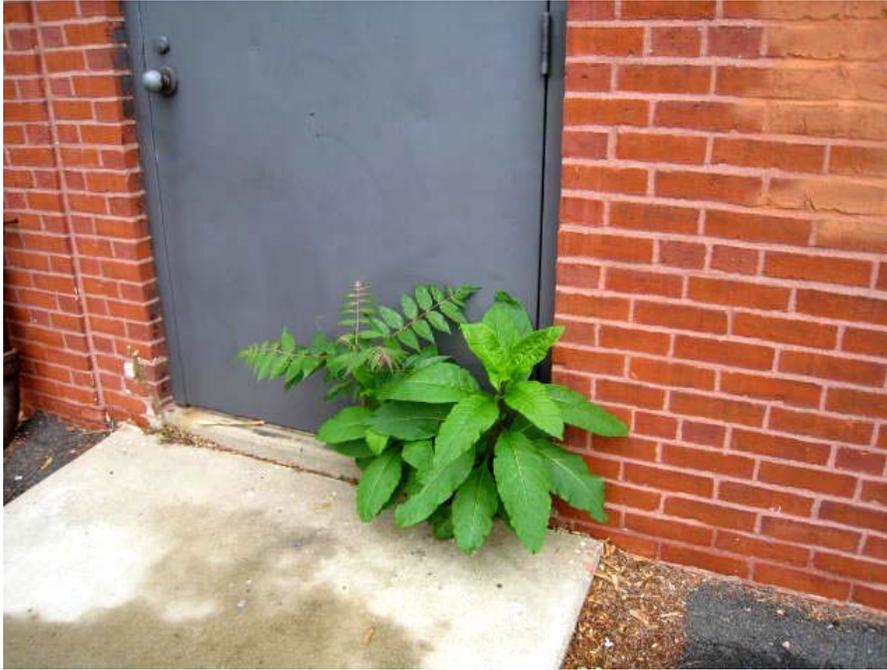
Picture 9

Finally, mulch and soil was piled against the building, and plants were noted growing through cracks in concrete around the building (Picture 9). These represent potential water penetration sources. Over time, these conditions can undermine the integrity of the building envelope and provide a means of water entry into the building via capillary action through foundation concrete and masonry (Lstiburek & Brennan, 2001). The freezing and thawing action of water during the winter months can create cracks and fissures in the foundation. In addition, these breaches may provide a means for pests/rodents to enter the building.

Plant growing out of door sill on exterior of building

15. Remove plants from perimeter and foundation and remove excess soil and mulch from around the building exterior.
16. If possible, add local exhaust ventilation to the copy room next to the teacher's lounge to remove pollutants generated by the copiers and laminator.

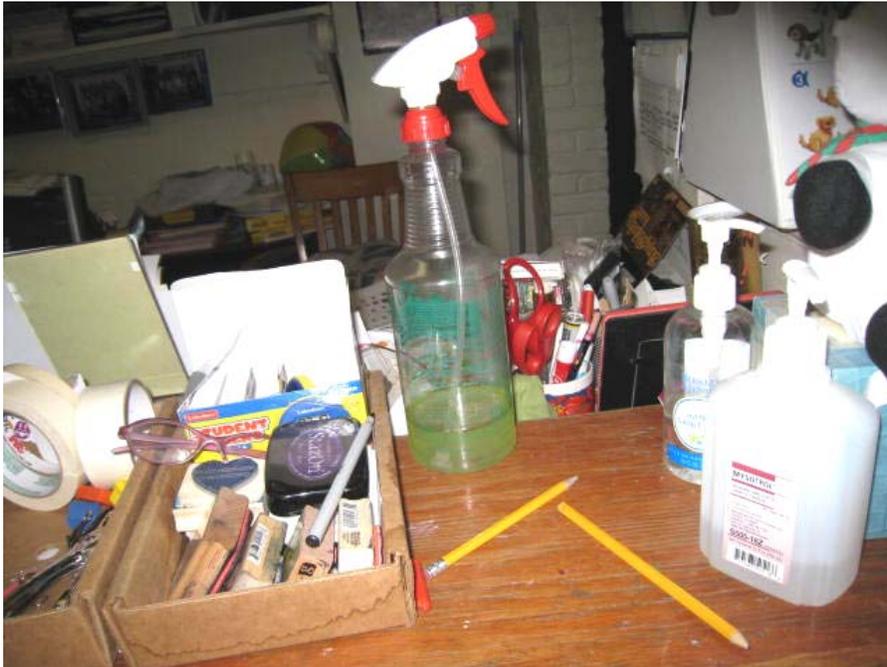
Picture 10

Household cleaning products were found in several areas (Picture 10, Table 1). Cleaning products and air deodorizers contain chemicals that can be irritating to the eyes, nose and throat of sensitive individuals. Additionally, a Material Safety Data Sheet (MSDS) should be available at a central location for all school chemicals in the event of an emergency such as an adverse chemical interaction between residues left from cleaners used by the facilities staff and those left by cleaners brought in by others.

Cleaning products

11. Ensure staff are provided with school-sanctioned cleaning products with appropriate MSDSs. Remove/discard any household cleaners and air deodorizing materials. Keep cleaning products out of reach of students.

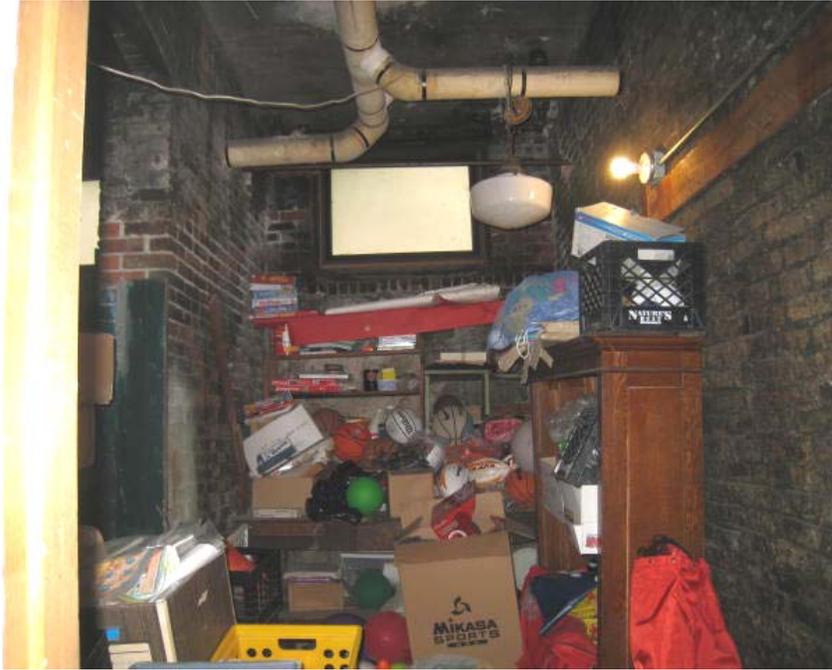
Picture 11

Other conditions that can affect indoor air quality were observed during the assessment. Of specific concern was the ELL room located in the basement. The walls consist of laminate paneling affixed to a frame of wood studs inside of a room which was the former coal bin (Picture 11), as evidenced by the sloped floor in the unfinished section of the room and the fire door on the hallway entrance. As previously noted, this room has neither mechanical ventilation or openable windows. The storage area contains athletic equipment which is reportedly accessed/moved several times a day through the room. Although no elevated levels of particulates were noted in the ELL room at the time of the visit, and no dust deposits suggestive

of coal were noted, the area was not designed originally nor converted subsequently into a room that could be routinely occupied. BEH staff suggests that its use be limited to storage only.

Athletic equipment storage in old coal bin off the ELL room

4. Discontinue use of the ELL room in the basement as soon as feasible with the exception of storage.
5. Ensure that no material that can be a source of mold growth is stored either directly on the floor or metal shelves in contact with the floor or foundation wall in basement area.

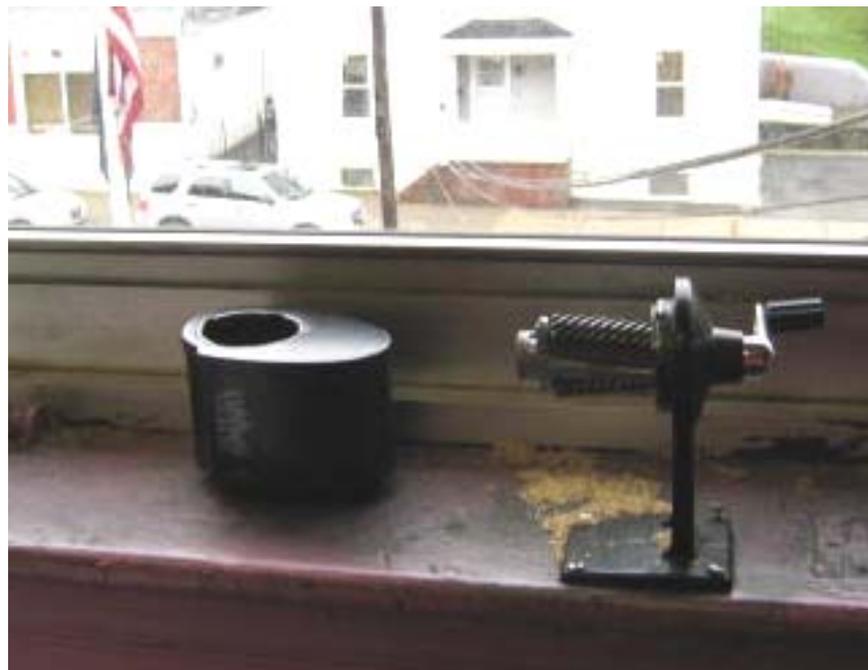
Picture 12

A build up of pencil shavings was observed in several classrooms (Table 1, Picture 12). These materials can be aerosolized by air movement from the ventilation system, doors opening and closing, or foot traffic and may present an eye or respiratory irritant.

Pencil shavings in classroom

17. Clean accumulated pencil shavings regularly.
18. Clean supply/exhaust vents and personal fans periodically to prevent excessive dust build-up.
19. Clean carpeting annually or semi-annually in soiled high traffic areas as per the recommendations of the Institute of Inspection, Cleaning and Restoration Certification (IICRC). Copies of the IICRC fact sheet can be downloaded at:
<http://www.certifiedcleaners.org/faq.shtml> (IICRC, 2005).

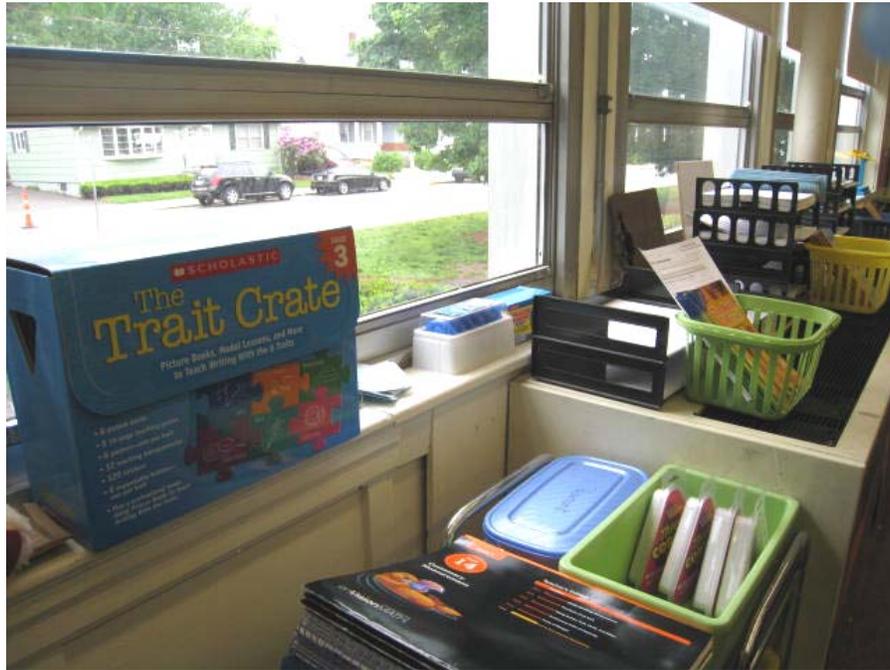
Picture 13

In several classrooms, items were observed on the floors, windowsills, tabletops, counters, bookcases and desks (Picture 13 and 14). The items stored in classrooms provide a source for dusts to accumulate. These items (e.g., papers, folders, boxes) make it difficult for custodial staff to clean. Curtains used to cover stored items can also collect dusts and be difficult to clean. Items should be relocated and/or be cleaned periodically to avoid excessive dust build up. In addition, these materials can accumulate on flat surfaces (e.g., desktops, shelving and carpets) in occupied areas and subsequently be re-aerosolized causing further irritation. Similarly, dust/debris from items placed on top of radiators and univents can become airborne through movement of the heated air.

Items in classroom, note baskets on top of univent diffusers

20. Relocate or consider reducing the amount of materials stored in classrooms to allow for more thorough cleaning of classrooms. Clean items regularly with a wet cloth or sponge to prevent excessive dust build-up. Use of plastic totes for storage of items not in use will allow for more thorough cleaning.

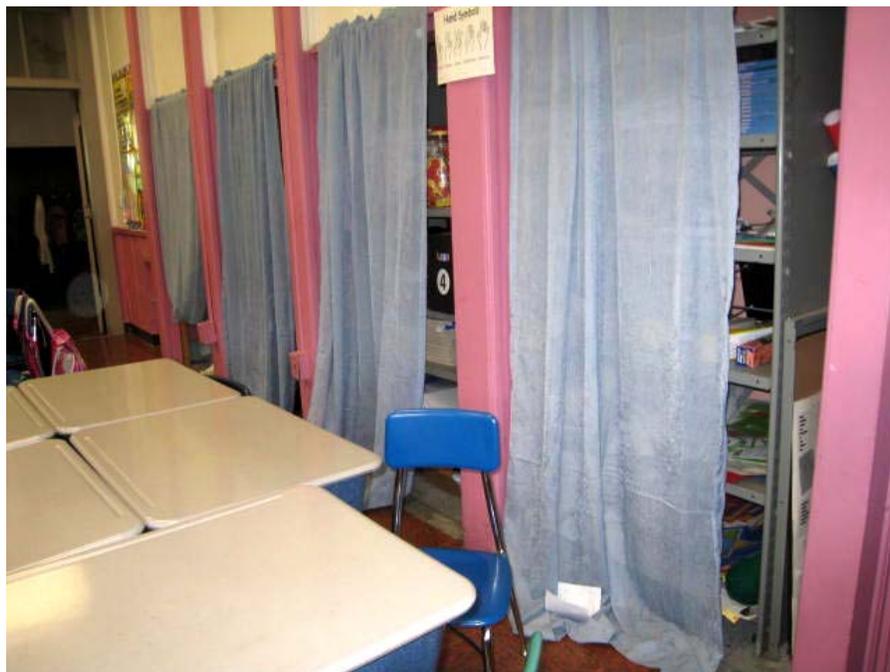
Picture 14

Storage of items in classroom behind fabric curtains
