INDOOR AIR QUALITY ASSESSMENT MOLD INVESTIGATION

**Tewksbury Hospital
Old Administration Building
DMH Office Server Room
365 East Street
Tewksbury, MA**

Prepared by:
Massachusetts Department of Public Health
Bureau of Environmental Health
Indoor Air Quality Program
December 2012

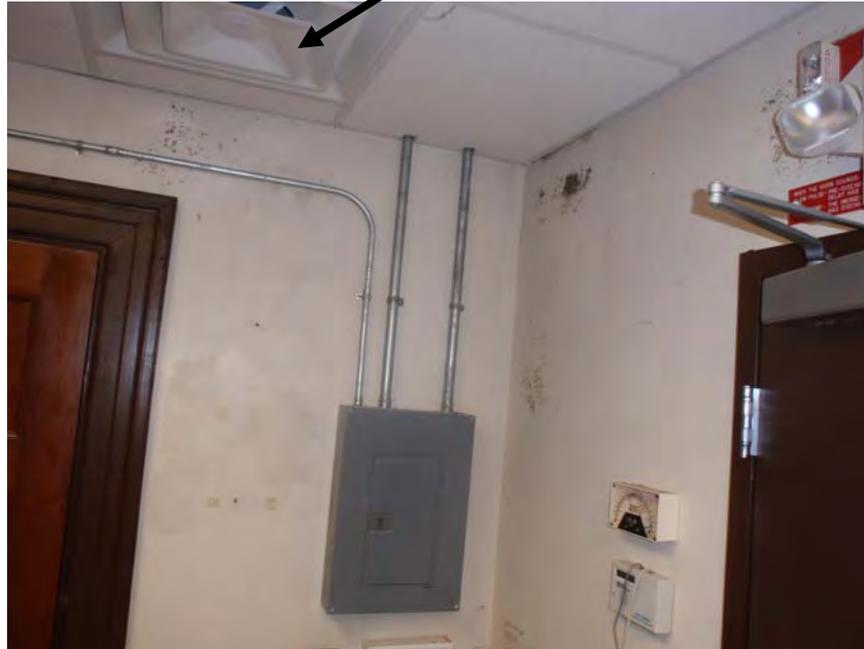
Picture 1

As noted earlier, the assessment was prompted by the presence of mold and staining on walls in the server room (Pictures 1 and 3). According to Mr. Lamothe, this condition occurred rapidly in the weeks prior to the assessment. During the assessment, BEH/IAQ staff observed mold growth and staining on two of the walls inside the server room. Both walls are adjacent to a supply vent that blows directly on them (Picture 1). Mold/staining was also observed on trim for the closet door and along the edges of fire alarm equipment. The walls in the server room appear to be composed of plaster with one or more coats of thick glossy paint. Plaster walls are not typically as vulnerable to penetration by microbial growth as gypsum wallboard or other porous materials. Instead, mold will grow on the surface of the plaster wall. Patches of mold/staining examined could be removed with a small amount of rubbing, suggesting that the mold growth is superficial and removable via cleaning with an anti-microbial cleansing agent and friction/abrasion. Where growth is found to be more deeply imbedded, such as in the wooden door trim, the surface may require sanding/scraping before it is cleaned with an antimicrobial cleaner.

Based on BEH/IAQ staff observations and considering the timing of the mold growth on the plaster walls, it appears that the mold growth may be accelerated by condensation forming along the walls. If a surface in contact with the air has a temperature at or below the dew point, it will collect condensed moisture and become wet. Dew point is another way of representing humidity; the dew point is the temperature at which the water vapor in the air will start to condense. Surface temperatures measured on the affected walls ranged from 62°F to 65°F (Table 1), below the temperature of the air in the room. Given the temperature and humidity described above, the dew point for the server room would be approximately 51°F. This suggests that under more humid conditions, air from the supply vent blowing directly on the wall could have reduced the wall temperature below the dew point and allowed moisture to condense there. Dust settling on these damp surfaces can lead to mold growth. Since the temperature of the top side of the supply vent was approximately 45°F (below the dew point of 51°F), this surface may also be subject to condensation under the conditions observed. However, at the time of assessment, the supply vent did not appear to be wet. The distribution of moisture, excessively/unevenly chilled air, and/or mold spores by a malfunctioning air-conditioning system can result in the rapid spread of the mold observed in this room.

**Supply vent (arrow), with vents facing wall with mold-staining
(Note: image provided by Paul Lamothe)**

1. Continue to work with the HVAC technician to repair or replace any compromised HVAC equipment. Ensure that humidity levels in the server room can be kept low enough via fresh air ventilation and exhaust to reduce the likelihood of condensation. Check condensation pans and other equipment regularly for signs of leaks.
2. Change the four-way supply vent fixture to one with only one or two sides, both facing towards the middle of the room rather than the walls.
3. If a non-ducted air conditioning system is installed, ensure that some method of ventilation is provided for this room to both supply fresh air and remove moisture, odors and pollutants. Ensuring the door remains open while the room is occupied may be necessary.

4. Clean the staining and mold-colonization from the walls using an anti-microbial cleaner and sanding/scraping if needed.
5. Replace any water-damaged ceiling tiles.

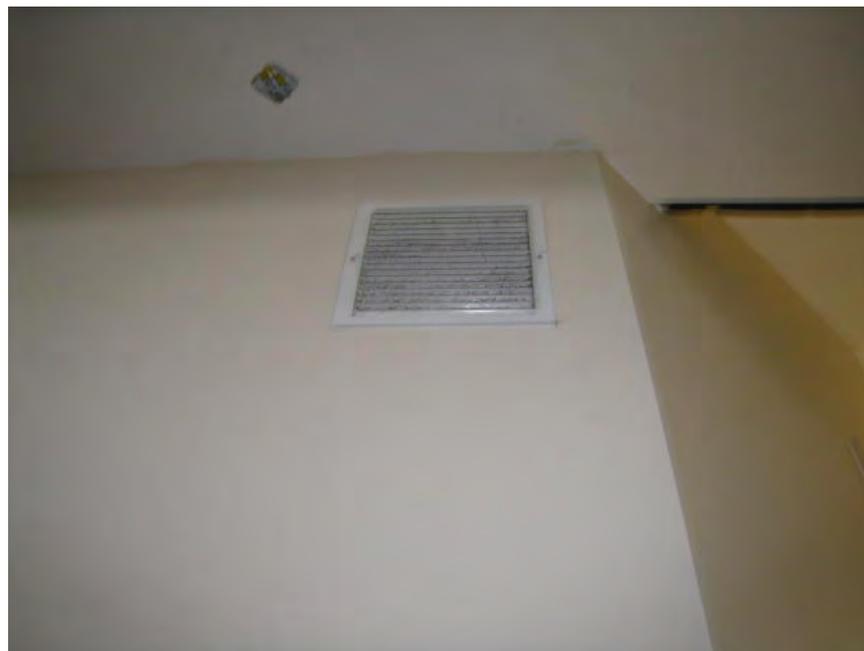
Picture 2

in the hallway through which makeup air is drawn were also dusty and should be cleaned (Picture 2). Improved storage of equipment inside this room and regular general cleaning will also reduce any impacts from dust.

Air intake for server room located in hall outside (note dust on grill)

8. Increase general cleaning in the server room and hallway outside, and improve storage of other materials, removing anything that is not needed.
9. If the equipment in this room is going to be moved to another location, clean and inspect items as they are removed to ensure that materials entering the new location are free of dust and microbial growth.

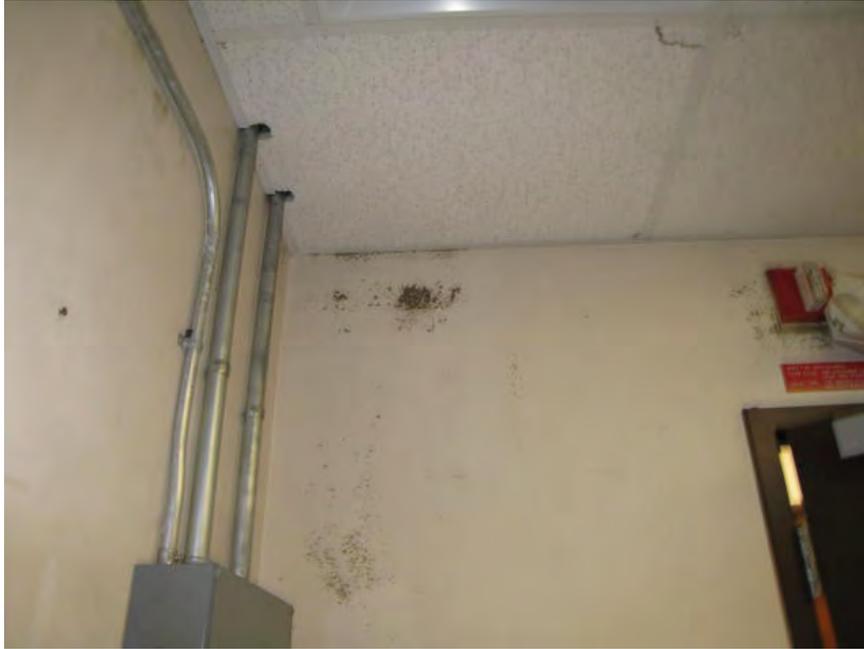
Picture 3

Mold staining on walls (dark spots)

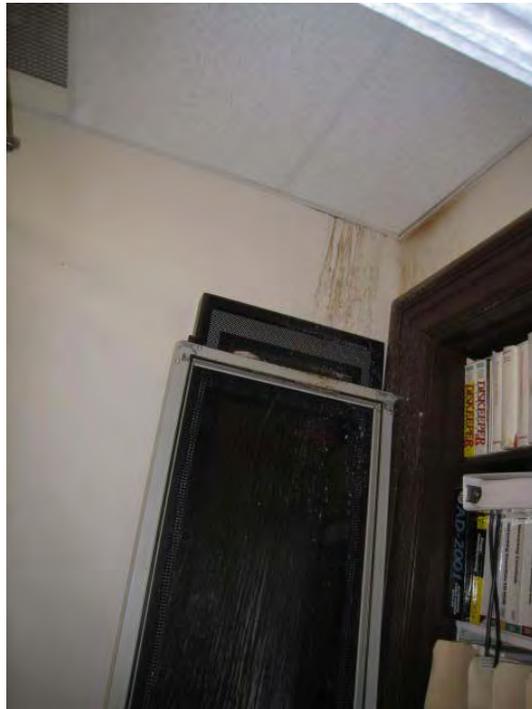
Picture 4

Additional water staining was noted on the wall opposite the side with the mold colonies, and some of the ceiling tiles there were water-damaged (Picture 4). This staining reportedly

resulted from an air conditioner condensation leak that had occurred several months previous to the BEH/IAQ visit. There was no sign of mold growth around these water stained spots at this time; however, water staining and damage should be cleaned and repaired as soon as the condition leading to the water leak is discovered and remediated.

Water damage/stains on wall in server room

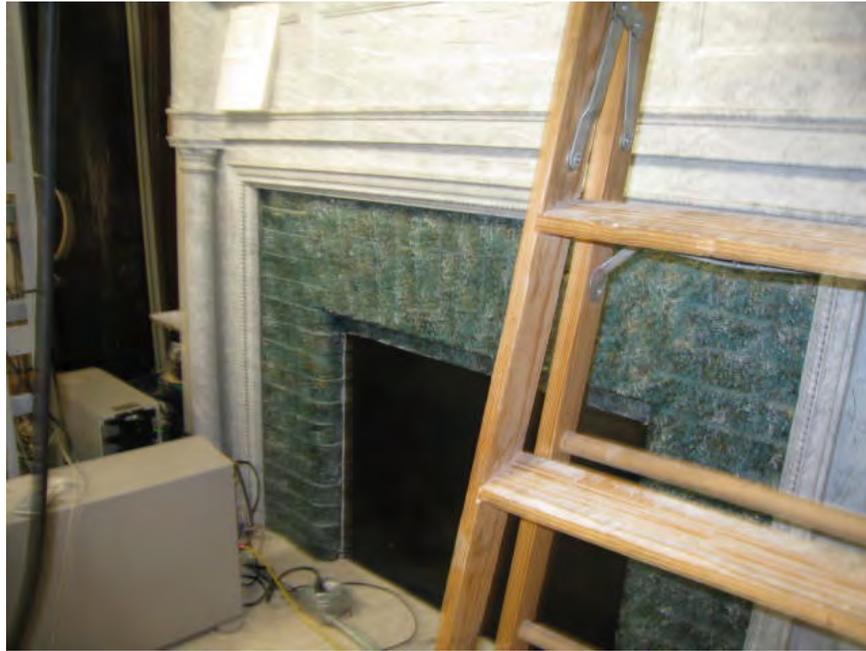
Picture 5

The room has several other features that can make it vulnerable to water damage and other indoor air issues. There is an old fireplace in the room (Picture 5) that has been blocked off and not in use for a long time. It is unknown whether the chimney has been removed, blocked or maintained in the intervening years. Old chimneys can become a conduit for moisture from outside or elsewhere in the building and a pathway for pests.

Old fireplace in the server room

6. Ensure that any holes or breaches in the ceiling above the tile system are repaired.
Inspect the old fireplace for evidence of water intrusion or pests and repair as needed.
Inspect the inside of the closet for breaches and pathways as well.
