INDOOR AIR QUALITY ASSESSMENT

**Schofield Elementary School
27 Cedar Street
Wellesley, Massachusetts**

Prepared by:
Massachusetts Department of Public Health
Bureau of Environmental Health
Indoor Air Quality Program
February 2012

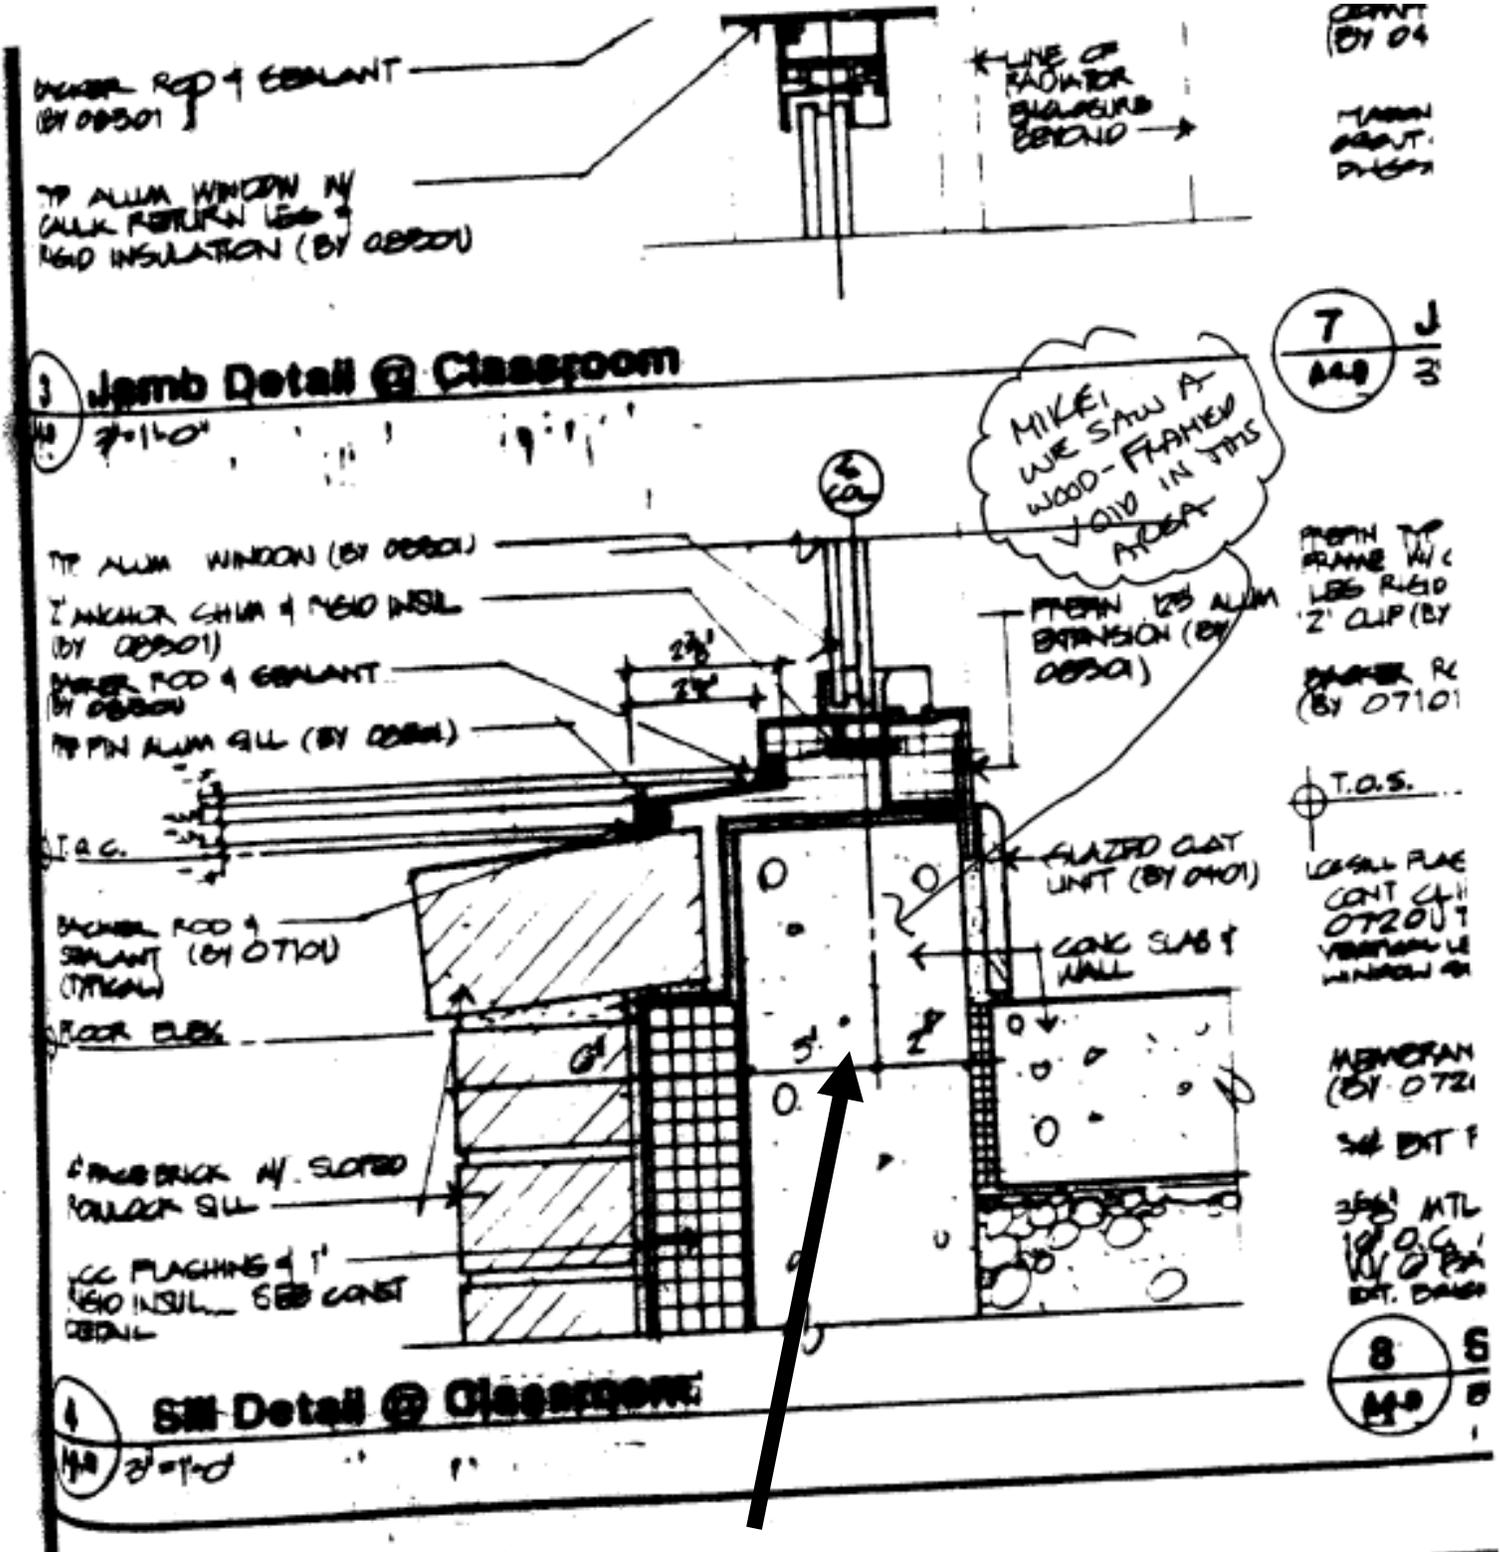
Figure 2

Visual observations and measurements of the window system in the 1993 wing indicate that the bottom of the window system terminates roughly four inches (4") above the floor slab. The window frame straddles a short brick exterior wall (Picture 7) and a plastic-covered interior wall. Originally, the design called for the remaining interior portion of the window system to be supported by cement blocks covered with glazed clay (Figure 2), which would prevent water penetration and provide thermal resistance. BEH staff examined the wall cavity and found that a plastic coving-covered wood frame was substituted for the planned cement block. Furthermore, no insulation was observed inside the wall cavity. In essence, a single line of brick separates the indoor environment from the outdoor elements.

Blueprint of 1993 Wing Exterior Wall and Slab

Note: Blueprint calls for a "concrete slab & wall".
Location indicated by arrow had wood supporting the window system.

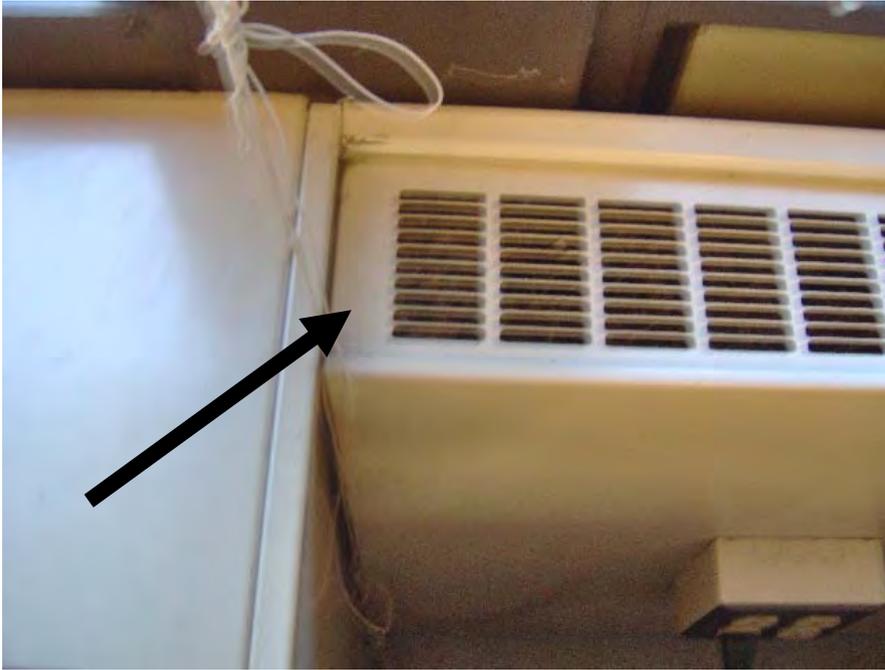
Picture 1

([Figure 1](#)). Fresh and return air are mixed, filtered, heated and provided to classrooms through an air diffuser located in the top of the unit. The univent configuration observed in the 1964 wing are typical of those observed by BEH staff in other schools.

Air Intakes for the univent in 1993 Wing

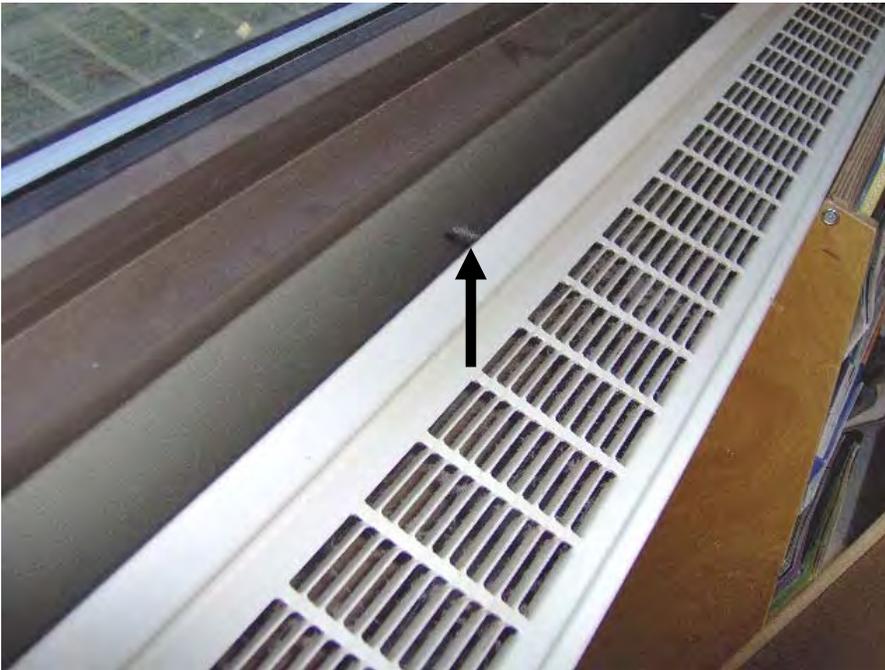
Picture 2

Exposed Fasteners in Wall Cavity (Arrow)

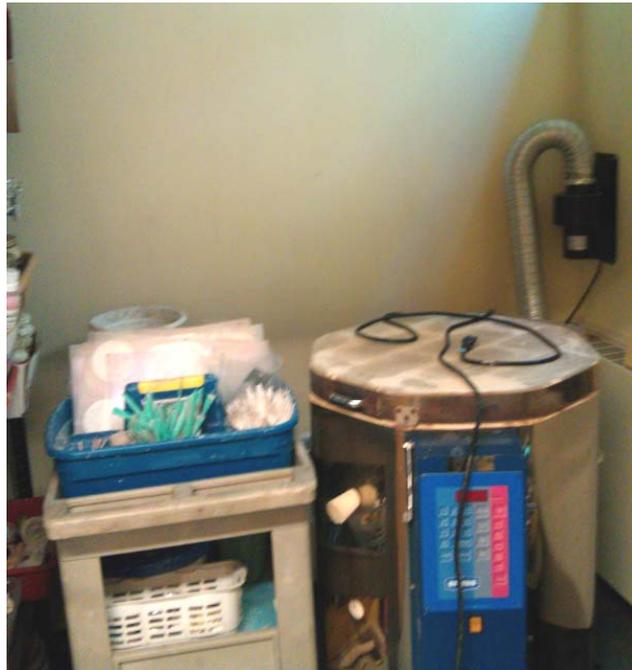
Picture 3

Dedicated exhaust ventilation was found in the kiln room (Picture 3). It appears that the flexible ductwork for the kiln was installed in a manner that creates a U-bend. This bend can create resistance, limiting the flow of air/movement of materials from the kiln to the outdoors. Measures should be taken to re-attach the flexible ductwork to the dedicated exhaust in a manner that reduces resistance. In addition, a general exhaust vent was observed in the kiln room

Flexible Ductwork for Dedicated Kiln Exhaust, Note U-bend at the Top

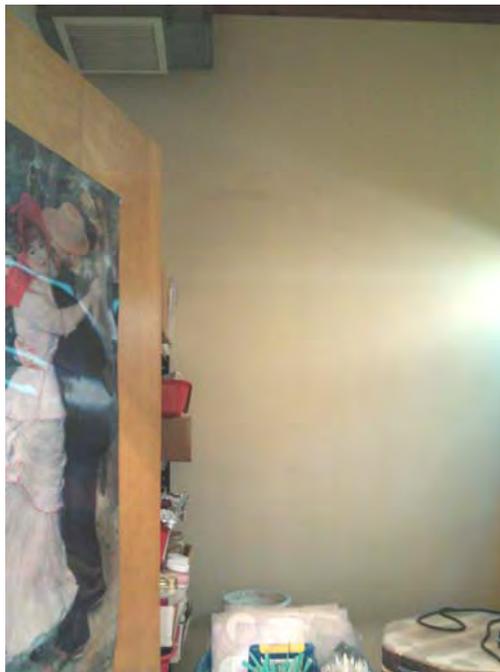
Picture 4

(Picture 4). The exhaust vent appears to be connected to the ductwork for a rooftop exhaust fan that services classrooms. If the exhaust fan is not operating, backdrafting can occur, which can force heat, particulates and odors that may escape the kiln into the art room. This general exhaust vent should be disconnected or sealed to ensure the kiln room remains depressurized.

General Exhaust Vent (Top Left Corner) in Kiln Room

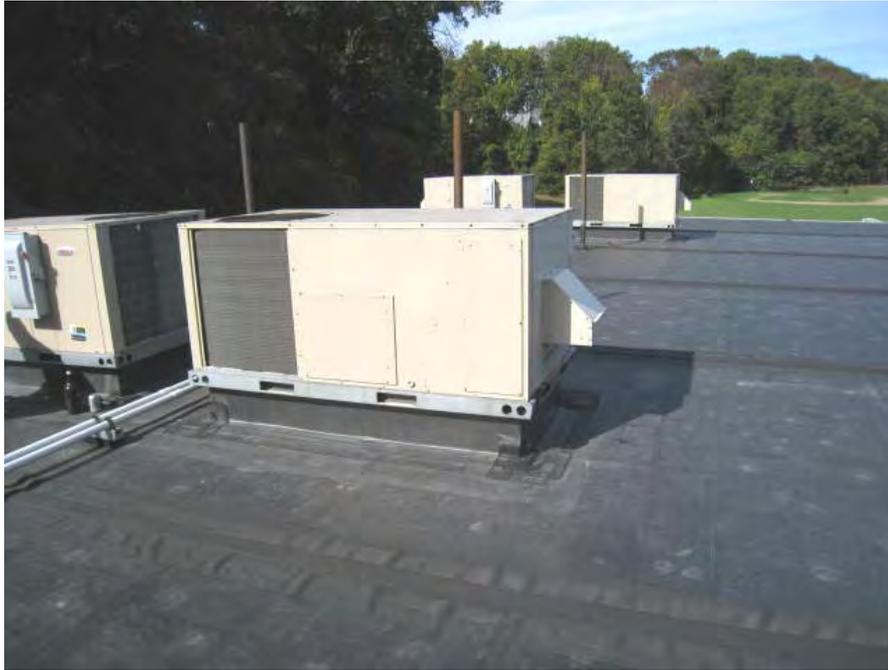
Picture 5

Each of the modular classrooms is fitted with a rooftop air handling unit (AHU) (Picture 5), which is ducted to a supply diffuser that provides a mix of fresh and returned air to the classroom. Return vents ducted to the AHU return air back to the unit. Please note, return vents in this classroom are fitted with supply diffusers. Supply diffusers that are used for return ventilation can inhibit the draw of air into return ductwork due to their configuration/shape (horizontal fins). Replacing supply diffusers with more appropriate return vents will decrease resistance, increasing the amount of air returned.

Please note, these classrooms have been noted to have slightly elevated (e.g., above 800 ppm) carbon dioxide levels. These elevated levels can be attributed to a lack of exhaust ventilation that would remove air from these classrooms. Without true exhaust ventilation, normally occurring environmental pollutants can build up and become irritating to the eyes, throat and respiratory system. At the time of the assessment, an HVAC technician that services the school suggested that economizers could be installed to provide exhaust ventilation.

Modular Classroom AHUs

9. Replace supply diffusers with more appropriate return vents in modular classrooms to decrease resistance and increase the amount of return air.
10. Install a passive door vent in the library classroom to provide air exchange.

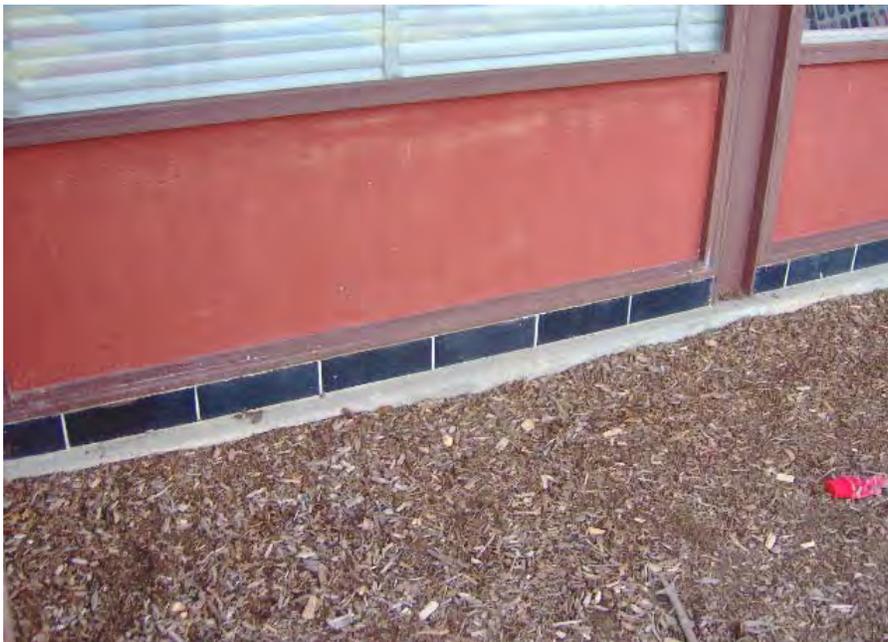
Picture 6

present, BEH staff examined and compared the exterior wall systems of the 1964 and 1993 wings. The window system of the 1964 wing rests on cement blocks covered with ceramic tile (Picture 6). The presence and condition of the ceramic covered blocks and the tiled floor adjacent to the window system indicates that water penetration does not readily occur through this material. The exterior wall/window system of the 1993 wing is constructed in a different manner than the original wing.

Window System in the Older Section of SES, Note Windows System Rests on Solid Stone Blocks, Which Would Resist Water Penetration

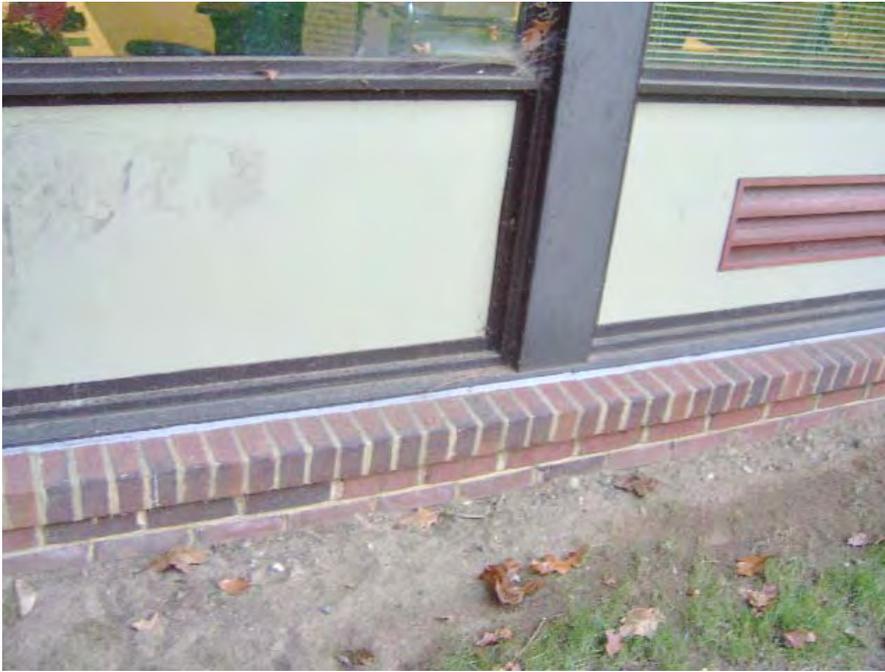
Picture 7

The 1993 wing does not have a curtain wall or drainage plane beneath the window system. In this configuration, water penetrating into the wall system below the windows has no means to drain. One method typically employed to prevent water penetration into brick is the installation of flashing beneath the window frame over the outer edge of the brick. No flashing was installed. Without flashing to prevent water from penetrating the brick and weep holes to allow water to drain moisture from the window system, water/condensation can accumulate in the wall cavity.

1993 Wing Window System Resting Partially on Brick Wall

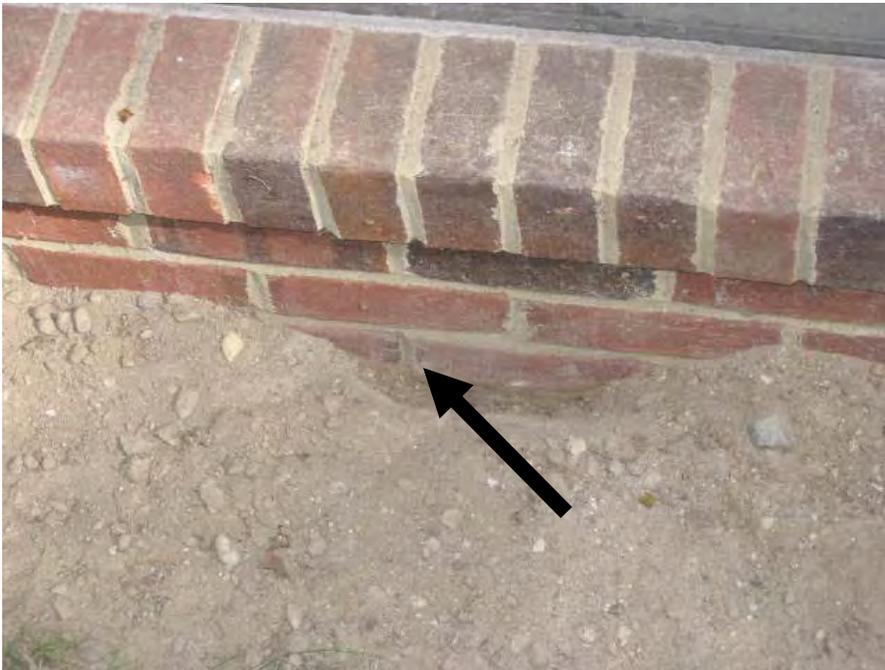
Picture 8

- The slab and brickwork for the lower portion of the exterior wall are buried beneath the ground/soil in places (Picture 8). In this configuration, the slab and brick temperature becomes that of the ground/soil.
- Temperature of the exterior wall system is uneven due to shading. The exterior wall faces a hill covered with trees (Picture 9). The shade reduces the amount of solar heat that would warm exterior walls and windows of the 1993 wing.
- The existing window/wall system configuration (i.e., wood-frame lacking insulation) makes the building highly susceptible to uneven heating.

**1993 Wing Exterior Wall and Slab Buried beneath Soil
(Arrow Indicates Depth of Slab below Grade of Soil)**

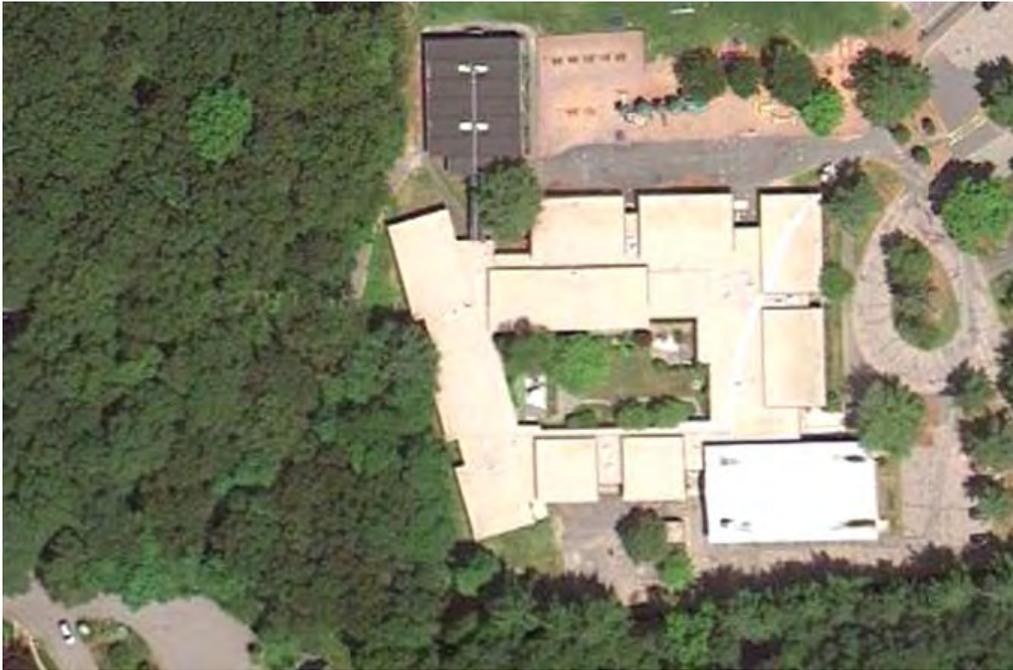
Picture 9

1993 Wing Shaded by Dense Stand of Trees

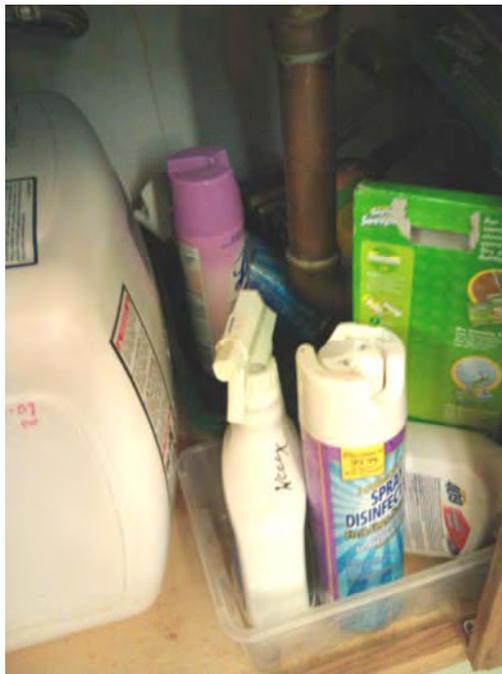
Picture 10

The school reportedly now uses green-seal certified cleaning products, but many rooms had cleaners that were not provided by the school. Household cleaning products, air fresheners and deodorizing materials (e.g., oil/reeds) were found in several areas (Table 1, Picture 10). Cleaning products and air deodorizers contain chemicals that can be irritating to the eyes, nose and throat of sensitive individuals. Many air fresheners contain 1,4-dichlorobenzene, a VOC which may cause reductions in lung function (NIH, 2006). Furthermore, deodorizing agents do not remove materials causing odors, but rather mask odors that may be present in the area. Additionally, a Material Safety Data Sheet (MSDS) should be available at a central location for all school chemicals in the event of an emergency such as an adverse chemical interaction between residues left from cleaners used by the facilities staff and those left by cleaners brought in by others.

Cleaning Products and Air Deodorizers under Sink Cabinet
