INDOOR AIR QUALITY ASSESSMENT

**Mount Greylock Regional School
1781 Cold Spring Road
Williamstown, MA**

Prepared by:
Massachusetts Department of Public Health
Bureau of Environmental Health
Indoor Air Quality Program
February 2012

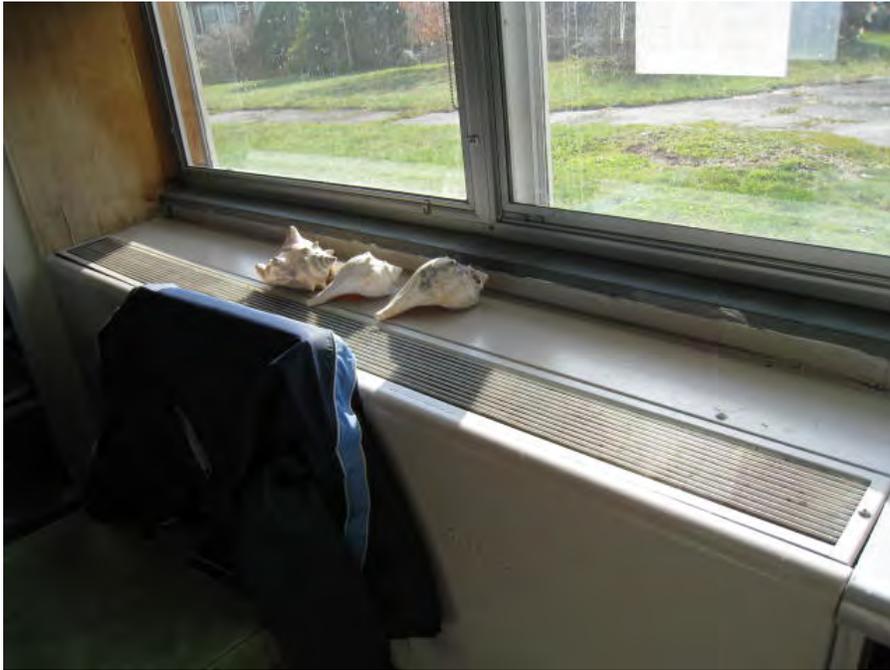
Picture 1

Fresh air in most classrooms is supplied by a unit ventilator (univent) system (Picture 1). Univents draw air from outdoors through a fresh air intake located on the exterior walls of a building and return air through an air intake located at the base of each unit. The mixture of fresh and return air is drawn through a filter and a heating coil, and is then expelled from the univent by motorized fans through fresh air diffusers ([Figure 1](#)). Univents were found turned off in classrooms throughout the school. Obstructions to airflow, such as papers and books stored on univents and bookcases, carts and desks in front of univent returns were seen in some classrooms. Some univents also contained accumulated dirt/debris. These univents should be cleaned before operating to prevent aerosolization of this material.

Unit Ventilator (Univent)

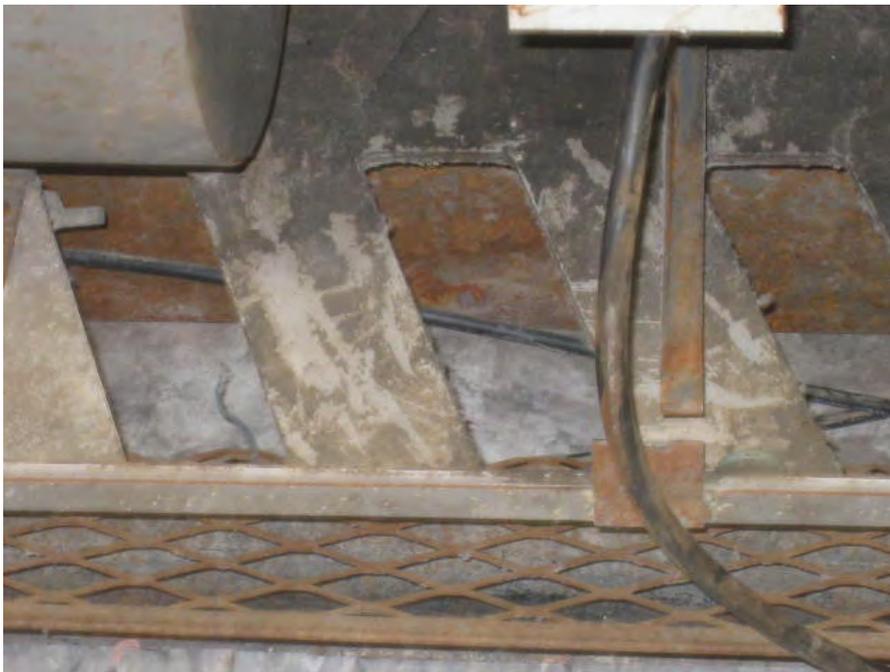
Picture 2

Louver holes in univent

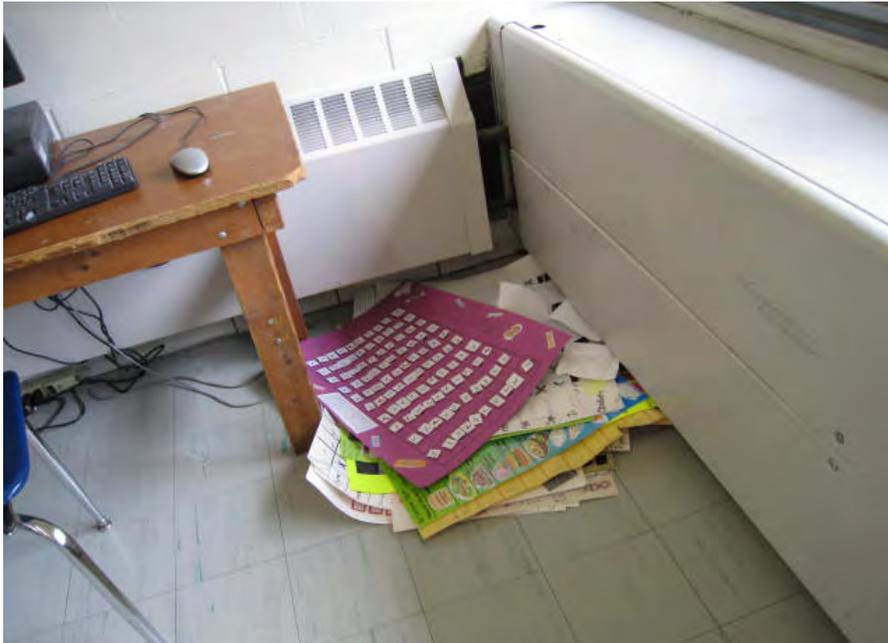
Picture 3

Mechanical exhaust ventilation in many of the classrooms with univents is supplied by a “univent exhaust” system. These units (Picture 3) are designed to exhaust air to the outside through vents in the lower portion of the unit. Both the univents and the univent exhausts are located along the same (outside) wall in each classroom. This means that even with the univent supply and exhaust operating optimally, the airflow in the classroom is concentrated in the area adjacent to the exterior wall, with little fresh air distributed to the interior side of the classroom, which may lead to airflow/comfort complaints. Some univent exhausts were found to be obstructed by items and many were found to be turned off or non-operable (Table 1).

As noted in a previous BEH IAQ assessment (MDPH, 2003), the manufacturer of the univents and univent exhausts [Schemenn (Picture 3)] appears to have ceased operations in the mid-1960s. Therefore, it is highly unlikely that replacement parts are available to restore univent fresh air intakes or univent exhausts to their original function.

**Univent Exhaust Unit (right side of picture)
Note materials on floor next to exhaust vent**

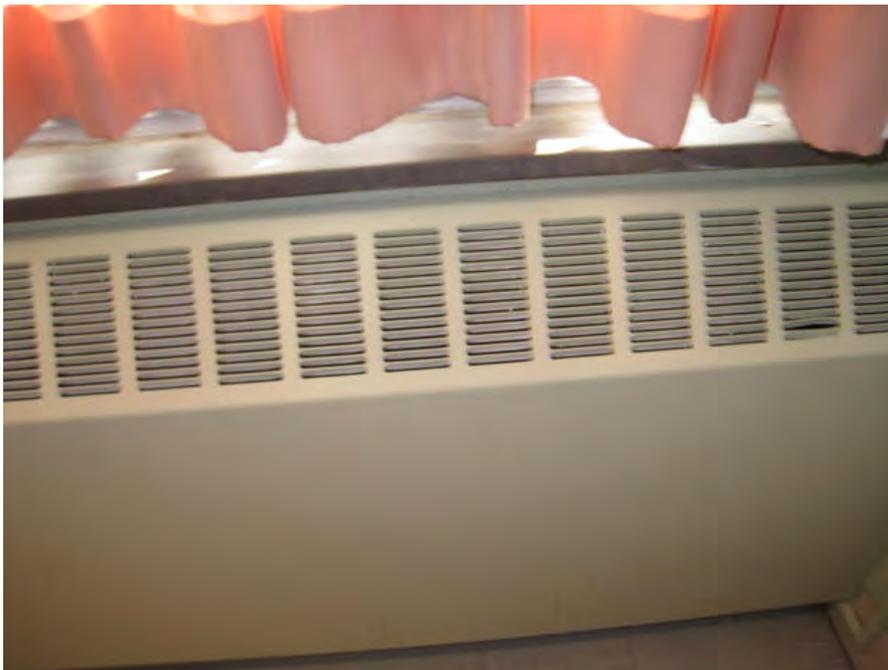
Picture 4

One type of radiator found in MGRS

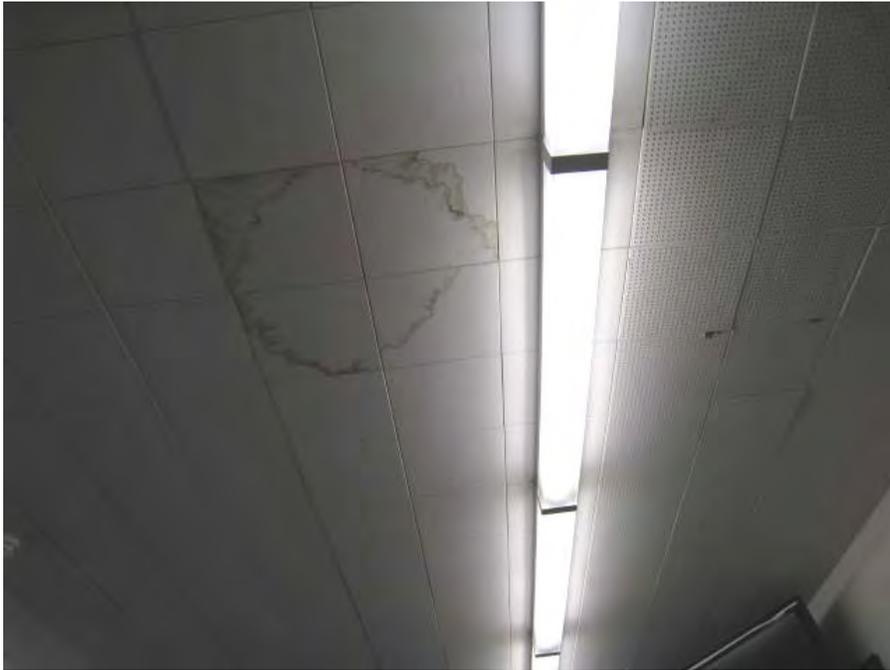
Picture 5

Water-damaged ceiling tiles were observed in a number of areas (Table 1, Pictures 5 and 6), which can indicate leaks from either the roof or plumbing system. The school has a ceiling tile system that is glued directly to the ceiling in some classrooms. Replacement of these tiles is difficult, since their removal appears to necessitate the destruction of the tile, which can result in the aerosolization of particulates. Water-damaged ceiling tiles may provide a medium for microbial growth and should be replaced after a water leak is discovered and repaired.

Water-damaged ceiling tile, type affixed to ceiling system

7. Ensure leaks are repaired and replace any suspended water-damaged ceiling tiles. Examine the area above these tiles for mold growth. Disinfect areas of water leaks with an appropriate antimicrobial, as needed. Make repairs to other water-damaged building materials throughout the building.

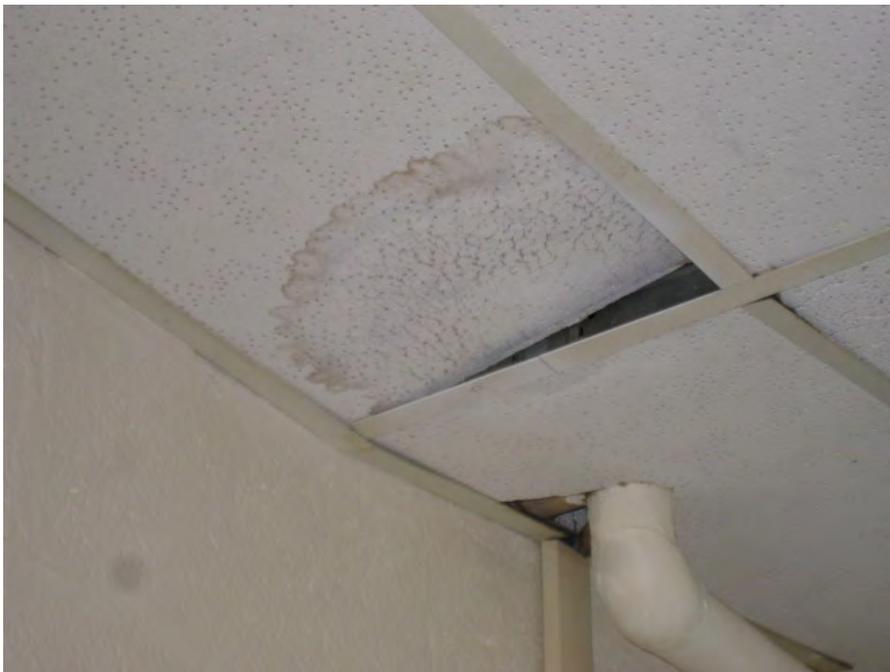
Picture 6

Water-damaged ceiling tile, suspended type

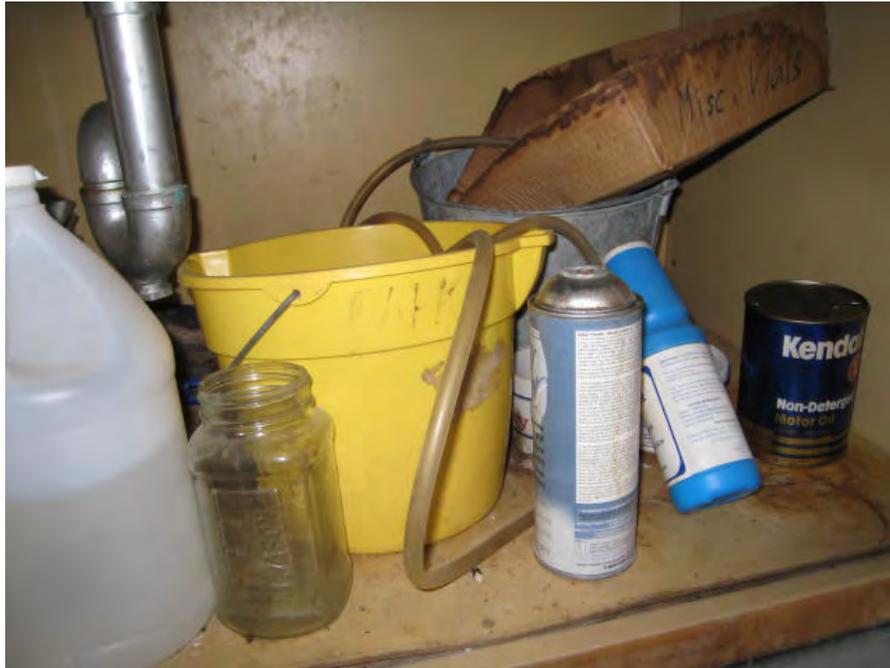
Picture 7

Sinks were noted in some classrooms, and many of them had items including paper and other porous materials stored underneath (Picture 7). Leaks from plumbing or condensation can moisten these materials. Porous items should be relocated and the spaces under the sinks should be examined periodically for leaks.

Items found under sink, including water-damaged cardboard and cleaning supplies

- c Remove trees and other plants abutting the building in the courtyard. Refrain from storing mulch directly against the building.
9. Remove items, particularly porous paper and cardboard, from beneath sinks. Check sinks for leaks periodically, and repair promptly.

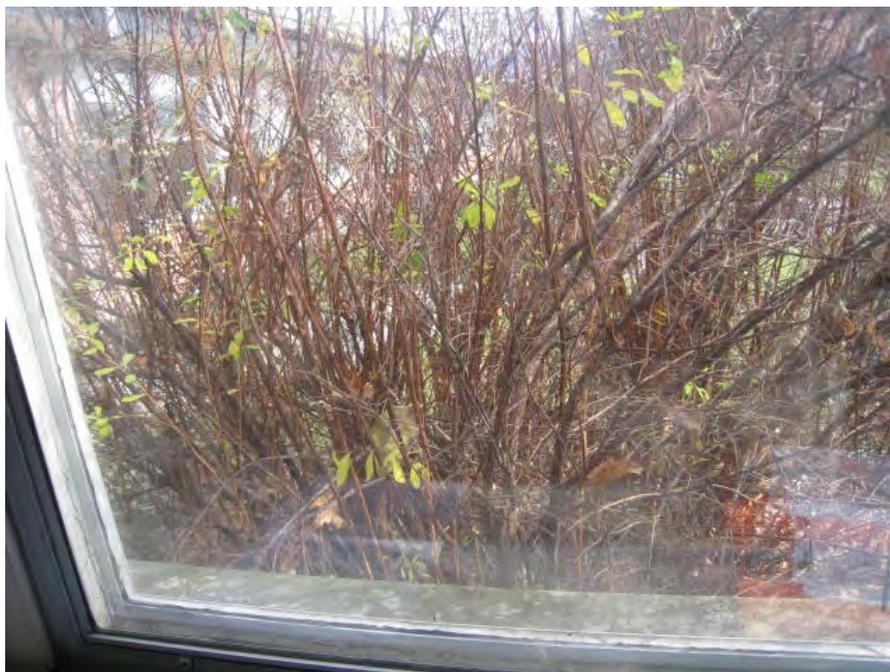
Picture 8

In classrooms that faced the courtyard, trees were noted to directly abut the windows (Picture 8). It was reported that plants and trees had recently been removed from the perimeter of the building. It is recommended that the remaining trees abutting the windows be removed as well. Pollen and debris from trees can clog the ventilation system or enter classrooms where they can be a source of allergens and mold. The roots from trees and plants can also penetrate the building envelope leading to breaches. Additionally, a pile of mulch was noted in direct contact with the building (Picture 9); this should be removed as these materials can hold moisture against the side of the building and provide harborage for pests.

Plant in contact with window overlooking courtyard

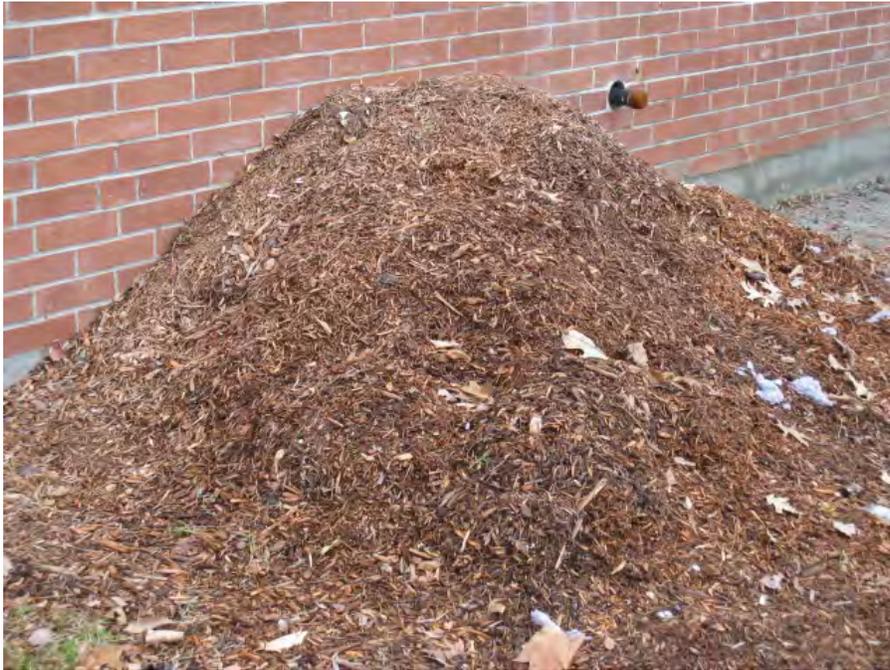
Picture 9

File of mulch in contact with building

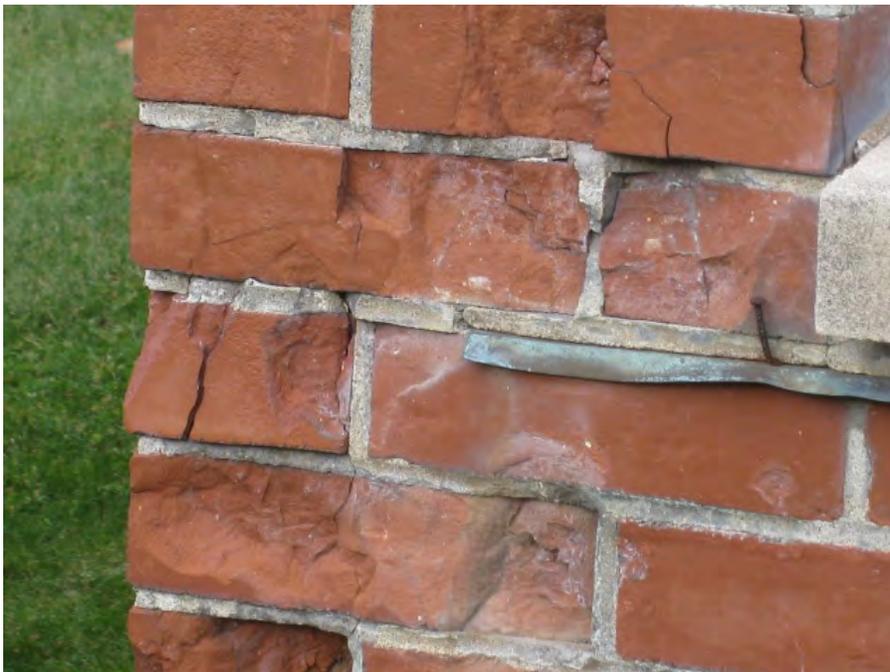
Picture 10

BEH staff examined the outside perimeter of the building to identify breaches in the building envelope and/or other conditions that could provide a source of water penetration. Pieces of the outer layer of brick are flaking and falling off, a condition known as spalling (Picture 10). It is believed that the spalling may be attributable in part to subflorescence. Subflorescence is indicative of moisture penetration through masonry. As moisture penetrates the brick surface, mineral salts are deposited on the interior of the brick. In the winter months, through the actions of freezing and thawing, the expansion within the brick creates spalling. Based on examination of the brick, it is believed that a weatherproofing sealant may have been

applied to the exterior, which would prevent moisture from the interior of the wall from exiting; this would create conditions resulting in subflorescence rather than efflorescence (a condition resulting in the mineral deposits occurring on the outside of the brick). Spalling was particularly notable on pilasters, which are decorative protrusions along the side of the building. Falling masonry can be a physical hazard.

Brick spalling

8. Remedy all exterior building envelope conditions that contribute to water infiltration into the building, such as:
 - a Repair cracked masonry and broken, missing mortar in exterior brickwork;

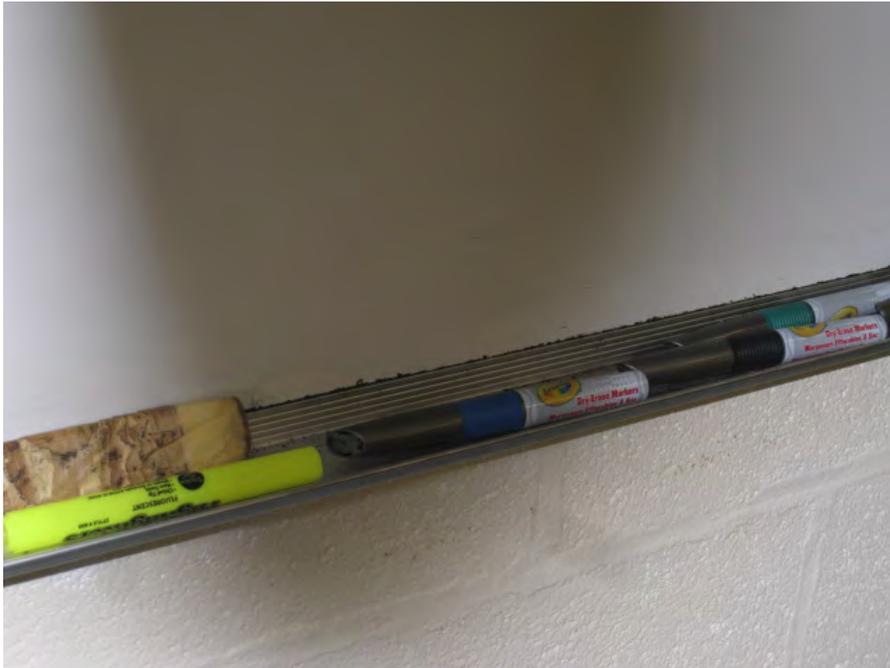
Picture 11

Dry erase tray with dusts

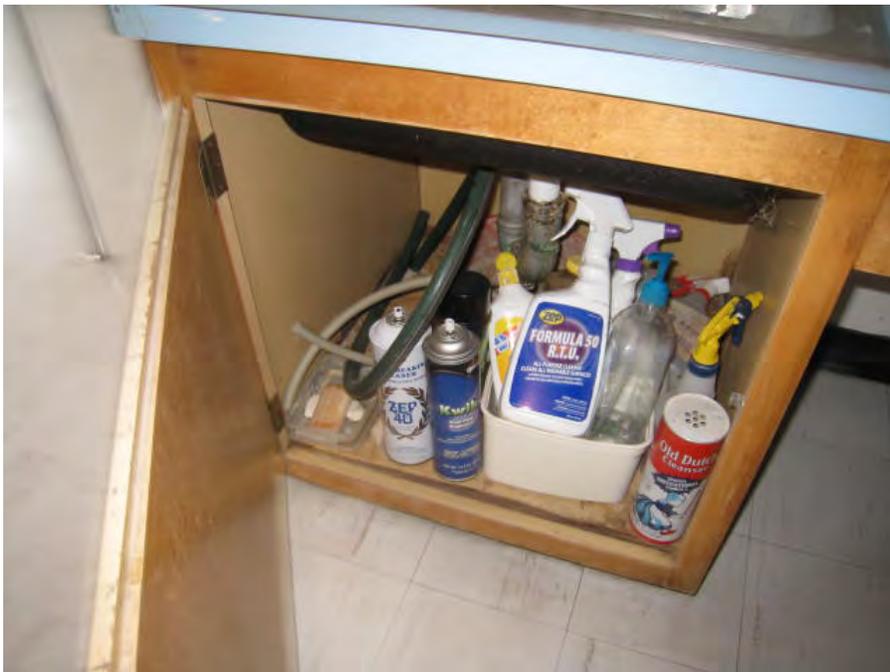
Picture 12

Household cleaning products were observed in several areas (Picture 12). A Material Safety Data Sheet (MSDS) for each product used should be available at a central location for all school chemicals in the event of an emergency. Consideration should be given to providing teaching staff with school-issued cleaning products and supplies to prevent any potential for

Cleaning products under sink

12. Ensure all cleaning products used at the facility are approved by the school department and kept out of the reach of children.
13. Consider adding additional exhaust ventilation to copier/laminator areas where feasible. Activate local exhaust ventilation when copiers and laminators are in use, make repairs as necessary.

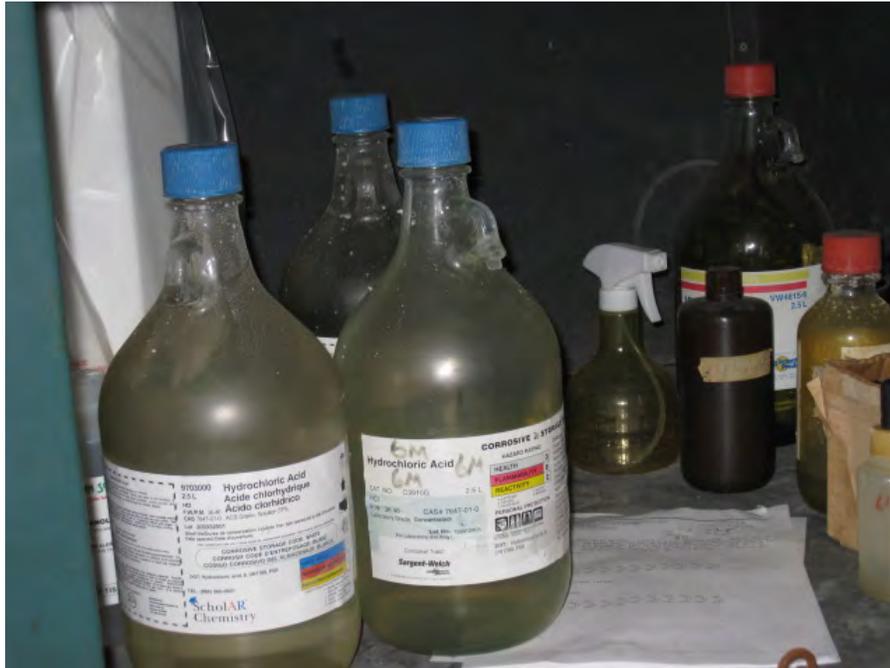
Picture 13

As mentioned above, an odor of sulfur was noted in room W417 even though the classroom had been vacated earlier indicating that insufficient exhaust ventilation was present in this room to remove odors from chemistry activities. Also noted in the chemistry storage area adjacent to this room were two fume hoods which were not active, but appeared to be used to store bottled chemicals labeled as “acids” (Picture 13). It was later reported by MGRS staff that none of the chemistry hoods were functional. Fume hoods should not be used for the storage of chemicals. Operable fume hoods are critical to providing control and removal of fumes and vapors from experiments that may produce toxic airborne products. If the chemistry curriculum at the school requires the use of fume hoods, these fume hoods should be repaired or replaced.

Acids stored in non-operable fume hood

14. Address the functioning of fume hoods by repairing or replacing the hoods, or determining that fume hoods are not necessary for the curriculum. Do not use fume hoods, active or deactivated, for storage of chemicals.

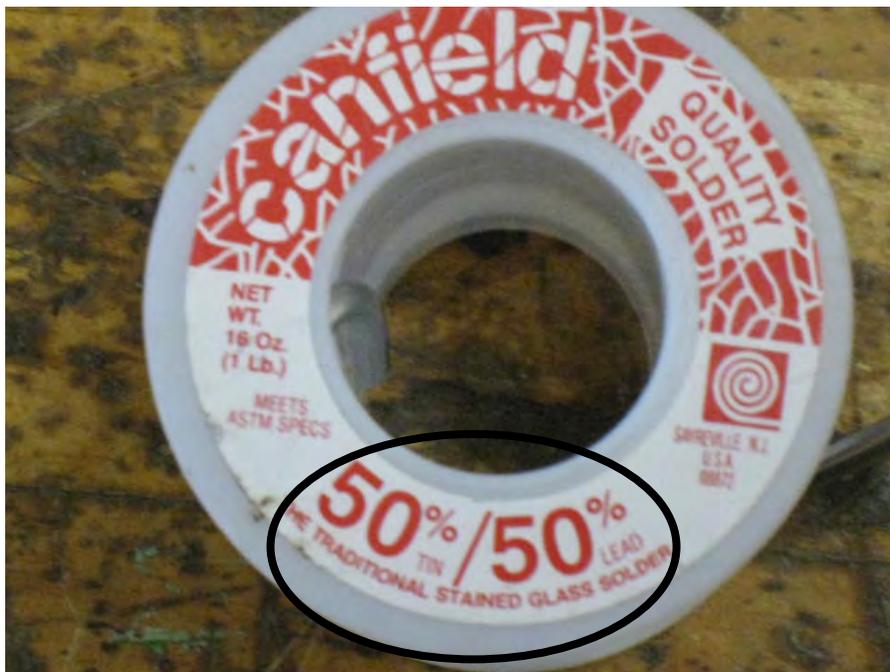
Picture 14

In addition, it was noted that the solder set out for use in this workshop was composed of 50 percent lead and 50 percent tin (Picture 14). Lead is toxic to people, particularly children; lead exposure in pregnant women can impact the development of the fetus and. Lead can be stored in the body for a lengthy period of time (ATSDR, 2007) and can be absorbed into the body through inhalation (breathing of dust or fumes) and through ingestion (eating or drinking lead-contaminated food or beverages). Use of lead-containing solder can expose users to both hazards, particularly with the lack of exhaust ventilation noted, and the potential for lead-containing dusts to persist on hands, clothing and other items in the classroom where they can later be transferred to food or other items placed into the mouth.

Spool of solder in the stained glass workshop, showing 50% lead 50% tin content

The use of lead-containing solder is not recommended in a secondary school-based program and should be eliminated. Only lead-free solders should be purchased and used. In addition, the stained glass room requires a thorough cleaning to remove accumulated lead dust and debris.

15. Prohibit the use of lead-containing solder in the stained glass workshop. Engage the services of an industrial hygiene consultant relative to cleaning of the room to remove built-up lead dusts and installation of appropriate soldering ventilation.

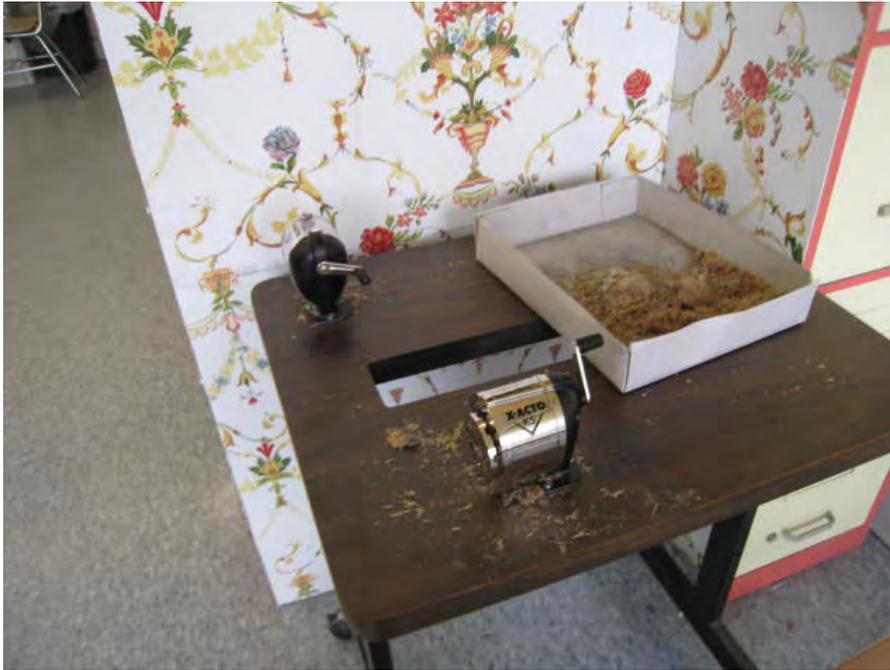
Picture 15

Pencil shavings

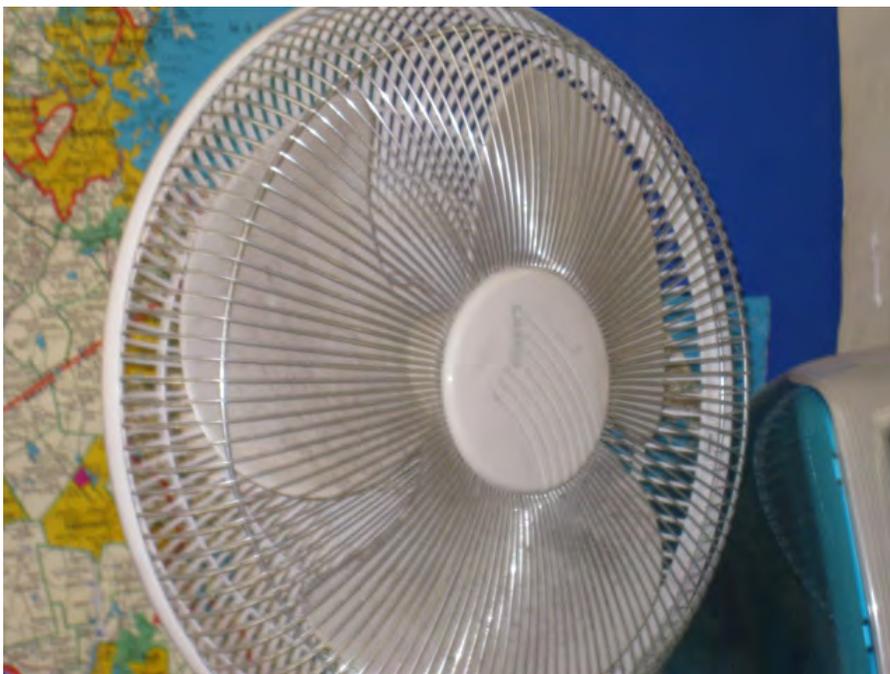
Picture 16

Dust was observed accumulated in univent interiors, exhaust vents, and personal/ceiling fans (Picture 16). This equipment should be cleaned periodically in order to prevent dust/debris from being aerosolized and redistributed throughout the room.

Dusty blades on personal fan
