# **INDOOR AIR QUALITY ASSESSMENT**

**Massachusetts Registry of Motor Vehicles  
116 Pleasant Street  
Easthampton, Massachusetts**

Prepared by:  
Massachusetts Department of Public Health  
Bureau of Environmental Health  
Indoor Air Quality Program  
February 2013

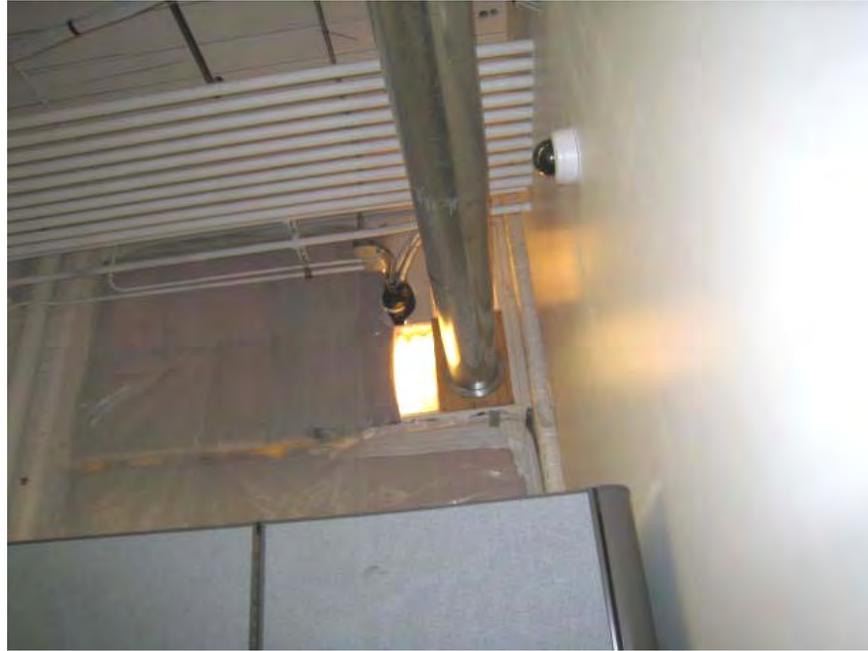
**Picture 1**

**Fresh air duct from outside into air handling unit**

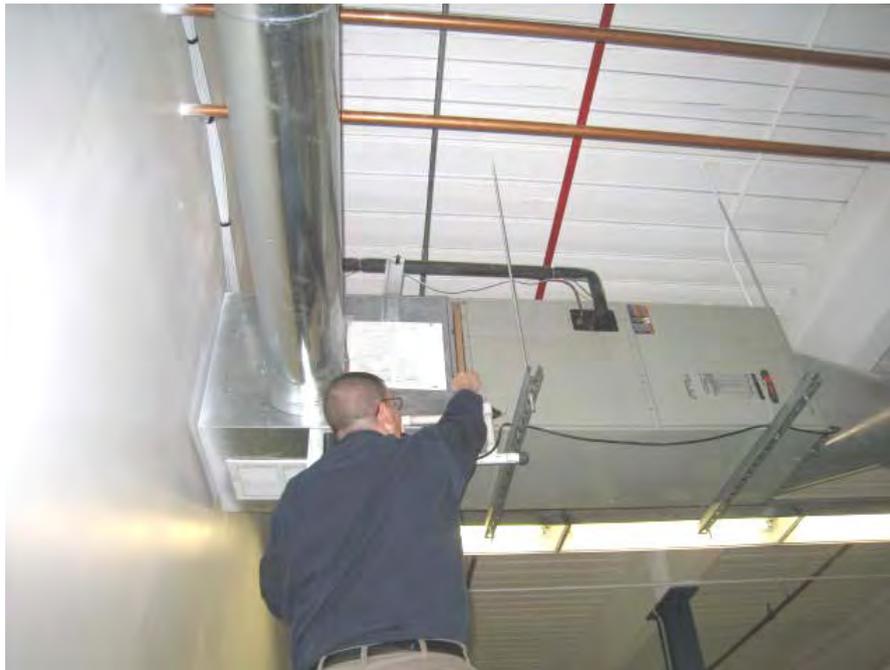
**Picture 2**

There appears to be a return vent to the duct supplying the AHU (Picture 2) but there are no other exhaust vents in the RMV space nor do there appear to be any in the hallway areas. The core-area bathrooms have exhaust vents that were functioning at the time of the visits.

**Ceiling-mounted air-handling unit**

To maximize air exchange, the MDPH recommends that both supply and exhaust ventilation operate continuously during periods of occupancy. In order to have proper ventilation with a mechanical supply and exhaust system, the systems must be balanced to provide an adequate amount of fresh air to the interior of a room while removing stale air from the room. It is recommended that HVAC systems be re-balanced every five years to ensure adequate air systems function (SMACNA, 1994). The date of the last balancing of this system was not available at the time of the assessment, and it is unclear if the system can be balanced in its current configuration.

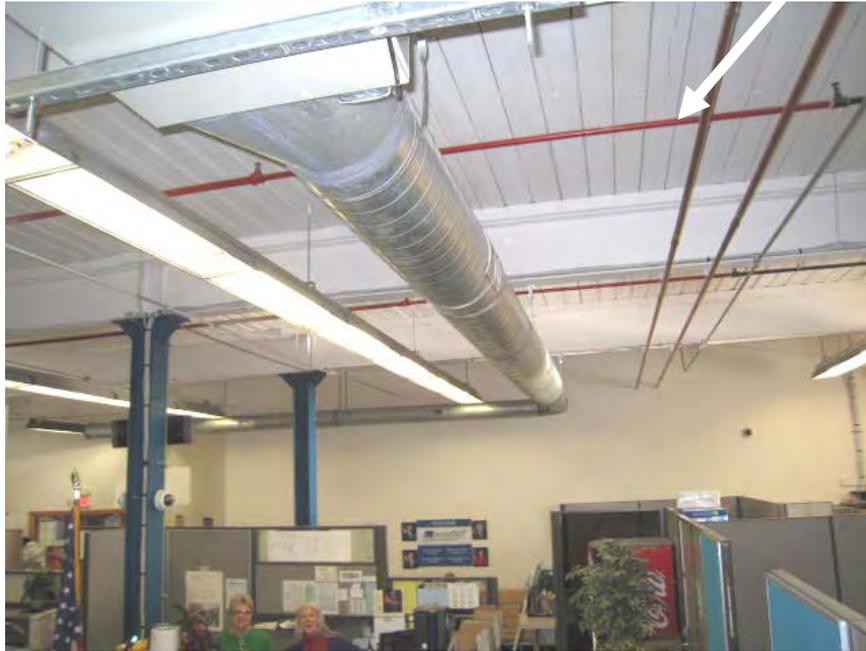
**Picture 3**

**Supply duct from AHU to the rest of the RMV office space**

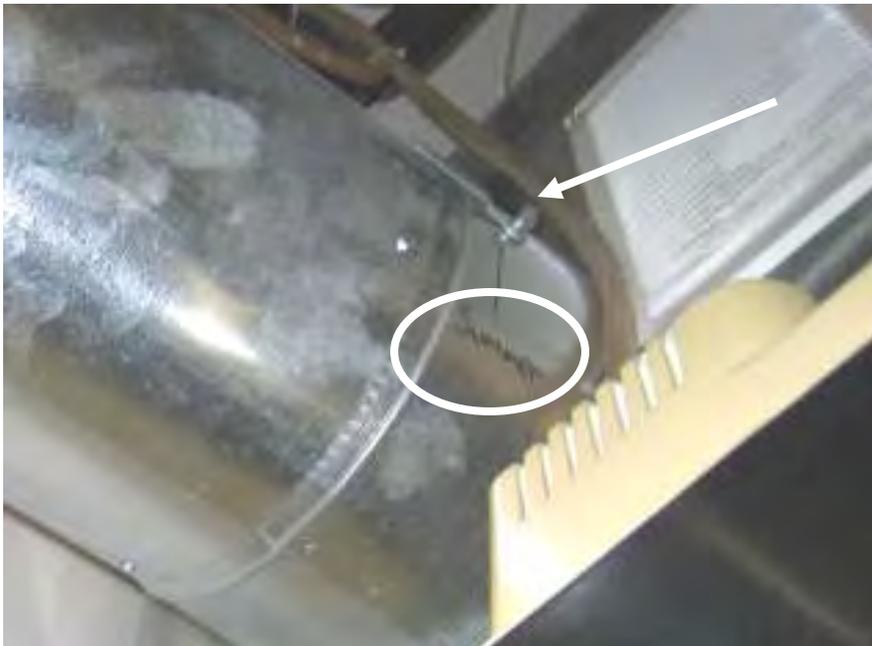
**Picture 4**

**Summer/winter lever (arrow) controlling damper on fresh air duct turned from summer setting (oval)**

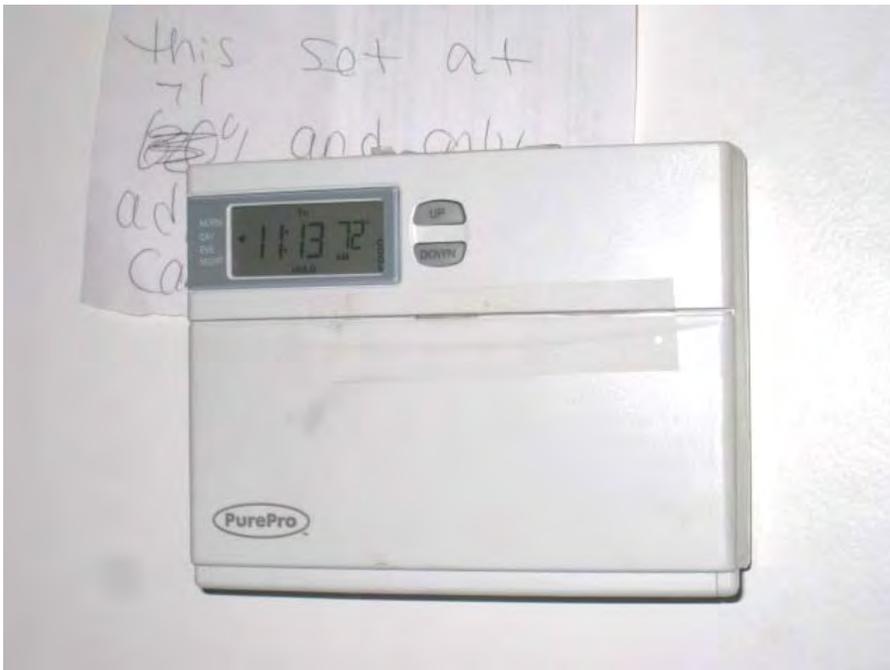
**Picture 6**

There is a digital wall-mounted thermostat in the space connected to the AHU (Picture 6). It has fan settings of “on” and “automatic”. The automatic setting on the thermostat activates the AHU at a preset temperature. Once the preset temperature is reached, the system is deactivated. Therefore, no mechanical ventilation is provided until the thermostat re-activates the system. In

the fan “on” mode, air will be continuously circulated and filtered, which should improve temperature/comfort control. MDPH recommends that thermostats be set to the fan “on” setting during occupied periods to provide continuous air circulation and filtration. The staff reports that since the AHU provides no heat, this thermostat only activates the fan on the AHU. In addition, the location of the thermostat, behind partition walls from most of the office, does not allow it to detect a temperature representative of the rest of the office.

**Thermostat in RMV**

4. Examine the feasibility of installing mechanical exhaust ventilation for the RMV.
5. Consider relocating thermostat to a more representative area of the building to maintain comfort.

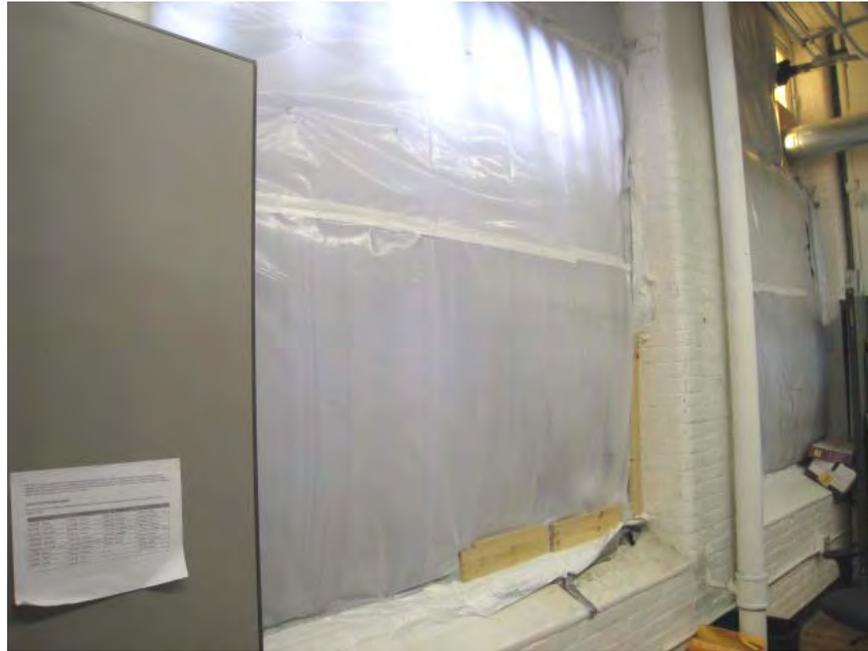
**Picture 7**

The windows along the back of the RMV space, as mentioned, are covered in a thick layer of plastic sheeting taped to the window frames (Pictures 7 and 8). It was reported that the windows behind the plastic may be broken/unsealed which may result in leaks into the window

well. Porous materials should not be stored in proximity to the windows to prevent damage in case of water infiltration.

**Plastic covering windows in the RMV**

9. If feasible, repair and restore windows so that they provide a barrier to the infiltration of water without the use of layers of plastic and, if possible, so they can be partially opened to provide ventilation during periods of clement weather.

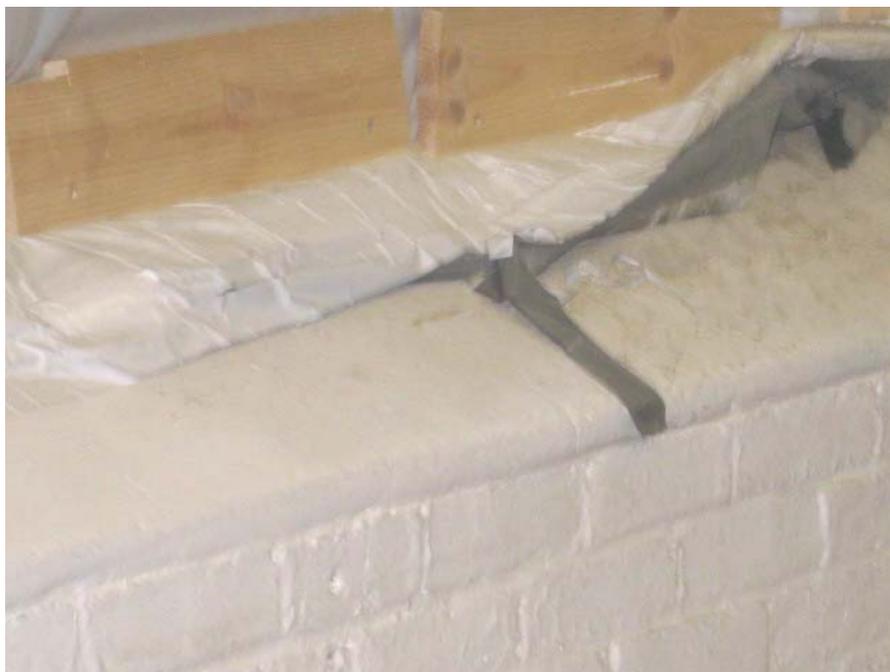
**Picture 8**

**Tape holding plastic on RMV windows**

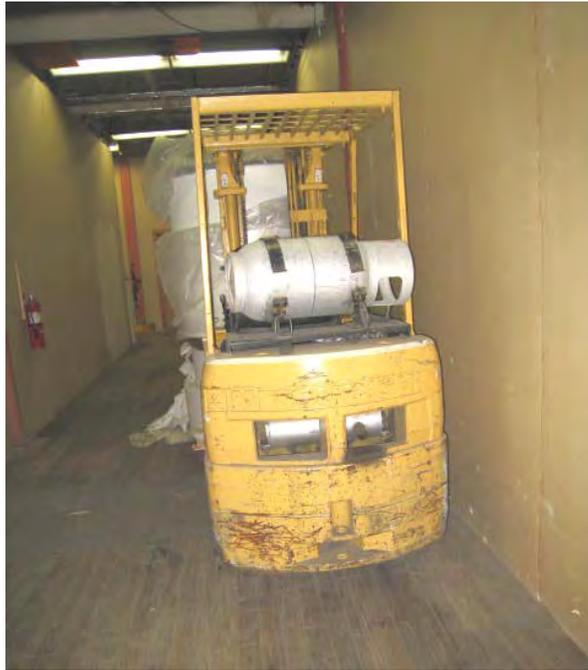
**Picture 9**

The elevated levels of carbon monoxide are believed to be due to the use of a forklift in the basement area below the RMV (Picture 9). The forklift is powered by combustible fuel (i.e., Propane), which, similarly to ice resurfacing equipment can produce carbon monoxide, which can build up if used indoors. The floors of the RMV that overlay the basement are composed of wooden beams which do not provide an air-tight seal between the RMV and the basement (Picture 10), allowing carbon monoxide to migrate between floors. In addition, there is a stairwell between the basement and the first floor with doors that were open or not tightly sealed at the time of the visit. Because carbon monoxide and related combustion gases have a high temperature, these gases, vapors and particles can rise to the ceiling and pass through the floor/stairwell into the RMV occupied space.

**Fuel-burning (Propane) forklift in basement area**

It is proper operating procedure to provide adequate exhaust ventilation when a fuel-fired forklift needs to be used indoors via mechanical ventilation, opening doors to the outside and/or using fans to remove exhaust during and for a period after use. Replacement of this forklift with an electric model would eliminate the potential for products of combustion to enter occupied spaces.

1. Discontinue the use of the fossil fuel powered forklift inside the building. Consider replacing the forklift with electric powered mode and use of carbon monoxide detectors within the occupied RMV space.

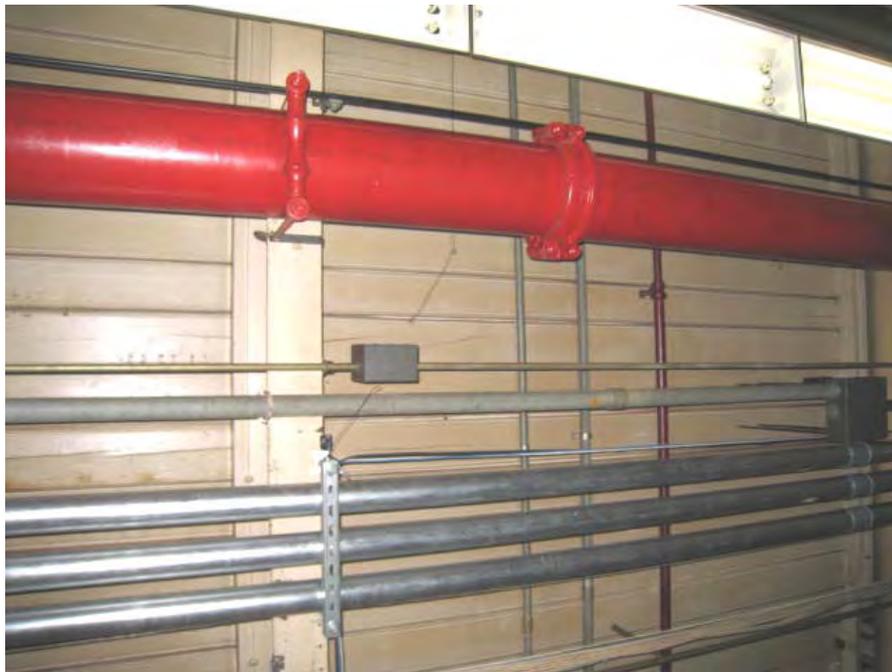
**Picture 10**

**Ceiling of basement area below the RMV, note gaps between beams**

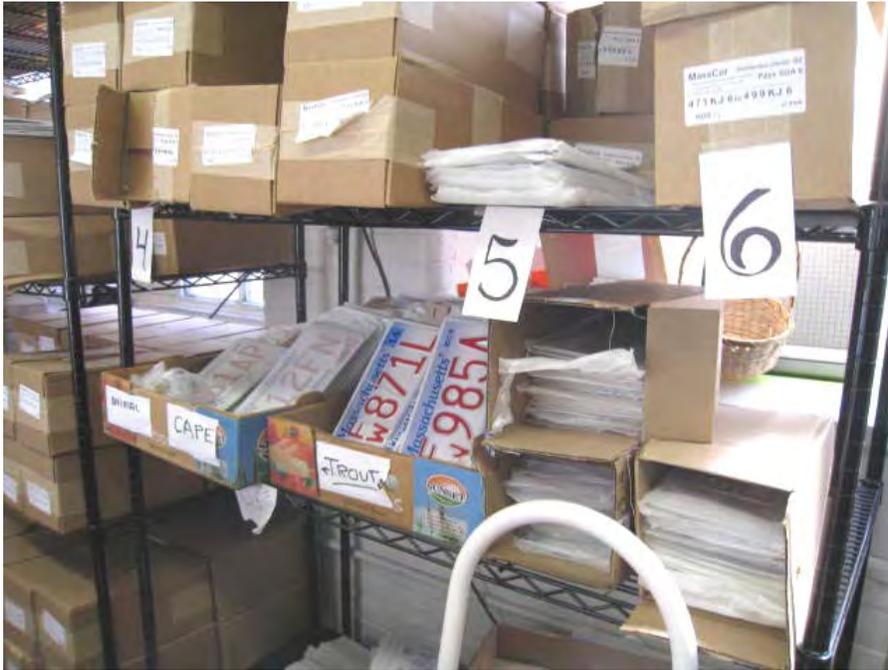
**Picture 11**

The new license plates for the RMV were stored in a room that is used for several other purposes, including an employee break room (Picture 11). When newly printed, license plates can give off TVOCs and associated odors. Improved ventilation in this area would decrease the potential for irritation effects from new license plates.

**Boxes of new license plates stored in employee area**

10. Clean vents, the tops of room dividers and stored items periodically of accumulated dust/debris.
11. Consider finding an alternative location to store both new and used license plates to prevent exposure to dirt and VOCs.
12. Install a bird screen over the fresh air intake of the HVAC system.
13. Refer to resource manuals and other related indoor air quality documents for further building-wide evaluations and advice on maintaining public buildings. Copies of these materials are located on the MDPH's website: <http://mass.gov/dph/iaq>.

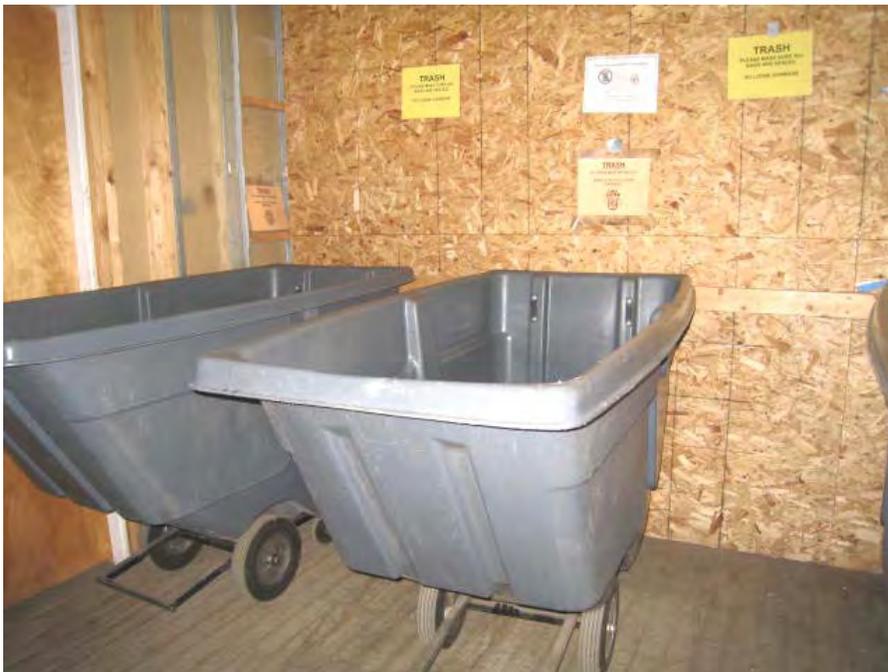
**Picture 12**

This area was free of trash and appeared clean and well-maintained at the time of the assessments, but it was noted that the trash bins do not have lids. It was not known how much trash may accumulate in this area or how often it may be emptied. Trash areas, especially when adjacent to occupied areas, should be kept as clean and neat as possible and the containers should be kept covered and in good repair, with trash being removed to outside containers or taken away for disposal regularly. If odors or pests from trash become a problem in warmer months, the area needs to be emptied and cleaned more frequently until the problem is eliminated. Consultation with a pest control professional experienced in Integrated Pest Management (IPM) should be sought if the problem becomes severe or continues to reoccur.

**Trash bins in the basement below the RMV**

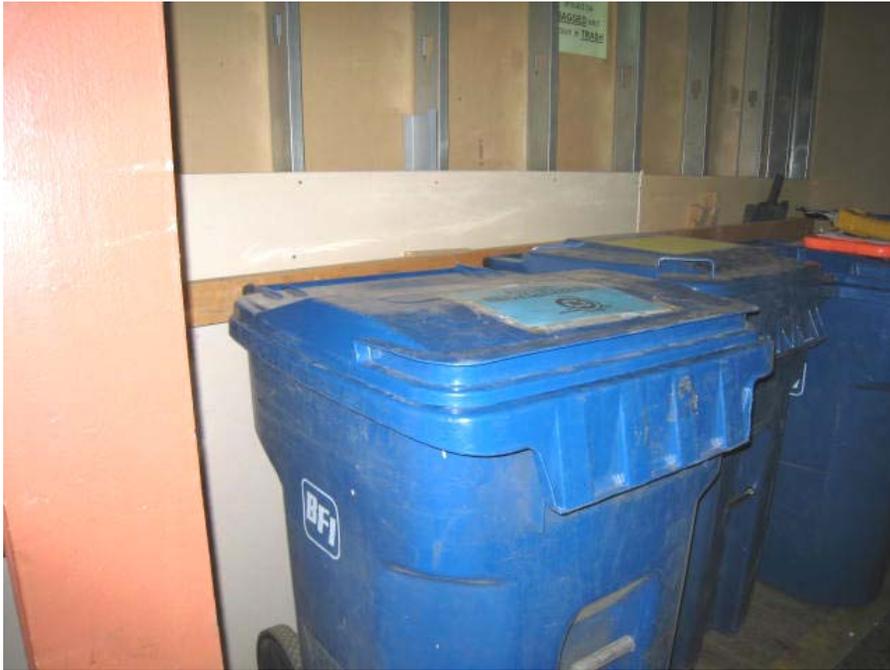
**Picture 13**

**Recycling/trash bins in basement below the RMV**
