INDOOR AIR QUALITY ASSESSMENT AND WATER DAMAGE/MOLD INVESTIGATION

**Massachusetts Department of Transitional Assistance
75 Fountain Street
Framingham, Massachusetts**

Prepared by:
Massachusetts Department of Public Health
Bureau of Environmental Health
Indoor Air Quality Program
December 2013

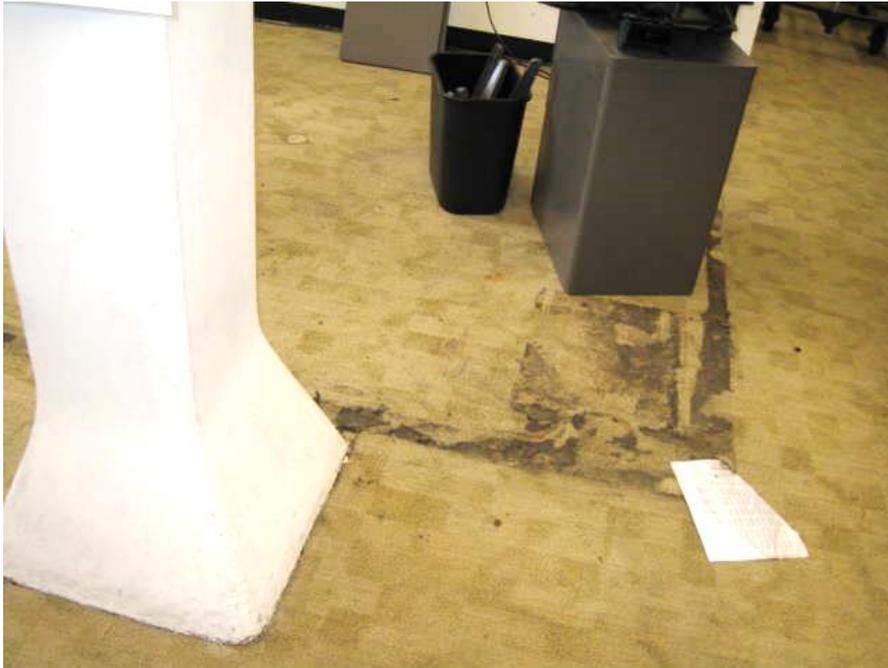
Picture 1

Sewage contamination (brown debris) on 1st floor carpeting and gypsum wallboard

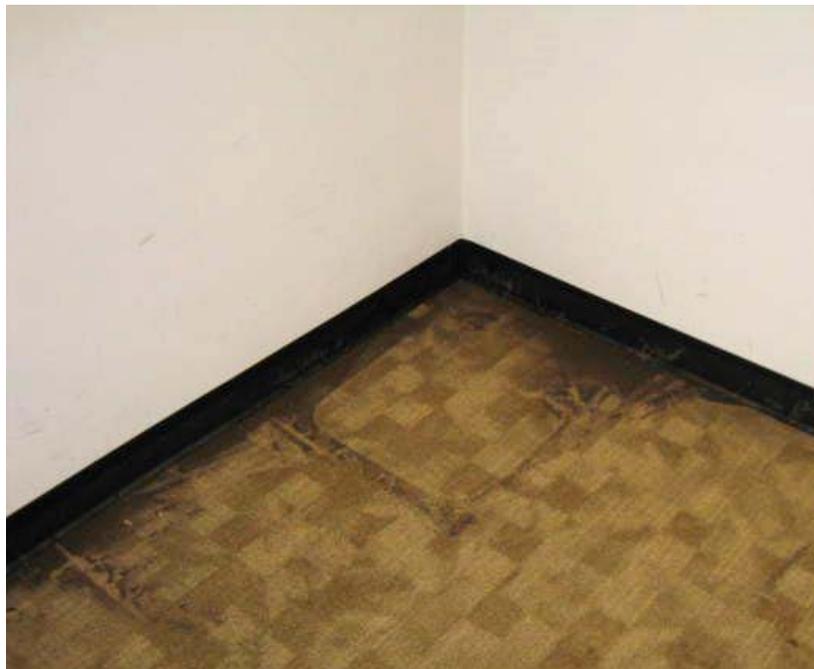
Picture 2

Sewage contamination (brown debris) on 1st floor carpeting and gypsum wallboard

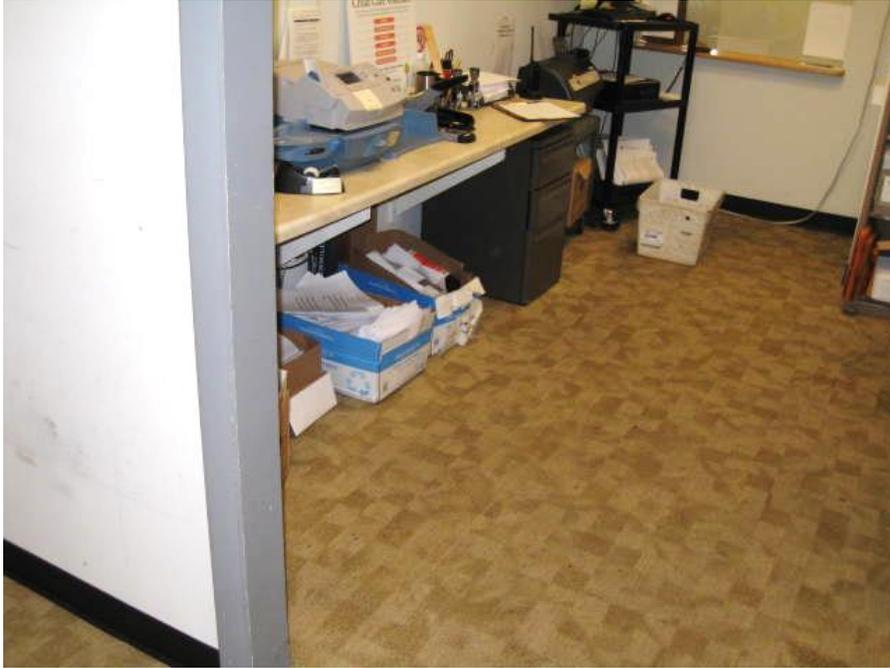
Picture 3

Porous materials on contaminated carpeting

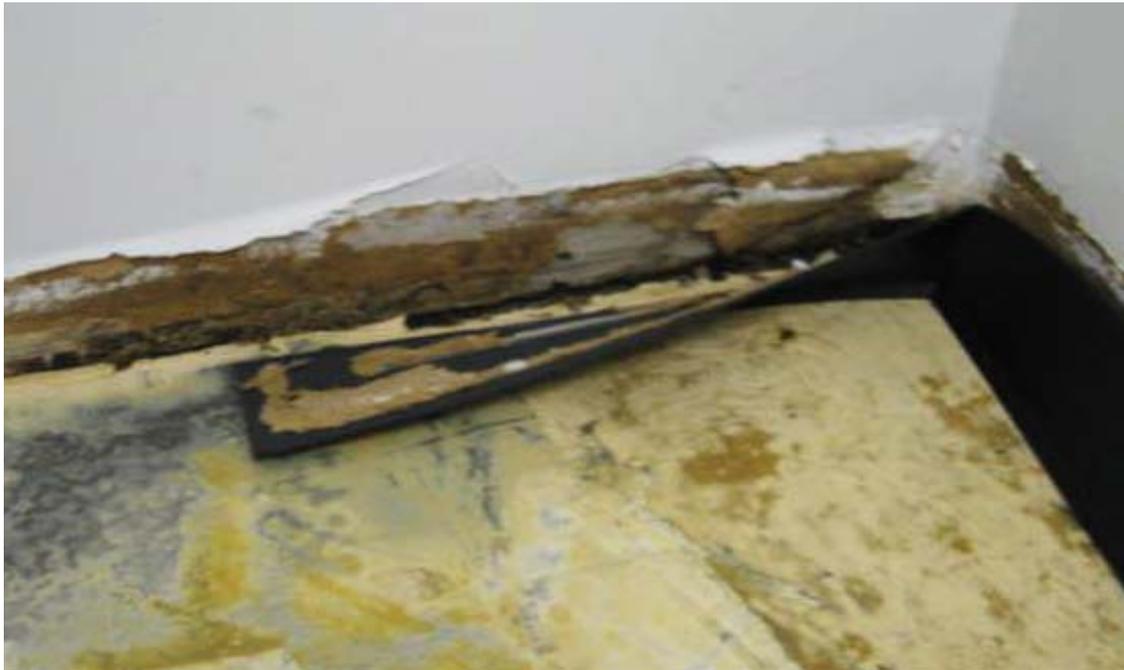
Picture 4

Damaged/contaminated gypsum wallboard

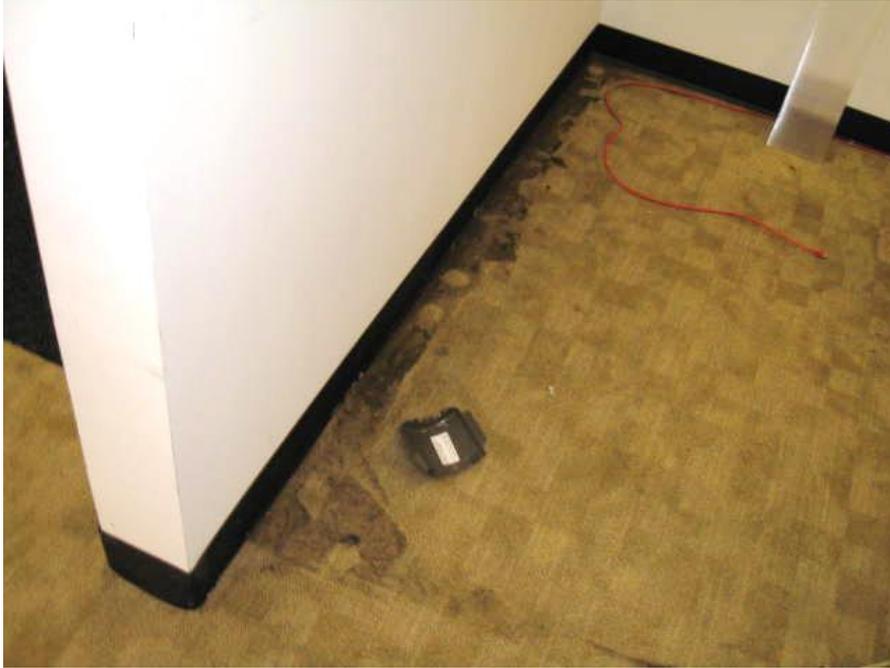
Picture 5

Sewage contamination (brown debris) on 1st floor carpeting and gypsum wallboard

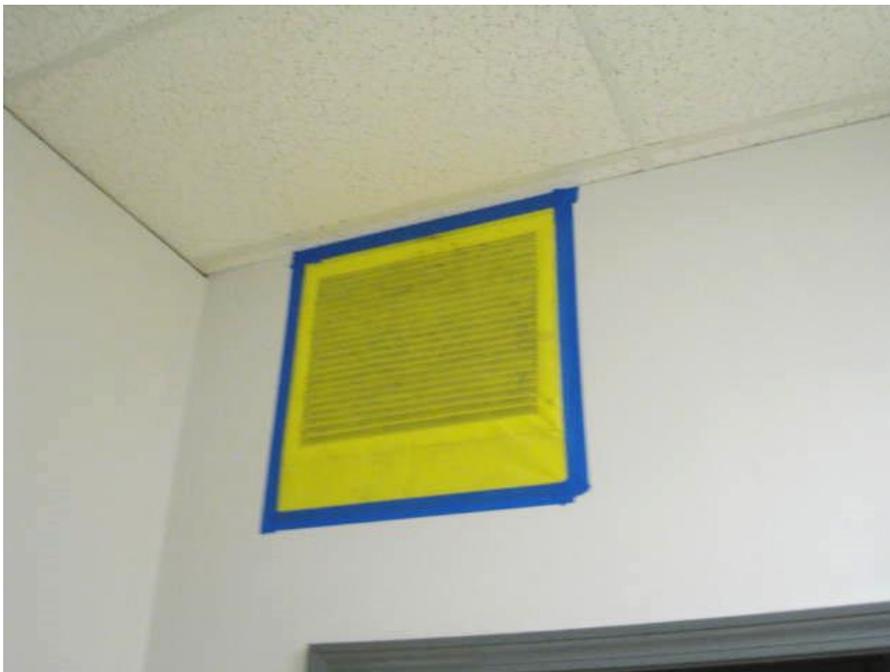
Picture 6

Sealed HVAC vent 1st floor

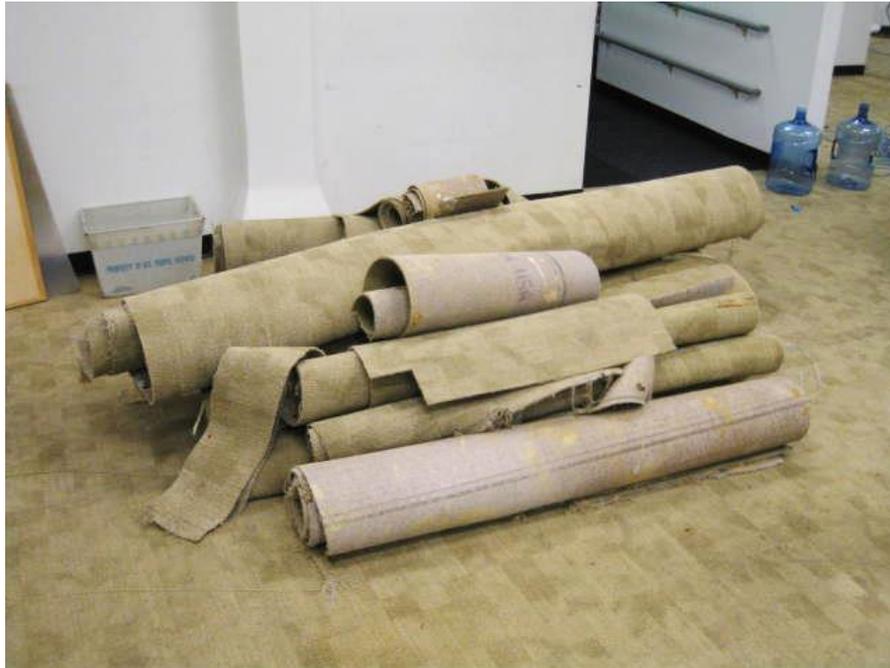
Picture 7

Carpet removal

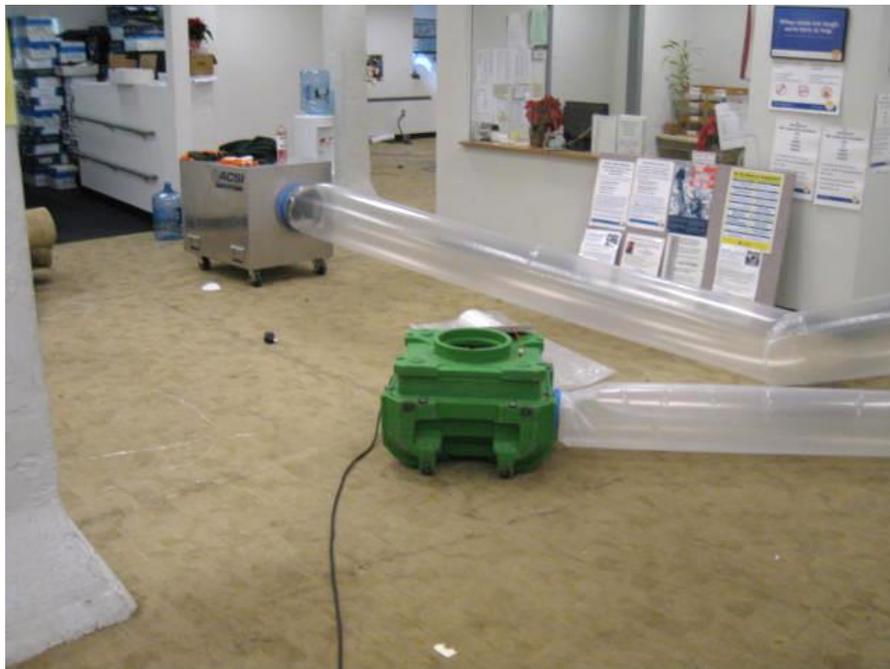
Picture 8

HEPA air filtration units on 1st floor ducted to outside

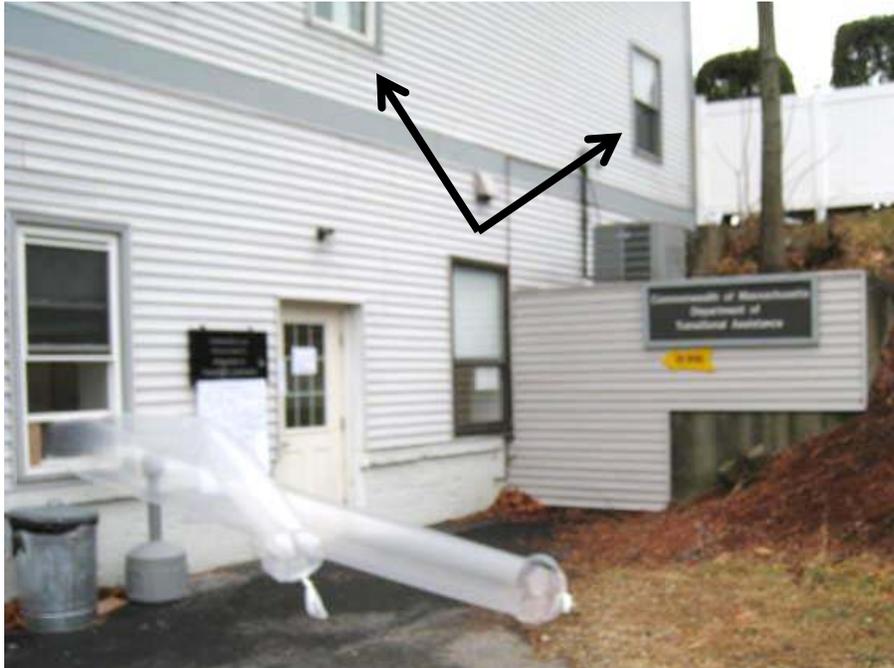
Picture 9

HEPA air filtration units on 1st floor ducted to outside, note proximity of openable windows (arrows)

5. Ensure windows directly above the exhaust effluence of the HEPA filtration units are closed (Picture 9) to avoid entrainment.
6. Disseminate scheduling itinerary to all affected parties through meetings, emails and/or weekly bulletins.

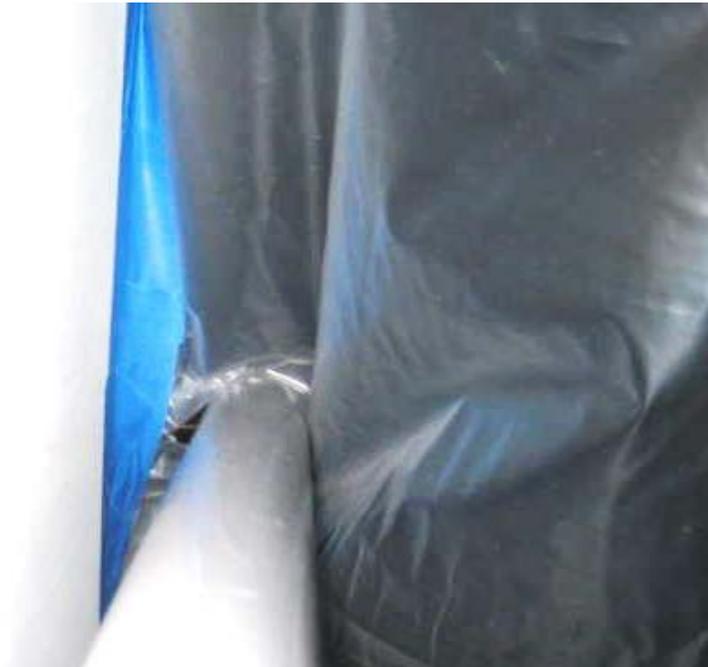
Picture 10

Spaces in plastic barrier around handrail in front stairwell

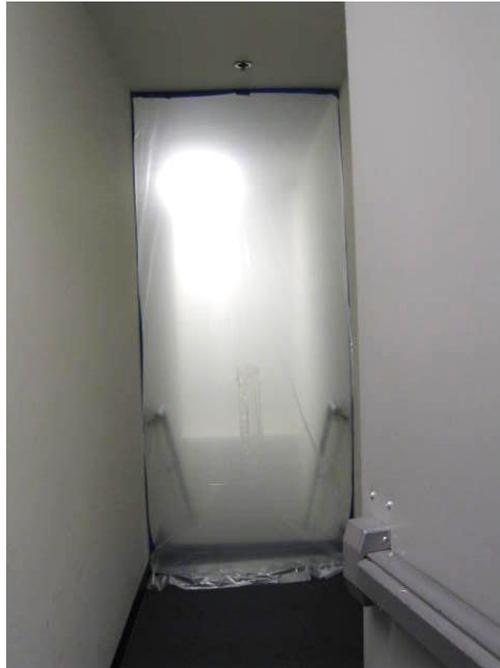
Picture 11

Dual plastic containment barriers in rear stairwell

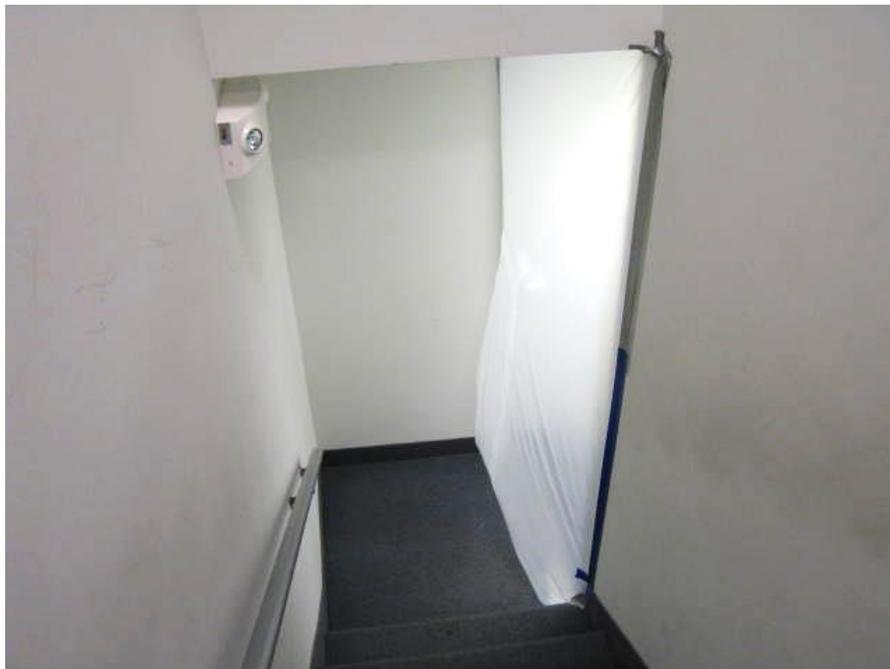
Picture 12

Dual plastic containment barriers in front stairwell

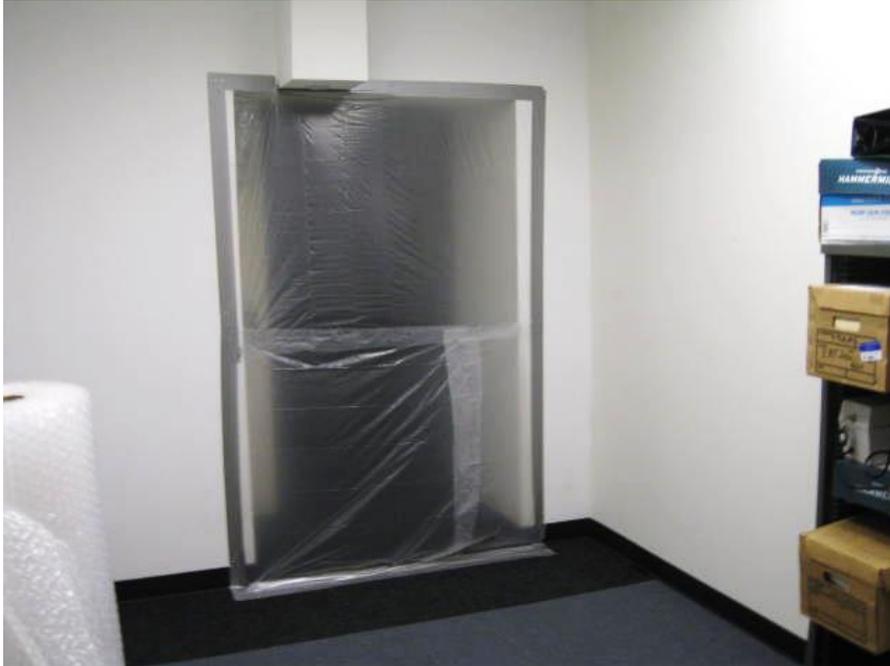
Picture 13

Second floor elevator doors sealed with plastic and tape

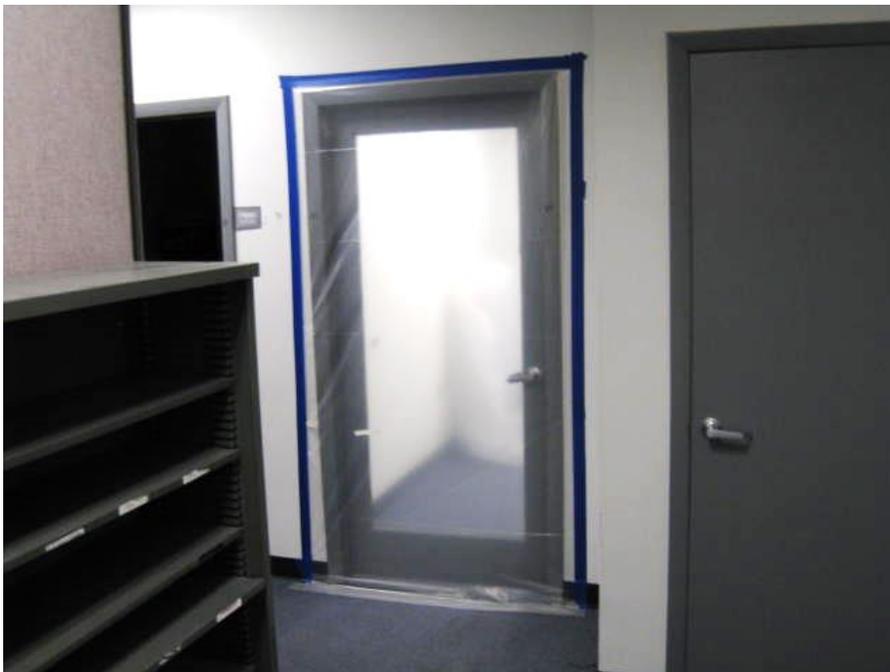
Picture 14

Door to 2nd floor elevator lobby sealed with plastic and tape

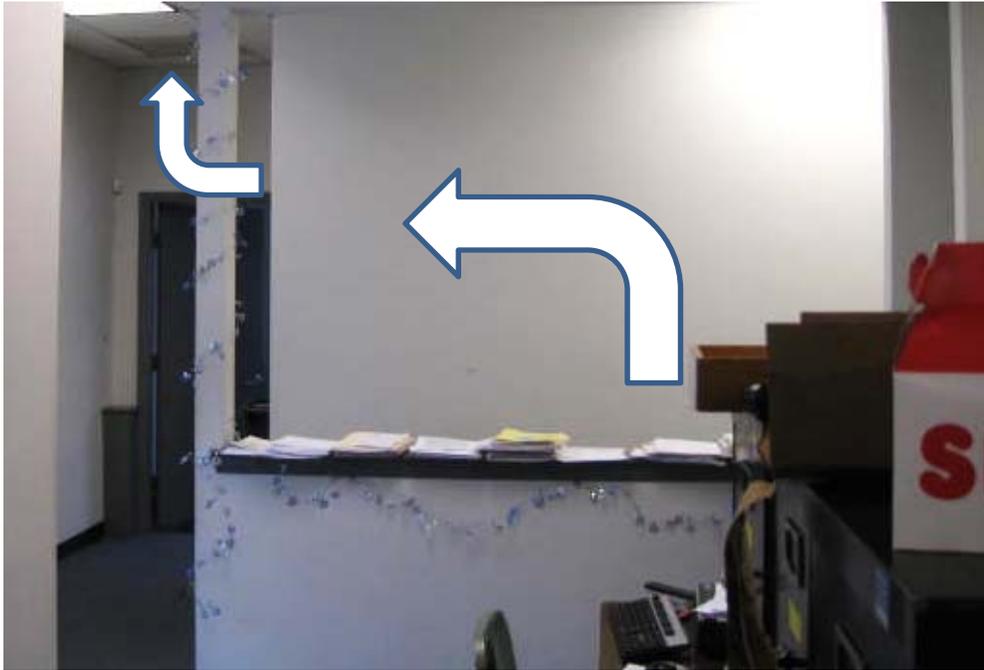
Proximity of return vent (top arrow) to front stairwell, arrows also indicate odor pathway from 1st floor remediation area

3. Operate HVAC system on 2nd floor in fan “on” mode to provide continuous air circulation and filtration.
4. Change filters in ceiling mounted return vents and AHU. Ensure the return vent at the front of the building shown in Picture 15 is re-sealed after the filter is changed.

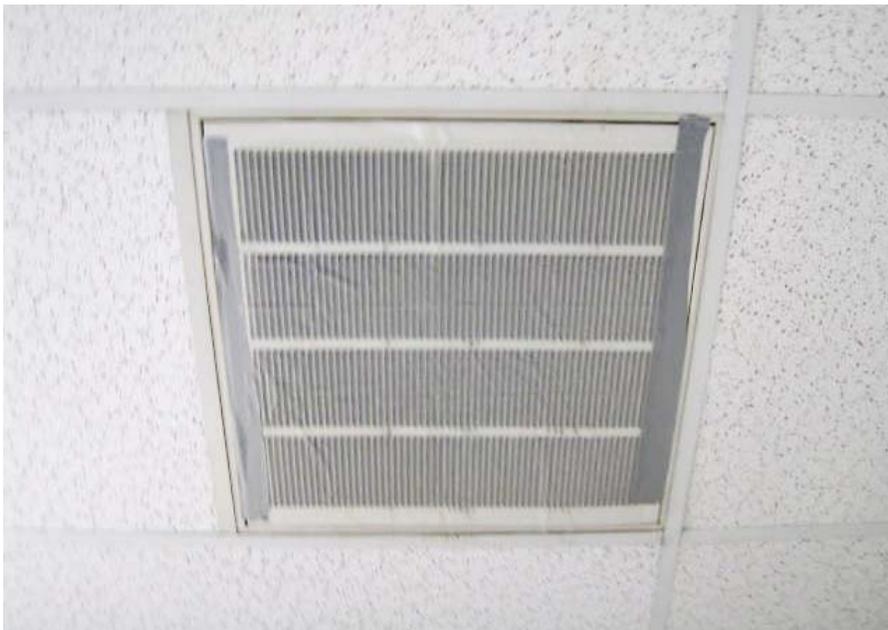
Picture 16

Close-up of sealed return vent above front stairwell
