# **INDOOR AIR QUALITY ASSESSMENT**

**Memorial Elementary School  
6 Prospect Street  
Hopedale, Massachusetts**

Prepared by:  
Massachusetts Department of Public Health  
Bureau of Environmental Health  
Indoor Air Quality Program  
October 2013

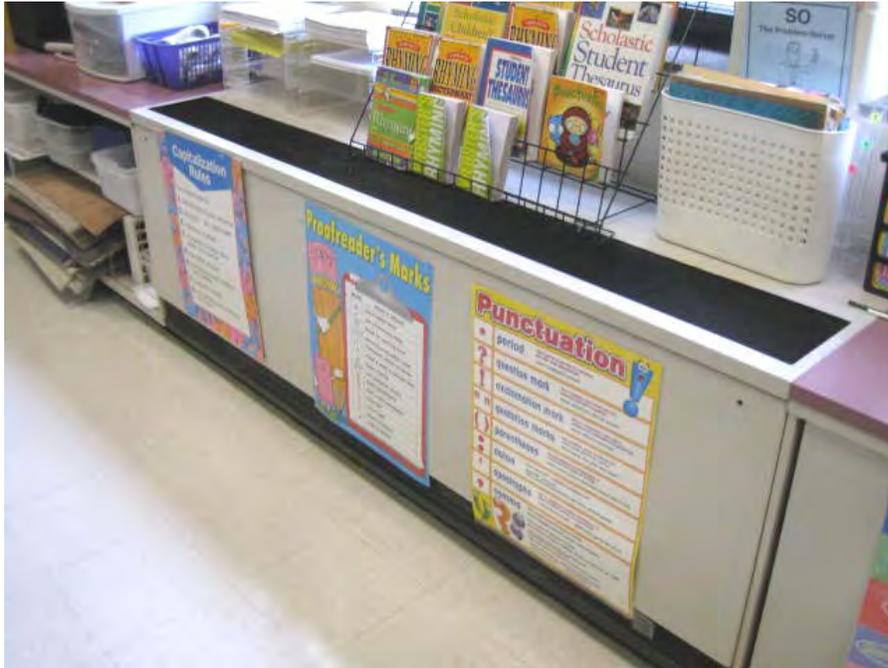
**Picture 1**

Fresh air in classrooms is supplied by unit ventilators (univents) (Picture 1). A univent is designed to draw air from outdoors through a fresh air intake located on the exterior wall of the building (Picture 2). Return air is drawn through an air intake located at the base of each unit where fresh and return air are mixed, filtered, heated and provided to classrooms through an air diffuser located in the top of the unit ([Figure 1](#)).

**Classroom unit ventilator (univent)**

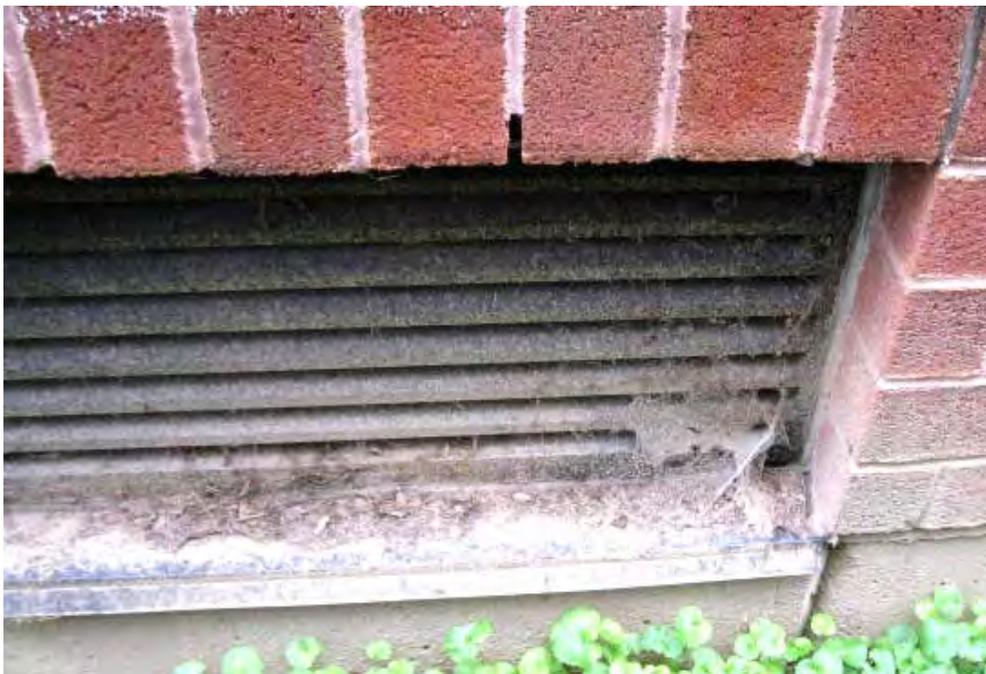
**Picture 2**

**Univent fresh air intake, note grass clippings and accumulated debris**

14. Ensure air intakes are thoroughly cleaned. Direct grass clippings *away* from air intakes during mowing.
15. Clean and disinfect interior of refrigerators and freezers with mild detergent or antimicrobial agent. If they cannot be adequately cleaned, replace mold-contaminated gaskets. Clean spilled food promptly, and clean the refrigerator of expired items on a regular schedule.

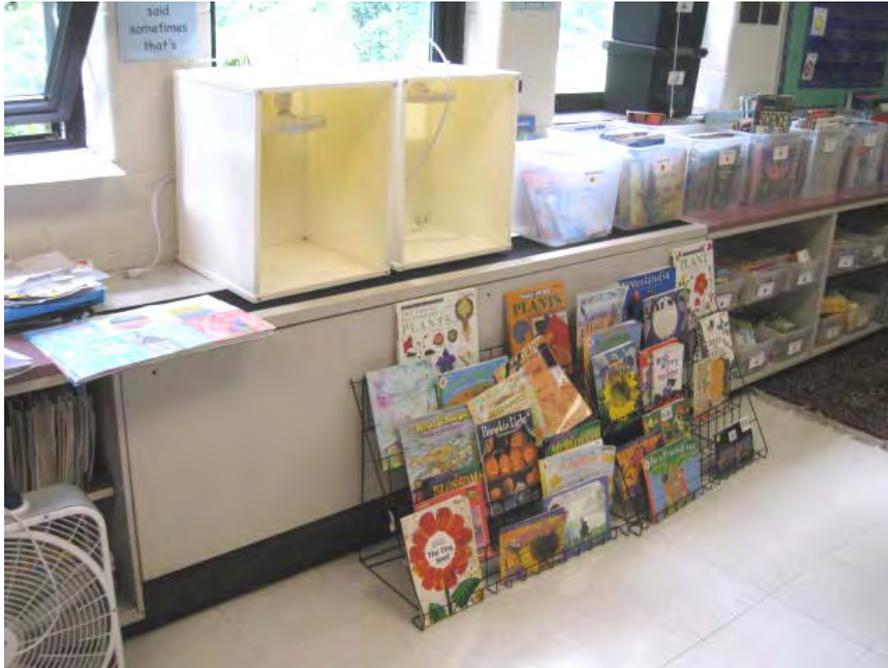
**Picture 3**

Univents were deactivated or obstructed with classroom items in several areas (Pictures 3 and 4; Table 1). In order for univents to provide fresh air as designed, intakes/returns must remain free of obstructions. Importantly, these units must remain on and be allowed to operate while rooms are occupied.

**Items obstructing univent supply diffuser (top) and return vent (bottom/front)**

5. Remove all blockages from the top and front of univents to ensure adequate airflow.
6. Close classroom doors for proper operation of mechanical ventilation system/air exchange.

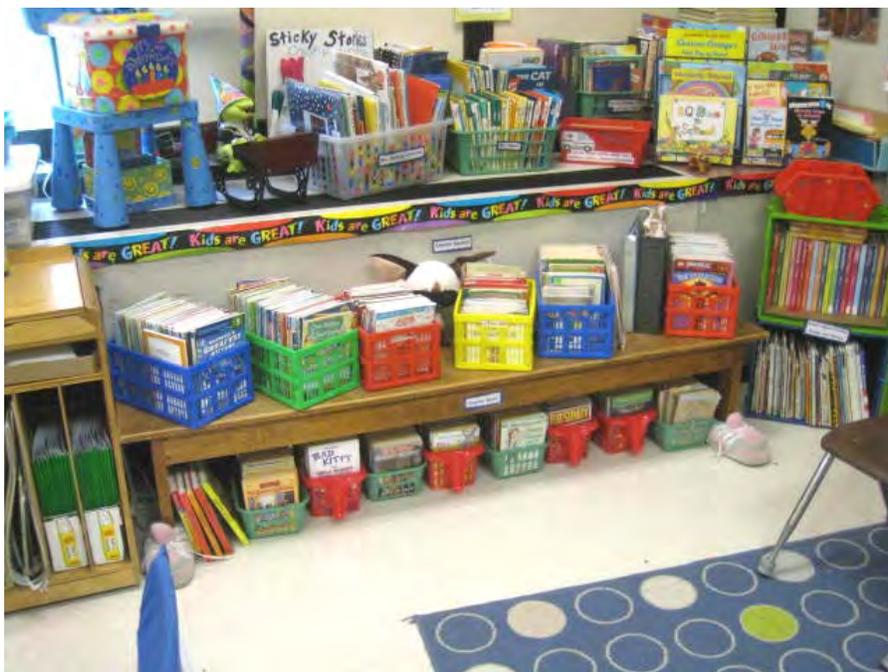
**Picture 4**

**Items obstructing univent supply diffuser (top) and return vent (bottom/front)**

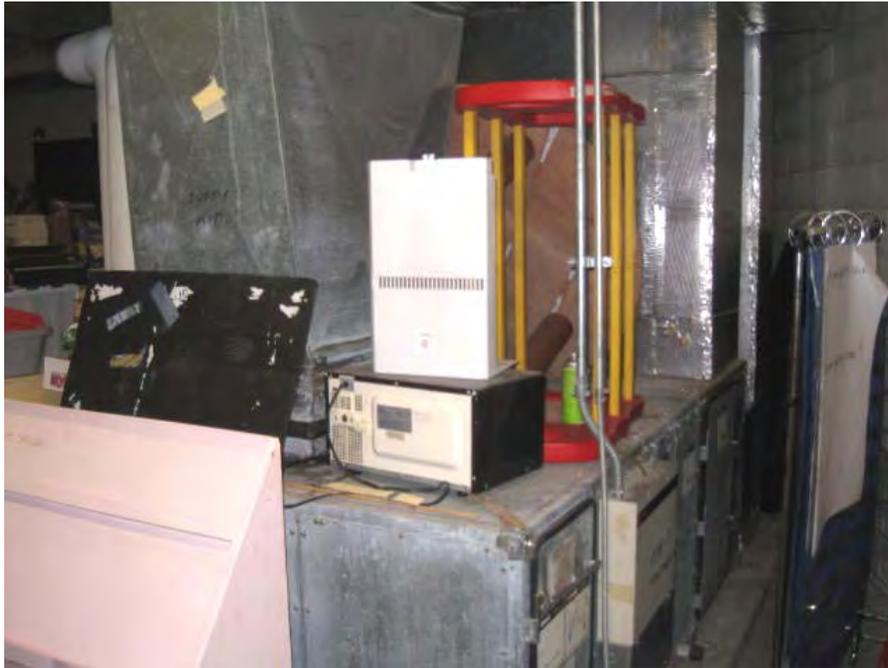
**Picture 5**

Mechanical ventilation for the gym is provided by an air handling unit (AHU) that is located in a mechanical room in the lower level. BEH/IAQ staff observed a number of items

being stored on top of the AHU (Picture 5), which should be removed/relocated to prevent damage.

**Various items stored on top of AHU in lower level mechanical room**

7. Remove items from the top of the AHU shown in Picture 5 to prevent damage to the AHU.
8. To facilitate airflow in computer room 220, utilize a stand-up oscillating fan at the front of the room.

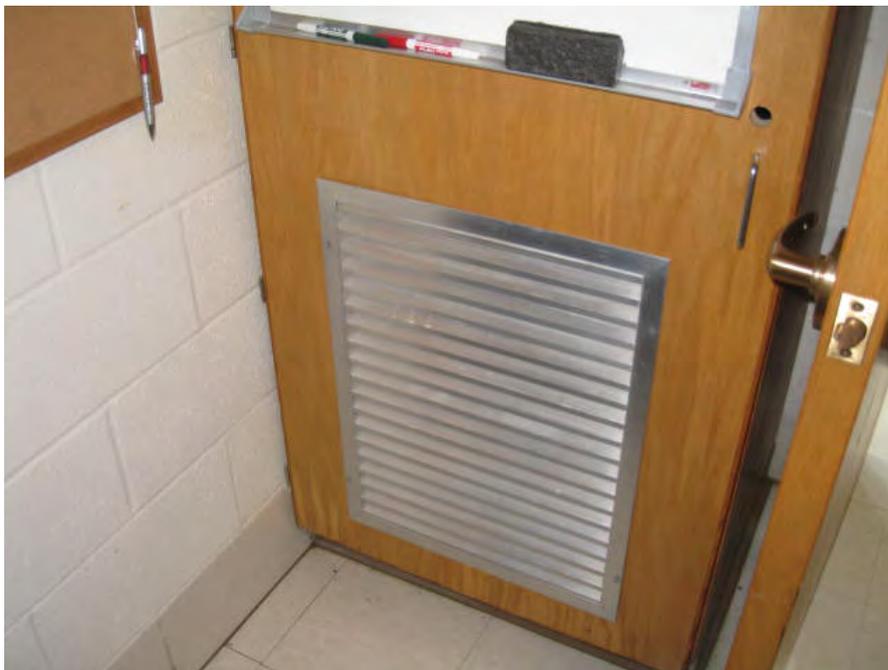
**Picture 6**

Exhaust ventilation in classrooms is provided by motorized vents located in the top of coat closets (Pictures 6 and 7). This is a suboptimal design that inhibits airflow. The exhaust system is designed to draw air into the coat closet via a passive grill in the front door of the cabinet. Air is pulled through the closet, drawn into the vent in top of the closet and ducted out of the building. In many cases the exhaust vents were off, louvers were shut and/or airflow was obstructed by items stored in or in front of the closets (Pictures 8 through 11).

**Passive grill on front of coat closet**

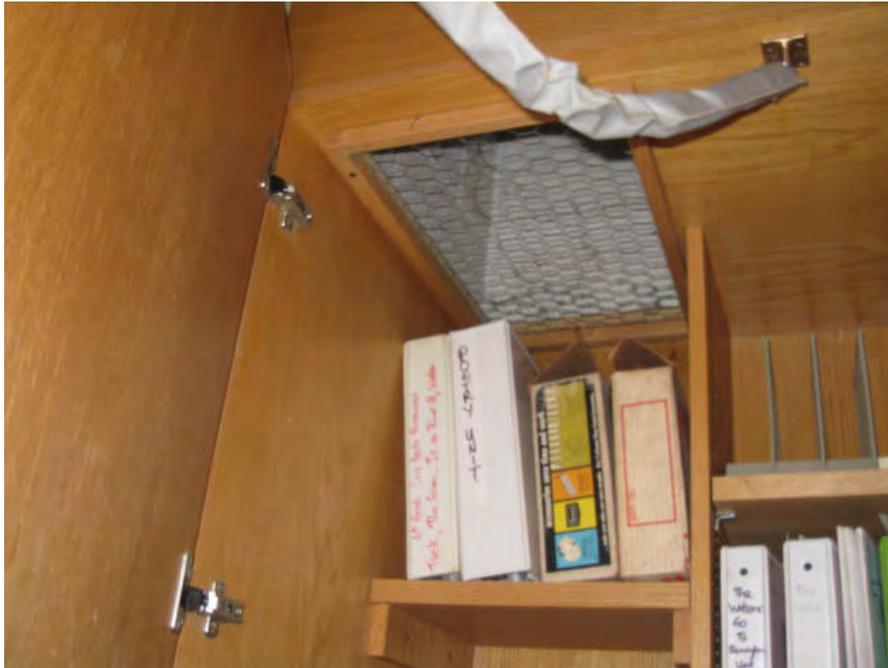
**Picture 7**

**Exhaust vent in top of coat closet**

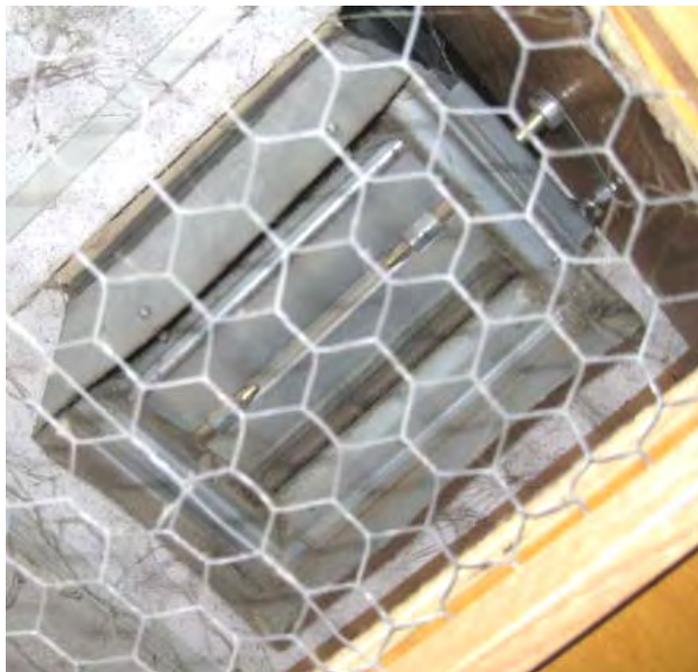
**Picture 8**

**Exhaust vent in coat closet with louvers shut**

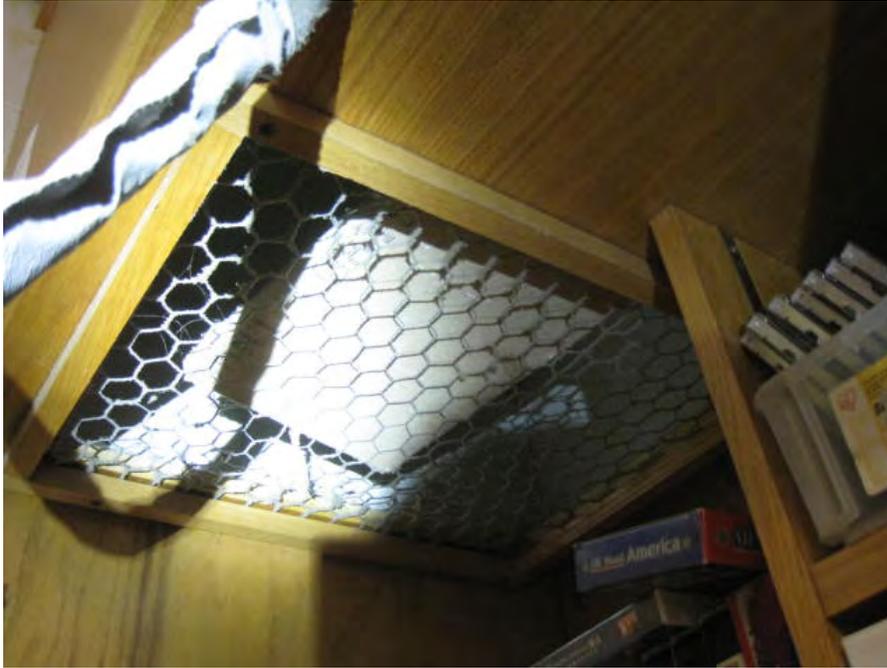
**Picture 9**

**Exhaust vent obstructed by debris**

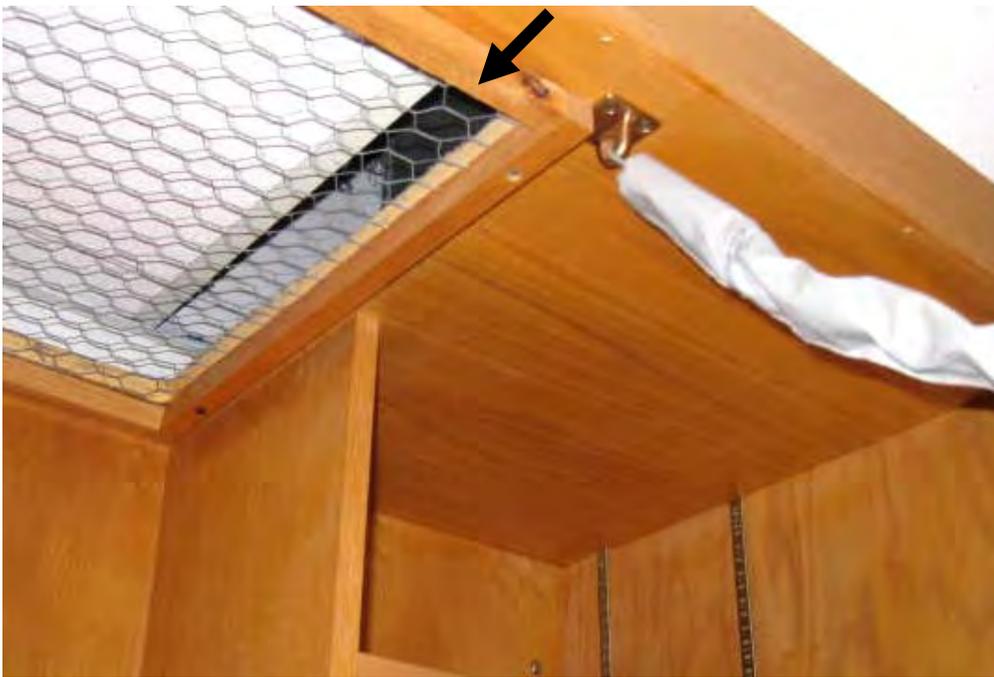
**Picture 10**

**Obstructed exhaust vent, note only thin slot allowing airflow (arrow)**

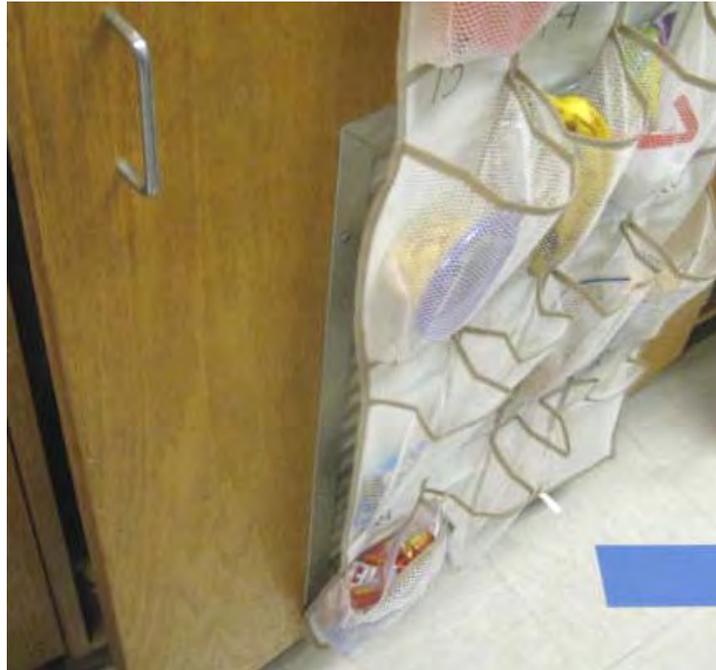
**Picture 11**

**Coat closet exhaust vent obstructed by hanging item**

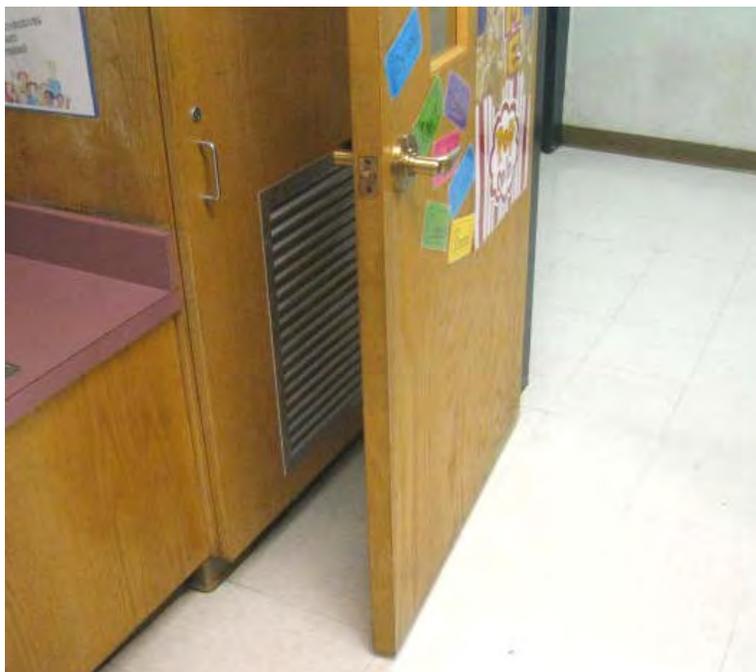
**Picture 12**

It is important to note that some exhaust vents are located near hallway doors, which are generally left open (Picture 12). With the hallway doors open, the exhaust vent can be obstructed and will tend to draw air from the hallway into the classroom, instead of drawing stale air *from* the classroom. Therefore it is recommended that classroom doors remain shut during periods of occupancy to allow exhaust vents to operate as designed. As with univents, in order to function properly, exhaust vents must be activated and remain free of obstructions.

**Coat closet exhaust vent obstructed by open hallway door**

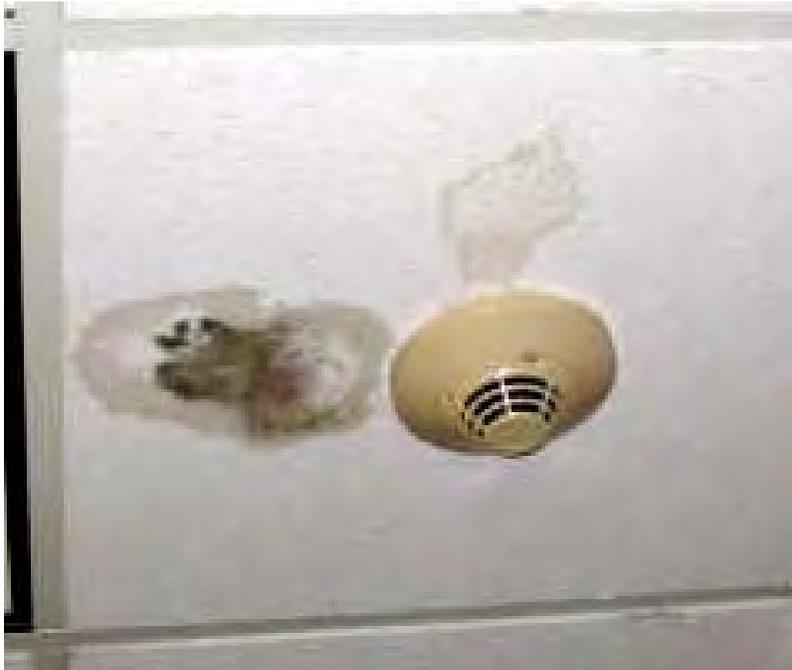
**Picture 13**

source of mold. Ceiling tiles should be replaced after a water leak is discovered and repaired. Once mold has colonized porous materials, they are difficult to clean and should be removed/discarded. A moldy ceiling tile was observed in computer room 220 (Picture 13). This ceiling tile is installed around a fire alarm unit, making it difficult to replace. At the time of the assessment BEH/IAQ staff recommended cutting the moldy portion of the tile and discarding it, until the alarm company can be contacted for assistance in replacement of the entire tile.

**Water-damaged/moldy ceiling tile in computer room 220**

12. Ensure roof/plumbing leaks are repaired and replace any remaining water-damaged ceiling tiles. Examine the area above these tiles for mold growth (e.g., computer room 220). Disinfect areas of water leaks with an appropriate antimicrobial, as needed.

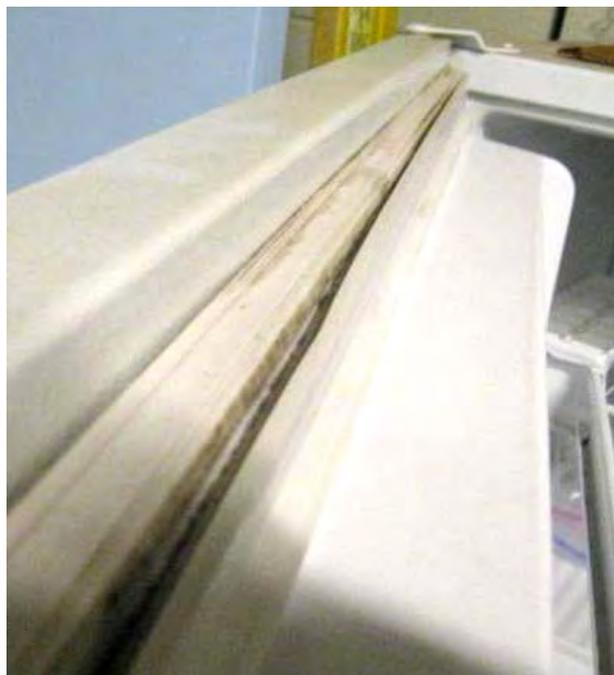
**Picture 14**

Visible mold growth was observed in the refrigerator in the lower level mechanical/storeroom. Upon opening the refrigerator BEH/IAQ staff found both the refrigerator and freezer door gaskets to be stained/colonized with mold (Picture 14). The refrigerator also had food spillage and appeared not to have been cleaned for some time (Picture 15).

**Staining/mold growth on freezer gasket**

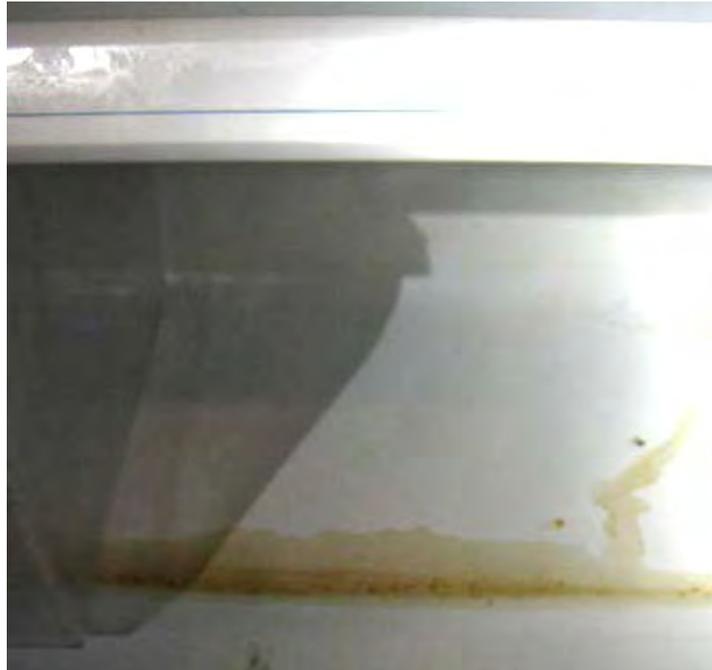
**Picture 15**

**Food spillage/staining at bottom of refrigerator**

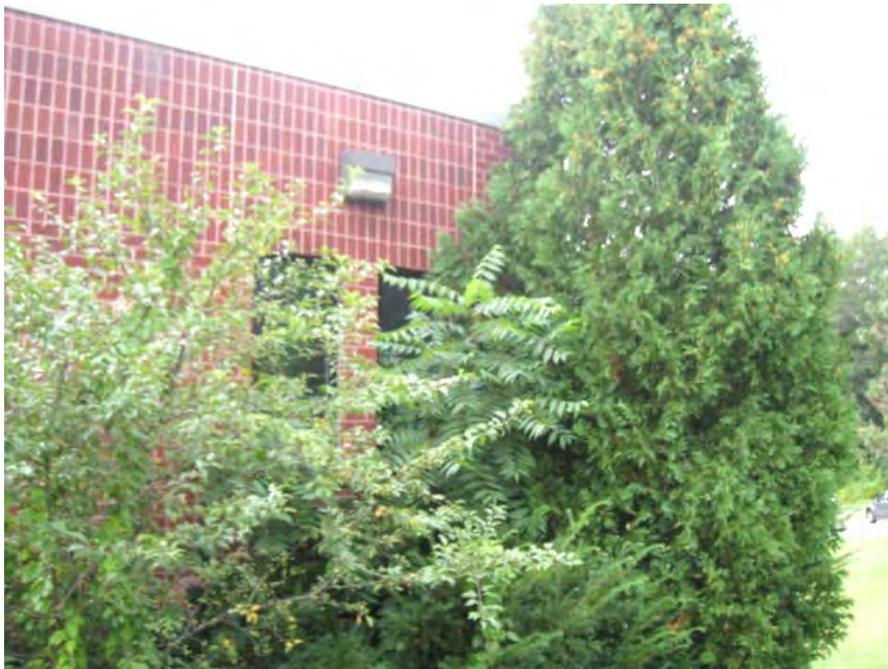
**Picture 16**

BEH/IAQ staff observed plants, shrubs and trees in close proximity to the building's exterior (Pictures 16 through 18) and in some cases near univent air intakes (Picture 18). Plants, shrubs and trees in close proximity to the building hold moisture against the building exterior.

The growth of roots against exterior walls can bring moisture in contact with the foundation. Plant roots can eventually penetrate the wall, leading to cracks and/or fissures in the foundation. Over time, these conditions can undermine the integrity of the building envelope and provide a means of water entry into the building via capillary action through exterior walls, foundation concrete, and masonry (Lstiburek & Brennan, 2001). The freezing and thawing action of water during the winter months can create cracks and fissures in the foundation that can result in additional penetration points for both water and pests. Trees, shrubs and plants can also be a source of pollen, debris and mold into univents and windows. Consideration should be given to removing landscaping in close proximity to exterior walls.

**Trees/shrubs in close proximity to exterior walls**

13. Ensure plants, trees and shrubs are located at least five feet away from exterior walls/foundation of the building, particularly those in close proximity to univent fresh air intakes.

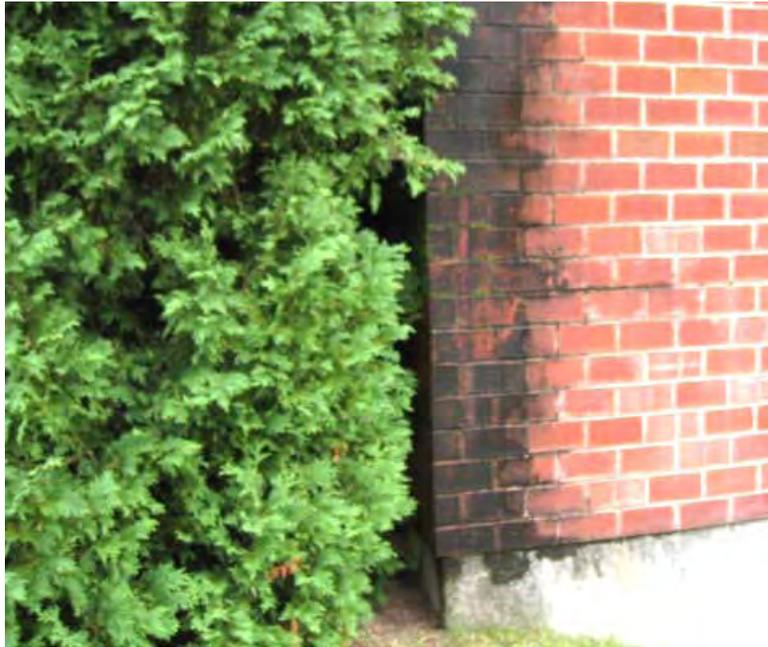
**Picture 17**

**Trees/shrubs in close proximity to exterior walls, note moss/mold growth (dark staining) due to chronic moisture exposure**

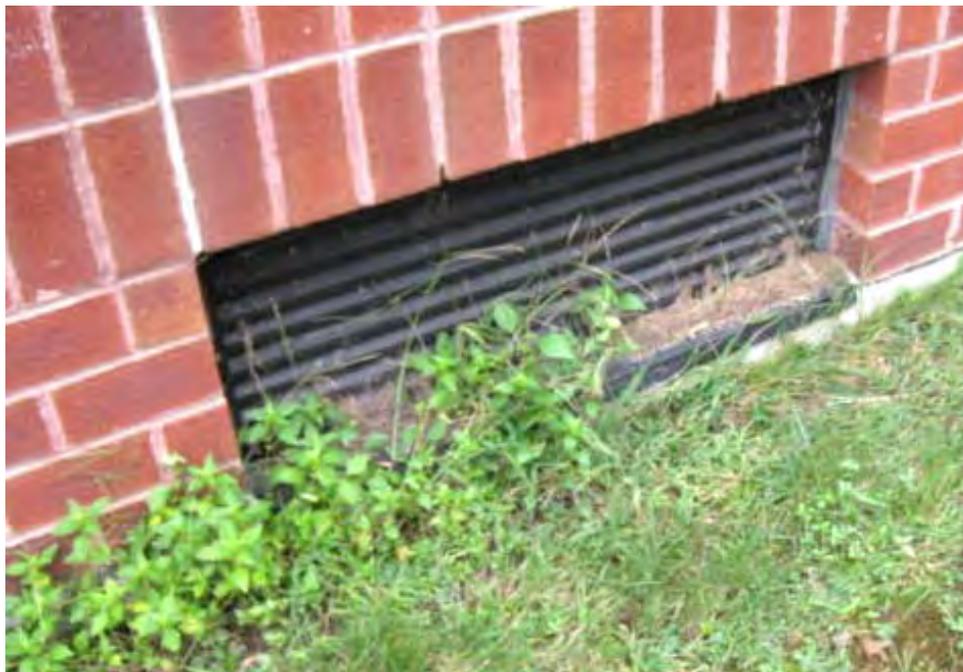
**Picture 18**

**Plant growth in front of univent air intake**

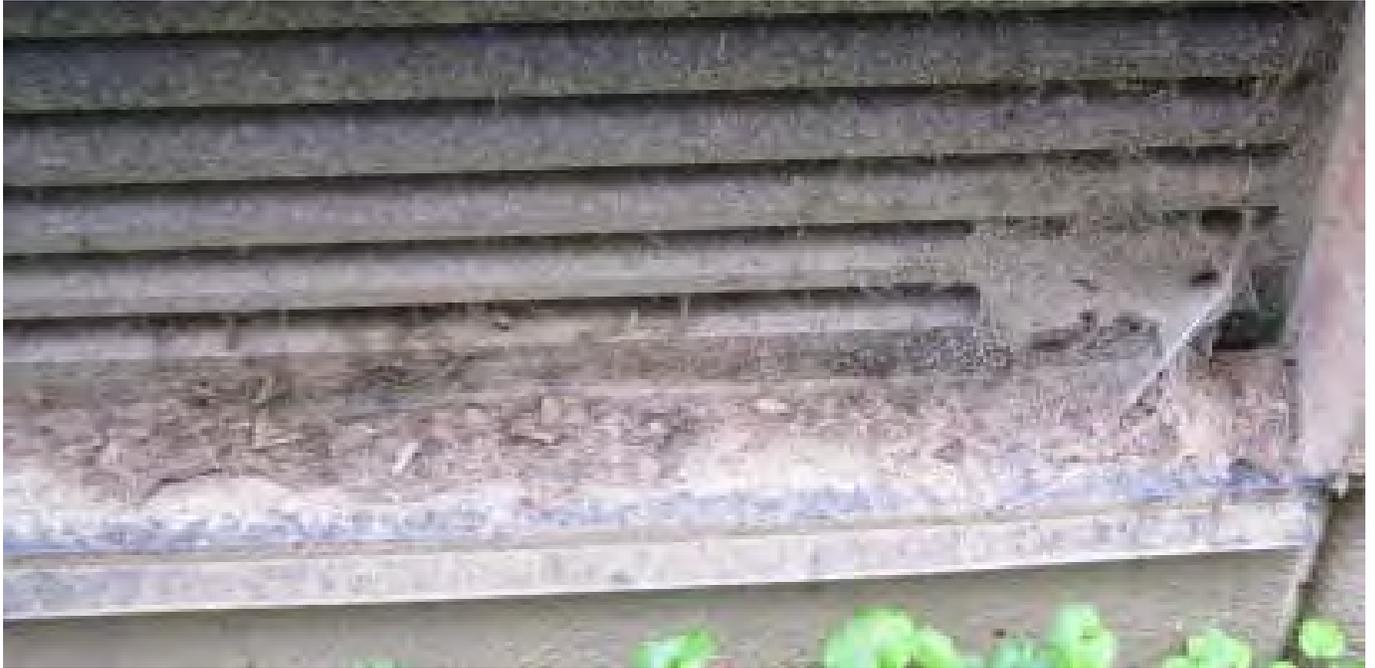
**Picture 19**

Also of note were accumulated grass clippings from lawn mowing on fresh air intakes (Picture 19). Grass clippings and associated debris from mowing can be a source of eye and respiratory irritation. These air intakes should be thoroughly cleaned and grass clippings should be directed *away* from air intakes during mowing.

**Accumulated grass clippings in/on univent fresh air intake**

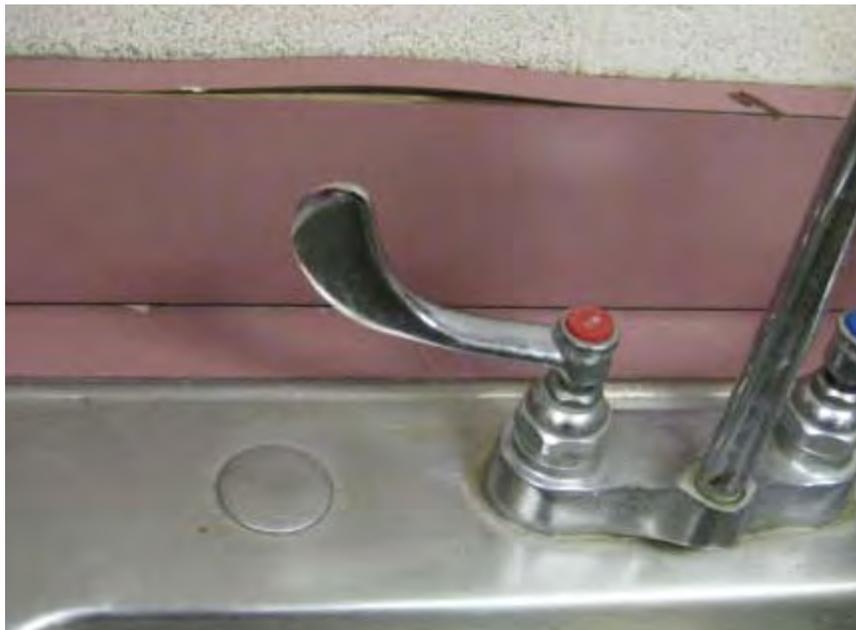
**Picture 20**

Open seams between sink countertops and backsplashes were observed in a number of rooms (Picture 20/Table 1). If not watertight, moisture can penetrate through seams, causing damage. Improper drainage or sink overflow can lead to water penetration into countertops, cabinet interiors and areas behind cabinets. Water penetration and chronic exposure of porous and wood-based materials can cause these materials to swell and show signs of water damage (Picture 20). Repeated moistening of porous materials can result in mold growth.

**Space between sink countertop and backsplash, note water-damaged/delaminating backsplash**

16. Seal areas between sink countertops and backsplashes to prevent water-damage to the interior of cabinets and adjacent materials. Consider replacing severely damaged units with a one-piece molded countertop (i.e., classroom 207).

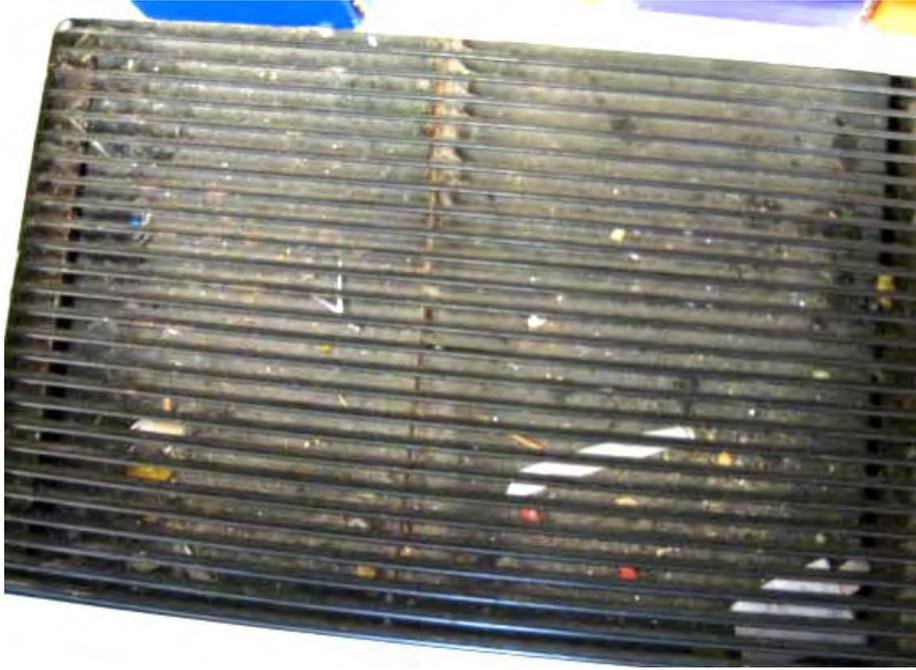
**Picture 21**

A number of air diffusers, exhaust/return vents and personal fans were found to have accumulated dust/debris (Pictures 21 and 22; Table 1). Of particular note were the grills along the top of univents, which had accumulated dust/debris. It was not clear if these units were accessible to clean by opening or removal of the grill. Re-activated supply vents and fans can aerosolize dust accumulated on vents/fan blades. If exhaust vents are not functioning, backdrafting can occur, which can re-aerosolize accumulated dust particles.

**Dust/debris in univent air diffuser**

20. Determine if univent diffuser grills can be removed to enable cleaning of accumulated dust/debris.
21. Clean exhaust vents, passive (coat closet) grills and personal fans periodically of accumulated dust/debris.

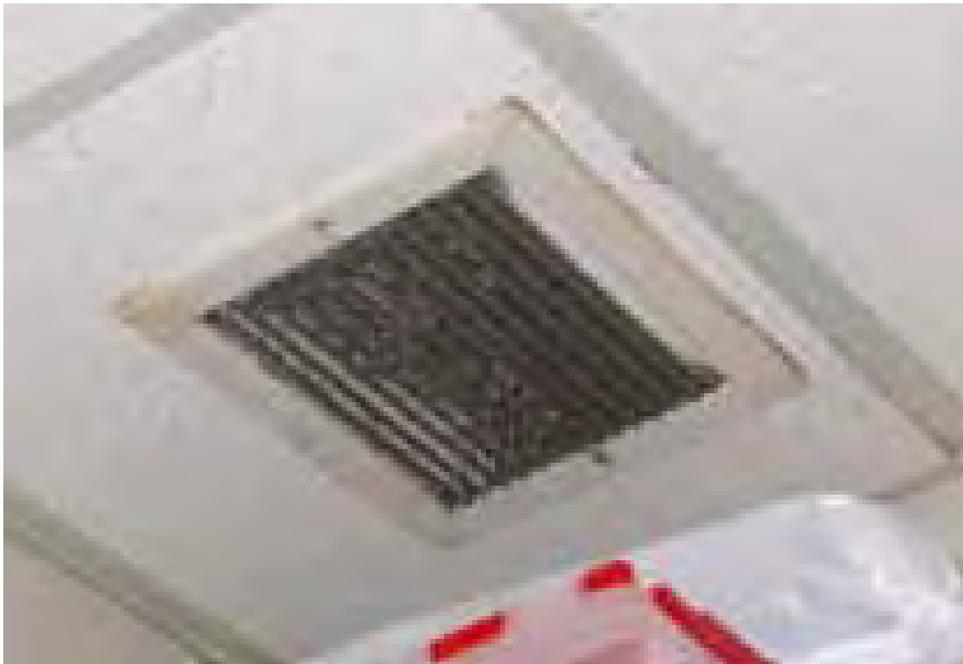
**Picture 22**

**Dust/debris on ceiling-mounted exhaust vent**

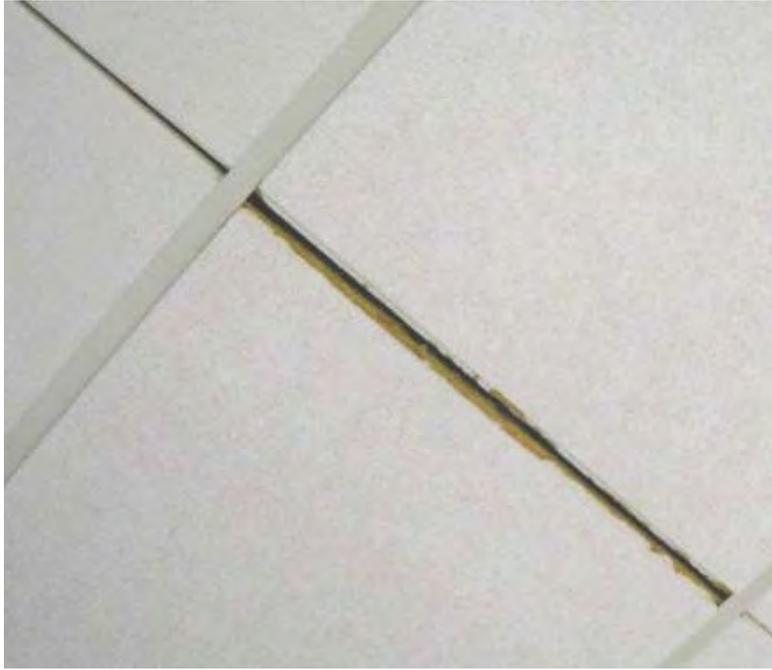
**Picture 23**

Sections of the ceiling tile grid in classroom 122 were missing, exposing fiberglass insulation (Picture 23). Fiberglass can be a source of irritation to the eyes, skin and respiratory system. In addition, the ceiling tile grid is a weight-bearing system that should be intact.

**Missing ceiling tile grid exposing fiberglass insulation in classroom 122**

22. Replace missing ceiling tile grid in classroom 122 (and other areas) to maintain structural integrity and prevent exposure to fiberglass insulation where present.
23. Continue with plans to remove wooden shelving in classroom 200 foyer/storeroom to determine if odors dissipate. Replace base coving that was removed in foyer, once investigation is complete.
24. Consider adopting the US EPA (2000) document, “Tools for Schools”, as an instrument for maintaining a good indoor air quality environment in the building. This document is available at: <http://www.epa.gov/iaq/schools/index.html>.
25. Refer to resource manual and other related indoor air quality documents located on the MDPH’s website for further building-wide evaluations and advice on maintaining public buildings. These documents are available at: <http://mass.gov/dph/iaq>.
