# **INDOOR AIR QUALITY ASSESSMENT**

**Advanced Math and Science Academy Charter School  
165, 199, and 201 Forest Street  
Marlborough, MA**

Prepared by:  
Massachusetts Department of Public Health  
Bureau of Environmental Health  
Indoor Air Quality Program  
December 2013

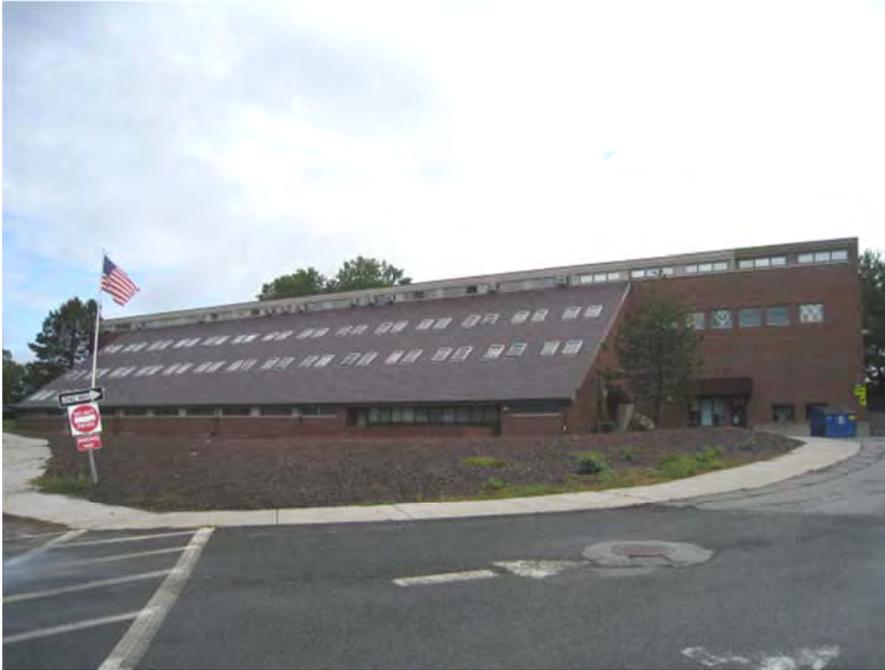
**Picture 1**

Building 201 is a three-story building with a large sloped roof. The building may have originally been constructed for manufacturing and was significantly remodeled prior to the school taking occupancy. The sloped roof forms the majority of the exterior wall to classrooms; the roof plane is interrupted by classroom windows (Picture 1). Of all the buildings on campus, only Building 201 has openable windows.

**201 Forest Street (Building 201) showing slanted roof with windows**

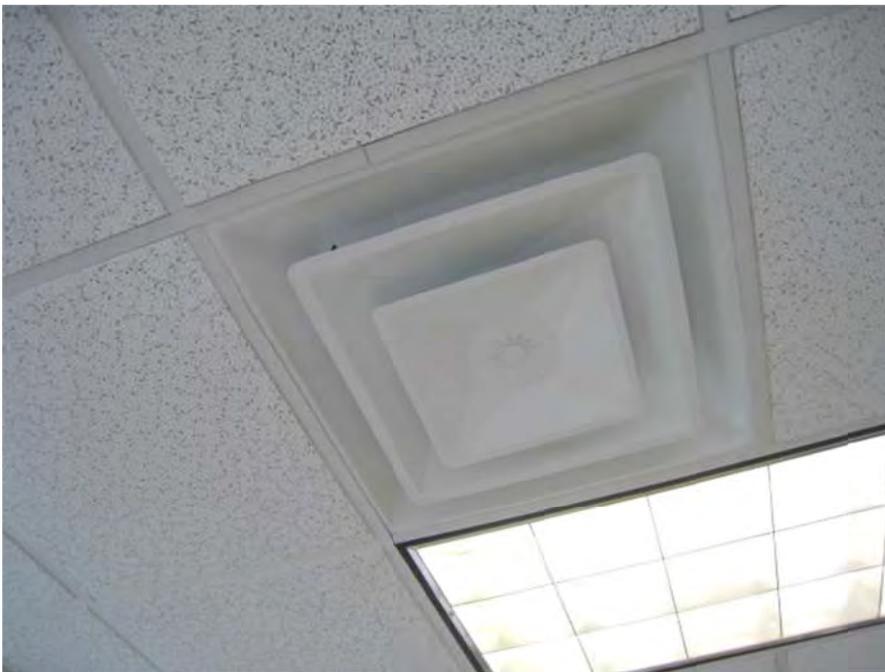
**Picture 2**

Buildings 165 and 199 are equipped with similar Heating, Ventilating and Air Conditioning (HVAC) systems. Fresh air is provided by rooftop air-handling units (AHU) and ducted to classrooms via ceiling-mounted supply diffusers (Picture 2). Exhaust air is drawn through ceiling-mounted vents and returned to AHUs via ductwork. In Building 199, many of the exhaust vents were located close to hallway doors, which were often found open. In this configuration, exhaust vents would be likely to draw air from the hallway instead of from the room, limiting the ability to remove stale air (Picture 3).

**Fresh air supply diffuser in Building 165**

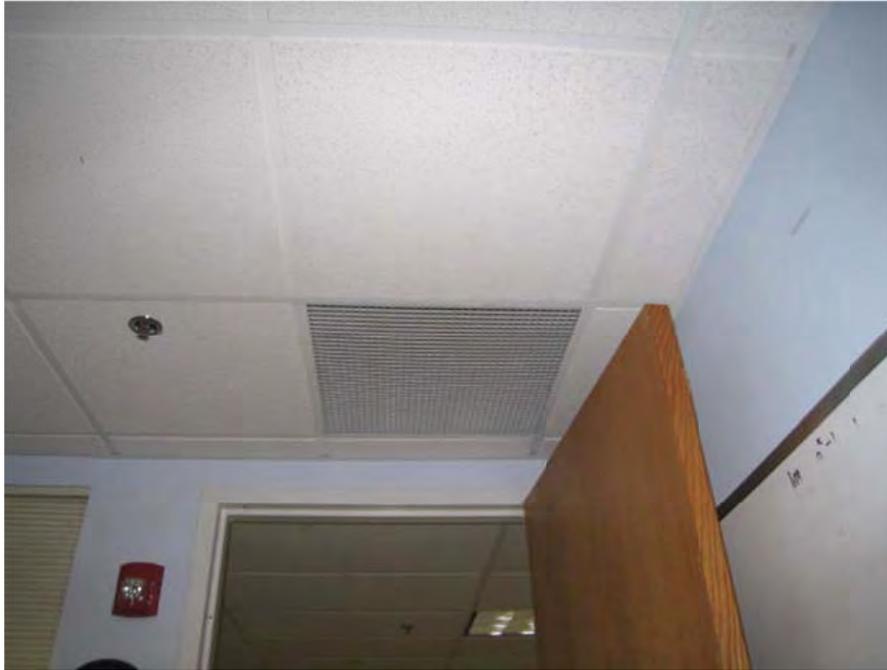
**Picture 3**

**Exhaust vent in Building 199, note proximity to open classroom door**

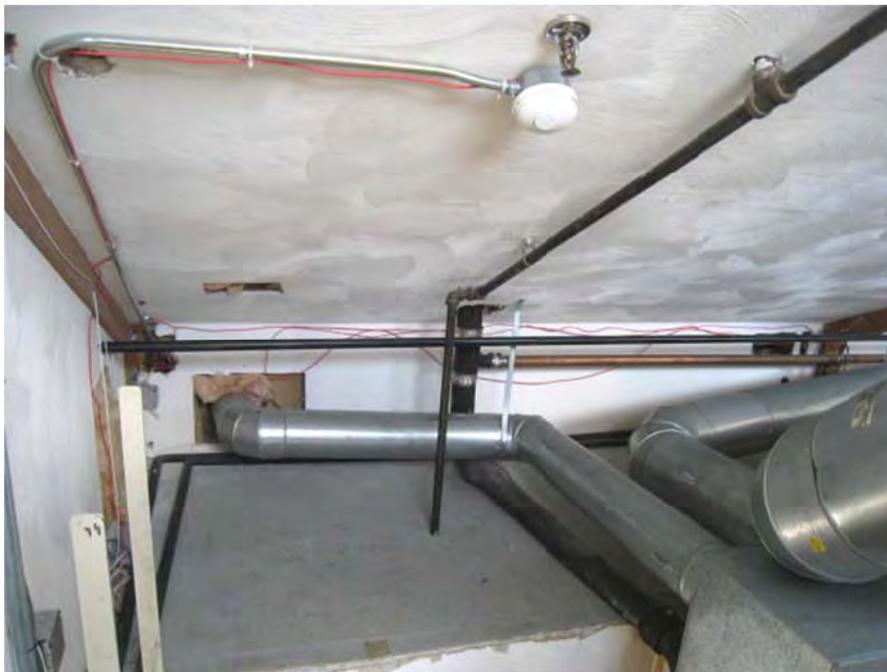
**Picture 4**

The supply of fresh air is further hindered by the current ductwork configuration. Ductwork from one of the AHUs was observed with an approximately 180-degree bend after leaving the AHU, which will reduce the ability for air to flow through the ducts (Picture 4). Gaps/holes were also noted in AHU walls (Picture 5), which allows the draw of air and other pollutants present in the mechanical space into the AHU, which would then be distributed to occupied areas of the building.

**Ductwork in mechanical room showing sharp turns, which restrict airflow**

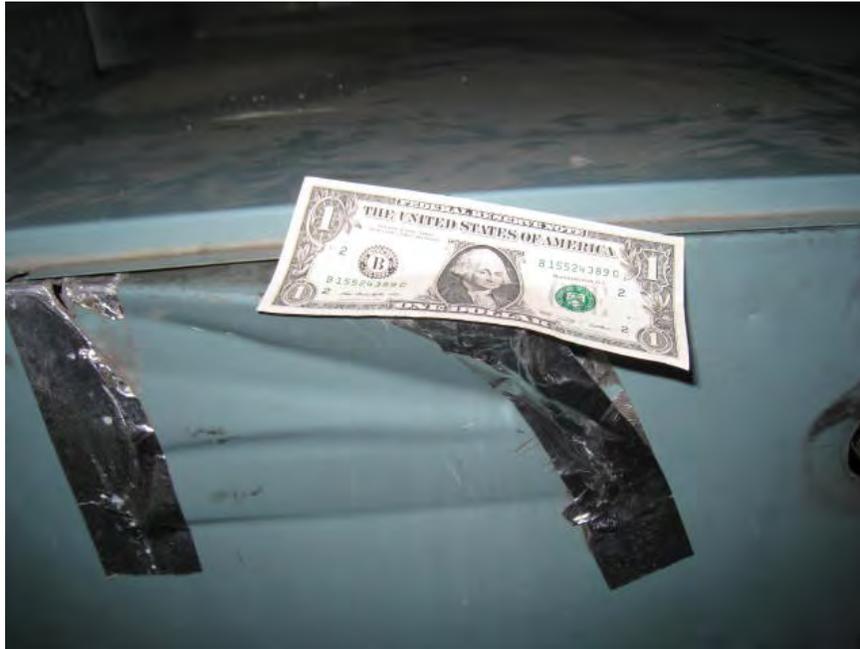
**Picture 5**

**Dollar bill adhering to hole in AHU casing, showing that air from the mechanical room is getting drawn inside**

5. Repair AHUs in Building 201 to remove gaps in casing and close AHU doors in all mechanical rooms.

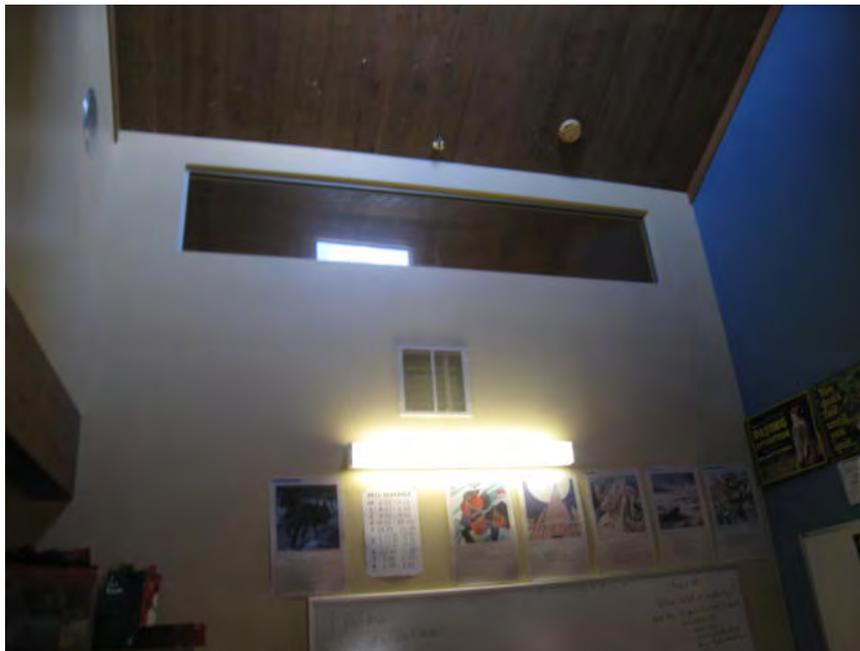
**Picture 6**

**Passive/transfer air vent in wall in Building 201**

1. Determine whether transfer air vents used for exhaust ventilation of classrooms in Building 201 are in compliance with current the Massachusetts Building Code as well as state and local fire codes.
2. Consider installing ducted exhaust vents or a ceiling plenum return system in Building 201.
3. Consider upgrading or replacing HVAC systems in all buildings. In order for the HVAC system to function appropriately, it may be necessary to replace the existing AHUs with those having a sufficient capacity to provide adequate fresh air supply for the current number of building occupants.
4. Regrade exterior around Building 201 to direct water away from building. Consider using a stone material instead of mulch for ground cover.

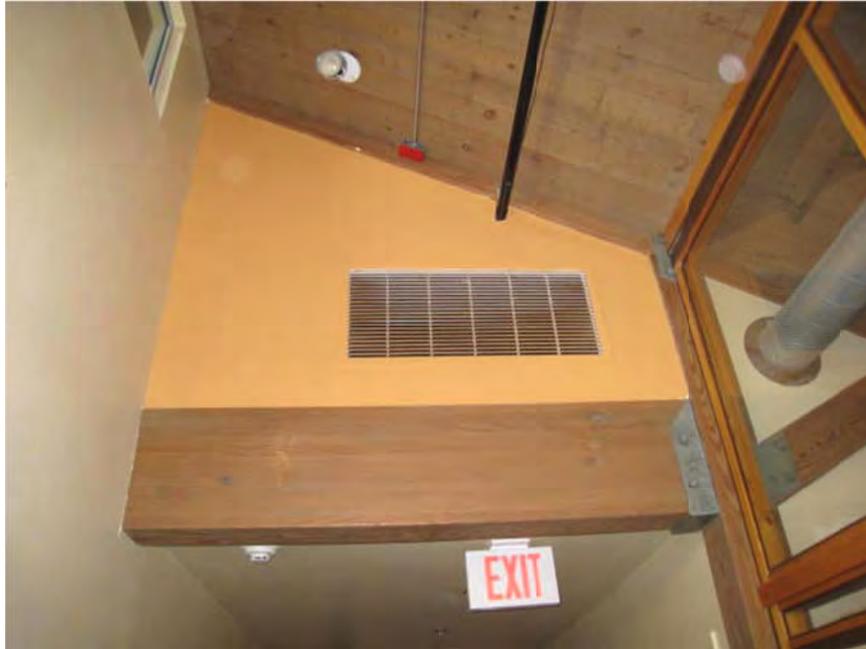
**Picture 7**

**Hallway vent in Building 201**

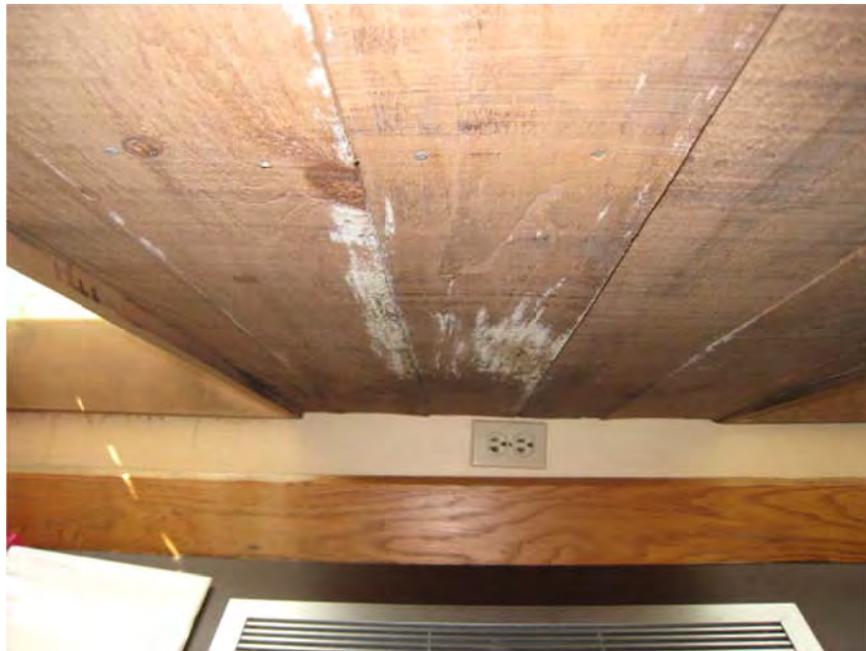
**Picture 8**

Building 201 has unusual construction and building component details that make it particularly prone to water damage and mold growth. The roof of the building is deeply sloped and reaches from the peak down to the first story of the building (Picture 1). Many classrooms have walls that follow the slope of the roof (Figure 2). In the experience of BEH/IAQ staff, FCUs are usually installed so that airflow from the diffuser does not directly impinge upon building components. In Building 201, the FCUs in most classrooms are located against the exterior wall/roof, with a section of the wood clad roof directly above the air diffuser (Picture 8). This is a poor design for the following reasons:

Due to the location of FCUs (e.g., beneath sloped, wood-clad, wall/roof), the operation of the FCUs appears to generate condensation, which can be a significant source of water damage and mold growth. In times of elevated relative humidity in the building, such as the day of assessment, there is the potential for wood to be chilled below the dew point. Note that the dew point is determined by air temperature and relative humidity that indicates the temperature at which the water in the air will begin to condense. For example, at a temperature of 73° F and relative humidity of 57 percent indoors, the dew point for water to collect on a surface is approximately 57° F (IICRC, 2000). Therefore, any surface that has a temperature below the dew point would be prone to condensation generation under those temperature and relative humidity conditions. Warping, discoloration, and other similar signs of water damage noted on wood paneling above FCUs is an indication of repeated exposure to moisture (Picture 8). Some wood panels had staining that appeared consistent with mold colonization.

**Top of fan coil unit and slanted wooden wall. Note staining, deterioration of wood and location of electrical outlet**

2. Retrofit each FCU with a diffuser system to direct airflow at an angle parallel to the roof slope to minimize moistening of woodwork once the water damaged/mold colonized woodwork is removed. This alteration should also result in better heat distribution during cold weather.

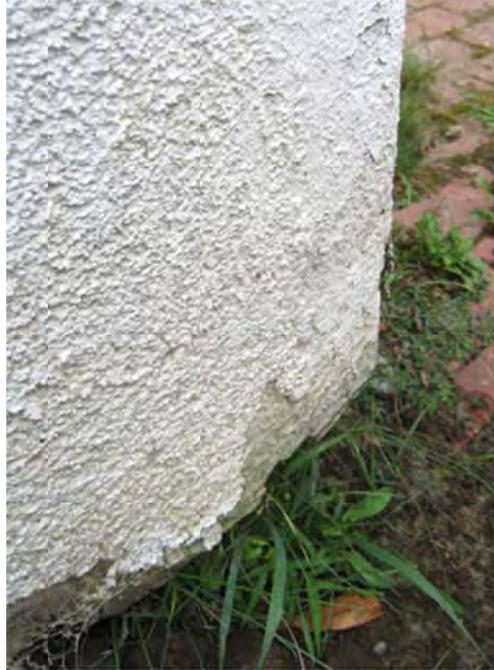
**Picture 9**

As mentioned previously, building 165 has an outer envelope constructed of EIFS panels. Damage to the panels could be seen at the lower edge (Picture 9), and the panels appear to be warped/buckled along the upper portion of the building (Picture 10). This type of damage is an indication of moisture penetration and weather damage. Seams between panels did not appear to be tight in some areas, despite reported recent attempts to reseal them. These observations suggest that the outer envelope of the building is not able to keep water out. Water-damaged paint was observed on the interior walls of room 805 (Picture 11). Moisture sampling indicated that some areas of gypsum wallboard (GW) were moist at the time of assessment. The external envelope of the building needs to be rendered watertight, including repairs to the EIFS panels and sealing between them.

**Damaged EIFS siding on building 165**

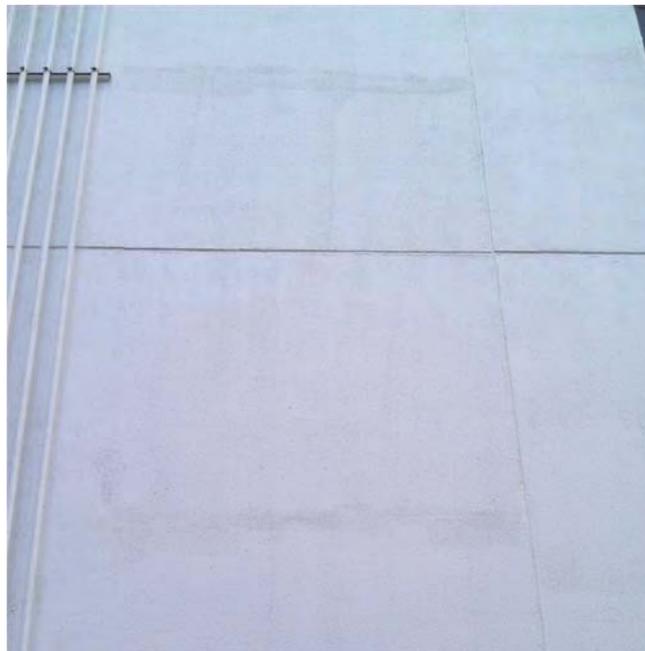
**Picture 10**

**Staining on panels consist with water penetration behind EIFS panels**

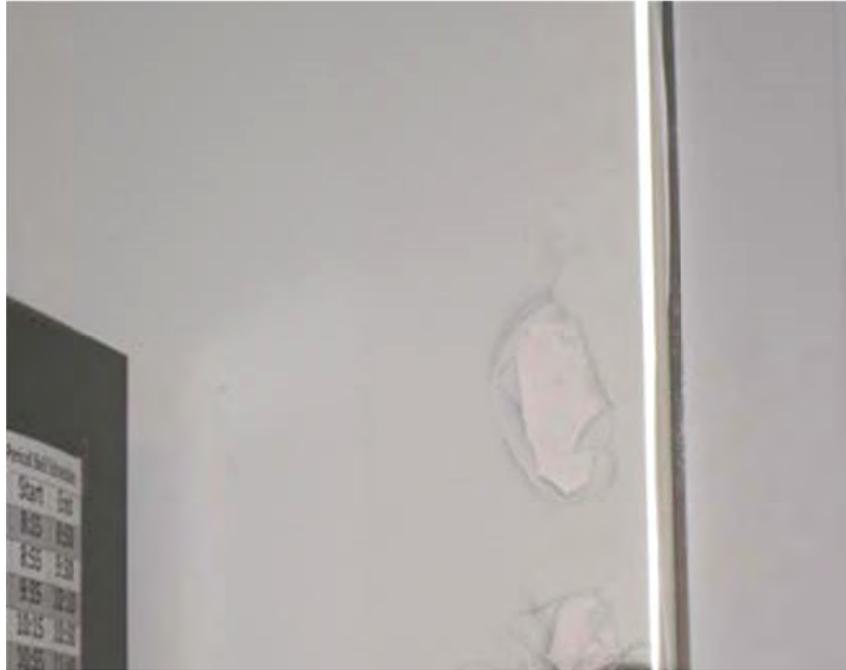
**Picture 11**

**Water-damaged wall in room 805 of Building 165**

16. Repair points of water penetration, and replace all water-damaged wall materials. For more information on mold consult *Mold Remediation in Schools and Commercial Buildings* published by the US EPA (2001). This document is available from the US EPA website: [http://www.epa.gov/mold/mold\\_remediation.html](http://www.epa.gov/mold/mold_remediation.html).

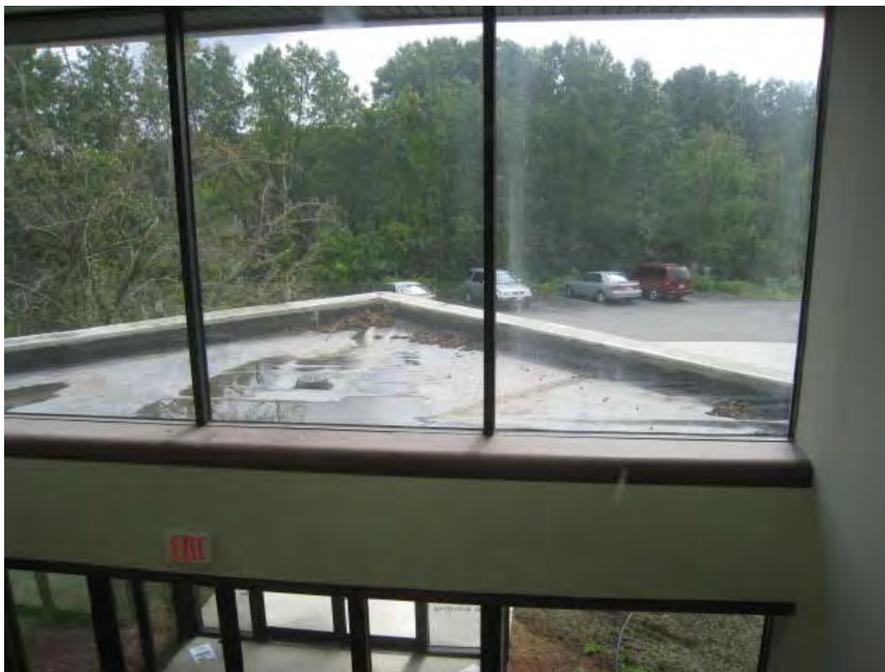
**Picture 12**

Building 165 has two small lower roof segments (Picture 12), both of which had water pooling on them. Water pooling can damage the roof and infiltrate the building. Drains on these roof segments appear to be above the level of the roof itself. Drains should be reconfigured to allow removal of water. Standing water can also be a breeding ground for mosquitoes.

**Entryway roof section on Building 165, note water accumulation showing poor drainage**

10. Monitor the roof membrane and drains for proper operation, particularly after severe weather events, and repair/reconfigure as needed.
  11. Consider moving refrigerators and water dispensing equipment to areas with tile floors or place them on waterproof mats to avoid moistening of carpeting.

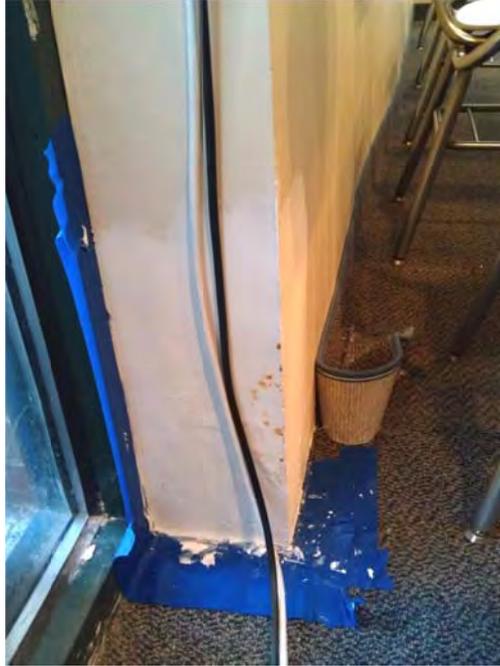
**Picture 13**

Water-damaged GW was noted in Classroom 420 (Picture 13). At the time of assessment, the GW was moist. BEH/IAQ staff observed conditions on the building's exterior, and noted that there was a crack in the cement apron where water was likely penetrating the classroom (Picture 14). The cement closest to the exterior of the building had settled to a lower grade than that cement to its foreground. Since the cement portions are at different grades, water can pool against the building and penetrate the classroom. Sealing and repaving this area to direct water away from the building will help to prevent future water penetration.

**Water-damaged wall in classroom 420 of Building 199**

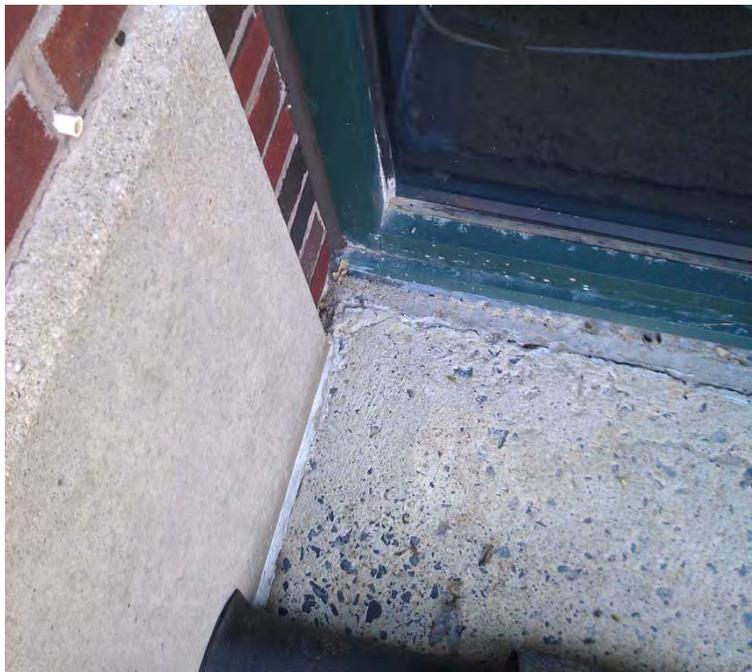
**Picture 14**

**Damaged cement outside classroom 420 of Building 199**

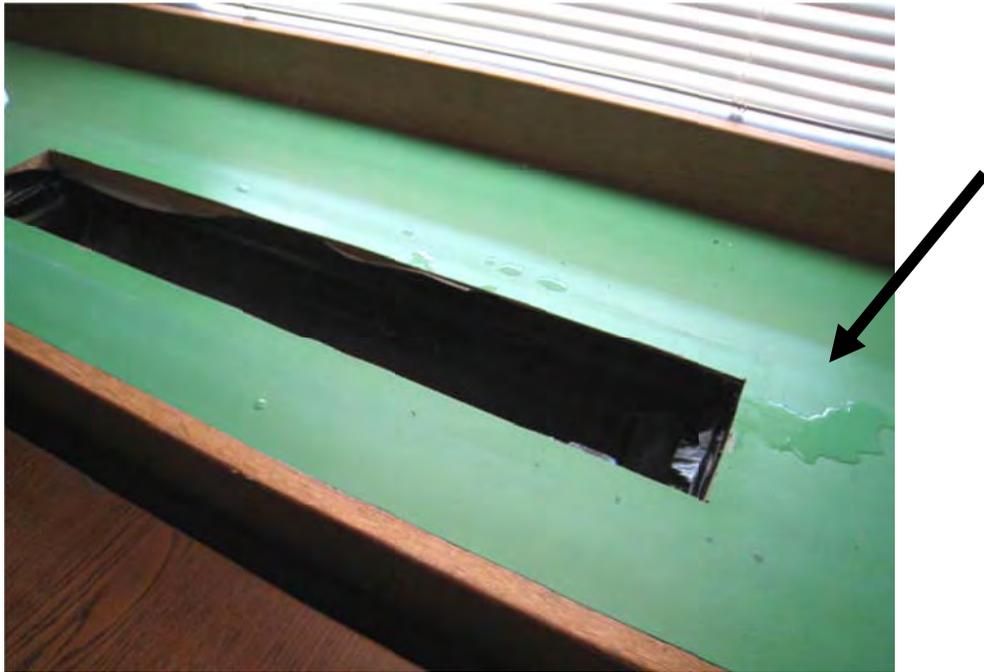
**Picture 15**

In some classrooms, the metal grates on some FCUs were observed to be wet with condensation (Picture 15; Table 1). Some classroom materials stored near or on top of air diffusers were found to be wet from the operation of FCUs. In the experience of BEH/IAQ staff, these conditions may result from operating FCUs with coolant at too low a temperature or excessive fan speed. The water vapor load in the building was likely increased by the lack of adequate exhaust ventilation in occupied areas. Alteration of airflow as well as the operation of FCUs needs to be changed in order to prevent the recurrence of condensation and water damage to woodwork.

**FCU on lower level of Building 201 with metal grate removed; water to the right (arrow) had condensed on metal grate**

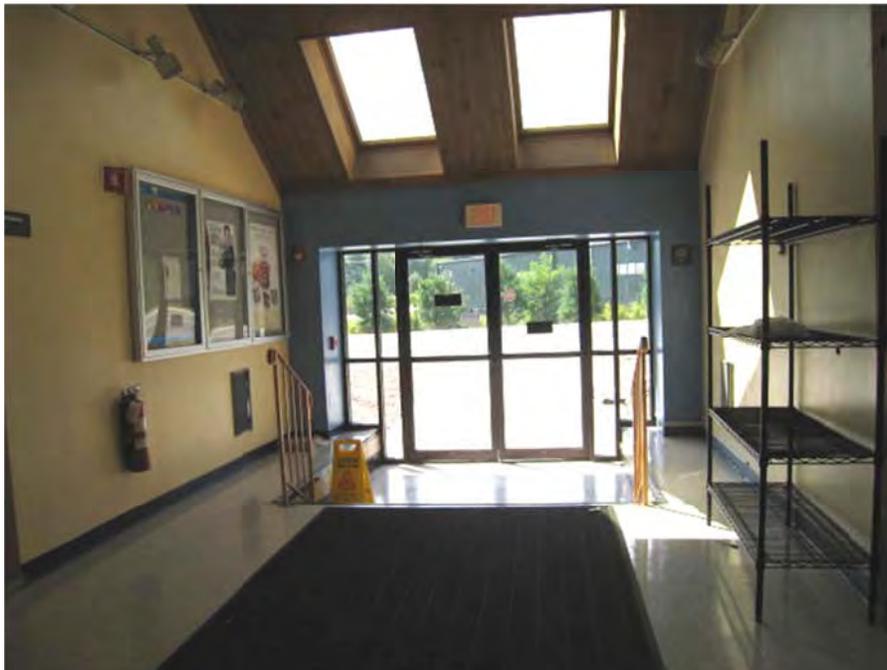
**Picture 16**

Lastly, water infiltration and damage was also observed in the hallway near an exterior door (Pictures 16 and 17). AMSA staff reported that water had penetrated the building in the days prior to the MDPH assessment. BEH/IAQ staff observed wood mulch debris in the hallways, indicating that water had penetrated into the hallway. Wood mulch could be observed on the exterior grounds of this area. During heavy rain, wood mulch likely clogs exterior drainage, allowing water to enter the building. Flooding is likely further exacerbated by the grade outside this area of the building. Due to repeated water issues in the area, the ground directly exterior to the building has become depressed and the overall grade is pitched towards the building. The trench drain (Picture 18) is also likely undersized. Consideration should be given to regrading this area, and using a stone material instead of mulch for ground cover.

**Hallway with repeated water penetration in Building 201**

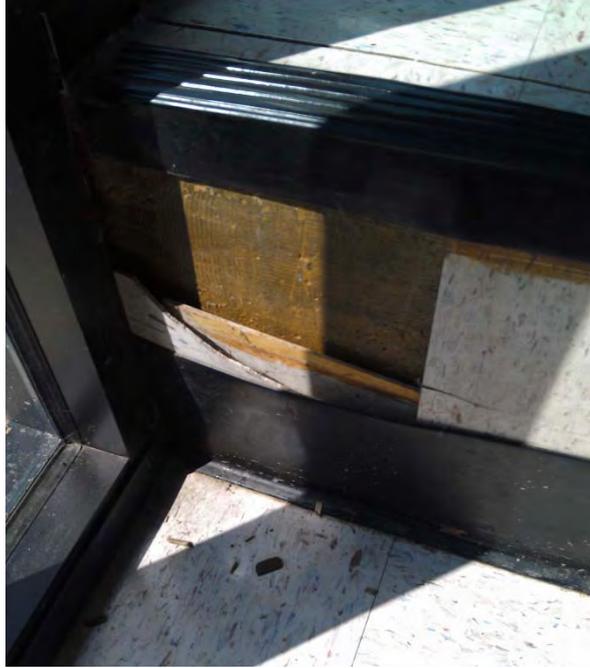
**Picture 17**

**Damaged tiling in hallway of Building 199, note wood mulch debris**

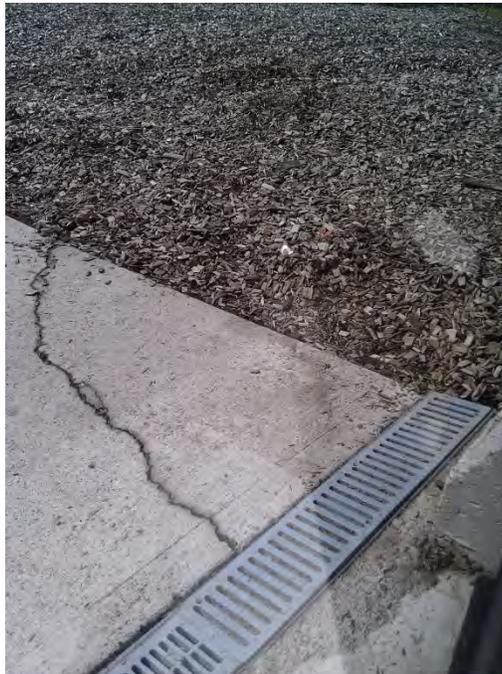
**Picture 18**

**Trench stormwater drain**

17. Consider installing a larger trench drain (Picture 18) to improve drainage along exterior of building.
18. Seal breaches, seams, and spaces between sink countertops and backsplashes to prevent water damage.

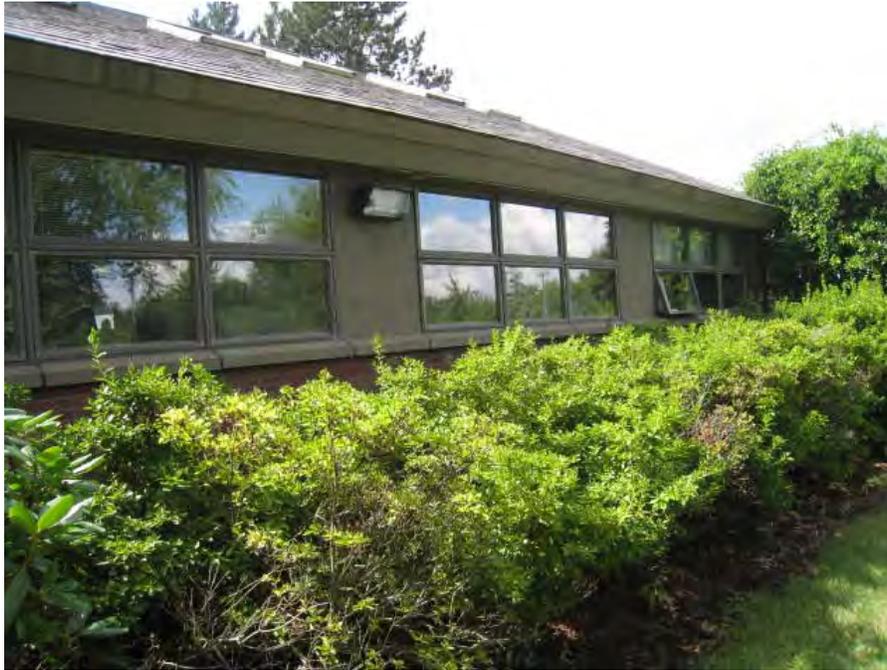
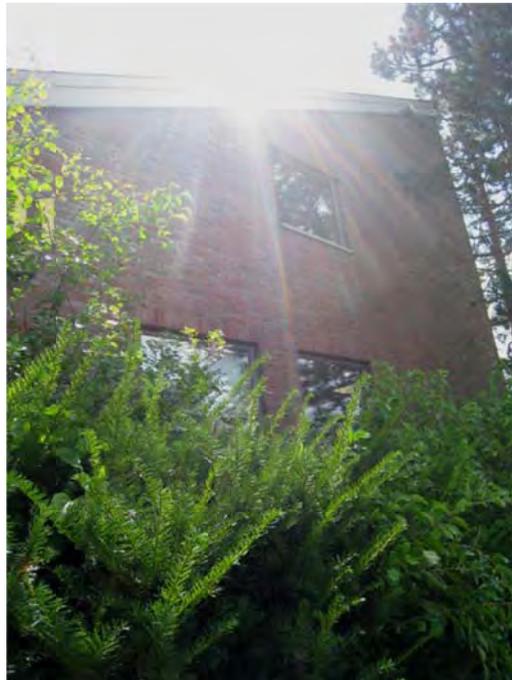
The exterior of each building was examined for possible sources of water infiltration and related conditions. Plants, trees and shrubbery were observed in close proximity to the buildings, particularly Building 201 (Picture 19 and 20). The heavy foliage can hold moisture against the side of the building, leading to deterioration of the brick façade. In some places, plants were rooted to the bricks themselves (Picture 21), which can damage the material. The growth of roots against exterior walls can bring moisture in contact with the foundation. Plant roots can eventually penetrate the exterior, leading to cracks and/or fissures. Over time, this process can undermine the integrity of the building envelope, providing a means of water entry into the building via capillary action through foundation concrete and masonry (Lstiburek & Brennan, 2001).

**Plants/foliage against building 201**

14. Ensure that aquariums and terrariums are maintained to prevent odors.
  15. Trim back plants, trees, and shrubs at least five feet away from exterior walls/foundation of the building.

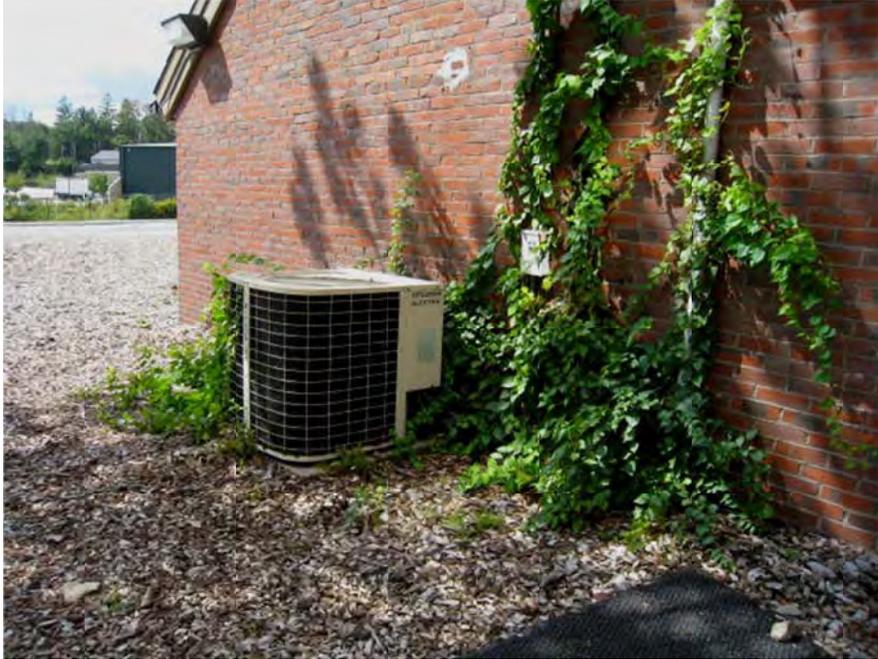
**Picture 21**

**Vines growing up Building 201 façade**

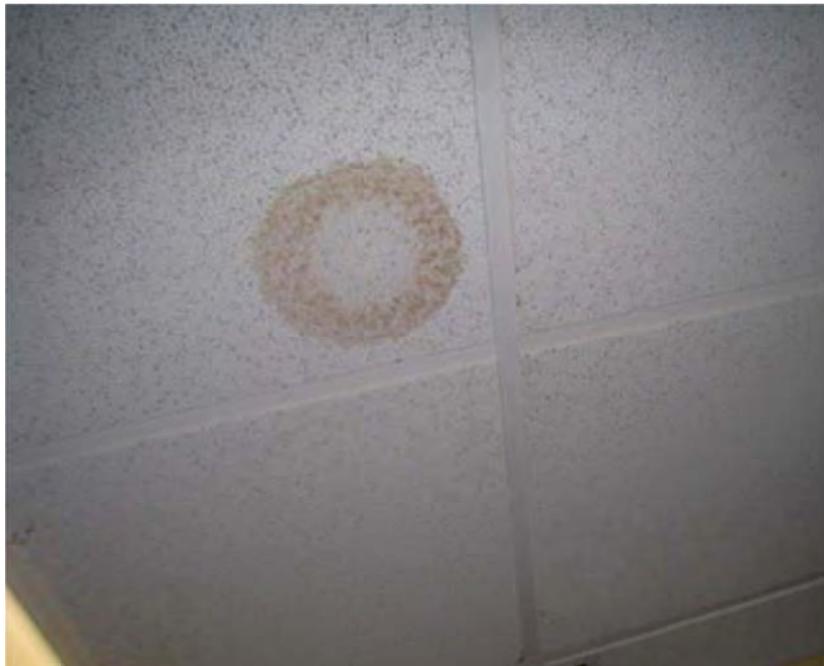
**Picture 22**

Water-damaged ceiling tiles were observed in some classrooms in Buildings 199 and 201 (Table 1; Picture 22), indicating water leaks from the building envelope or plumbing. Water-damaged ceiling tiles can be a source of mold and should be replaced once a water leak has been repaired.

**Water-stained ceiling tile**

7. Ensure roof/plumbing leaks are repaired and replace/repair any remaining water-damaged ceiling tiles and building materials. Examine the area above these tiles for mold growth.

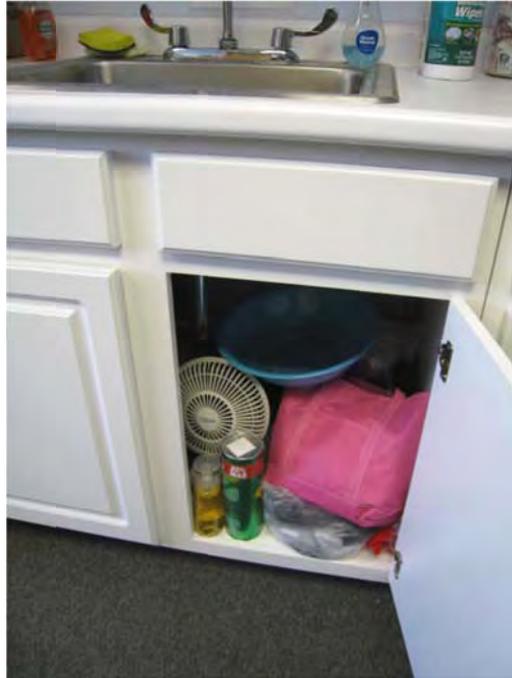
**Picture 23**

Some classrooms had sinks, and BEH/IAQ staff observed that a few of the backsplashes were open or not fully sealed (Table 1). If not watertight, water can penetrate through the seam, causing water damage. Water-damaged wood was observed in one sink cabinet from a historic plumbing leak or condensation from cold-water piping. Several classroom sinks were also found to have porous materials (e.g., cardboard, paper, cloth; Picture 23) stored beneath them where the materials can be subject to water exposure.

**Items, including porous items and cleaning products, stored beneath sink**

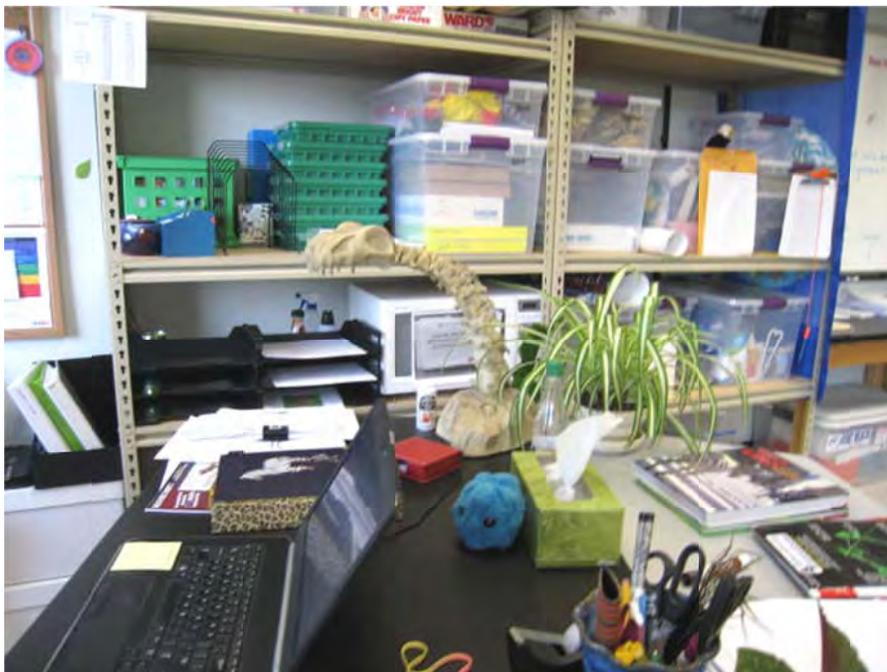
**Picture 24**

Plants and terrariums were noted in several classrooms (Table 1; Picture 24). In some cases, plants were observed near ventilation sources. Plants, soil and drip pans can serve as

**Plant in classroom**

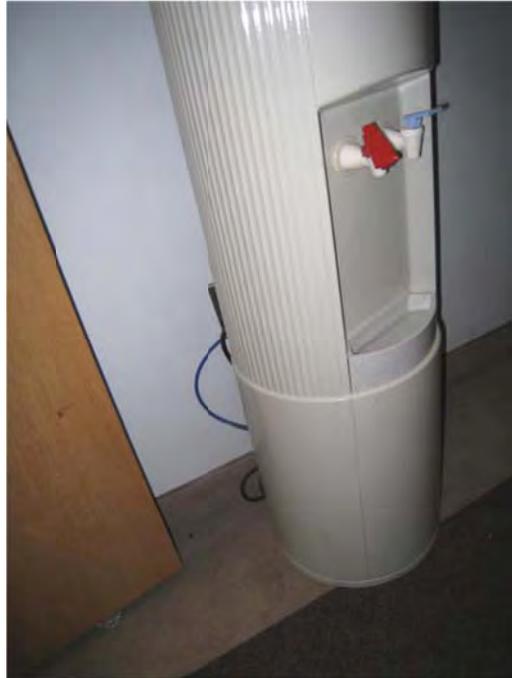
**Picture 27**

Refrigerators and water dispensing equipment were observed on carpeting (Picture 27). These appliances can leak or spill, which can moisten carpet. It is recommended that these items be located on a non-porous surface.

**Water dispenser on carpet**

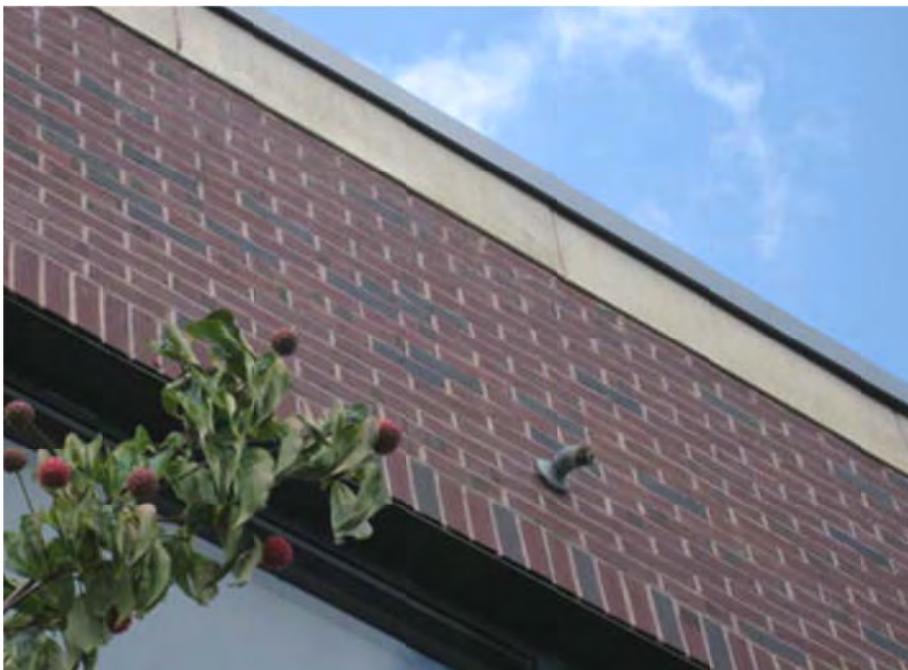
**Picture 28**

In two classrooms in Building 199, occupants reported seeing insects (likely wasps) in the classroom, and BEH/IAQ staff observed one in a classroom. One potential route of entry for wasps was noted on the outside of the building, where a pipe for the sprinkler system exited through the brick (Picture 28). It appears that there may be gaps between the pipe and the wall, which may allow insects to enter the ceiling plenum above classrooms in this area. Sealing of this and any similar space is recommended to prevent continued pest entry. A wasp nest was also observed in the eaves of Building 201. A professional exterminator may be needed to address ongoing pest issues.

**Protruding sprinkler pipe, may have annular space wide enough to admit wasps**

8. Repair sweeps and weather-stripping on exterior doors. Ensure tightness by monitoring for light penetration and drafts around doorframes.
  9. Examine and repair space around sprinkler pipe as shown in Picture 28. Seal any similar breaches in the building's exterior to prevent pest entry.

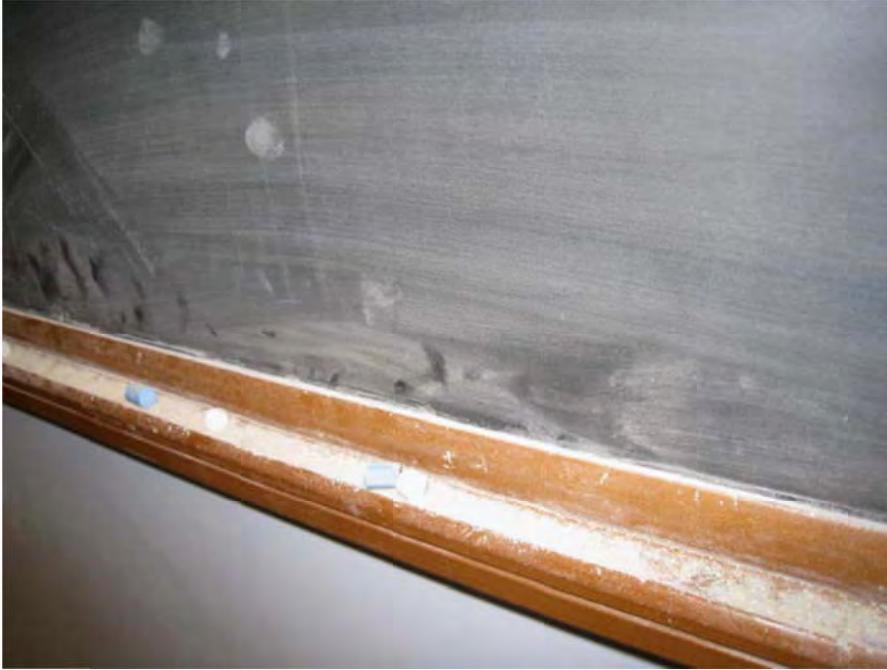
**Picture 29**

A buildup of chalk dust was observed in one classroom (Picture 29). Chalk dust may be aerosolized and become a respiratory irritant. Trays should be cleaned regularly to prevent irritation.

**Chalk dust in chalk tray**
