INDOOR AIR QUALITY ASSESSMENT

**North Reading Town Hall
235 North Street
North Reading, MA 01864**

Prepared by:
Massachusetts Department of Public Health
Bureau of Environmental Health
Indoor Air Quality Program
April 2013

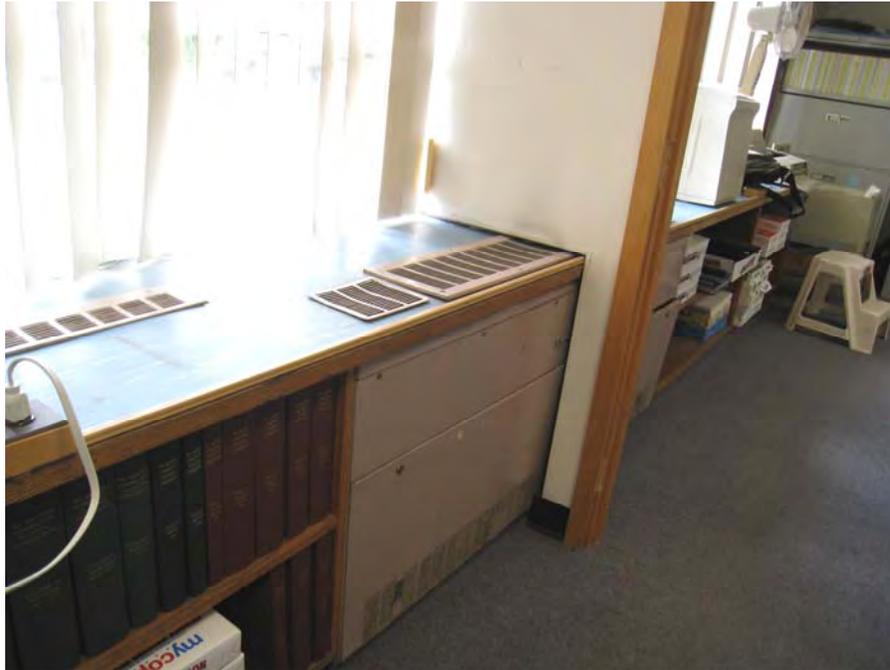
Picture 1

Fresh air to office spaces was originally supplied by unit ventilator (univent) systems (Picture 1). A univent draws outdoor air through a fresh air intake located on the exterior wall of the building (Picture 2) and returns air from the room through an air intake located at the base of the unit ([Figure 1](#)). Fresh and return air are mixed, filtered, heated, and then provided through an air diffuser located in the top of the unit. Some newer univents (installed in the 1990s) were found operating at the time of assessment but most univents were not. In a majority of areas, air diffusers, intakes and returns were obstructed by items. Univents must remain free of obstructions and be allowed to operate while rooms are occupied.

Spaces were also observed around pipes in some univent cabinets (Picture 4). These gaps should be sealed with an appropriate fire-rated material to prevent the draw of odors and materials from other areas of the building into the univent. Please note, some univents are difficult to access due to partition walls that prevent access to the main compartment (Picture 1).

Univent, note dividing wall makes access to main cabinet and filter difficult

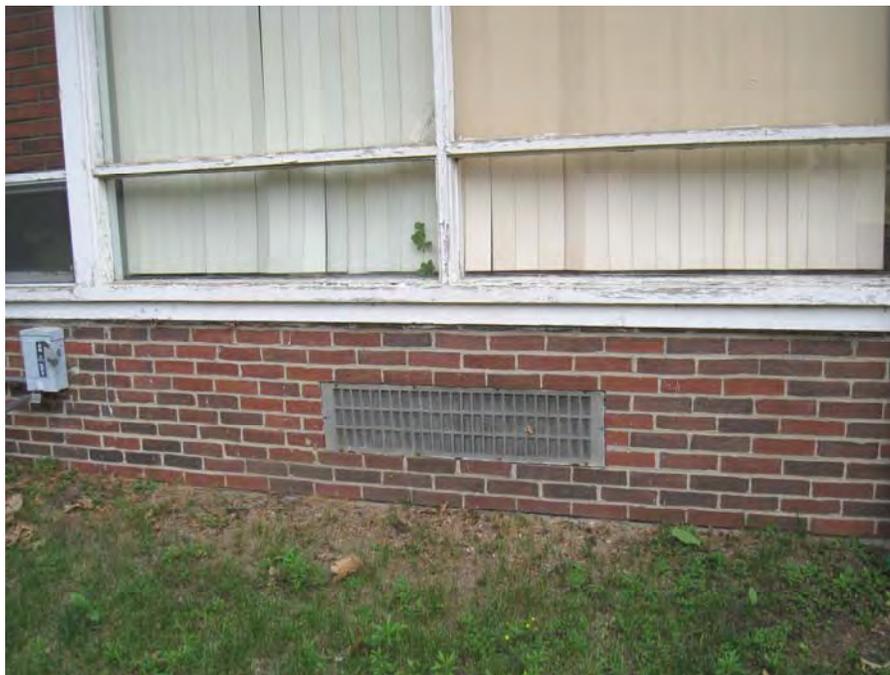
Picture 2

Univent fresh air intake

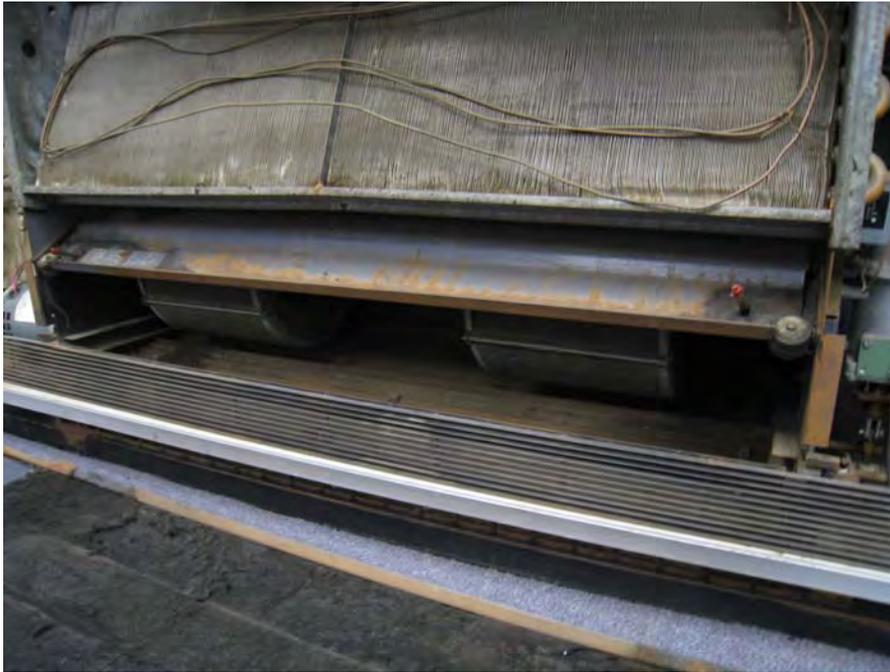
Picture 3

BEH/IAQ staff also examined the interior conditions of a few univents. Dust and debris were found accumulated inside cabinets and on radiator fins (Picture 3); this material should be removed through vacuuming during each filter change. Some univents did not have filters installed; filters are needed to remove particulates from the air before it is circulated. Disposable filters with an appropriate dust spot efficiency should be installed in univents. The dust spot efficiency is the ability of a filter to remove particulates of a certain diameter from air passing through the filter. Filters that have been determined by ASHRAE to meet its standard for a dust spot efficiency of a minimum of 40% would be sufficient to reduce airborne particulates (MEHRC, 1997; ASHRAE, 1992). Note that increased filtration can reduce airflow produced by the AHU by increased resistance. Prior to any increase of filtration, each AHU should be evaluated by a ventilation engineer as to whether it can maintain function with more efficient filters.

Main interior compartment of univent, note dust and lack of filter

6. Examine, clean and vacuum the interior of all HVAC equipment, including univents, radiators, and air-conditioning units, to prevent the aerosolization of dirt, dust and particulates. Change filters as per manufacturer's recommendation or more frequently if needed and install filters in univents lacking them. Ensure filters fit flush in their racks with no spaces in between allowing bypass of unfiltered air into the unit.

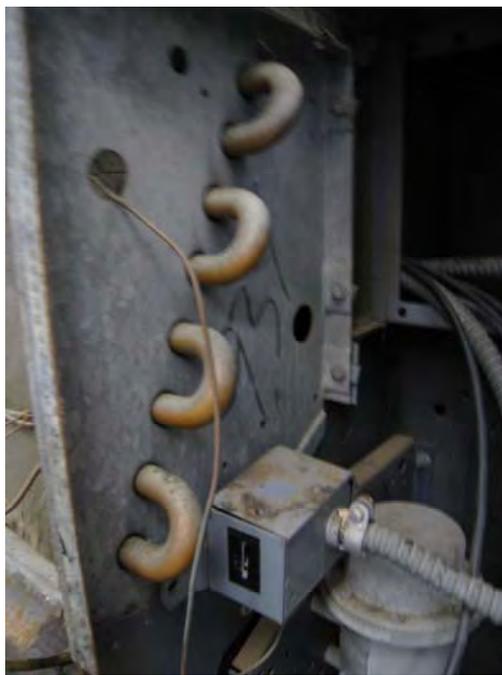
Picture 4

Spaces/breaches in the univent side cabinet

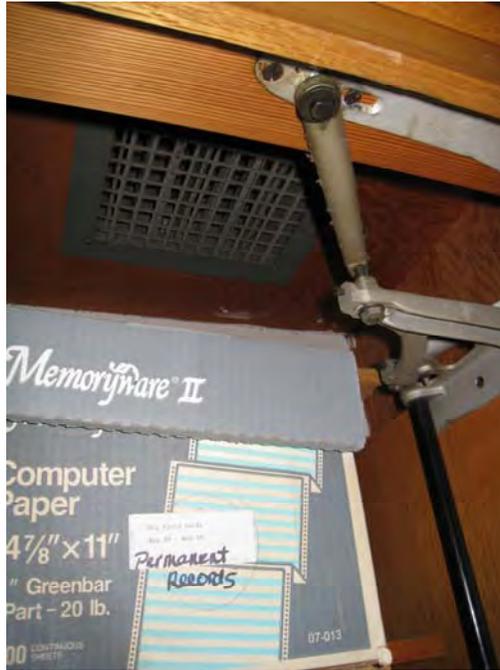
Picture 5

Exhaust ventilation in offices is provided by vents located in closets and ducted to rooftop motors (Pictures 5 and 6). The exhaust ventilation system is designed to continuously remove moisture, odors, and pollutants from the indoor environment. As with the univents, exhaust vents were not operating in the majority areas surveyed during the assessment. NRTTH Staff indicate that these exhaust vents are not operated regularly. In many areas, furniture and other items were hindering the flow of air into the exhaust vent. In order to function properly, exhaust vents must be activated and allowed to operate, without obstructions, while rooms are occupied. Without adequate exhaust ventilation, excess heat and normally occurring indoor air pollutants can accumulate, leading to indoor air/comfort complaints. Operating exhaust ventilation will not only aid removal of pollutants, but also aid air movement within the space.

Exhaust vent in closet

8. Inspect all exhaust motors and belts periodically for proper function. Repair and replace as necessary.
9. Remove all blockages from univents and exhaust vents to ensure adequate airflow. NRTTH staff should be encouraged not to deactivate univents and to report any complaints concerning temperature control to the facilities department.

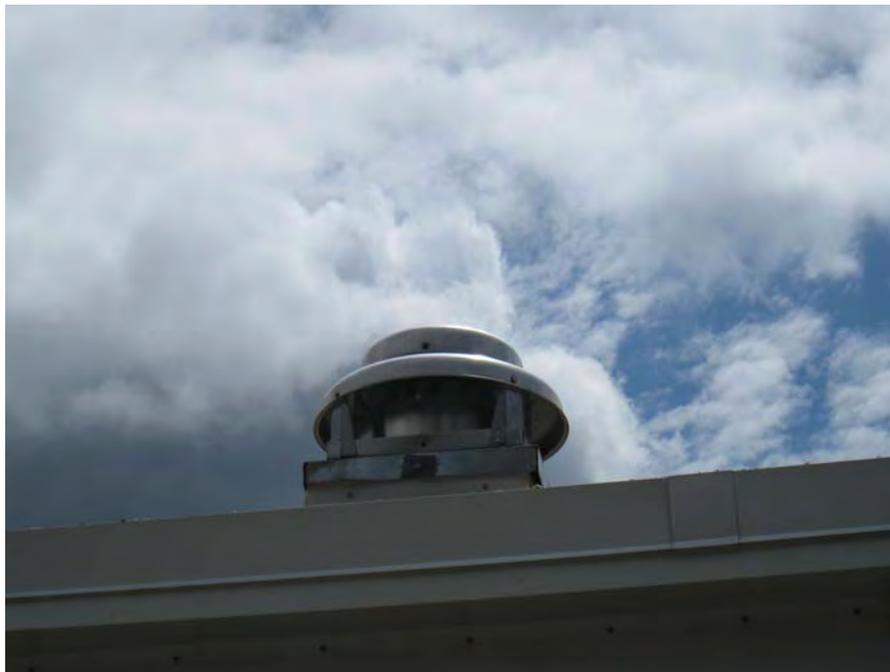
Picture 6

Rooftop exhaust fan

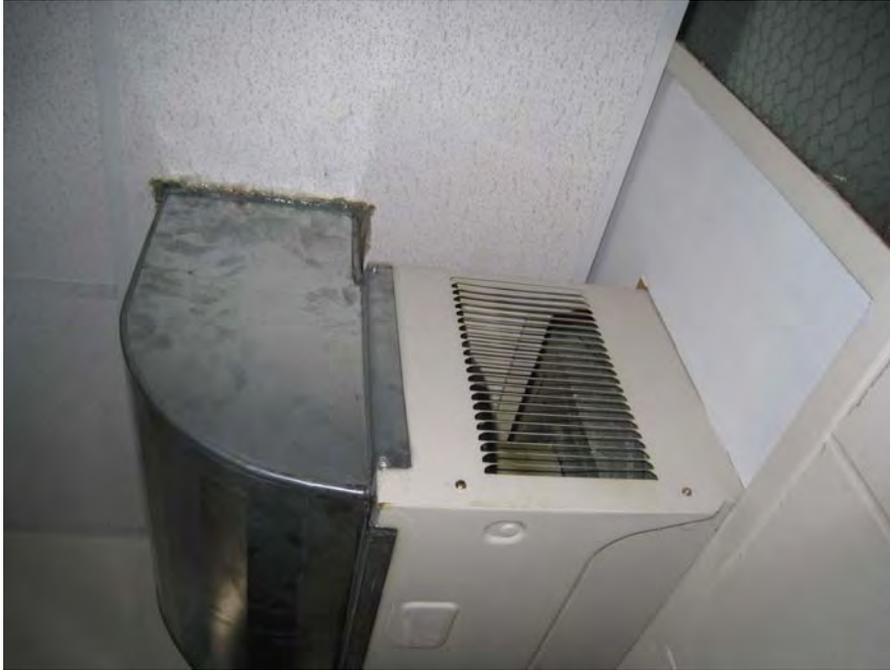
Picture 7

Air-conditioning units were installed throughout the building as a means for cooling office areas during the summer. In some areas, the units were installed through the hallway wall (Picture 7). In this configuration, air drawn from the hallway is mixed with air drawn from the cooled space before it is “re-cooled”, and provided to the office or room; warm, moist air is exhausted through ductwork to the ceiling plenum² in the building’s hallway. This configuration can result in pressurization of the ceiling plenum, resulting in movement of materials from the plenum into the occupied areas. Air-conditioning units are also equipped with washable filters, which were occluded with dust at the time of assessment (Picture 8). These filters should be cleaned periodically as per manufacturer’s instructions to avoid the build-up and re-

Air-conditioner installed through wall and ducted to hallway ceiling plenum

5. Examine walls between offices and the hallway in the plenum area to ensure they are continuous and separate the office plenum areas from hallway plenums. As discussed, the configuration of ducted exhaust for air-conditioning systems installed in the hallway can result in moistening of materials in the ceiling plenum system, which could potentially result in mold growth.

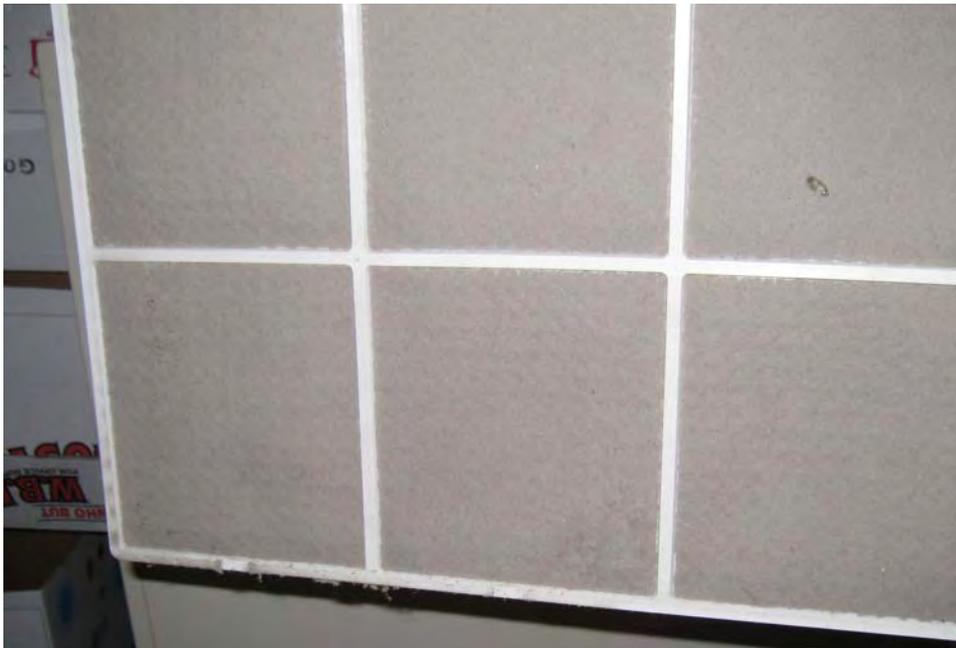
Picture 8

Air-conditioner filter occluded with dust

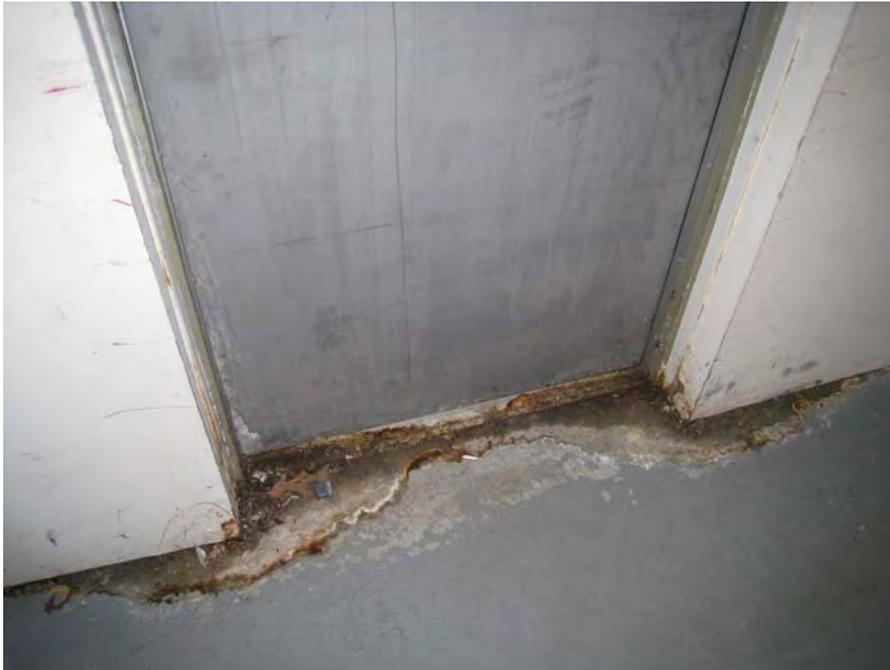
Picture 9

Evidence of water penetration through an exterior door was observed in the vault/records storage area in the Assessor's Department (Picture 9). Moisture measurements taken of gypsum wallboard (GW) revealed that the GW was wet at the time of the assessment (Picture 10). These materials have likely become wet repeatedly. GW is a porous material that can become a source of mold growth/exposure. Discoloration/staining observed on the GW suggests the presence of mold on these walls. Measures should be taken to remove and replace these damaged materials in conformance with available guidance (US EPA, 2001).

Evidence of water intrusion through door,

2. Consider re-grading the apron near the exterior door to the vault/records storage area in the Assessor's Department to prevent water infiltration into the building. Install a sweep or gasket to render the door more weatherproof.

4. Remove and replace water-damaged wallboard near the doorway in the vault/records storage area as well as behind the bookcase in the Assessor's Department office. Repair or replace the water-damaged bookcase and examine any items that were stored on it for water damage.

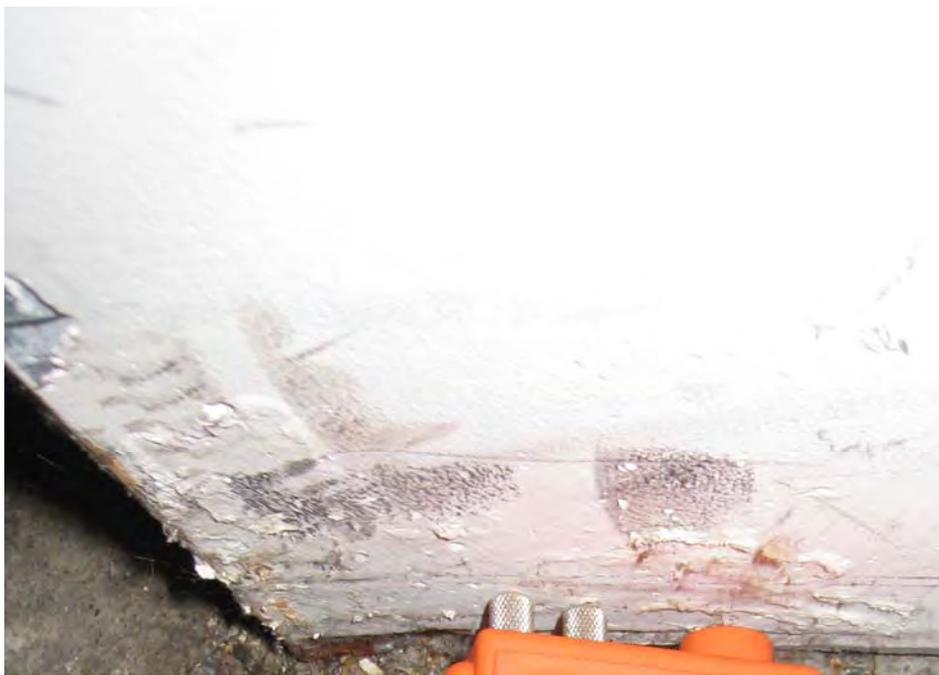
Picture 10

Discoloration/black staining and damaged paint indicated water damage to wall

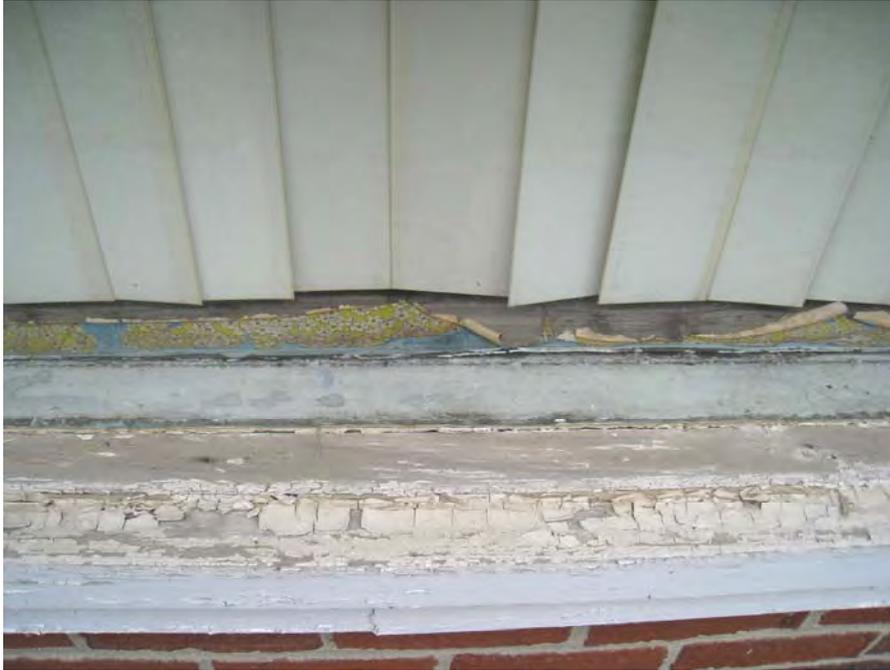
Picture 11

NRTH staff in the Assessor's Department also reported window leaks. BEH/IAQ staff examined the window and the bookcase along this wall. These original windows appeared to be single-paned glass framed in wood. Evidence of age-related damage was observed, including peeling paint, brittle caulking, and wood splintering (Picture 11). Deterioration observed around the windows, particularly missing/damaged caulking, can result in air/moisture infiltration and damage to interior building materials. Depending on its age, window (and joint) sealant may be composed of regulated materials [i.e., polychlorinated biphenyls (PCBs)]. If so, materials should be addressed in accordance with US Environmental Protection Agency (US EPA) regulations. For additional information regarding PCBs, please consult MDPH guidance (Appendix B).

Water-damaged window, note damaged pane and wood in interior

3. Re-seal damaged windows with new caulking to prevent water infiltration, particularly outside the Assessor's Department office. Remove/handle old caulking in conformance with appropriate regulations if it is found to contain regulated materials such as PCBs.

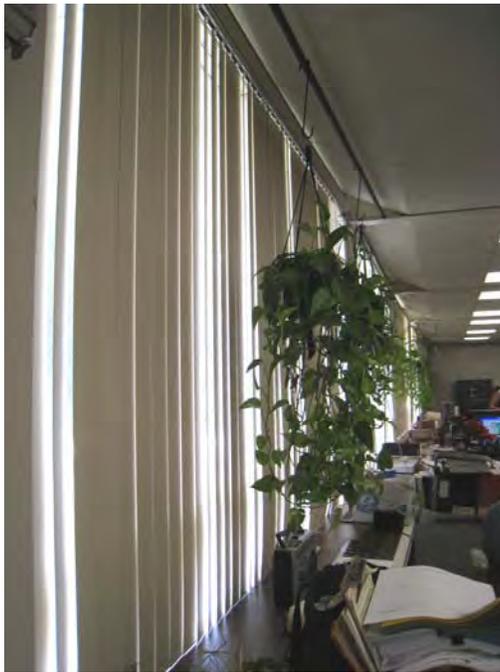
Picture 12

Several offices had a number of plants (Table 1). In some areas, plants were placed directly on or hanging above heating and ventilation equipment (Picture 12), which can result in debris dropping into the equipment. Moistened plant soil and drip pans can be sources of mold spores. Plants should be equipped with drip pans; the lack of drip pans can lead to water pooling and mold growth. Plants are also a source of pollen and should be located away from the air stream of air diffusers to prevent the aerosolization of mold, pollen or particulate matter throughout the room.

Hanging plants, note univent and radiator vents below

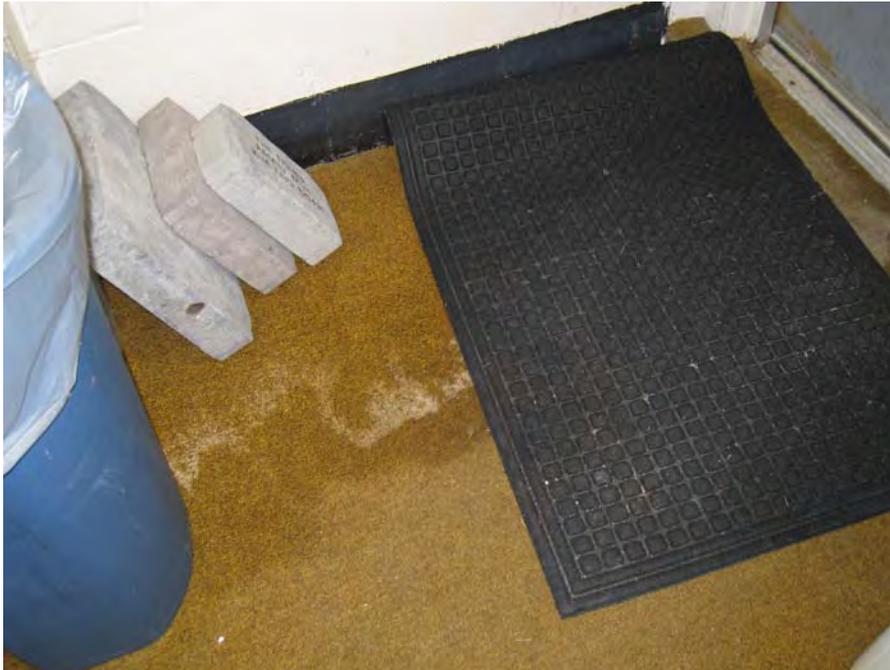
Picture 13

Water-stained carpet was observed in a few areas (Pictures 13 and 14), likely contributing to the musty odors observed in the carpeted areas. Spills from a water dispenser placed on the carpet likely resulted in the staining shown in Picture 14. Carpeting moistened for a prolonged period of time can lead to mold growth. When possible, water-dispensing units should be located in tiled areas or placed on a waterproof mat that can catch spilled water.

Water-damaged carpet

22. Clean carpeting regularly and consider replacing worn/stained carpeting with carpet squares or floor tiles.

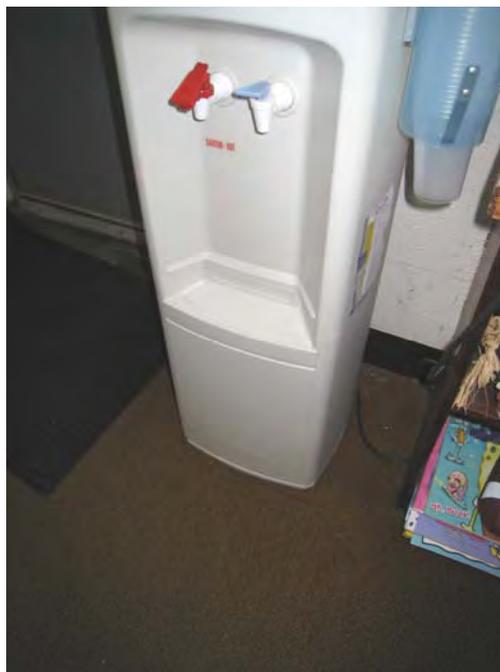
Picture 14

Water dispenser on water-stained carpet

17. Equip water-dispensing equipment with waterproof mats or move these items to a non-carpeted area.
18. Refer to “Mold Remediation in Schools and Commercial Buildings” published by the US Environmental Protection Agency (US EPA, 2001) for information concerning mold growth and remediation of water-damaged materials. This document can be downloaded from the US EPA website at: http://www.epa.gov/iaq/molds/mold_remediation.html.

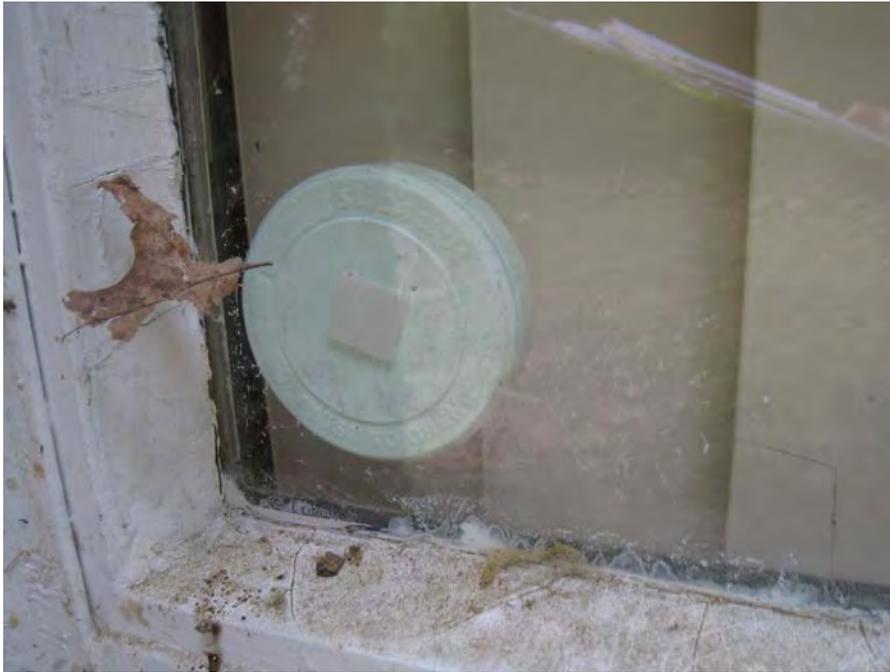
Picture 15

Air fresheners/deodorizers were observed in some areas (Picture 15). Air fresheners contain chemicals that can be irritating to the eyes, nose and throat of sensitive individuals. Further, air fresheners do not remove materials causing odors, but rather mask odors which may be present in the area.

Air freshener on window

20. Refrain from using air fresheners or other air deodorizers to prevent exposure to VOCs.
21. Use the principles of Integrated Pest Management to reduce impacts from pests inside the building, including sealing openings and preventing pest access to food and water in the building. Additional resource materials for building managers can be found on the Massachusetts Department of Agricultural Resources webpage at:
<http://www.mass.gov/eea/docs/agr/pesticides/publications/ipm-kit-for-bldg-mgrs.pdf>

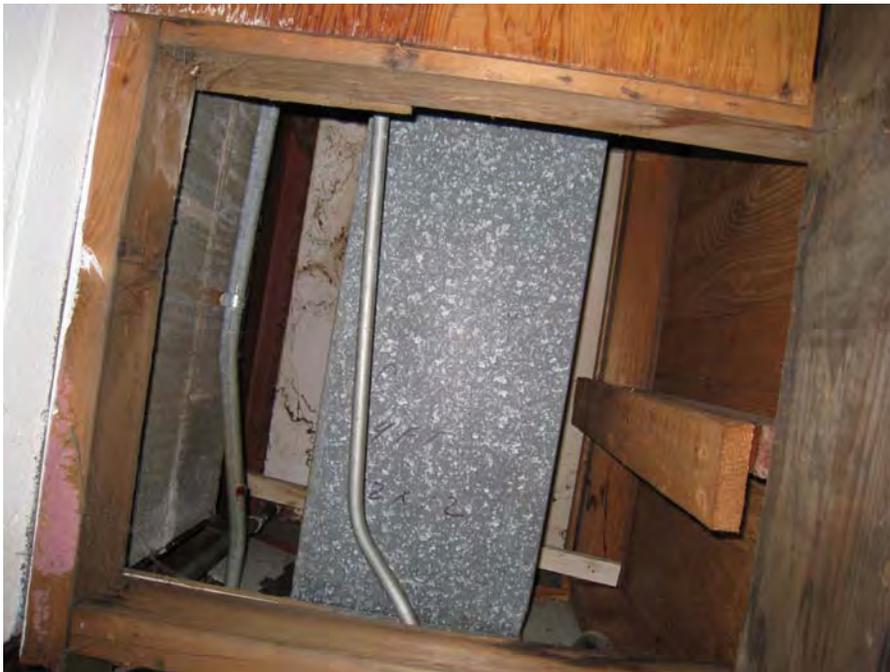
Picture 16

Breaches were observed around exhaust ductwork; ceiling panels in some closets were also missing (Picture 16). Breaches and missing panels should be sealed/replaced to prevent movement of materials/debris into occupant areas.

Missing panel in closet exposing ductwork

10. Replace missing components in the ceiling in closets to prevent movement of materials through breaches into occupied areas.
11. Use openable windows in conjunction with mechanical ventilation to increase air exchange. Care should be taken to ensure windows are properly closed at night and weekends to avoid the freezing of pipes and potential flooding.
