INDOOR AIR QUALITY REASSESSMENT

**Hampshire County Family and Probate Court
33 King Street
Northampton, Massachusetts**

Prepared by:
Massachusetts Department of Public Health
Bureau of Environmental Health
Indoor Air Quality Program
October 2013

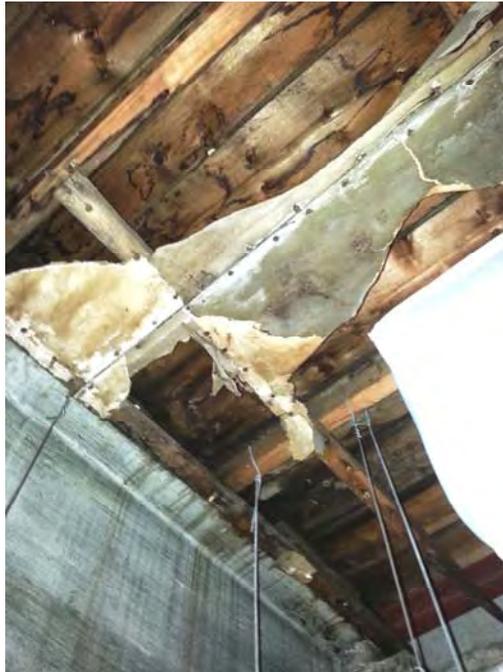
Picture 1

The ceiling has experienced repeated water damage to GW in the ceiling plenum according to building occupants (Pictures 1 and 2). As previously mentioned, the building does

not appear to be equipped with a fire suppression system. It seems likely that GW has been installed on the underside of wood roof/floor decking to provide a fire barrier. With the ceiling tiles removed and GW missing, the wood roof decking is exposed and has no fire protection.

Water damage to GW in the ceiling plenum above the Probation office

4. Increase nightly cleaning of Probation office areas during the course of renovations.
5. Water-damaged GW in the ceiling plenum should be removed/replaced.

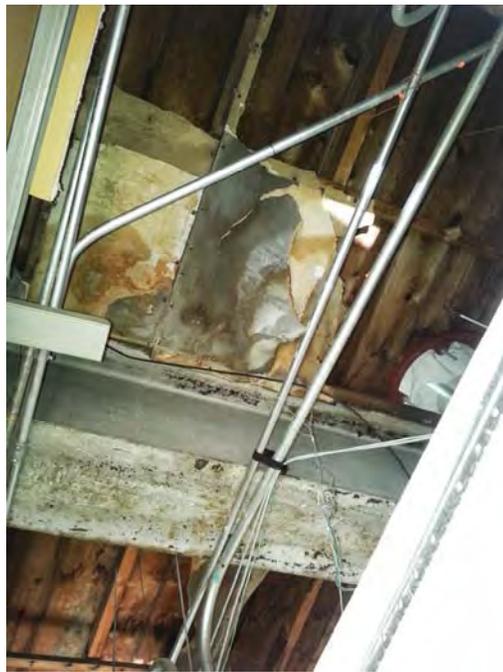
Picture 2

Water damage to GW in the ceiling plenum above the Probation office

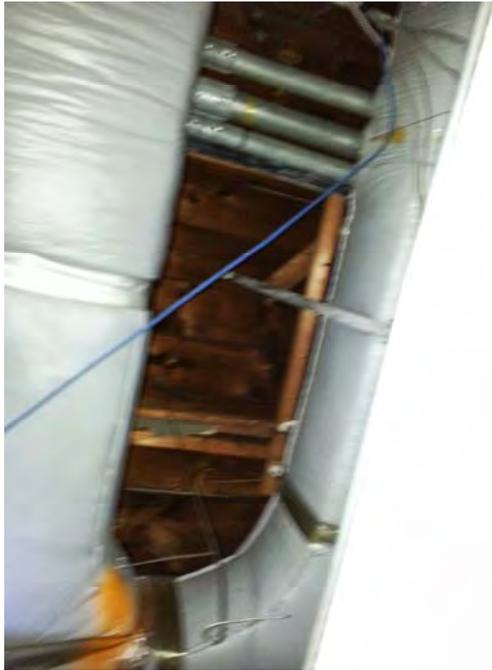
Picture 3

BEH/IAQ staff conducted a visual inspection of the supply ductwork in the Probation office and did not observe any water damage to duct insulation (Pictures 3 through 5). BEH/IAQ staff did note water staining on an insulated pipe in the ceiling plenum (Picture 6); however no mold growth was observed. It is important to note that similar ductwork was not examined in other areas of the building. Aside from microbial concerns, if insulation is visibly water-damaged, this may result in a reduction of the efficiency of the insulation.

Duct insulation

6. Examine supply ductwork and pipe insulation and replace if visibly water-damaged.
7. Ensure that the HVAC system operates at an appropriate temperature to prevent condensation.

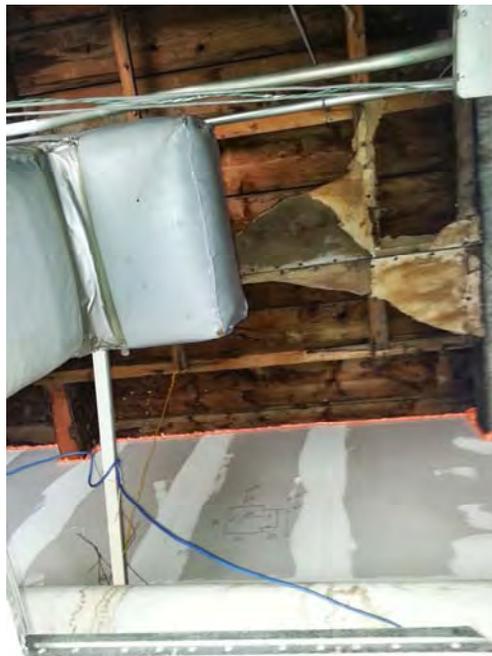
Picture 4

Duct insulation

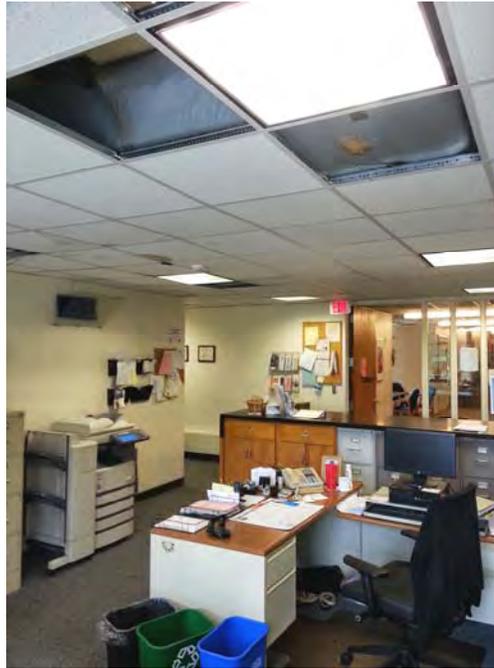
Picture 5

Duct insulation

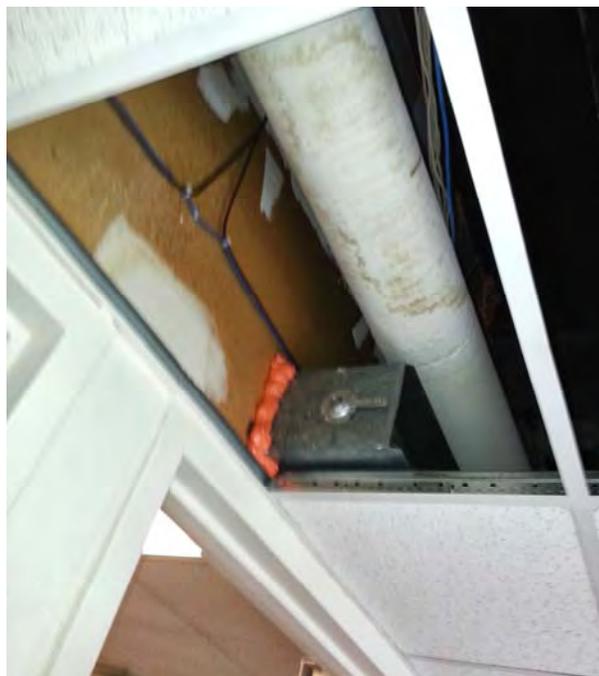
Picture 6

Water staining on insulated pipe in the ceiling plenum

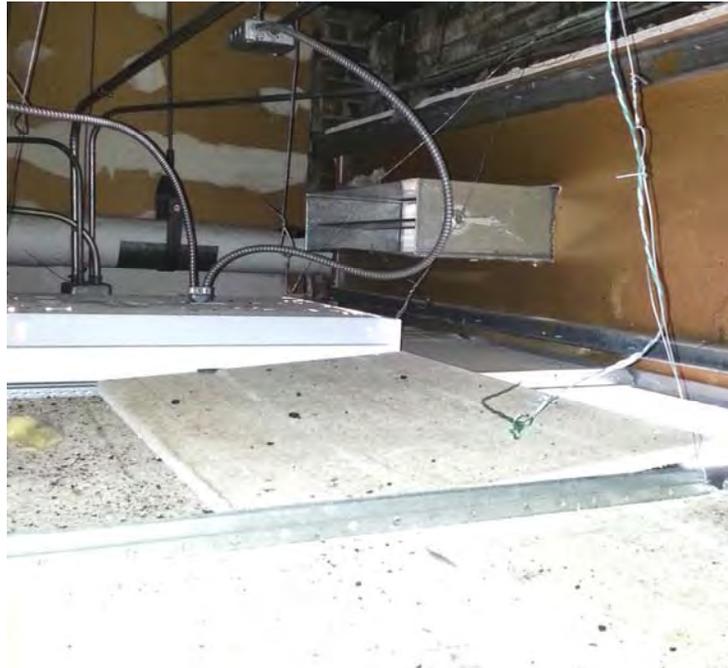
Picture 7

Ceiling plenum intake vents

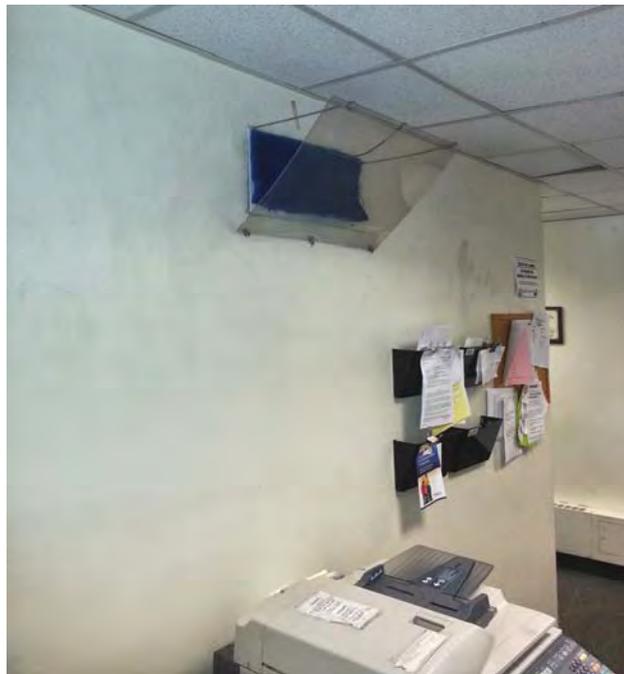
Picture 8

Likely location of vent closest to the rooftop AHU in the main Probation office
