INDOOR AIR QUALITY ASSESSMENT

**Quincy District Court
District Court of Eastern Norfolk
One Dennis F. Ryan Parkway
Quincy, Massachusetts**

Prepared by:
Massachusetts Department of Public Health
Bureau of Environmental Health
Indoor Air Quality Program
May 2013

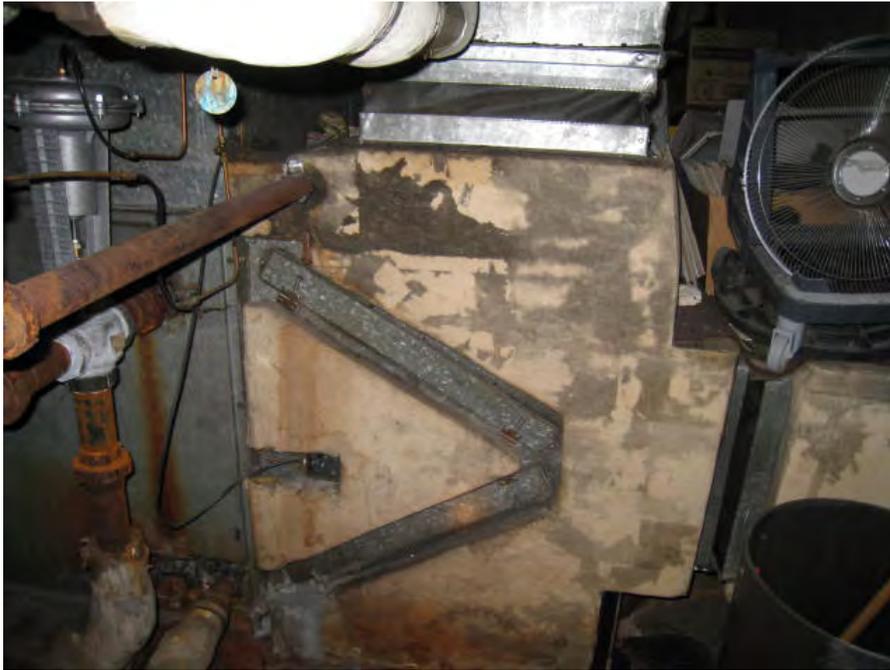
Picture 1

Air handling unit in mechanical room

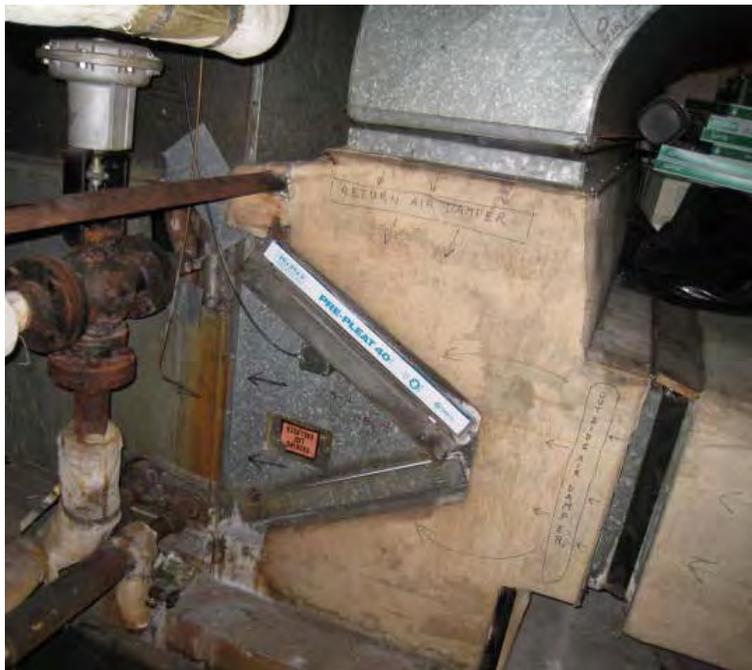
Picture 2

reportedly changed four times a year under a preventative maintenance plan by a private HVAC engineering firm. Although filters were clean and appeared to have been recently changed, a number of the filters access panels were in disrepair, did not close properly and/or were missing latching mechanisms (Pictures 2, 19 and 20). Open/improperly closing access panels will render the AHU casing non-airtight and draw air from the mechanical room into the unit. As air bypasses filters, the opportunity exists for airborne dirt, dust, odors, particulates and in this case, damaged fiberglass insulation (Picture 20), to be drawn into the HVAC system and be distributed to occupied areas. Aerosolized dust, particulates and odors can provide a source of eye, skin and respiratory irritation to certain individuals. In addition, these materials can accumulate on flat surfaces in occupied areas and subsequently be re-aerosolized causing further irritation.

Air handling unit in mechanical room, note open filter access panel

3. Contact an HVAC engineering firm to repair/replace filter access panels on AHUs, to ensure they close tightly to prevent bypass of unfiltered air.
4. Do not store items on top of AHUs/ductwork (Picture 25).

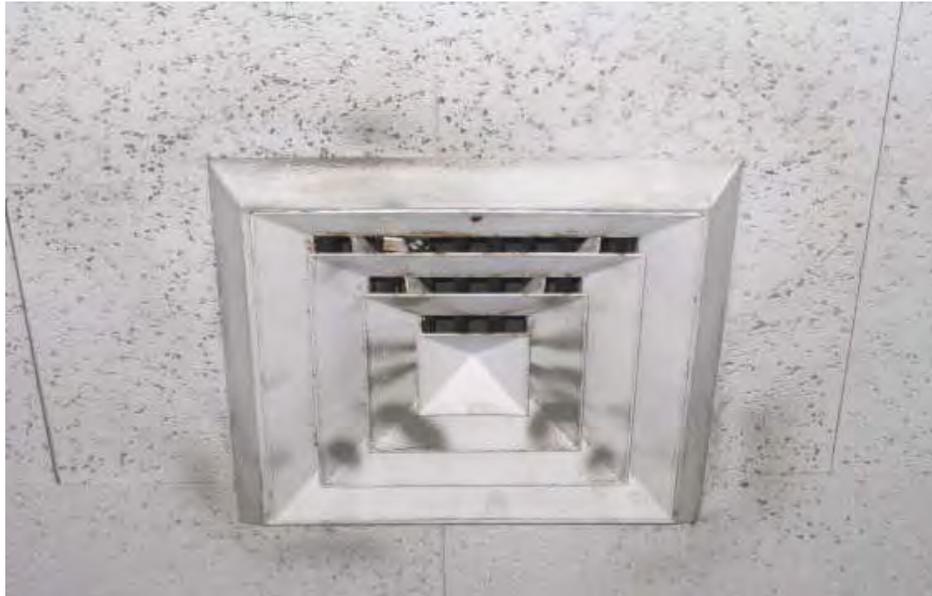
Picture 3

A number of flat surfaces (e.g., shelving, carpeting), air diffusers, exhaust, return vents and, in some cases, adjacent ceiling tiles/surfaces throughout the building were observed to have accumulated dust/debris (Pictures 3 through 7). If exhaust/return vents are not functioning, backdrafting can occur, which can re-aerosolize accumulated dust particles. Re-activated supply vents can re-aerosolize dust accumulated on louvers and adjacent surfaces causing further irritation.

Ceiling-mounted supply diffuser, note accumulated dust/debris on vent and surrounding ceiling tiles

17. Clean air diffusers, exhaust, return vents and surrounding ceiling tiles/surfaces periodically of accumulated dust/debris. If soiled ceiling tiles cannot be cleaned replace.

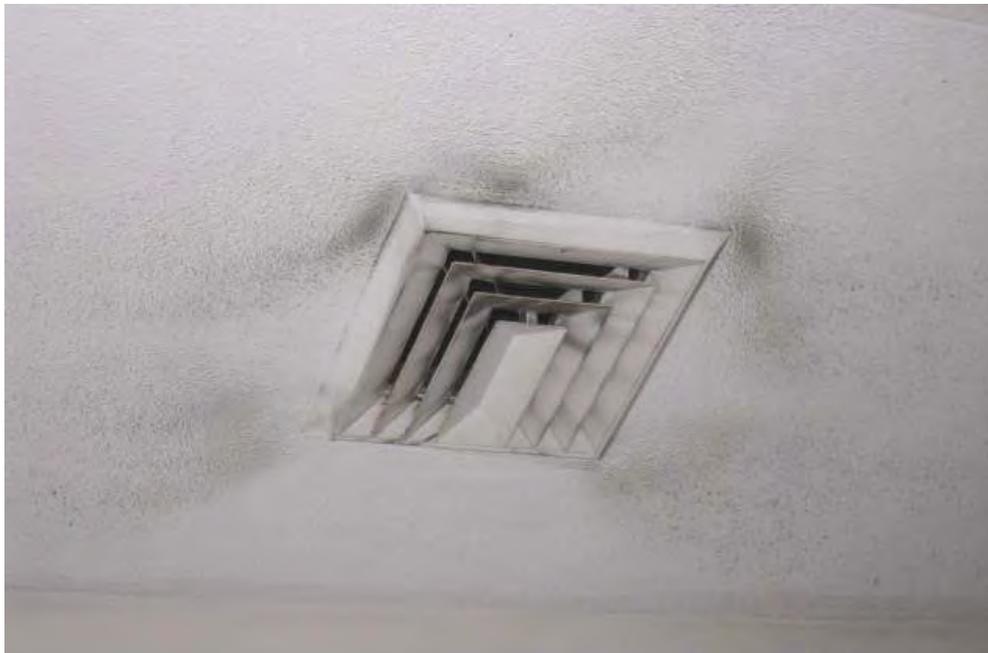
Picture 4

Ceiling-mounted supply diffuser, note accumulated dust/debris on vent and surrounding ceiling tiles

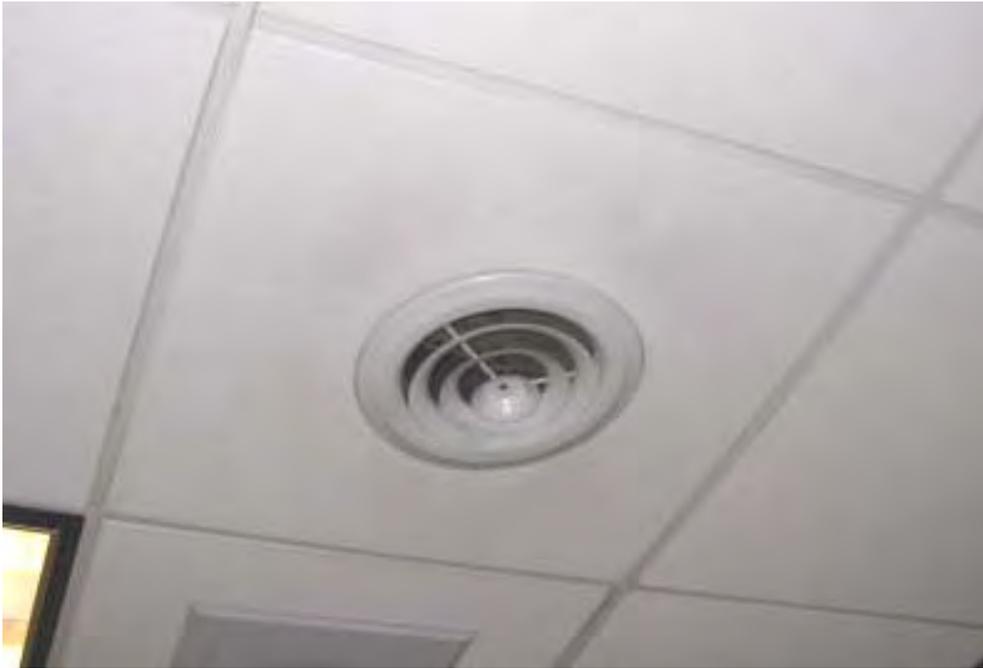
Picture 5

Ceiling-mounted supply diffuser

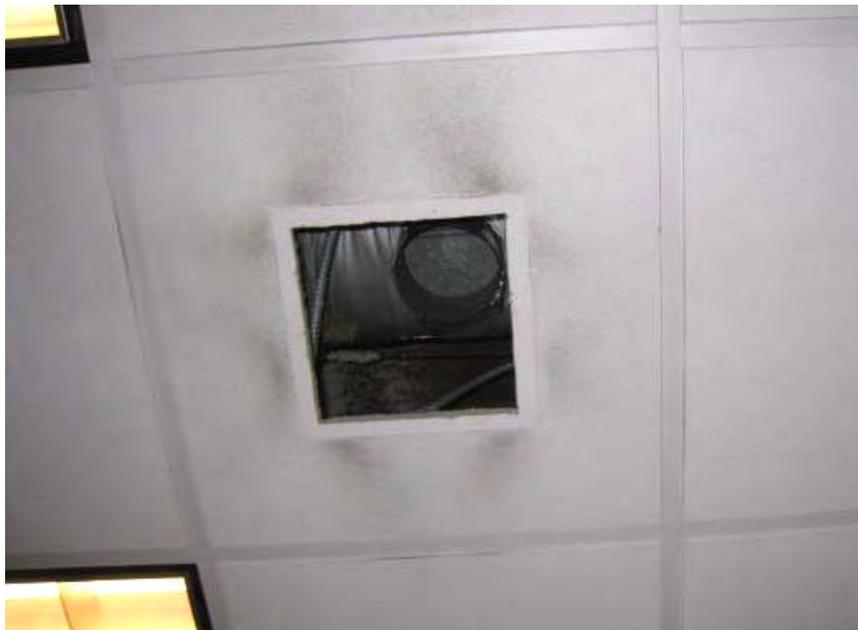
Picture 6

Missing ceiling-mounted supply diffuser in juvenile probation department, note accumulated dust/debris on surrounding ceiling tiles

8. Replace supply diffuser in Juvenile Probation Office.
9. Due to reported overcrowding, staff from the Juvenile Probation Office should work with building management and QDC administration to discuss possible alternative space options.

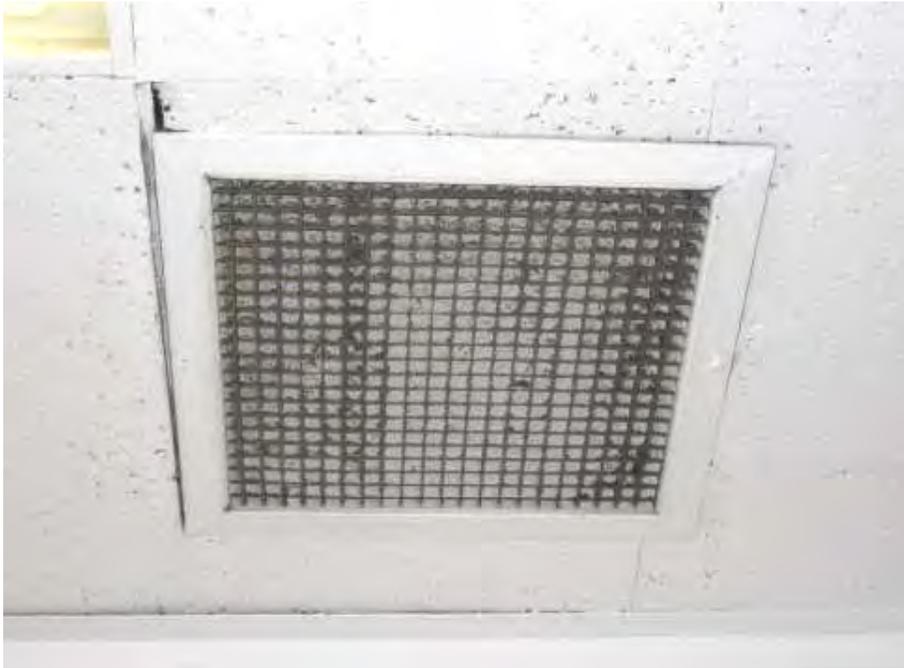
Picture 7

Ceiling-mounted return vent, note accumulated dust/debris

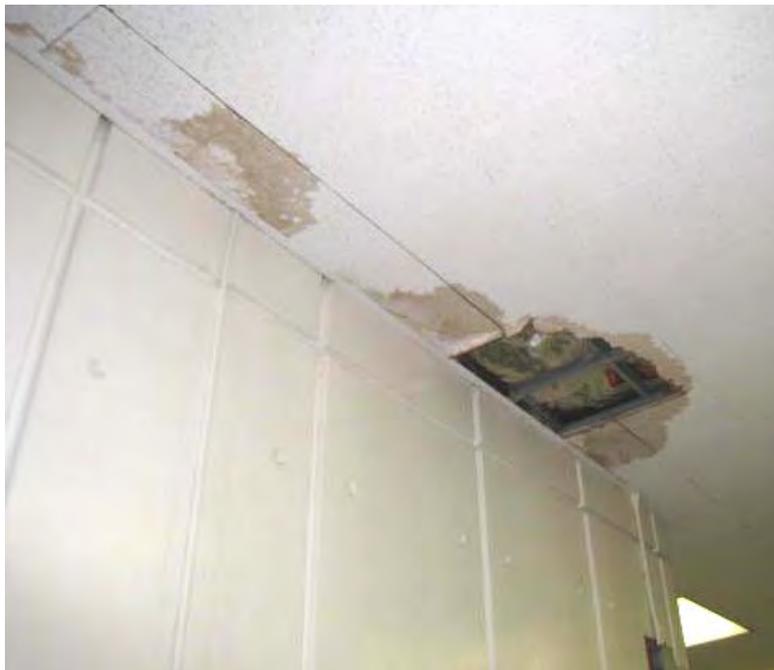
Picture 8

A number of areas had water-damaged ceiling tiles (Table 1; Pictures 8 through 12). Water-damaged ceiling tiles indicate leaks from either the roof or plumbing system and can provide a source for mold growth. Water-damaged ceiling tiles should be replaced after a water leak is discovered and repaired. Active leaks were observed in two areas during the assessment, the Juvenile Clerk's office (Pictures 13 and 14) and Probation Office, which reportedly occurred during heavy wind-driven rain conditions (Pictures 15 through 18).

Missing/damaged ceiling tiles were noted in a number of areas throughout the building, where fiberglass insulation was exposed (Pictures 8, 9, 10 and 13). Missing ceiling tiles and open holes in floors/walls can provide a means of transport for odors, fumes, dusts and vapors between rooms and floors. Fiberglass insulation can be a source of skin, eye and respiratory irritation. As previously mentioned, the supply vent in the basement Juvenile Probation Office was removed (Picture 6), which allows air from the duct to disturb dust, debris and particles in the ceiling plenum.

Missing/water-damaged ceiling tiles in 2nd floor hallway, note exposed fiberglass insulation

14. Consider removing carpeting in areas of leaks and replacing with a non-porous surface (e.g., tile).
15. Ensure that all missing/damaged ceiling tiles are replaced and that they fit snugly within their frames.

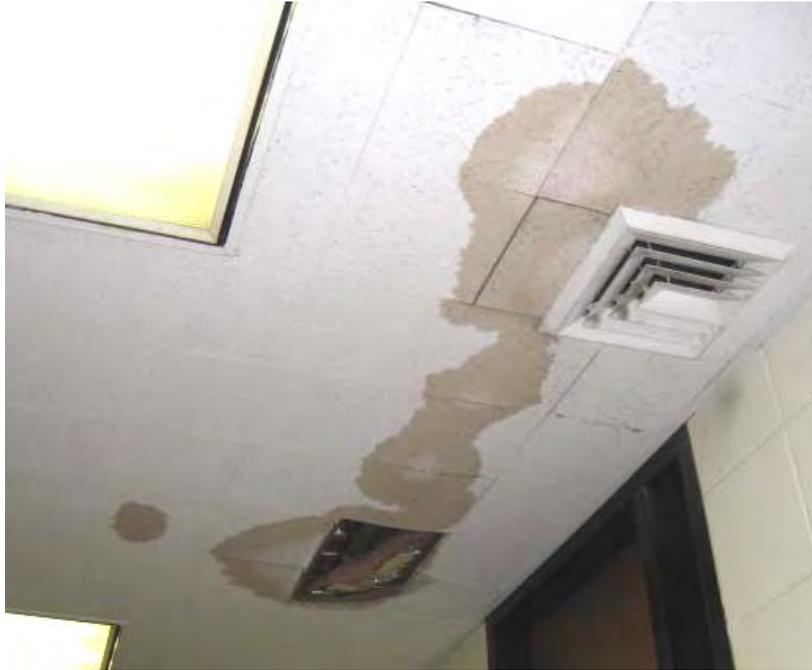
Picture 9

Missing/water-damaged ceiling tiles in 2nd floor hallway, note exposed fiberglass insulation

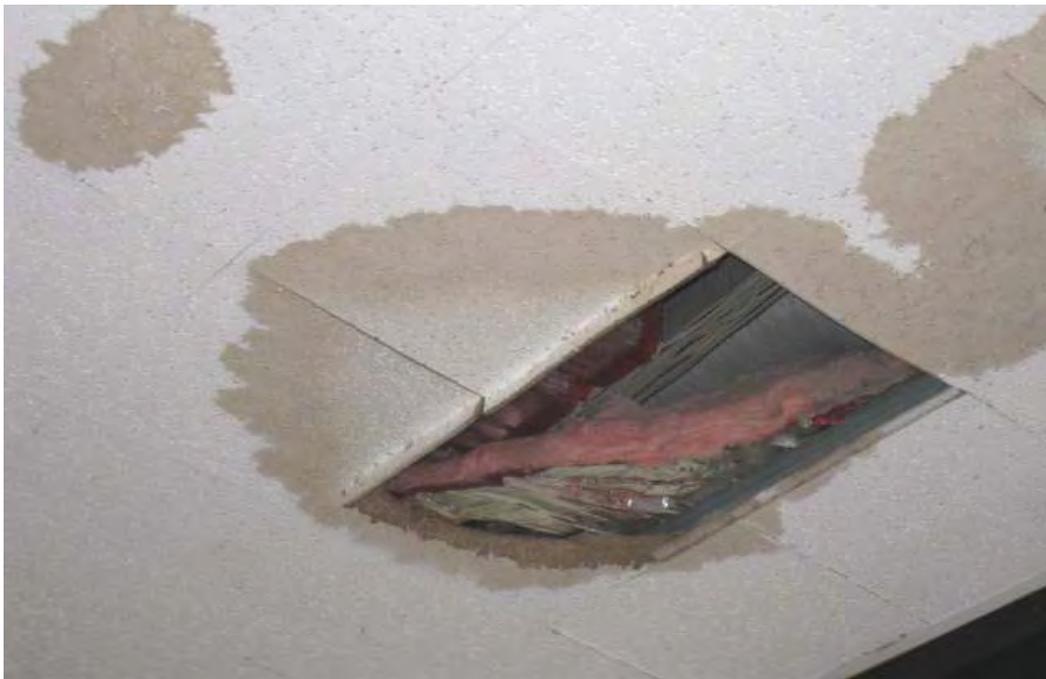
Picture 10

Missing/water-damaged ceiling tiles in 2nd floor hallway, note exposed fiberglass insulation

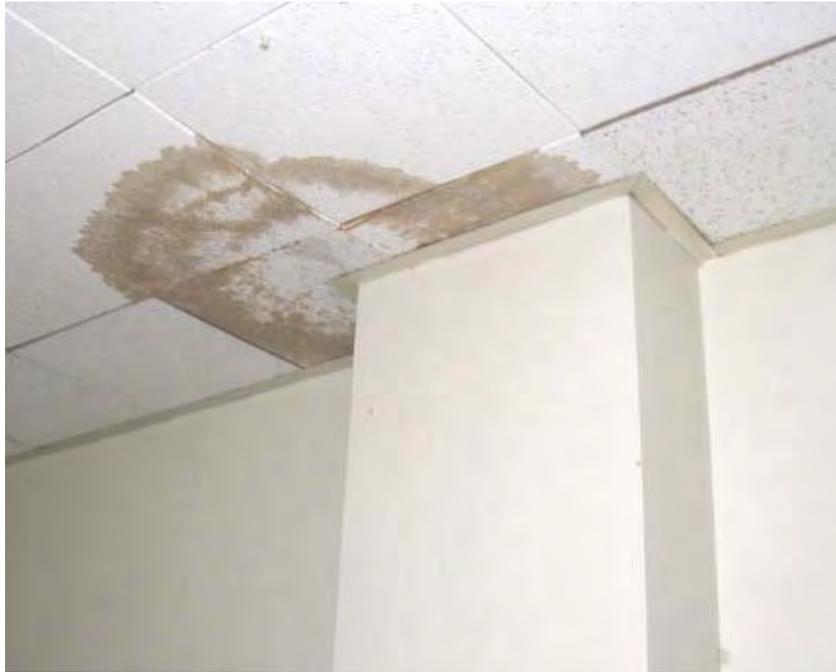
Picture 11

Water-damaged ceiling tiles

13. Continue to monitor areas of the building for roof/building envelope leaks, replace or make repairs to water-damaged building materials (e.g., ceilings and walls). Examine the area above and around these areas for mold growth. Disinfect areas of water leaks with an appropriate antimicrobial as needed. Avoid placing/storing porous and sensitive materials (e.g., power strips) in areas where leaks are known to occur.

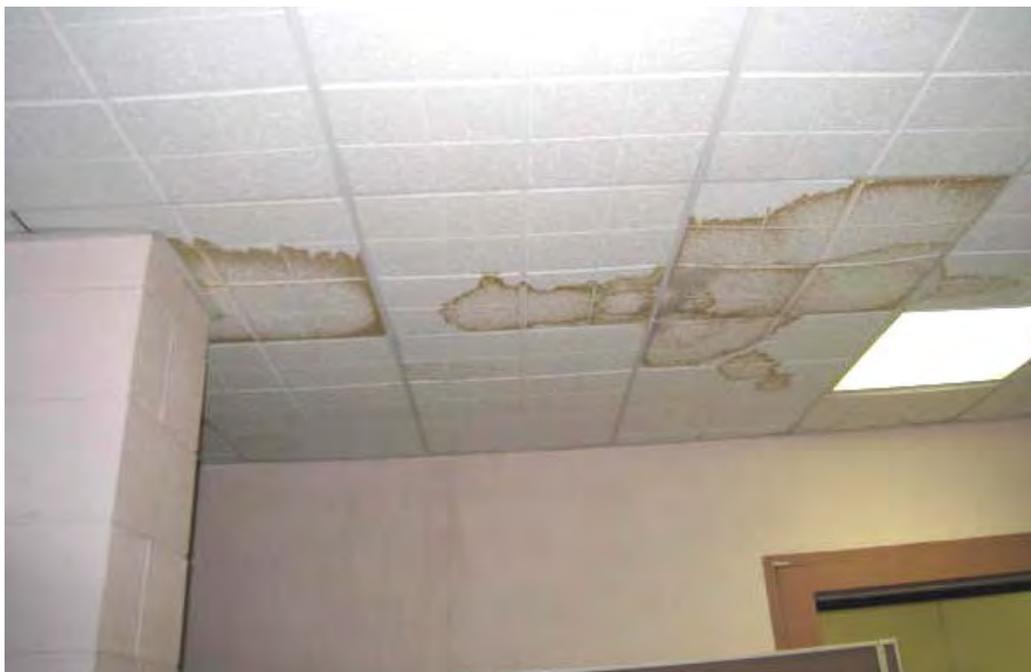
Picture 12

Water-damaged ceiling tiles

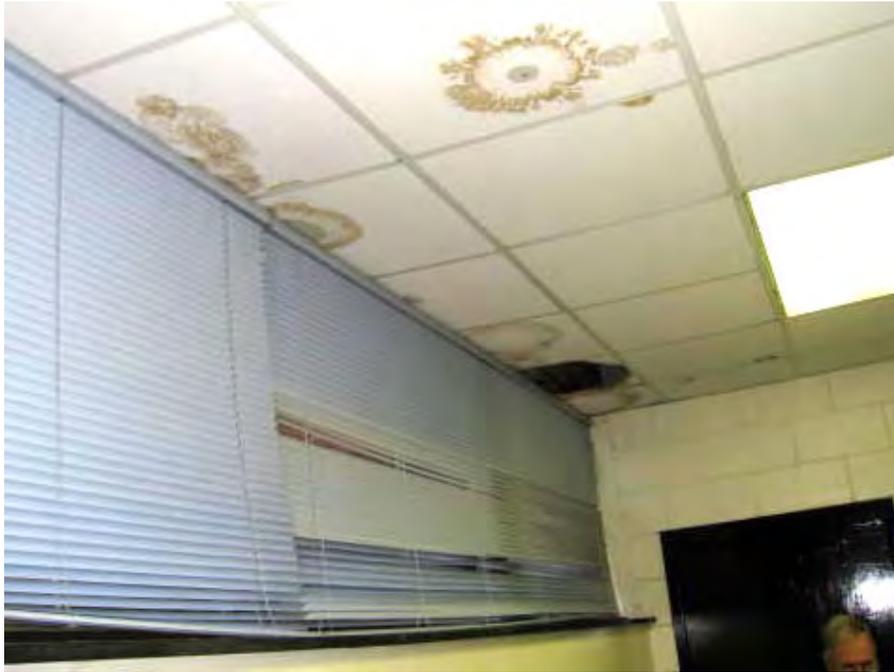
Picture 13

Water-damaged ceiling tiles, site of active leak in Juvenile Clerk's Office

12. Consult a building engineer/building envelope specialist about possible options to eliminate water infiltration in areas of chronic leaks (e.g., Probation and Juvenile Clerk's Offices).

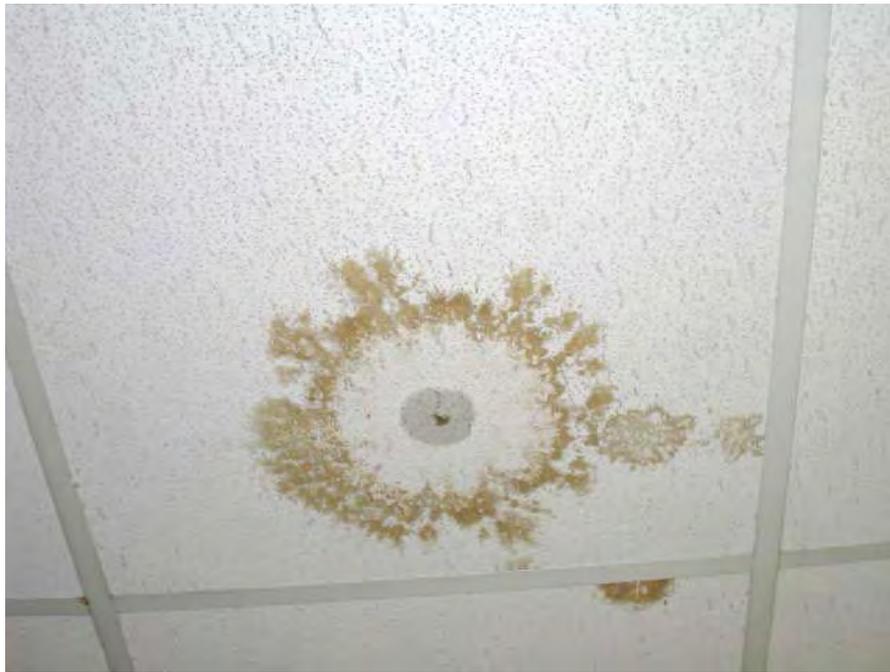
Picture 14

Active leak in Juvenile Clerk's Office

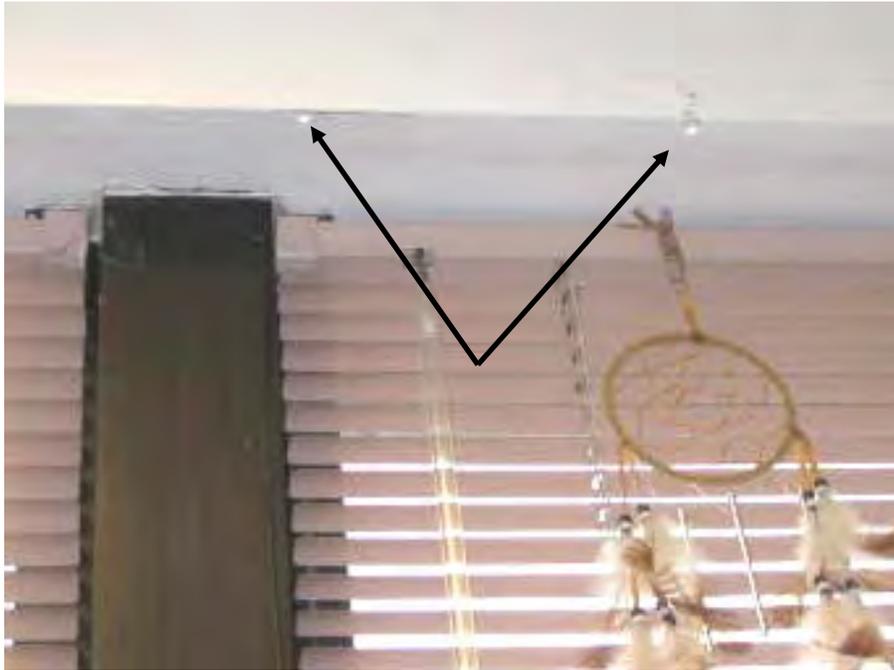
Picture 15

Active leaks in Probation Office, note water dripping from above windows (arrows)

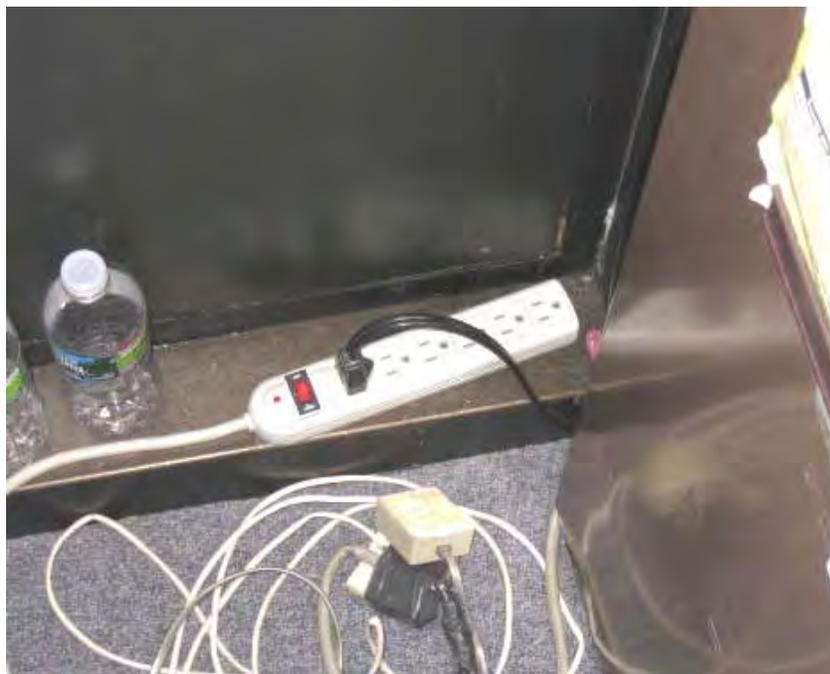
Picture 16

Active leak in Probation Office dripping on power strip and carpeting

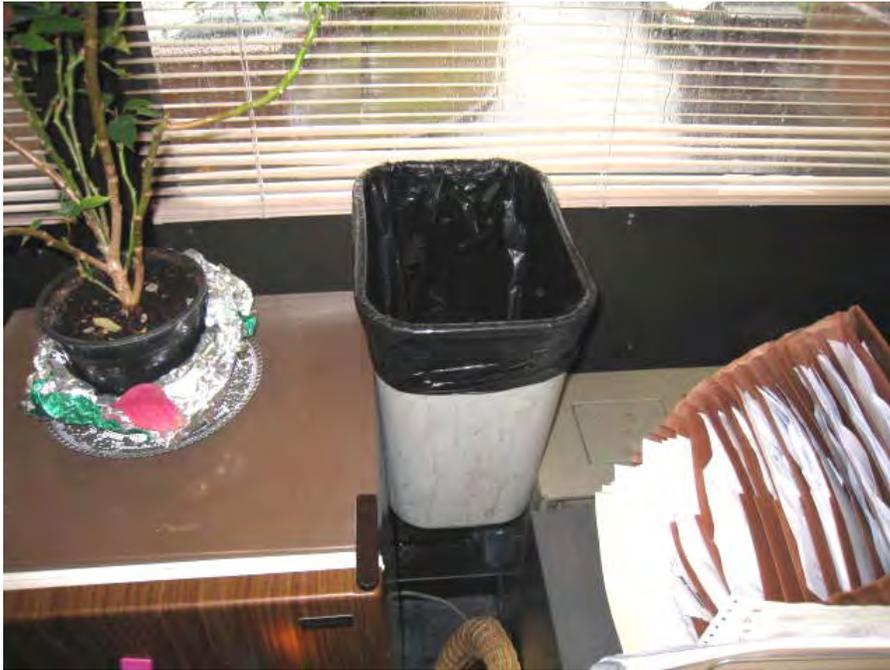
Picture 17

Waste basket catching leaking water in Probation Office

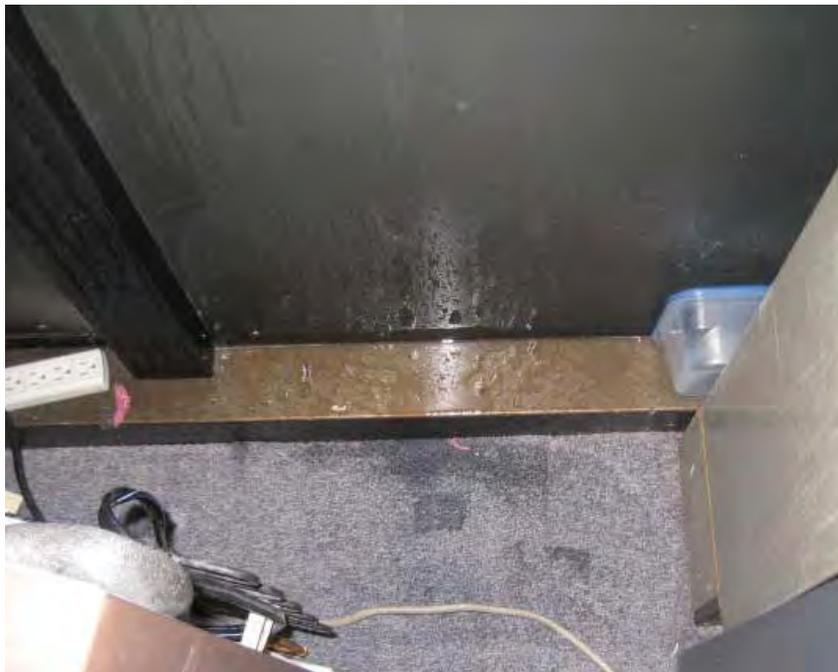
Picture 18

Wet carpeting and wall from leak in Probation Office

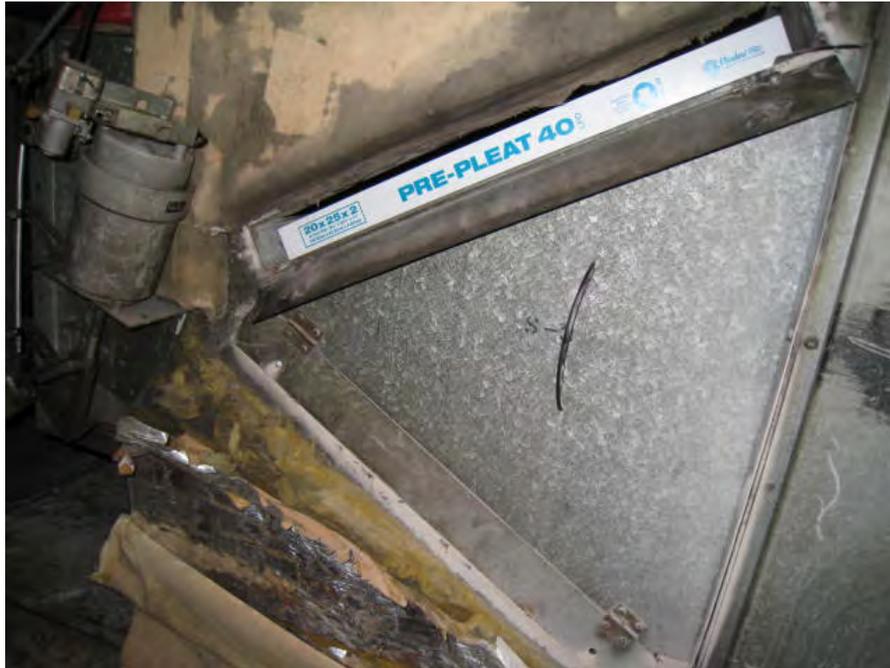
Picture 19

Other conditions that can affect indoor air quality were observed during the assessment. The HVAC filters installed at the QDC are high efficiency-pleated filters (Picture 19) that are

Filter access panel left open

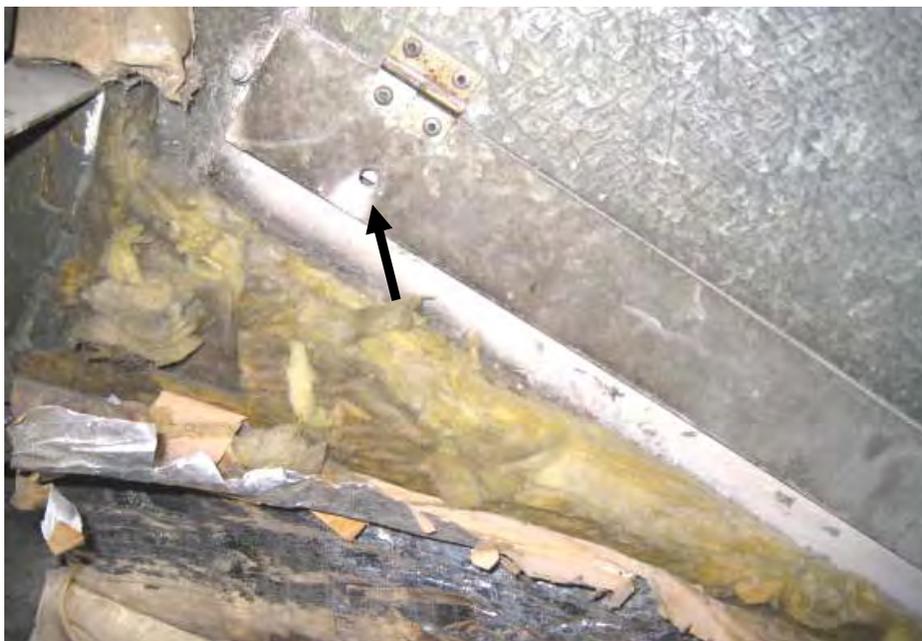
Picture 20

Filter access panel ajar due to missing latching mechanism (arrow), note damaged fiberglass insulation directly below open access panel

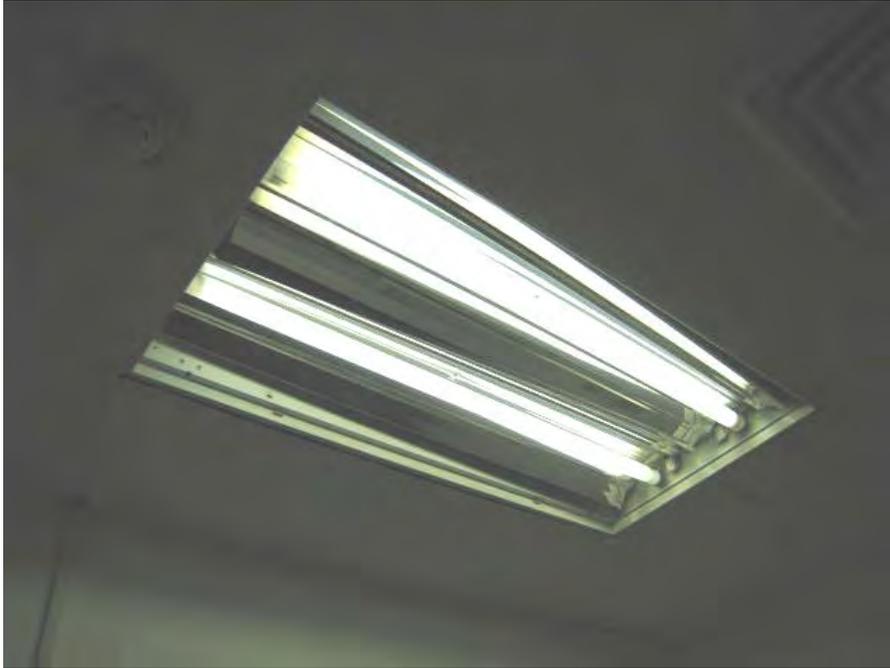
Picture 21

Ceiling-mounted florescent light fixtures were missing covers in a number of areas throughout the building (Table 1, Picture 21). Fixtures should be equipped with access covers installed with bulbs fully secured in their sockets to prevent accidental breakage. Breakage of glass can cause injuries and may release mercury and/or other hazardous compounds.

Florescent light fixture missing protective panel

18. Replace covers for florescent light fixtures.
19. If not already addressed, contact a licensed asbestos abatement contractor/or qualified personnel to identify and remediate exposed pipe insulation in mechanical rooms in conformance with all applicable Massachusetts asbestos abatement and hazardous materials disposal laws.

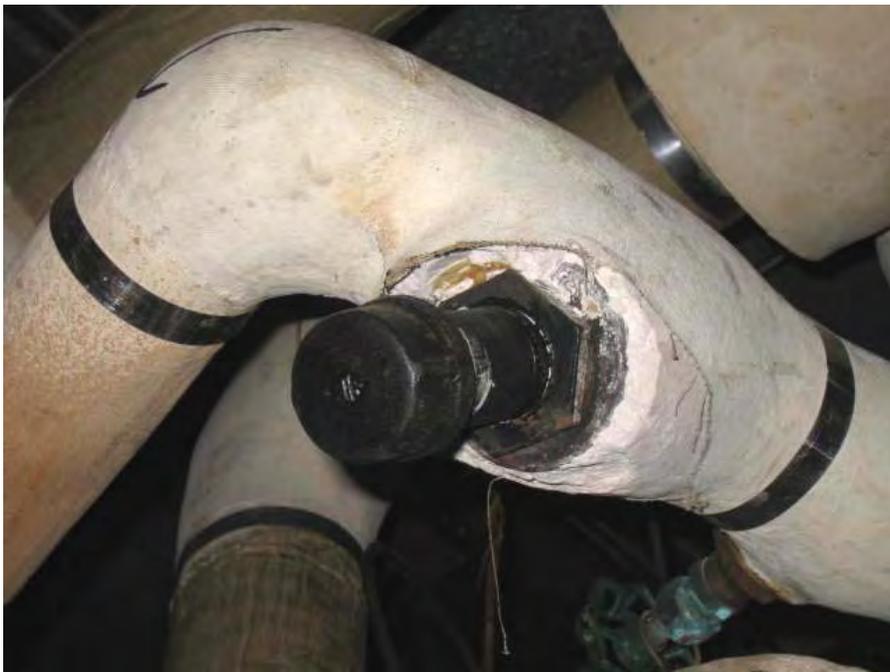
Picture 22

Finally, exposed insulation material around pipes that may contain asbestos was observed in the HVAC mechanical rooms (Pictures 22 through 24). Although exposed, the material appeared to be intact. Intact asbestos-containing material (ACM) does not pose a health hazard. If damaged, ACM can be rendered friable and become aerosolized. Friable asbestos is a chronic (long-term) health hazard, but will not produce acute (short-term) health effects (e.g., headaches) typically associated with buildings believed to have indoor air quality problems. Where asbestos-containing materials are found damaged, these materials should be removed or remediated in a manner consistent with Massachusetts asbestos remediation laws (MDLI, 1993). At the time of the assessment, BEH/IAQ staff strongly recommended that this material be encapsulated by a licensed asbestos remediation firm or other qualified personnel as soon as possible.

Exposed insulation material around pipes in HVAC mechanical room

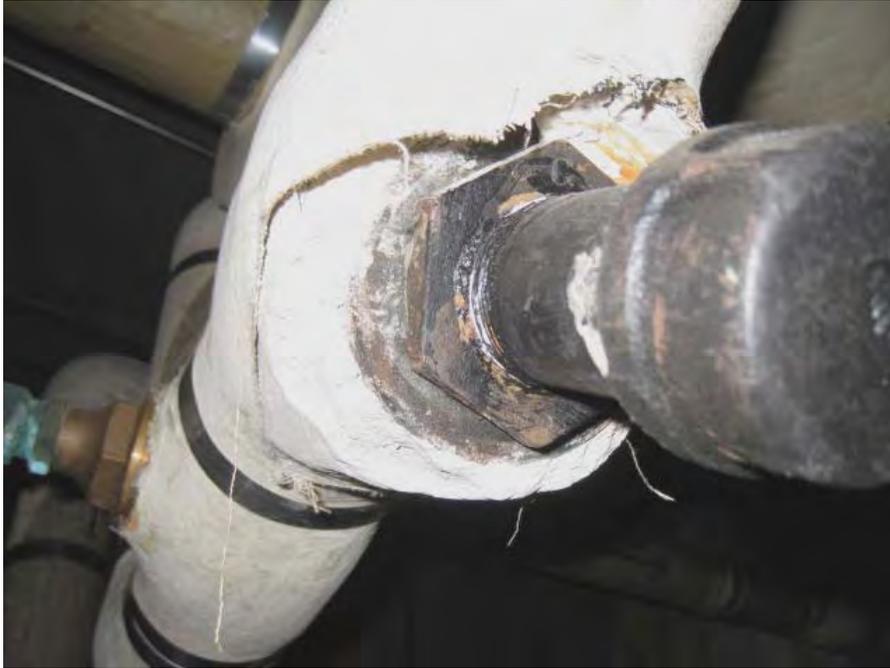
Picture 23

Exposed insulation material around pipes in HVAC mechanical room

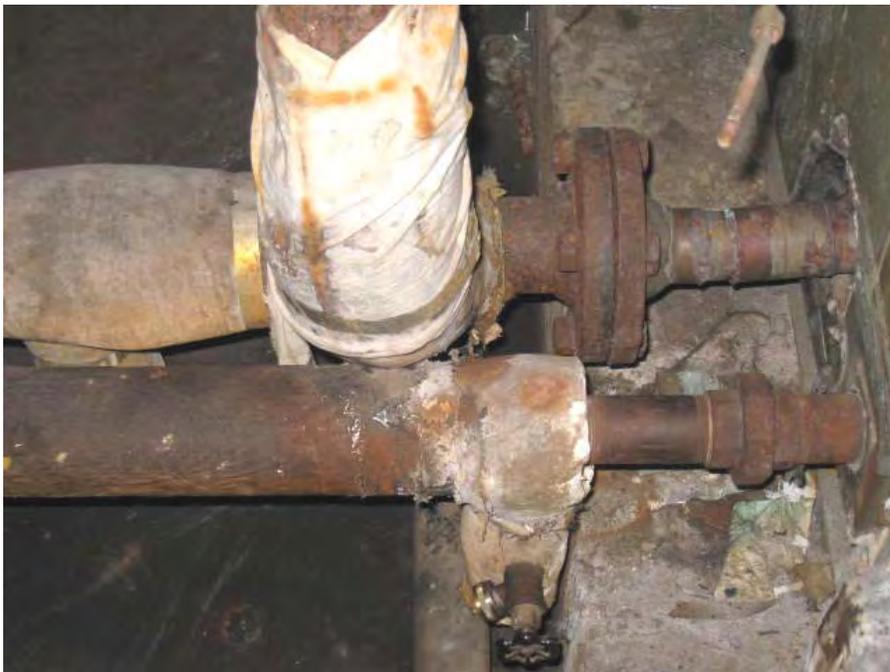
Picture 24

Exposed insulation material around pipes in HVAC mechanical room

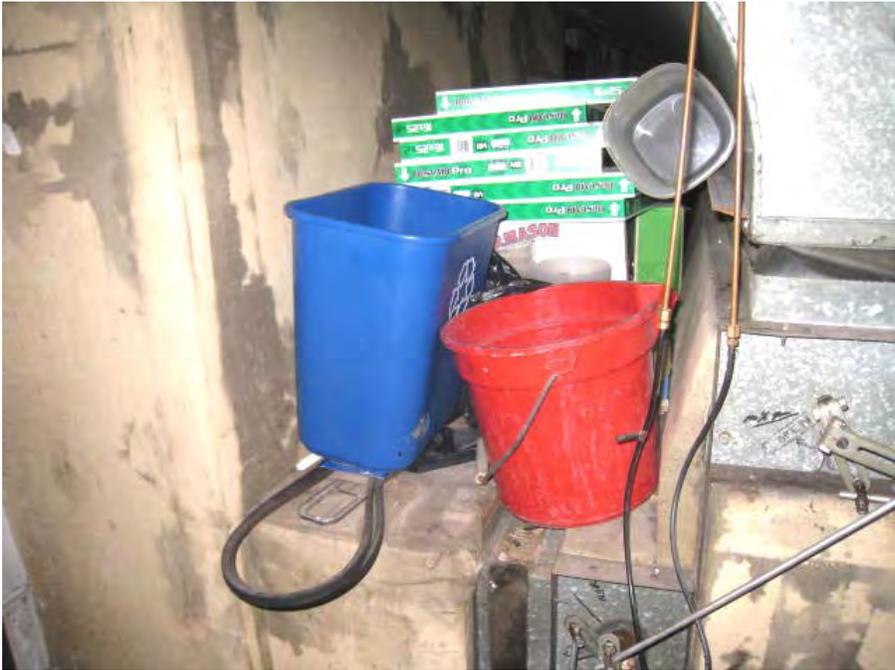
Picture 25

Various items stored on top of AHU/ductwork in mechanical room
