INDOOR AIR QUALITY REASSESSMENT

**Massachusetts Registry of Motor Vehicles
165 Liberty Street
Springfield, Massachusetts**

Prepared by:
Massachusetts Department of Public Health
Bureau of Environmental Health
Indoor Air Quality Program
May 2013

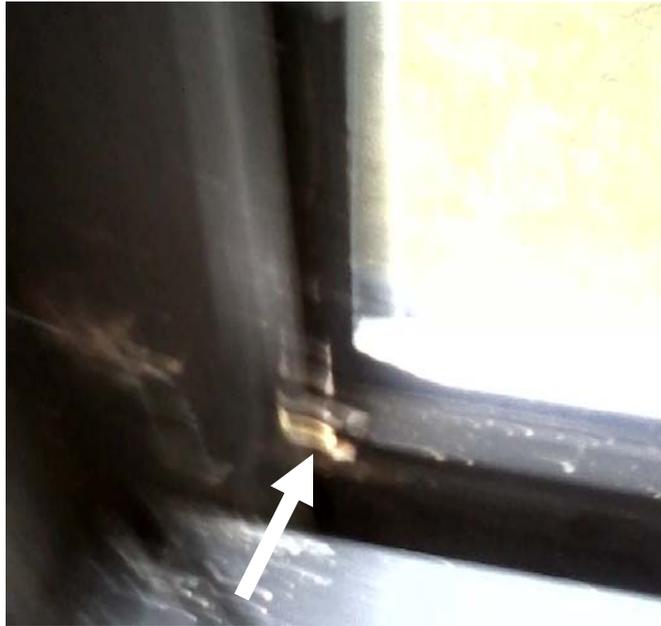
Picture 1

It is believed that the RMV building may have been subjected to stress and damage on November 23, 2013, when a gas explosion leveled a building at 453 Worthington Street, located about 1000 feet to the south (Figure 1; Walsh, 2012). According to RMV officials, doors were blown open throughout the RMV from the blast. After examining the building, BEH/IAQ staff believe the window system was damaged by the explosion pressure and shock waves from the gas explosion, resulting in water leaks/envelope breaches in areas not seen during the April 2012 visit. As an example, the seam of the window system in the area where the RACE office is located has opened (Picture 1). BEH/IAQ staff could see through this opening to the outdoors. In addition, original window panels on the ground floor had been replaced with plywood (Picture 2), and gaskets for the lower level window system were either detached (Picture 3) or were failing as evidenced by sliding panels (Picture 4).

**Open seam of the window system in the RACE office
(arrow indicates opening)**

1. The exterior window system should be examined for water leakage and damage. A building engineer should be consulted regarding the integrity of the window system and to provide guidance regarding the reparability of the existing windows systems, including the plywood replacement panels.
2. Consult with a building engineer concerning reparability of the roof. If not feasible, roof replacement would be necessary.
3. Once repairs are made, replace water-damaged ceiling tiles. Remove and discard any other porous water-damaged materials inside the building.
4. Continue to operate the ventilation system during business hours on the upper and lower levels of the building. Repair all supply and exhaust equipment as needed to improve ventilation and reduce noise.

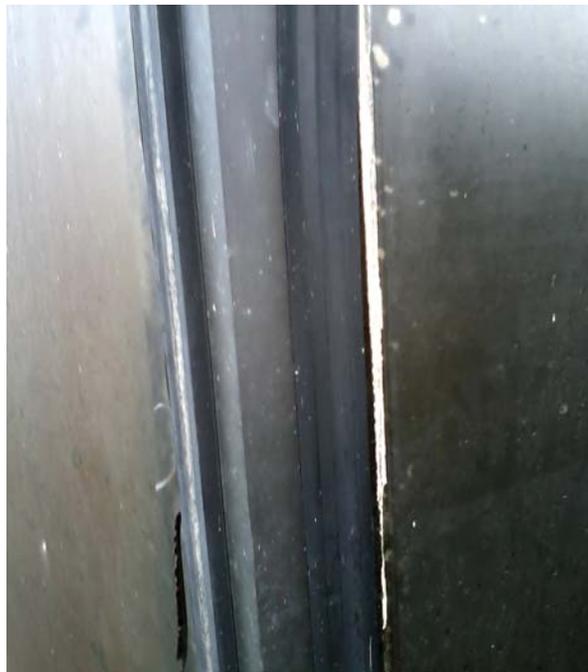
Picture 2

Plywood replacement panel

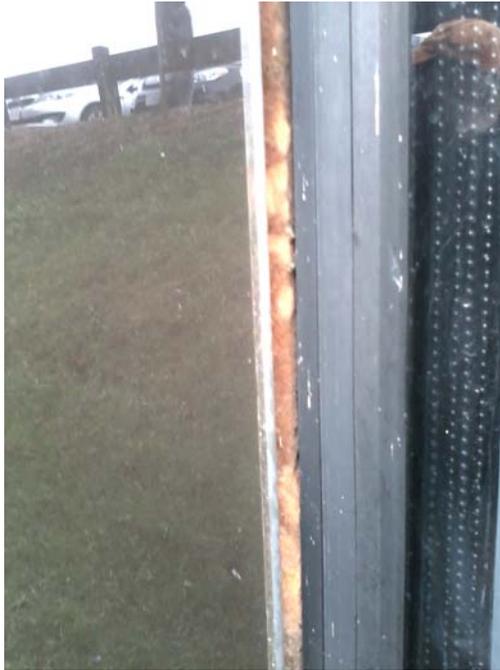
Picture 3

Detached gasket on window

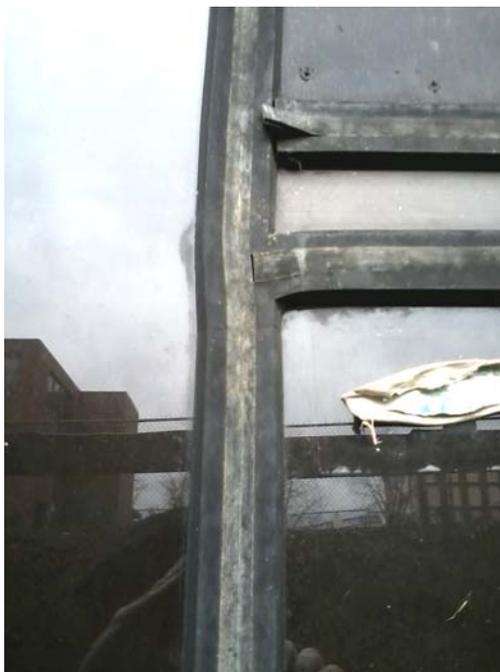
Picture 4

Sliding window panel

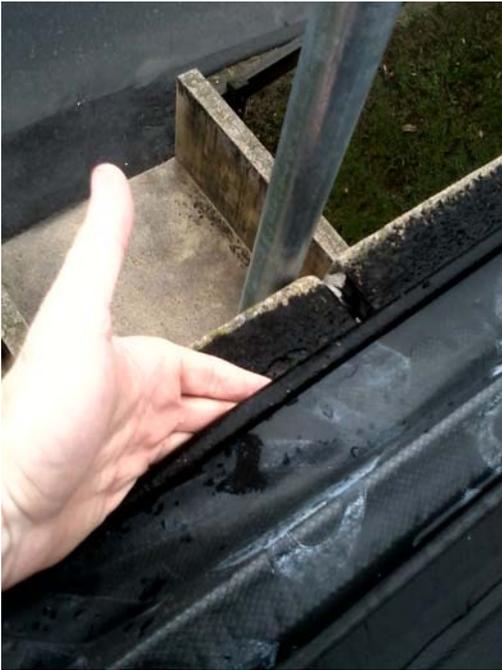
Picture 5

examined the roof and found a large section of roof membrane that was detached from the building edge (Picture 5), which may be responsible for the observed leaks.

Detached roof membrane

Repairs to this building will need to include the roof and window systems. Water-damaged ceiling tiles, wallpaper and other porous materials can provide a source of mold and should be replaced after a water leak is discovered and repaired. The US Environmental Protection Agency (US EPA) and the American Conference of Governmental Industrial Hygienists (ACGIH) recommend that porous materials be dried with fans and heating within 24 to 48 hours of becoming wet (US EPA, 2001; ACGIH, 1989). If not dried within this time frame, mold growth may occur. Once mold has colonized porous materials, they are difficult to clean and should be removed.
