INDOOR AIR QUALITY PREOCCUPANCY ASSESSMENT

**Central Elementary School
New Stoneham Middle School Construction Project
36 Pomeworth Street
Stoneham, Massachusetts**

Prepared by:
Massachusetts Department of Public Health
Bureau of Environmental Health
Indoor Air Quality Program
October 2013

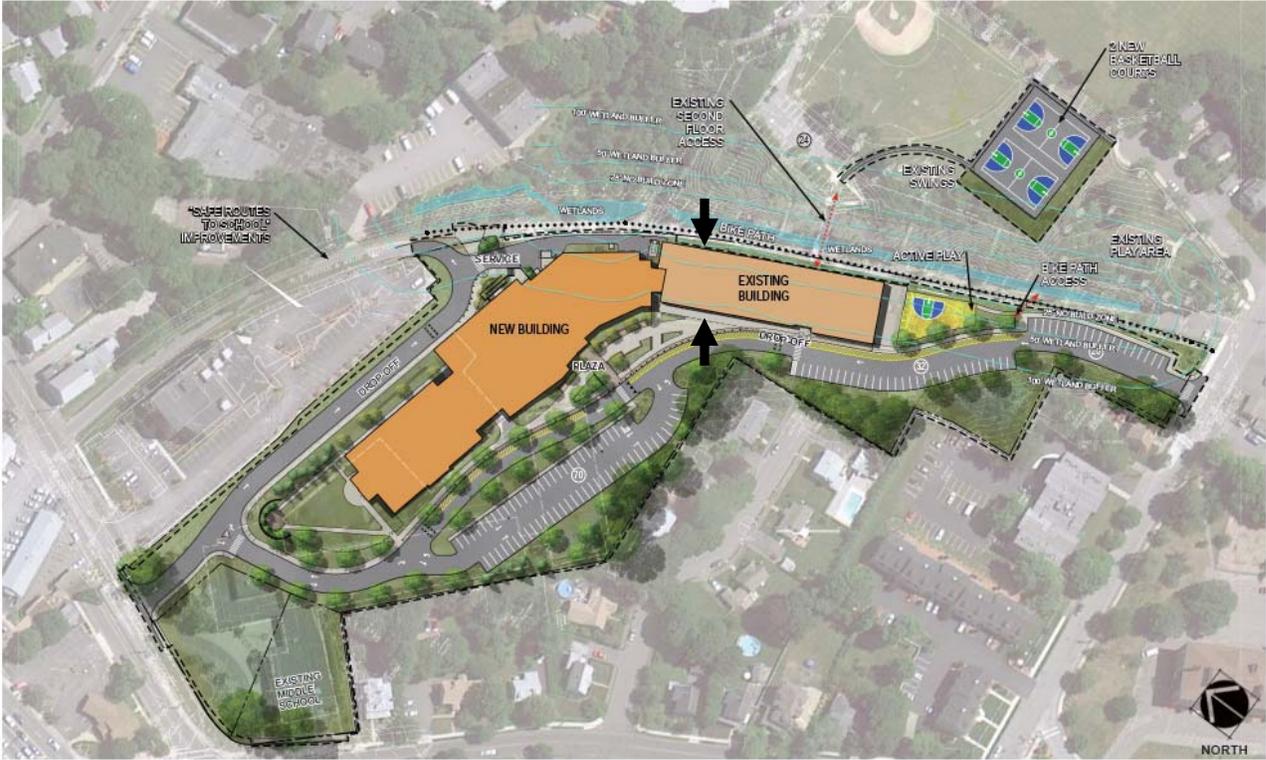
Figure 1
Site Plan of the New Stoneham Middle School Construction/Renovation Project
 (Arrows indicate the position of univent fresh air intakes)

The CES is a three-story school building that was originally completed in 2002. The current building/renovation project involves the construction of a large addition on the west side of the CES (Figure 1), which will connect the existing Middle School to the CES forming one

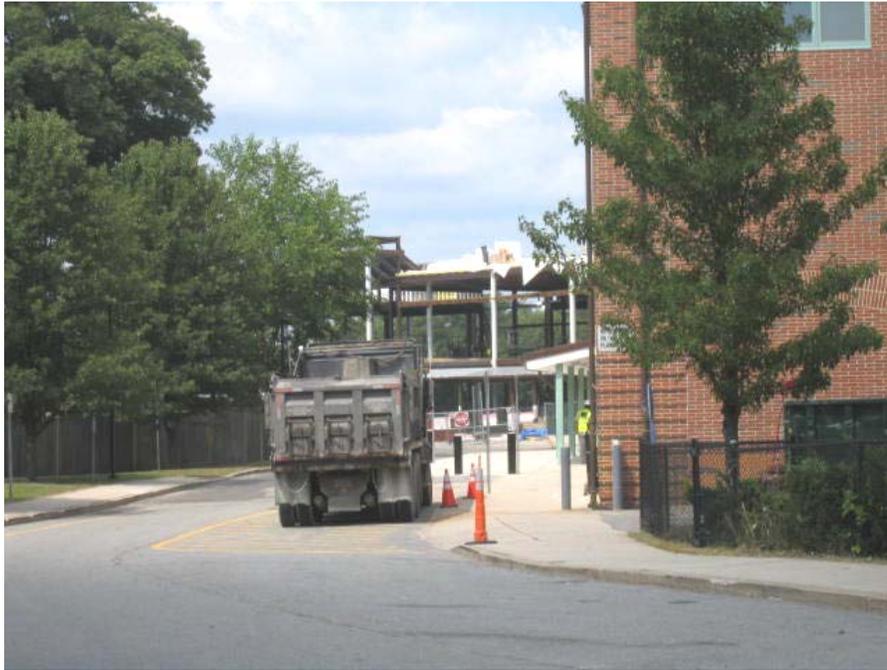
Picture 1

View of Central Elementary School showing construction zone next to existing building

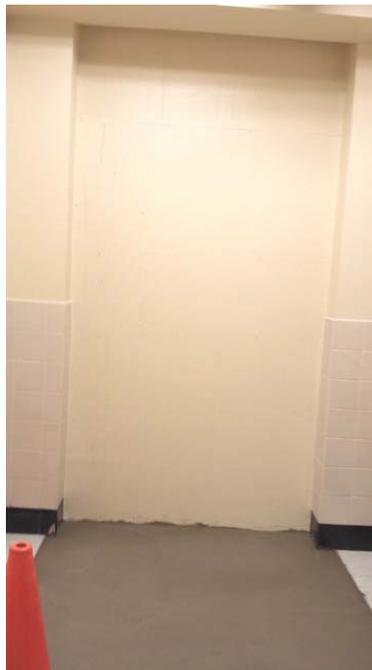
Picture 2

BEH/IAQ staff inspected areas that had containment barriers installed between the construction areas and areas to be occupied. Since the previous visit, a barrier composed of plywood and other construction materials had been erected at the western end of the first floor hallway where a door had originally existed, leading to the construction area. This barrier appeared solid, had been painted over, and no light/drafts could be seen/detected around it (Picture 2). Windows in upper floor hallways on the same side of the building had similarly-installed painted plywood barriers, which also appeared to be tightly constructed (Picture 3).

Constructed barrier at location of former door

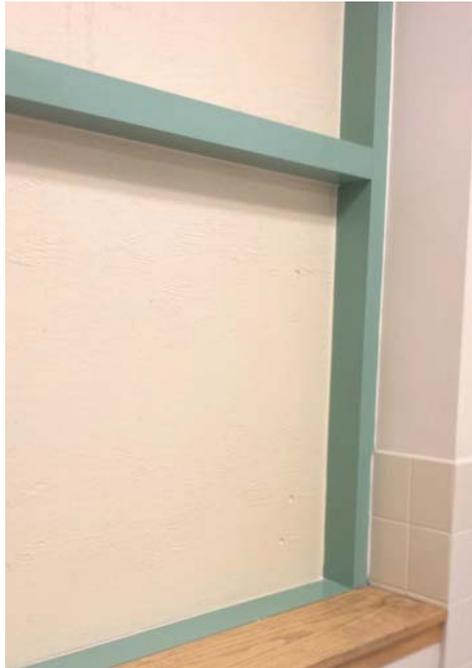
Picture 3

Constructed barrier at location of former hallway window

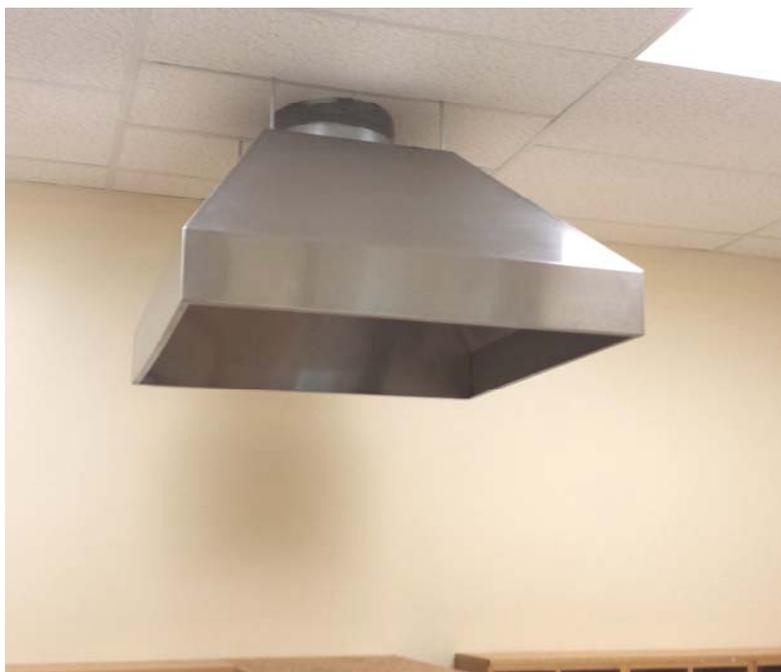
Picture 4

Other remodeling had also occurred in rooms abutting the construction zone to protect these areas and allow for connection to the new wing when the construction is complete. These renovations also included installation of an exhaust hood (Picture 4) to be used when a kiln is

New hood for planned kiln, not to be used this school year

installed in the room. This hood should be completely sealed until it is needed to eliminate it as a pathway for contaminants into the building.

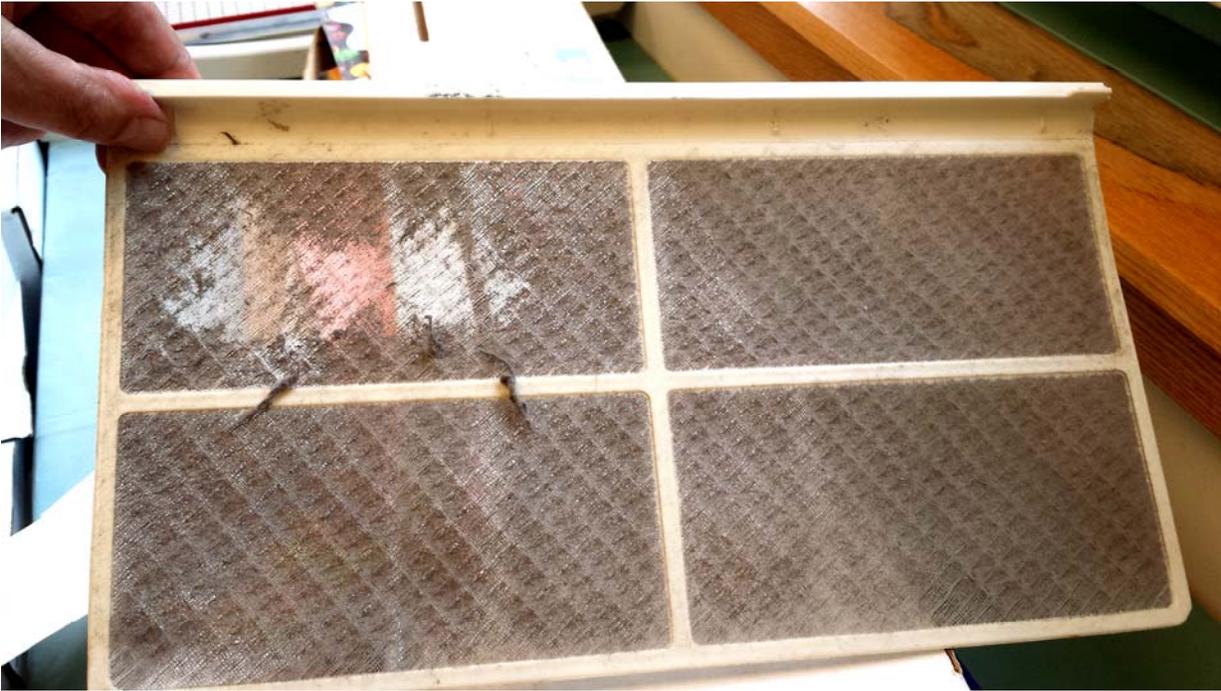
Picture 5

Dirty filter from window air conditioner

- **Consider changing HVAC filters more regularly in areas impacted by construction/renovation activities, including the rooftop AHU as needed.**
- **Action:** This is reportedly being done. More attention is needed for portable air conditioner filters.

1. Continue to follow recommendations made in the previous report for both construction and occupied operations.
2. Ensure that items are cleaned prior to occupancy, including floors, stored furniture, classroom items and window AC filters. Increase cleaning as needed to control construction-related dusts and debris.
