MOLD ASSESSMENT

**Sutton Memorial High School
383 Boston Road
Sutton, Massachusetts**

Prepared by:
Massachusetts Department of Public Health
Bureau of Environmental Health
Indoor Air Quality Program
September 2013

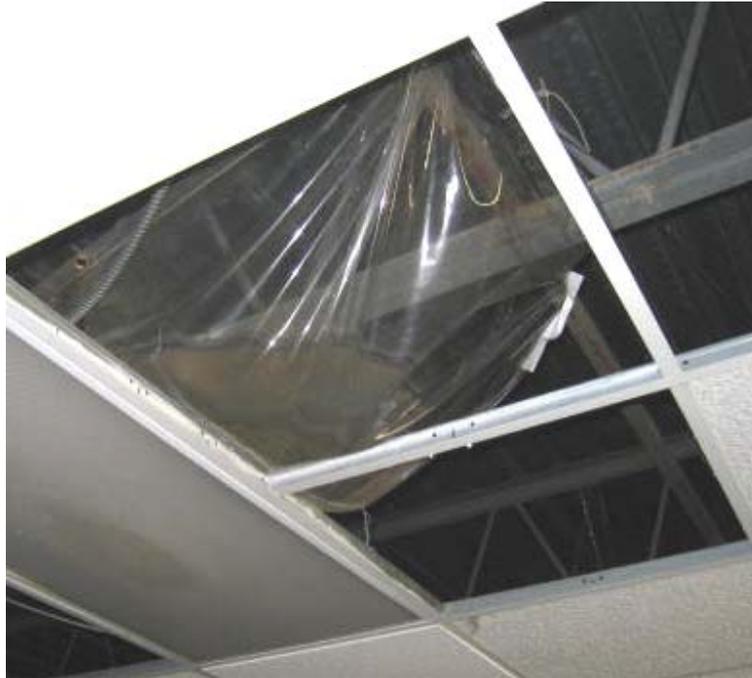
Picture 1

BEH/IAQ staff conducted a visual inspection of the building and found water-damaged ceiling tiles on the top floors of the building complex. As reported by school officials, these water-damaged ceiling tiles are attributed to a failed roof membrane. In room 205, a plastic

collection device installed above the ceiling was found to have accumulated significant water and had a musty odor (Picture 1).

Plastic with water accumulation in room 205

2. Remove all water-damaged ceiling tiles. Replace if needed.
3. Ensure that all drains in disused sinks are sealed and the water service is turned off.

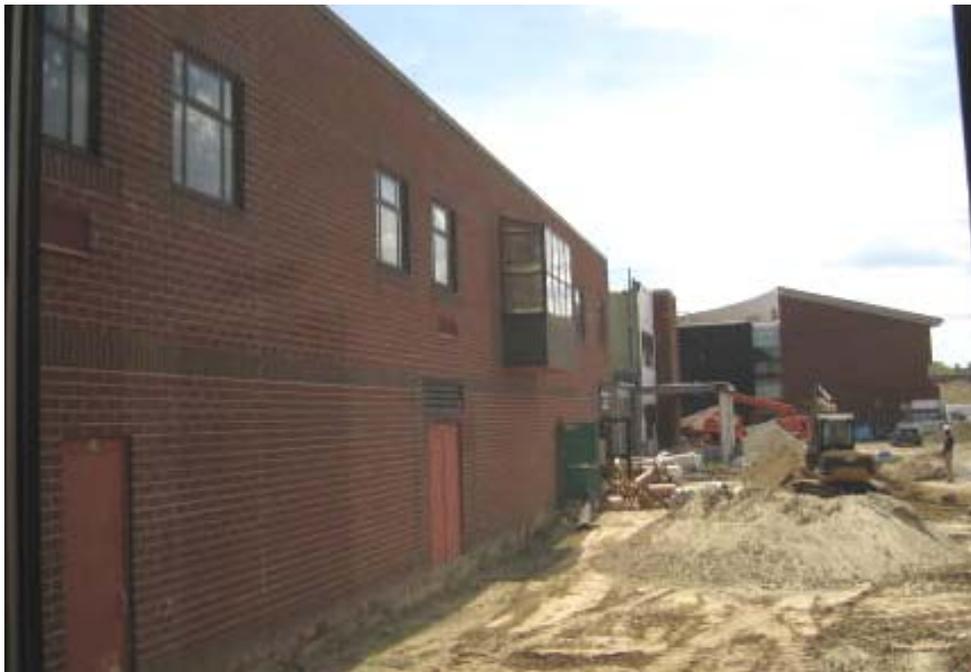
Picture 2

A number of science classrooms have abandoned sinks. If the drains are not properly sealed, they can serve as a source of water vapor and sewer gas odors in the building. Along the west exterior wall of the building, unit ventilator (univent) fresh air intakes are located within the construction zone for the new school (Picture 2). Unless the univents are properly shielded and have adequate filtration, airborne pollutants from the construction project may be entrained when these univents are activated.

Univent fresh air supply vents (along exterior wall) in construction zone

4. Take appropriate measures to shield univent fresh air intakes for construction impact. Monitor and replace filters regularly. Set up a notification system for room occupants to reports construction odor/debris entrainment in classrooms.
